Homescape Inspections
826 Orange Ave, Suite 400
San Diego, CA 92118
(619)865-1084

Report #: LAW 01-30-26 Inspector: Kevin Brenden

Dwelling Address: 7087 Camino Degrazia #141
San Diego, CA 92111

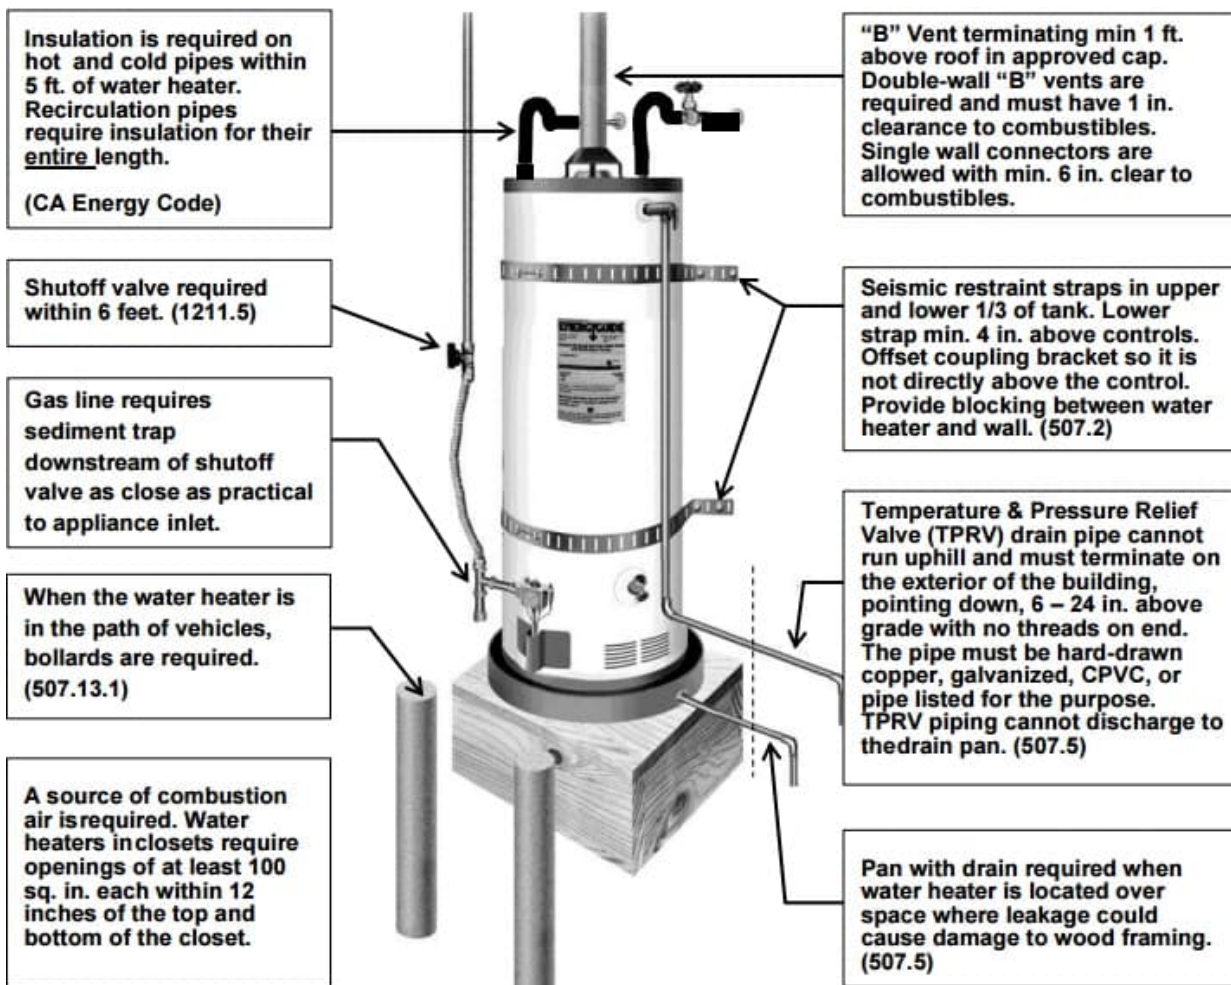
27

Upgrade Recommended. Location:+Exterior Closet; Type:+Conventional Natural Gas; Capacity:+40 gal.; Water shut off installed:+Yes; TPR valve installed:+Yes; TPR discharge pipe properly installed:+Yes; Vent flue piping:+Appears Serviceable; Combustion air:+appears serviceable; Seismic straps:+Appears Serviceable. **Recommend further evaluation and repairs by a qualified professional (Licensed Plumber). (2)**

Hot water heater gas line is not equipped with sediment trap. Upgrade - A sediment trap or drip leg was not installed before the gas appliance shutoff valve. This is a simple pipe assembly made of a tee and nipple that catches moisture and debris in the gas. Debris can clog the gas valve causing the appliance to malfunction. This device is required by all manufactures of water heaters and furnaces or any gas appliance that has automatic ignition. Present on the furnace, missing on the water heater(s)Recommend installation by qualified contractor. (2)

Inspector tested water temp utilizing FLIR Infrared camera and water temp tested at 124 degrees Fahrenheit which is within the safe operating temperature to prevent scalding. Recommended setting to prevent scalding is at 120 degrees or less.

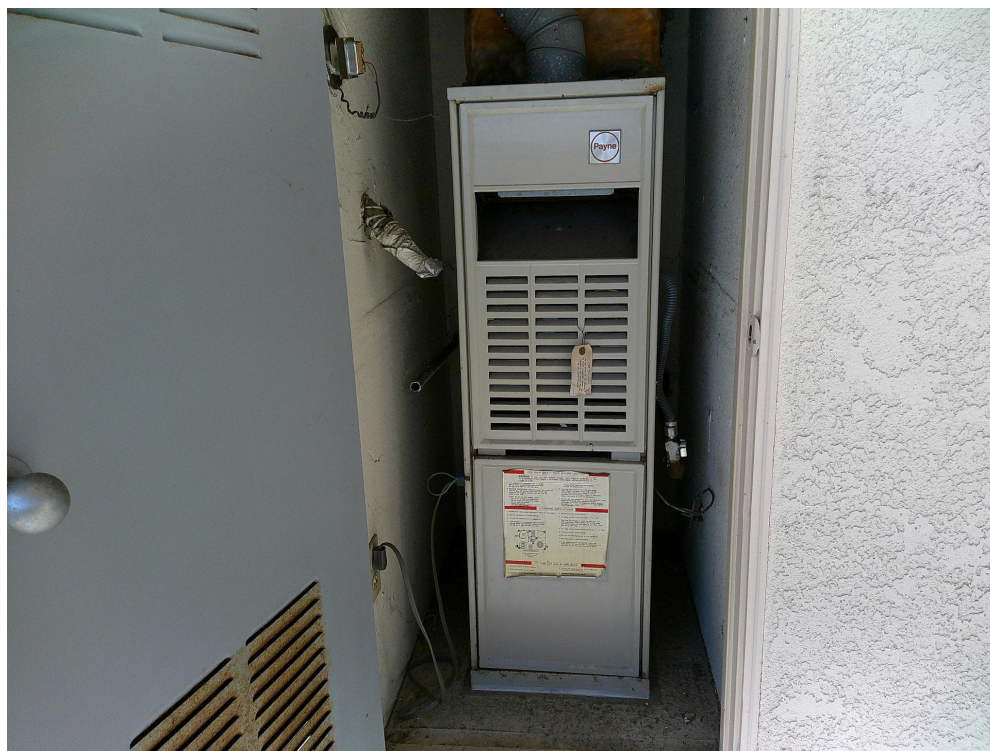
29

Repairs Recommended. Flexible gas tubing has been installed through the appliance exterior housing. Per Mfr Installation Instructions and current building codes this installation is not permitted and is considered a safety hazard. Recommend repairs be completed by qualified professional contractor by installing rigid gas piping through appliance housing to gas valve in appliance.(2)(5)

**Furnace gas line is not equipped with sediment trap. Upgrade - A sediment trap or drip leg was not installed before the gas appliance shutoff valve. This is a simple pipe assembly made of a tee and nipple that catches moisture and debris in the gas. Debris can clog the gas valve causing the appliance to malfunction. This device is required by all manufactures of water heaters and furnaces or any gas appliance that has automatic ignition. Recommend installation by qualified contractor.
(2)**

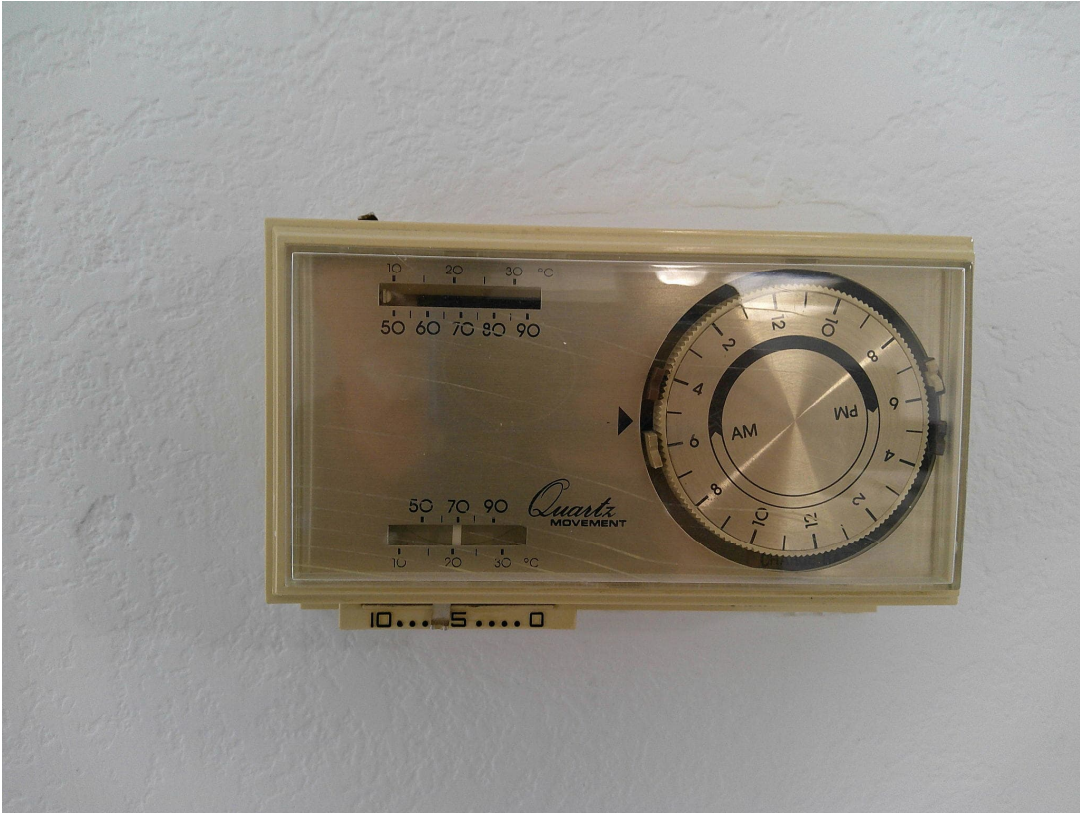
Step #	Component	Comments
34	Normal Controls	Upgrade Recommended. Inspector recommends installation of programable thermostat. Programable thermostats allow you to set the time that occupant wants the furnace/AC to activate and proper temperature while the home is occupied. This allows for greater energy efficiency by heating/cooling the home when occupied only. *

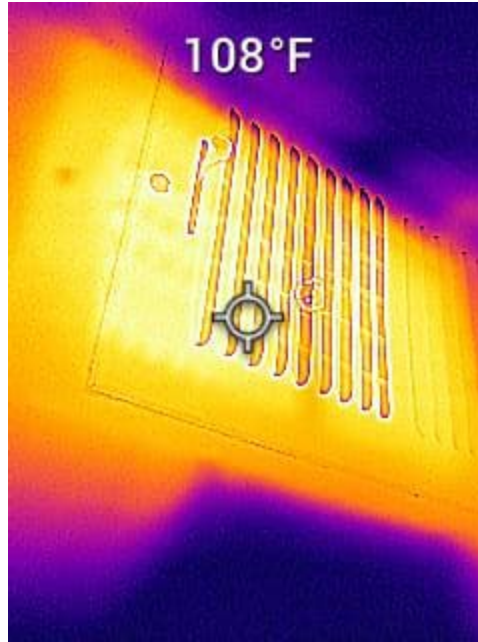
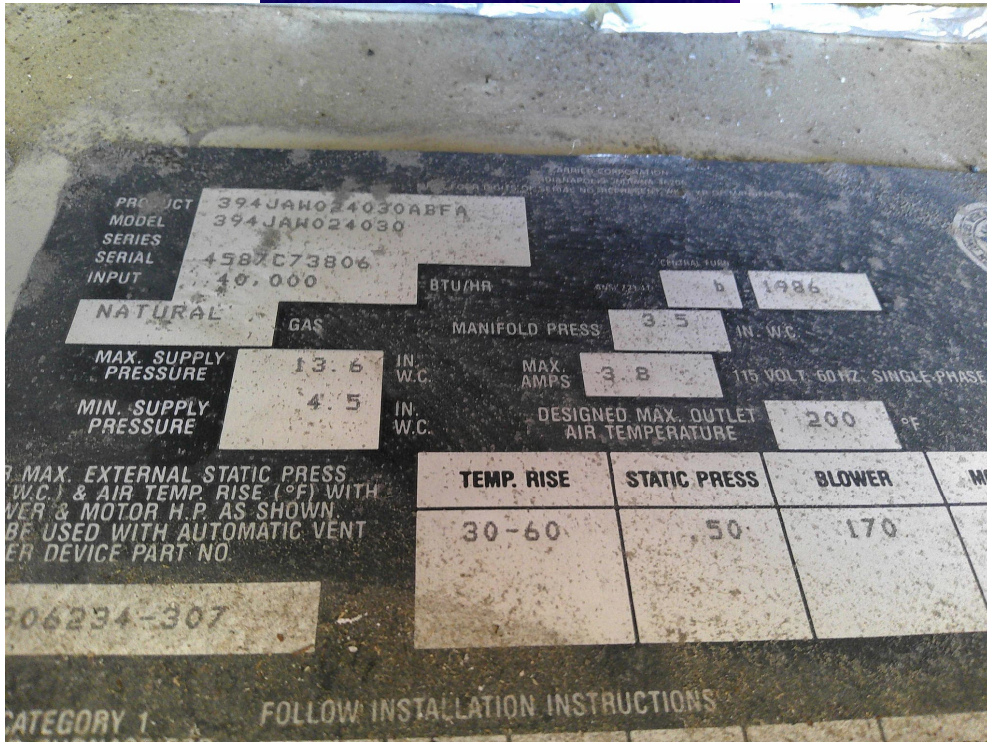
36 Heating Notes **Upgrade Recommended. The furnaces is more than 20 years old. Most heating contractors consider units over 20 years old to be at the end of their life span. Since Southern California has a mild climate, furnaces can last longer than the industry standards. We advise consulting with a heating contractor to review the system for an estimate of life remaining, and the cost of replacement prior to the end of your contingency period. We also recommend having SDG&E or a heating contractor perform an annual safety test each season before use. Note: We specifically disclaim cracks in furnace heat exchangers because proper evaluation requires invasive, technically exhaustive measures that exceed the scope of the General Home Inspection.**

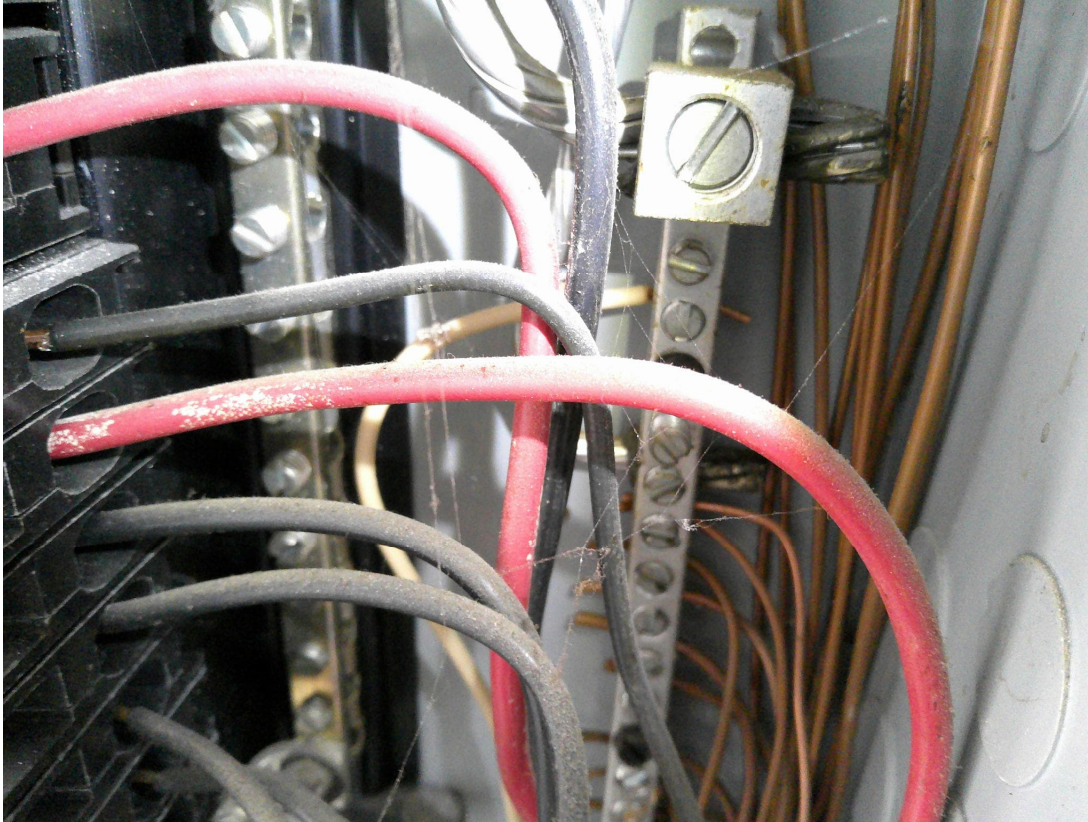
43 Panel Notes **Repairs Recommended. Overcurrent protection devices inspected - type: +Breakers. Recommend further evaluation and repairs by a qualified professional (Licensed Electrician). (2) (4)**

Though the neutral does not have significant voltage, it does carry current. In a 2-wire circuit, the neutral carries just as much current as the hot conductor. If the neutral and ground are connected in a sub-panel, that current will travel on other paths, such as bare ground wires, equipment enclosures, and metal piping systems, on its way back to the service panel. One problem created by this condition is possible shock hazards, the severity of which depends on the locations of the equipment and the person touching the enclosure or piping system. Another problem is magnetic fields that do not cancel themselves out. Since the return current has multiple paths, the current remaining in the neutral will not counterbalance the current in the hot wire. The resulting imbalance creates a magnetic field that can interfere with sensitive electronic equipment. In a metal conduit system, the imbalance will induce current into the conduit, which could cause the conduit to overheat.*

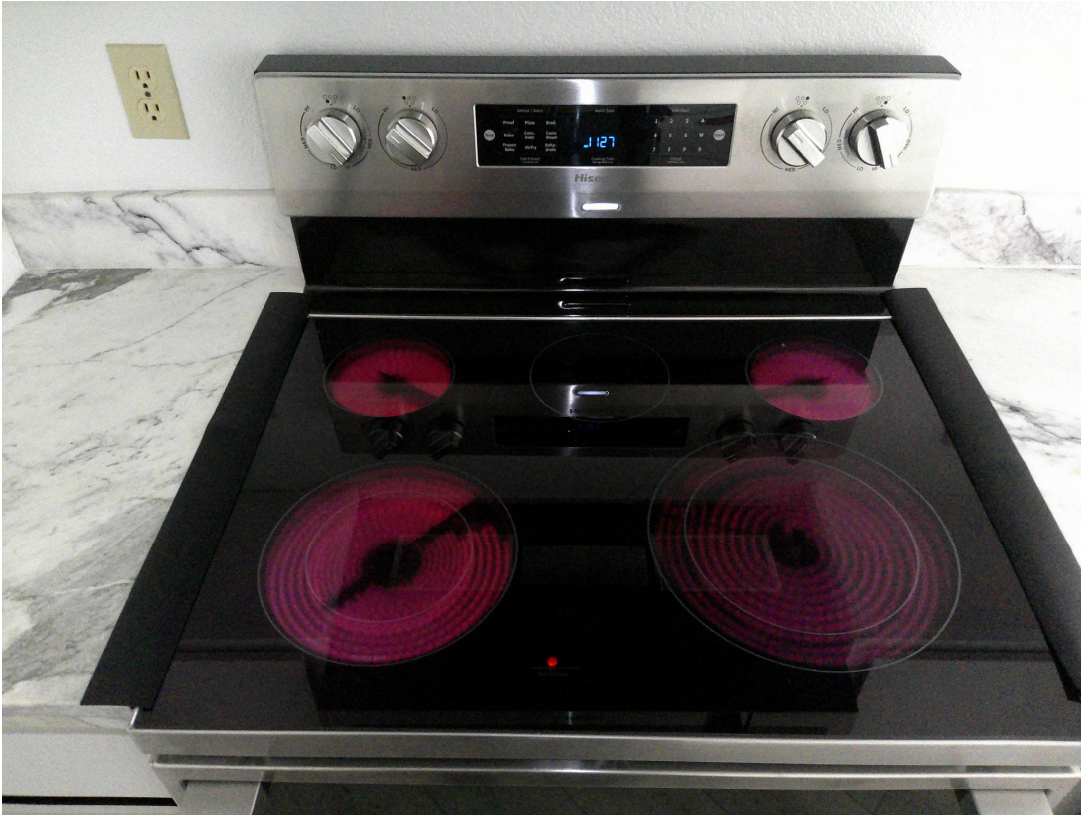
69

Safety Hazard. Number of ovens:+1; Fuel type:+electric; Oven door appears serviceable; Ventilation hood:+appears serviceable; Ventilation fan filter:+appears serviceable. Recommend further evaluation and repairs by a qualified professional.

The anti-tip leg assembly on the range is not operational, creating a tip hazard. (2) (4)

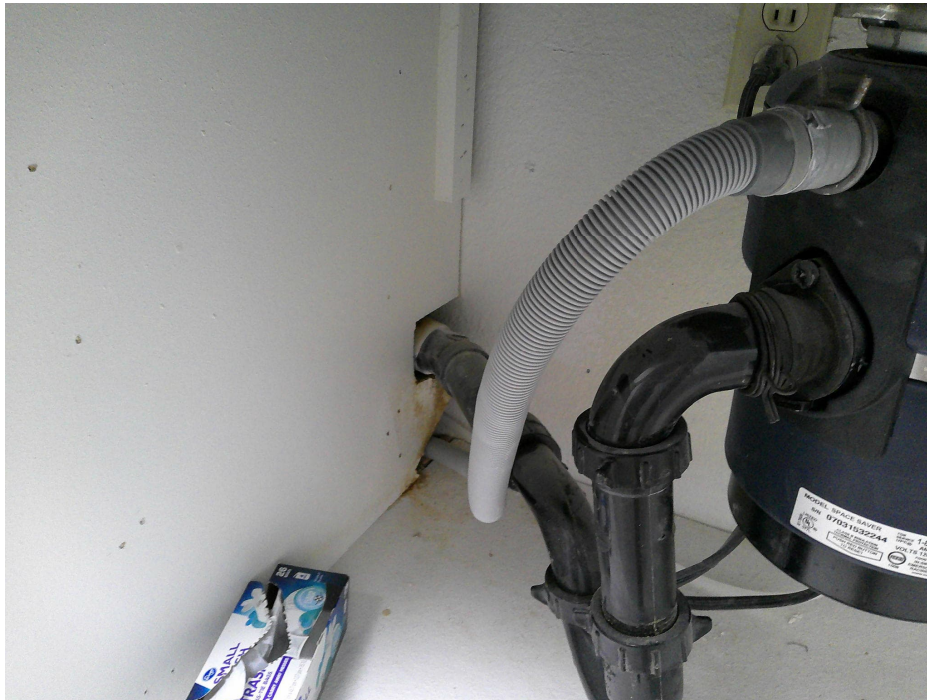
70

Repairs Recommended. Door seal:+appears serviceable; Drain line installed:+improperly (2) (3). Recommend further evaluation and repairs by a qualified professional.

No High-Loop/Air Gap: A high loop or air gap is required at the DW drain line. The presence or absence of a high-loop could not be confirmed as none was observed in the cabinet. Some dishwashers have a built in high loop. Removing the DW to determine proper installation is beyond the scope of a general home inspection. Client is advised to confirm the appropriate installation of the DW drain line. *(2)

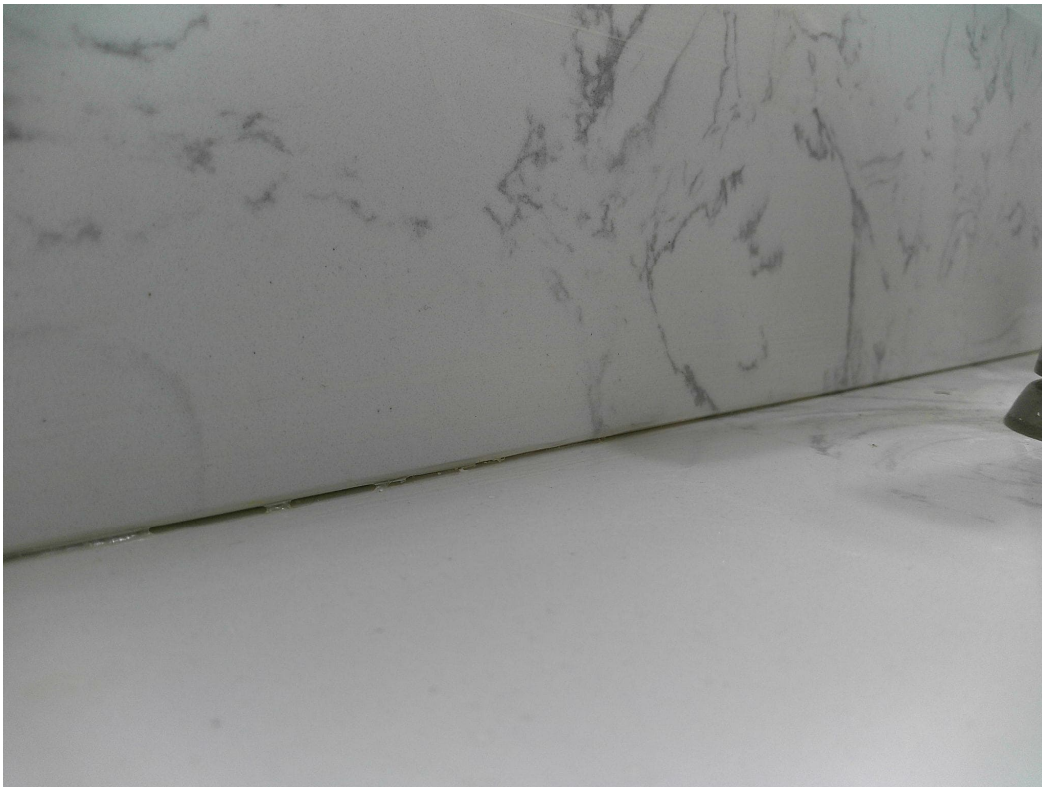
73.2a Sink #2

Repairs Recommended. Faucet appears serviceable; Cabinet is:+appears serviceable. Recommend further evaluation by a qualified professional (Licensed Plumber). (2)

Improper piping at the bathroom sink(s) drain. (2)
