## USA Home Inspectors

## Home Inspection Report

**782 W Renette Ave**

Inspected On: Wed, Feb 25 2026 at 9:00AM

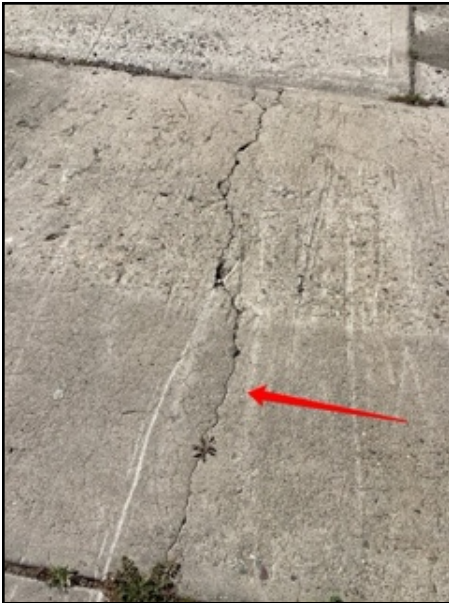
Figure 5-1

**Comment 5:**  
Cracks, stains and uneven surfaces noted at driveway, walkways and patio.

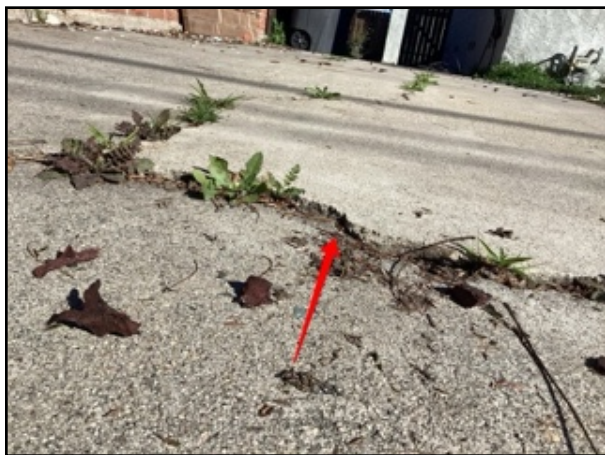
Figure 6-1

REPAIR OR REPLACE: Lifted concrete and holes in concrete noted in various places in driveway/walkway. This is a possible trip hazard.

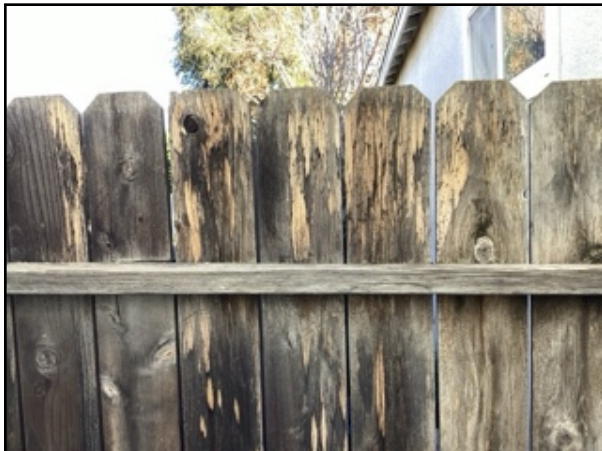
Figure 7-1

REPAIR OR REPLACE: Earth-to-wood contact, corroded hardware, loose and leaning sections, warped boards, previous repairs, peeling/damaged paint, evidence of possible wood destroying organisms/dry rot, vegetation growing against fence and other damage noted at various locations throughout fence.

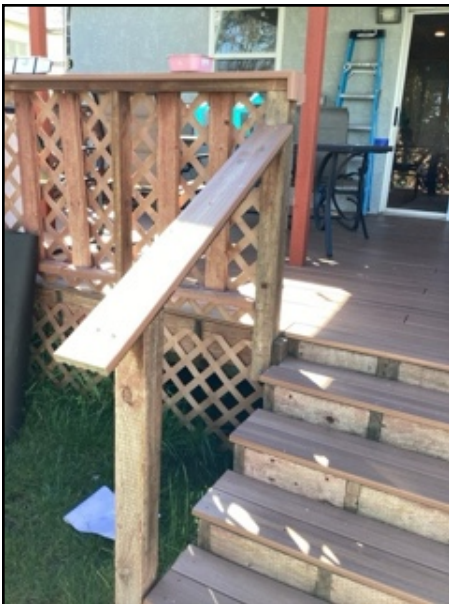
Figure 8-1

REPAIR OR REPLACE: Handrails and guardrails at back yard deck noted as loose.

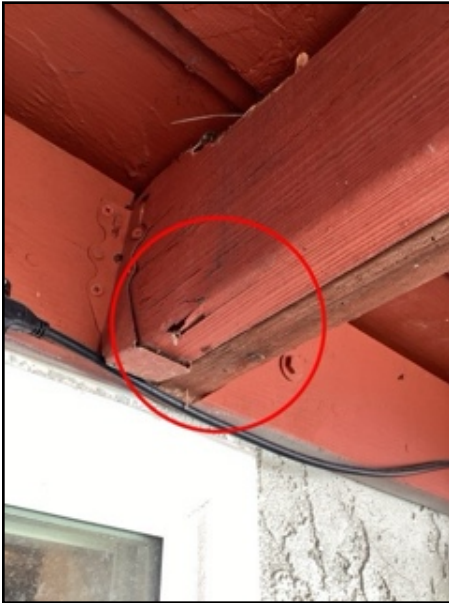
Figure 9-1

REPAIR OR REPLACE: Evidence of possible wood destroying organism/dry rot noted in various places throughout back patio cover. Previous repairs noted in various places. Support beams noted as twisted.

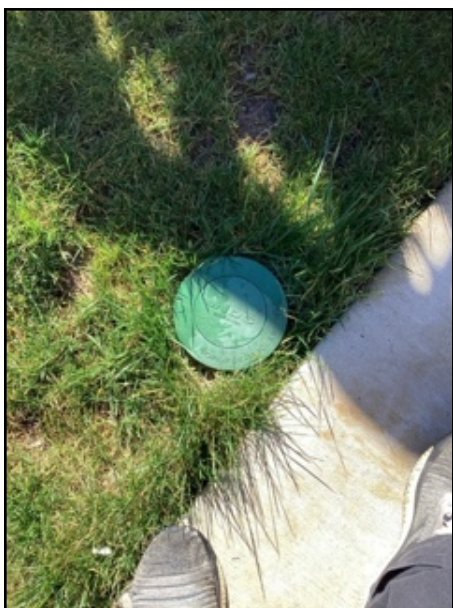
Figure 10-1

**FURTHER EVALUATION REQUIRED:** Perimeter drains noted as installed around the property. Inspector notes it is not raining at time of inspection so he's unable to validate if drainage is working properly.

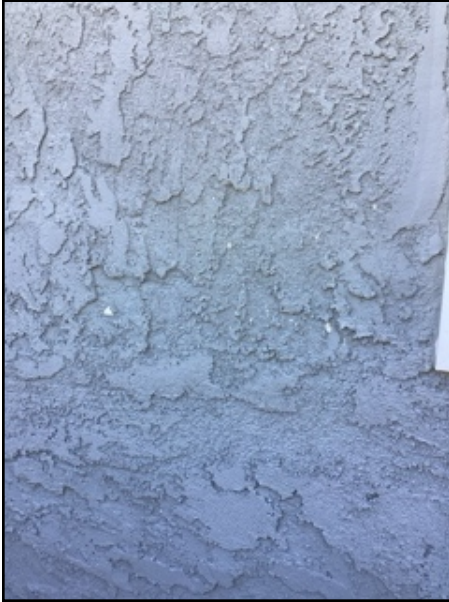
Figure 11-1

**Comment 11:**  
Defects such as peeling, holes, cracks, and patches noted at various places throughout exterior.

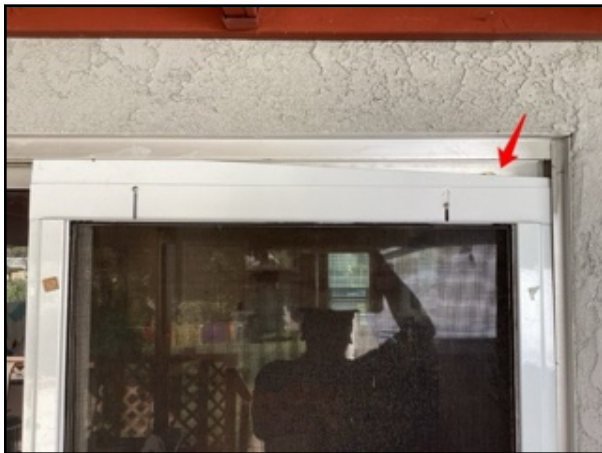
Figure 12-1

**Comment 12:**  
**REPAIR OR REPLACE:** Backyard screen door noted as damaged, and unable to stay on track.

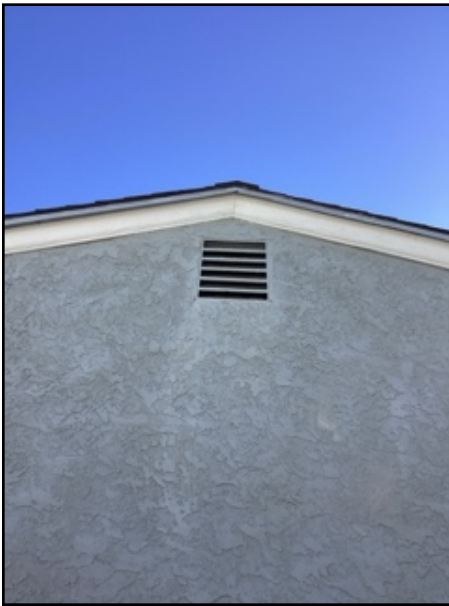
Figure 13-1

REPAIR OR REPLACE: Gable end vent screens noted as deteriorated.

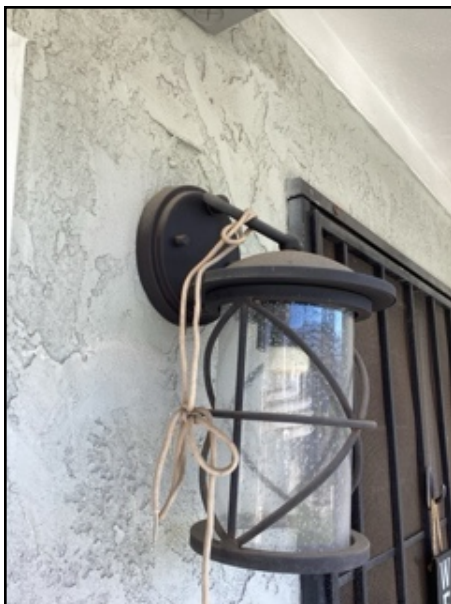
Figure 15-1

REPAIR OR REPLACE: Front door light noted as loose and not sealed at wall.

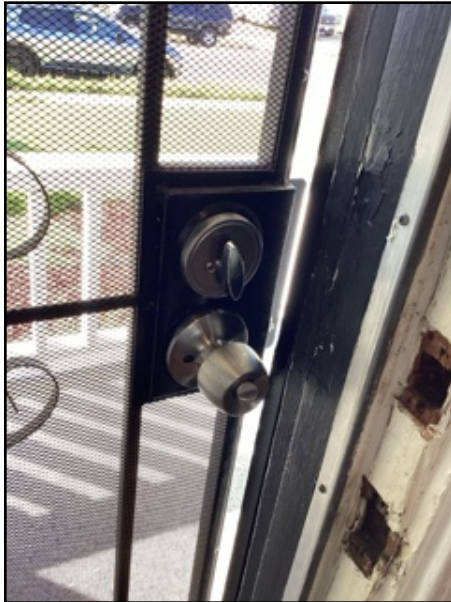
Figure 16-1

**Comment 16:**  
REPAIR OR REPLACE: Front security screen door latch noted as installed backwards, unable to stay latched.

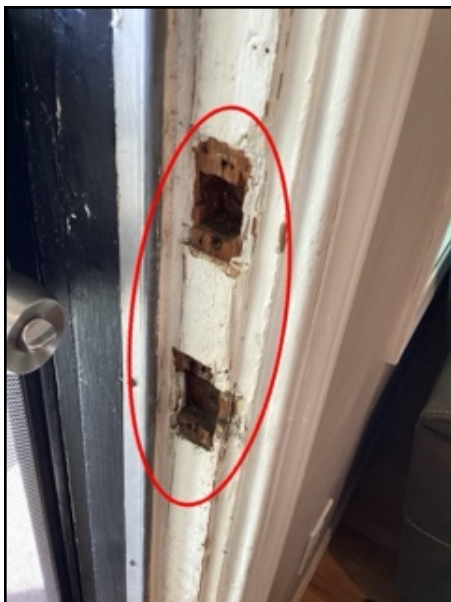
Figure 17-1

**Comment 17:**  
REPAIR OR REPLACE: Front door noted as scratched/worn, striker plates noted as missing at door frame.

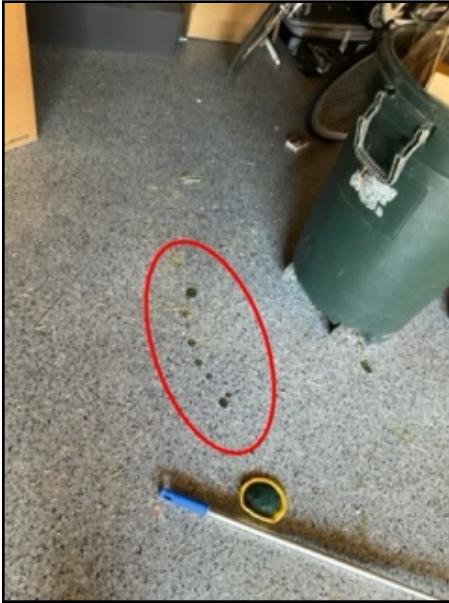
Figure 19-1

Comment 19:  
Cracks and stains noted at garage floor.

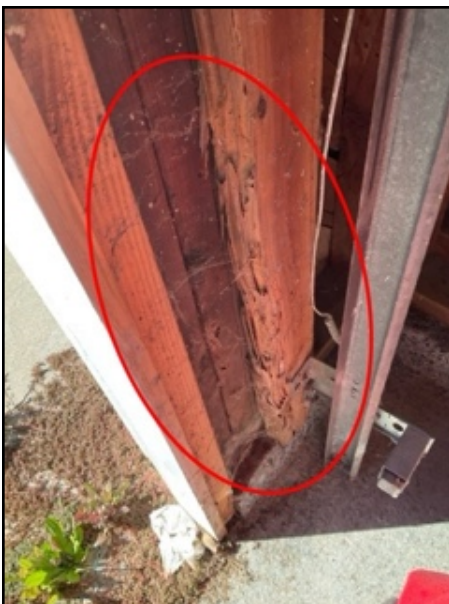
Figure 20-1

Comment 20:  
FURTHER EVALUATION REQUIRED: Evidence of possible wood destroying organisms/dry rot noted around garage trim, and framing in garage at various locations.

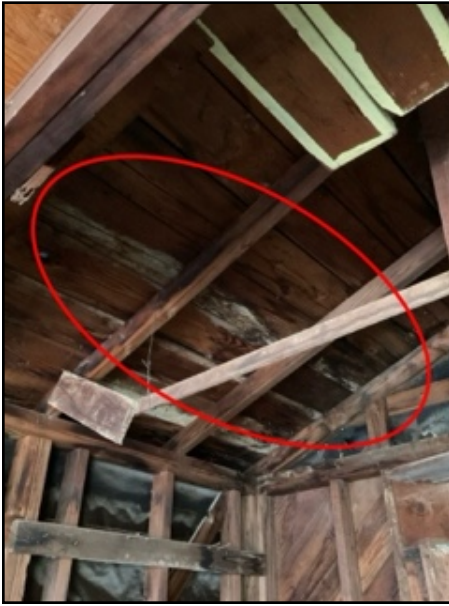
Figure 21-1

FURTHER EVALUATION REQUIRED: Water stains noted at various locations on roof sheeting in garage. Inspector notes roof is at the end of its life and is torn and missing shingles. Inspector notes it is not raining at time of inspection. Have a more qualified professional to evaluate.

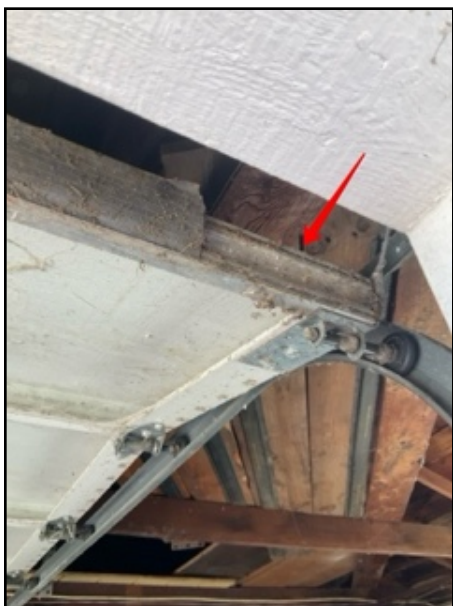
Figure 22-1

REPAIR OR REPLACE: Weatherstripping on bottom of vehicle door noted as torn.

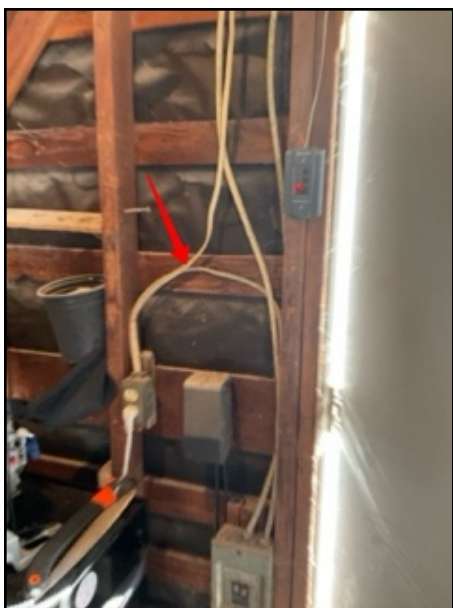
Figure 23-1

REPAIR OR REPLACE: Exposed wires in garage noted under 7 feet.

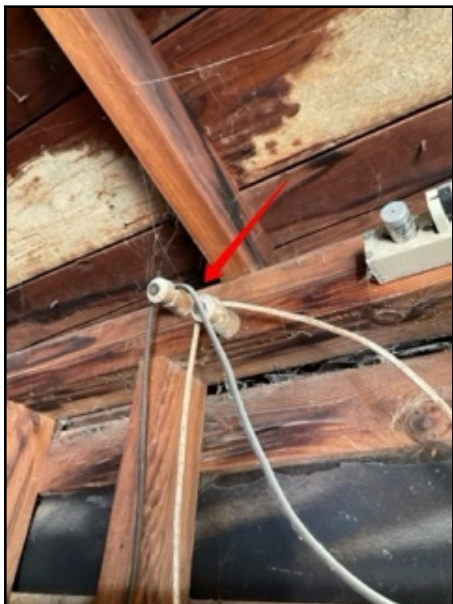
Figure 24-1

FURTHER EVALUATION REQUIRED: Active knob and tube wiring noted in garage. Have a more qualified professional to evaluate.

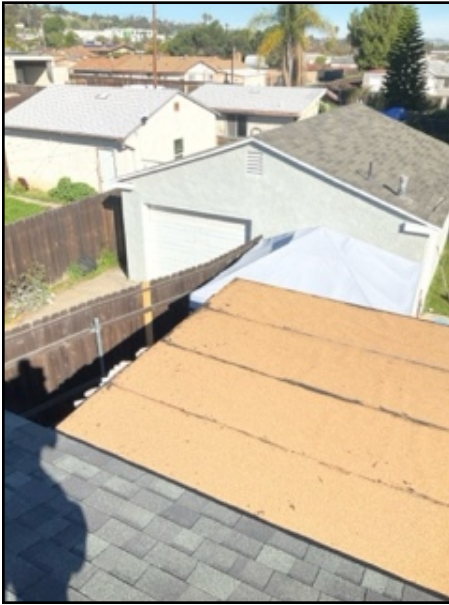
Figure 26-1

REPAIR OR REPLACE: Fiberglass noted as showing around edges of asphalt shingles on north side. Metal flashing noted as incorrectly installed over ducting. Metal flashing noted as lifting up. Rolled roofing over patio cover noted as delaminating. Previous repairs noted on patio cover. Have a more qualified professional to evaluate and repair.

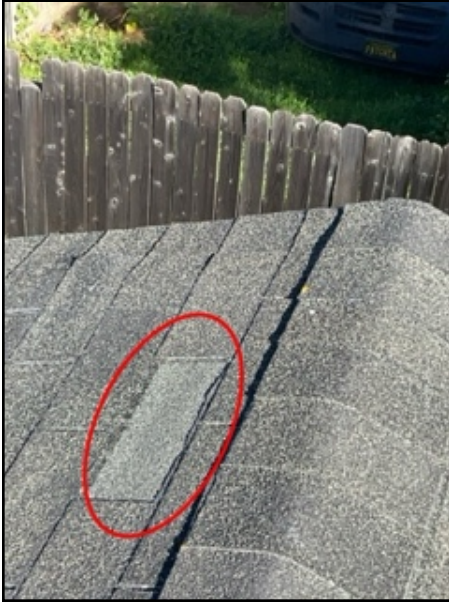
Figure 27-1

**REPAIR OR REPLACE:** Asphalt shingles over roof at garage noted as torn and deteriorated. Multiple shingles noted as missing. Asphalt granular loss noted on shingles. Fiberglass noted as showing around edges. Asphalt shingles noted as brittle. Exposed nails noted at various locations. Have a more qualified professional to evaluate and repair.

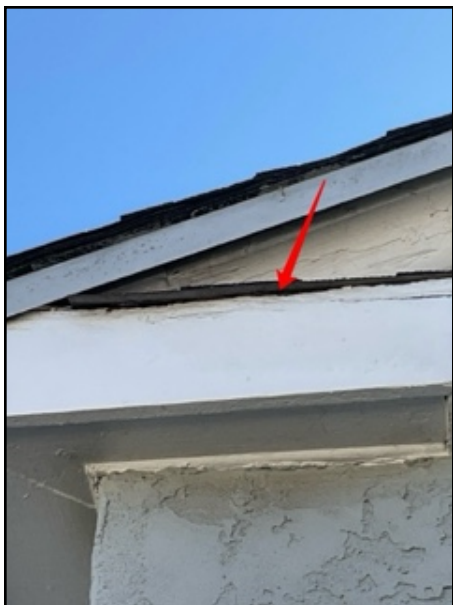
Figure 28-1

**FURTHER EVALUATION REQUIRED:** Evidence of possible wood destroying organisms/dry rot noted on soffit and/or fascia.

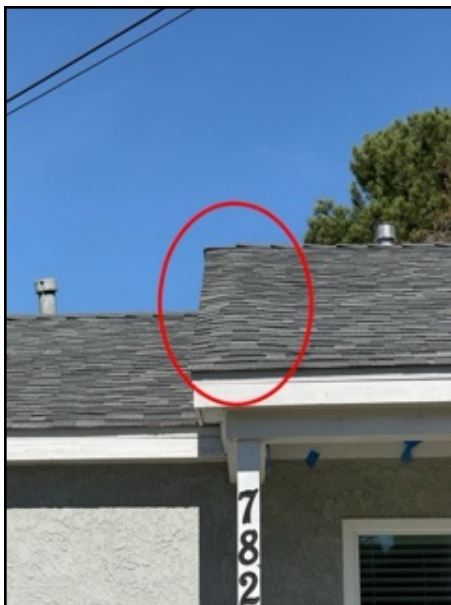
Figure 29-1

**FURTHER EVALUATION REQUIRED:** Shingles noted as lifting at the front of the house above support post.

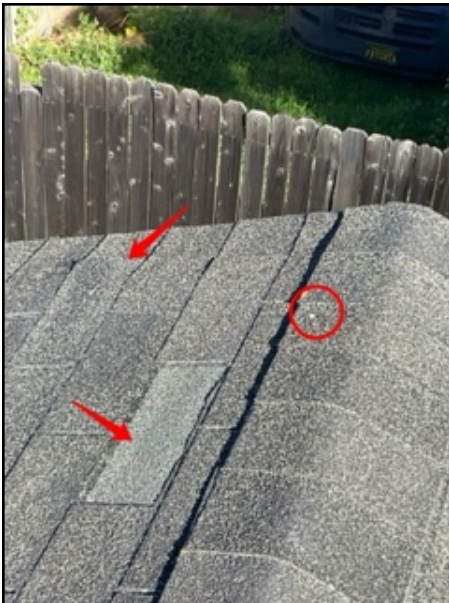
Figure 30-1

REPAIR OR REPLACE: Asphalt shingles over roof at garage noted as torn and deteriorated. Multiple shingles noted as missing. Asphalt granular loss noted on shingles. Fiberglass noted as showing around edges. Asphalt shingles noted as brittle. Exposed nails noted at various locations. Mastic around vent pipes noted as cracked and deteriorated. Have a more qualified professional to evaluate and repair.

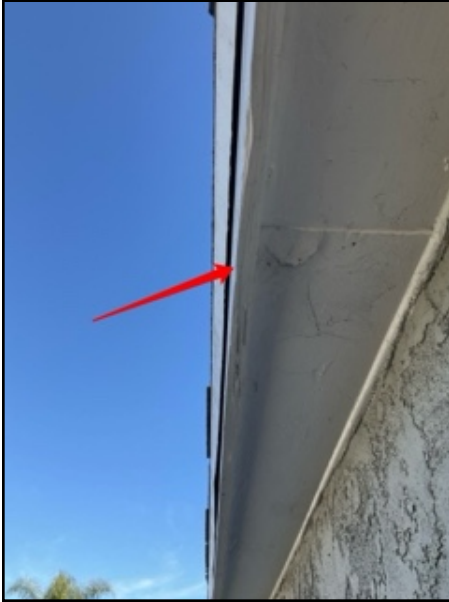
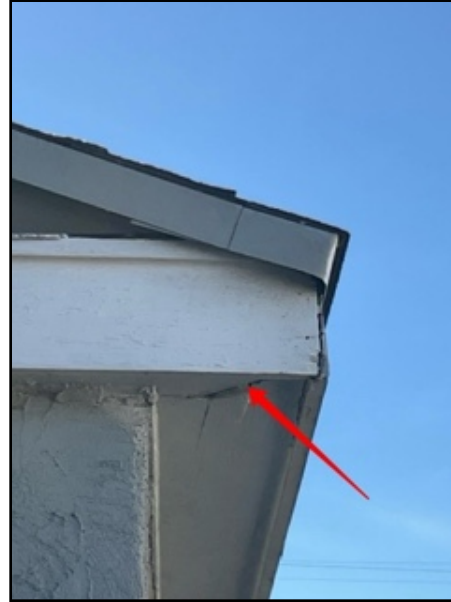
**Comment 31:**  
FURTHER EVALUATION REQUIRED: Evidence of possible wood destroying organisms/dry rot noted on soffit and/or fascia.

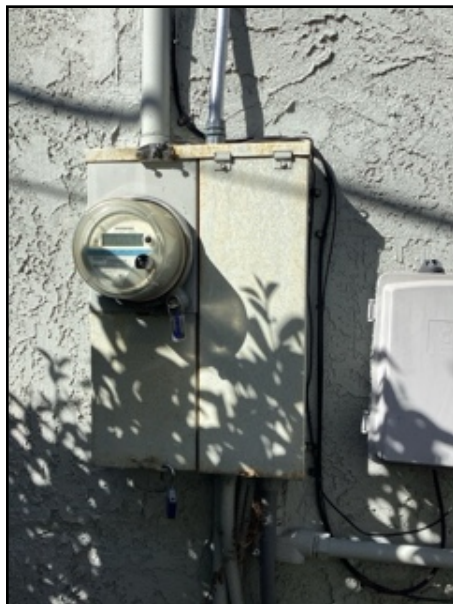
Figure 34-1

**Comment 34:**  
Service panel inspection pictures. A thermal scan was conducted and no significant hot spots were noted.

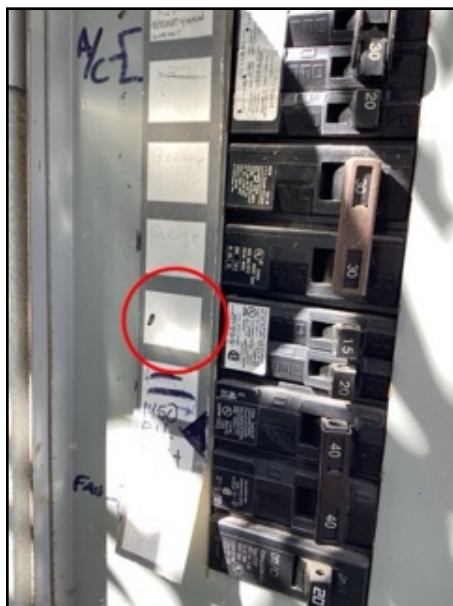
Figure 35-1

**Comment 35:**  
REPAIR OR REPLACE: Individual circuit breaker labels noted as incomplete.

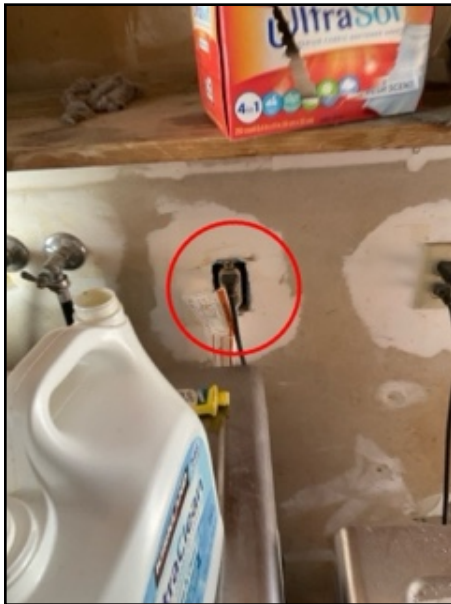
Figure 36-1

**Comment 36:**  
REPAIR OR REPLACE: Several minor electrical discrepancies (such as missing or burned-out lightbulbs, missing covers, loose fixtures, exposed romex, improperly installed outlets, and other easily reparable defects) noted at various locations throughout the property. Shock hazards, exposed conductors, and fire hazards will be labeled separately in their own individual comments.

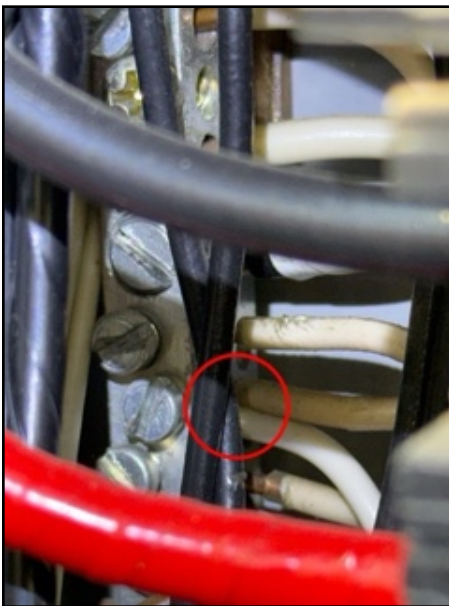
Figure 37-1

**REPAIR OR REPLACE:** No two or more neutral wires should generally not be terminated under the same screw on a busbar in a panel. While some panels may allow for multiple ground wires to be terminated under one screw, this is not typically the case for neutral wires. Electrical codes and professionals suggest that each neutral wire should have its own individual terminal to prevent potential issues like overheating, arcing, or voltage fluctuations.

Have a qualified electrician to evaluate and repair.

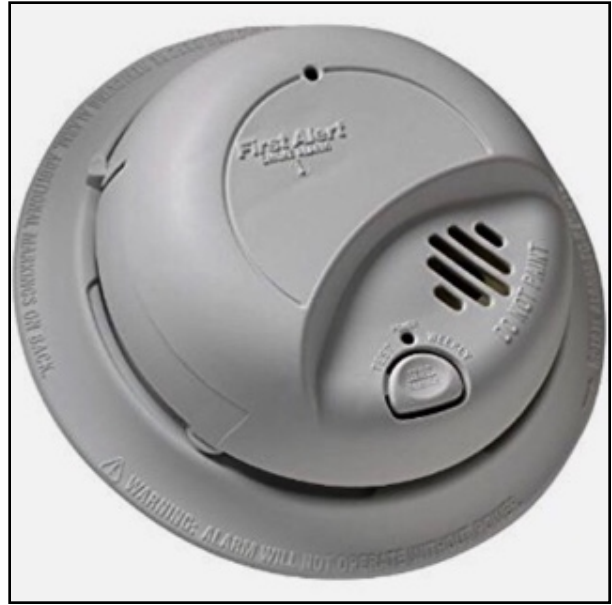
Figure 39-2

**REPAIR OR REPLACE:** Bedroom hallway noted as missing smoke detector.

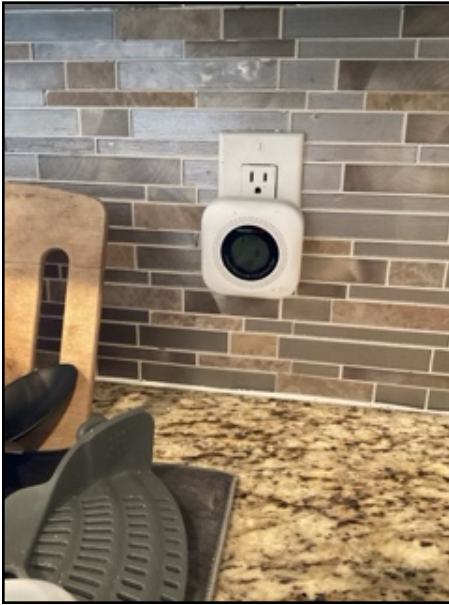
Figure 40-1

REPAIR OR REPLACE: CO detector noted as not installed in the immediate vicinity of the bedrooms.

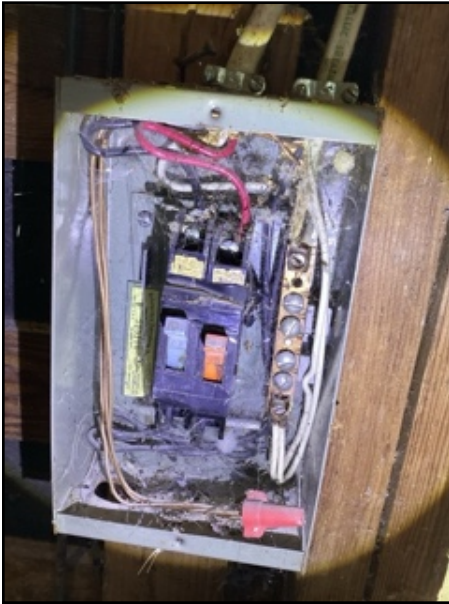
Figure 41-1

FURTHER EVALUATION REQUIRED: The sub panel for this home was manufactured by Zinsco. Some reports have noted that the circuit breakers for these panels can fail under certain conditions and design flaws may exist throughout the panel system. It is noted that all breakers for this panel carry an Underwriters Laboratories certification sticker. Have a more qualified professional to evaluate.

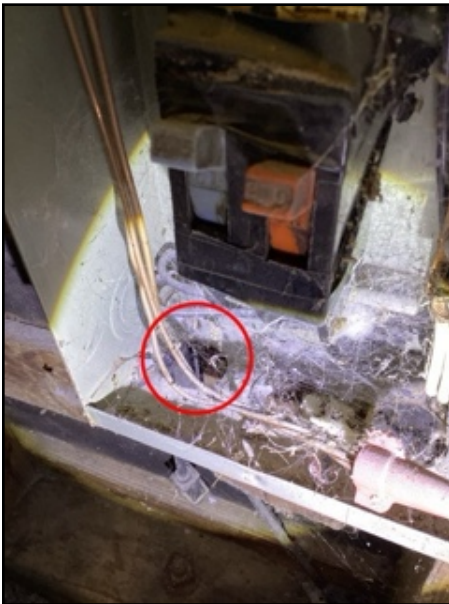
Figure 42-1

REPAIR OR REPLACE: Knockouts noted as missing covers.

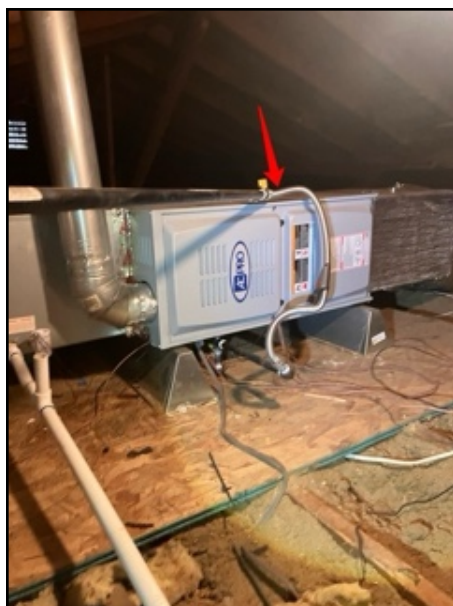
Figure 49-1

REPAIR OR REPLACE: Gas drip leg noted as not installed on 2021 furnace.

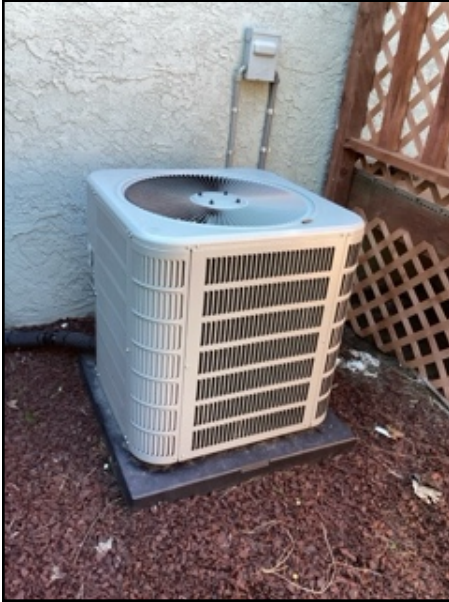
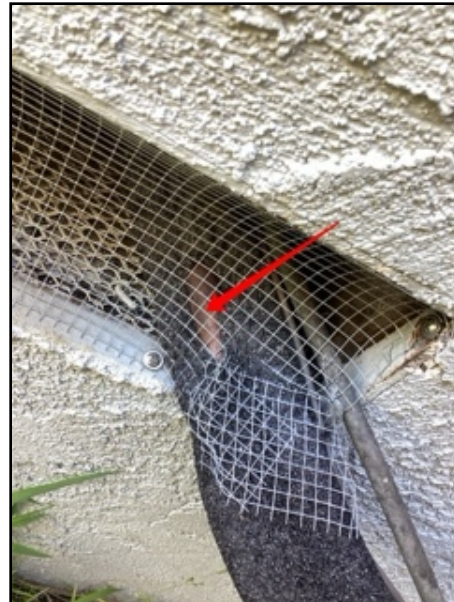
REPAIR OR REPLACE: AC refrigerator line insulation noted as partially missing and deteriorated, and condenser unit is not strapped down to the pad.

A licensed contractor should conduct an annual service and maintenance for all air conditioners over 10 years old and heat pumps over 5 years old.

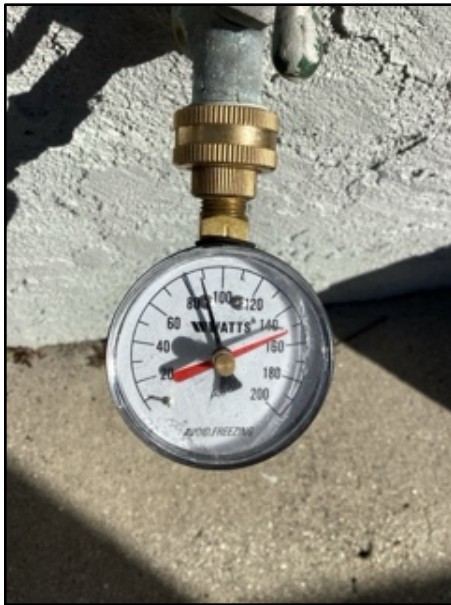
Figure 62-1

REPAIR OR REPLACE: Water pressure is 89psi. Most appliance manufacturers recommend pressure to be set between 50 and 80 psi.

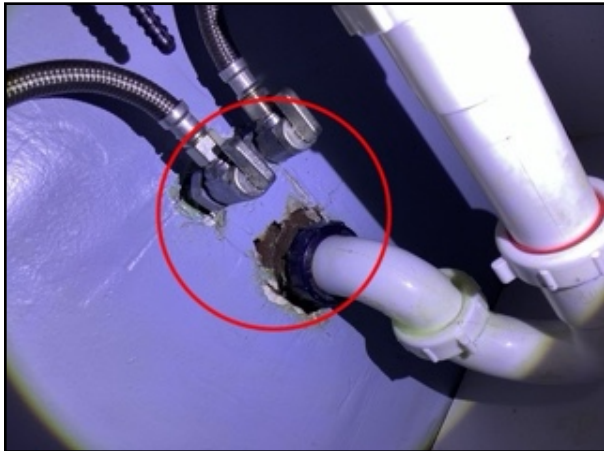
Figure 64-1

REPAIR OR REPLACE: Under sink plumbing lines noted as not sealed at wall.

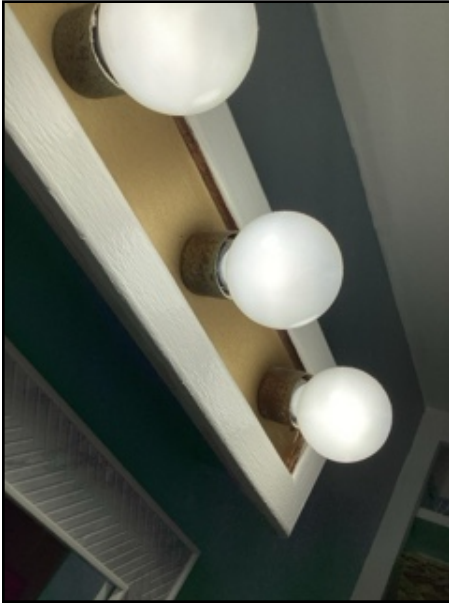
Figure 65-1

REPAIR OR REPLACE: Vanity light fixtures noted as corroded.

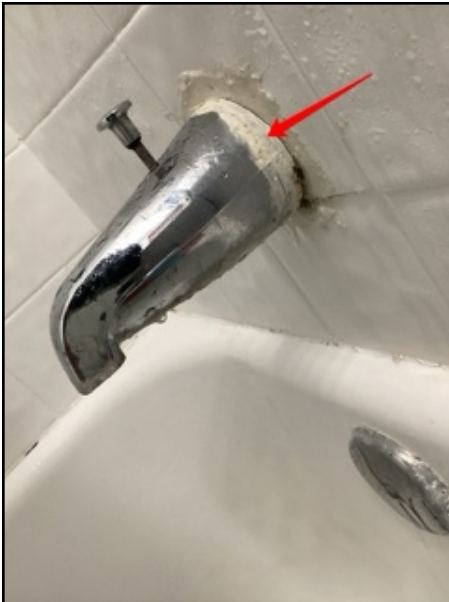
Figure 66-1

REPAIR OR REPLACE: Bath faucet and showerhead noted as loose and not sealed. Shower diverter allows water to leak by.

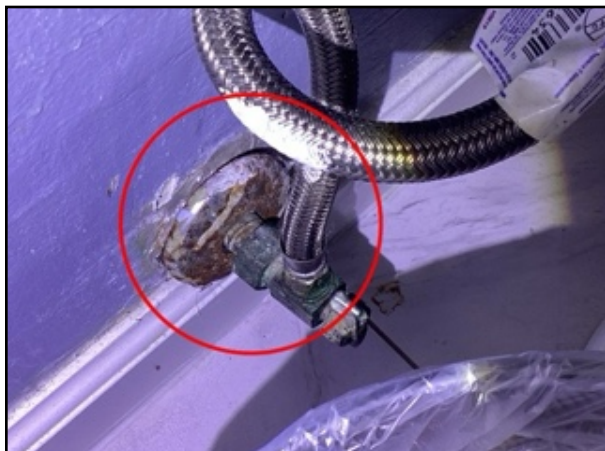
Figure 67-1

REPAIR OR REPLACE: Toilet angle stopped noted as corroded.

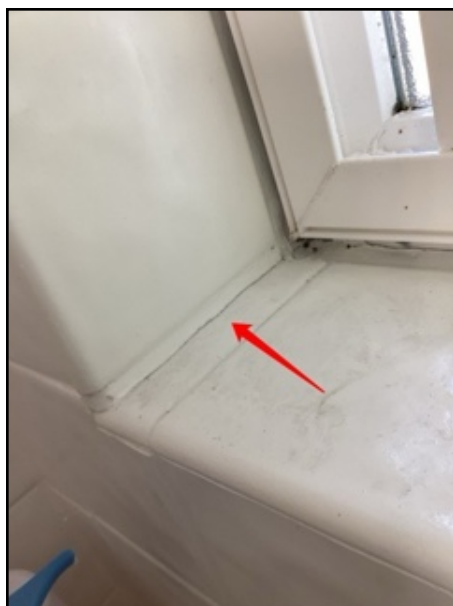
Figure 68-1

REPAIR OR REPLACE: Caulking noted as cracked deteriorated in various locations.

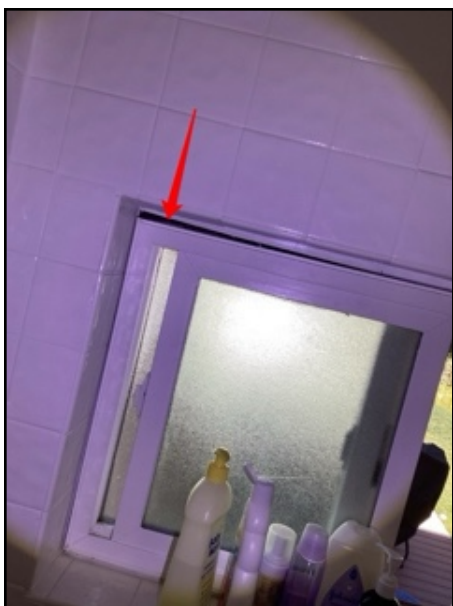
Figure 69-1

REPAIR OR REPLACE: Bathroom window noted as missing trim.

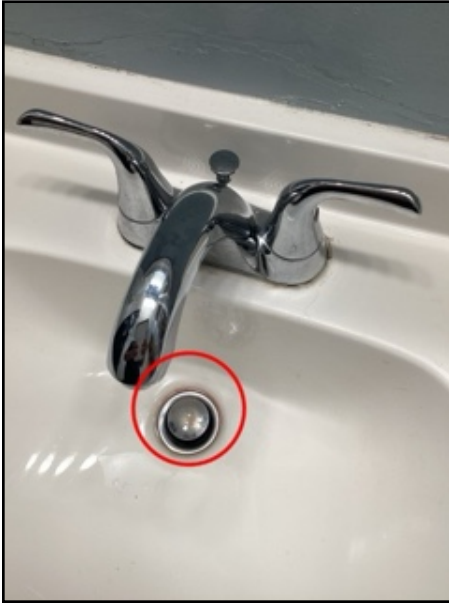
Figure 70-1

REPAIR OR REPLACE: Sink faucet noted as loose, stains noted around drain.

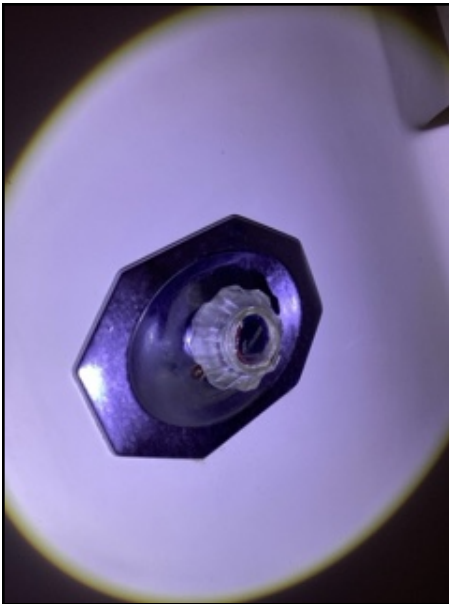
Figure 71-1

**REPAIR OR REPLACE:** Showerhead, shower controls, shower frame/door, and drain noted as stained/corroded. Shower controls noted as loose and not sealed at wall.

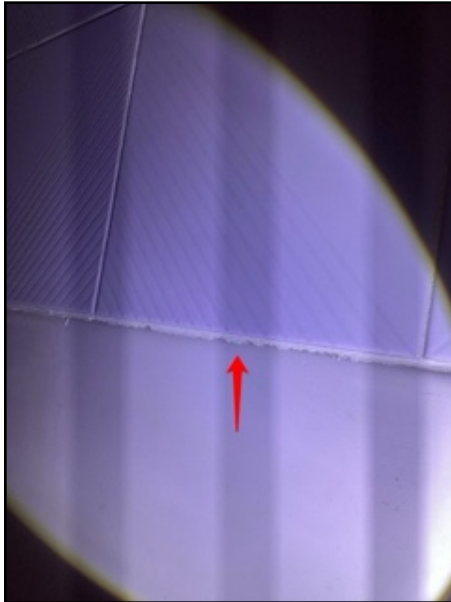
Figure 72-1

REPAIR OR REPLACE: Grout and caulking noted as cracked/deteriorated in various locations.

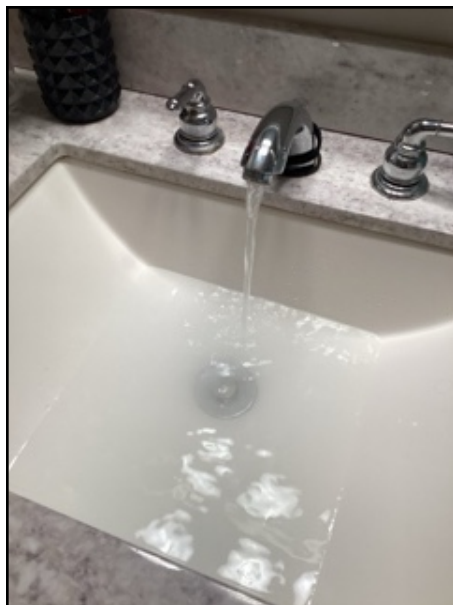
Figure 73-1

REPAIR OR REPLACE: Sink drains slowly, drain noted as stained/corroded, and broken stopper/control. Push button stopper noted as installed and is clogged.

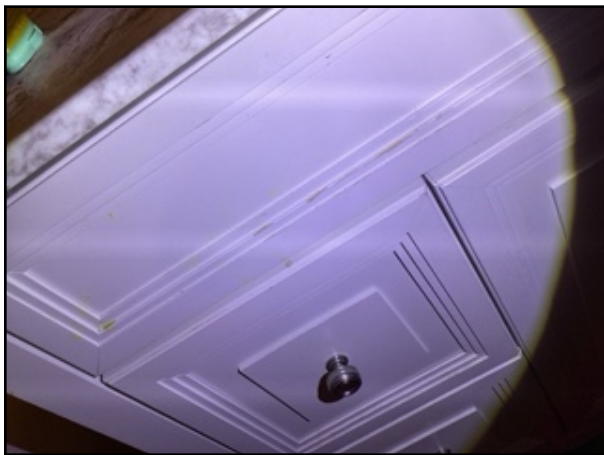
Figure 74-1

MARGINAL: Vanity cabinets noted as worn.

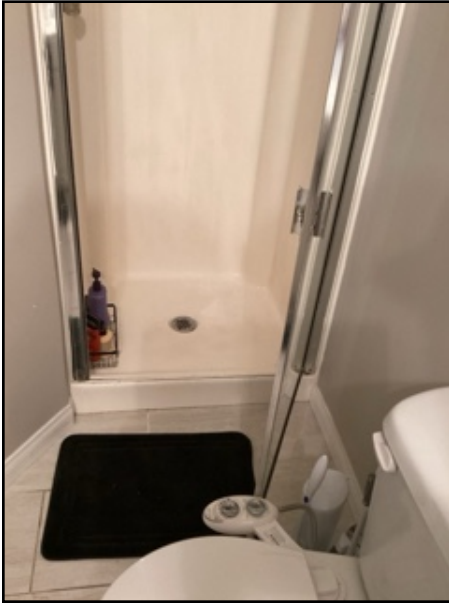
Figure 75-1

**Comment 75:**  
REPAIR OR REPLACE: Glass shower door noted as opening up into toilet.

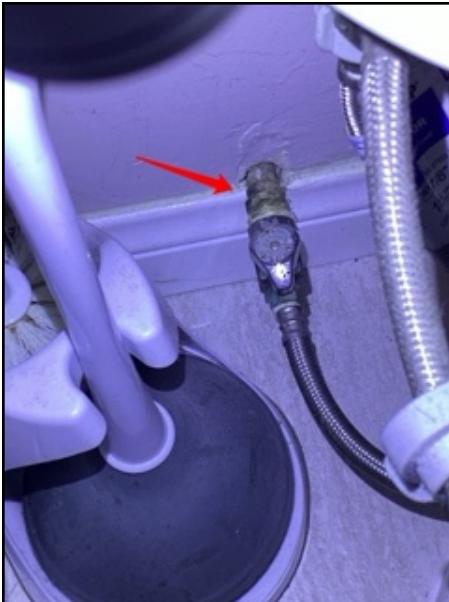
Figure 76-1

**Comment 76:**  
REPAIR OR REPLACE: Toilet angle stop noted as corroded and missing cover plate trim.

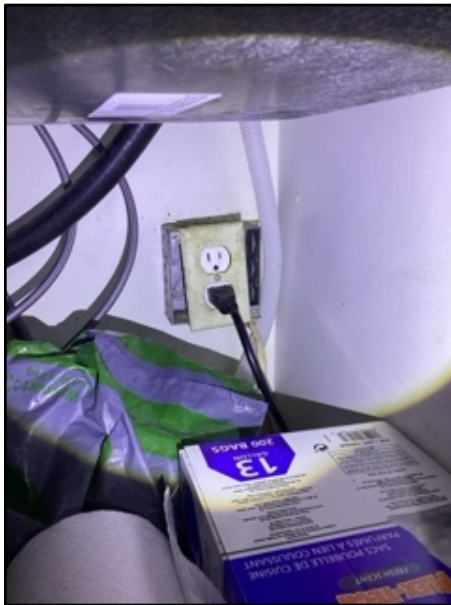
Figure 77-1

REPAIR OR REPLACE: Incorrect cover plate noted as installed at under sink outlet.

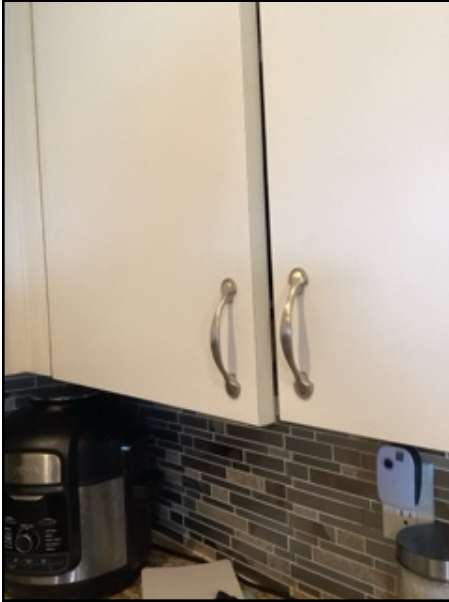
Figure 78-1

REPAIR OR REPLACE: Cabinets noted as misaligned, worn and unable to stay shut all the way in various locations.

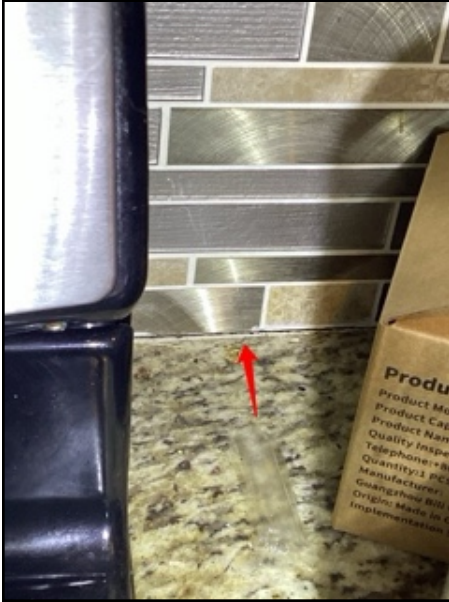
Figure 79-1

REPAIR OR REPLACE: Caulking and grout noted as cracked/deteriorated in various places around sink and backsplash.

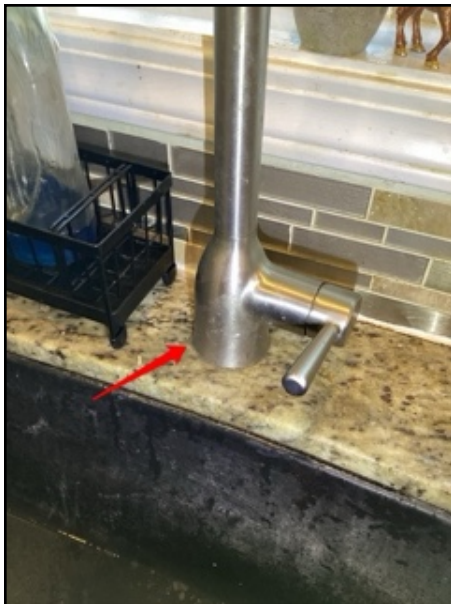
Figure 80-1

REPAIR OR REPLACE: Faucet noted as loose and not sealed.

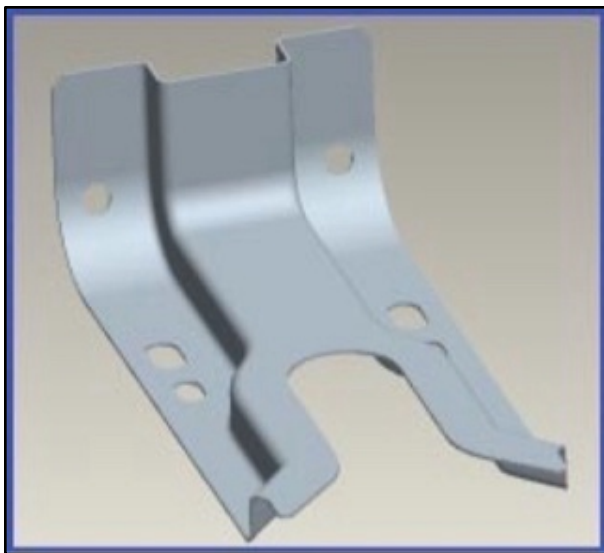
Figure 81-1

As of 2012 anti-tip devices are required to be installed on all new range installations. Age of range is unknown. Anti tip device not installed at range.

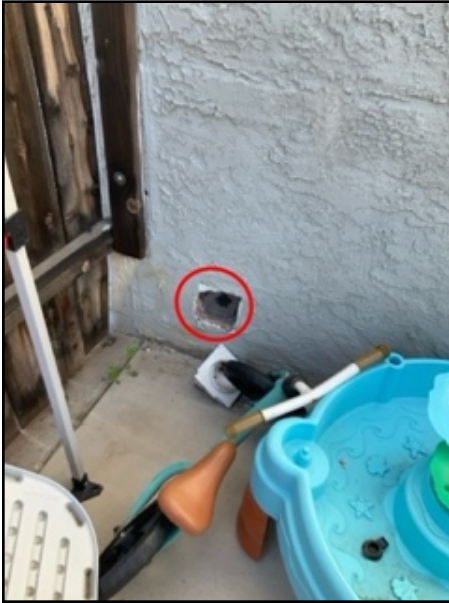
Figure 88-1

REPAIR OR REPLACE: Dryer vent cover noted as not securely fastened to exterior.

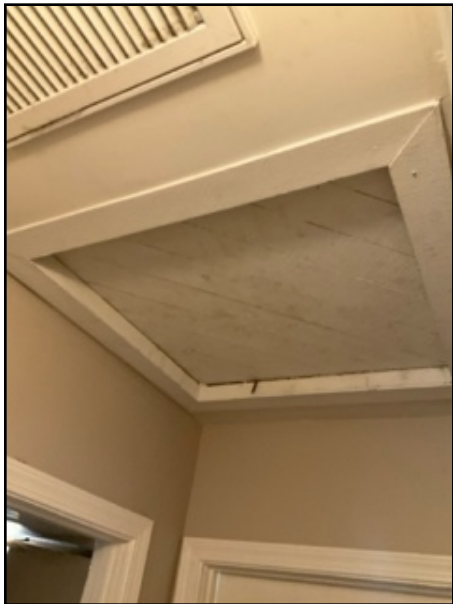
Figure 90-1

REPAIR OR REPLACE: Attic hatch cover is made of wood. Fire code requires the hatch to be made of fire-resistant material such as drywall or metal.

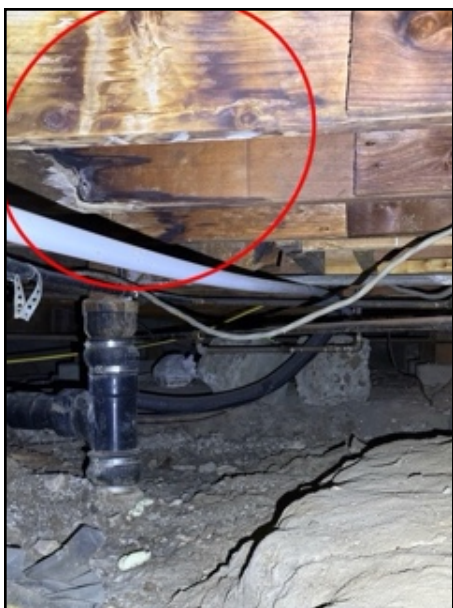
Figure 93-1

**FURTHER EVALUATION REQUIRED:** Evidence of previous water stains and wood destroying organisms/dry rot noted in various places through subfloor and floor framing.

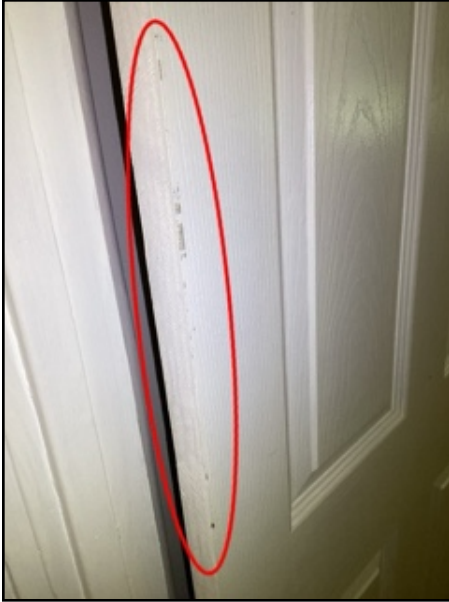
Figure 94-1

Minor paint, drywall damage, burned out bulbs, broken/missing covers and other minor cosmetic defects noted at various locations throughout the home.

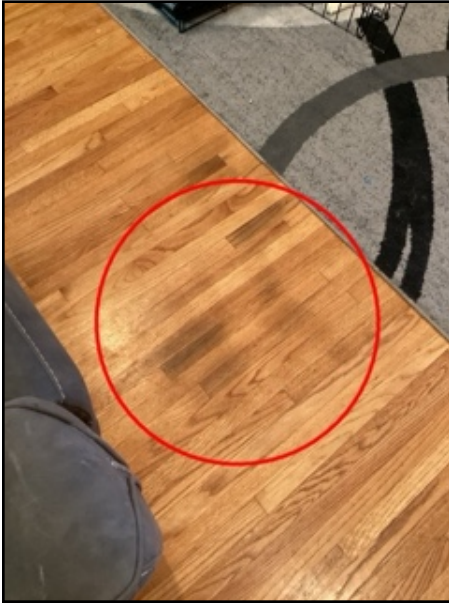
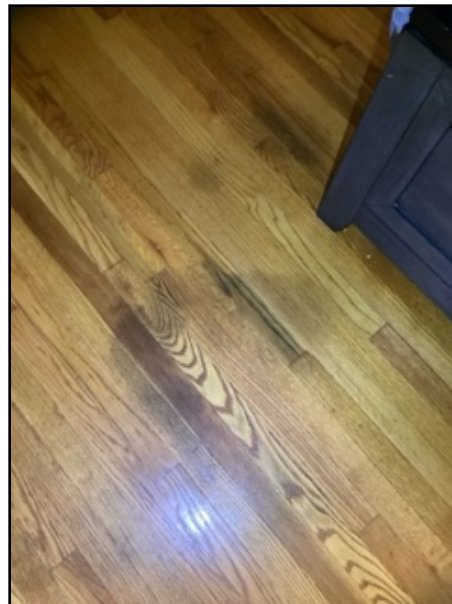
REPAIR OR REPLACE: Wood flooring noted as worn in various places throughout.
