SUBJECT PROPERTY:  
401 N Coast Hwy Unit 308, Oceanside, CA 92054

PREPARED FOR:  
Harry Yagubyan

INSPECTION DATE:  
03/30/2026

INSPECTOR:  
Greg Campbell, CCI  
Cell: 858.335.1279  
Email: [greg@InspectRite.com](mailto:greg@InspectRite.com)

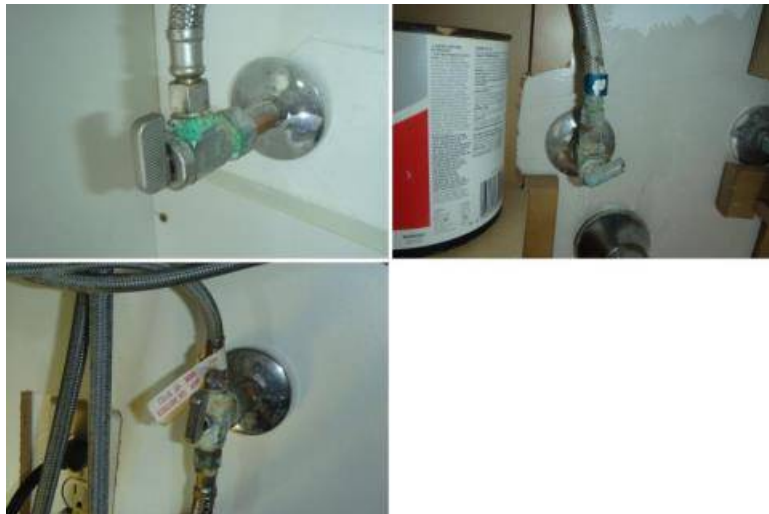
**10.7 Local Water Shutoffs & Connectors:**

**Marginal** - Corrosion was noted at local shutoff valves and/or plumbing connections serving sinks and/or toilets. Although there were no leaks at the time of inspection, replacement is recommended as preventative maintenance. Condition was observed at master bathroom, powder bathroom, kitchen.

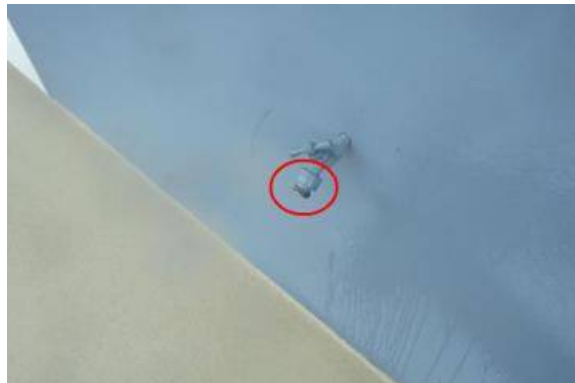
**10.8 Hose Faucets:**

**Maintenance** - Defective anti-siphon devices were noted at exterior hose faucets.

These are simple devices that screw onto the hose faucets and are tightened with set screws. Replacement is recommended.

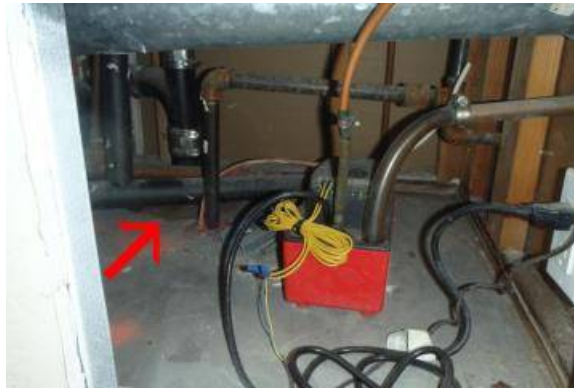
**Further Evaluation** - A possible active or past leak was noted with the waste line as indicated by water stains. Further evaluation and repair as needed by a licensed plumbing contractor is recommended. This may be the responsibility of the HOA. Condition was observed at: 1st floor utility closet.

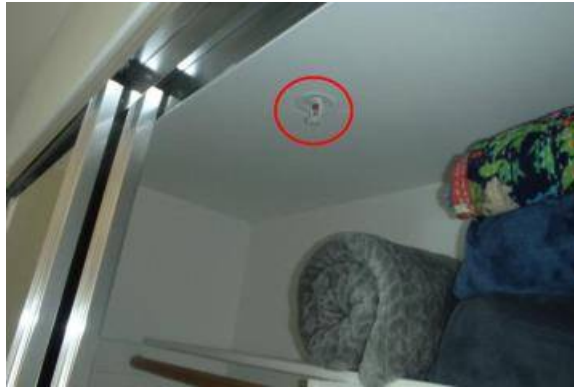
**10.19 Concerns:**

**Upgrade** - Sprinkler heads were unprotected and protruding below the ceiling at lower ceiling heights or utility areas. Damage to the sprinkler head could cause an unnecessary release of water. Recommend inquiring about protective covers or cages that protect the sprinkler heads from damage and do not compromise function. Condition was observed at: one or more closets.

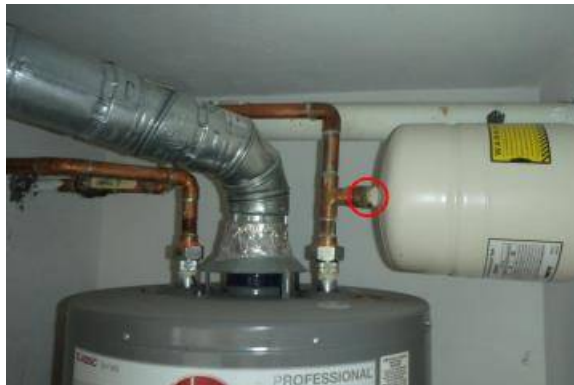
**11.10 Plumbing Connections:**

**Marginal** - Early signs of rust/corrosion was noted on plumbing connections. Repairs are needed to protect against unexpected leaking.

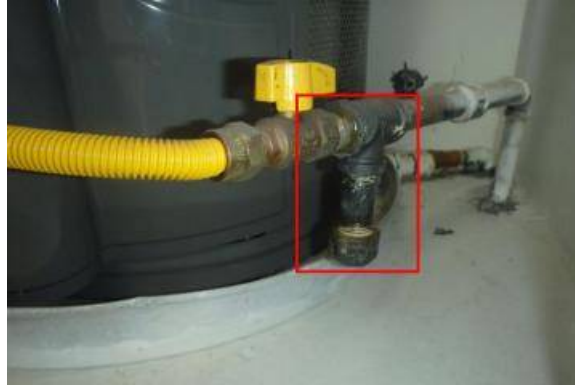
**11.11 Fuel:**

**Maintenance** - A sediment trap or drip leg was not installed properly for the gas appliance. The gas flow must change direction above the trap in order for the trap to be effective in catching any moisture and/or debris which might cause the appliance to malfunction.

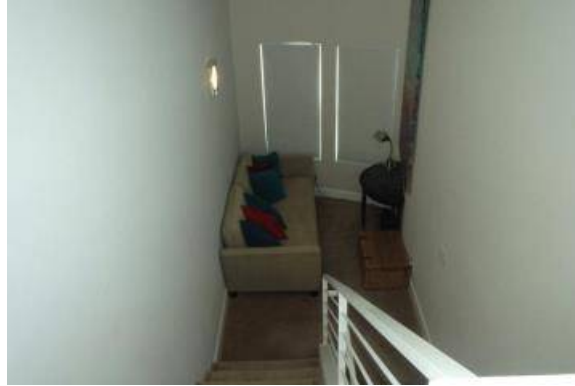
**12.23 Distribution:**

**Marginal** - Air registers were not observed/not provided in all rooms. A permanent source of heat is required in or to reach all habitable rooms. This area may be considered a stair landing and heat may not be required. Regardless, this may be a nuisance being an unconditioned space. Condition was observed at: 3rd floor sitting area.

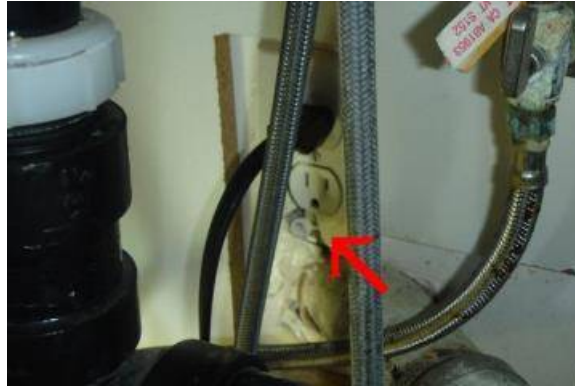
**Maintenance** - Missing or damaged coverplate(s) were noted. This is considered a shock hazard and fire risk. Covers should be installed on all open services. Condition was observed at: kitchen.

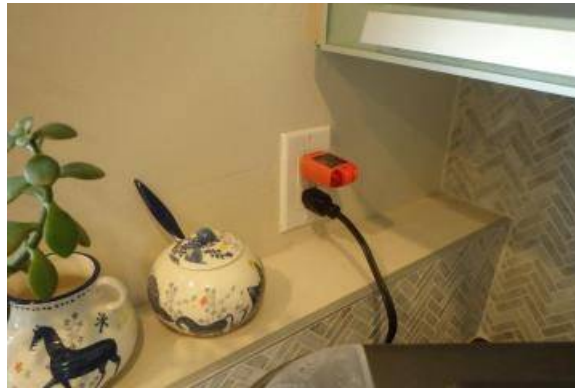
**13.16 GFCI's Not Functional:**

**Repair** - GFCI safety device(s) were not functional at the following locations: kitchen to the right of the sink. Won't trip.

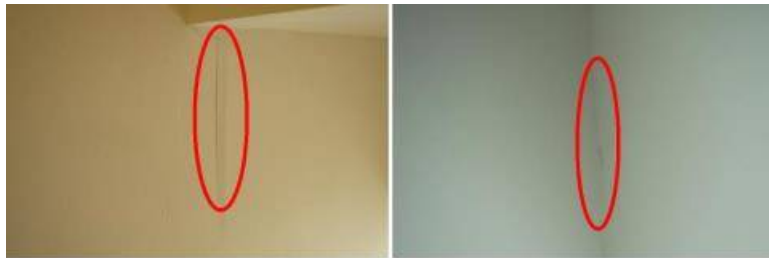
**14.6 Associated Comments:**

**Maintenance** - Loose and separated drywall tape was noted. The condition appears to be from modest settlement of framing connections. Condition was observed at: 3rd floor and stairway.

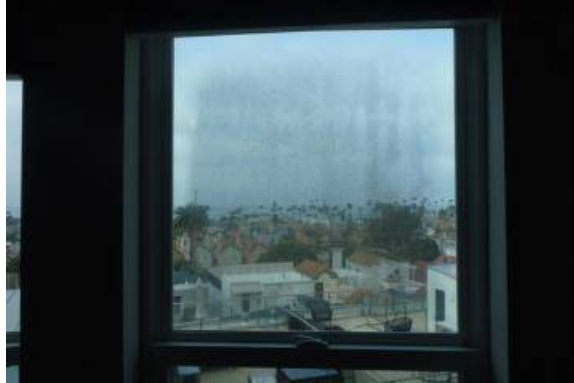
**Repair** - Abnormal or damaged factory tinting was observed. The tinting is on the inside of the dual glazing, and therefore can not be removed or repaired. Not all defective glazing may be readily apparent due to lighting and weather conditions, or from dust/dirt on the glazing. Further evaluation of all glazing is recommended by a window replacement contractor. Condition was observed at: 3rd floor.

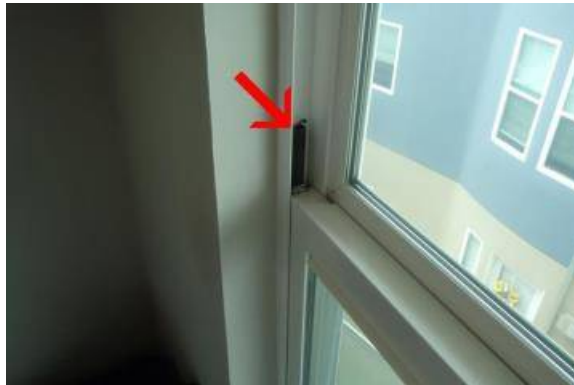
**14.12 Windows:**

**Repair** - Springs or counter balances were not working (counter balances hold the sash open) at one or more of windows sampled. Condition was observed at: Master bedroom retreat.

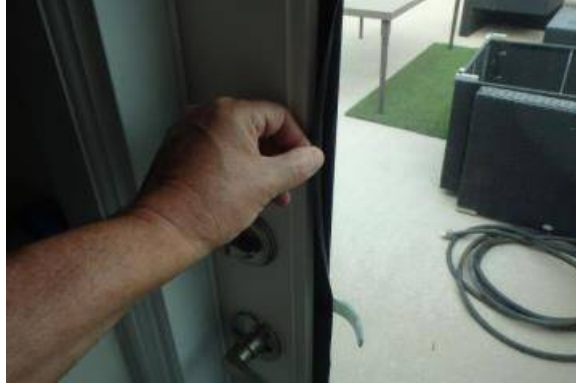
**14.15 Exterior Door(s):**

**Maintenance** - Glazing tape or trim was loose. Condition was observed at: 3rd floor door to rooftop deck.

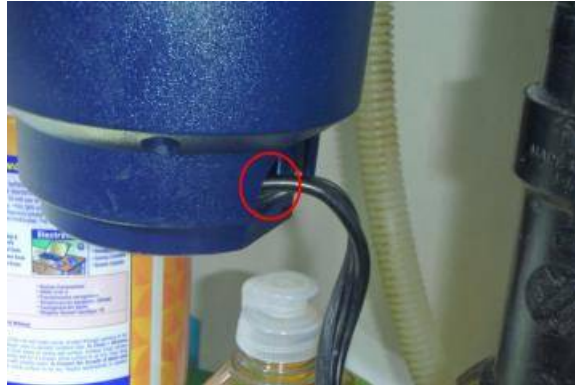
**15.6 Disposal:** **Repair** - Not functional. The unit is jammed / stuck.

**Safety** - The power cord is not properly attached to the disposal. This is a potential shock hazard. Repair is needed.

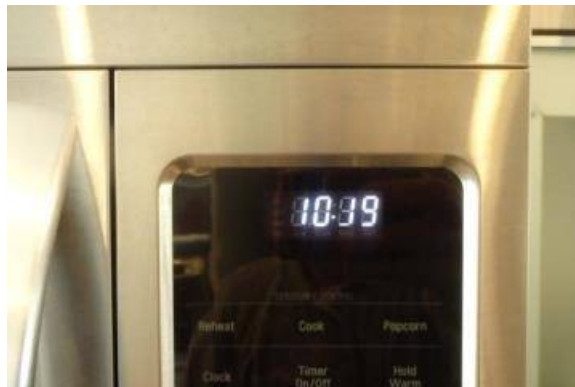
**15.8 Microwave:**

**Marginal** - The digital display was flickering and appears to be failing.

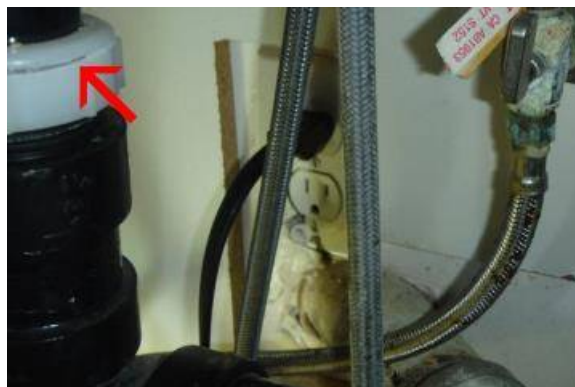
**15.10 Sink Drain Plumbing:**

**Maintenance** - Damaged/Cracked drain fitting noted. Replacement is recommended.

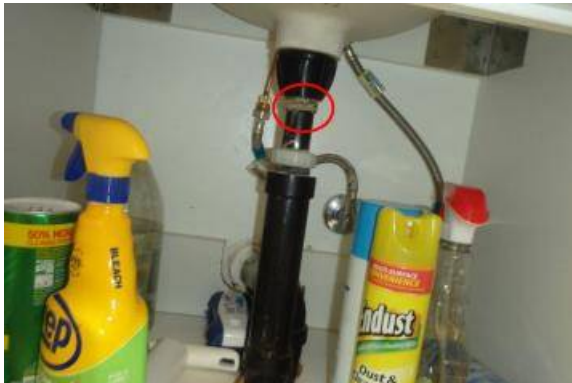
**Maintenance** - Corrosion and/or signs of past leaking noted to the drain line and/or drain fitting. Routine maintenance recommended to prevent leaking.

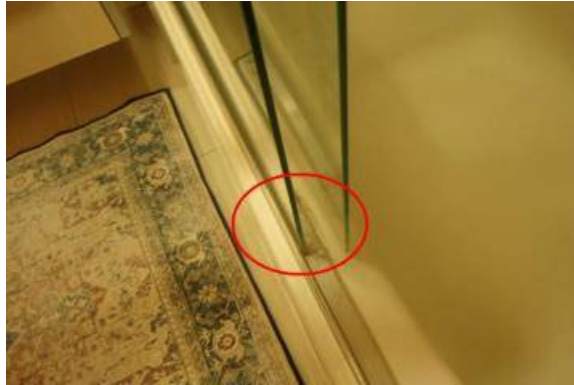
**17.11 Tub/Shower Enclosure:**

**Maintenance** - The shower door track was missing a bottom guide. Doors can fall off track more easily, potentially causing injury or damage.
