# WOOD DESTROYING PESTS AND ORGANISMS INSPECTION REPORT

| Building Address:<br><b>10904 1st Av., Whittier, CA</b> | | Date of Inspection<br><b>02/25/2026</b> | Number of Pages<br><b>6</b> |
| | | Report #<br><b>W56111</b> | |
| General Description:<br>Single story stucco/wood siding single family residence with an attached garage | | Inspection Tag Posted:    Attic | |

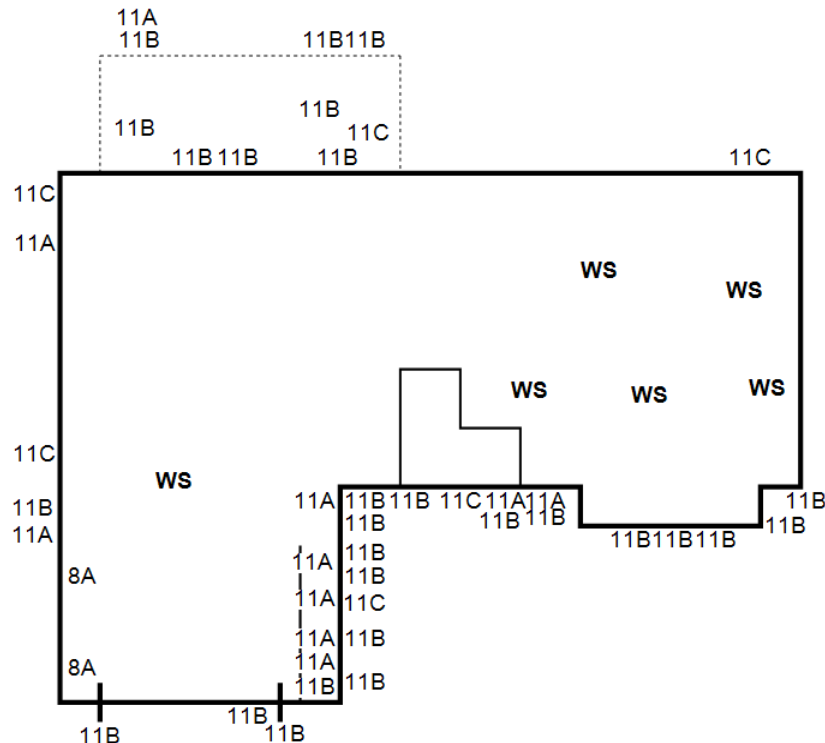
This Diagram is not to scale

8A PRICE: \$1,987.00 (Section I)  
 FINDINGS: Evidence of drywood termite infestation noted at time of inspection.  
 RECOMMENDATION: Vacate the premises and seal the structure for fumigation. Remove or cover accessible evidence of infestation. Fumigation awareness notice must be signed prior to fumigation. See fumigation notice for terms and liabilities. Fumigation warranty three years.

11A PRICE: See 8A (Section I)  
 FINDINGS: Evidence of drywood termite infestation noted at time of inspection.  
 RECOMMENDATION: Vacate the premises and seal the structure for fumigation. Remove or cover accessible evidence of infestation. Fumigation awareness notice must be signed prior to fumigation. See fumigation notice for terms and liabilities. Fumigation warranty three years.

- 11B PRICE: \$3,700.00 (Section I)  
FINDINGS: Evidence of termite damaged wood members noted at time of inspection.  
RECOMMENDATION: Repair or replace termite damaged wood members as required. Bugmasters is not responsible for any damage to roofing materials that may occur during repairs made to roof members.
- 11C PRICE: See 11B (Section I)  
FINDINGS: Dry-rot wood members found at time of inspection.  
RECOMMENDATION: Replace dry-rot damaged wood members, as necessary. Bugmasters is not responsible for any damage to roofing materials that may occur during repairs made to roof eve members. If additional adverse conditions are uncovered during repairs, further inspection will be recommended, and a supplemental report will be issued indicating any additional costs.

NOTE: Water stains noted at time of inspection. Bugmasters does not guarantee the presence or non-presence of any leaks or hidden damage from same. See "WS" on diagram. Contact proper tradesman to inspect and repair if deemed necessary by parties involved.
