Jun 3rd, 2025

222 North Lassen Street, Willows, CA, 95988

Home Inspection Report

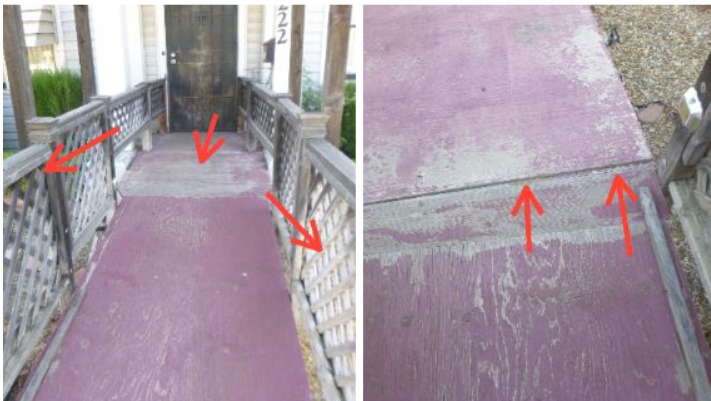
The front wood ramp needs to be re painted and has a trip hazard

Defective

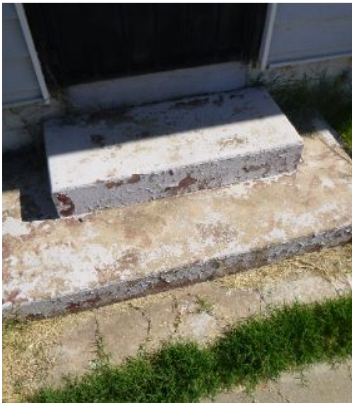
Paint peeling

Defective

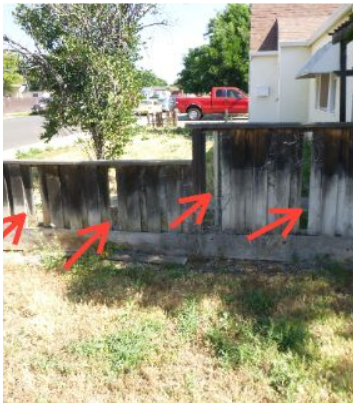
The fence is in need of repair

Defective

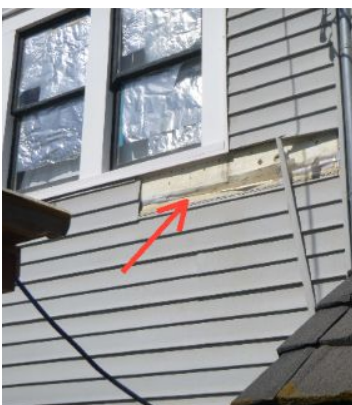
Missing pieces in the back

Defective

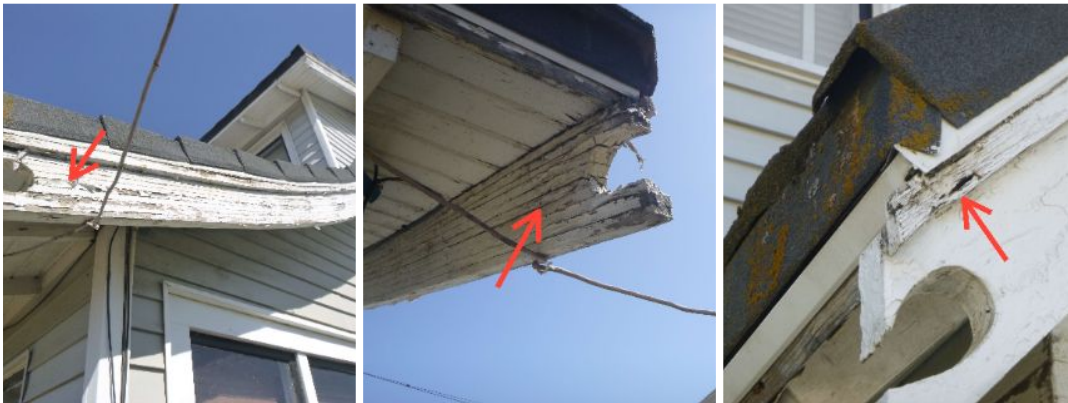
Delaminating and dry rot

Defective

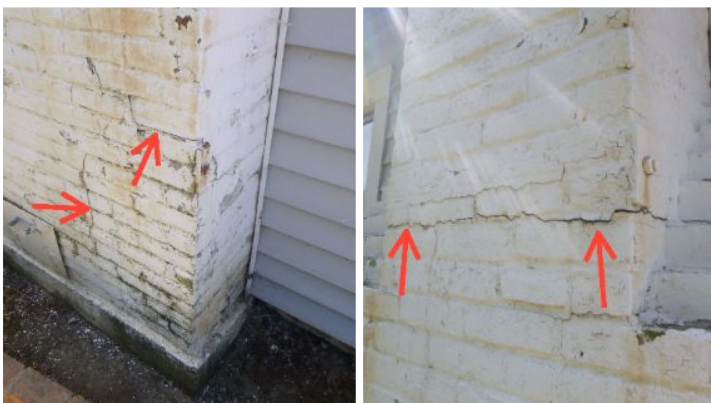
The box is cracked down low. The chimney is cracked at the sholder. The fire place should be removed and rebuilt

Defective

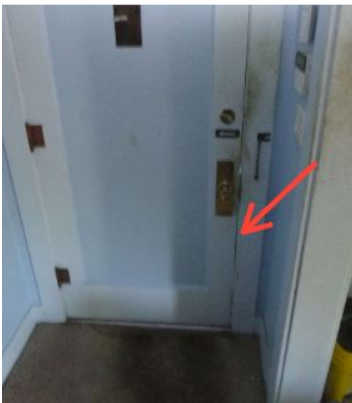
The weather stripping needs to be fixed

Defective

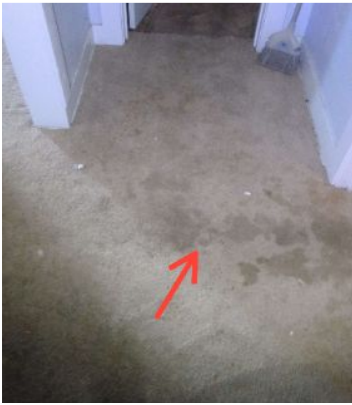
Damaged carpet

Defective

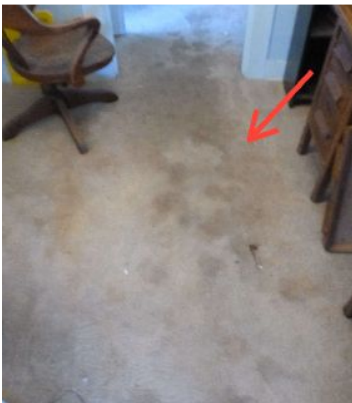
Damaged carpet

Defective

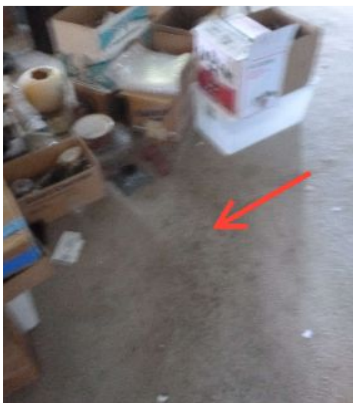
Damaged carpet

Defective

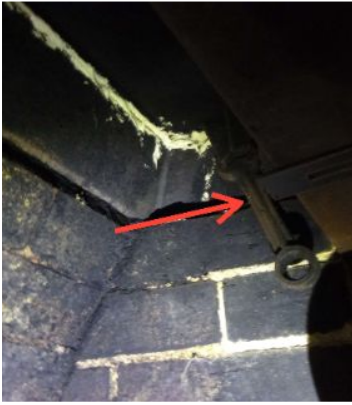
The damper is stuck

Defective

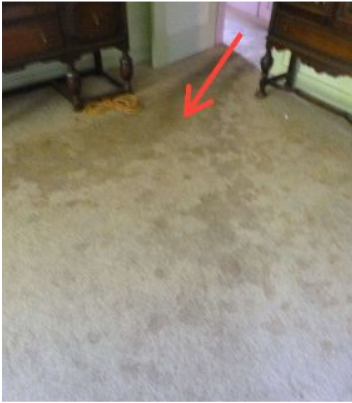
Damaged carpet

Defective

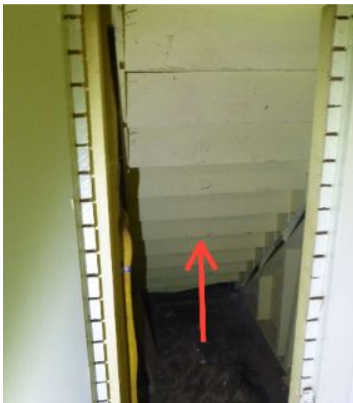
Current code requires that the inside of the closet be sheet rocked for fire safety

Defective

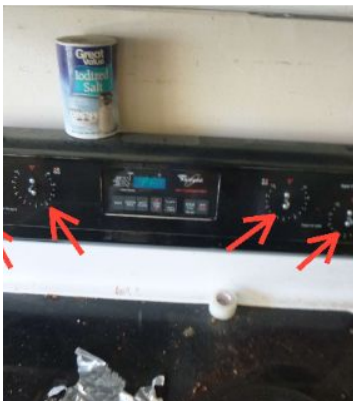
All of the knobs are missing

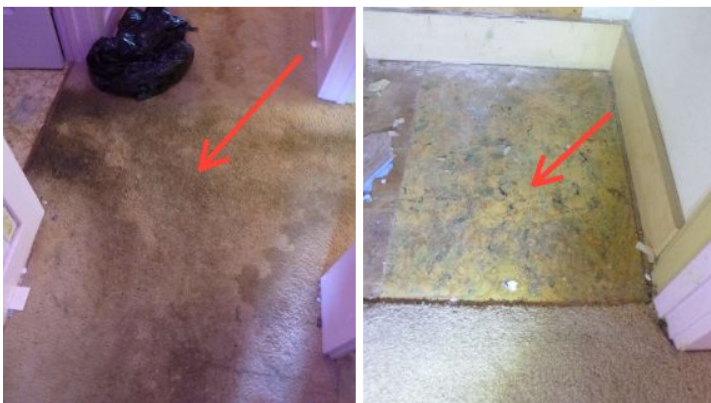
Damaged carpet. The old linoleum in the closet possibly contains asbestos. Most of the old floorings have asbestos. This is not a problem if left alone

Defective

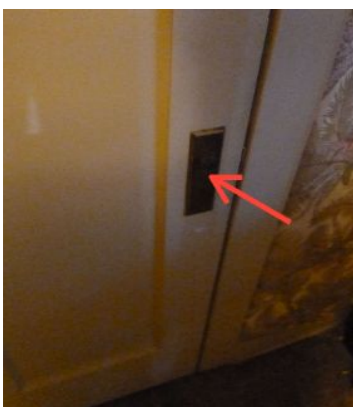
The closet knob is missing

Defective

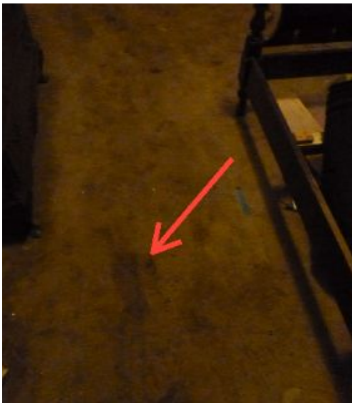
Damaged carpet

Defective

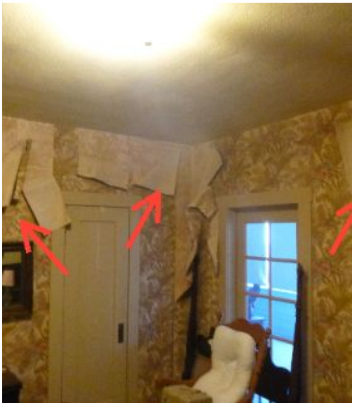
Cracks present The wall paper is falling off

Defective

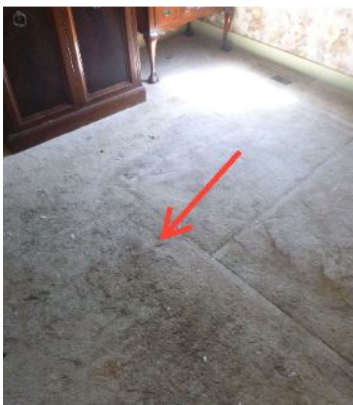
Damaged carpet

Defective

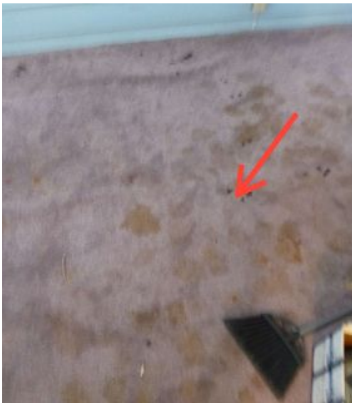
Damaged carpet

Defective

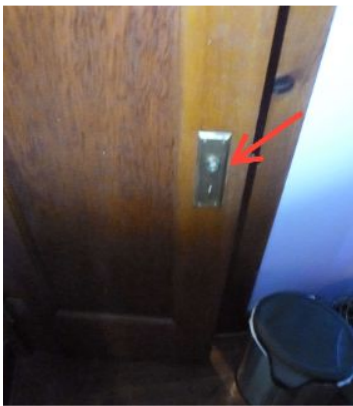
The door knob is missing

Defective

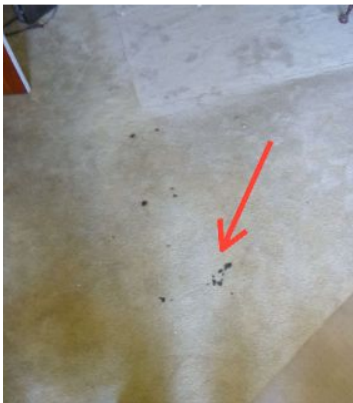
Damaged carpet

Defective

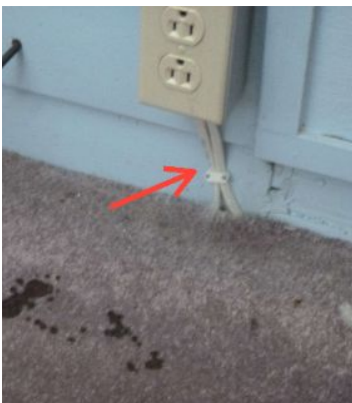
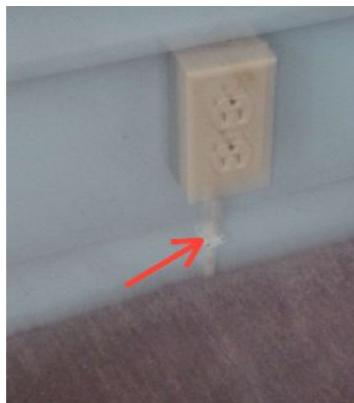
One missing plug cover. The light cover is missing

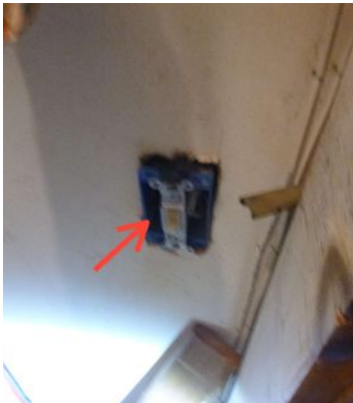
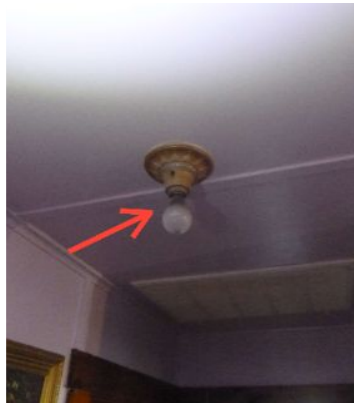
Missing switch cover and one light is out

Marginal

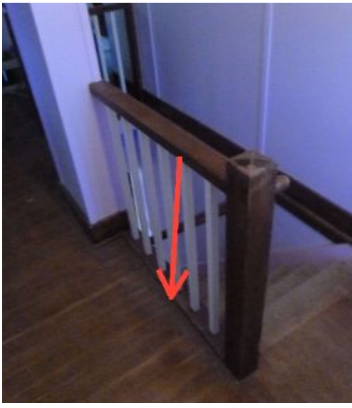
The railing is too low

Defective

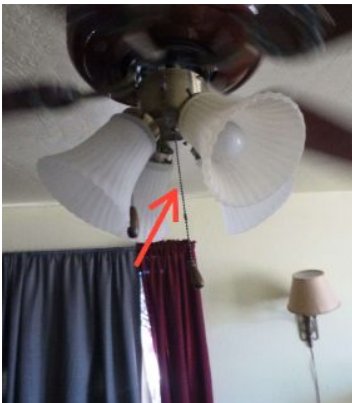
The light chain is stuck

Defective
