Inspection Report

Address: 165 N 5th St Shandon, CA 93461

06/01/2026

Inspector: Taylor Vreeken, CCI

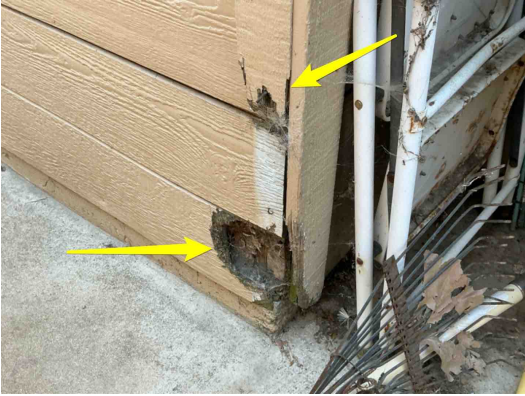
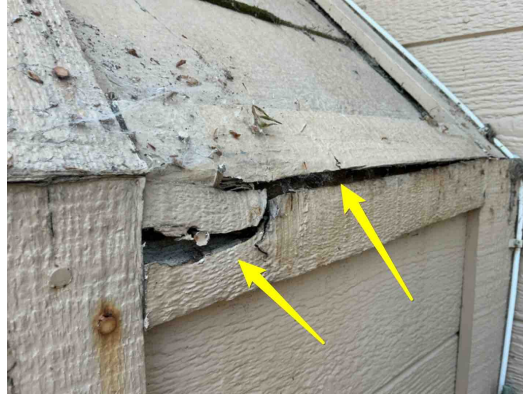
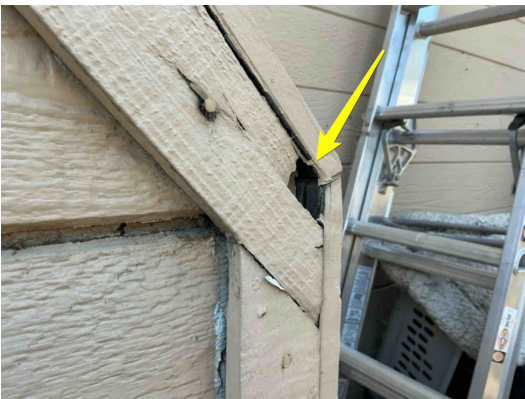
E&C 34: Some moisture and/or bug-type damage and deterioration found at areas of the exterior wood siding and/or trim. Refer to the termite report for additional comments, recommendations, locations and extent.

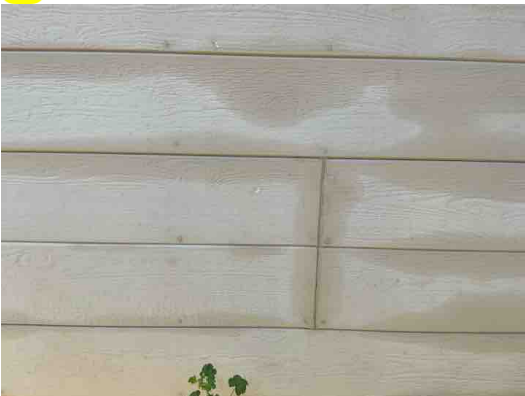
MR 35: Deteriorated paint at areas of the exterior.

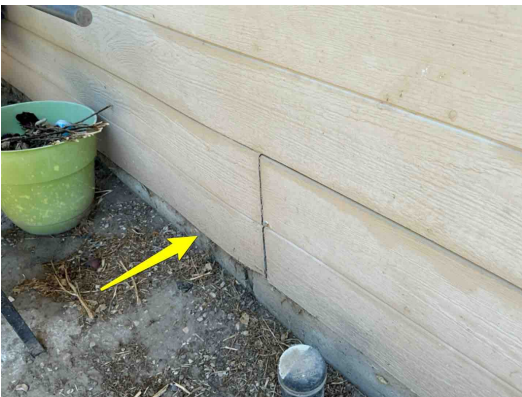
E&C 38: Multiple areas of the exterior siding found warped/ cupped. Cause and current condition behind warped siding is unknown.

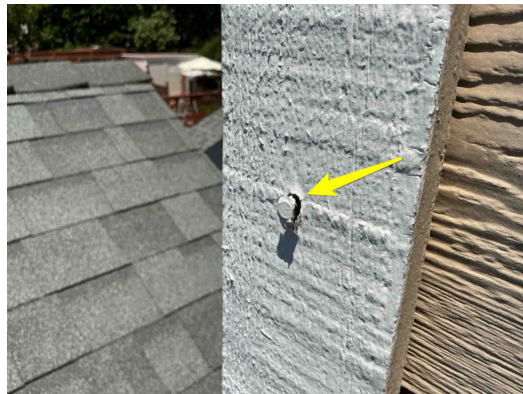
E&C MR 39: Multiple loose, unsealed, and/or damaged fasteners noted throughout the exterior. Further evaluation in corrections/ maintenance recommended.

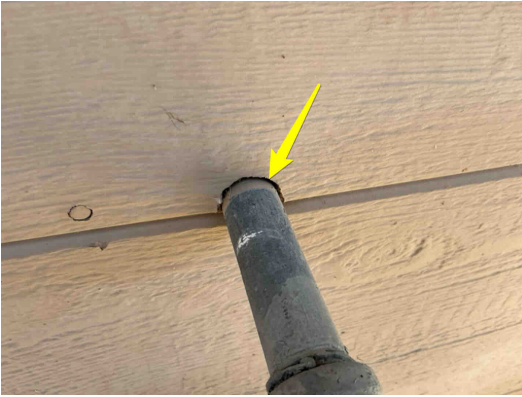
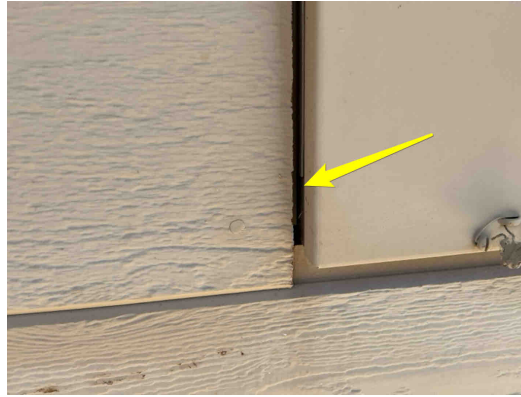
MR 40: Recommend sealing holes in exterior walls to prevent water intrusion around areas such as unused open holes in the exterior siding and trim, exterior light fixtures, around exterior electrical boxes and covers, and where utility pipes and/or wires pass through the exterior walls. Have a qualified painter or licensed professional evaluate the entire exterior and seal where needed.

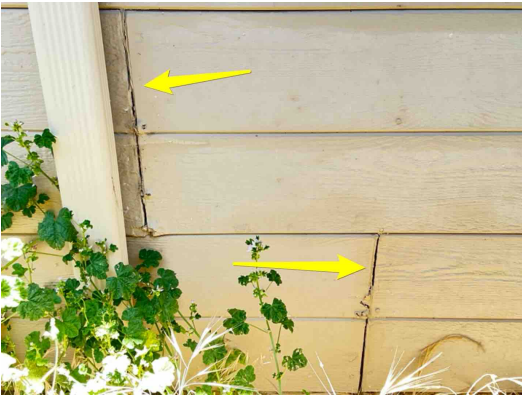
MR 41: Recommend sealing the open joints, gaps, and separations at the exterior siding. Unsealed openings may allow moisture intrusion behind the siding and potential ultraviolet / sun damage of the underlying weather-resistive barrier (tar paper/underlayment).

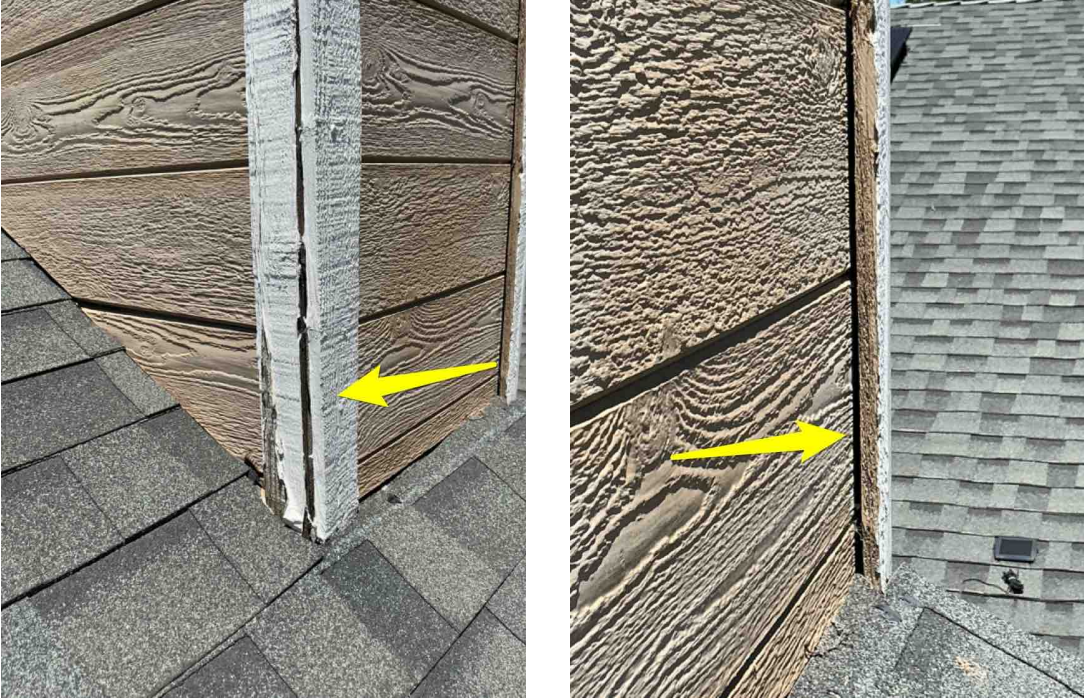
E&C FI 45: Some loose, damaged or missing trim noted at some areas of the exterior. Contact an appropriate professional to correct all areas of the exterior as needed.

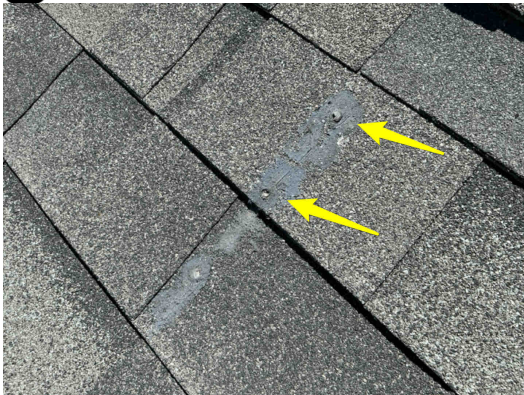
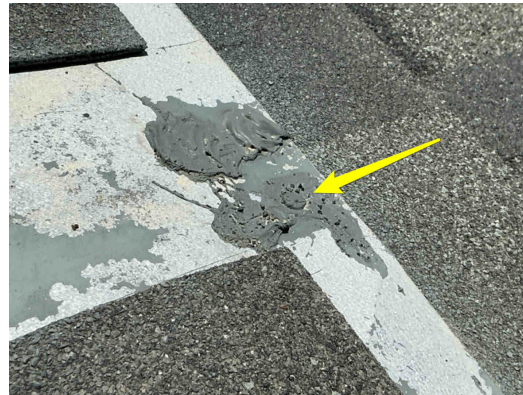
DS 58: Disclosure: Exposed fasteners noted at areas of the roof and/ or roof flashings.

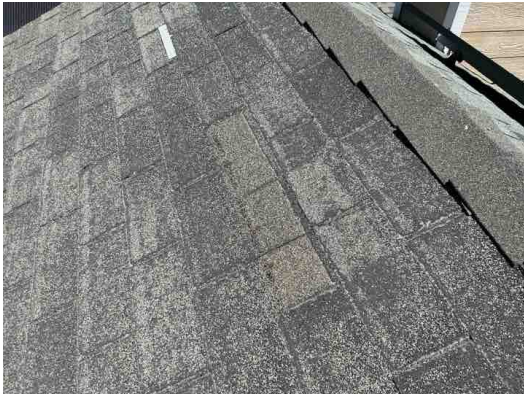
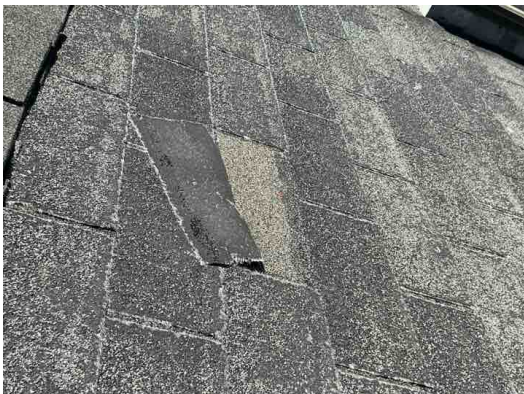
E&C DS 63: **ROOF CONDITION:** The WEST SIDE Roof is at the end of its life expectancy. Recommend contacting a licensed roofing contractor for a price / proposal for replacement.

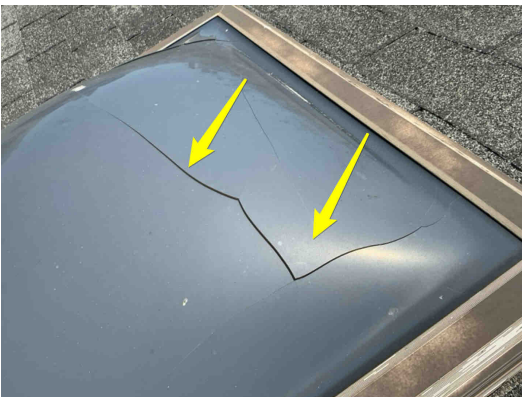
E&C 66: Some of the plastic roof skylights are cracked and damaged. Replacement is recommended. Contact a qualified roofer to evaluate and replace damaged skylights.

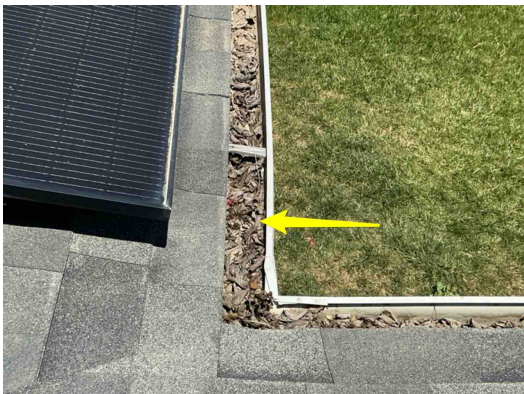
MR 75: Recommend some typical rain gutter maintenance. This should at minimum consist of cleaning, sealing, and re-fascinating of loose gutters and downspouts.

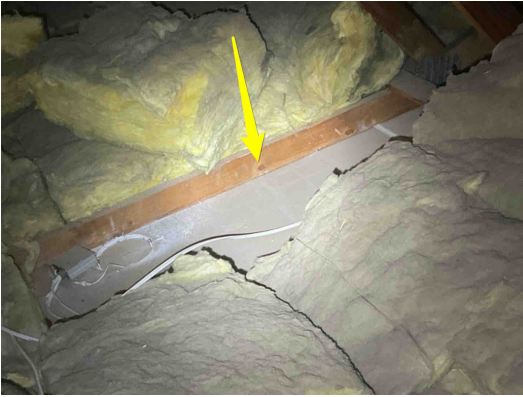
E&C 76: Missing insulation in the areas attic. Some of the attic Insulation in has been moved, displaced or was not originally installed for reasons unknown.

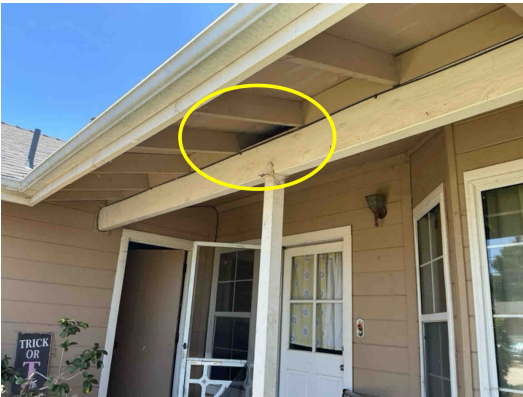
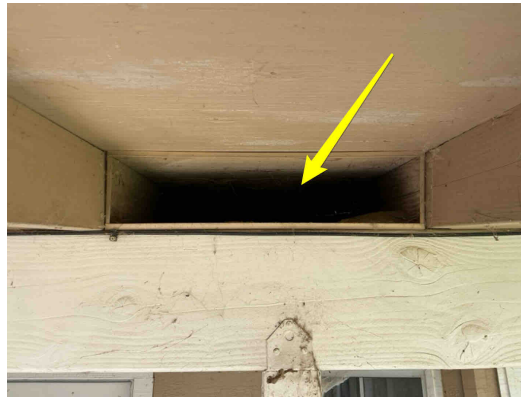
E&C MR 78: Some damaged or missing attic eave vent screens on areas of the exterior at the roof overhangs. Repair or replacement of the damaged or missing vent screens is recommended to help prevent critter intrusion into attic areas.

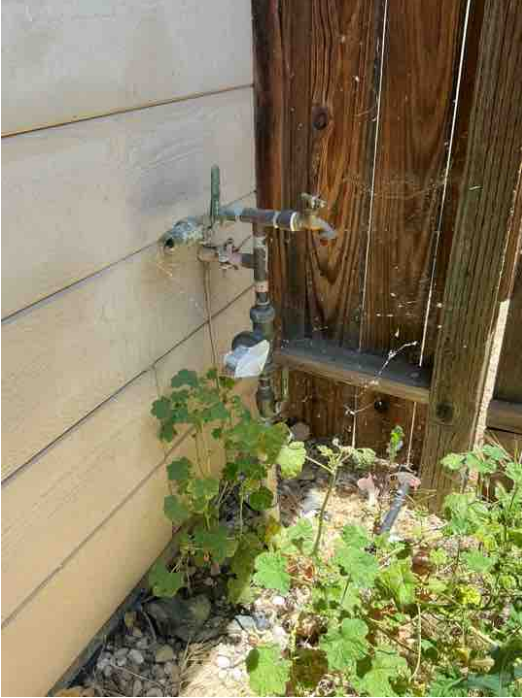
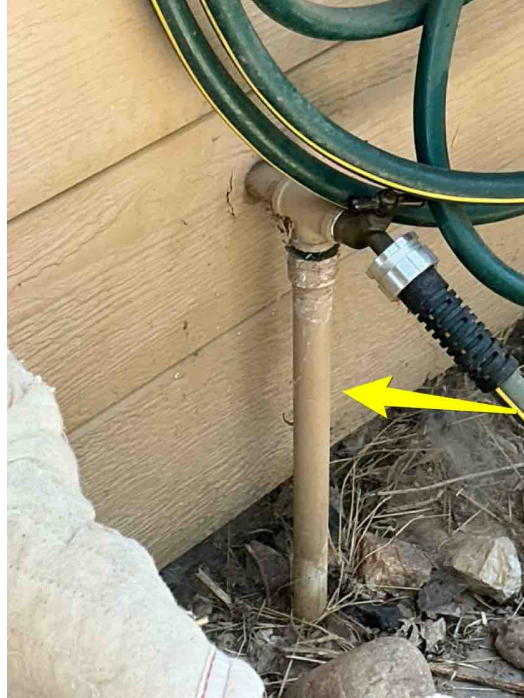
MR UPG 86: Exposed exterior water supply pipes subject to freezing are not insulated, not insulated well or have damaged or deteriorated insulation installed. Upgrades are recommended.

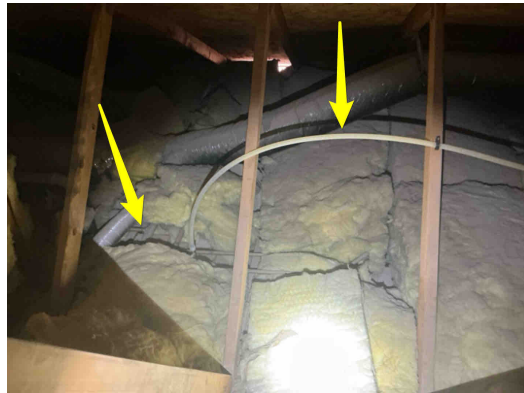
E&C 87: Some exposed plumbing pipes above the insulation, subject to freezing are not insulated in areas in the attic as required by standards. Upgrades and/or repairs recommended to help prevent freezing or breaking of pipes.

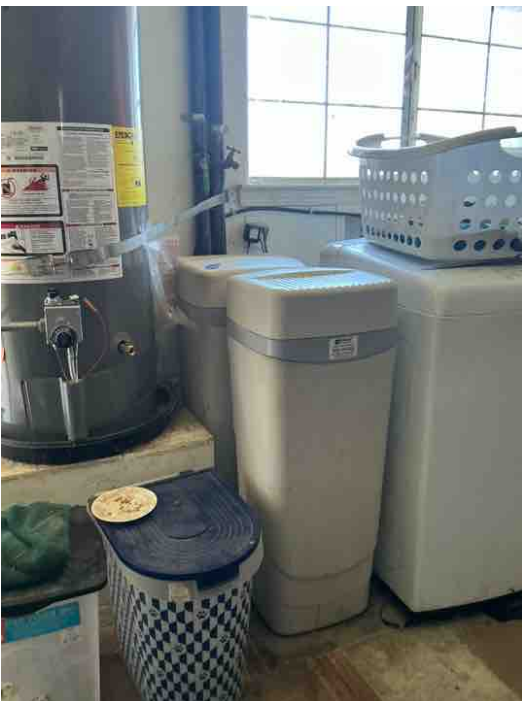
MR DS 89: Water softener installed in the Garage
Water quality not tested. Water softeners require continuous and ongoing maintenance. Please read owner's manual for recommendations. Water softener not tested for operation.

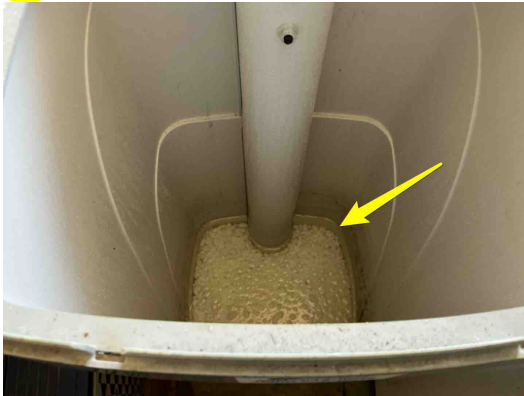
MR 90: Recommend servicing water softener. Water softener found low on salt and dirty.

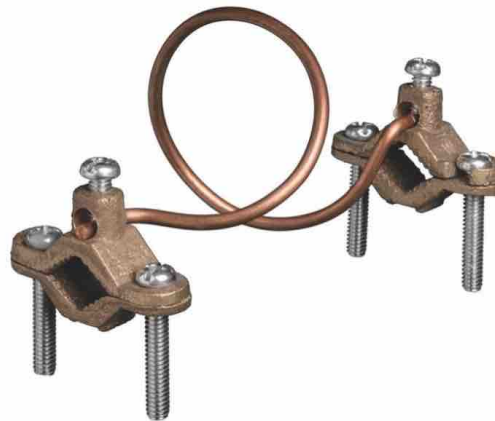
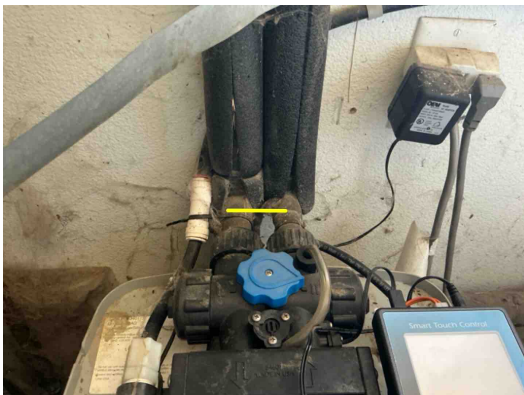
SC 91: Missing a proper bond jumper (ground connection) across the water softener pipes due to the plastic water valve assembly.

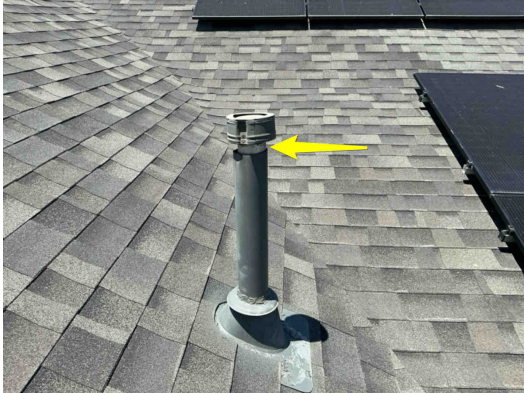
E&C 103: The water heater "B" vent double-wall type pipe found to have a damaged and disconnected interior sleeve. Contact a qualified plumbing professional to replace the damaged section of water heater and pipe for safety.

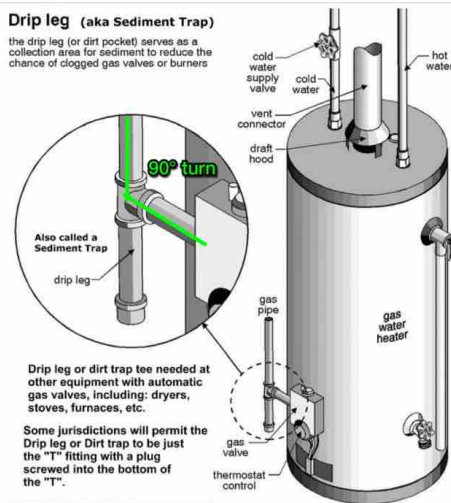
SU 106: Recommend the installation of the missing sediment trap / drip leg at the WATER HEATER gas piping at flex connection by a certified or licensed plumbing professional familiar with minimum requirements. [CPC 1212.8]

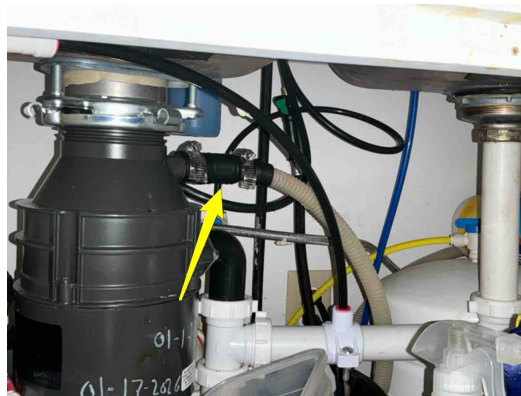
SU 115: Improper installation of the dishwasher drain hose. Missing the Air Gap Device at the dishwasher drain per minimum codes and standards (California does not allow for high-loop methods or direct waste connections). {CPC 801.2}

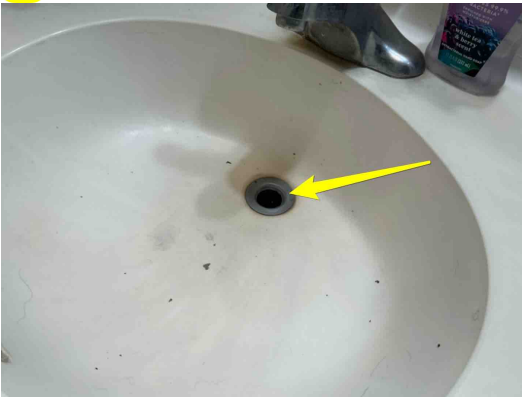
MR 141: The bathroom sink drain stopper missing: HALLWAY BATHROOM

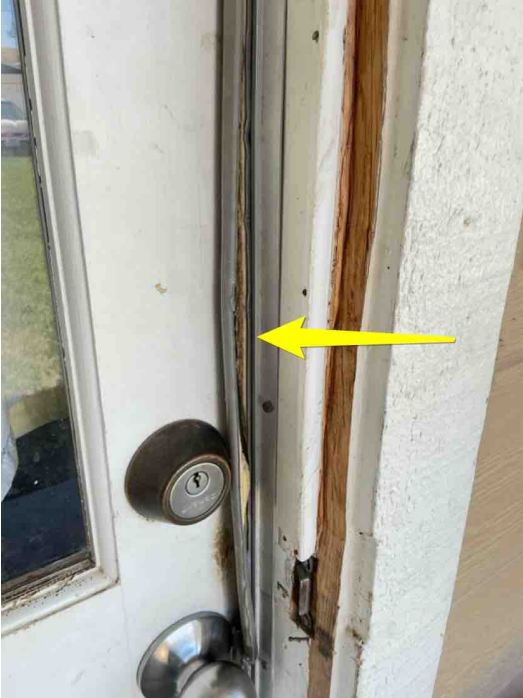
MR 151: Damaged weather stripping at the FRONT ENTRY DOOR.

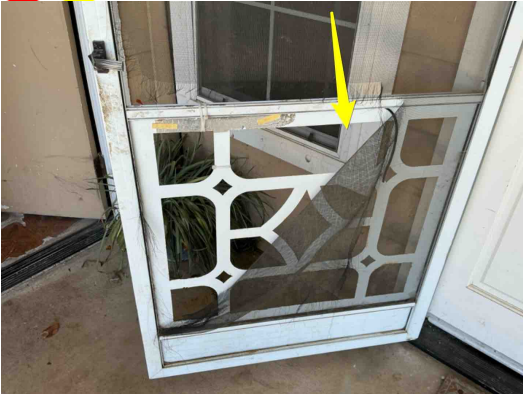
E&C MR 152: Damaged screen found at the front entry door.

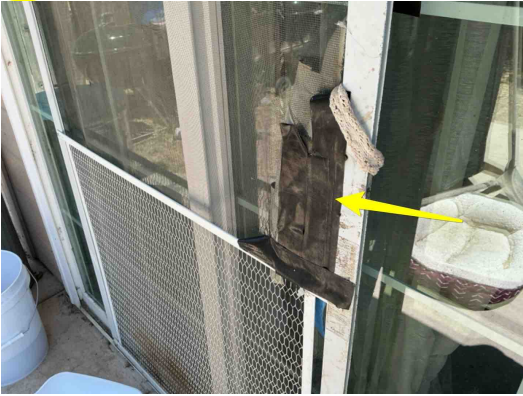
MR 155: Damaged screen at the DINING AREA exterior sliding glass door.

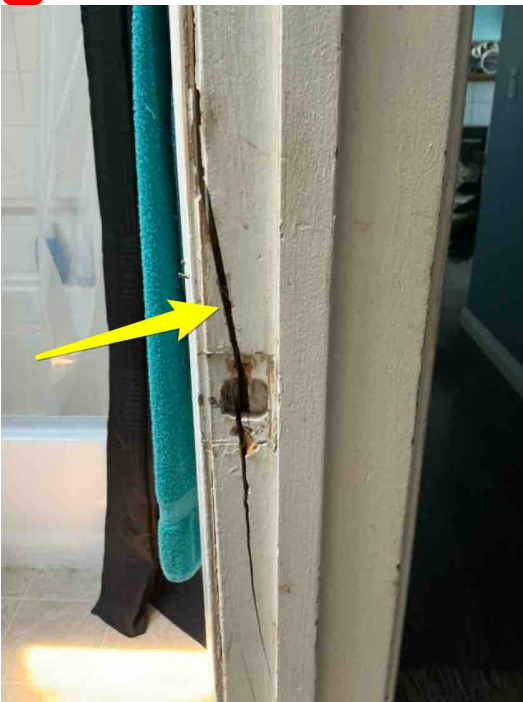
E&C 158: Interior door jamb found damaged: HALLWAY BATHROOM

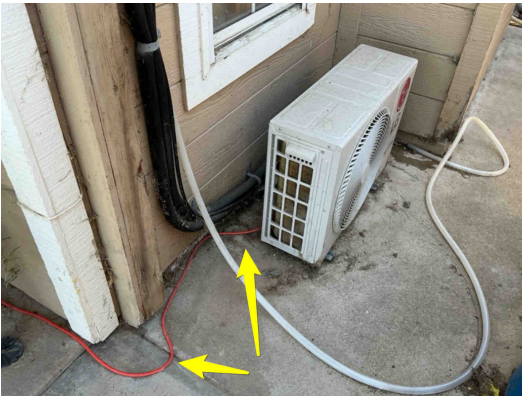
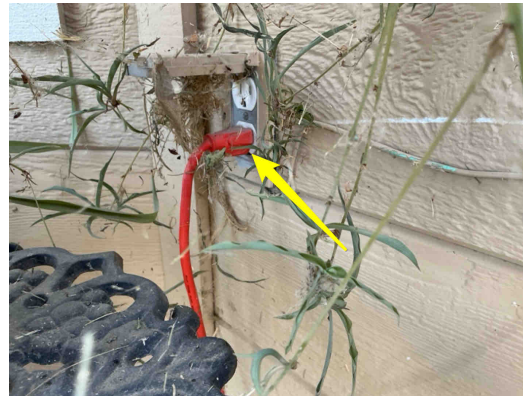
E&C FI 182: Permanently installed HVAC equipment is generally required to be installed in accordance with the manufacturer's installation instructions (CRC/CEC and NEC 110.3(B)). The installation does not appear consistent with typical LG manufacturer requirements for a dedicated branch circuit and approved disconnecting means for permanently installed HVAC equipment. Compliance with the manufacturer's installation instructions could not be verified. Improper power-supply methods may present safety, reliability, and servicing concerns. Recommend evaluation and correction by a licensed HVAC contractor and qualified electrical contractor.

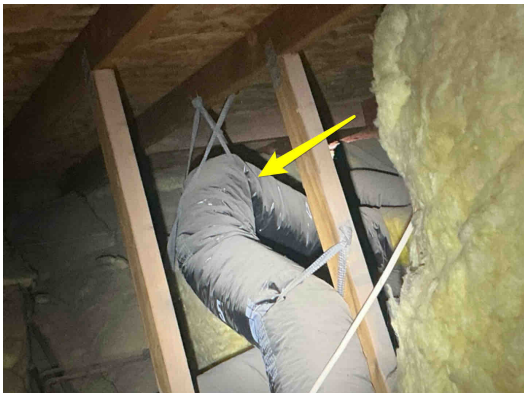
E&C 190: Areas of the heating ducting in the attic found kinked or over-bent limiting intended air flow. Corrections recommended.

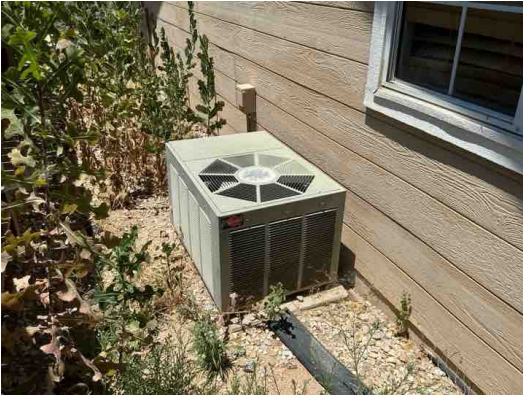
E&C 194: AIR CONDITIONING CONDITION: The air conditioner did not function when tested. Recommend further evaluation, opinion and repairs by a qualified HVAC professional.

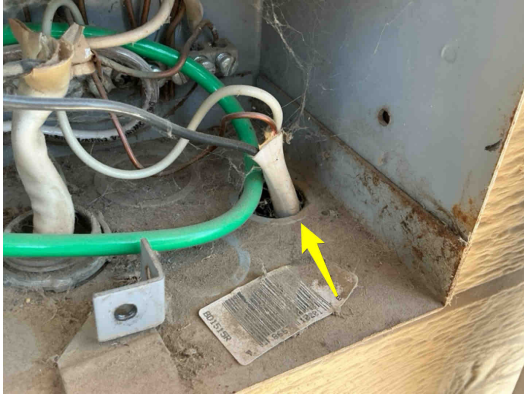
SU 197: Missing a bushing clamp as wires are passing into the metal MAIN ELECTRICAL PANEL. Wires are improperly rubbing on the sharp metal edge of the electrical panel as they pass through.

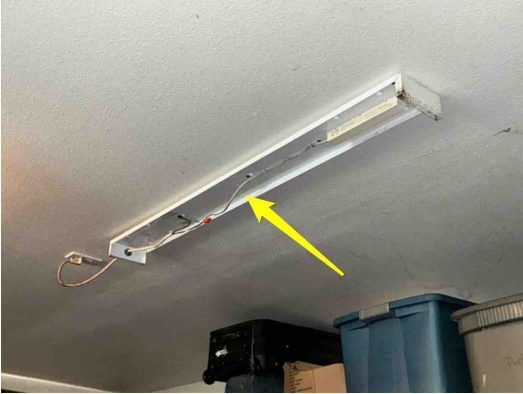
SC 203: A damaged light fixture found in the: GARAGE. Replacement needed.

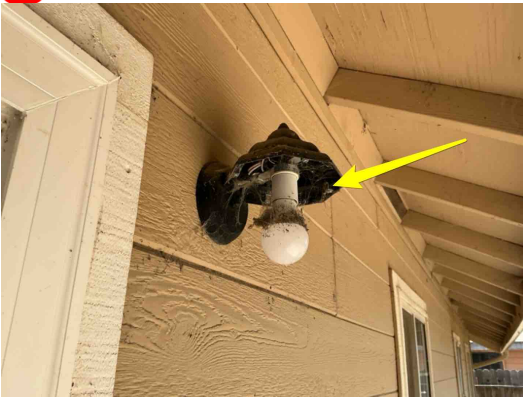
E&C 204: Lens at light fixture is missing: EXTERIOR AT BACKYARD PATIO

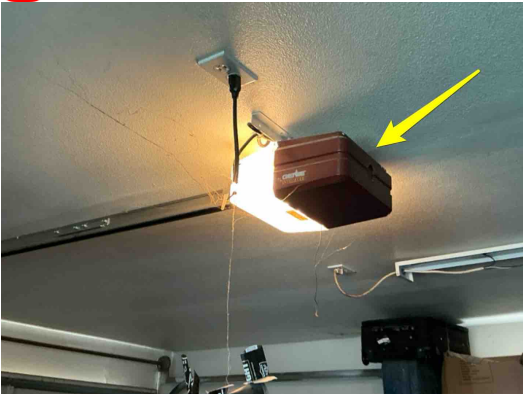
E&C 219: The garage vehicle door auto opener did not operate properly when tested. Servicing or repair warranted.

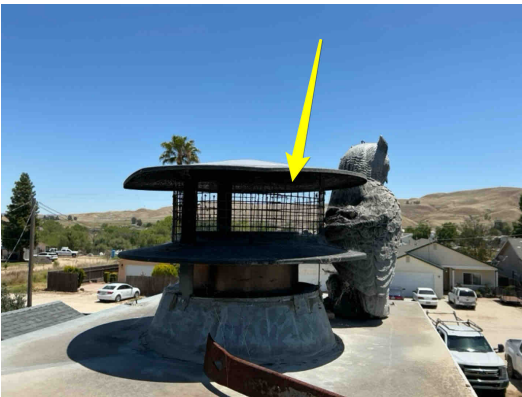
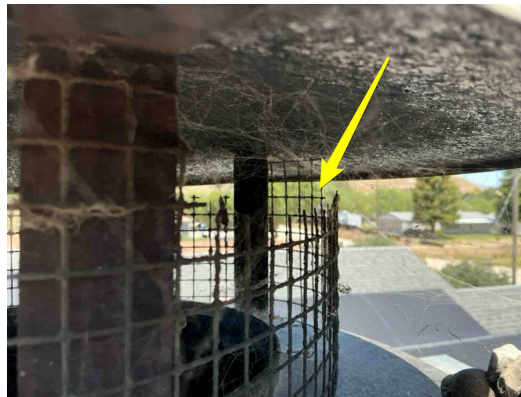
E&C 227: The spark screen found rusted, deteriorated and/or damaged atop the LIVING ROOM fireplace chimney. Recommend replacement for fire safety. Contact a qualified professional.

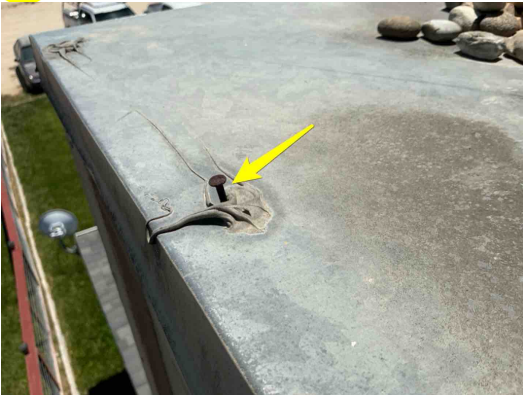
MR 229: Recommend resealing the fasteners at the metal fireplace chimney chase cap.

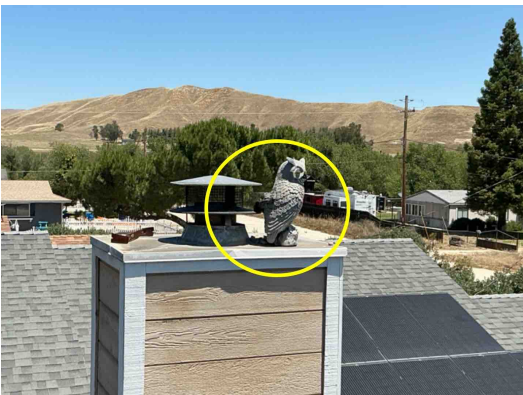
E&C SC 230: Improper installation of a plastic owl on the fireplace chimney chase near the cap as a bird deterrent device. The plastic owl is melted with evidence of a small past fire. Removal warranted for safety.
