# WOOD DESTROYING PESTS AND ORGANISMS INSPECTION REPORT

| Building No. | Street | City | Zip | Date of Inspection | Number of Pages |
|---|---|---|---|---|---|
| 2832 | E Virginia Avenue | Anaheim | 92806 | 07/09/2026 | 1 of 5 |

| | <b>Bord's Termite &amp; Construction</b><br><b>28870 Canyon Hts.</b><br><b>Trabuco Canyon 92679</b><br><b>949-463-6143</b><br><b>Registration No. PR9368</b> | <b>Report Number: 451314</b> |

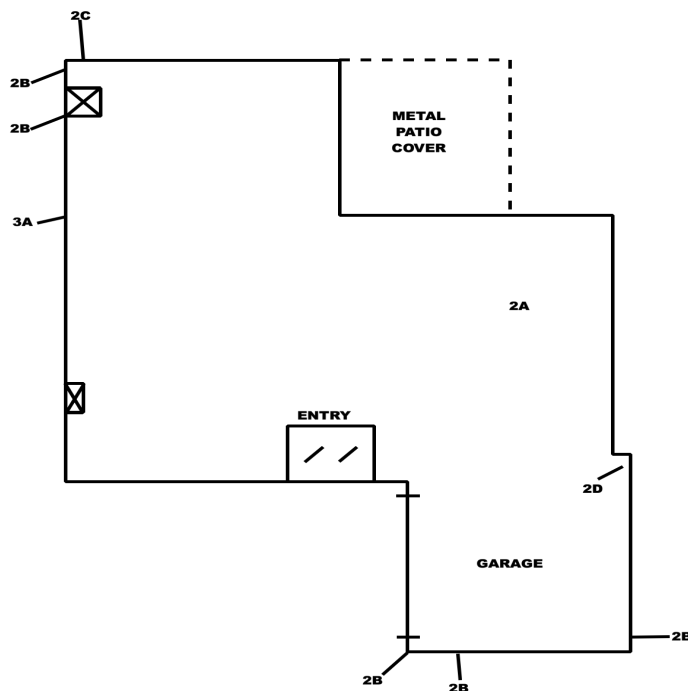
Key: 1 = Subterranean Termites    2 = Drywood Termites    3 = Fungus/Dryrot    4 = Other Findings    5 = Further Inspection  
 DRAWING NOT TO SCALE

| Item | Finding | Recommendation |
|---|---|---|
| 2A | Evidence of drywood termites identified at attic framing Section I | (LOCALIZED TREATMENT):<br>1.)Drill and chemically treat visible and accessible infestation(s) with a state registered termiticide, (Termidor SC). ***TWO YEAR WARRANTY OF LOCAL TREATMENT*** at genereal treated area(s)<br><br>Chemical to be used: Termidor® SC Termiticide/Insecticide |
| 2B | Evidence of drywood termite damage identified at rafter tail Section I | 1.)Drill and chemically treat visible and accessible infestation(s) with a registered termicide, (Termidor SC) at surrounding area(s). 2.)Repair damage with an exterior grade wood filler. 3.)Sand and primer area. Chemical to be used: Termidor® SC Termiticide/Insecticide |
| 2C | Evidence of drywood termite damage identified at outlooker Section I | 1.)Drill and chemically treat visible and accessible infestation(s) with a registered termicide, (Termidor SC) at surrounding area(s). 2.)Repair damage with an exterior grade wood filler. 3.)Sand and primer area. *** SEE 2B FOR PRICE ***<br>Chemical to be used: Termidor® SC Termiticide/Insecticide |
| 2D | Evidence of drywood termites identified at garage framing Section I | (LOCALIZED TREATMENT):<br>1.)Drill and chemically treat visible and accessible infestation(s) with a state registered termiticide, (Termidor SC). ***TWO YEAR WARRANTY OF LOCAL TREATMENT*** at genereal treated area(s)<br><br>***SEE 2A FOR PRICE*** Chemical to be used: Termidor® SC Termiticide/Insecticide |
| 3A | Evidence of fungus damage identified at fascia board due to a past roof leak Section I | 1.)Scrape all damage from wood, treat infection(s) with a state registered fungicide, (Timbor).<br>2.)Repair damage with a fiberglass filler.<br>3.)Sand and primer repair.<br>4.)***OWNER TO SUPPLY MATCHING PAINT***, Paint repair to Match. Chemical to be used: Tim-bor® Borate wood preserv., insect/fungicide |
