# SB - 326 INSPECTION REPORT

Inspection location : 1324 - 1328 Iris Avenue Imperial Beach, CA 91932

Dear Sea Breeze Gardens HOA,

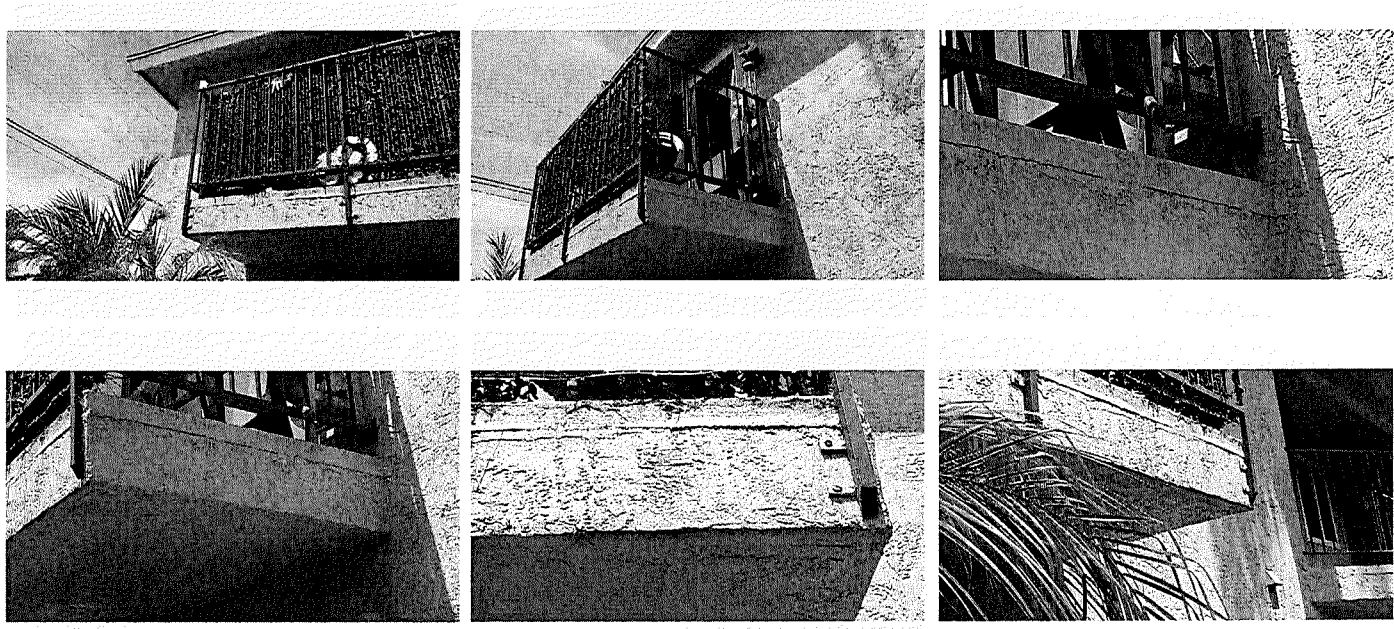
Location 1324 - Unit 4

EEE's Description Balcony

RECOMMENDATIONS: No Access.

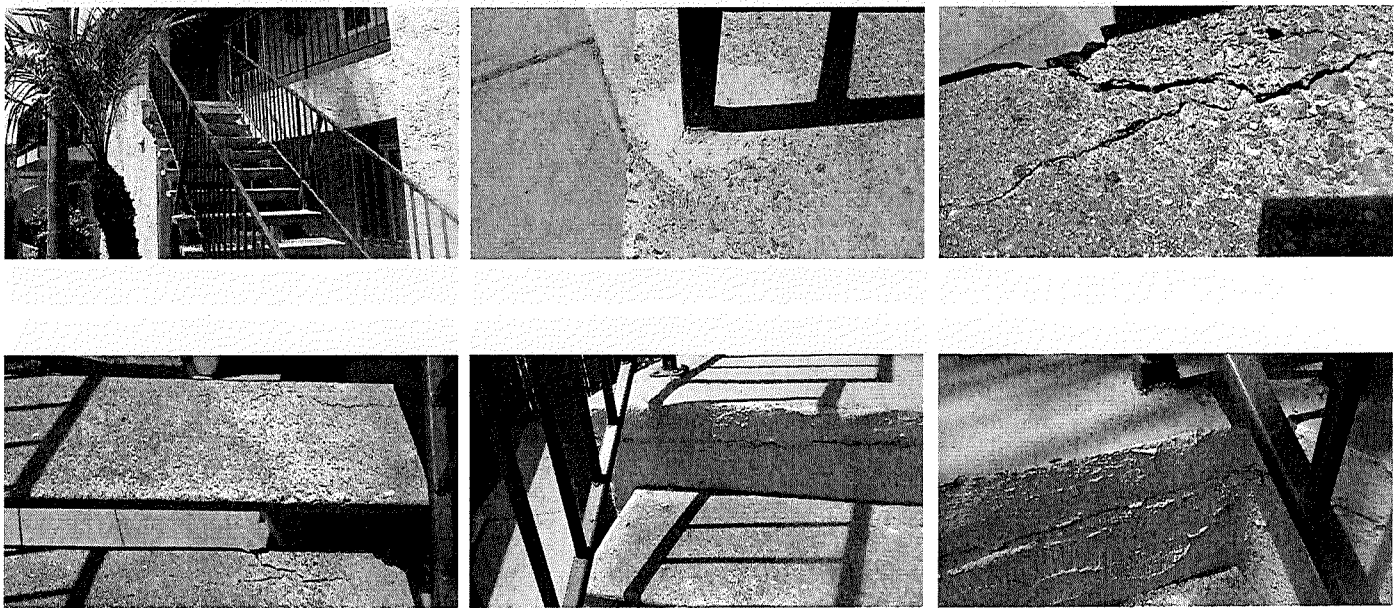
Location 1324 - Unit 4

EEE's Description Staircase & Landing

- ☐ Structurally Sound
- ☒ Needs Attention
- ☐ Hazardous / Failing

- ☐ Satisfactory Service Life
- ☒ Reduce Service Life
- ☐ End of Life

RECOMMENDATIONS: Open deck at landing where cracks appear to inspect framing for dry rot. Replace affected framing as needed. Remove/replace all cracked pre-cast concrete treads.

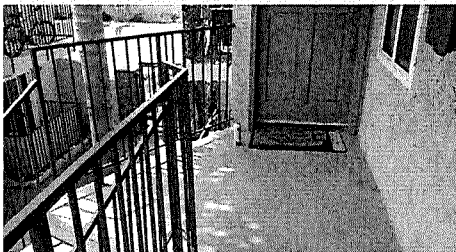
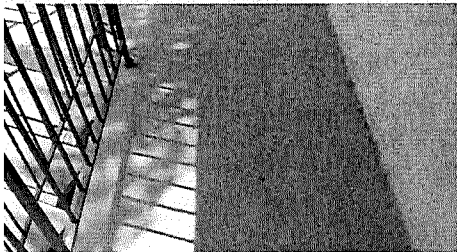
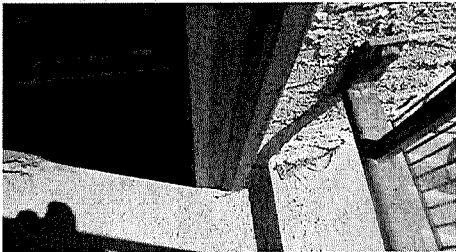
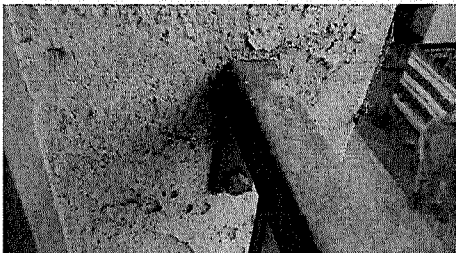
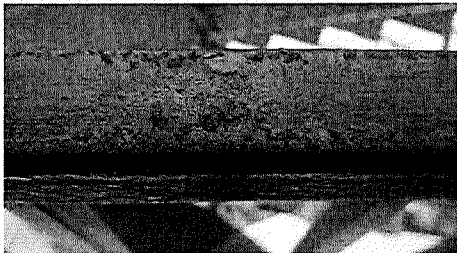
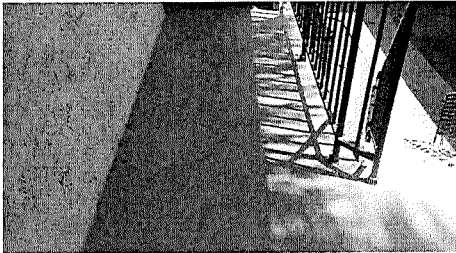
**Location** 1324 - Unit 4 - 5

**EEE's Description** Walkway

- ☐ Satisfactory Service Life
- ☒ Reduce Service Life
- ☐ End of Life

- ☐ Structurally Sound
- ☒ Needs Attention
- ☐ Hazardous / Failing

**RECOMMENDATIONS:** Sand, primer & paint railings to inhibit rust and prevent further corrosion.

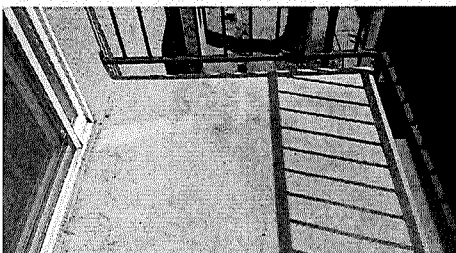
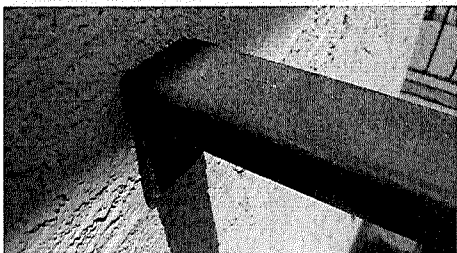
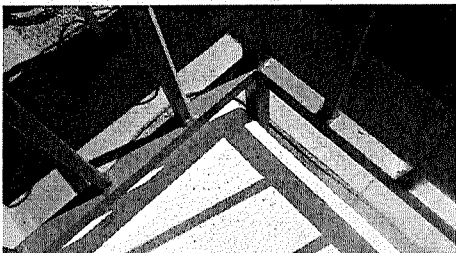
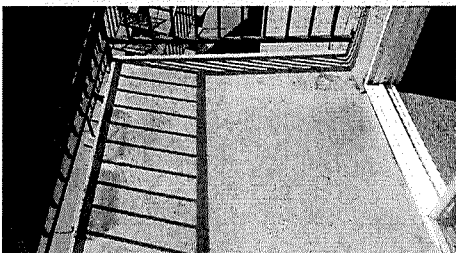
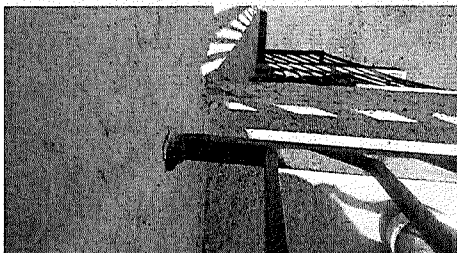
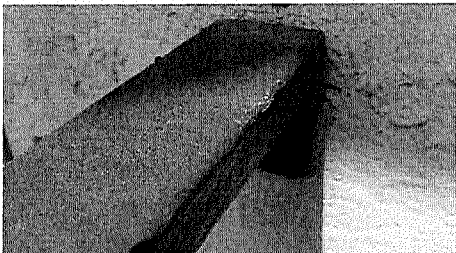
**Location** 1324 - Unit 5

**EEE's Description** Balcony

- ☒ Structurally Sound
- ☐ Needs Attention
- ☐ Hazardous / Failing

- ☒ Satisfactory Service Life
- ☐ Reduce Service Life
- ☐ End of Life

**RECOMMENDATIONS:** None.

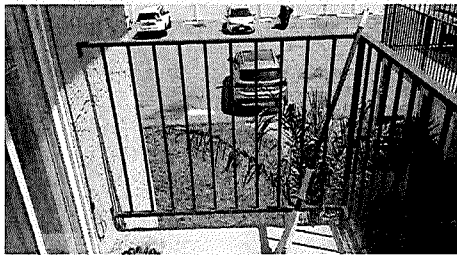
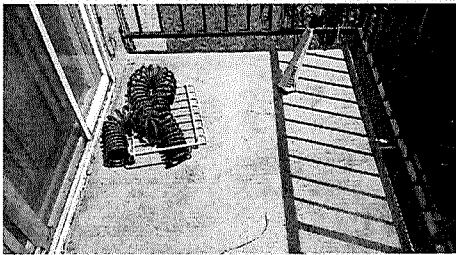
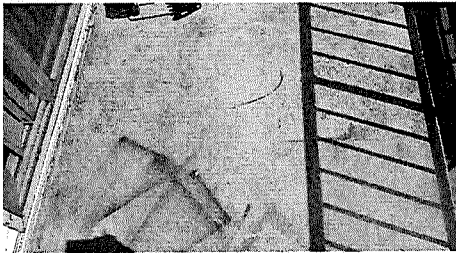
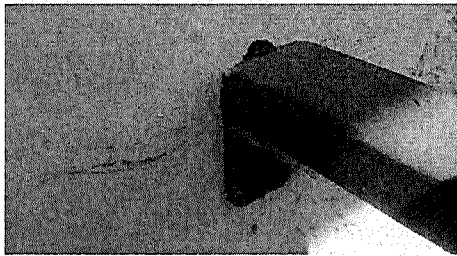
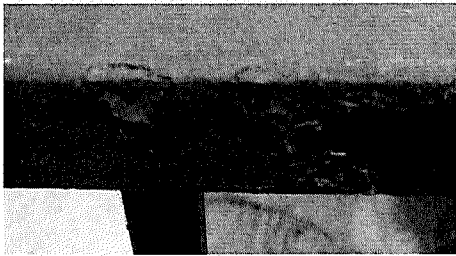
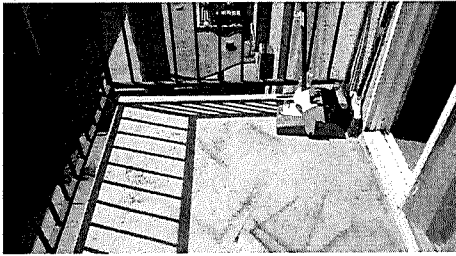
**Location** 1324 - Unit 6

**EEE's Description** Balcony

- ☐ Satisfactory Service Life
- ☒ Reduce Service Life
- ☐ End of Life

- ☐ Structurally Sound
- ☒ Needs Attention
- ☐ Hazardous / Failing

**RECOMMENDATIONS:** Sand, primer & paint railings to inhibit rust and prevent further corrosion.

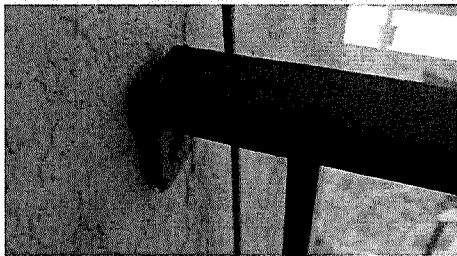
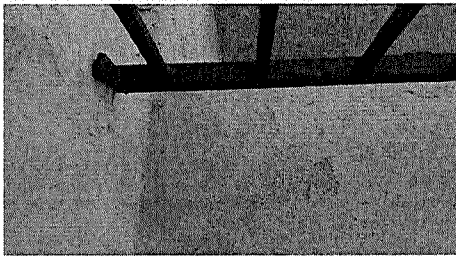
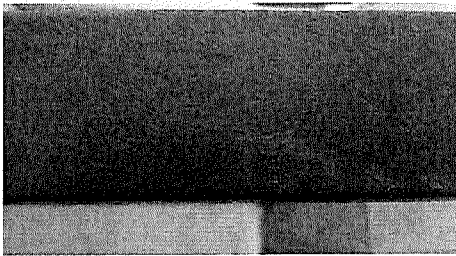
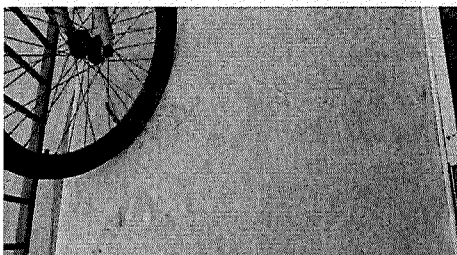
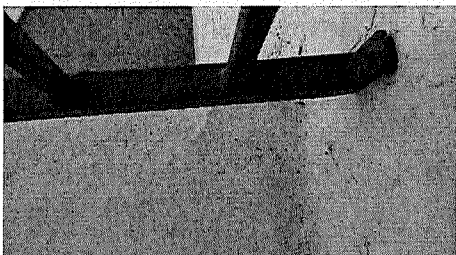
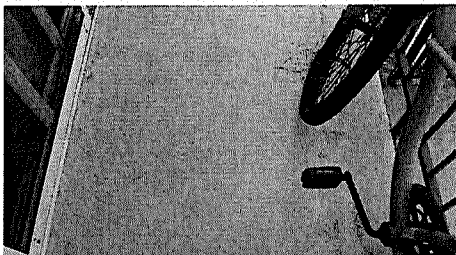
**Location** 1328 - Unit 4

**EEE's Description** Balcony

- ☒ Structurally Sound
- ☐ Needs Attention
- ☐ Hazardous / Failing

- ☒ Satisfactory Service Life
- ☐ Reduce Service Life
- ☐ End of Life

**RECOMMENDATIONS:** None.

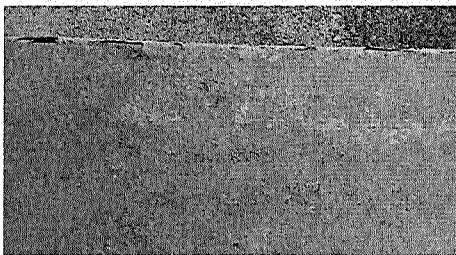
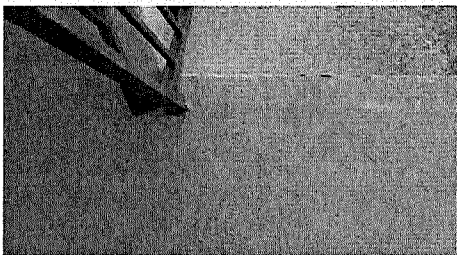
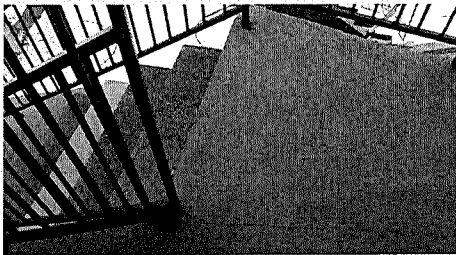
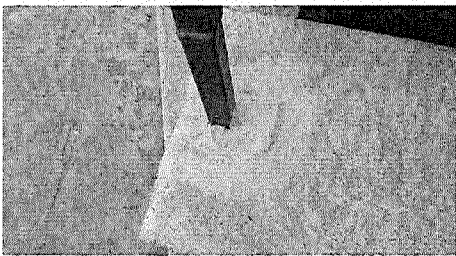
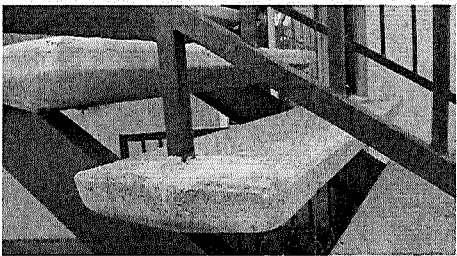
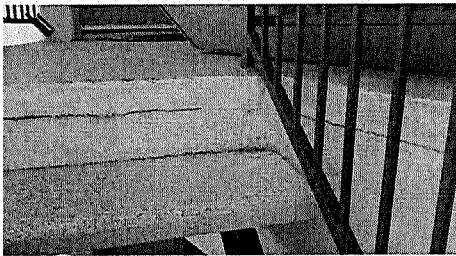
Location 1328 - Unit 4

EEE's Description Staircase & Landing

- ☐ Structurally Sound
- ☒ Needs Attention
- ☐ Hazardous / Failing

- ☐ Satisfactory Service Life
- ☒ Reduce Service Life
- ☐ End of Life

RECOMMENDATIONS: Open deck at landing where cracks appear to inspect framing for dry rot.  
Replace affected framing as needed.

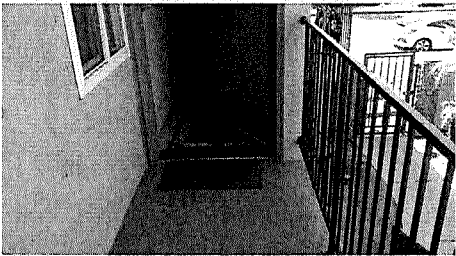
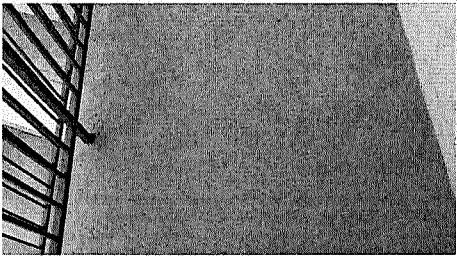
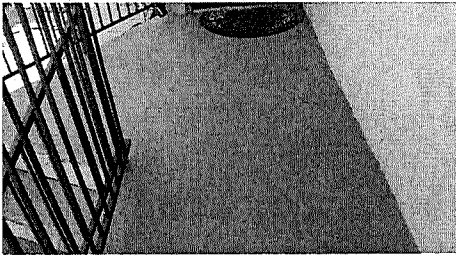
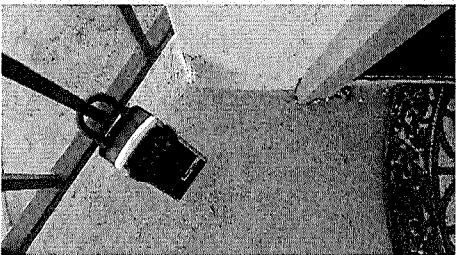
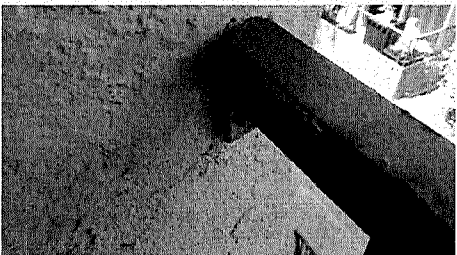
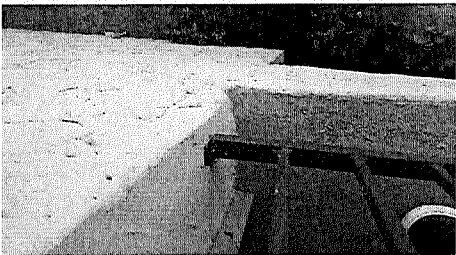
Location 1328 - Unit 4 - 5

EEE's Description Walkway

- ☒ Structurally Sound
- ☐ Needs Attention
- ☐ Hazardous / Failing

- ☒ Satisfactory Service Life
- ☐ Reduce Service Life
- ☐ End of Life

RECOMMENDATIONS: None.

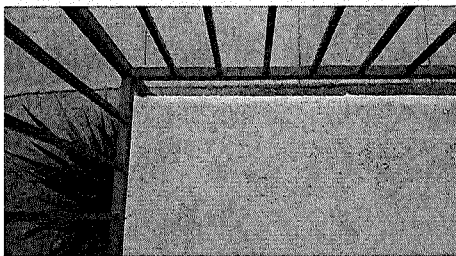
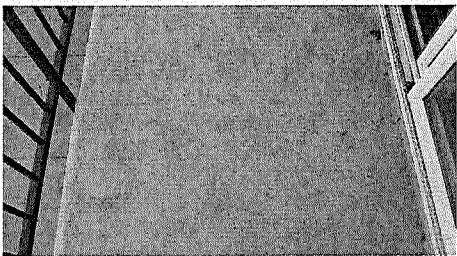
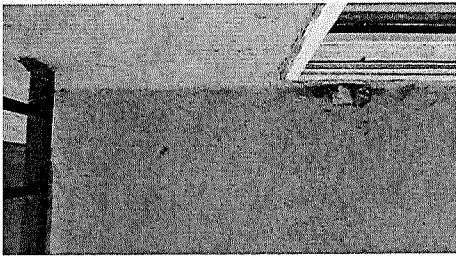
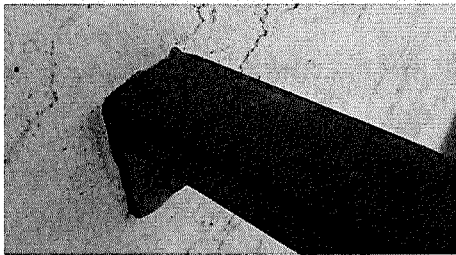
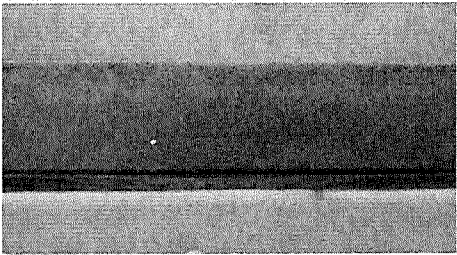
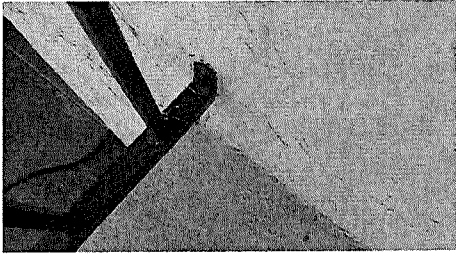
Location 1328 - Unit 5

EEE's Description Balcony

- ☐ Satisfactory Service Life  
☒ Reduce Service Life  
☐ End of Life

- ☒ Structurally Sound  
☒ Needs Attention  
☐ Hazardous / Failing

RECOMMENDATIONS: Sand, primer & paint railings to inhibit rust and prevent further corrosion.

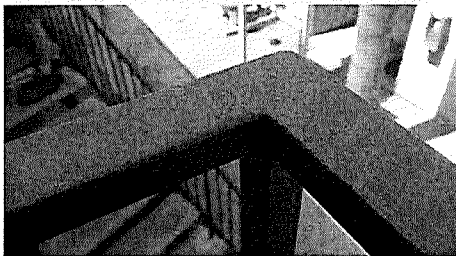
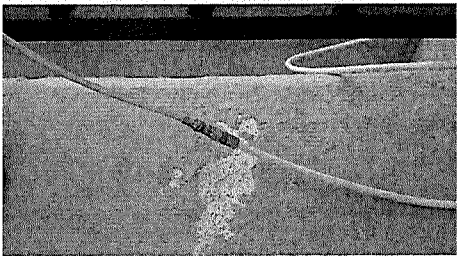
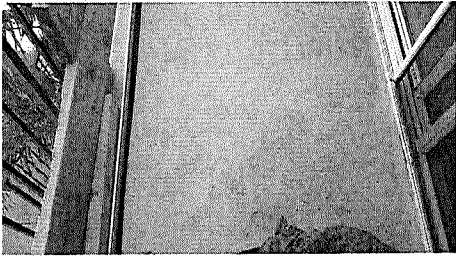
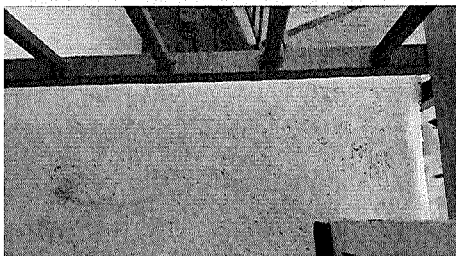
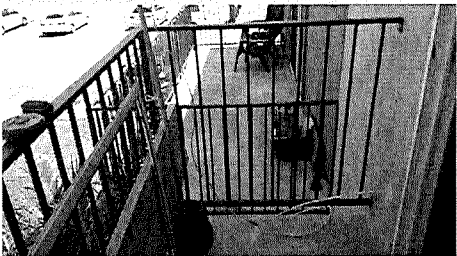
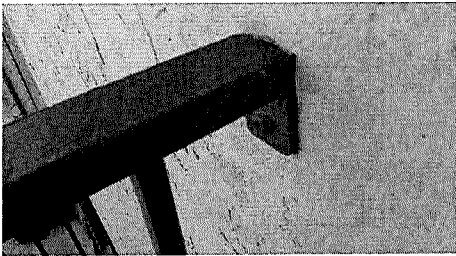
Location 1328 - Unit 6

EEE's Description Balcony

- ☒ Structurally Sound  
☒ Needs Attention  
☐ Hazardous / Failing

- ☐ Satisfactory Service Life  
☒ Reduce Service Life  
☐ End of Life

RECOMMENDATIONS: Apply new waterproof deck coating as per manufacturer specifications.

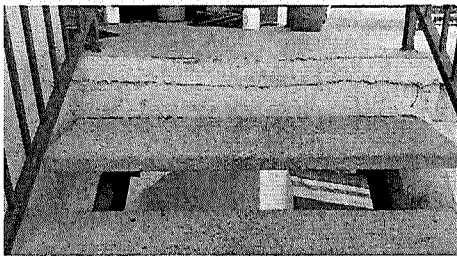
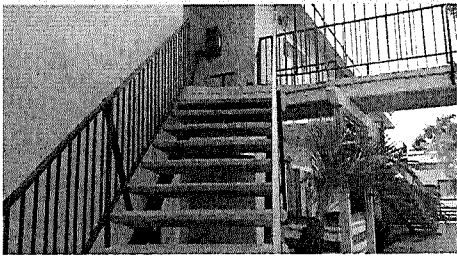
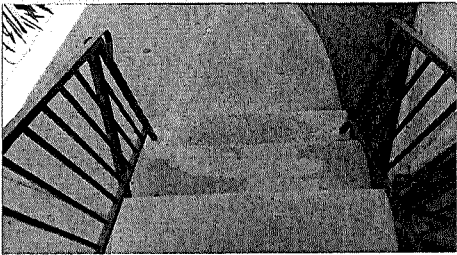
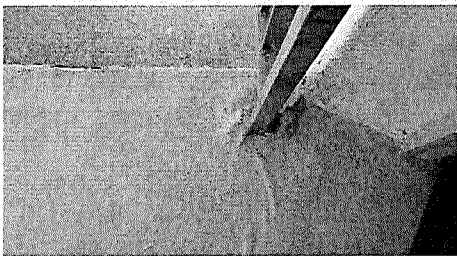
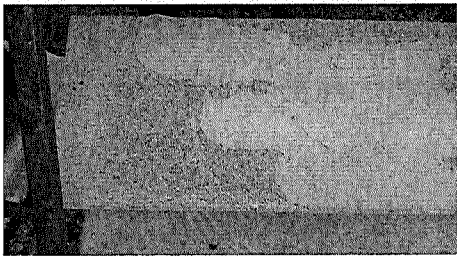
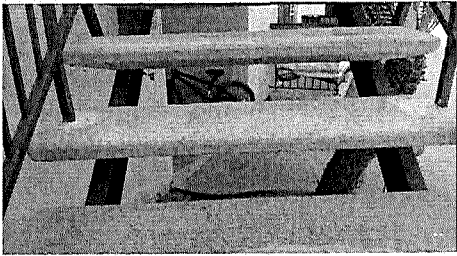
Location 1328 - Unit 6

EEE's Description Staircase & Landing

- ☐ Structurally Sound  
☒ Needs Attention  
☐ Hazardous / Failing

- ☐ Satisfactory Service Life  
☒ Reduce Service Life  
☐ End of Life

RECOMMENDATIONS: Open deck at landing and where deck is bubbling to inspect framing for dry rot.  
Replace affected framing as needed. Remove/ replace all cracked pre-cast concrete treads on staircase.

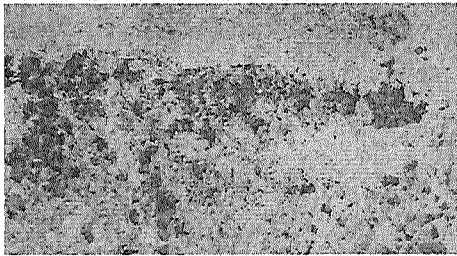
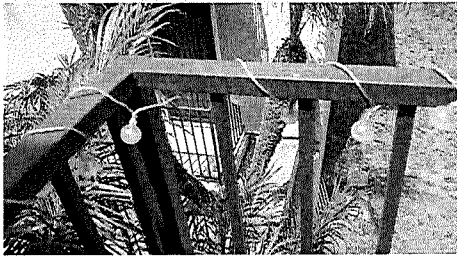
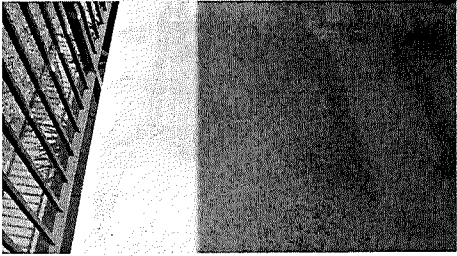
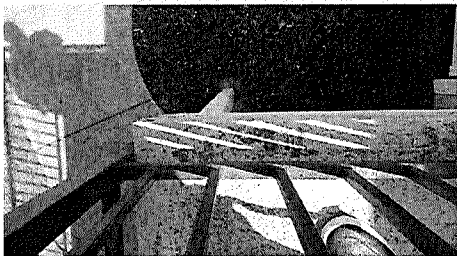
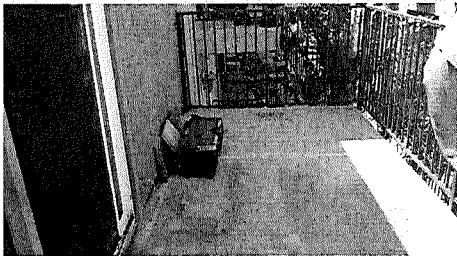
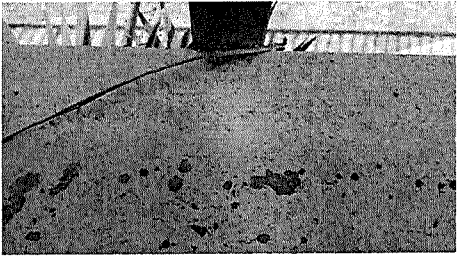
Location 1328 - Unit 7

EEE's Description Balcony

- ☒ Structurally Sound  
☒ Needs Attention  
☐ Hazardous / Failing

- ☐ Satisfactory Service Life  
☒ Reduce Service Life  
☐ End of Life

RECOMMENDATIONS: Apply new waterproof deck coating as per manufacturer specifications.
