# INSPECTION REPORT

**PROPERTY ADDRESS:**  
642 Lincolnville Avenue, Searsmont, ME 04973

| <b>Date:</b> 8/27/2026 | <b>Time:</b> 01:30 PM | <b>Report ID:</b> 2026082701 |

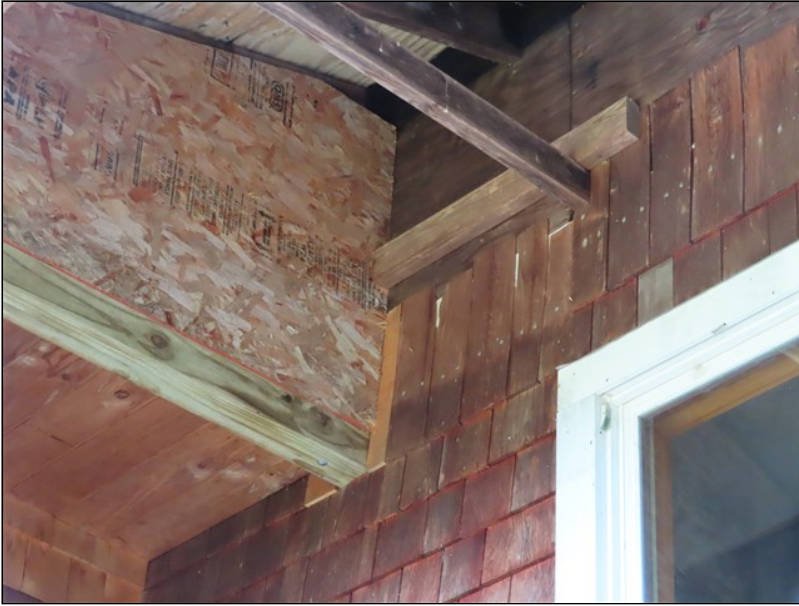
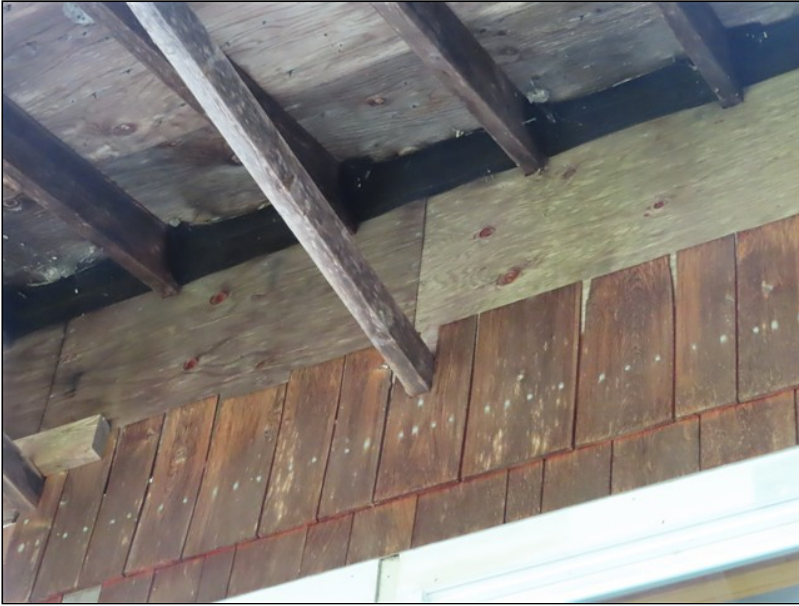
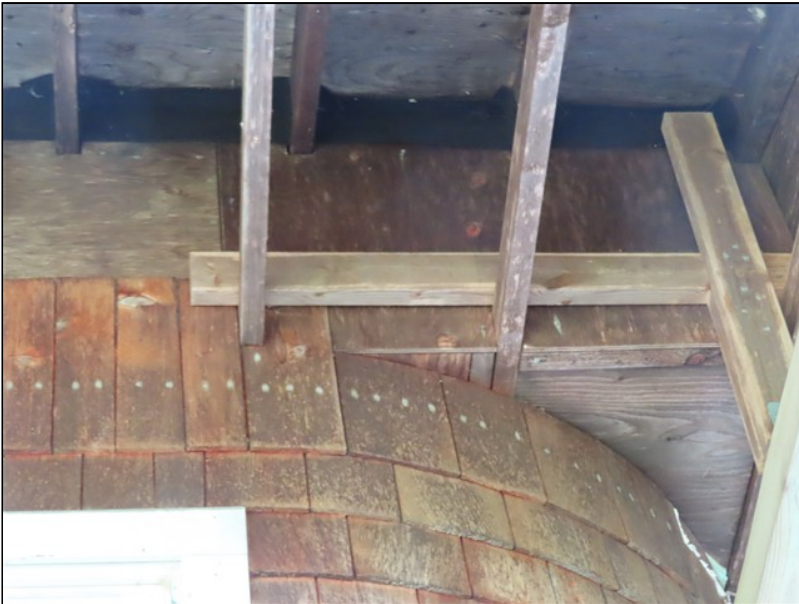
(2) Areas of the right side siding were missing. Siding on a building performs an important role in keep weather, moisture, and pests out of a building. It also helps protect the structure of the building from decay and damage. It is recommended that repairs be effected.

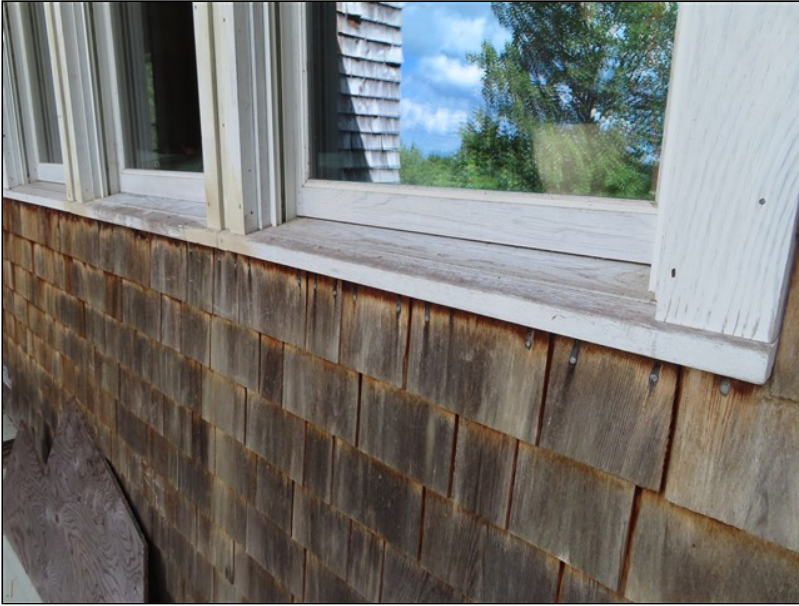
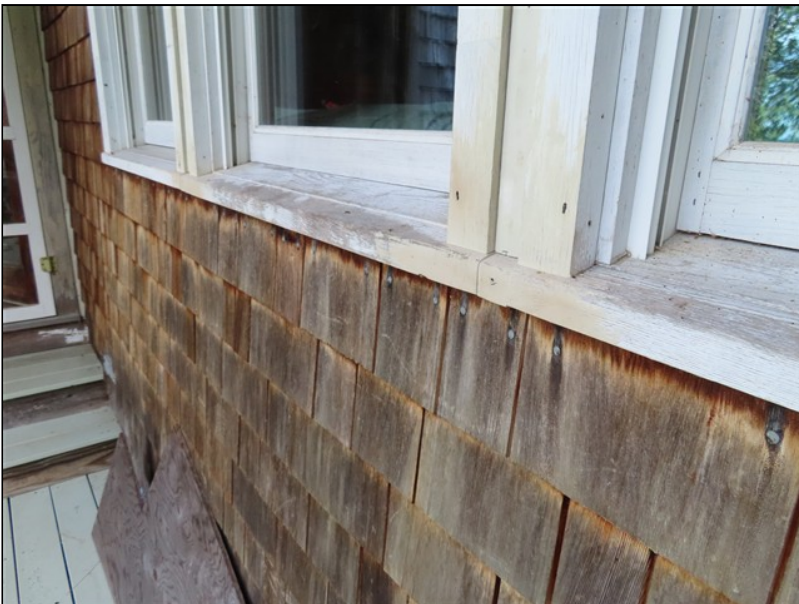
(2) Areas (substantial) of failing paint were noted with some window trim around the building. These issues should be addressed by removing the failing paint and repainting the affected areas. It should be noted that the exterior surfaces of the window trim that are painted wood and will require re-painting from time to time. While a simple task, it is necessary to help preserve the integrity of the surfaces. It is recommended that repairs be effected and that these tasks should be regarded as routine maintenance tasks. (Note: The photos are not an exhaustive list of the affected areas, but a representation.)

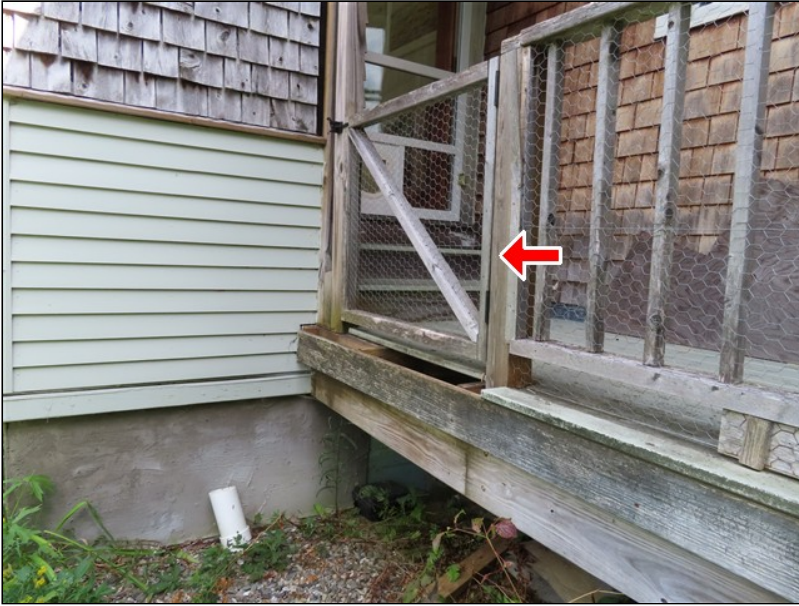
1.5 Item 4 (Picture) Right side

(2) The right side door is missing steps. Entrances to buildings that are more than 8 inches in height should have one or more steps. The absence of steps in this context is a potential safety hazard and should be repaired.

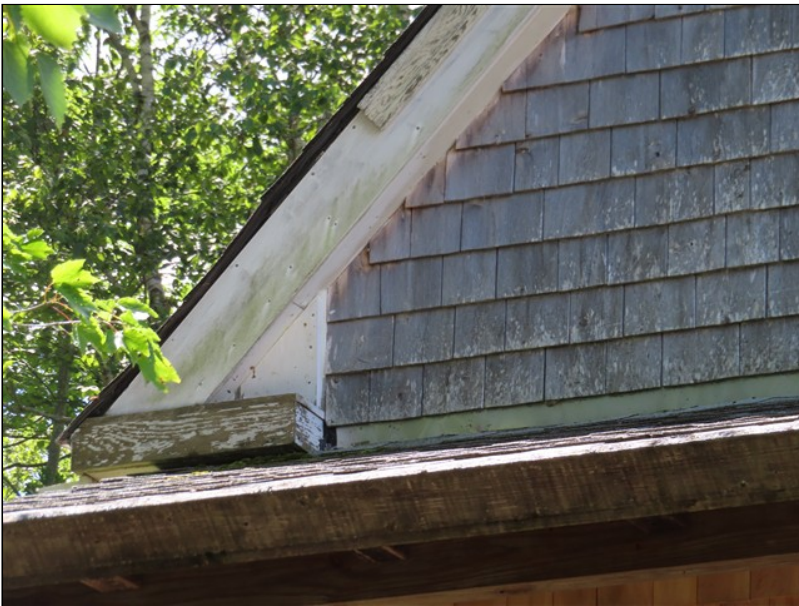
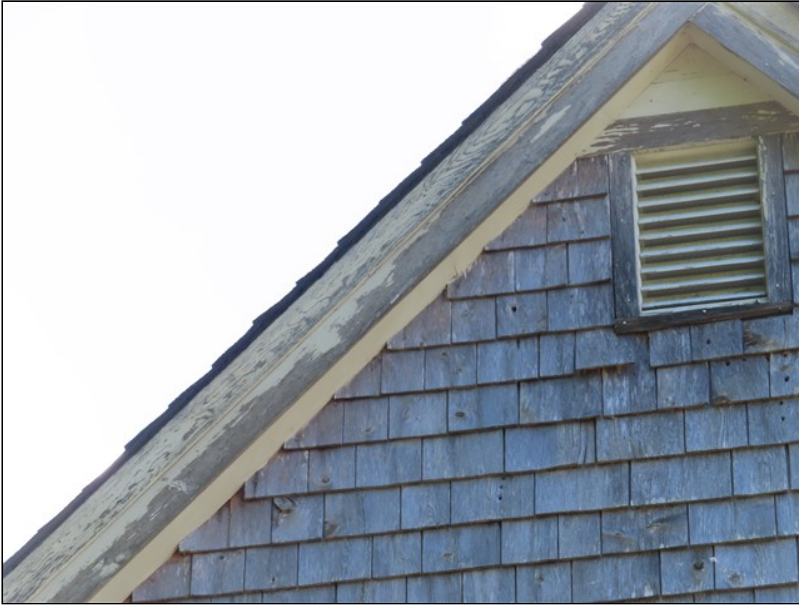
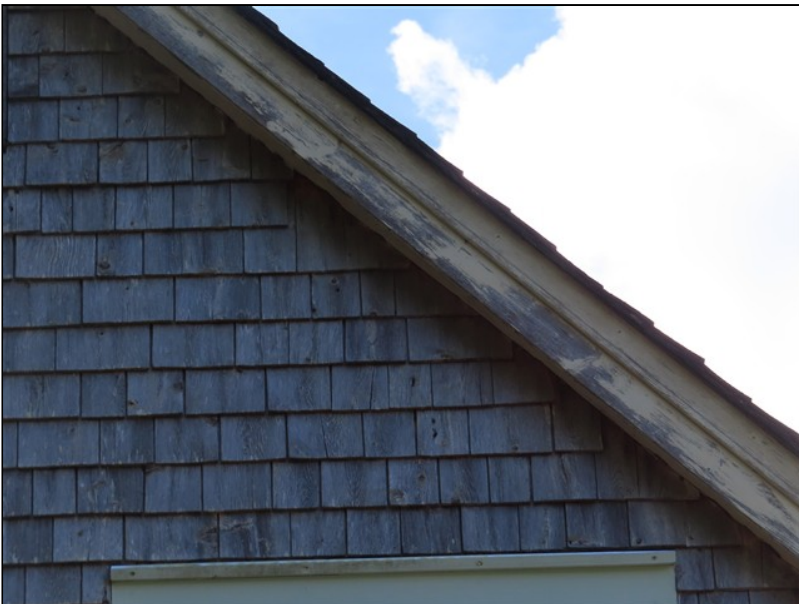
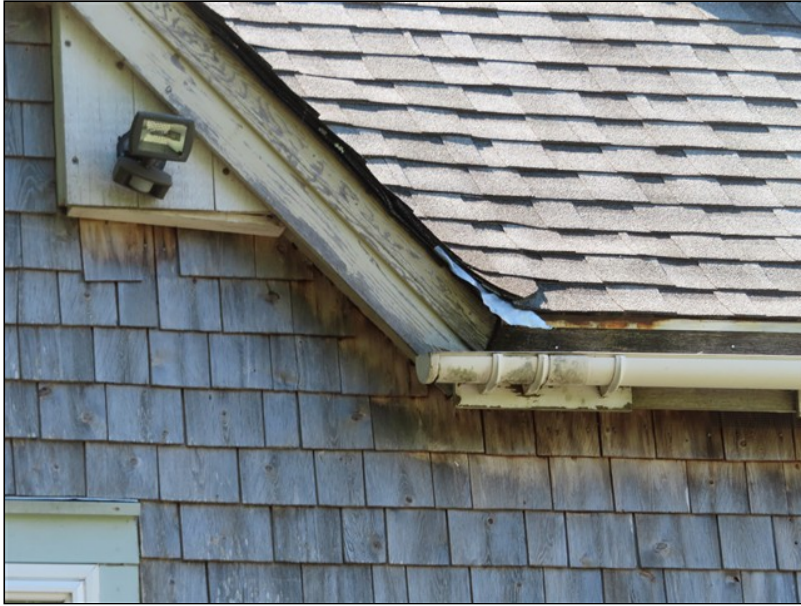
(1) A notable amount of failing and peeling paint was noted on the fascia. While this type of deterioration of the paint is not unexpected with wood trim, it does require periodic maintenance and repair. When left unattended, such areas can deteriorate and require significant repair and reconstruction. It is recommended that repair and maintenance of the wood and paint be considered as a regular ongoing maintenance activity and be attended to. (Note: The photos are not an exhaustive list of the affected areas, but a representation.)

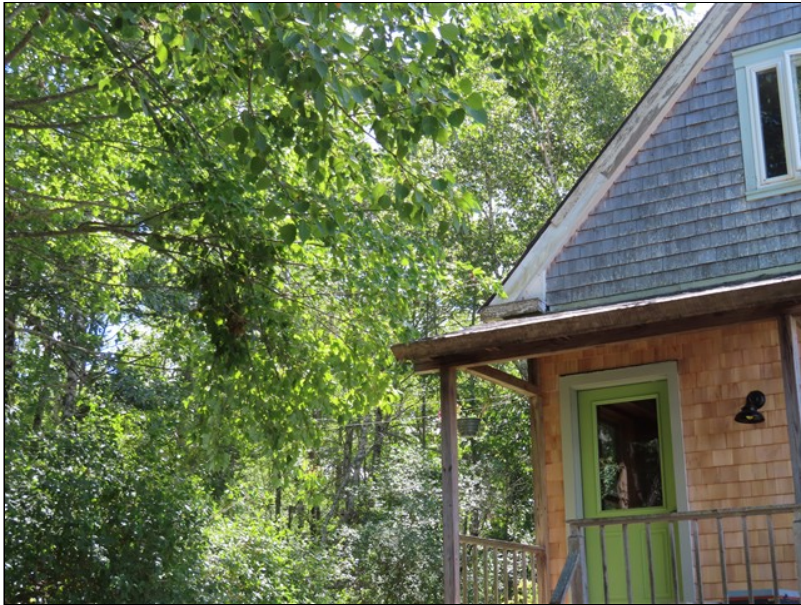
1.6 Item 5 (Picture) Left side

(5) Tree limbs were observed to be overhanging the roof. Vegetation and trees should not overhang roofs or structures as there is a risk of falling branches or debris damaging the underlying roof. Additionally, the fallen leaves and matter can accumulate on the roof leading the potential of roof deterioration and leaks. Finally, the potential added shade can allow moss and mildew to grow on the roof potentially leading to deterioration and leaks. The vegetation should be maintained so as not to overhang the structure. This should be regarded as a normal ongoing maintenance activity.

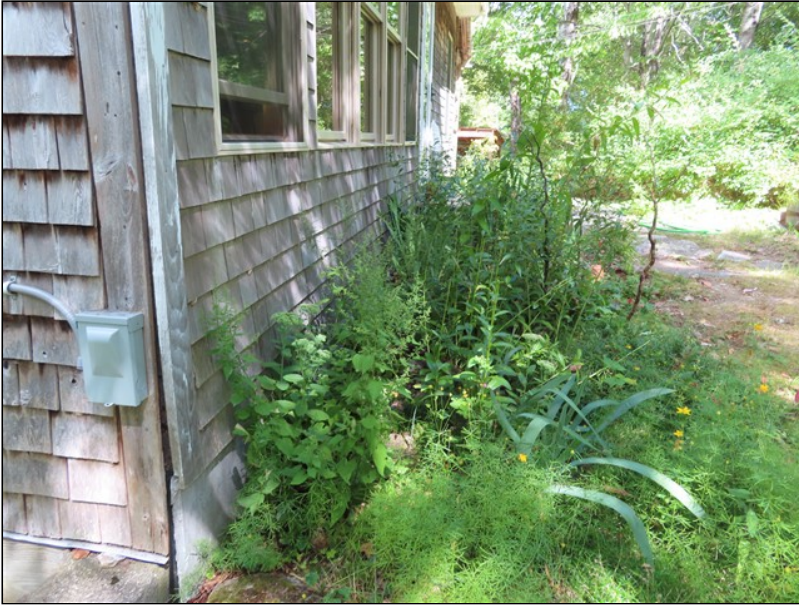
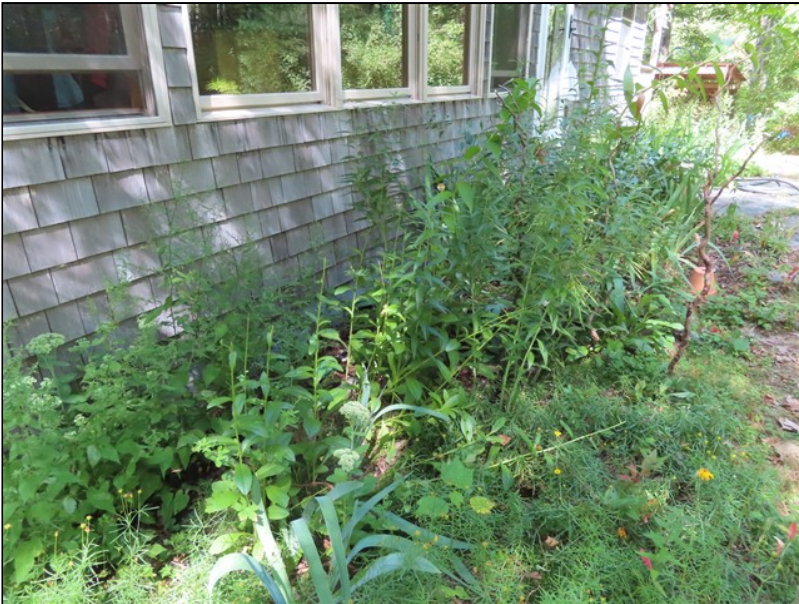
(6) Vegetation is in contact with the structure or foundation in one or more places. When vegetation is allowed to grow on to or touch a structure it can allow excessive moisture to build up in the area and also facilitate the entry of insects and pests to the structure. Moisture build-up can facilitate the growth of mold, mildew and rot. Vegetation should be kept trimmed and away from contact with buildings. This should be regarded as a normal ongoing maintenance activity.

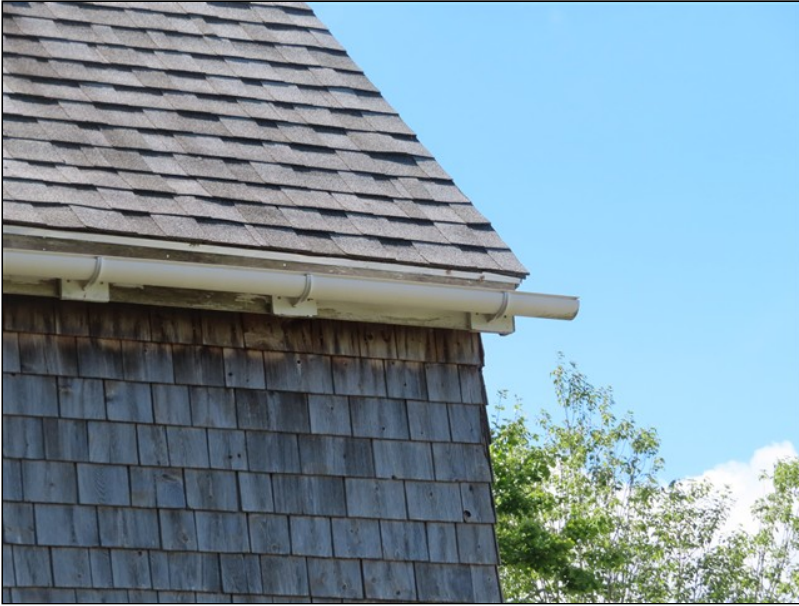
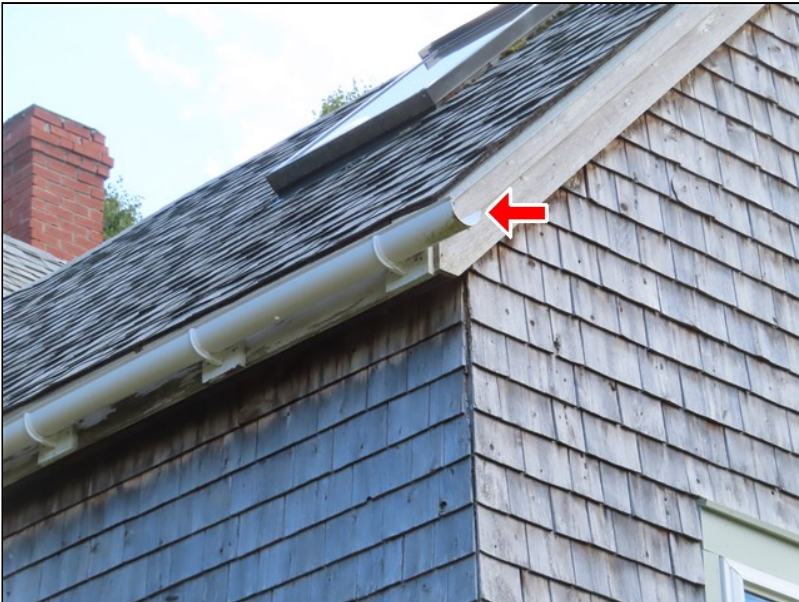
(1) The end cap is missing on the front gutter. Gutters should be in good working order in order to perform their intended function of directing water away the perimeter of the building. It is recommended that repairs be effected (and repairs be effected for all such occurrences).

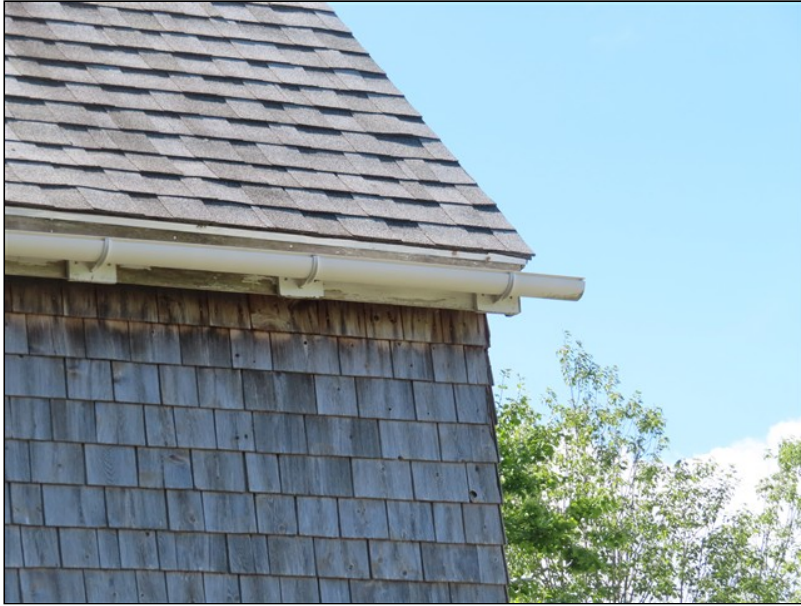
2.4 Item 3 (Picture) Front

(2) Downspouts were observed to be missing from one or more of the gutters. Downspouts are a critical part of the roof drainage system as they direct the water away from the structure. Inadequate downspouts can result in excessive moisture at the foundation of the structure that can cause structural deterioration. Repairs should be effected.

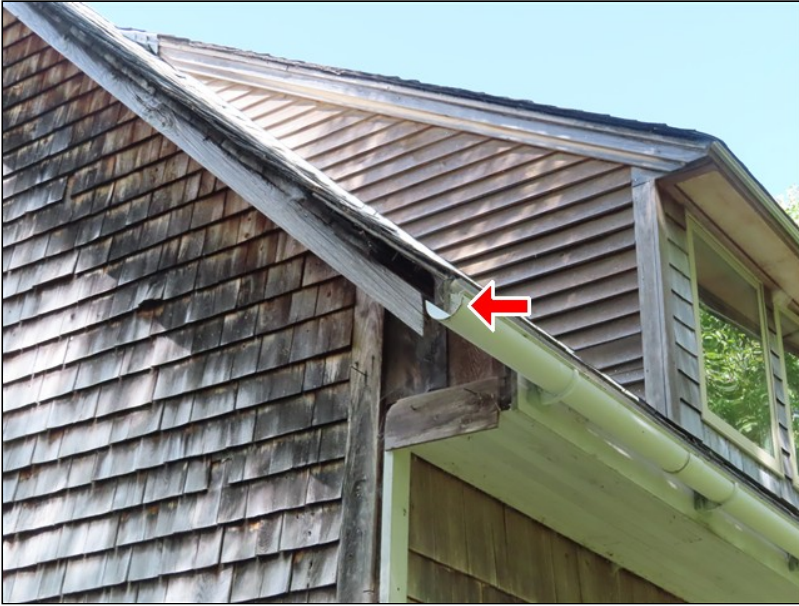
2.4 Item 5 (Picture) Left side

(3) The end cap is missing on the left side gutter. Gutters should be in good working order in order to perform their intended function of directing water away the perimeter of the building. It is recommended that repairs be effected (and repairs be effected for all such occurrences).

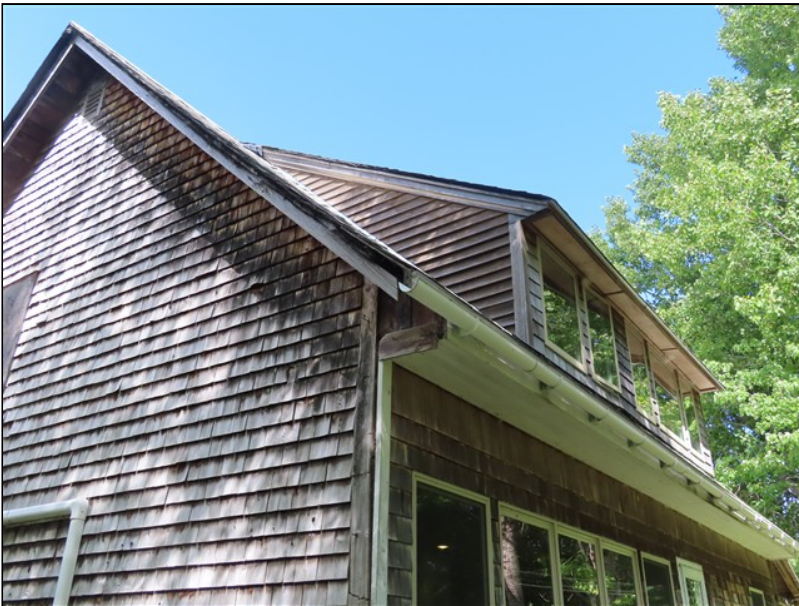
2.4 Item 6 (Picture) Left side

(4) Downspouts were observed to be missing from one or more of the gutters. Downspouts are a critical part of the roof drainage system as they direct the water away from the structure. Inadequate downspouts can result in excessive moisture at the foundation of the structure that can cause structural deterioration. Repairs should be effected.

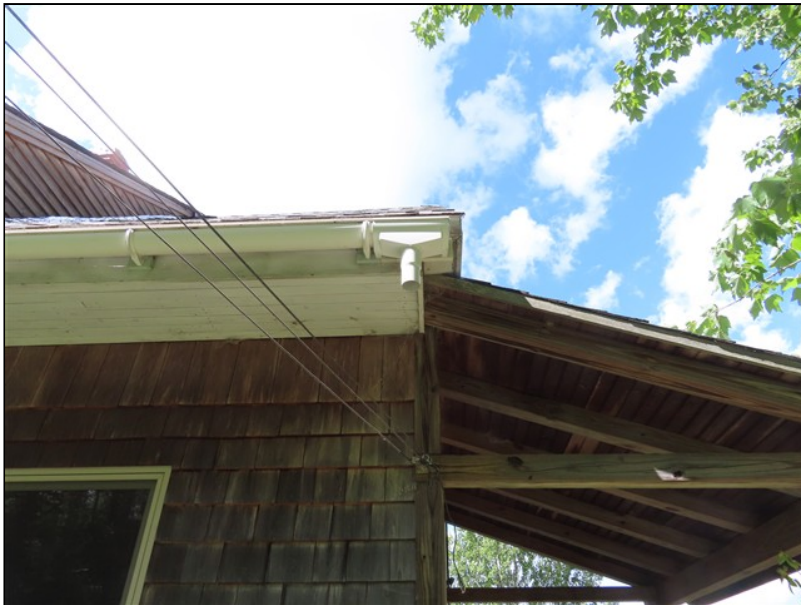
2.4 Item 8 (Picture) Left side

(5) Downspouts were observed to be missing from one or more of the gutters. Downspouts are a critical part of the roof drainage system as they direct the water away from the structure. Inadequate downspouts can result in excessive moisture at the foundation of the structure that can cause structural deterioration. Repairs should be effected.

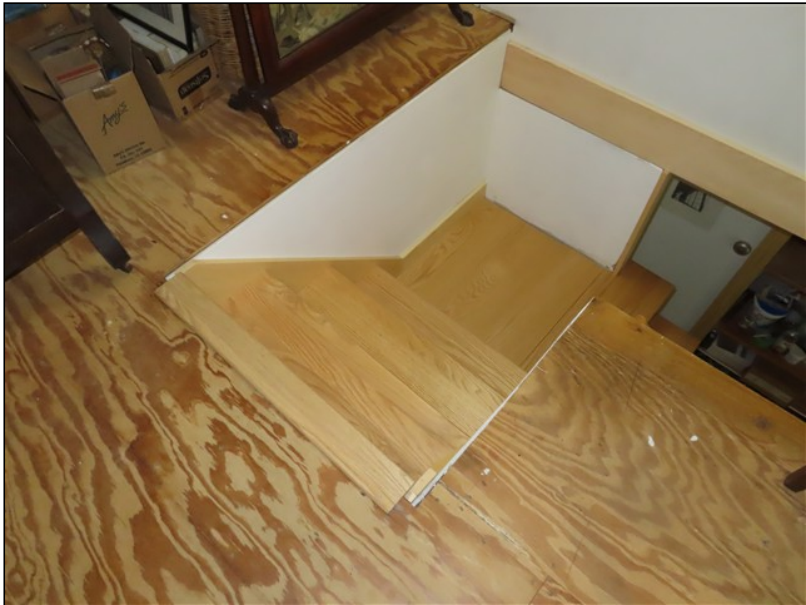
3.4 Item 1 (Picture) Stairway

(1) The stairway leading from the first floor to the second floor has no handrails/guards, continuous handrail, or an inappropriate handrail/guard. The absence of appropriate handrails or guards is a safety hazard, as a person ascending or descending the stairs has nothing to hold on to in the event that they may trip or fall. All stairways with more than 3 steps should have continuous handrails from the bottom to the top. It is advisable that an appropriate handrail or guard be installed.

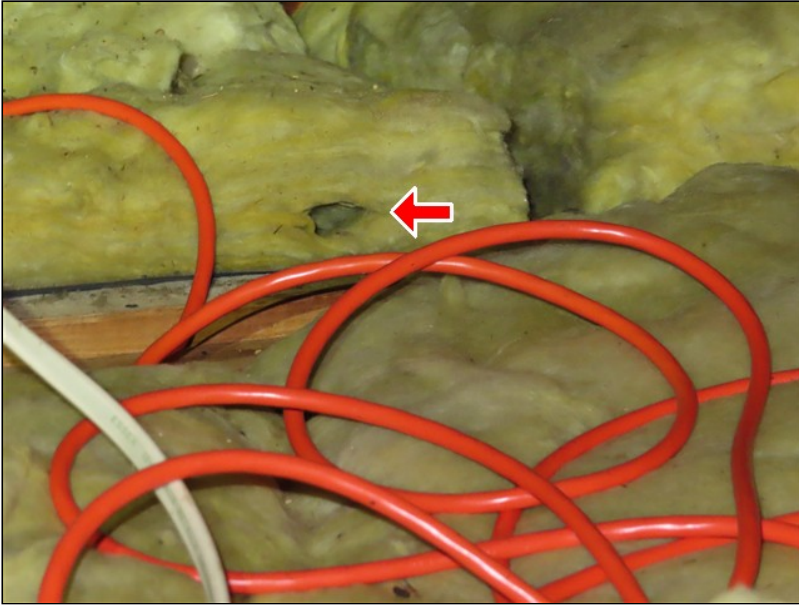
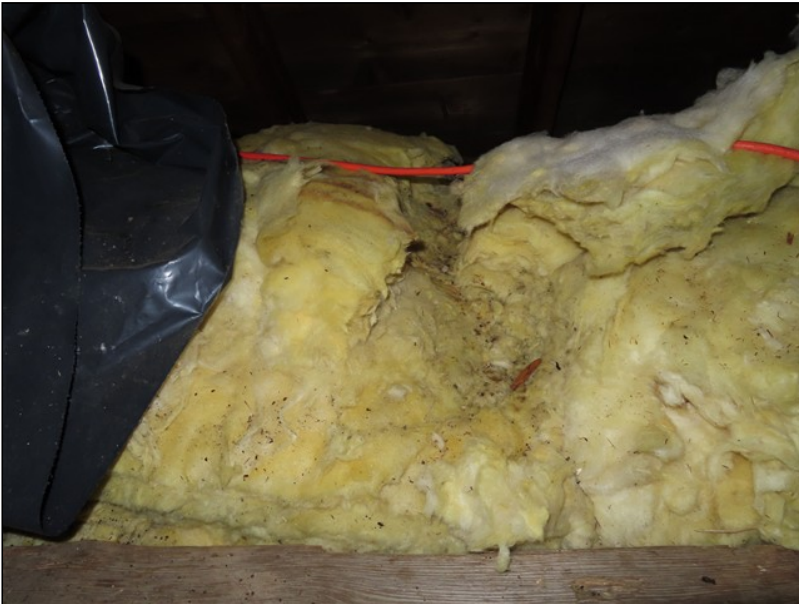
(4) Evidence of potential pests were observed in the attic. Patterns and disturbance in materials (insulation) consistent with pest nesting or intrusion were noted. This appearance of potential nesting in materials is similar in appearance to those made by mice. It was not possible to determine if the disturbance is recent, ongoing, or old. In the event that there is ongoing rodent or pest activity, remediation is recommended. It is recommended that the issue be further assessed.

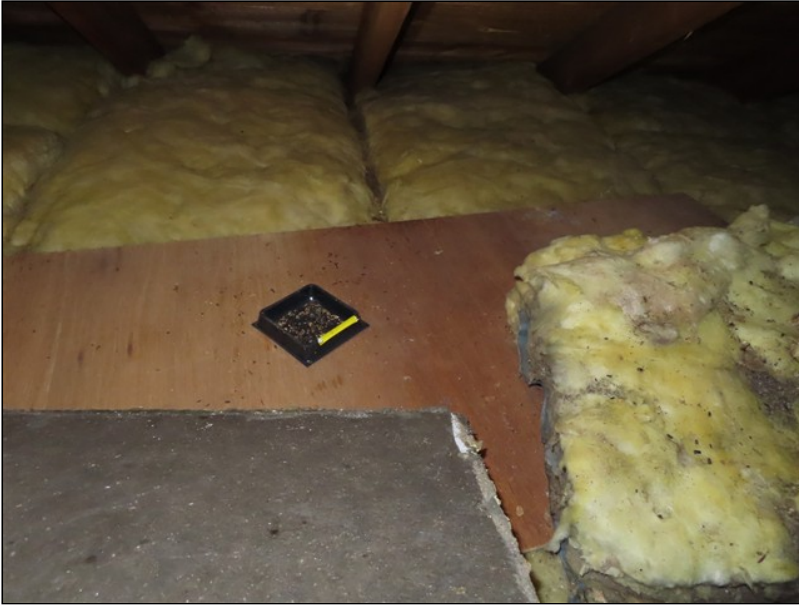
4.8 Item 2 (Picture) Attic

(2) Evidence of pests were observed in the attic. While the potential sources of the fecal matter that was observed are varied, it is possible that it is mice. It is recommended that means be undertaken to remove the mice from the building, and that the nesting be cleaned and removed. Further, it is recommended that any damaged building materials be repaired or replaced.

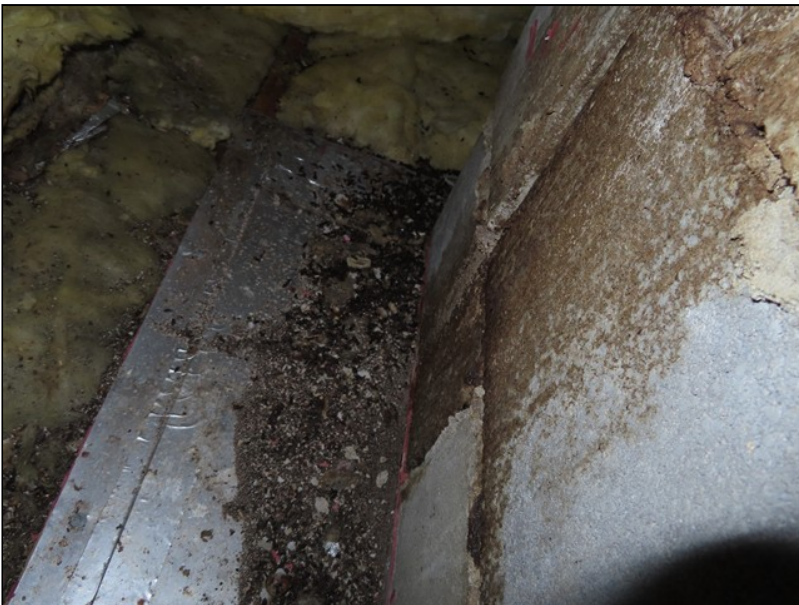
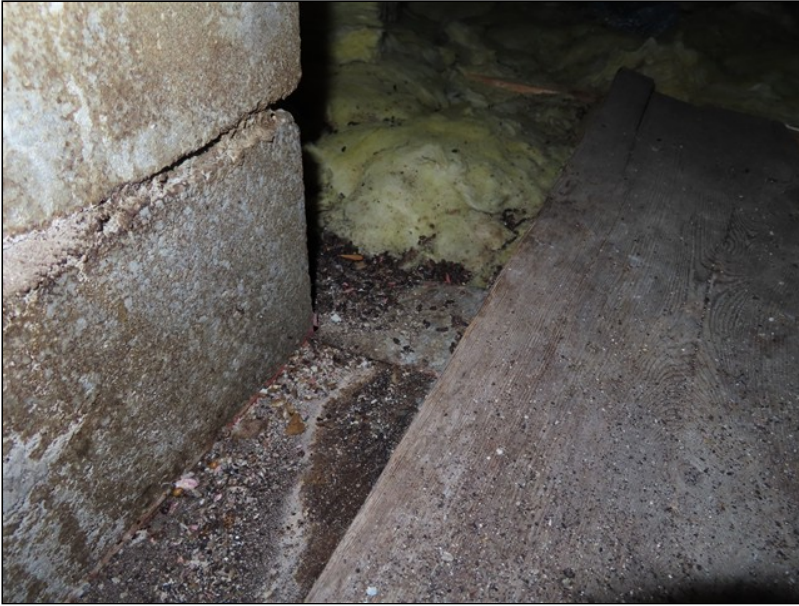
(3) Evidence of pests were observed in the attic. While the potential sources of the fecal matter that was observed are varied, the possible cause is bats. Bats and other pests should not remain untreated in homes as they can bring disease. Bats can carry rabies which is a hazard to humans, Further, a fungus called histoplasma can grow on guano (bat fecal matter) which can cause a lung disease called histoplasmosis in humans which can be a serious health concern. Generally, a contractual arrangement with a reliable exterminator is the most advisable course of action. Treating pests requires skills and chemicals that are specialized.

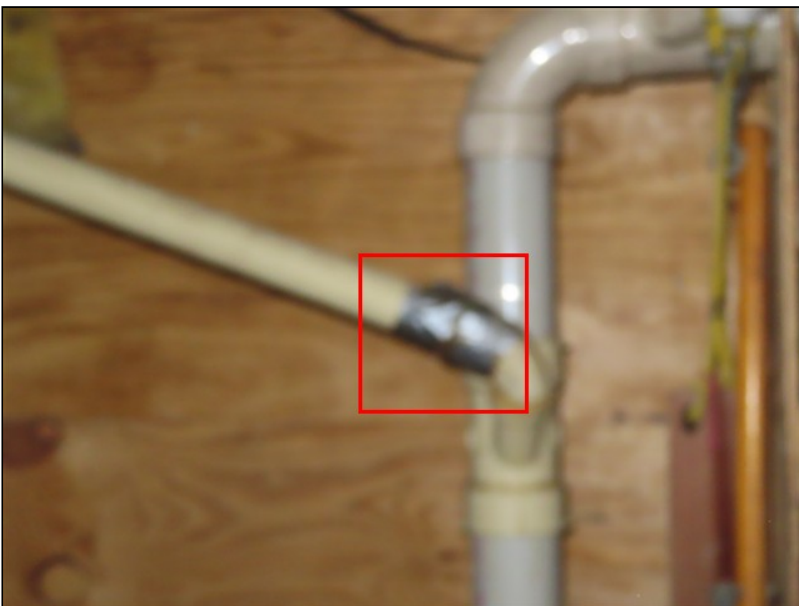
5.1 Item 1 (Picture) Basement

(3) A repair to a drain pipe was noted that was not performed in a way that was not consistent with best practices, or what would be considered a workman-like manner. The risk is that substandard repairs are at greater risk of leaking, which can result in additional issues. It is recommended that repairs be effected.

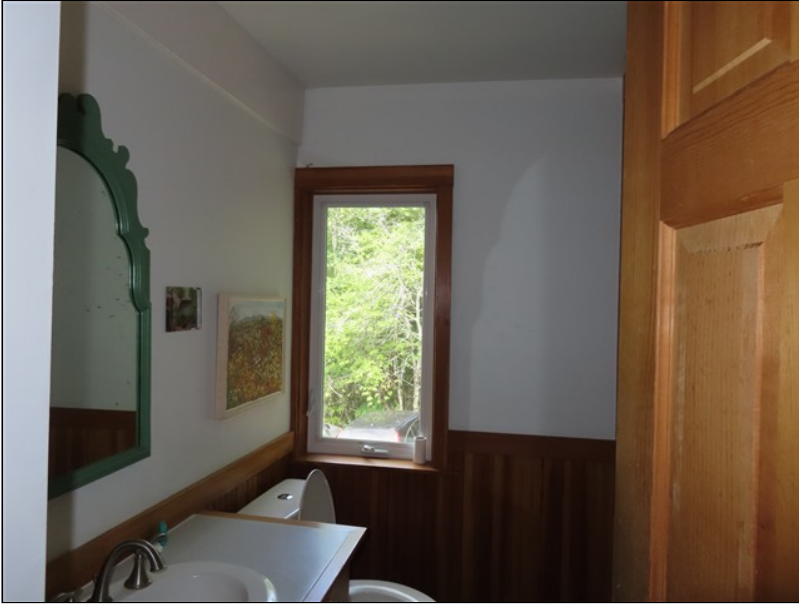
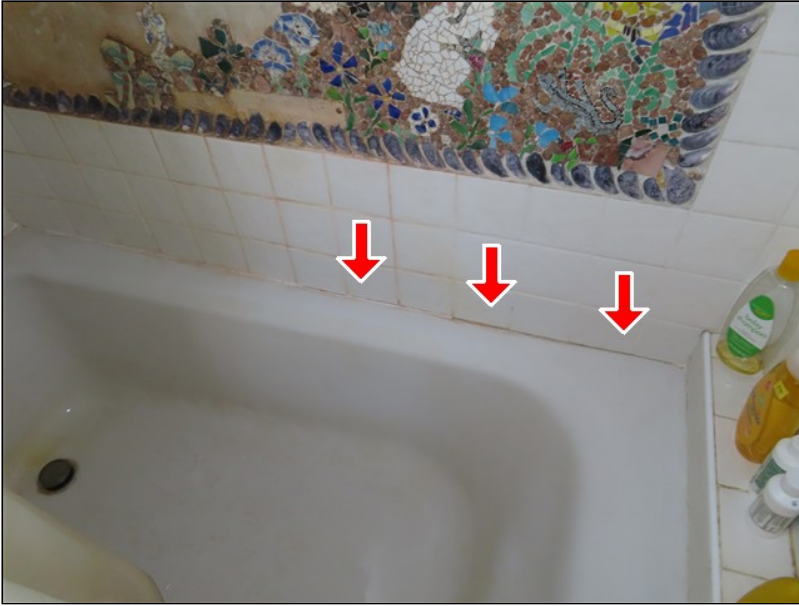
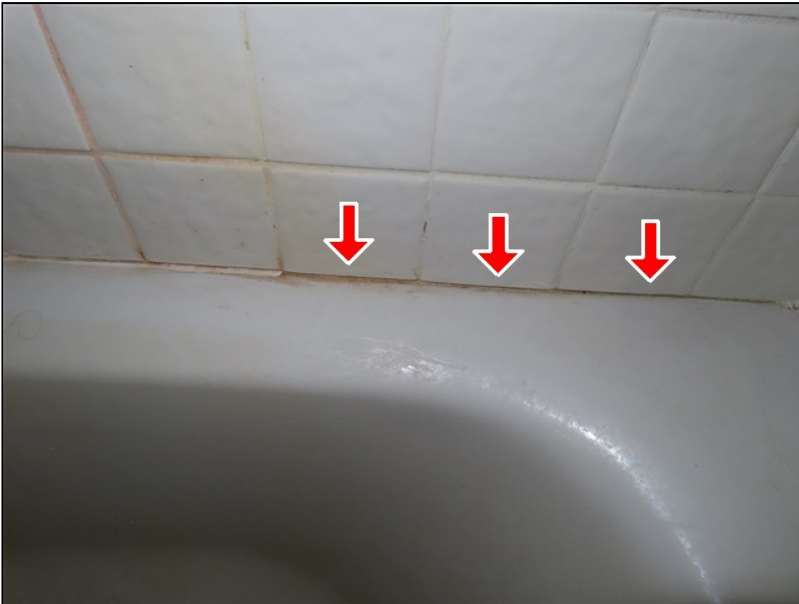
(1) The caulking around the bathtub or shower in the hall bath was observed to be failing which can potentially lead to leaks. Caulking around bathtubs and showers should be maintained on a periodic basis to ensure that it is not cracking, tearing or separating from the adjacent surfaces. Leaks around showers and bathtubs can result in mold, rot, and potentially structural damage. This type of repair is generally regarded as regular ongoing maintenance that should be performed from time to time.

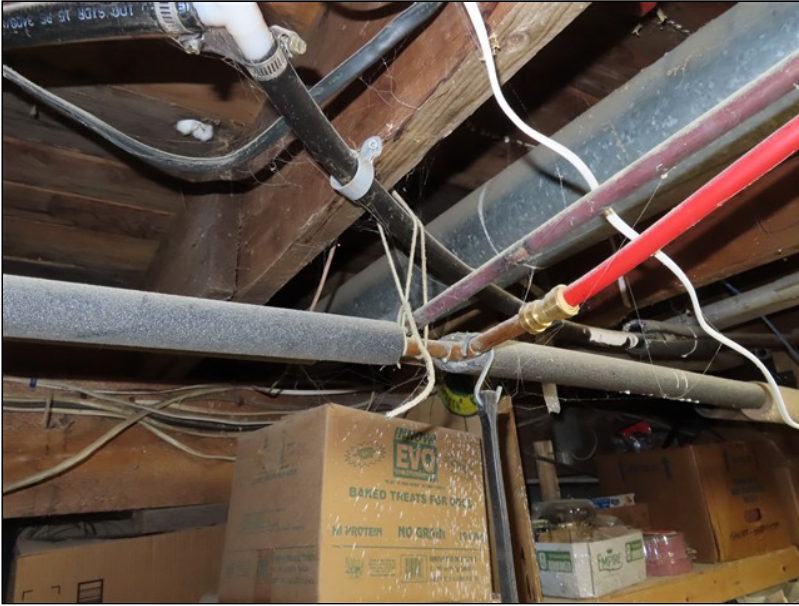
5.2 Item 4 (Picture) Basement

(2) Supply or distribution pipes were noted to be inappropriately or inadequately supported. Wire, rope, string, wood blocks, and other such materials are not regarded as best practice approaches. Additionally, pipes need to be supported and appropriate intervals. The principal issue with improper support the pipes can become damaged resulting in a leak. It is recommended that the supports be replaced with appropriate supports intended for the purpose. The spacing of the horizontal supports should generally be:

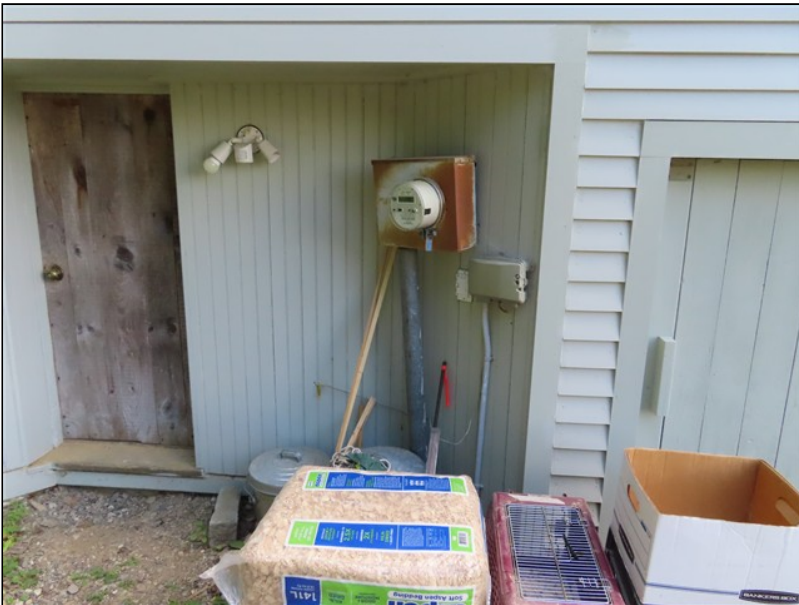
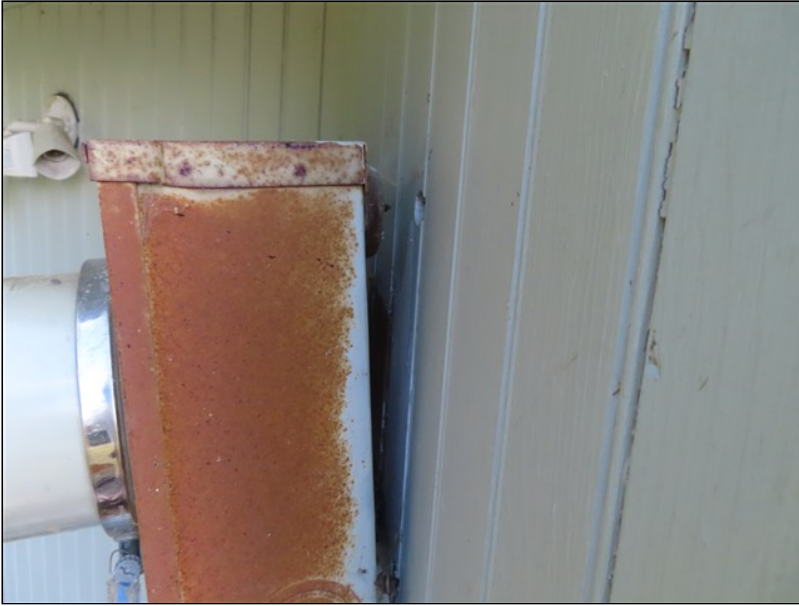
The electric meter enclosure (meter pan) was not securely affixed to the building and was loose. This condition can place unnecessary stress on the service entrance conductors and associated electrical connections and may allow movement or damage to the equipment. The meter enclosure should be securely mounted to the building using an appropriate method. It is recommended that the issue be further assessed and required repairs effected.

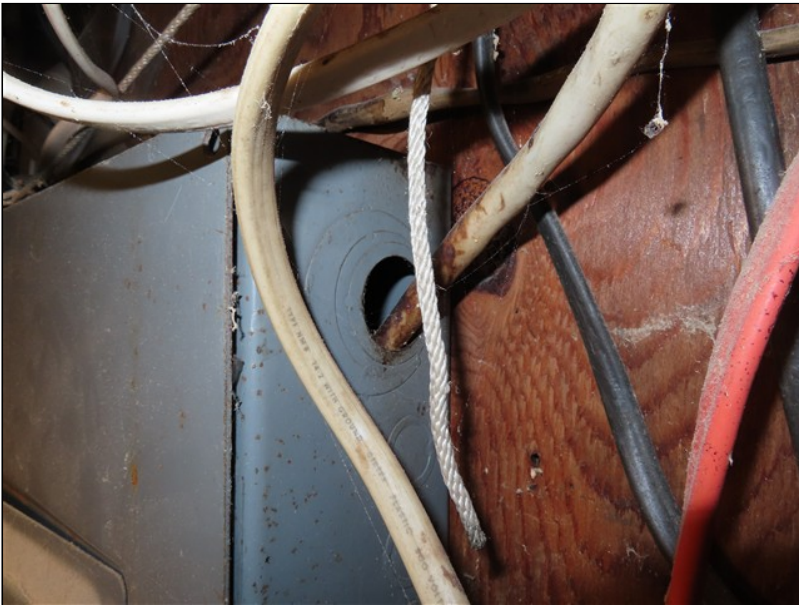
6.4 Item 1 (Picture) Basement

(3) Wire bushings were missing from the electrical panel in the basement. These are important components as they help protect electrical wire from mechanical damage, as well as potentially being pulled out of the electrical box. Finally, they also help prevent pests from getting into and nesting in the electrical panels. It is recommended that the missing bushing components be installed.

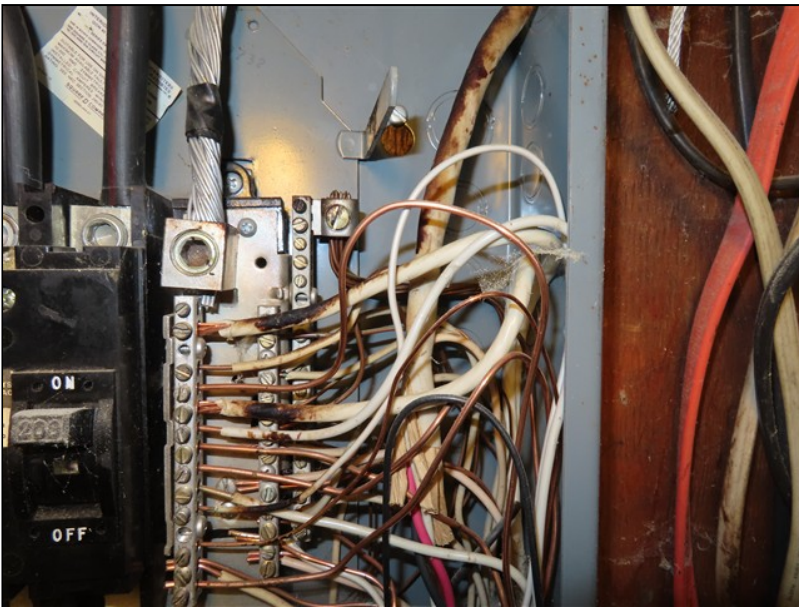
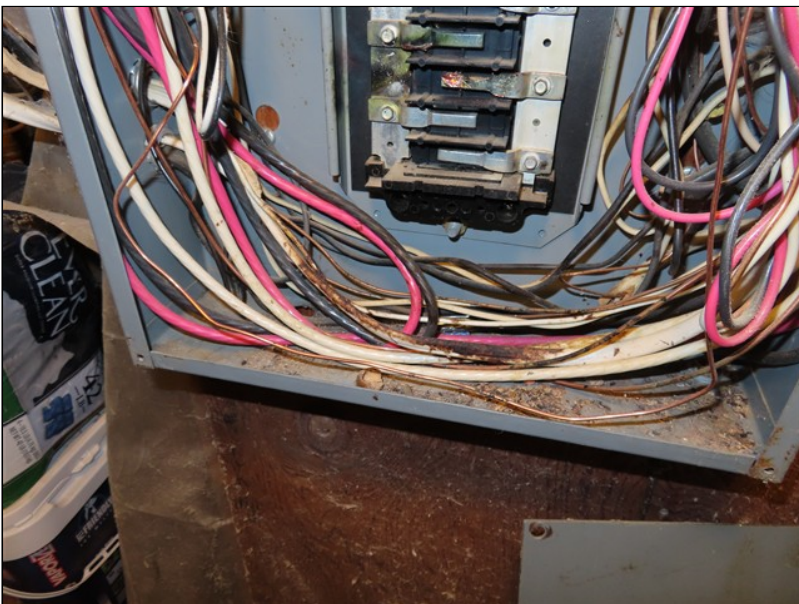
(5) Evidence of pests was noted in the panel. It is advisable the potential means of access for the pests be closed and eliminated. Allowing pests into an electrical panel can result in electrical fires. It is advisable that repairs be effected.

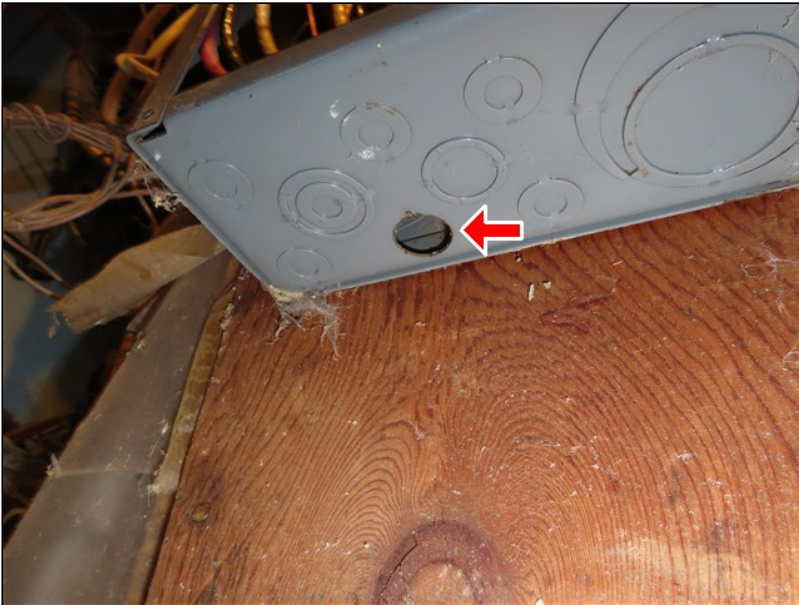
6.4 Item 12 (Picture) Basement

(7) One or more open knock-out holes were noted in the basement electrical panel. There is a risk that pests can enter and nest in the panel through exposed openings of this type, resulting in potential danger. There have been documented cases of rodents being electrocuted in electrical panels and starting fires. It is advisable that filler plugs be installed. (Note: the acceptable method to fill the knock-out is with approved metal plugs only) See the illustration for an example.

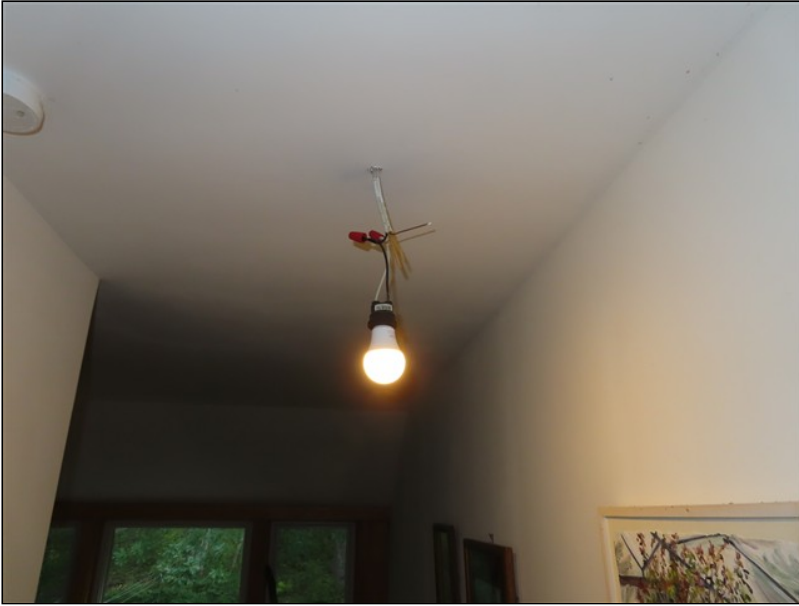
6.6 Item 1 (Picture) Upper hallway

(3) A light fixture in the upper hallway was noted to be dangling by its wire. This arrangement is dangerous. All electrical connections should be secured in electrical boxes, and all fixtures securely installed. It is advisable that repairs be effected.

Improper electrical connections were observed in the upper hallway. All electrical connections and splices should be in electrical boxes or done through other approved means. Improper electrical connections can present a risk of personal injury or electrical fire. It is advisable that repairs be effected.

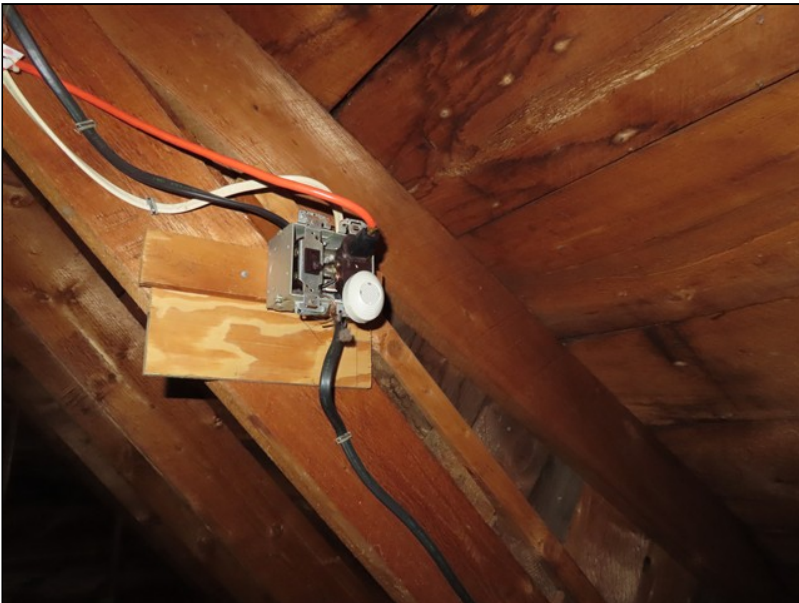
6.6 Item 2 (Picture) Attic

(4) Electrical boxes without covers were noted in the attic. Uncovered electrical boxes are safety hazards as they pose a risk of electric shock. It should also be noted that all metal electrical boxes should be grounded. It is advisable that all open/uncovered electrical boxes have an appropriate cover installed and any missing grounding installed.

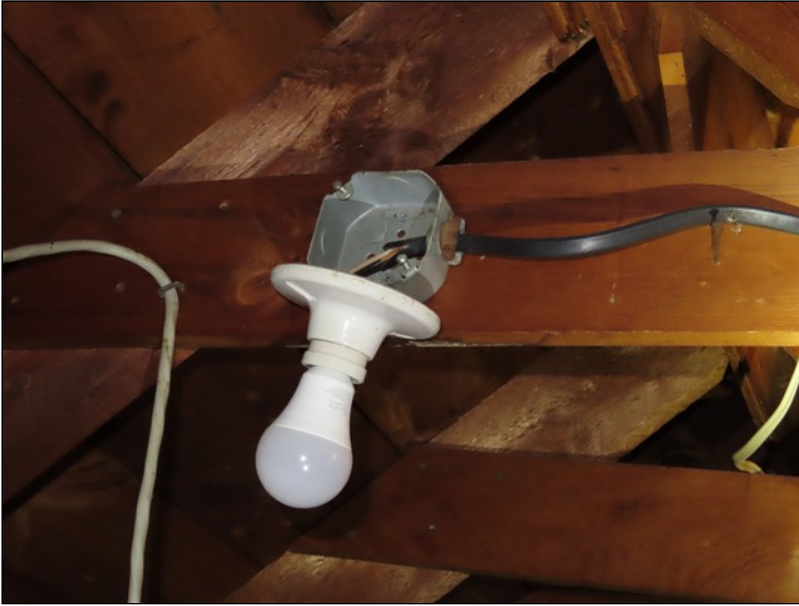
6.6 Item 3 (Picture) Attic

(5) An installed light fixture in the attic is in a state of disrepair. In its present condition, there is a hazard of electrical shock and injury. It is recommended that repairs be effected.

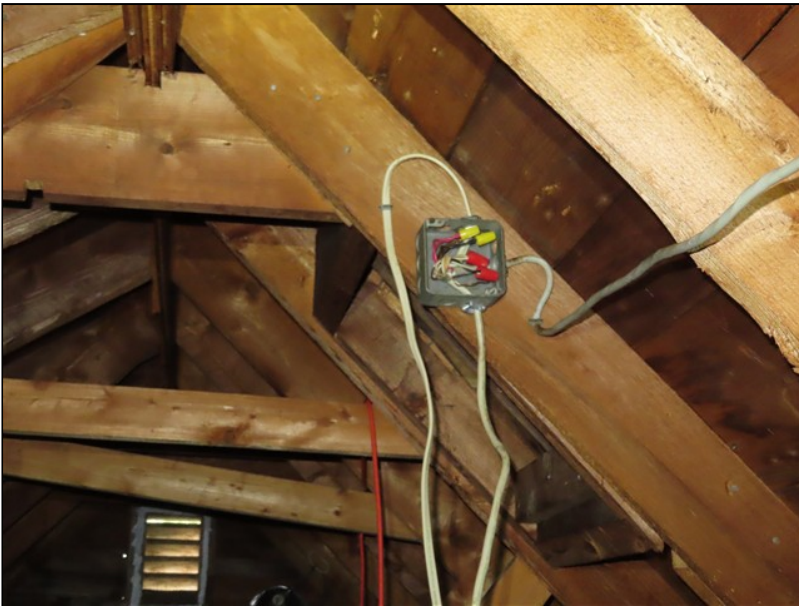
6.6 Item 4 (Picture) Attic

(6) Electrical boxes without covers were noted in the attic. Uncovered electrical boxes are safety hazards as they pose a risk of electric shock. It should also be noted that all metal electrical boxes should be grounded. It is advisable that all open/uncovered electrical boxes have an appropriate cover installed and any missing grounding installed.
