# INSPECTION REPORT

**PROPERTY ADDRESS:**  
642 Lincolnville Avenue, Searsmont, ME 04973

| <b>Date:</b> 8/27/2026 | <b>Time:</b> 01:30 PM | <b>Report ID:</b> 2026082701 |

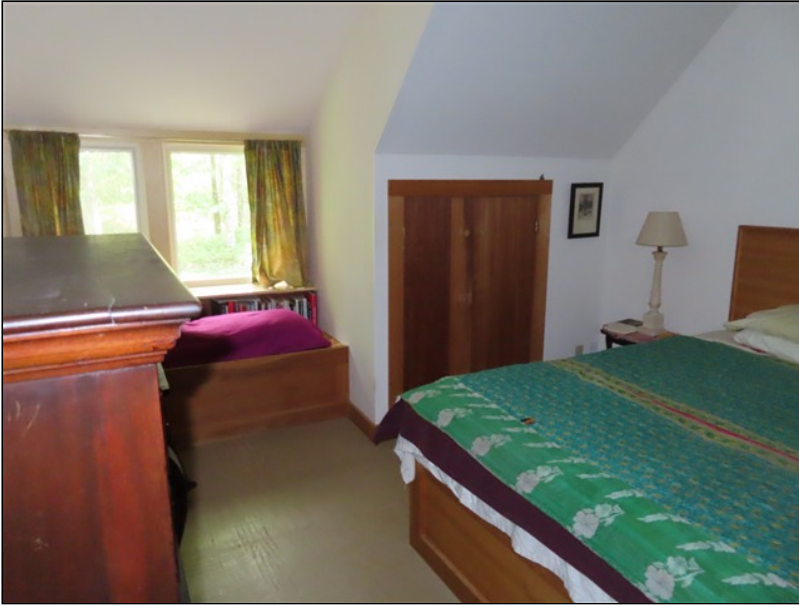
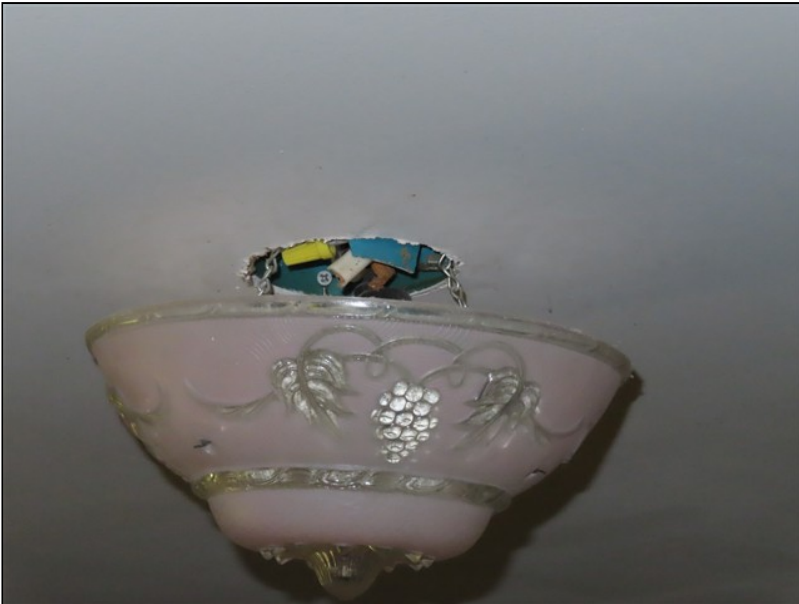
(7) Electrical boxes without covers were noted in the upper bedroom. Uncovered electrical boxes are safety hazards as they pose a risk of electric shock. It should also be noted that all metal electrical boxes should be grounded. It is advisable that all open/uncovered electrical boxes have an appropriate cover installed and any missing grounding installed.

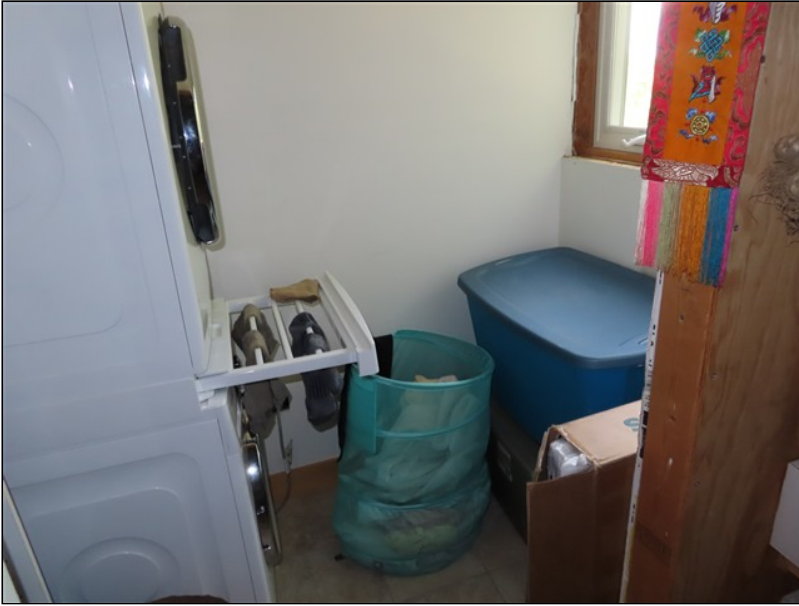
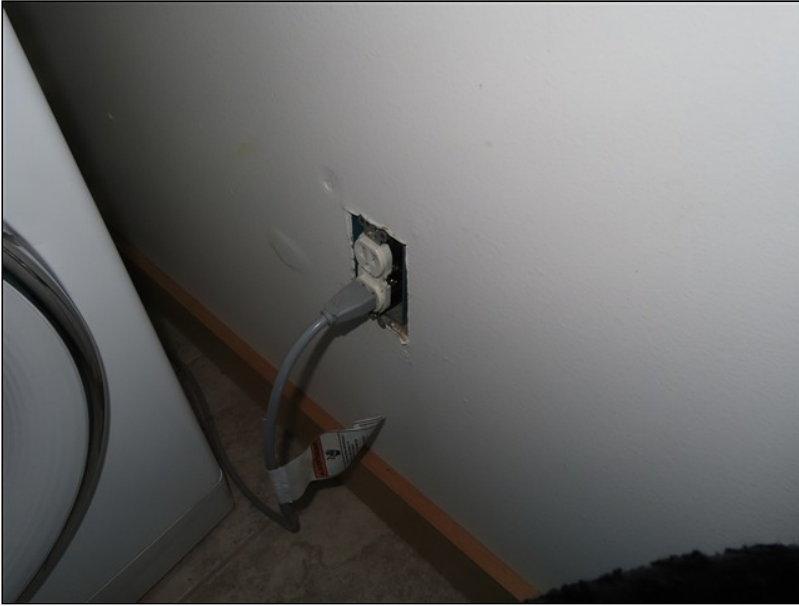
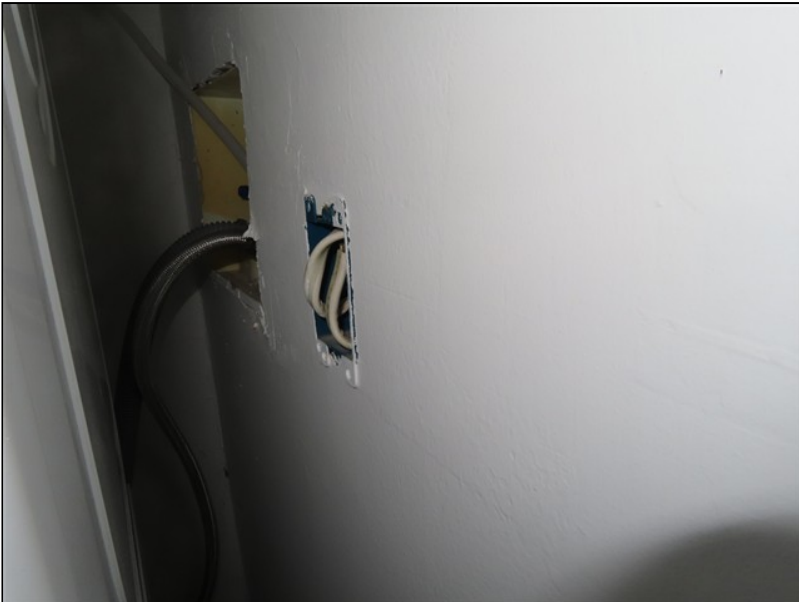
(8) Electrical boxes without covers were noted in the utility room. Uncovered electrical boxes are safety hazards as they pose a risk of electric shock. It should also be noted that all metal electrical boxes should be grounded. It is advisable that all open/uncovered electrical boxes have an appropriate cover installed and any missing grounding installed.

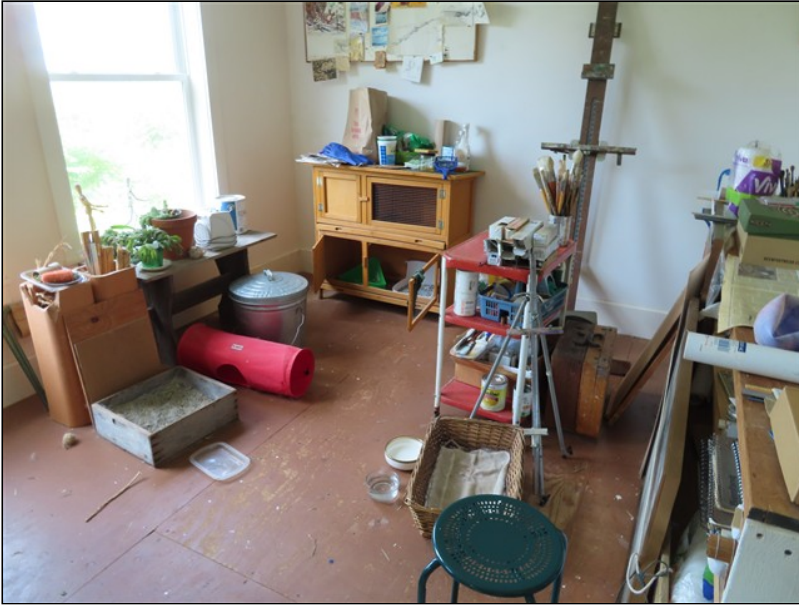
6.6 Item 10 (Picture) Lower right room

(9) A light fixture in the lower right room was noted to be dangling by its wire. This arrangement is dangerous. All electrical connections should be secured in electrical boxes, and all fixtures securely installed. It is advisable that repairs be effected.

Improper electrical connections were observed in the lower right room. All electrical connections and splices should be in electrical boxes or done through other approved means. Improper electrical connections can present a risk of personal injury or electrical fire. It is advisable that repairs be effected.

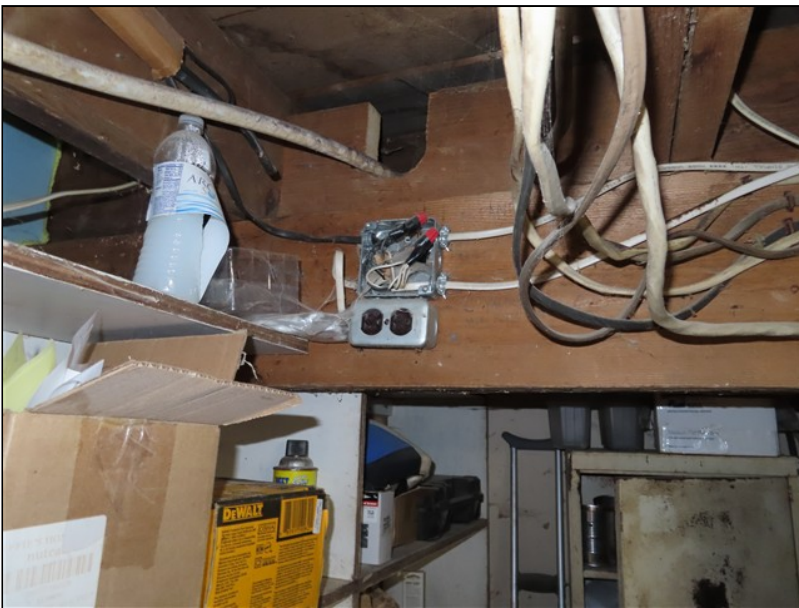
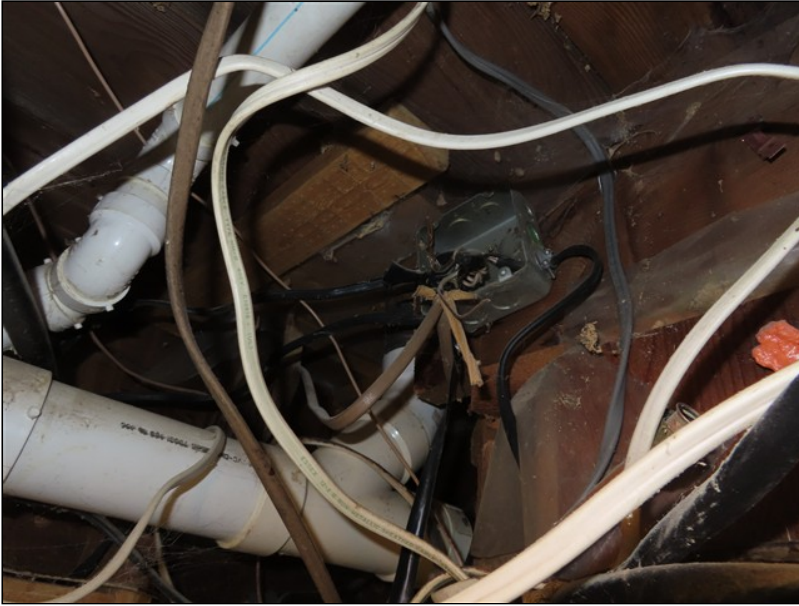
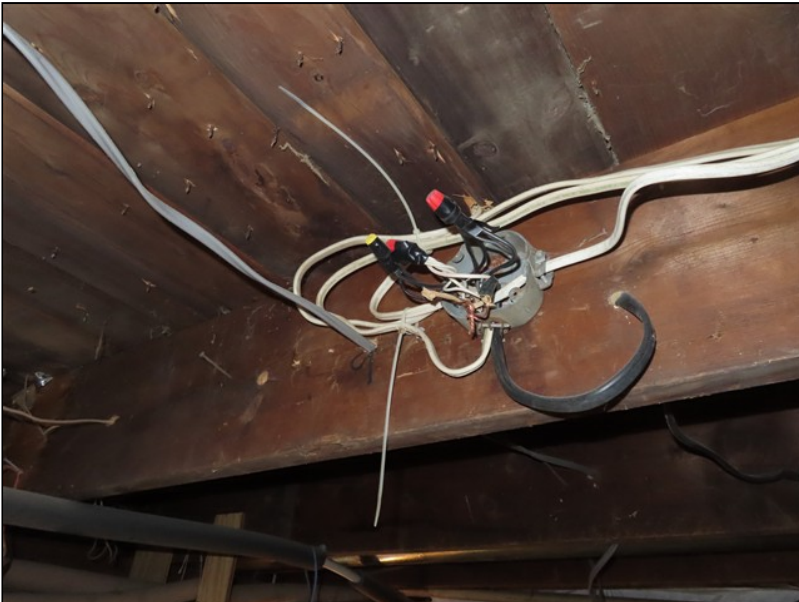
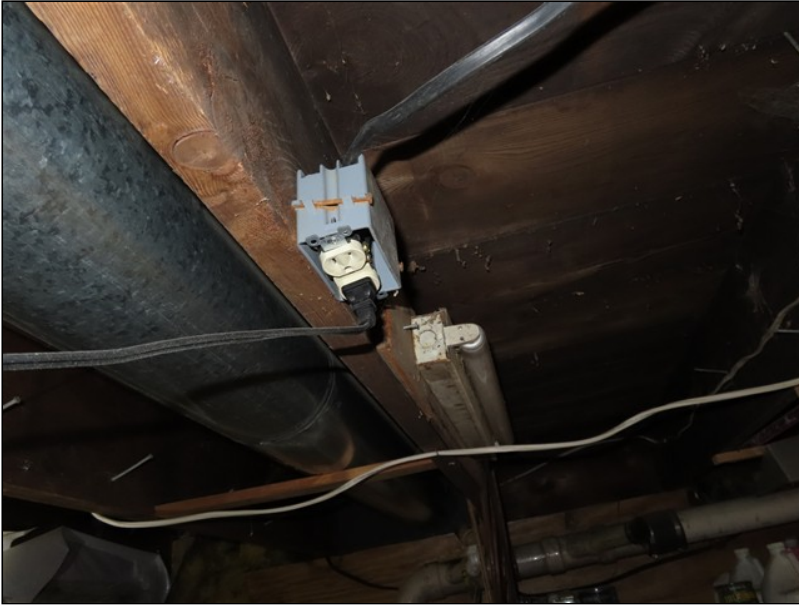
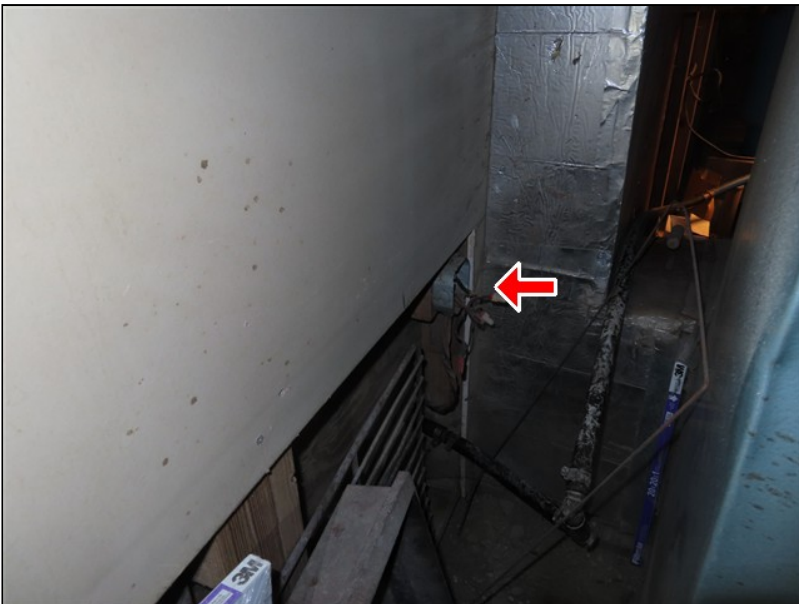
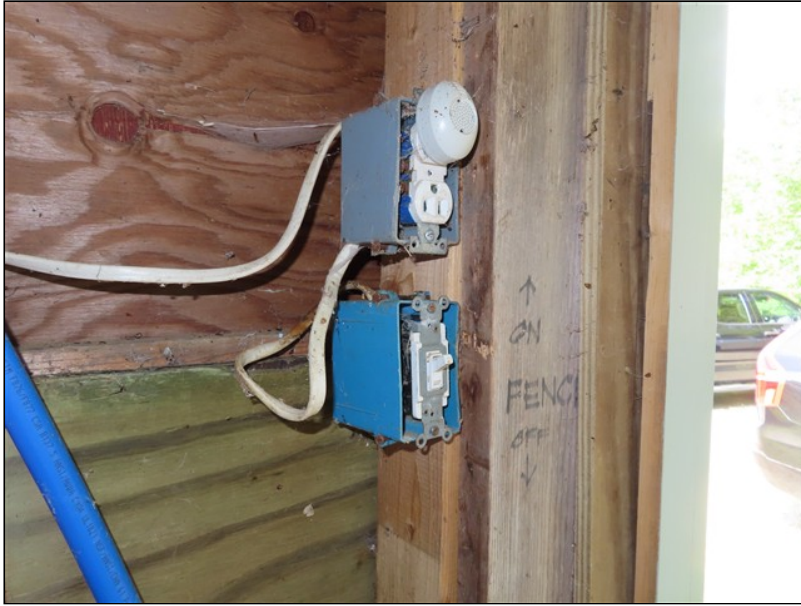
(10) Electrical boxes without covers were noted in the basement. Uncovered electrical boxes are safety hazards as they pose a risk of electric shock. It should also be noted that all metal electrical boxes should be grounded. It is advisable that all open/uncovered electrical boxes have an appropriate cover installed and any missing grounding installed.

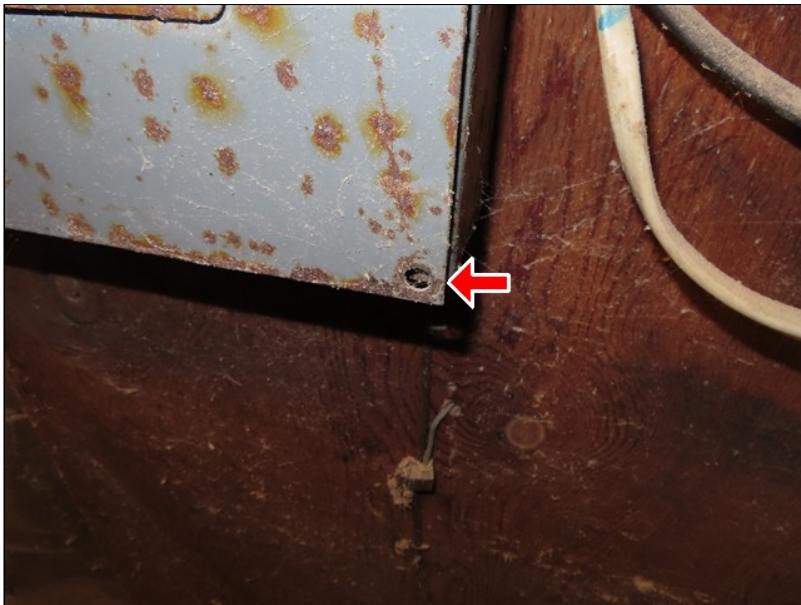
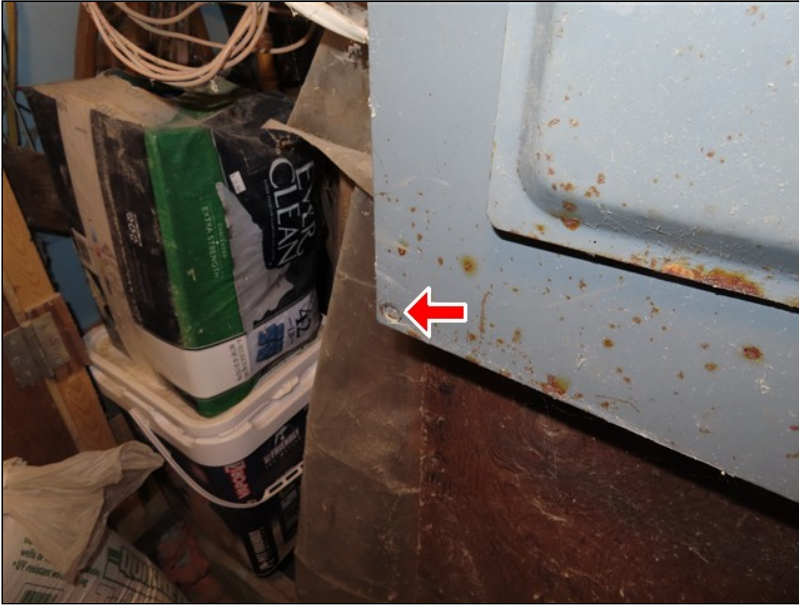
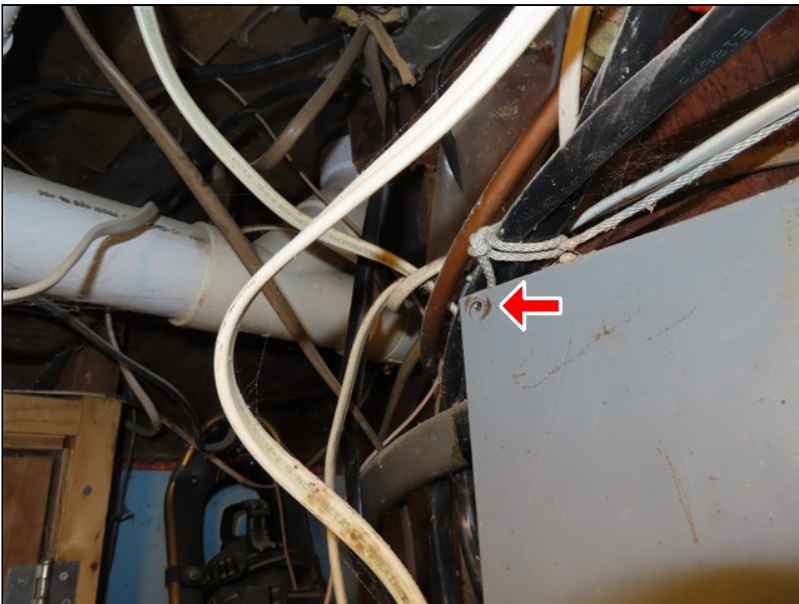
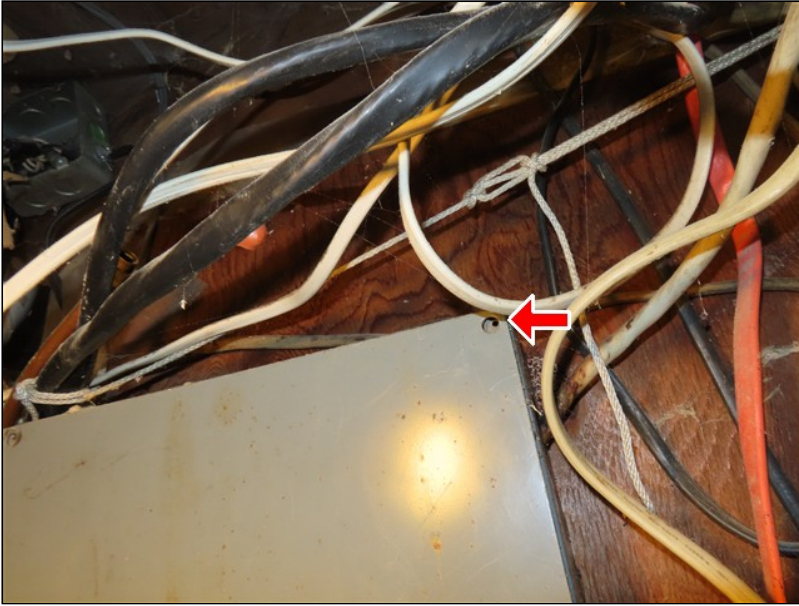
(4) Some of the screws used to secure the front cover of the panel were noted to be missing. While the panel cover appeared to be generally secure, it is designed and intended to be secured by all the intended screws. It is recommended that the missing screws be added, and that the correct screws be used.

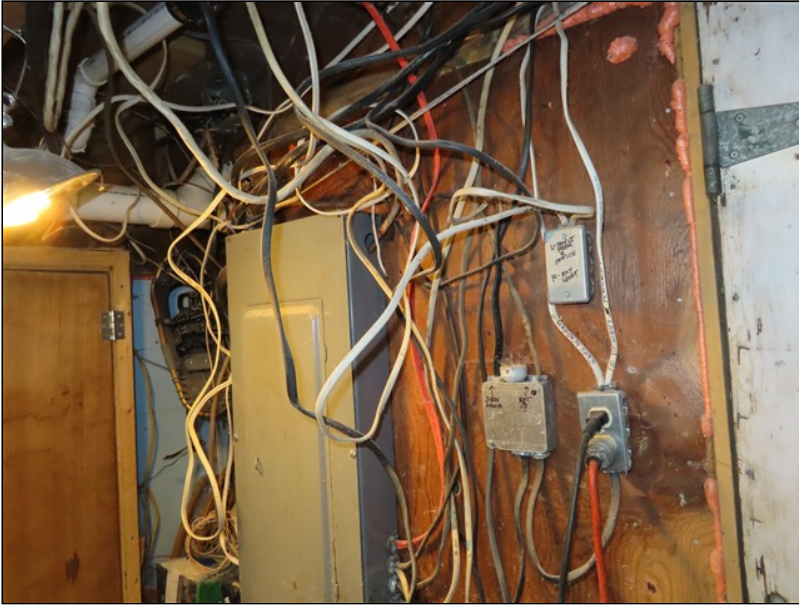
6.5 Item 1 (Picture) Basement

The wiring in the basement was not installed in accordance with standards or best practices. Wires should be installed in walls or conduits, or secured to surfaces so that they are not loose or exposed. Wiring should also be protected such that it is not in the course of traffic or at risk of sustaining damage. Incorrectly installed wires are potential hazards and dangerous. It is recommended that repairs be effected.

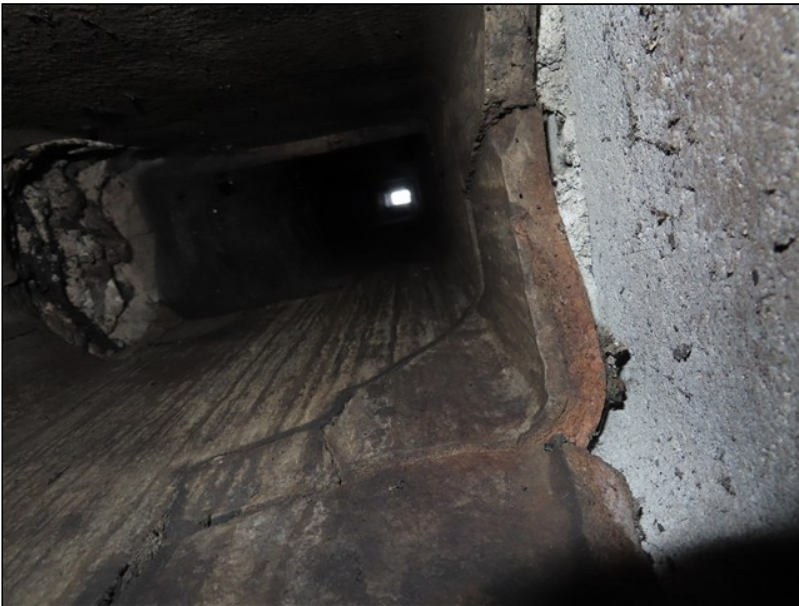
7.6 Item 1 (Picture) Chimney

(1) Minor cracks were noted in the chimney flue liner. While not large in size, there is a potential breach in the integrity of the flue liner. It is recommended that the issue be further assessed and required repair effected.

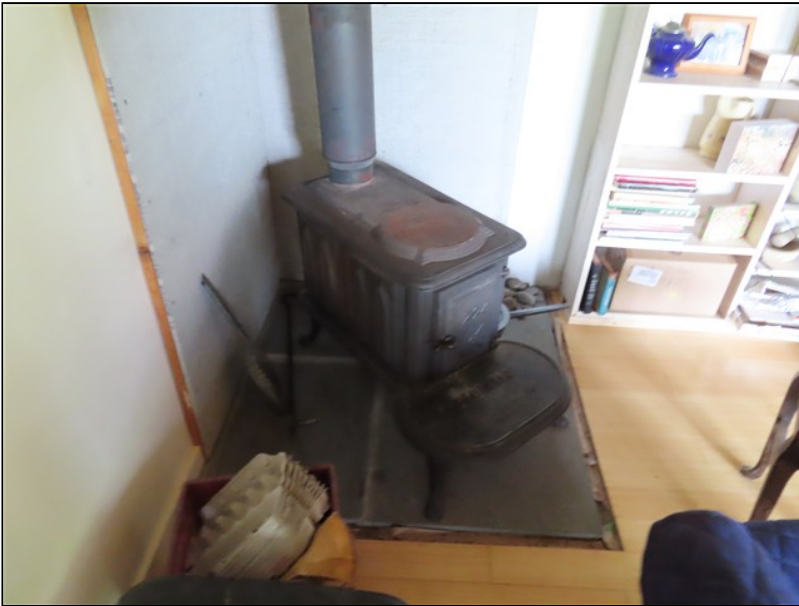
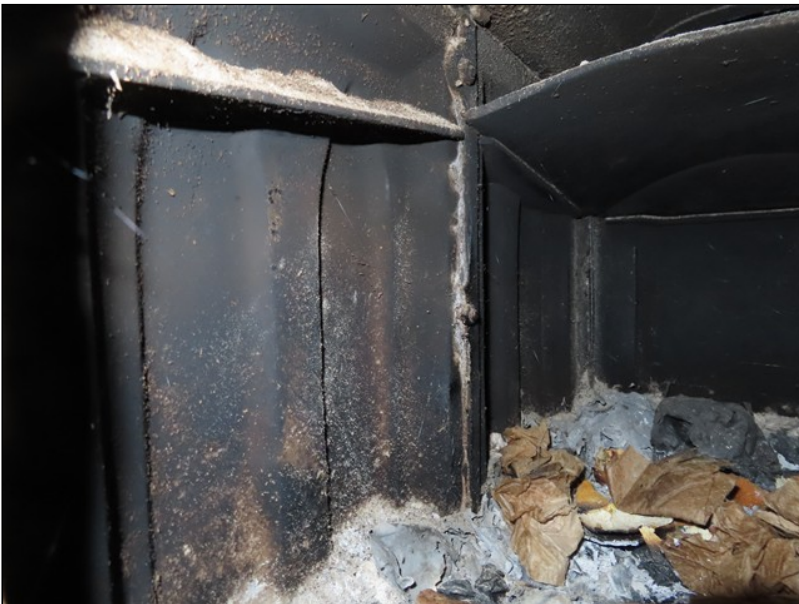
The woodstove in the living room presented with signs of wear. There were interior components that were visibly worn, and may require repair or replacement at a time in the future. The degree of wear did not appear unusual for an older woodstove. It is recommended that the issue be re-inspected from time to time and repairs effected as required. It would not be unreasonable to consider further assessment and repairs at this time.

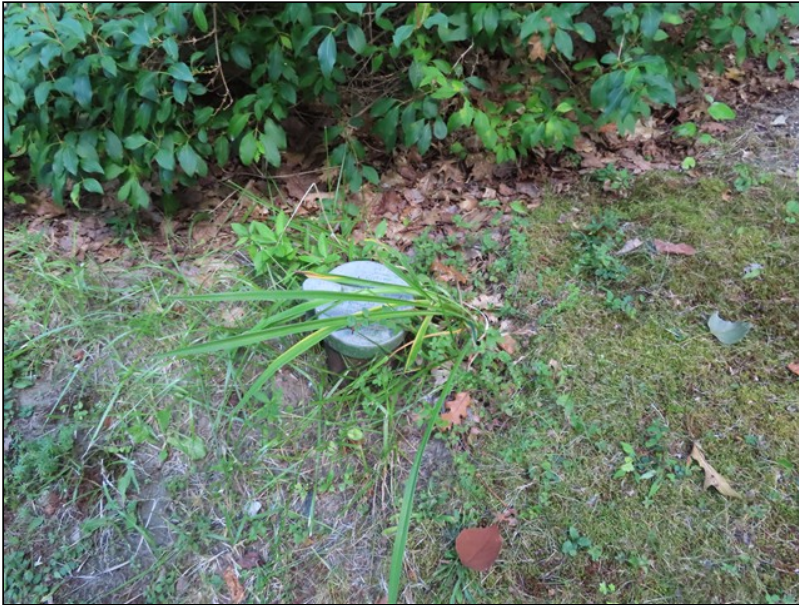
12.0 Item 2 (Picture) Left side

(4) The well casing was noted to be shorter (lower) than industry standards and best practices. Well casings are supposed to extend 8 inches above the surrounding grade (according to CMR CHAPTER 232 - Well Drillers and Pump Installers Rules). When a well casing is too short, there is an increased risk of contaminants getting into the well shaft and the water. Extending well casings is typically done by welding additional lengths onto the existing casing.
