## Home Inspection Report

**10600 Sheldon Street, Oakland**

Dominic Dambrosio  
November 4, 2022

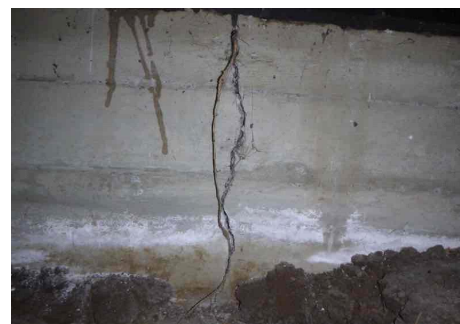
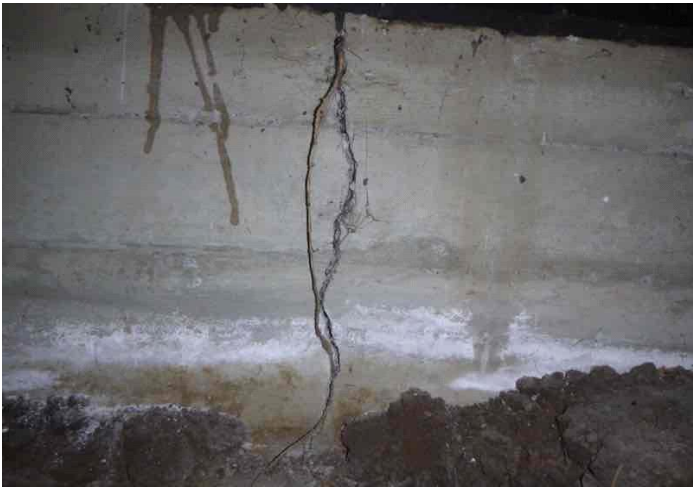
Photo 19

1. Large cracks, deterioration and/or movement was observed in the foundation of the structure at the left crawlspace This implies that structural movement and/or settlement of the building has occurred. The rate of movement cannot be predicted during a one-time inspection. A thorough evaluation of this condition is beyond our qualifications. For additional information we recommend contacting a licensed foundation contractor for further evaluation. (See Photo 19)

- ! 1. Large cracks, deterioration and/or movement was observed in the foundation of the structure at the left crawlspace. This implies that structural movement and/or settlement of the building has occurred. The rate of movement cannot be predicted during a one-time inspection. A thorough evaluation of this condition is beyond our qualifications. For additional information we recommend contacting a licensed foundation contractor for further evaluation. (See Photo 19)

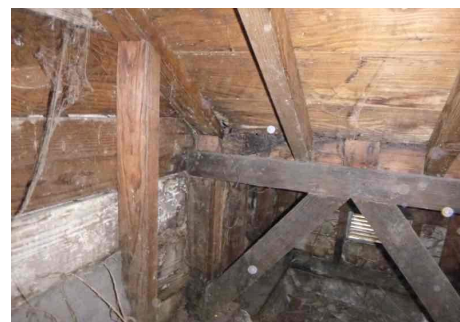
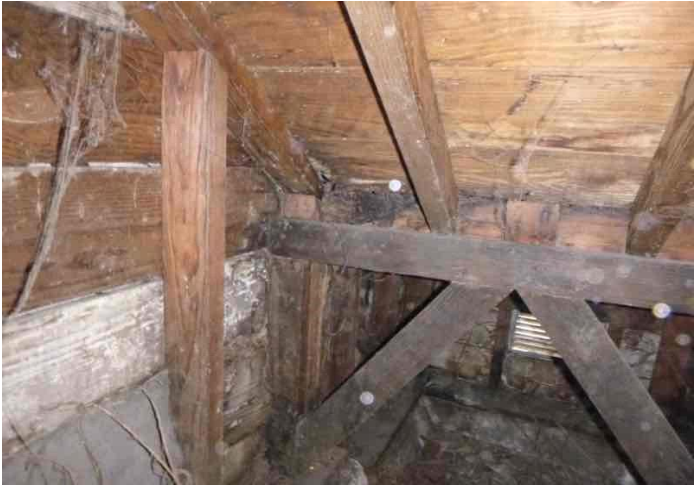
Photo 18

2. The wood members under the front porch show evidence of water damage. We recommend the services of a licensed structural pest control operator for investigation of this condition. (See Photo 18) (See Photo 20) (See Photo 21)

- ! 2. The wood members under the front porch show evidence of water damage. We recommend the services of a licensed structural pest control operator for investigation of this condition. (See Photo 18) (See Photo 20) (See Photo 21)

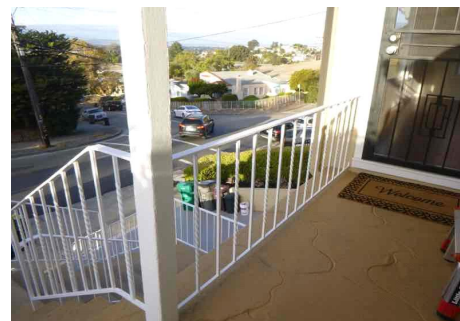
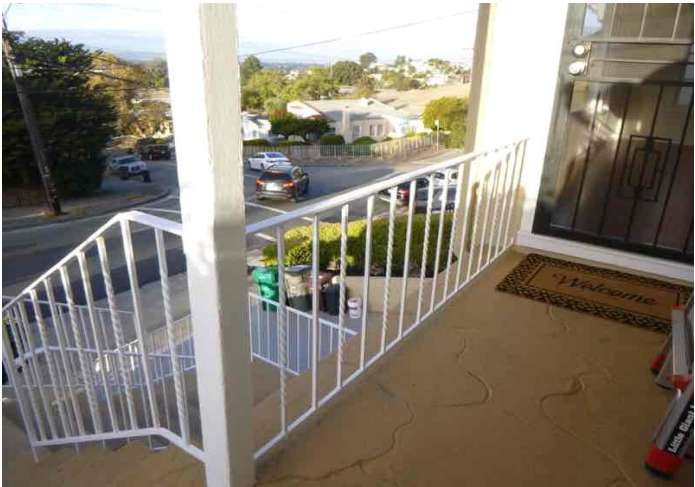
Photo 08

3. The height of the railing and/or hand rail at the front is improper by today's standards and is a potential safety hazard. We recommend installation of a properly sized railing in accordance with current industry standards. (See Photo 8)

- ! 1. The height of the railing and/or hand rail at the front is improper by today's standards and is a potential safety hazard. We recommend installation of a properly sized railing in accordance with current industry standards. (See Photo 8)

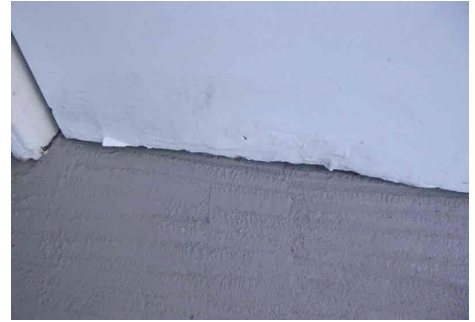
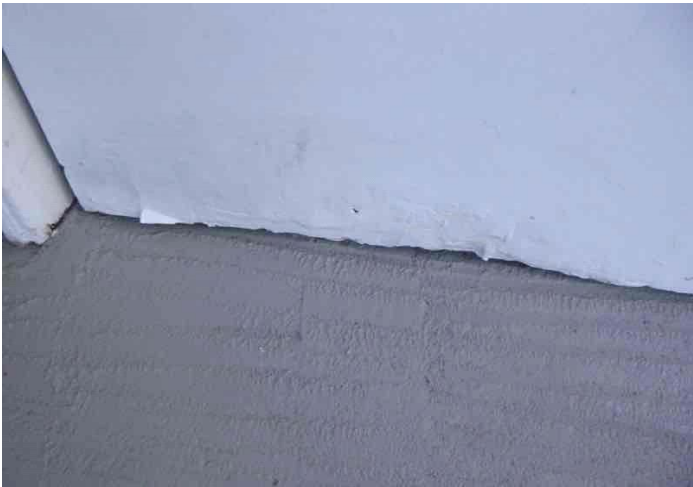
Photo 07

4. The main garage door is water damaged. We recommend the services of a licensed general contractor and/or structural pest control company regarding repairs. (See Photo 7)

- ! 2. The main garage door is water damaged. We recommend the services of a licensed general contractor and/or structural pest control company regarding repairs. (See Photo 7)

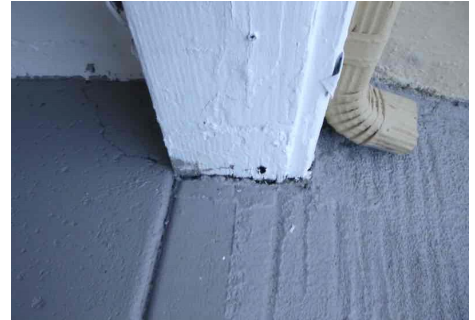
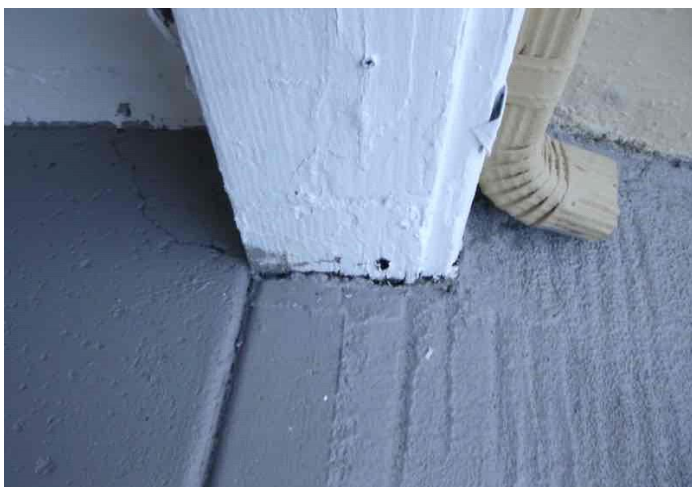
Photo 05

5. The main garage door jamb and/or trim shows evidence of water damage. We recommend the services of a licensed general contractor and/or structural pest control company regarding repairs. (See Photo 5)

- ! 3. The main garage door jamb and/or trim shows evidence of water damage. We recommend the services of a licensed general contractor and/or structural pest control company regarding repairs. (See Photo 5)

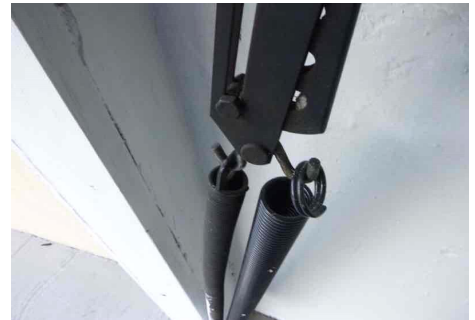
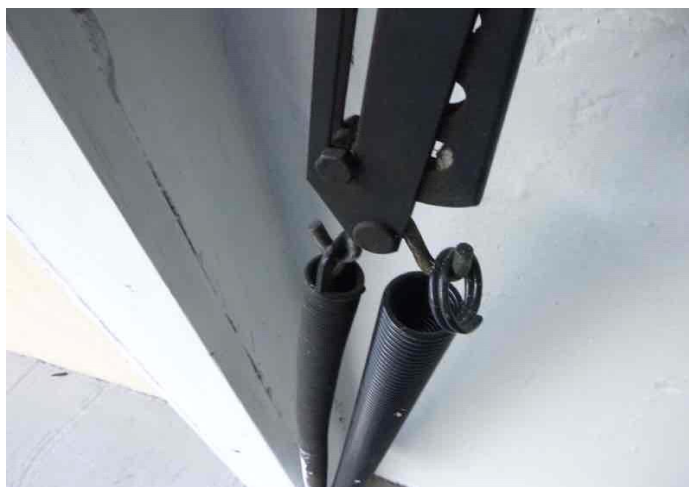
Photo 06

6. No safety springs/cables were noted on one or more of the garage door springs. The installation of safety springs or cables would improve safety in the event of spring failure. (See Photo 6)

- ! 4. No safety springs/cables were noted on one or more of the garage door springs. The installation of safety springs or cables would improve safety in the event of spring failure. (See Photo 6)

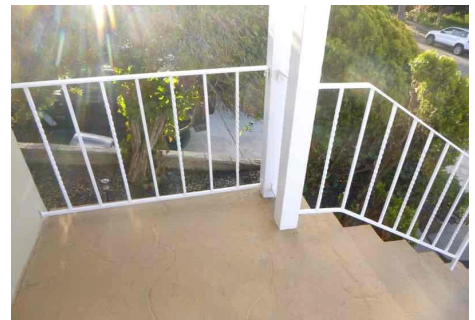
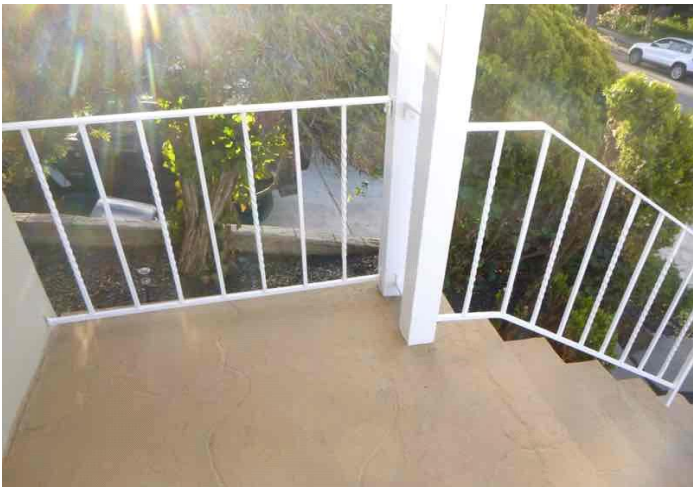
Photo 09

7. The openings in the front railing(s) are larger than 4" inches. It is recommended that this be corrected for improved safety. (See Illustration 3N) (See Photo 9)

- ! 5. The openings in the front railing(s) are larger than 4" inches. It is recommended that this be corrected for improved safety. (See Illustration 3N) (See Photo 9)

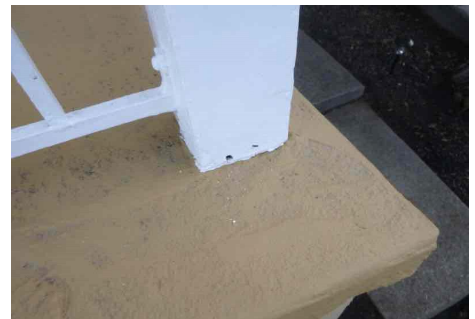
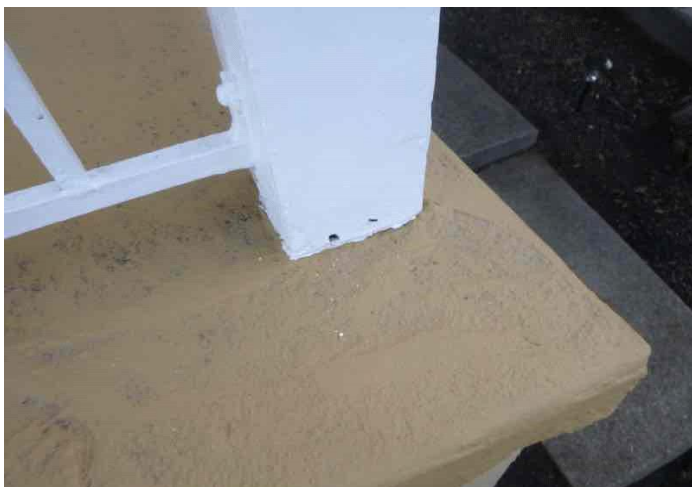
Photo 01

8. The base of the support post(s) at the front deck/porch cover or overhang are water damaged. We recommend the advice and services of a licensed contractor and/or structural pest control company. (See Photo 1)

- ! 6. The base of the support post(s) at the front deck/porch cover or overhang are water damaged. We recommend the advice and services of a licensed contractor and/or structural pest control company. (See Photo 1)

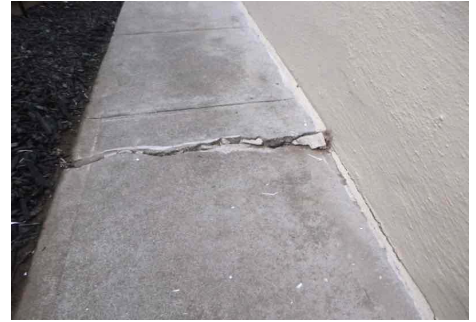
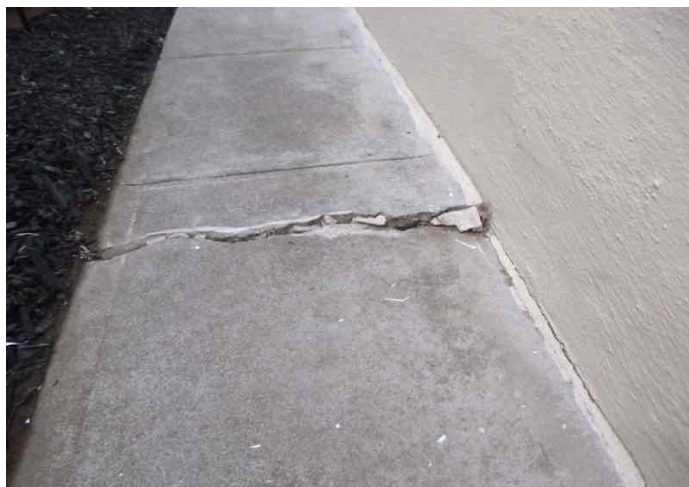
Photo 02

9. The cracked and heaved walkway section(s) at the right present a trip hazard. This condition should be corrected for improved safety. (See Photo 2)

- ! 7. The cracked and heaved walkway section(s) at the right present a trip hazard. This condition should be corrected for improved safety. (See Photo 2)

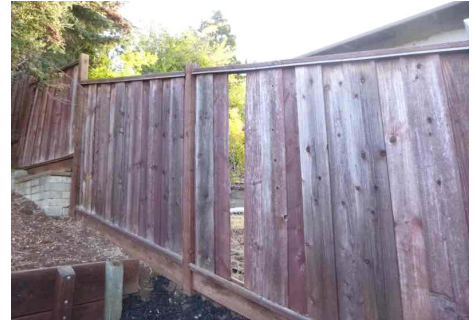
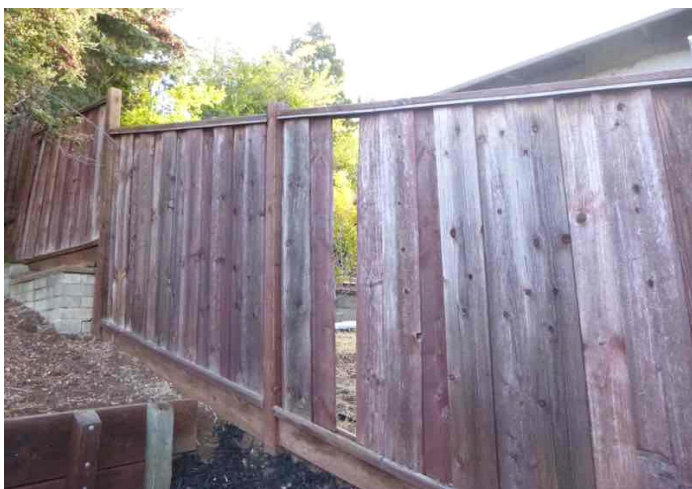
Photo 03

10. The wood fencing at the right of the property is in need of repairs. (See Photo 3)

- ! 8. The wood fencing at the right of the property is in need of repairs. (See Photo 3)
- ! 9. There is no fencing at the back -front left. We recommend all sections of missing fence be replaced. Missing - loose boards at various areas (See Photo 4) (See Photo 3)

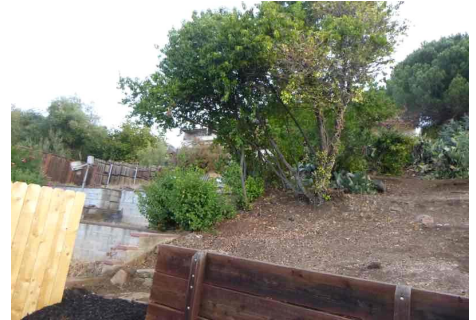
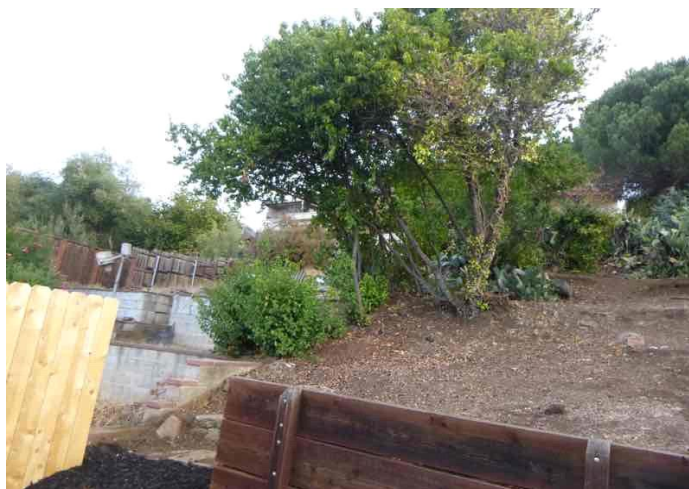
Photo 04

11. There is no fencing at the back -front left We recommend all sections of missing fence be replaced. Missing - loose boards at various areas (See Photo 4) (See Photo 3)

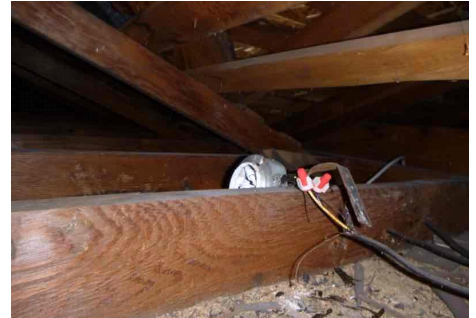
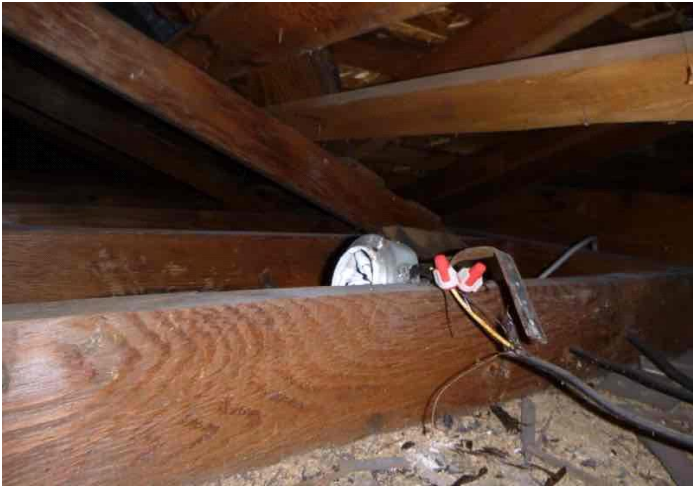
Photo 15

12. Running splices, which are improper connections outside of a junction box, were observed in the attic We recommend connections be joined with approved connectors inside a junction box to prevent accidental contacts or mechanical damage. (See Photo 15) (See Photo 16)

13. Exposed electric connections or open junction boxes at the front closet/ attic should be corrected. All electric connections should be made inside approved junction boxes fitted with proper cover plates. (See Photo 10) (See Photo 15)

- ! 1. Running splices, which are improper connections outside of a junction box, were observed in the attic We recommend connections be joined with approved connectors inside a junction box to prevent accidental contacts or mechanical damage. (See Photo 15) (See Photo 16)

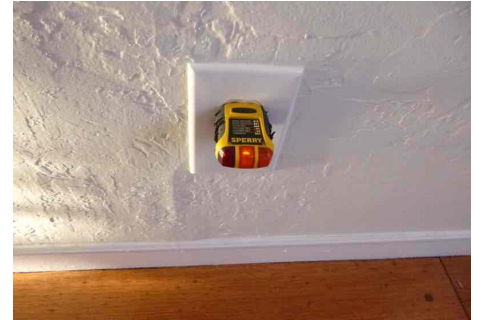
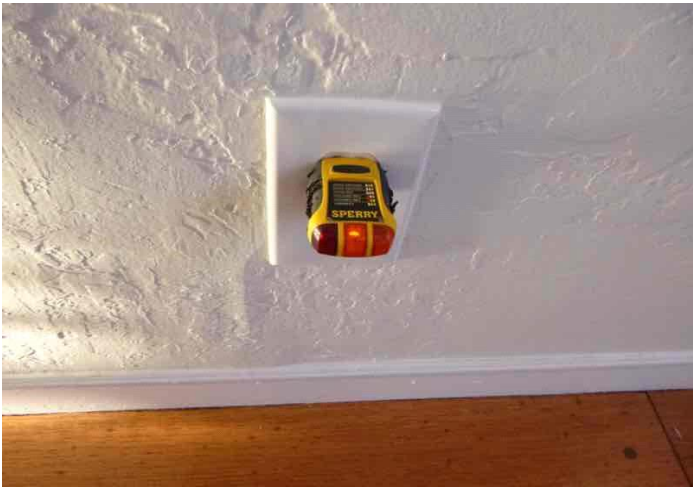
Photo 11

14. Ungrounded "3-prong" outlets at the living room / hall bathroom should be improved. A grounded cable or ground wire could be installed at these outlets, the outlet labeled as ungrounded or the original "2-prong" receptacle could be reinstalled. Based upon our inspection of a representative number of outlets, we recommend testing of every outlet. Repairs or rewiring are recommended at all deficient locations. For additional information we recommend a licensed electrician be consulted. (See Illustration 4O) (See Photo 11) (See Photo 14)

- ! 4. Ungrounded "3-prong" outlets at the living room / hall bathroom should be improved. A grounded cable or ground wire could be installed at these outlets, the outlet labeled as ungrounded or the original "2-prong" receptacle could be reinstalled. Based upon our inspection of a representative number of outlets, we recommend testing of every outlet. Repairs or rewiring are recommended at all deficient locations. For additional information we recommend a licensed electrician be consulted. (See Illustration 4O) (See Photo 11) (See Photo 14)

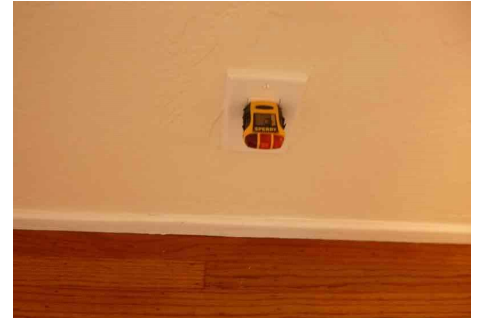
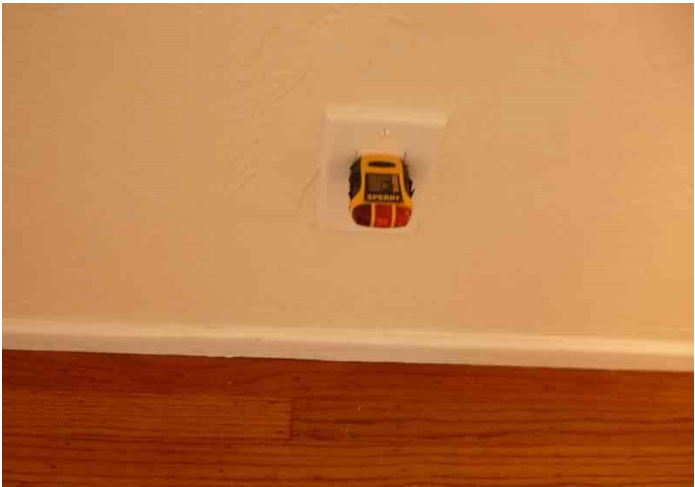
Photo 12

15. One or more outlets at the lower left bedroom were inoperative at the time of our inspection. Possibly due to turned off switches which were not located during our inspection. These outlets and circuits should be investigated and corrected as necessary. Based upon our inspection of a representative number of outlets, we recommend testing of every outlet at a later date. Repairs or rewiring are recommended at all deficient locations. (See Photo 12)

- ! 3. One or more outlets at the lower left bedroom were inoperative at the time of our inspection. Possibly due to turned off switches which were not located during our inspection. These outlets and circuits should be investigated and corrected as necessary. Based upon our inspection of a representative number of outlets, we recommend testing of every outlet at a later date. Repairs or rewiring are recommended at all deficient locations. (See Photo 12)

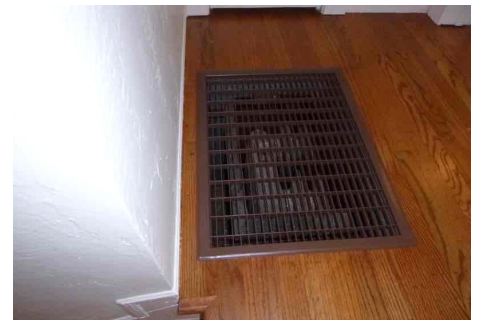
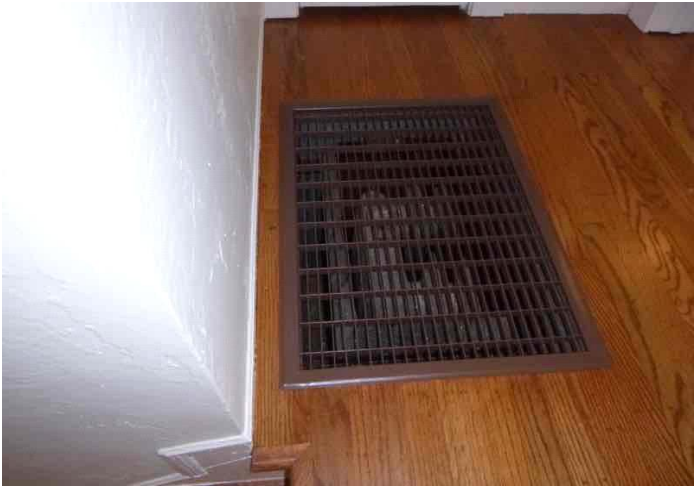
Photo 22

16. The heating systems energy source was shut off and the system was not operational at the time of our inspection. We cannot offer opinions about system performance or general state or repair. We recommend inspection by a licensed HVAC contractor when service has been restored. (See Photo 22)

The heating systems energy source was shut off and the system was not operational at the time of our inspection. We cannot offer opinions about system performance or general state or repair. We recommend inspection by a licensed HVAC contractor when service has been restored. (See Photo 22)

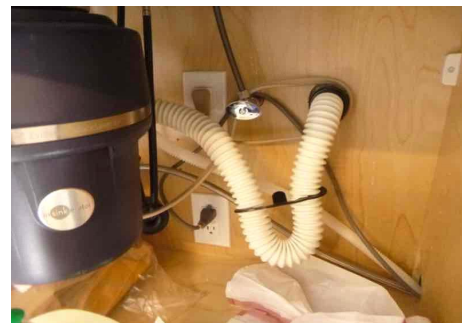
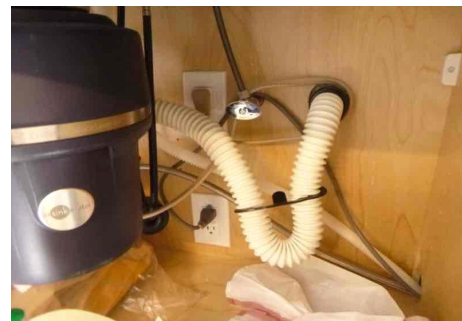
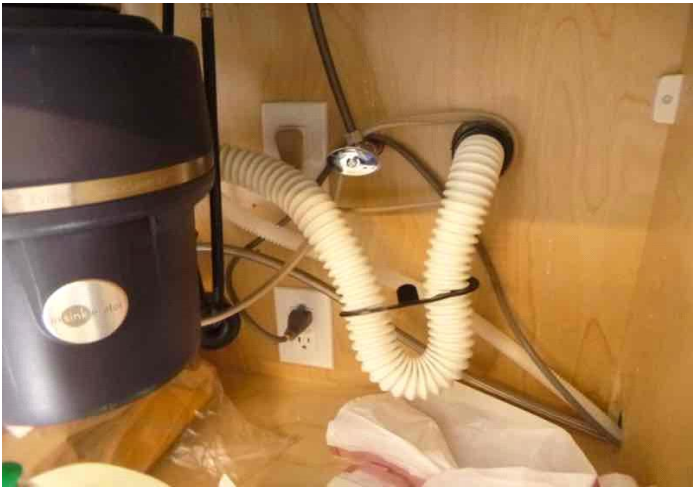
Photo 13

18. The waste piping at the kitchen does not have sufficient slope for proper drainage. We recommend this condition be corrected. (See Photo 13)

19. A plastic corrugated flex material has been used at the kitchen drain. This is not an approved configuration. We recommend an approved drain be installed. (See Photo 13)

- ! 3. The waste piping at the kitchen does not have sufficient slope for proper drainage. We recommend this condition be corrected. (See Photo 13)
- ! 4. A plastic corrugated flex material has been used at the kitchen drain. This is not an approved configuration. We recommend an approved drain be installed. (See Photo 13)

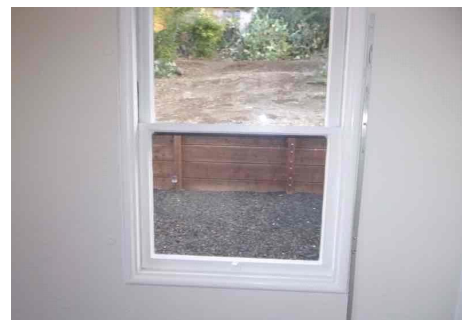
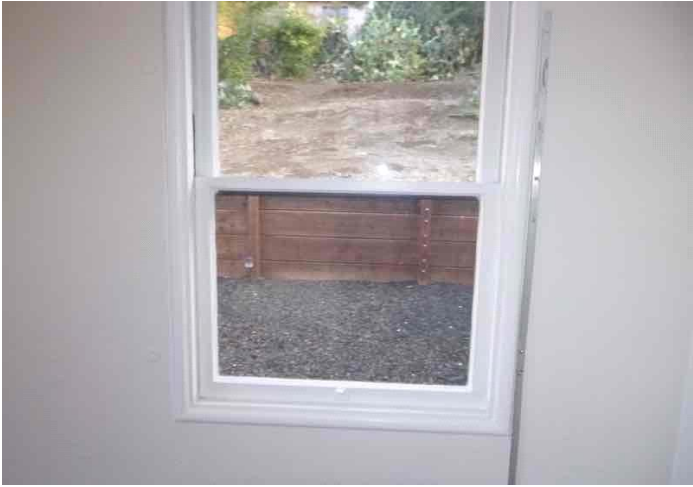
Photo 17

20. The interior windows at the upstairs bedroom are inoperable, stuck, or painted shut. We recommend repair or replacement to restore functional use of these areas. (See Photo 17)

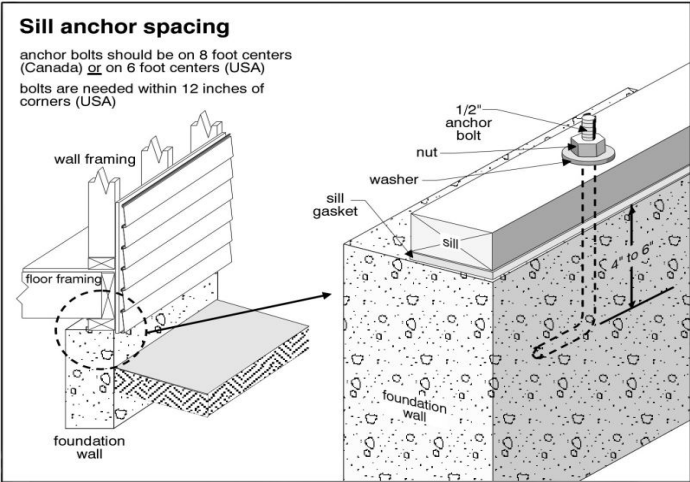
Illustration 1C

5. A minimum number of foundation anchor bolts were noted in the crawl space. While this condition has existed for many years with no adverse consequences, we recommend as an upgrade, that installation of additional anchor bolts be considered. (See Illustration 1C)
