Real Estate Inspection Report

305 Canyon Highlands Drive
Oroville, CA 95966

Prepared For: Chris Heebink
Inspected On Wed, Mar 25, 2026 at 11:00 AM

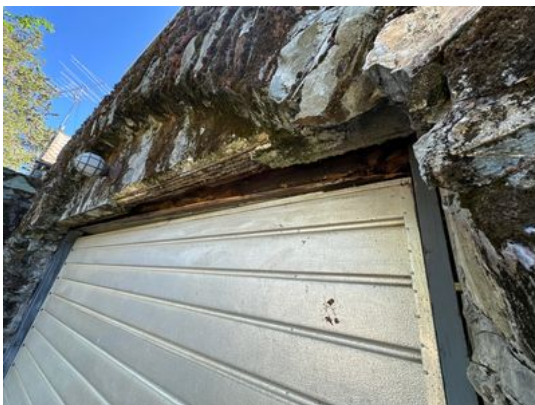
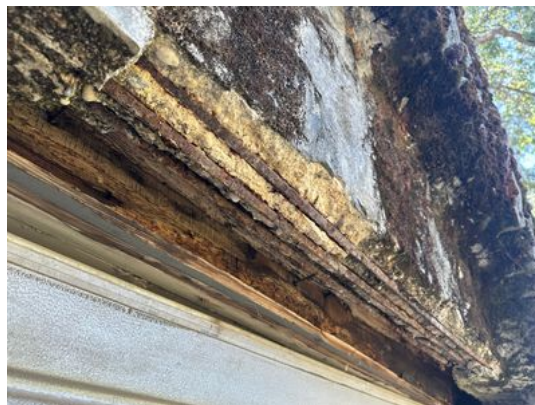
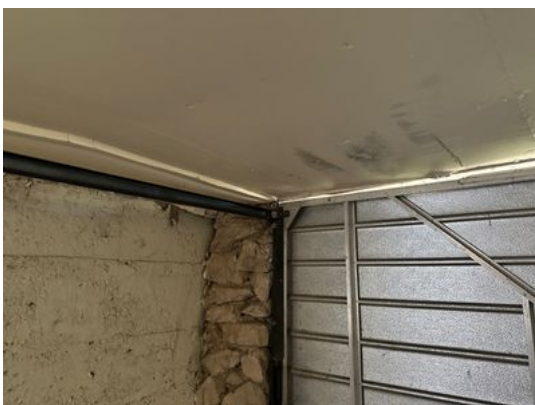
Damaged header at garage door, exposed rebar, spalling concrete above garage door, structural issue noted. Recommend review, repair by a qualified tradesperson.

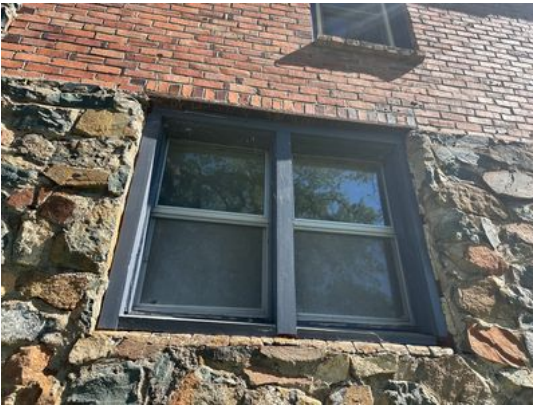
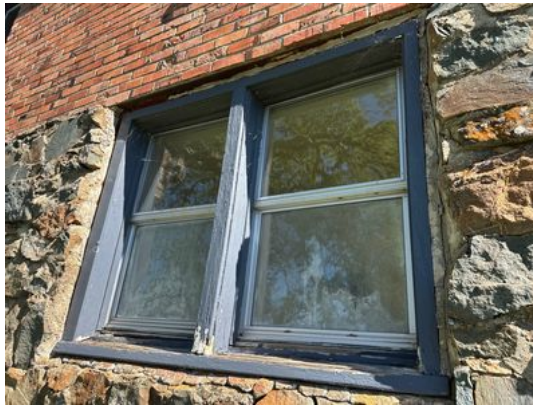
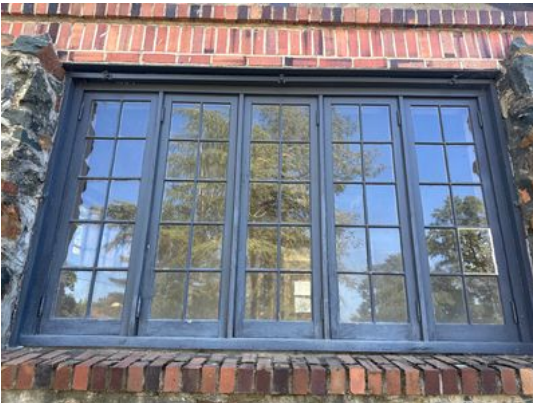
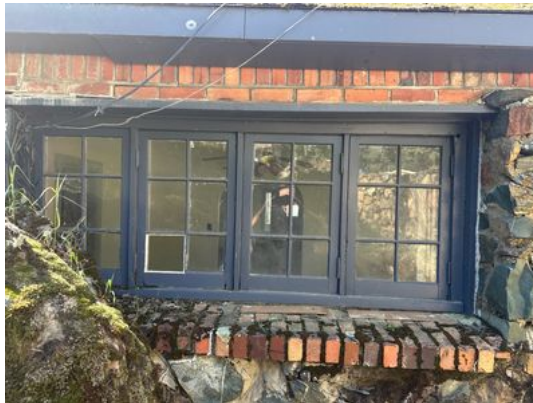
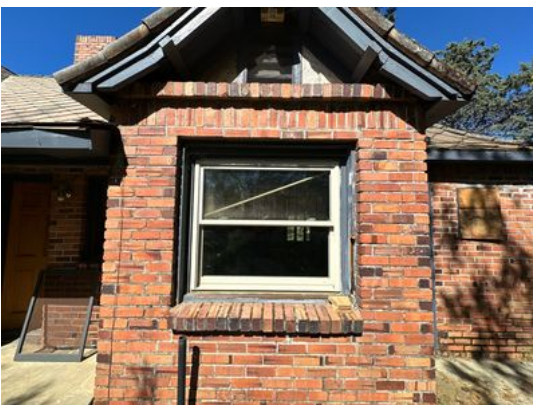
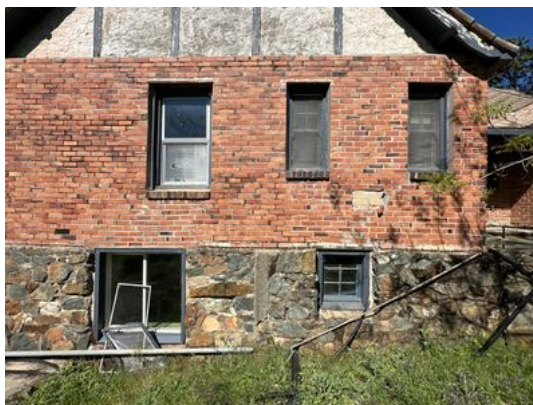
Damaged widow at front entry. Damaged windows, frames at southwest elevation. Damaged window north elevation. Damaged windows east elevation. Recommend review for repair.

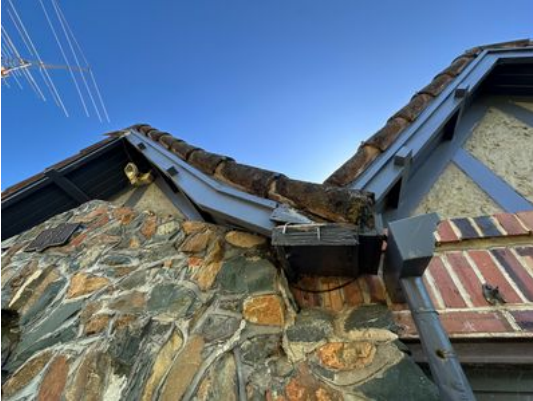
Damaged barge rafter, fascia at front entry.

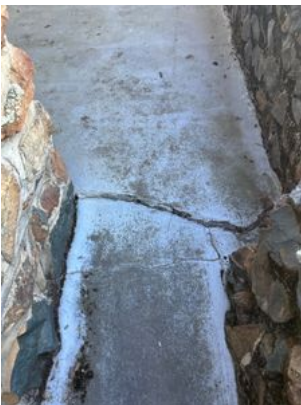
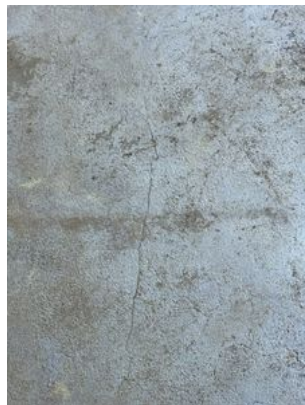
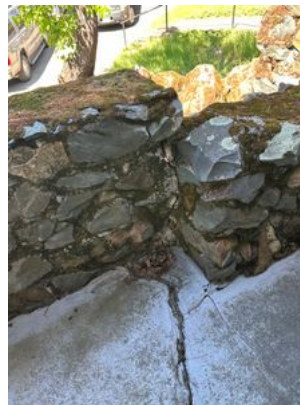
Cracked concrete patio, stone wall over garage. Recommend sealing to prevent moisture intrusion below.

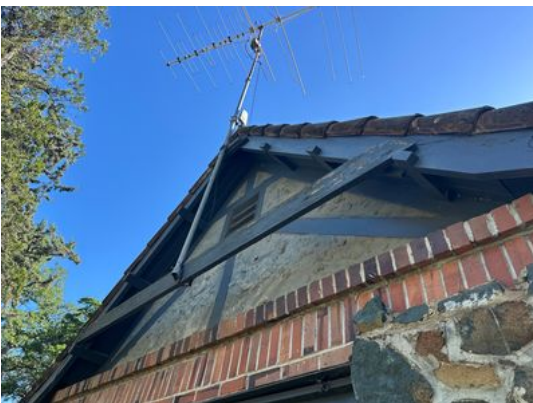
Damaged support at TV antenna. Recommend removing.

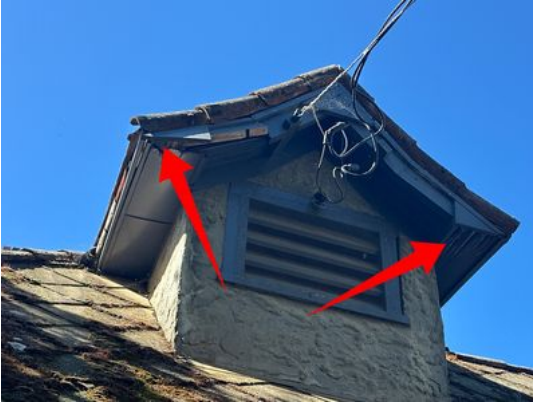
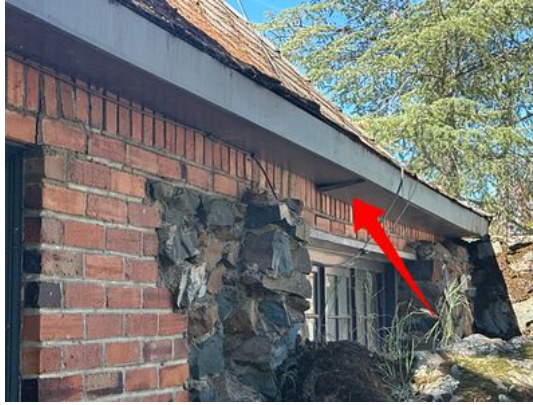
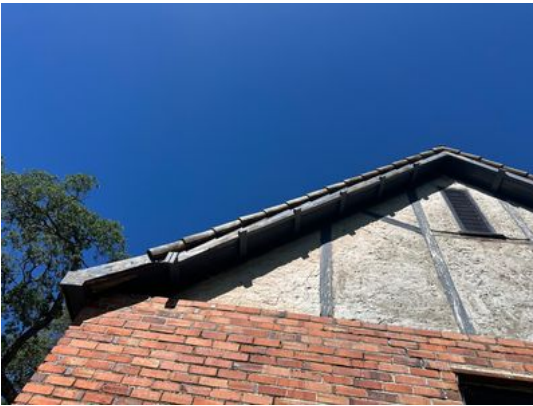
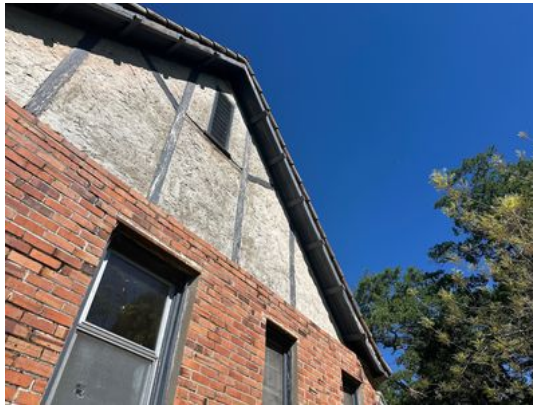
Damaged eaves at north facing roof dormer. Damaged eaves at north ground floor north. Damaged barge rafters at east elevation. Recommend review for repair.

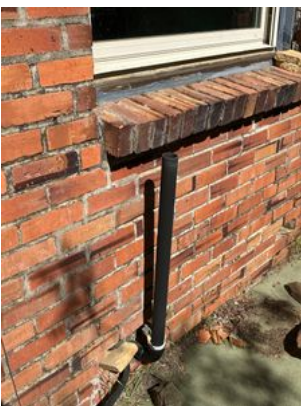
Plumbing waste should not vent below a window.

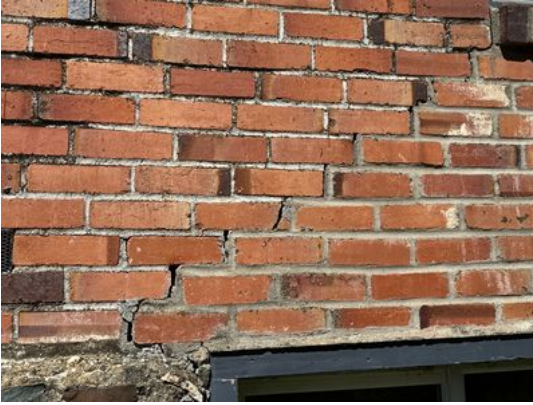
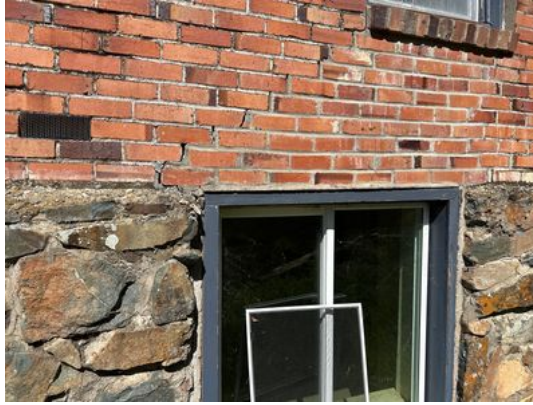
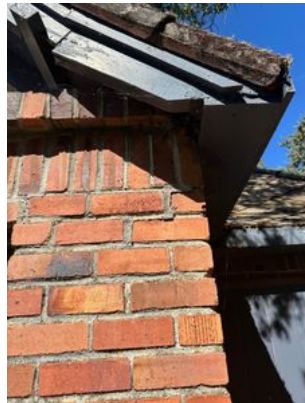
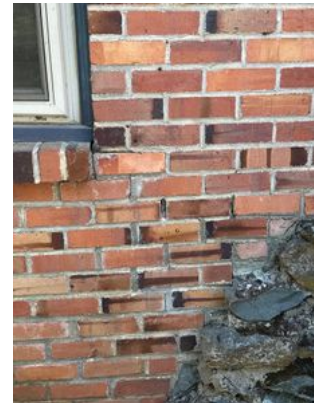
Step cracking in brickwork east elevation. Step cracking north elevation. Structural issue noted. Recommend review for repair.

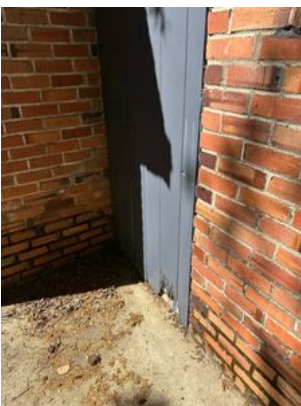
Damaged siding at east elevation.

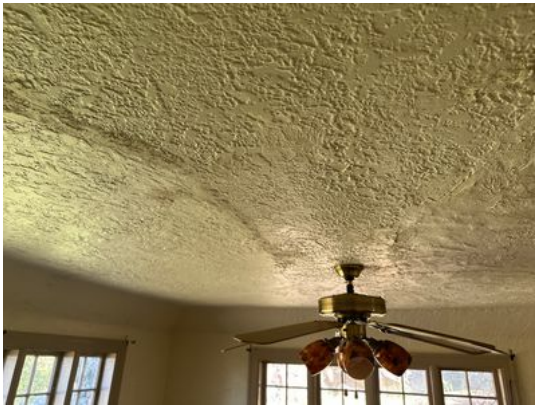
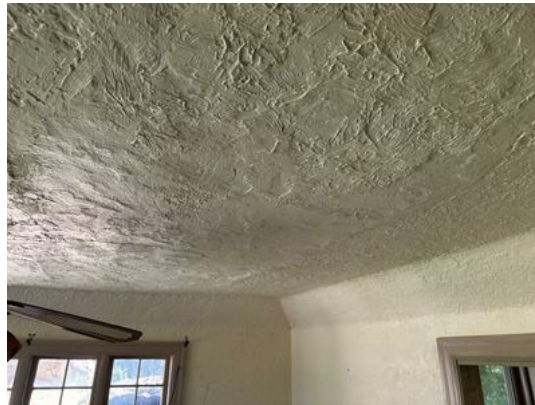
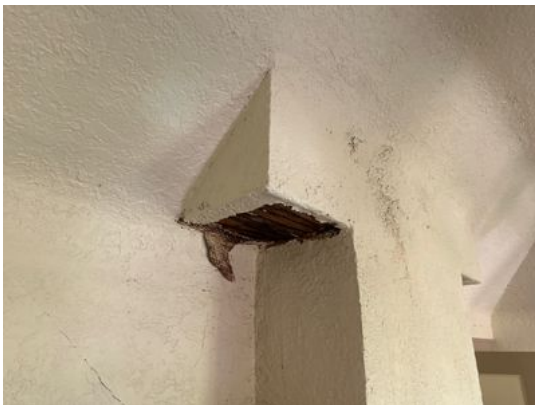
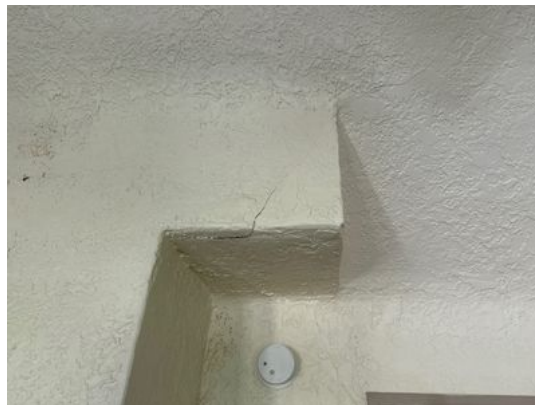
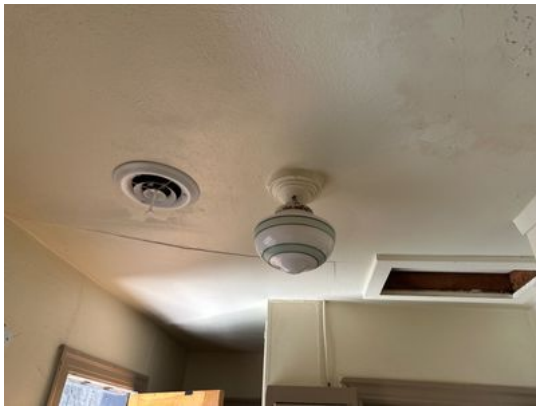
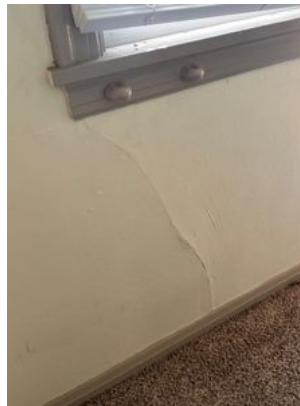
Lath and plaster detaching from ceiling joists. Recommend review for repair.

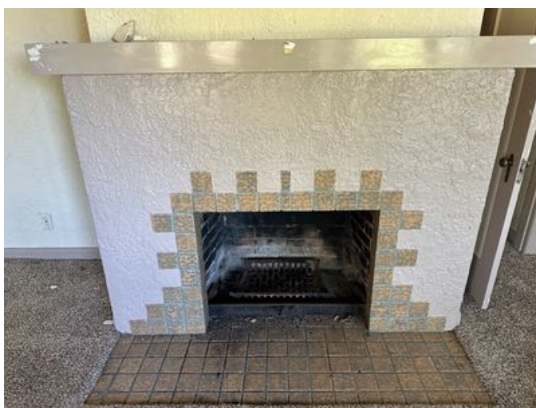
No fireplace fixed glass present. Most fireplaces with fixed glass do not require a hearth extension. The manufacturers usually require a 36" clear space in front (no furniture, etc.)

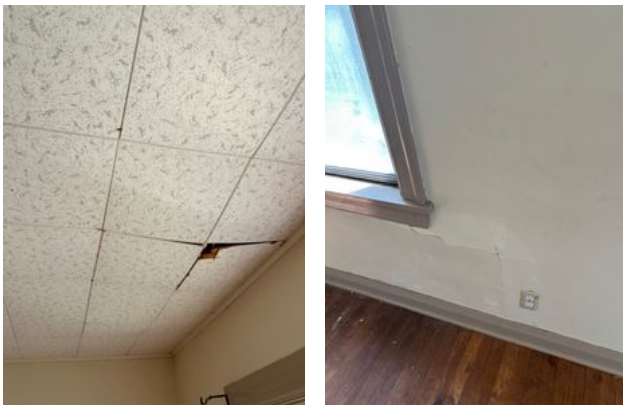
Damaged ceiling, wall in guest bedroom, recommend review for repair.

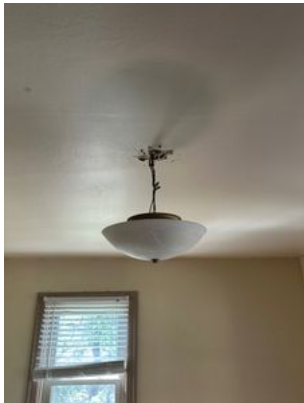
Light fixture detached in guest bedroom. Recommend review for repair.

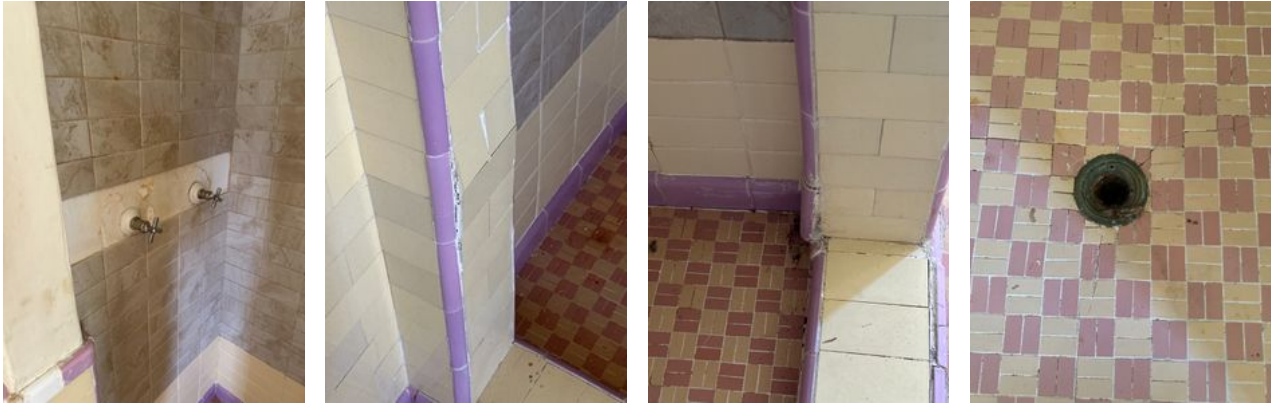
Detached tile in bathroom surround, drain missing screen. Recommend review for repair.

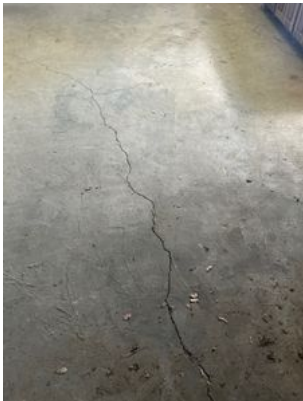
Cracking on garage concrete surface. Recommend sealing to prevent deterioration.

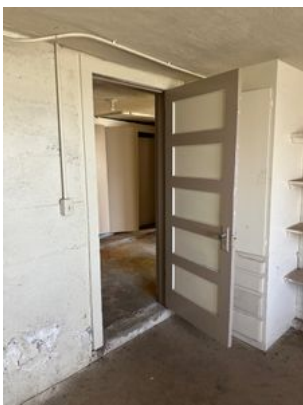
A house to garage fire door is required along with a working auto closure device.

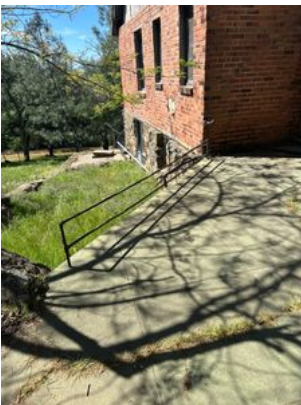
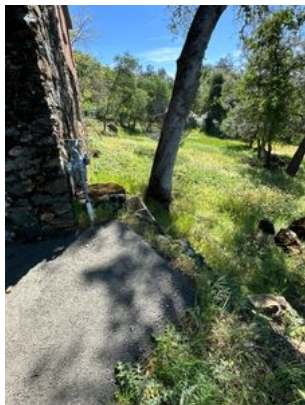
Railings are recommended in areas greater than 30".

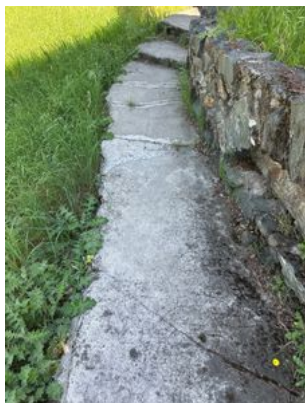
Predictable settling cracks on concrete walkway surfaces noted.

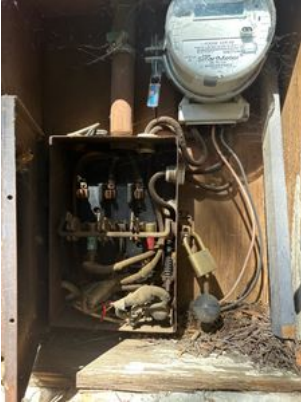
Damaged electrical box, outdated service panel. Main disconnect padlocked in off position. Recommend further review by an electrical contractor for recommended upgrade.

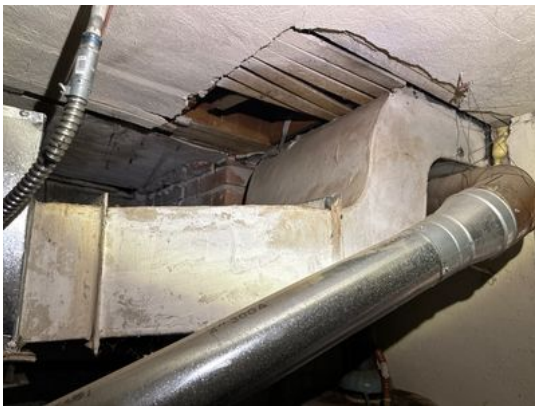
Possible asbestos materials observed. The materials appeared to be in serviceable condition at the time of inspection. Asbestos materials are considered safe by the EPA if they are not disturbed, torn, ripped, or damaged. No torn, ripped, or damaged materials were observed. If client has any concerns regarding asbestos materials, an asbestos testing lab should be consulted for further review to ensure safety. Ducting wrap at furnace.

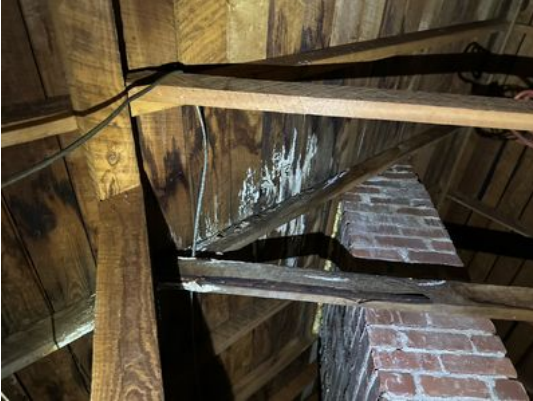
Damage to sheathing, roof joists in area of chimney. Recommend review for repair.

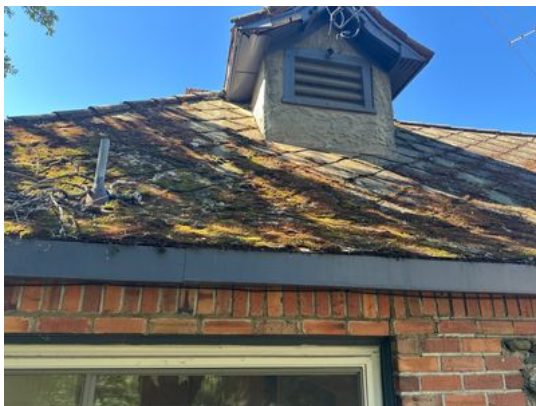
Moss on roof. This can lead to the premature failure of the roof and subsequent leaks. Recommend treating moss during its growing season (wet months) with a moss killer. For information on various moss treatment products and their pros and cons, visit <http://bryophytes.science.oregonstate.edu/page24.htm>

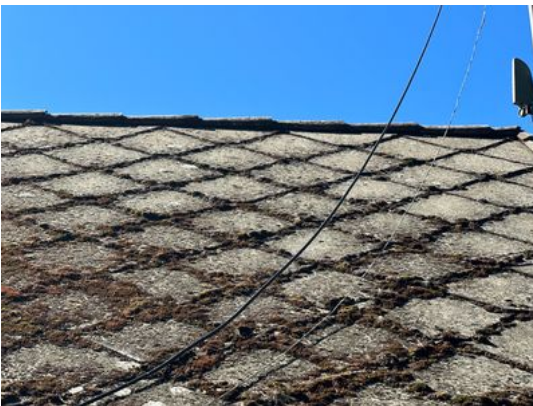
Cement roofing material may contain asbestos. It is common knowledge that asbestos is usually found in building materials such as siding, roofing, the interior ceilings and walls in some aged homes. However, did you know that asbestos can also be found in older ovens, popcorn making machines and even in hairdryers? Be very careful when scouring through flea markets and yard sales; although asbestos has been banned from inclusion since 1979, there are still some oldies out there.

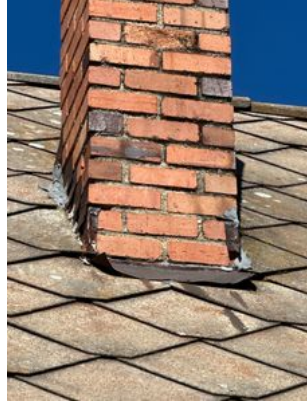
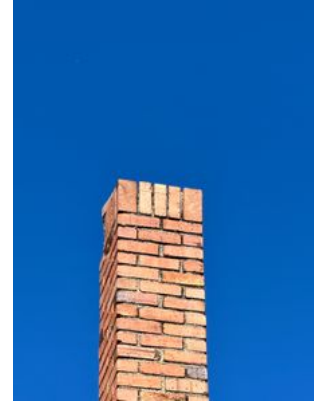
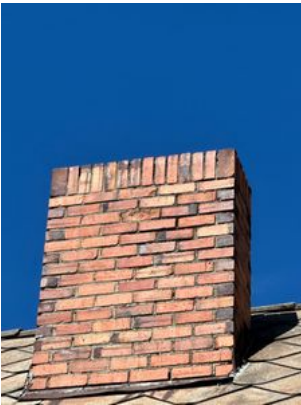
Flashings at chimney are rusted. Rain caps and spark arrestors not present. Recommend review for repair.

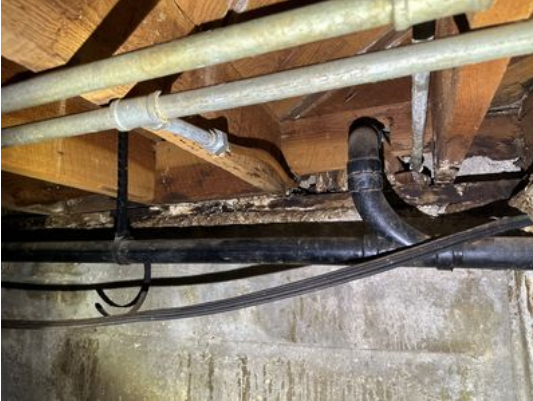
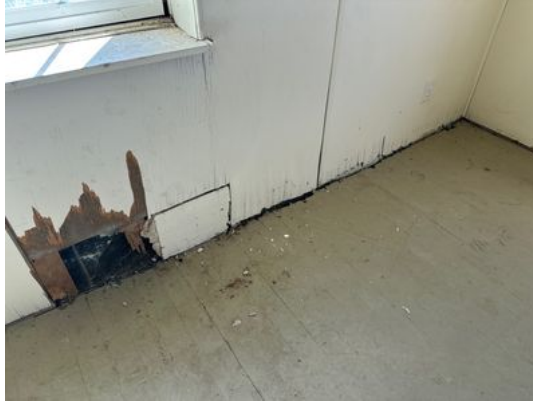
Damaged subfloor, framing in basement area. Recommend review for repair.
