HOME INSPECTION REPORT

771 W. 91st Street, Los Angeles

670819

February 7, 2026

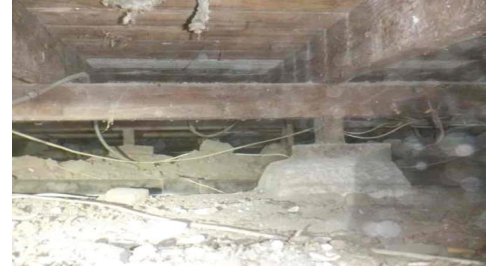
Photo 74

4. Due to the lack of clearance between the ground and ducting, plumbing, and/or floor joist/girders, the rear section of the crawl space was not inspected. With access and an opportunity for a complete inspection, conditions in need of attention may be discovered. We recommend further inspection when a minimum of 16 inches between the ground and any obstructions is provided. (See Photo 74)

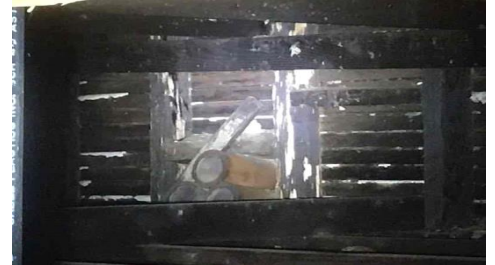
Photo 70

5. The wall framing of the attic shows evidence of damage. We recommend the advice and services of a licensed contractor and/or structural pest control operator. (See Photo 70)

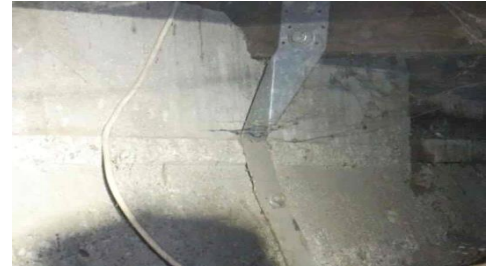
Photo 78

6. Evidence of past repairs and/or modifications have been made to the foundation. The owner may have information about the repairs or remodeling work, and any permits that were required, obtained and completed. (See Photo 78)

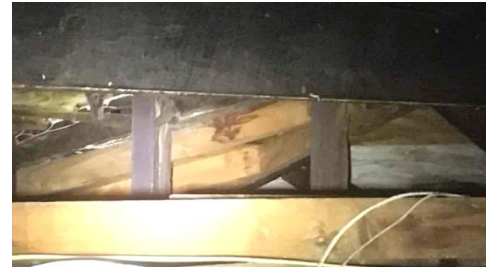
Photo 71

7. Water stains were evident in the attic. This could indicate leakage through the roof covering. We recommend the services of a licensed roofing contractor to further evaluate this condition. (See Photo 71)

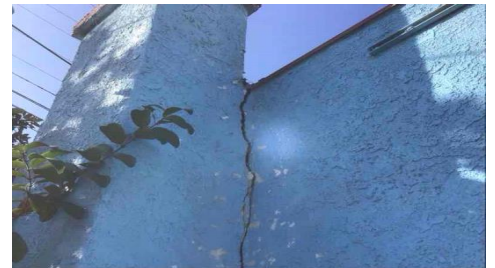
Photo 12

8. There is a large crack at the chimney. This condition may indicate movement of the chimney. It is impossible to determine the rate of movement during a one time visit to the property. We recommend the advice of a licensed masonry contractor. (See Photo 12)

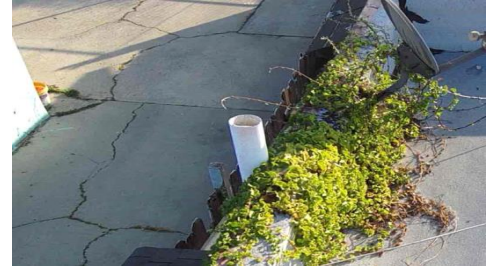
Photo 22

- 9. All missing roof plumbing or appliance vent caps should be replaced. (See Photo 22)

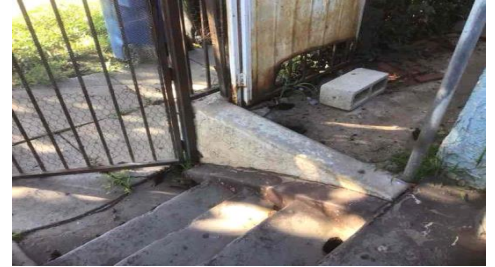
Photo 01

- 10. For safety purposes, railing(s) should be provided at the front. (See Illustration 3J) (See Photo 1)

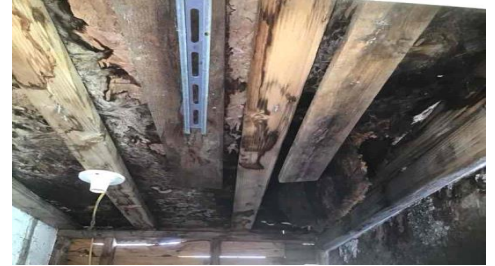
Photo 25

- 11. Evidence of water damage was noted at the rear patio cover. Consult a licensed structural pest control company regarding necessary repairs. (See Photo 25)

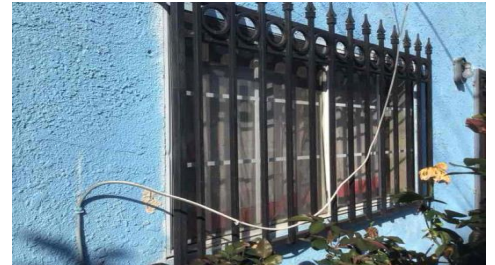
Photo 14

- 12. There are metal bars on one or more of the windows which do not all open from the inside. This is a significant safety hazard. We recommend that all window bars be removed or modified so they can be opened from the interior in case of an emergency. (See Photo 14)

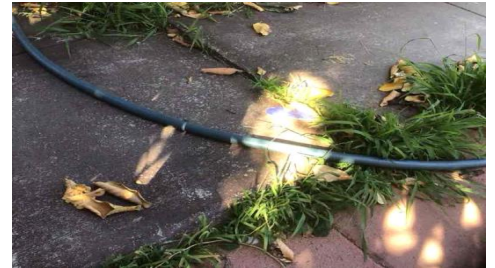
Photo 11

- 13. The cracked, heaved, or uneven walkway sections at the exterior pose a potential trip hazard. We recommend corrective action to improve safety and reduce the risk of injury. A qualified contractor should assess the affected areas and perform necessary repairs to ensure a level walking surface. (See Photo 11) (See Photo 2)

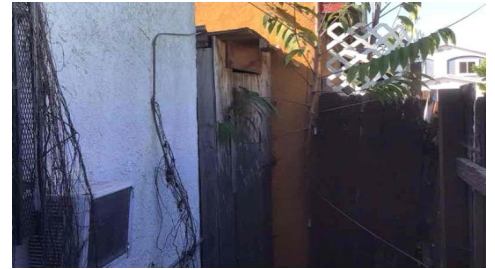
Photo 35

14. Portions of the exterior of the structure or property at the rear and rear left side were inaccessible due to owner storage. Reportable conditions may be hidden from inspection. We recommend this area be cleared to allow for further inspection. (See Photo 35) (See Photo 36)

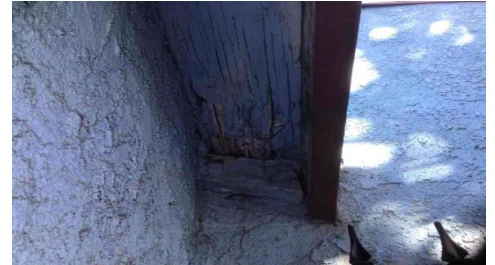
Photo 03

15. Water damage was observed to the roof eaves/sheathing at the front. We recommend the services of a licensed general contractor and/or structural pest control company. (See Photo 3)

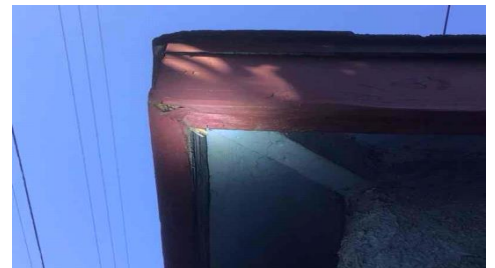
Photo 06

16. Water damage was observed to the fascia at the front. We recommend the services of a licensed general contractor and/or structural pest control company. (See Photo 6)

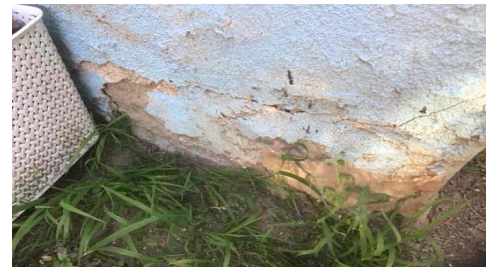
Photo 09

17. The exterior sty siding material shows evidence of weathering, cracking and/or delaminating (coming apart). Localized repairs, replacement and/or painting may extend the life of the siding. Replacement may eventually be necessary. (See Photo 9) (See Photo 7)

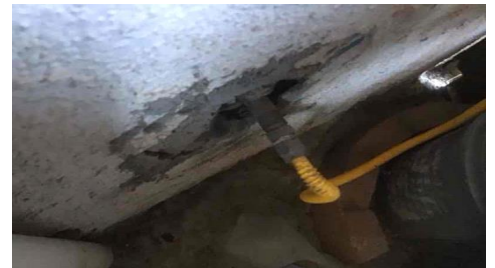
Photo 32

18. The openings in the exterior siding at the various plumbing or gas piping penetrations should be filled to prevent rodent and moisture entry. (See Photo 32)

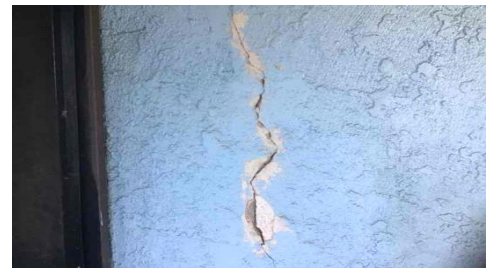
Photo 04

19. Localized damage and/or large stucco cracks at the front and rear should be further evaluated by the appropriate tradesperson to determine if any moisture intrusion has occurred and to repair the stucco in this area. (See Photo 4) (See Photo 8) (See Photo 32)

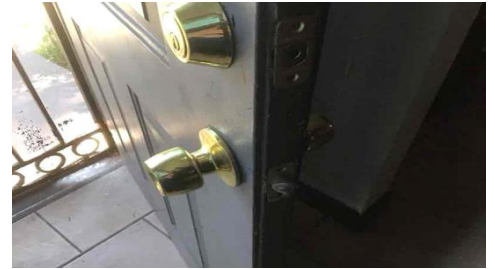
Photo 72

20. Loose and/or damaged hardware was noted at the rear right side door. We recommend that hinges, knobs, latches and strike plates be adjusted or replaced to restore full operation. (See Photo 72)

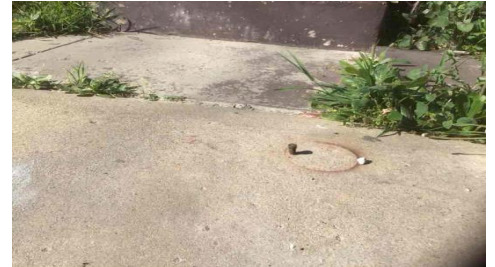
Photo 33

21. The abandoned anchor bolts at the rear right side section of the walkway presents a trip hazard. This condition should be altered for improved safety. (See Photo 33)

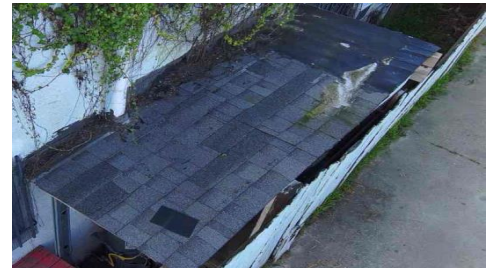
Photo 26

22. The patio cover roofing is damaged or in need of repairs. Damaged or missing roofing material should be repaired or replaced as necessary. (See Photo 26)

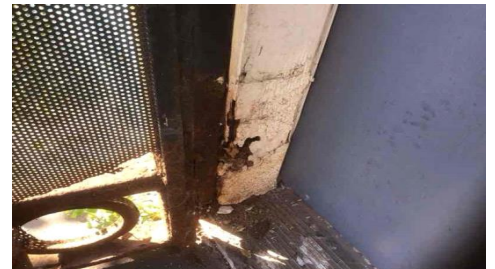
Photo 34

23. Water damage was noted at the rear right side door jamb. We recommend the services of a licensed general contractor and/or structural pest control company. (See Photo 34)

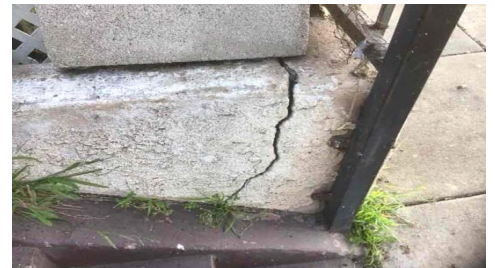
Photo 05

24. The retaining wall at the front shows evidence of movement. It is impossible to determine the rate of movement during a one time visit to the property. We recommend further evaluation by the appropriate trades for any recommendation deemed necessary to prevent further movement. (See Photo 5)

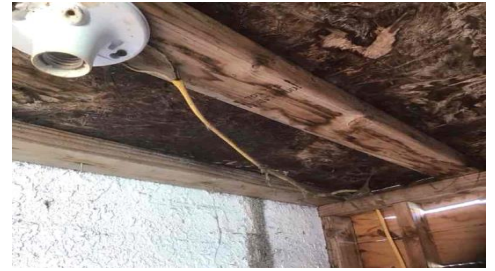
Photo 29

25. The installation of the distribution wiring at the rear is non-standard. It is suspected that installation was performed by someone other than a licensed electrician. We recommend the services of a licensed electrician. (See Photo 29)

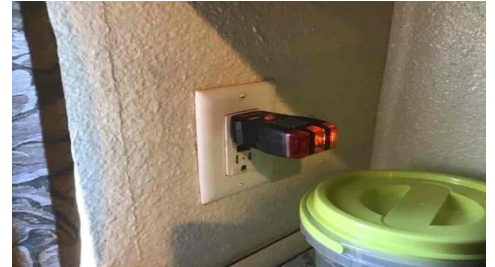
Photo 50

26. One or more outlets and/or receptacle housings at the kitchen are loose. Based upon our inspection of a representative number of outlets we recommend testing of every outlet. All loose outlets and receptacles should be repaired as necessary. (See Photo 50)

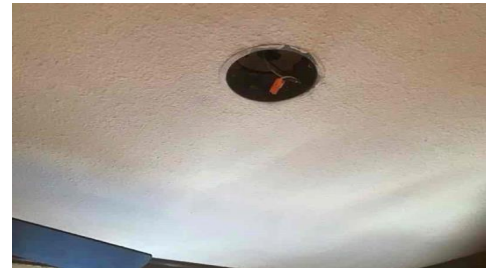
Photo 48

27. The loose, missing, damaged, or improperly installed light fixture at the kitchen should be repaired or replaced. (See Photo 48)

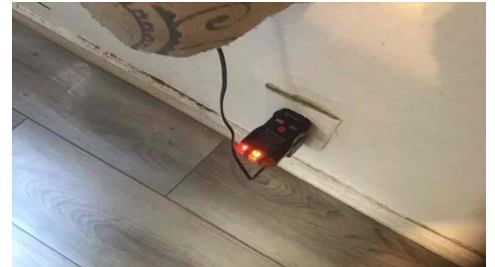
Photo 41

28. One or more outlets at the living room have reversed polarity, i.e. the hot and neutral connection inside the outlet are wired backwards. These outlets and the circuit should be investigated and corrected. Based upon our inspection of a representative number of outlets, we recommend testing of every outlet at a later date. Repairs or rewiring are recommended at all deficient locations. (See Illustration 4M) (See Photo 41)

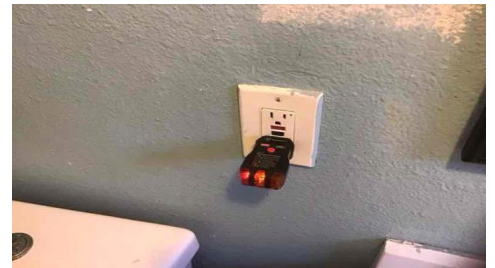
Photo 59

29. A ground fault circuit interrupter (GFCI) outlet at the hall bathroom did not function or did not trip when tested with an outside source and/or the test button. This outlet and circuit should be investigated and repaired. (See Photo 59)

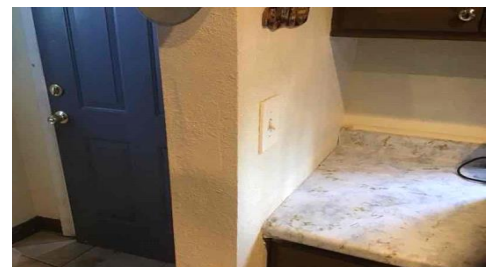
Photo 54

30. A switch at the kitchen is faulty or damaged. We recommend it be replaced. (See Photo 54)

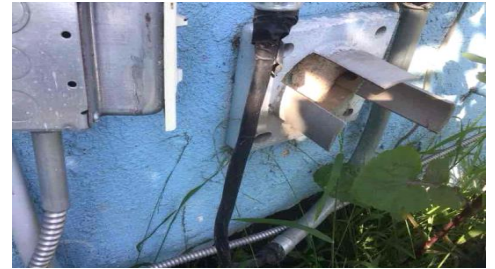
Photo 18

31. We found exposed wiring at the right side and rear. Even if insulated, we recommend all wiring be encased in conduit or otherwise protected in accordance with present standards. (See Photo 18)

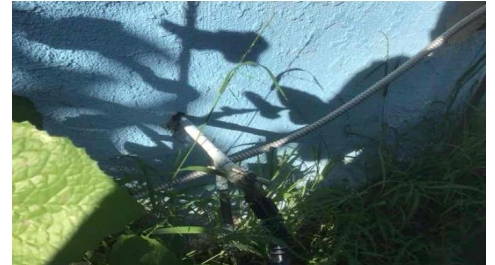
Photo 15

32. Loose, sagging or unsecured conduit at the right side and crawlspace should be properly re-secured or strapped. (See Photo 15) (See Photo 79)

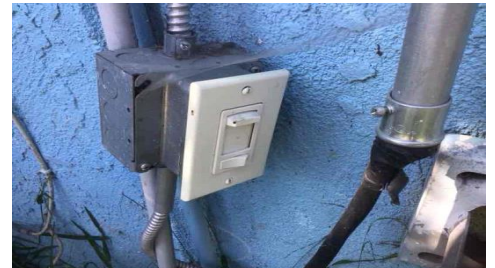
Photo 16

33. An exterior switch at the right side is missing a water proof cover plate. We recommend an exterior approved cover be installed. (See Photo 16)

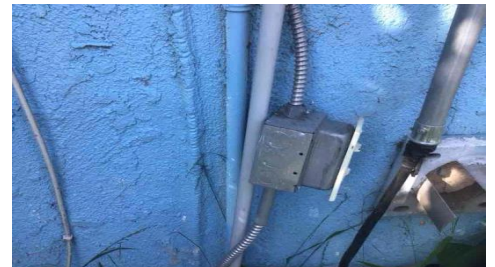
Photo 17

34. One or more electrical outlets or junction boxes at the right side were noted to be loose or unsecured. We recommend all loose or unsecured junction boxes be repaired. (See Photo 17)

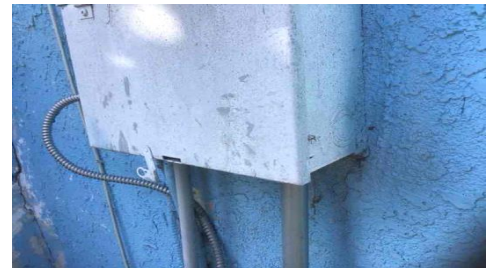
Photo 19

35. The main electric panel weatherproof cover plate latch is loose, damaged or missing. We recommend it be repaired or replaced. (See Photo 19)

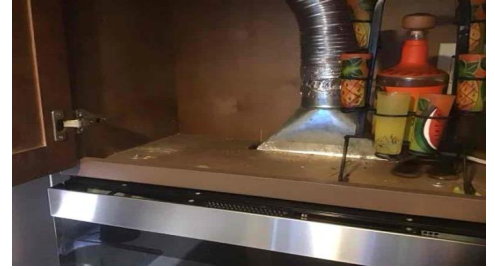
Photo 52

36. The exhaust vent built into the microwave is not configured to vent the air to the exterior, the air is currently blown out the front grill. As a gas cooktop was present, we recommend the exhaust vent be repaired to properly exhaust the air to the exterior. (See Photo 52)

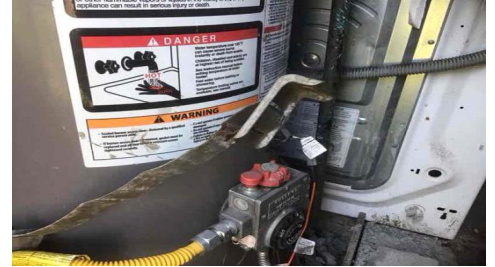
Photo 28

37. The water heater seismic straps are loose or disconnected, this will allow movement of the tank in an earthquake. We recommend tightening the straps and/or adding bracing between the tank and wall to improve safety. (See Photo 28)

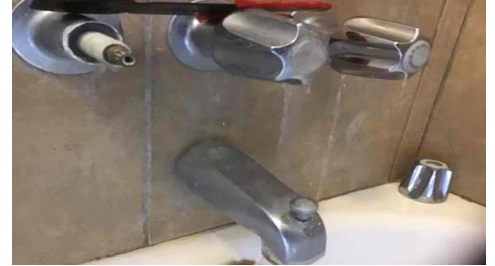
Photo 66

38. The tub faucet and/or handles are leaking at the hall bathroom. We recommend all leaks be repaired. (See Photo 66)

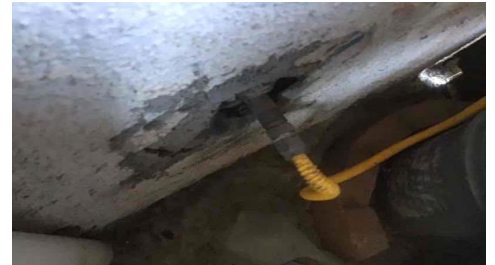
Photo 32

39. The gas shut off valve at the laundry area is within the structure at the rear. We recommend that installation of an approved valve be installed on the outside to be readily accessible. (See Photo 32)

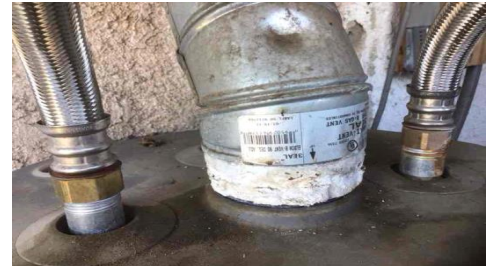
Photo 27

40. For enhanced safety, it is recommended that the loose or damaged connections of the water heater venting system be improved. A minimum of 3 screws at each section of the duct is recommended. (See Illustration 8M) (See Photo 27)

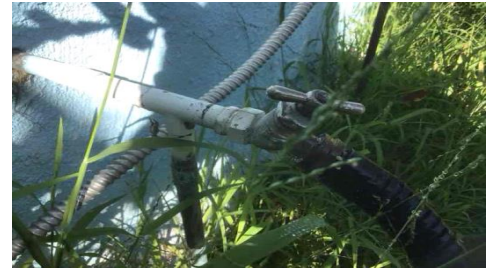
Photo 13

41. The exterior hose bib at the right side is leaking. We recommend all leaks be repaired. (See Photo 13)

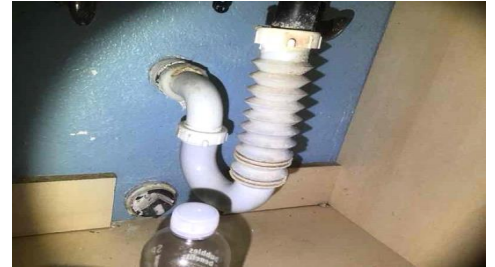
Photo 58

42. A plastic corrugated flex material has been used at the hall bathroom drain. This is not an approved configuration. We recommend an approved drain be installed. (See Photo 58)

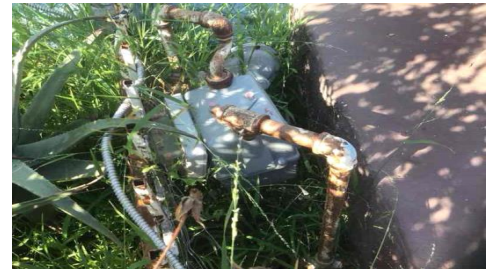
Photo 21

43. There is evidence of corrosion and rust on the exterior of the exposed and accessible metal gas supply piping at the main meter. This section of piping should be protected and/or replaced as necessary. (See Photo 21)

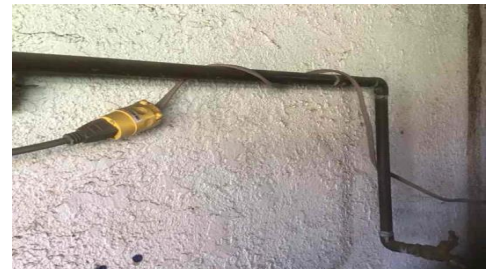
Photo 30

44. The supply piping at the rear does not have sufficient support. Additional support or bracing is recommended. (See Photo 30)

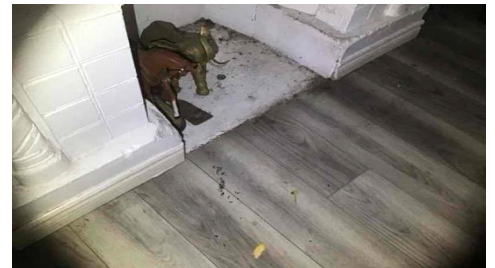
Photo 44

45. The fireplace hearth and/or face is made of combustible materials or the clearance from combustible materials is inadequate. This is a potential fire hazard and we recommend further evaluation by a licensed fireplace specialist. (See Photo 44)

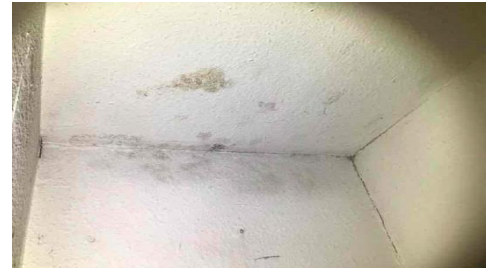
Photo 56

46. The ceiling at the rear left bedroom closet and hall bathroom shows evidence of water stains and/or damage. We recommend the services of a licensed structural pest control company for investigation of this area. (See Photo 56)
(See Photo 67)

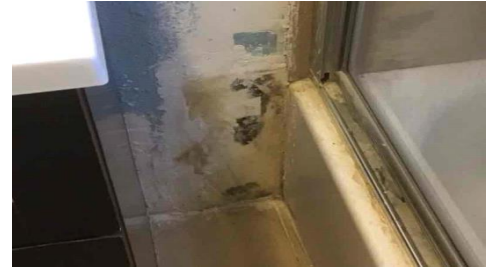
Photo 60

47. The wall at the hall bathroom shows evidence of water damage. We recommend the services of a licensed structural pest control company for investigation. (See Photo 60)

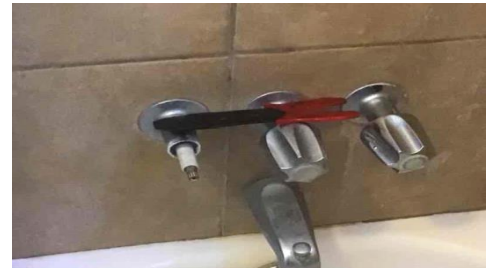
Photo 64

48. The faucet handles at the hall bathroom are damaged or missing. We recommend the handles be repaired or replaced for full use of the faucet. (See Photo 64)

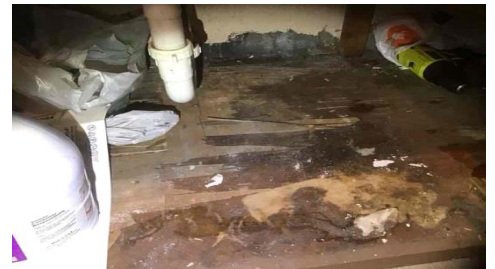
Photo 51

49. The base and/or side of the kitchen cabinet sink shelf is water damaged. We recommend the services of a licensed structural pest control operator for investigation of this condition. (See Photo 51)

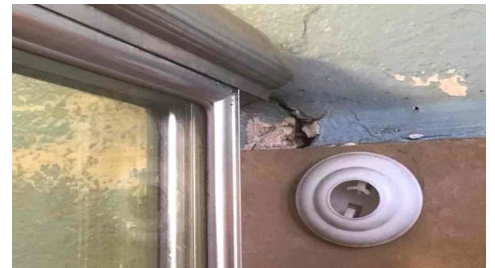
Photo 65

50. The wall at the hall bathroom is damaged. We recommend it be repaired. (See Photo 65)

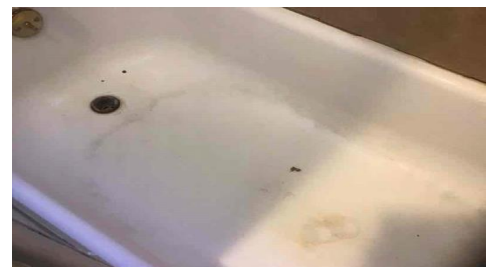
Photo 63

51. The tub in the hall bathroom shows evidence of wear and/or chipping. It may be desirable to refinish or repair it for cosmetic considerations and/or prolong the life of the tub. (See Photo 63)

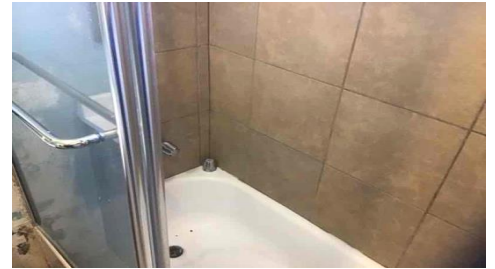
Photo 62

52. Cracked, deteriorated and/or missing grout and caulk in the hall bathroom shower should be replaced. Water leaking through non-sealed areas can cause damage. Damage caused by water seepage cannot be determined by this visual observation. A flexible caulking material is recommended rather than rigid cementitious grout. (See Photo 62)

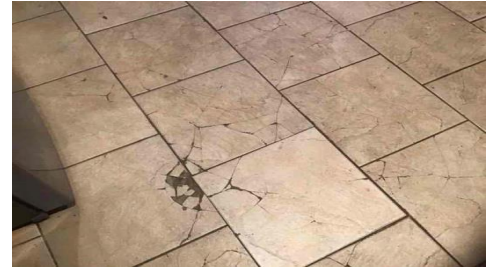
Photo 47

53. Cracked floor tile in the kitchen and hall bathroom should be replaced. Water leaking through non-sealed areas can cause damage. Damage caused by water seepage cannot be determined by this visual inspection. (See Photo 47)

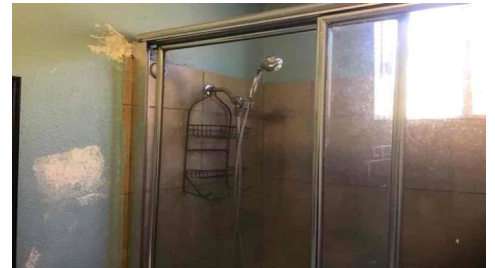
Photo 61

54. The tub/shower door in the hall bathroom is not installed or adjusted properly. We recommend it be properly reinstalled and/or adjusted to function properly. (See Photo 61)

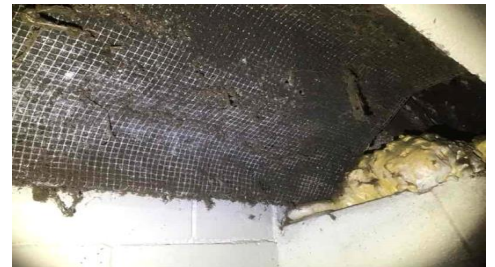
Photo 42

55. There does not appear to be a damper in the fireplace. We recommend the installation of a damper. (See Photo 42)

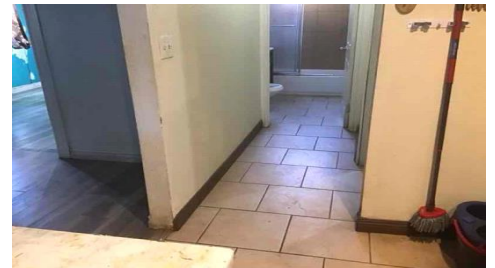
Photo 55

56. California law requires that all homes have a State Fire Marshall approved Carbon Monoxide Detector be installed outside of the sleeping areas in the hallway and on each level of the home including basements. At the time of this inspection a Carbon Monoxide Detector could not be located. We recommend consulting with the owner to see if a Carbon Monoxide Detector exists and if not they should be installed in all required locations. (See Photo 55)

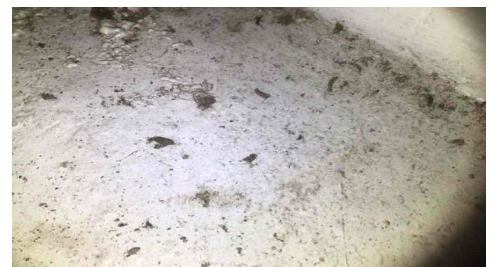
Photo 43

57. Evidence of vermin activity was observed within the structure. It is likely this evidence will extend into inaccessible areas. The owner is advised to contact the appropriate trade for further evaluation and remedial measures if necessary. (See Photo 43)

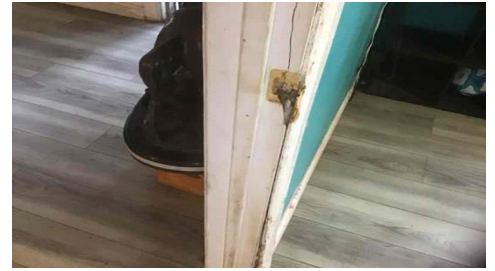
Photo 45

58. The door frame (jambs and/or trim) is cracked, split or damaged at the front left bedroom. We recommend all damaged door framing be repaired or replaced. (See Photo 45)
