Inspection Report

This inspection performed in accordance with current "Standards of Practice" of the California Real Estate Inspection Association.

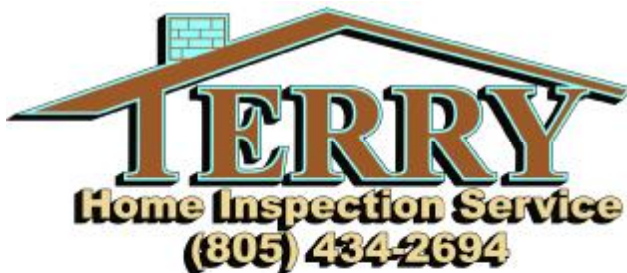
Inspected by: **Gregory S. Terry**

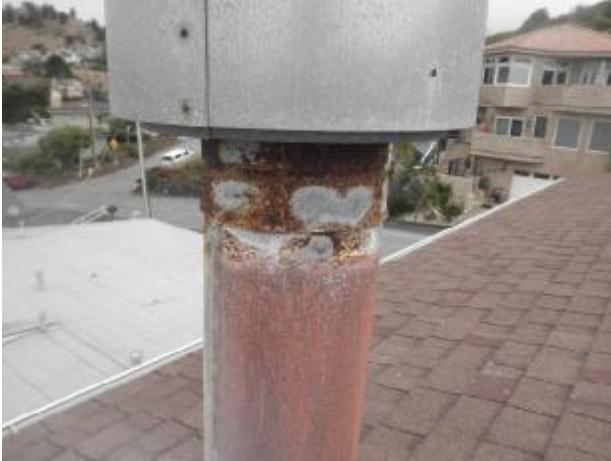
Rust damage at the chimney exhaust.

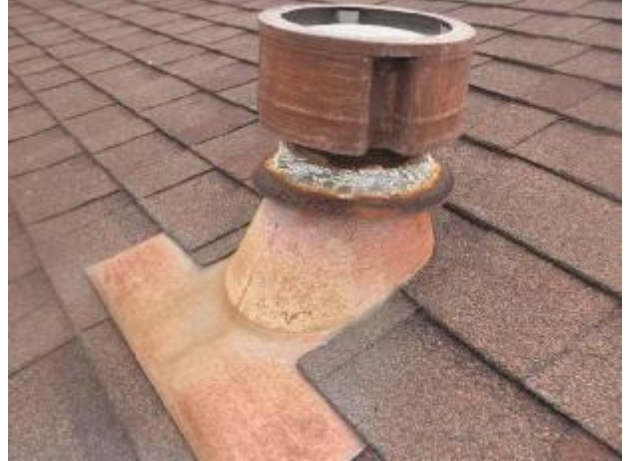
Rust damage at the furnace exhaust.

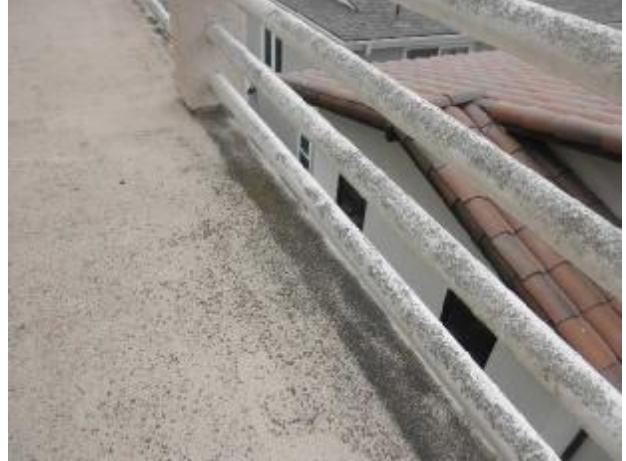
General deterioration of the deck coating due to age.

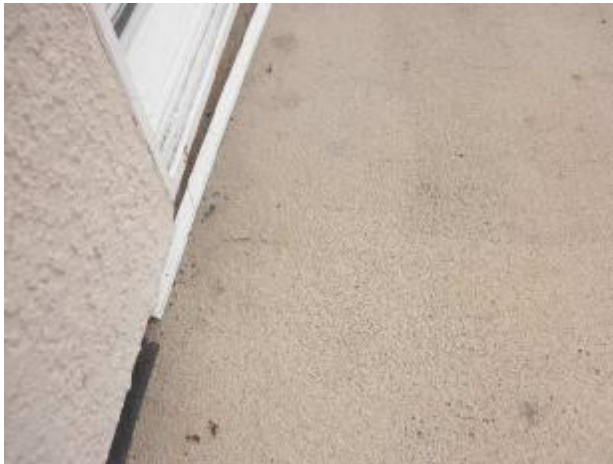
Surface cracking at the deck water proof coating.

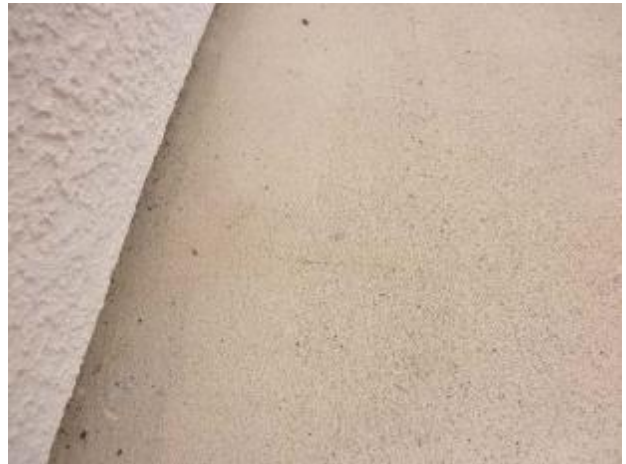
Surface cracking at the deck water proof coating.

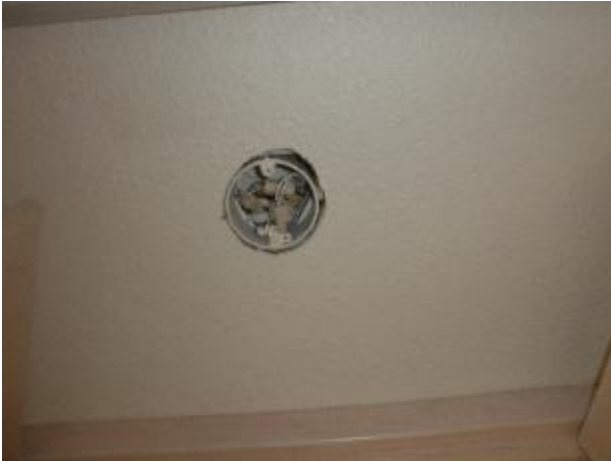
Junction box missing cover plate in the laundry area.

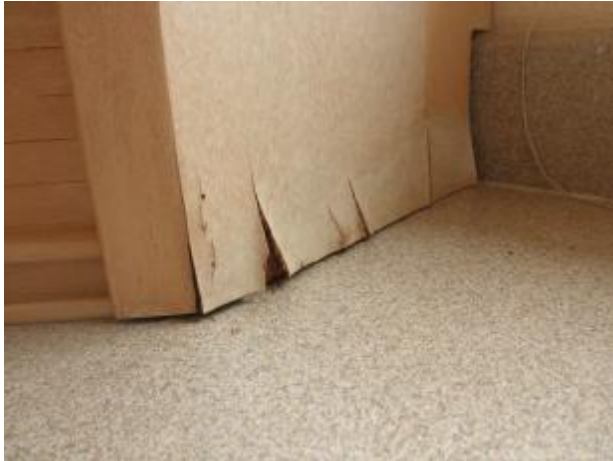
Moisture damage to the side of the cabinet.

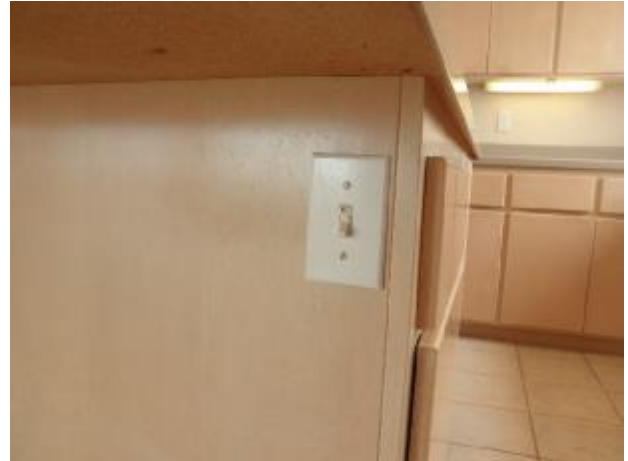
Garbage disposal switch at the side of the island.

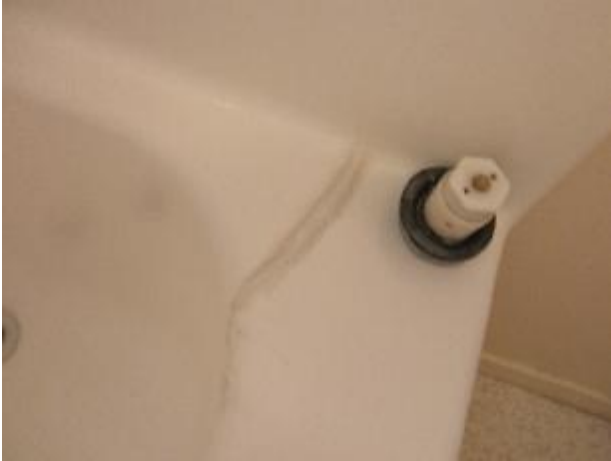
Sealed crack at the hall bathroom tub.

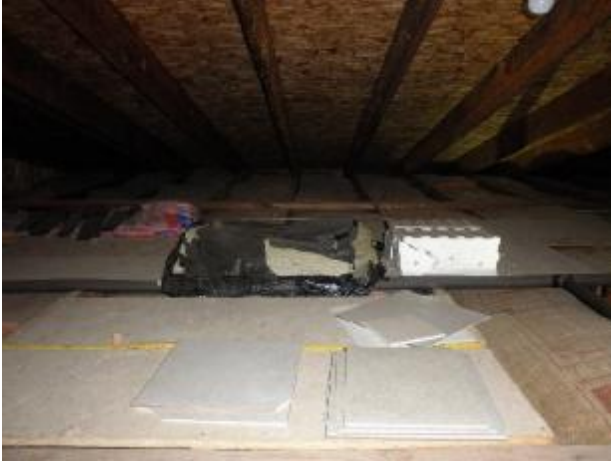
The insulation in the attic is installed up-side-down.
