REAL ESTATE INSPECTION REPORT

LARocca
INSPECTIONS

3540 N Knoll Dr, Los Angeles, CA 90068

DATE OF INSPECTION: Friday, September 12, 2025

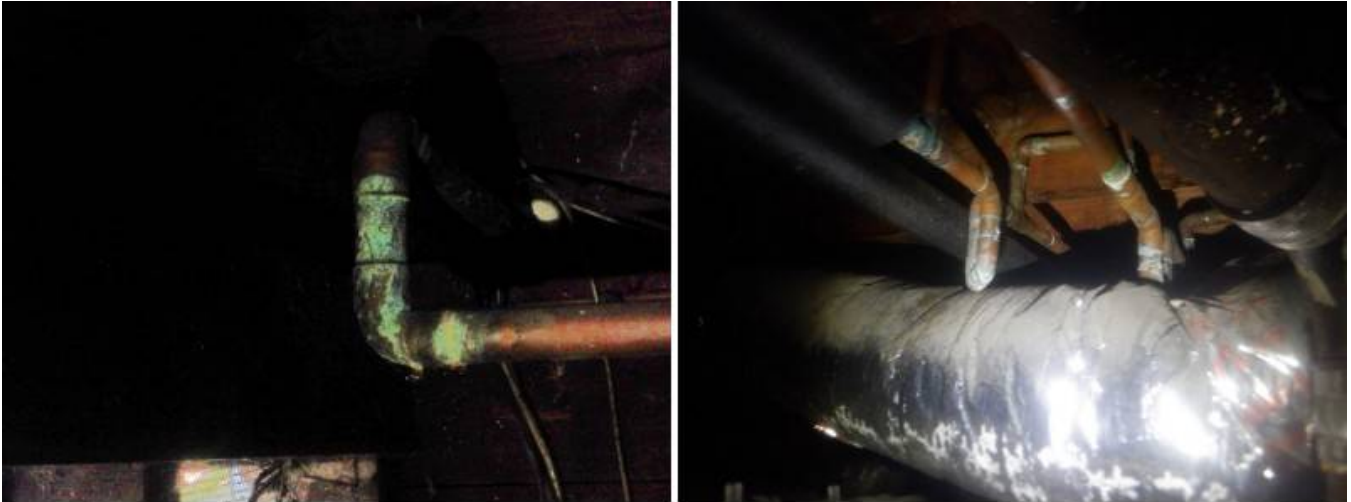
WATER SUPPLY CONDITION

NEEDS ATTENTION. There is staining/corrosion on the pipes that appears to be soldering acid that was not removed. This can cause premature wear and failure. crawl space areas.

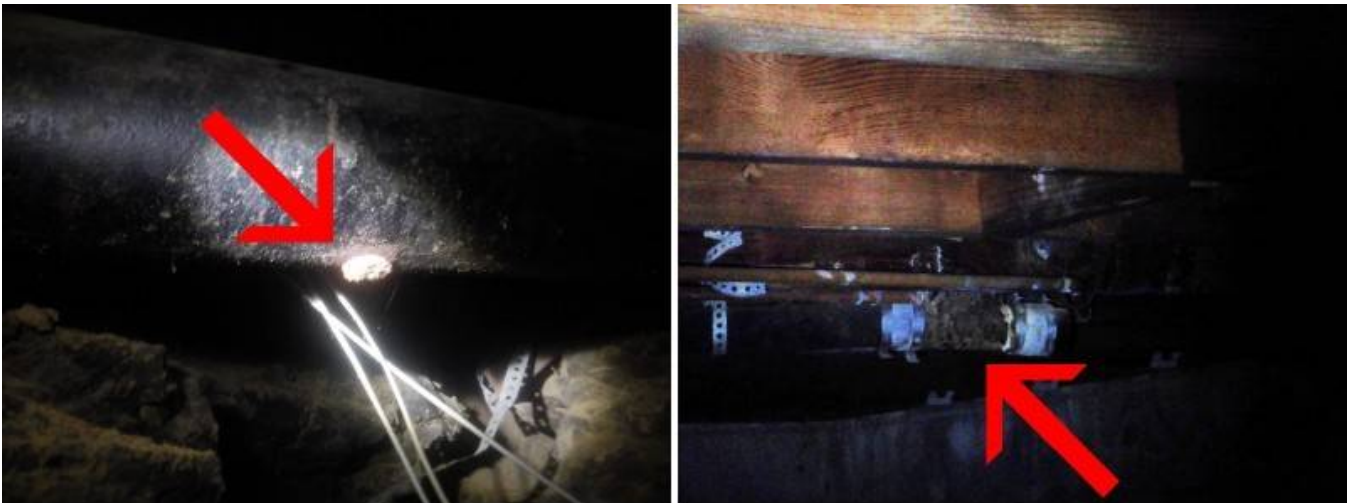
WASTE LINE CONDITION

NOT ACCEPTABLE. There are areas with significant rust and deterioration, with rust blisters on the exterior of the lines. These may seep and leak or could break in the future and allow for flooding under the building.

These sections of lines have essentially failed. A plumbing specialist should evaluate the

EVALUATION/REPAIR. Repairs and/or further evaluation are needed to the waste line system at this time.

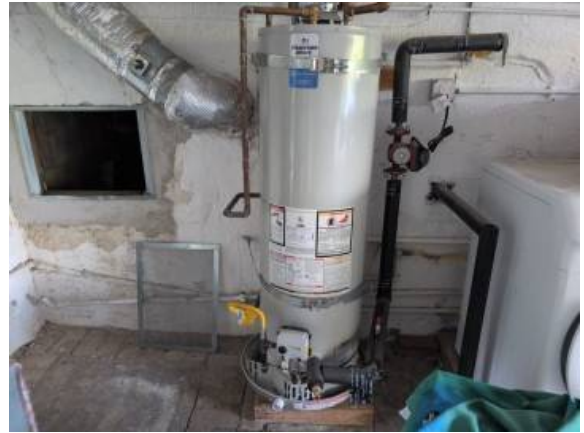
LOCATION CONDITION

NEEDS ATTENTION. There is a drip pan under the water heater but there is no drain line attached to direct the water to an appropriate location.

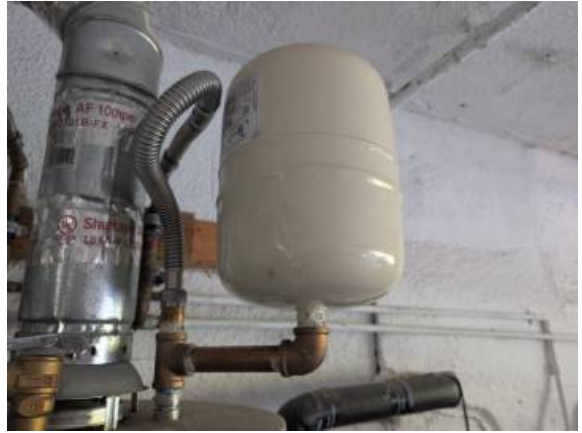
EXPANSION TANK

NEEDS ATTENTION. The hot water Expansion tank is not strapped/secured.

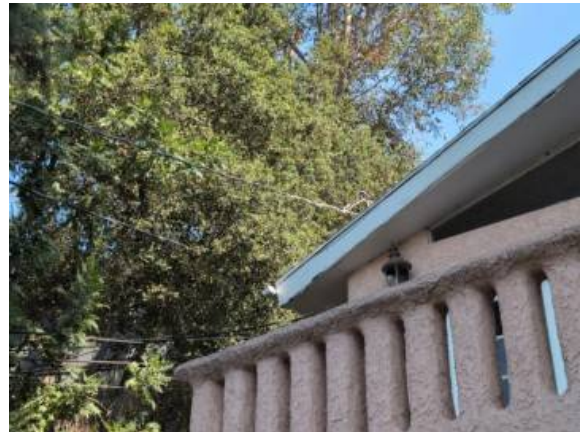
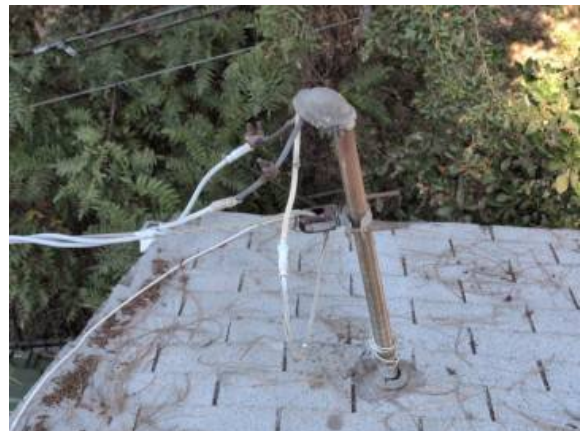
MAIN ELECTRICAL CONDITION

NEEDS ATTENTION. SAFETY ALERT. The electrical mask is not well supported and is leaning toward the power pole.

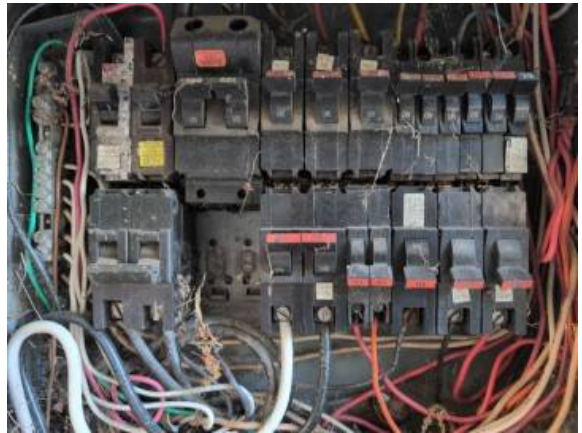
NOT ACCEPTABLE. This is an FPE Federal Pacific brand panel and breakers. This brand of breakers appears to have significant flaws that increases the risk of failure. They tend to fail to trip off, increasing the risk of wire overheating and shock / fire hazard. The breakers tend to malfunction at the panels creating arcing, disconnecting, falling out etc. This system should be fully evaluated by an electrical specialist who will likely recommend the panel and breakers be replaced.

The panel cover is missing inside the electrical box and the live wiring and circuits are exposed when the outside cover is opened. (Missing 'deadfront' cover)

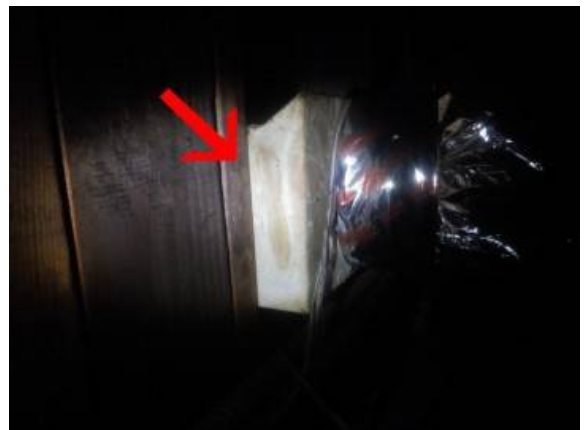
DUCTING

NEEDS ATTENTION. The insulation on the outside of the ducts is a material that is usually found to contain asbestos. It would have to be tested in a laboratory to confirm if it is asbestos or not. Ideally this ducting would be replaced. Further evaluation of this ducting is recommended to determine its true condition. The thermostat is an older model device.

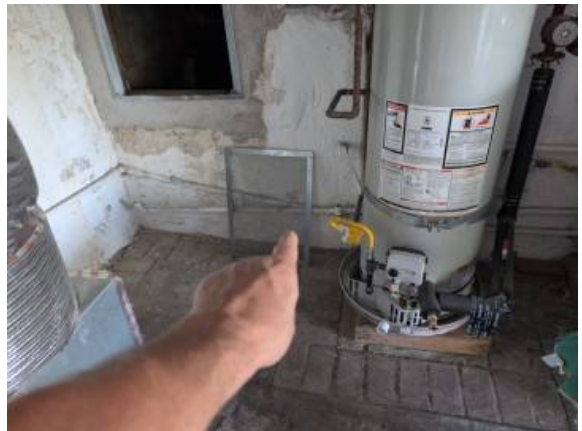
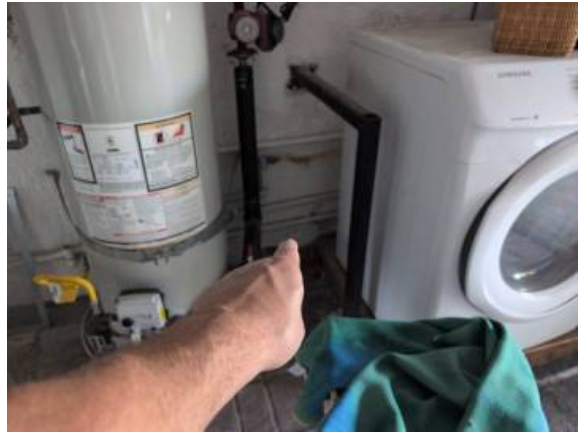
CONDENSATE LINE

NEEDS ATTENTION. The condensate line appears to be sagging and not gradually going downward towards the end of the drain point.

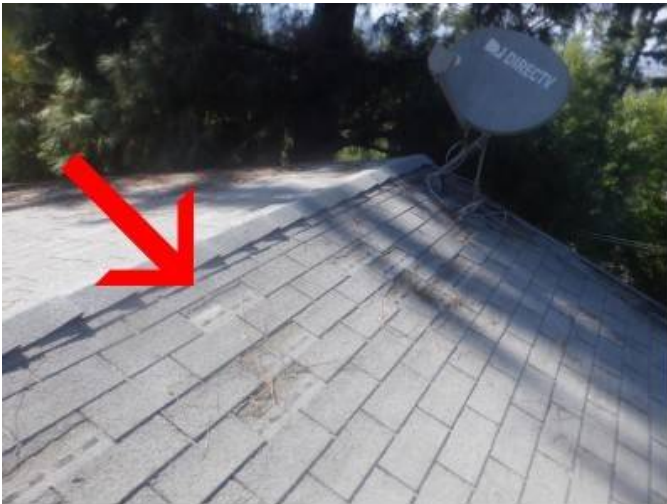
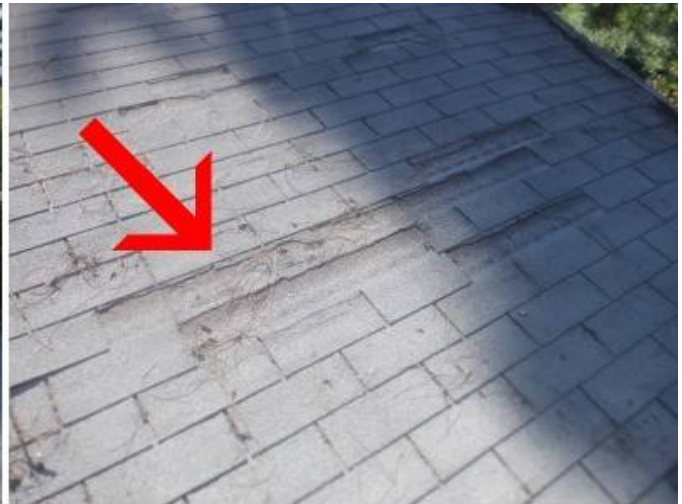
ROOF CONDITION

NEEDS ATTENTION. On the composition roof: There are areas of displaced, damaged and deteriorated shingles. This roof appears to be near it's expected reliable service life. Consult with a qualified roofing contractor for more information regarding any needed repairs/replacement.

NEEDS ATTENTION. The shingles are cupped in areas and moisture cannot drain off easily or properly in those areas.

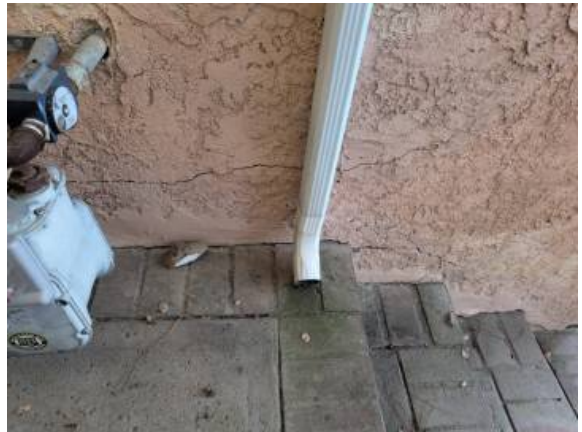
DOWNSPOUT CONDITION

NEEDS ATTENTION. The downspouts do not route the water away from the building but instead deposit it next to the structure which commonly causes problems to the foundation over time. These should be extended away from the building.

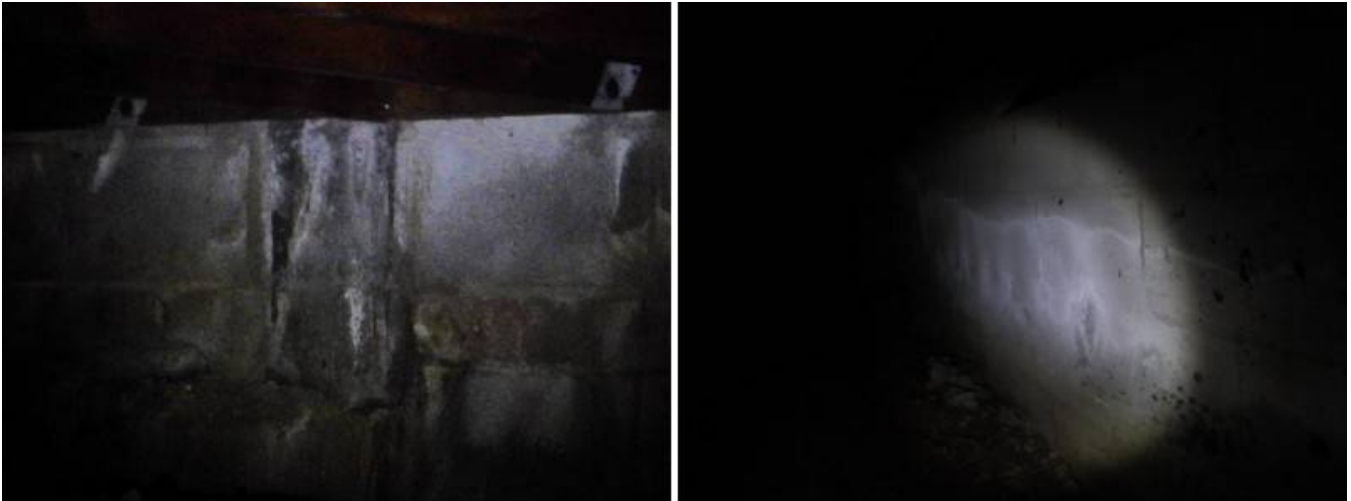
RAISED FOUNDATION

SERVICEABLE. The concrete foundation appeared in functional condition for a building of this age, based on my ability to observe and the access available. Typical wear is noted.

NOTE. There is white staining and powder that may be efflorescence, indicating moisture in / through the foundation. This can damage any steel 'rebar' in the foundation and is not ideal

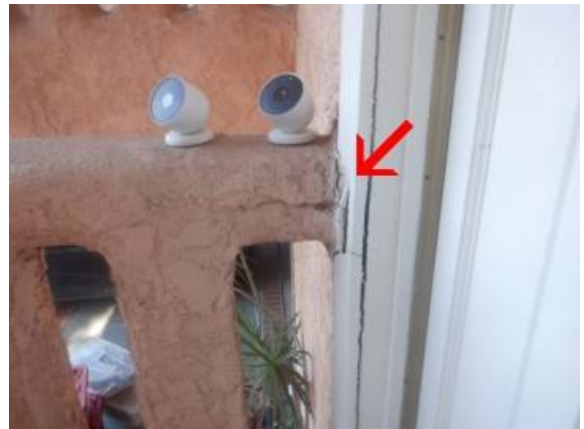
The railings do not meet current safety standards - it is recommended that there is no space greater than four inches in any portion of the railing for child safety.

The front porch appears to have moved away from the structure slightly

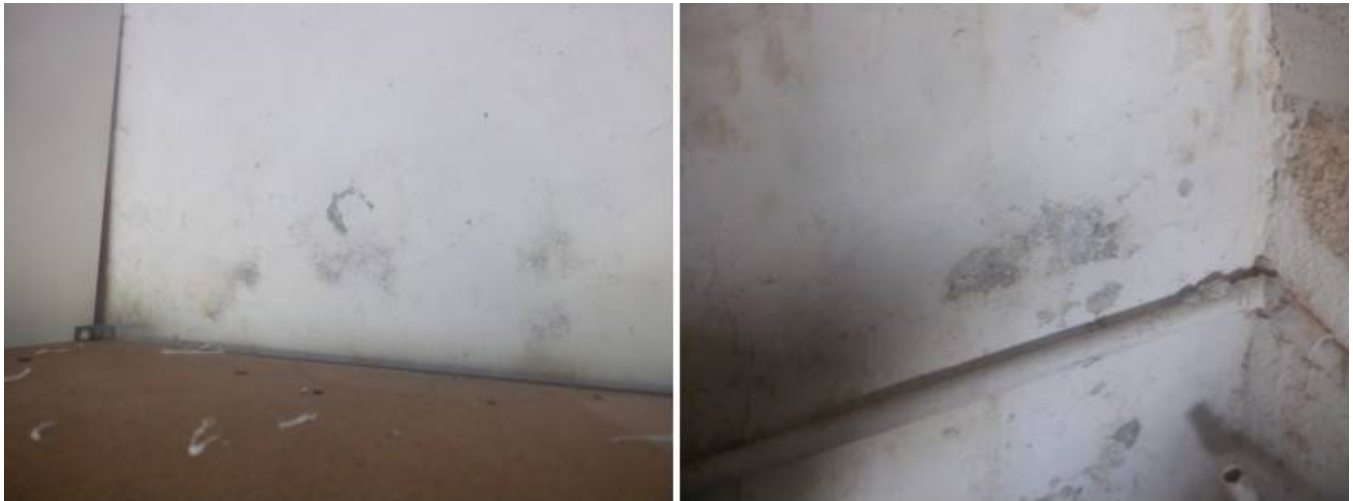
CONDITION

SAFETY ALERT. The wall between the house and the garage is a fire separation safety wall between the parking area and the living space. It is supposed to give someone 20 minutes to get out of the building in case of fire. There are not supposed to be any gaps or openings in it to maintain this rating. It has been compromised. At the ceiling

NEEDS ATTENTION. There are darkened areas that may contain mold-like substances. Such as at the back wall.

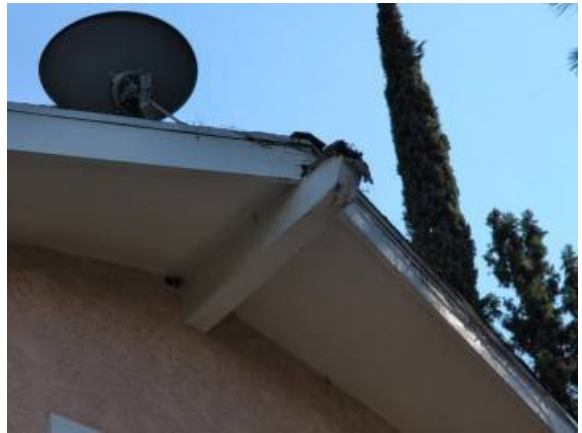
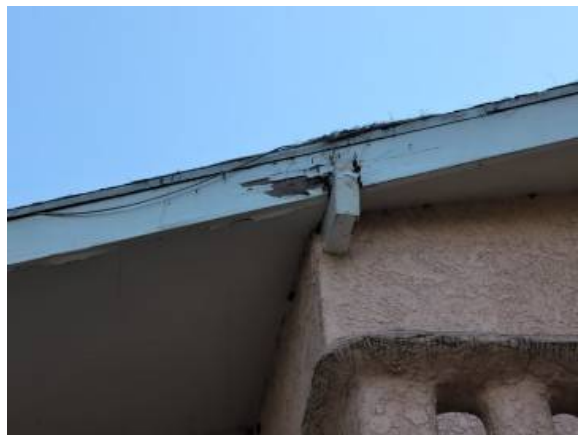
NEEDS ATTENTION. The trim has areas of damage / deterioration - It is recommended that a structural pest control operator fully evaluate the properly and perform all needed repairs.

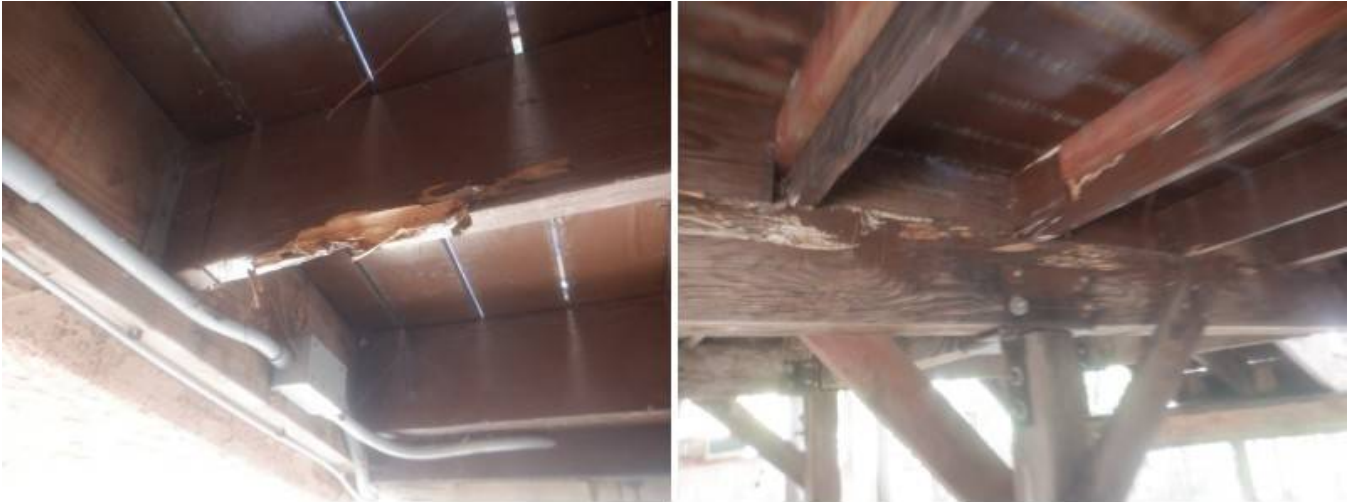
DECK SURFACE CONDITION

NEEDS ATTENTION. SAFETY ALERT. The deck wood is damaged in areas.

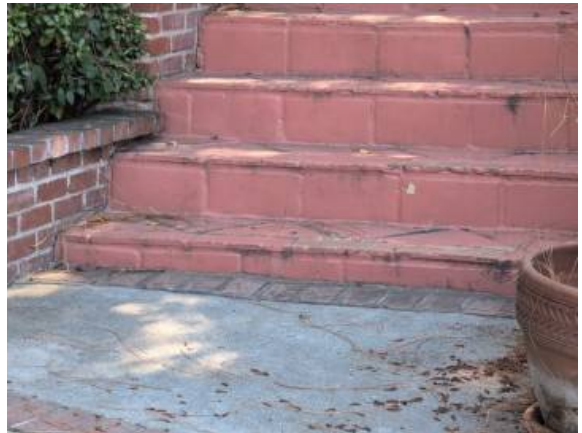
SAFETY ALERT. The risers of the stairs have uneven heights and may be a trip hazard.

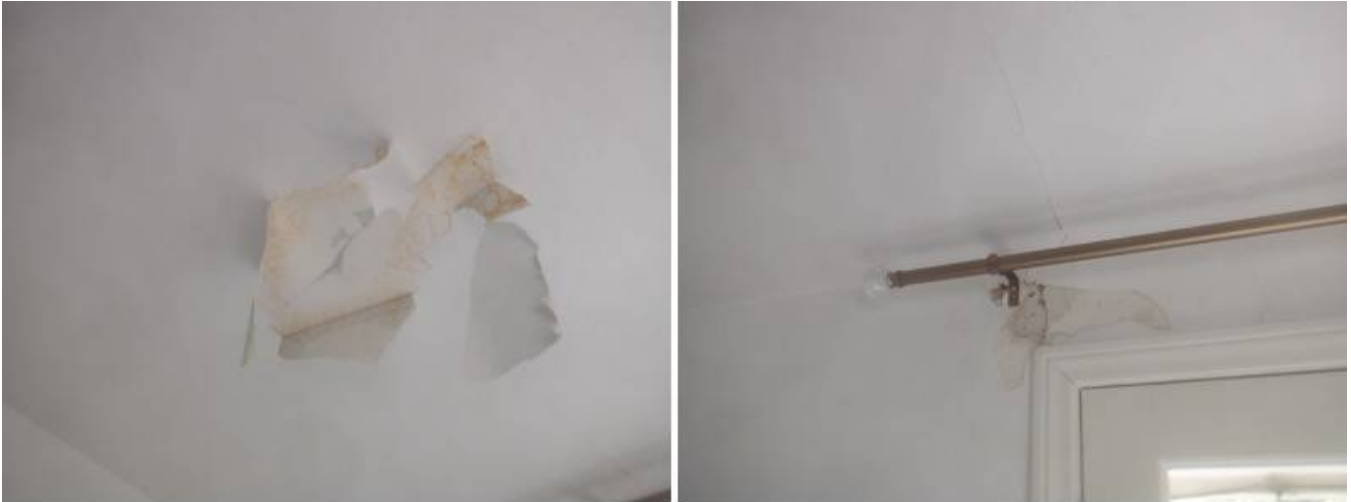
MASTER BEDROOM

NEEDS ATTENTION. There are areas of moisture stains / paint peeling on the ceiling / upper wall.

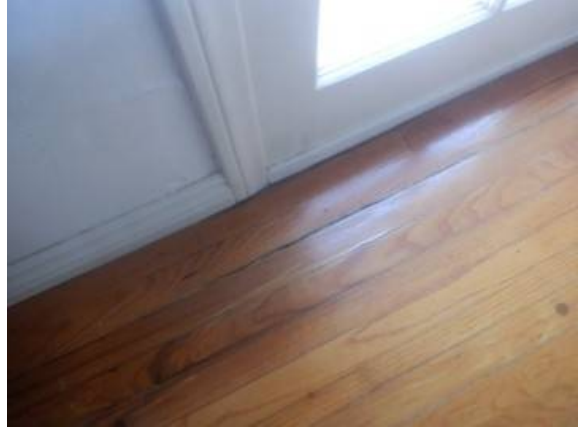
NEEDS ATTENTION. The flooring is cupped / warped and separated in areas, this is usually due to moisture. It usually will not go back to its original position and be completely flat with refinishing. Such as in the living room by the rear door.

NOTE. There are areas where the flooring is sloping and not level. This can be due to typical building settlement.

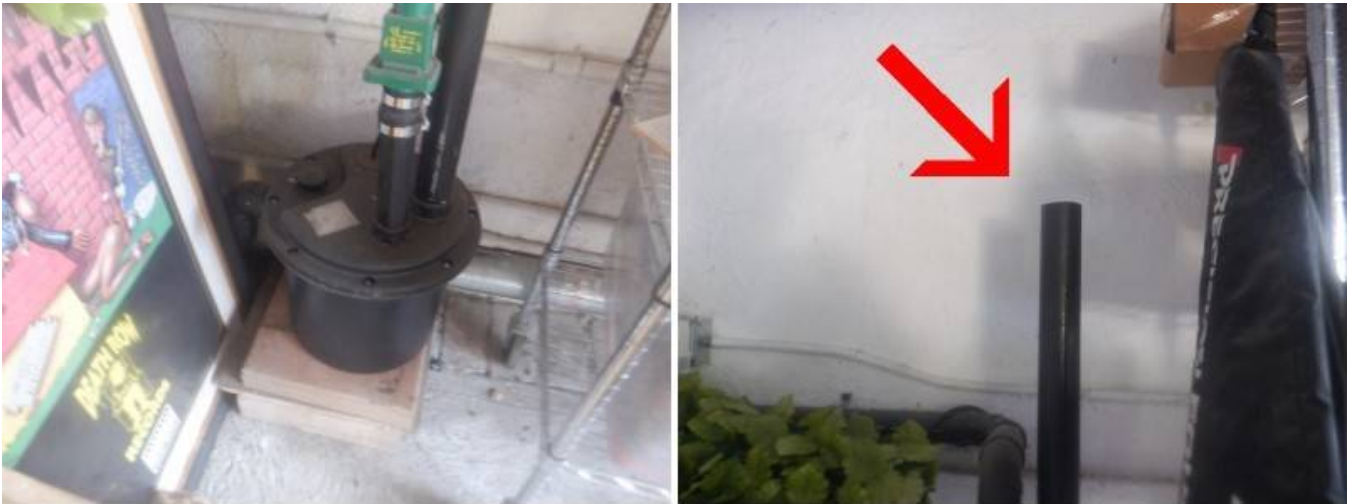
CLOTHES WASHER HOOKUPS

NEEDS ATTENTION. SAFETY ALERT. The washer drains into a small ejection pump that is not vented to the exterior of the bldg.

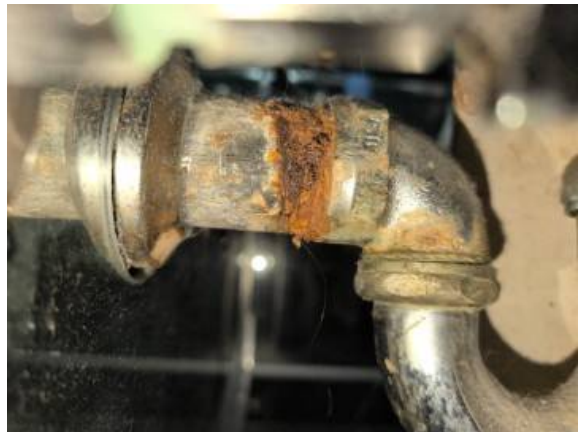
NOT ACCEPTABLE. The sink drain is badly rusted and ready to be replaced in areas.

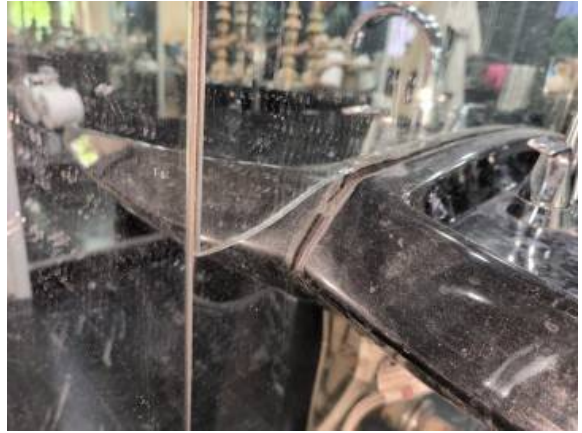
NOT ACCEPTABLE. The mirrors are cracked.

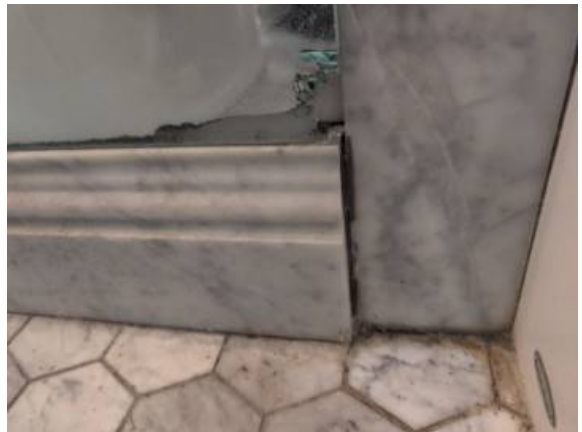
NEEDS ATTENTION. The mirror is damaged.

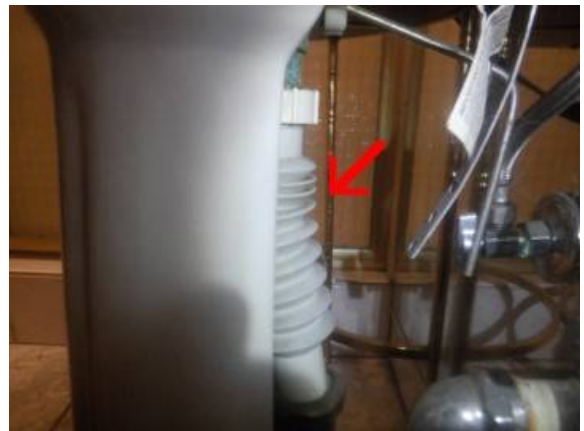
NOT ACCEPTABLE. A flex drain connector has been installed below the sink. Only a smooth inner wall drain line is supposed to be used in this case.
