Re: Foundation system review
25 Pamela Jane Ct.
Oroville CA 95966

WOOD DESTROYING PESTS AND ORGANISMS INSPECTION REPORT

Building No	Street	City	Zip	Date of Inspection	Number of Pages
25	Pamela Jane Ct	Oroville	95966-5224	03/23/2026	1 of 6

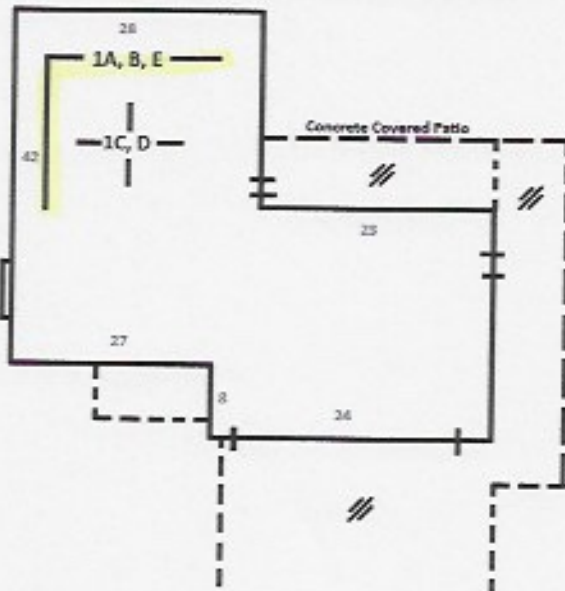
- Finding: 1A Wood boring beetle damage was noted to the joists, girder, and rim joist at the substructure. Damage appears to extend into inaccessible areas.
Recommendation: Remove and replace, repair, or re-support the beetle damaged wood member(s). NOTE: Any item being treated/repared may require further inspection due to possible hidden damage uncovered during repairs. This report may not be all inclusive of all findings.
Price: \$3,512.21

- Finding: 1B Fungus damage was noted to the subfloor at the substructure. In the opinion of the inspector the infected wood members are not able to perform the duties of which they were designed.
Recommendation: Remove and replace, repair, or re-support wood members found to be damaged by wood-destroying fungus. Perform treatment as necessary for the control of fungal growth. Note: Repairs and/or removal of damaged materials may expose additional concealed damage that was not visible at the time of inspection. If additional damage is discovered, further repair recommendations may be required. This report reflects conditions observed at the time of inspection and may not include all concealed or inaccessible areas.
Price: \$1,100.00

- Finding: 1C A wood destroying surface fungus was noted to be infecting portions of the subfloor, rim joist, and adjoining wood members at the substructure.
Recommendation: Remove fungus from the surface of the exposed wood member(s) and treat infected members with a registered fungicide. Treatment to be applied by a state licensed applicator.
Price: \$391.60

- Finding: 1E Evidence of wood boring beetles noted to the joists, girder, and rim joist at the substructure.
Recommendation: Locally treat for the control of wood boring beetles in the accessible wood members. Treatment to be applied by a state licensed applicator.
Price: \$721.97

- Finding: 1D Excessive moisture damage was noted at the substructure.
Recommendation: Install vapor barrier to the subarea soil to prevent condensation from forming on the substructure wood members. Vapor barrier should not cover more than 80% of the subarea soil.
Price: \$1,734.01
