Address of Property: 465 Hillcrest Drive, Lakeport CA 95453  
Inspection Date: 10/30/2025  
Report #: 27617  
Title Co. & Escrow #:

# WOOD DESTROYING PESTS AND ORGANISMS INSPECTION REPORT

| General Description:<br>Two Story, Single Family Dwelling, Wood & Brick Exterior, Attached Decks.<br>Furnished/Occupied | | Inspection Tag Posted:<br>Subarea | |

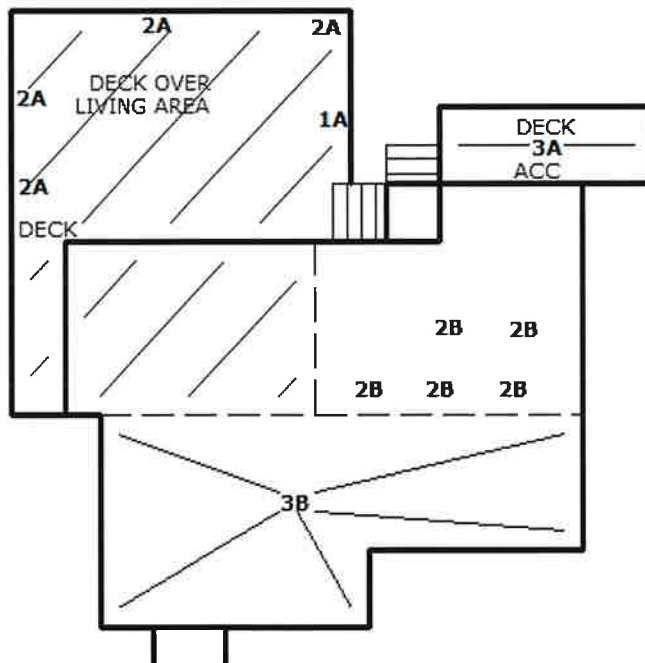
ITEM 1A **FINDING:** Fungus damage was found at the downstairs exterior door.

ITEM 2A **FINDINGS:** The upper deck cover was found to be peeling up creating voids. Creating a moisture condition.

ITEM 2B **FINDING:** Earth to wood contact was noted at the subarea support posts. Untreated wood members in contact with soil may lead to and/or conceal infestations or fungus infections and damage.

ITEM 3A **FINDING:** The area under the deck is inaccessible due to a lack of clearance between the decking and soil.

ITEM 3B **FINDING:** A portion of the sub area is inaccessible for physical inspection due to no access opening being provided.

**RECOMMENDATION:** Install a new pre hung white steel or fiberglass door of similar design.

**RECOMMENDATION:** Other trades to make repairs as needed.

**RECOMMENDATION:** Grade the soil away from the support posts to correct the earth to wood contact.

**RECOMMENDATION:** Remove several deck boards to allow for further inspection. A supplemental report shall be filed on all further findings.

**RECOMMENDATION:** Install an access opening in the closet floor to provide for inspection of the sub area. Any findings will be listed on a supplemental report.
