Johnson / Clarion Inspection

Client(s): **Colin & Susan Johnson**

Property address: **14405 Clarion Way
Magalia, Ca. 95954**

Inspection date: **Friday, October 3, 2025**

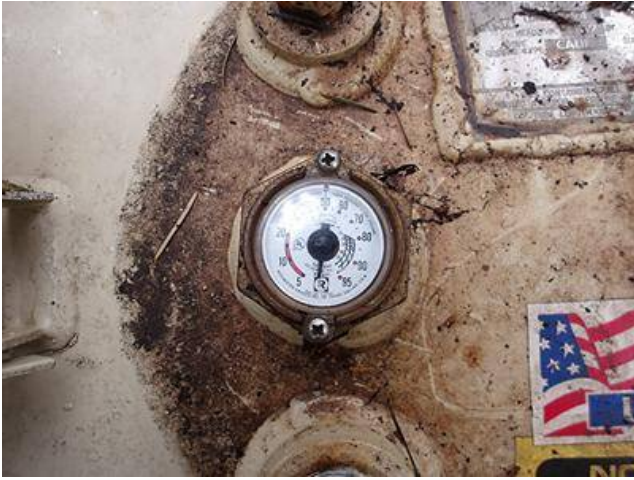
Propane was not available during the inspection (tank empty, shut off valve turned off, no tank installed, etc.). As a result, some appliances such as water heater(s), forced air furnace(s), gas fireplace(s), stove(s), range(s) and/or gas supply lines weren't fully evaluated. The inspector was unable to test for gas leaks.

Photo 1-1 Propane tank empty

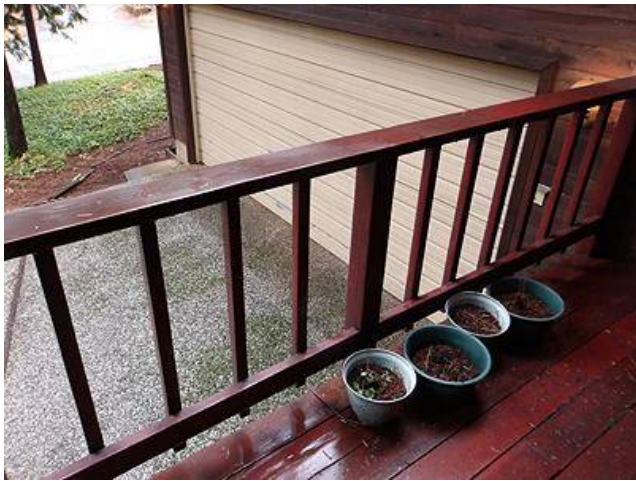
Guardrails in some areas with drop-offs higher than 30 inches were substandard with gaps over 4". This is a safety hazard. Standard building practices require that they:

Photo 2-1 Front porch guardrail

A qualified contractor should evaluate and repair, replace or install guardrails as necessary, and as per standard building practices.

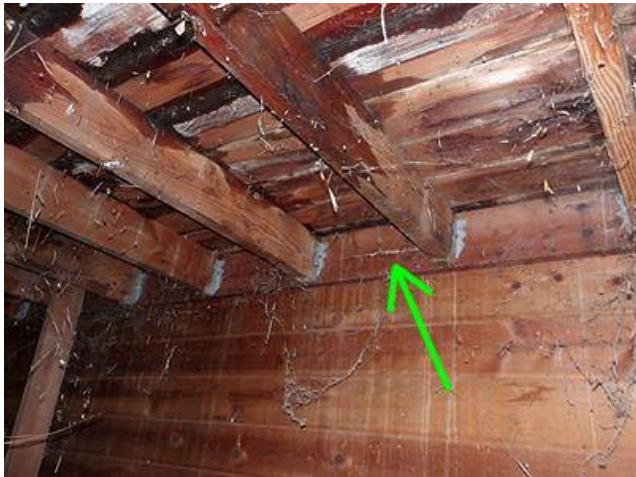
One or more deck ledger boards were nailed to the building rather than being attached by adequate fasteners. This poses a significant safety hazard since the ledger board(s) may separate from the building, causing the deck(s) to collapse. A qualified contractor should install lag screws or bolts as per standard building practices to securely attach the ledger board(s) to the building. For more information on installing deck ledger boards visit: http://www.hometime.com/Howto/projects/decks/deck_4.htm

Photo 3-1 Front porch ledger board

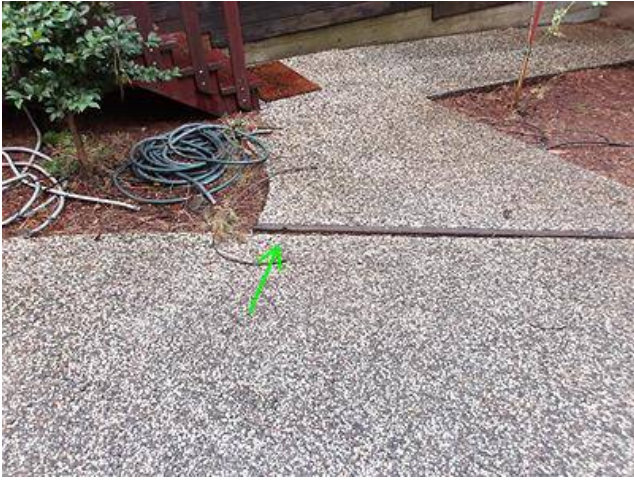
One or more trip hazards were found in sidewalk and/or patio sections due to cracks, settlement, heaving and/or deterioration. A qualified contractor should evaluate and repair or replace sections as necessary to eliminate trip hazards.

Photo 4-1 East side

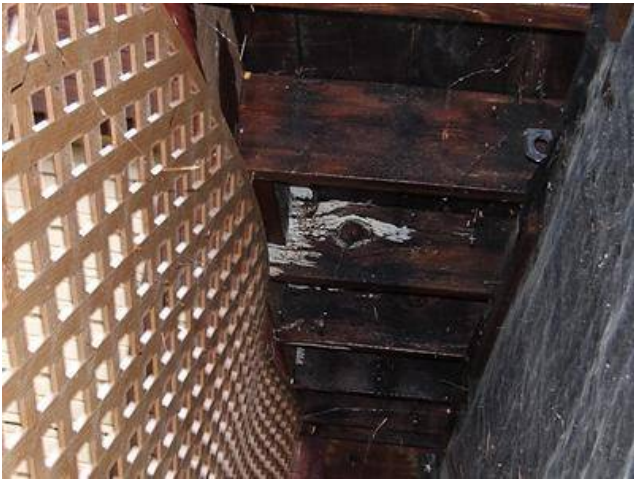
Rot or water damage was found at one or more decks, porches or balconies in decking boards and/or joists. A qualified person should evaluate and repair as necessary. All rotten wood should be replaced.

Photo 5-1 Front porch joists

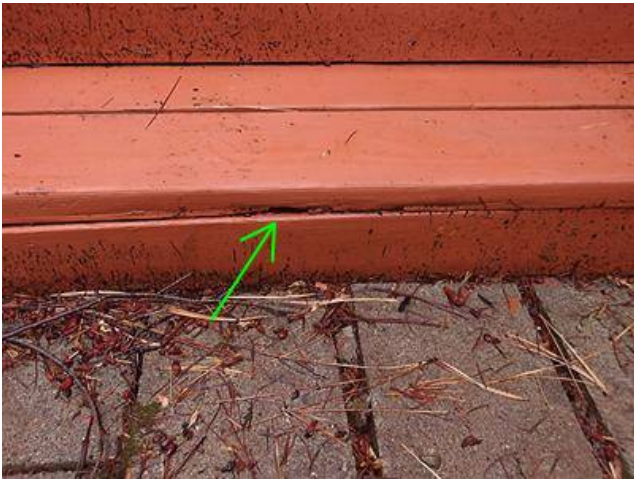
Rot or water damage was found at one or more sets of exterior stairs in treads and/or support posts. A qualified person should evaluate and repair as necessary. All rotten wood should be replaced.

Photo 6-1 West deck stairs

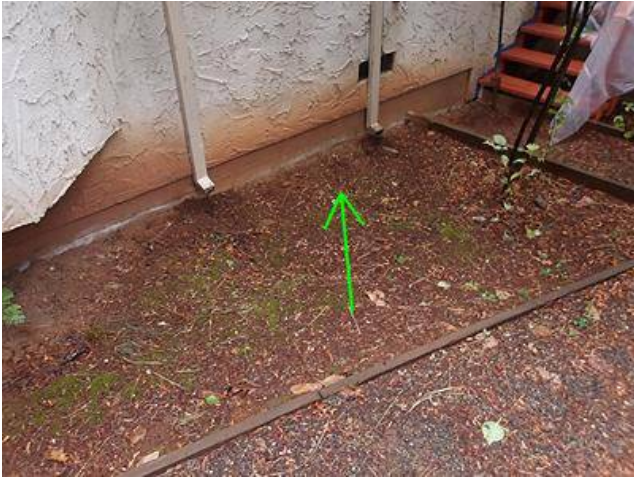
The perimeter grading sloped towards the building in one or more areas. This can result in water accumulating around the building foundation. Recommend grading soil so it slopes down and away from the structure with a slope of at least 5% (10% or better is optimal) for at least 6 feet.

Photo 7-1 South side

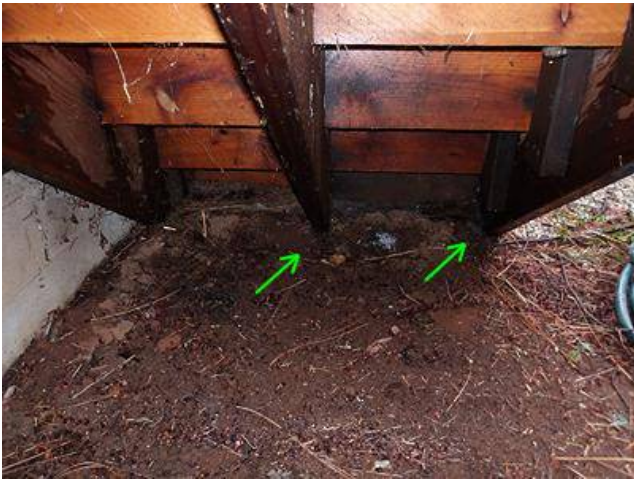
Soil was in contact with or too close to wooden support posts and/or stairs. This is a conducive condition for wood destroying insects and organisms. Standard building practices require the following clearances to soil below:

Photo 8-1 Front porch stairs

Efforts should be made, such as grading and/or removing soil, to maintain these clearances. If this is not practical, then installing borate based Impel rods may help to prevent infestation and damage. For more information, visit:

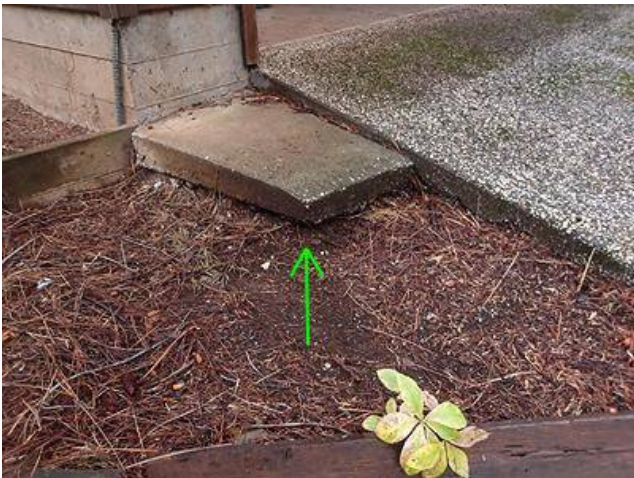
Sidewalk(s) and/or patios were undermined in one or more areas, where soil has eroded out from beneath. Repairs should be made to prevent further erosion and undermining.

Photo 9-1 NE corner garage

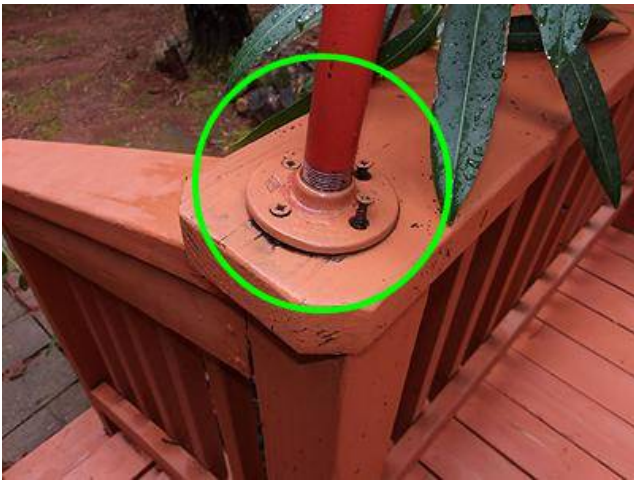
One or more decks, porches and/or balconies were damaged. A qualified person should evaluate and repair or replace as necessary.

Photo 10-1 West deck

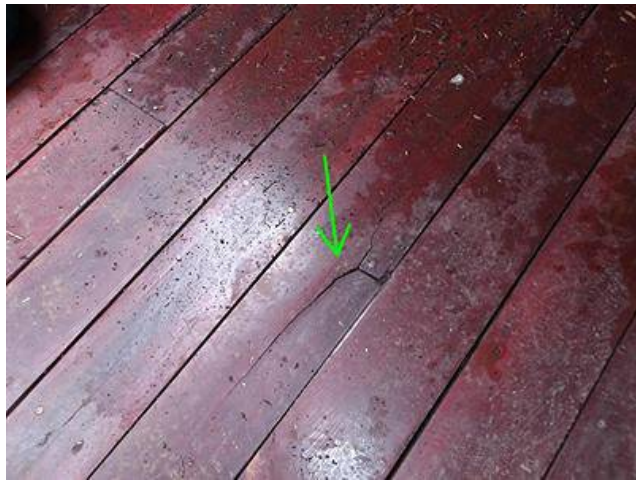
Photo 10-4 Front porch

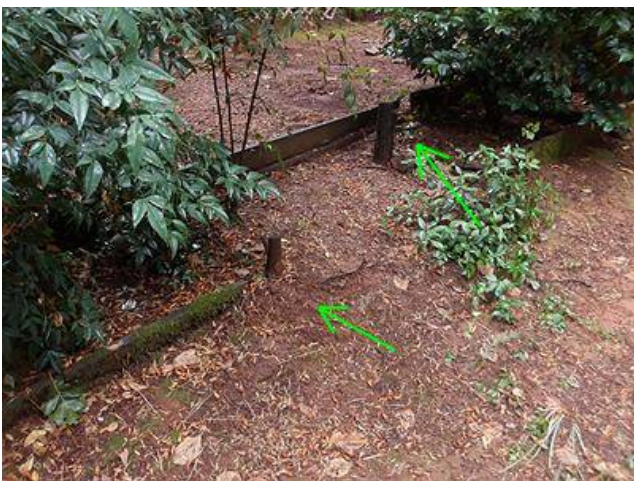
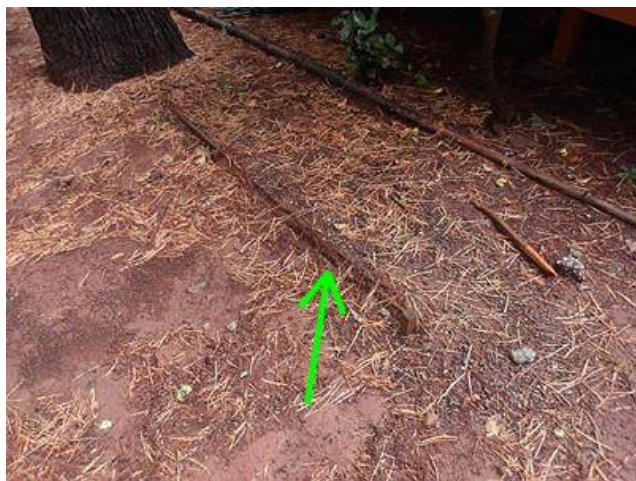
11) 🗑️ 🐛 One or more landscaping timbers were rotten or damaged by wood destroying insects. Landscaping timbers should be replaced as necessary.

Photo 11-1 South side

Photo 11-2 West side

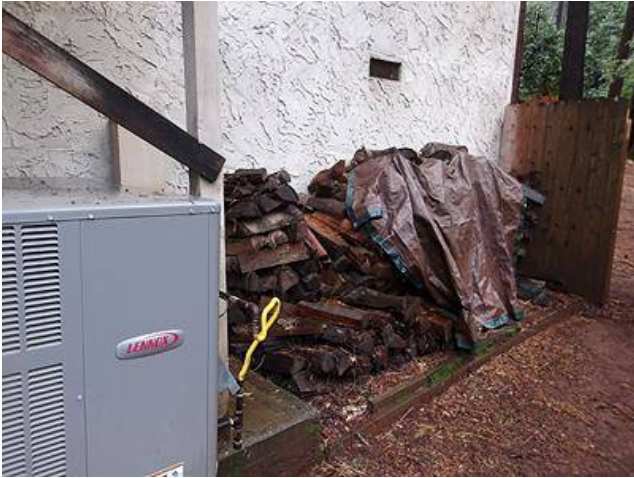
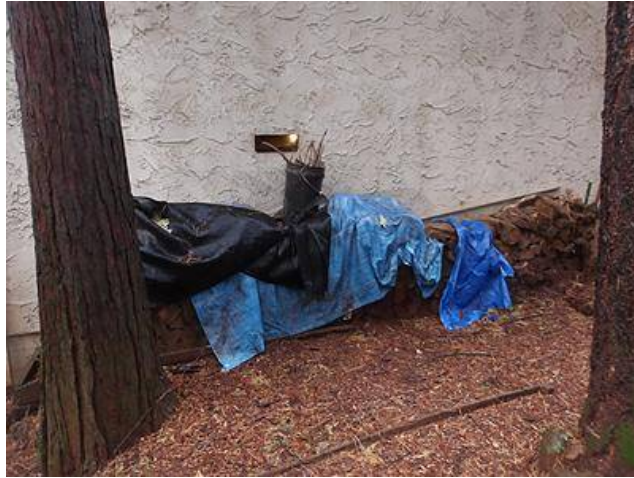
12) ⓘ 💧 Firewood was stored so that it was either in contact with the building or very close to it. This is a conducive condition for wood destroying insects. Recommend storing firewood outdoors in an open area, as far away from the building as practical, to keep away insects. For more information visit <http://ohioline.osu.edu/hyg-fact/2000/2065.html>

Photo 12-1 North side

Photo 12-2 West side

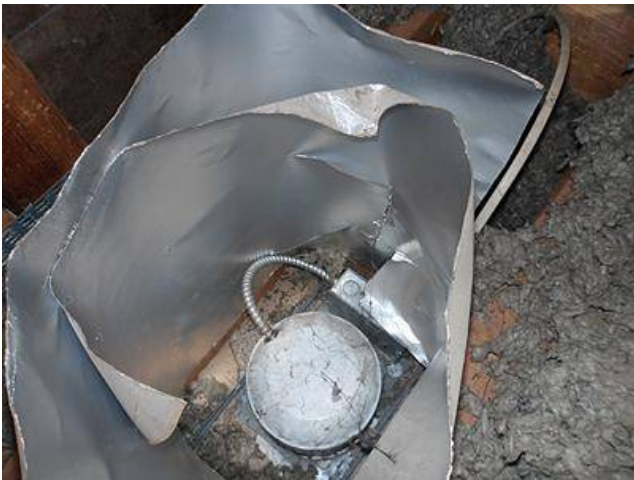
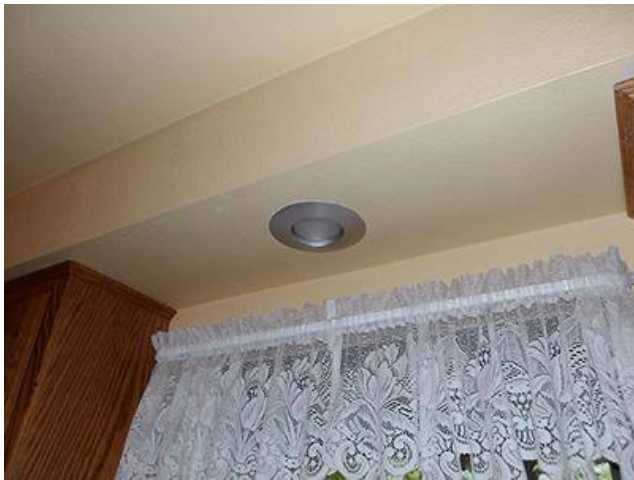
16) 🚧🔧 Recessed "can" lights that are not rated for contact with insulation were installed in the ceiling below the attic. One or more of these lights are in contact with insulation. This is a fire hazard. Insulation should be moved, and wells or barriers should be installed or repaired as necessary to keep the insulation away from these lights as per the manufacturer's installation instructions.

Photo 16-1 Kitchen sink light

Photo 16-2 Kitchen sink light

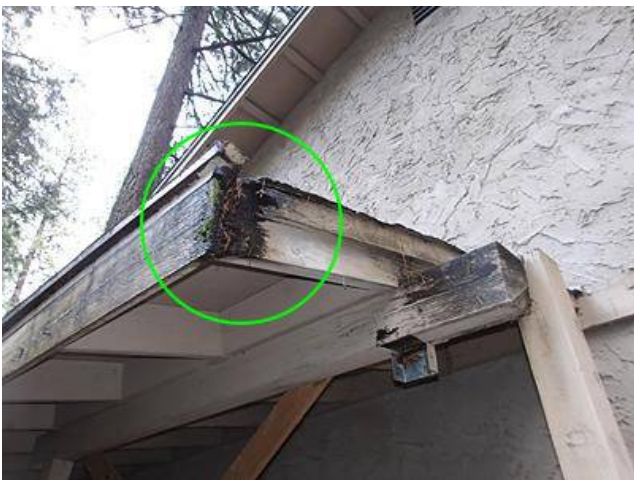
17) 🛠️🔍🚰 Rot or water damage was found at one or more sections of the roof structure, including: trim, fascia and/or rafters. A qualified person should evaluate and repair as necessary. All rotten wood should be replaced.

Photo 17-1 North side above HVAC unit

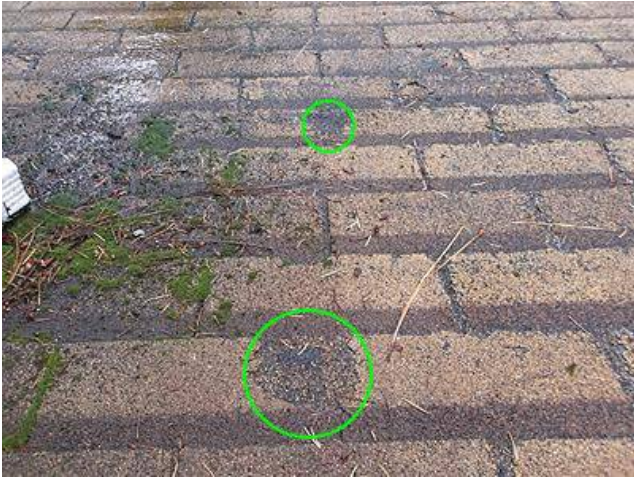
18) 🛠️🔍💧 Roof repairs were needed because some composition shingles had the following conditions: damage and/or deterioration. Leaks may occur as a result. A qualified contractor should evaluate and repair as necessary.

Photo 18-1 Carport roof

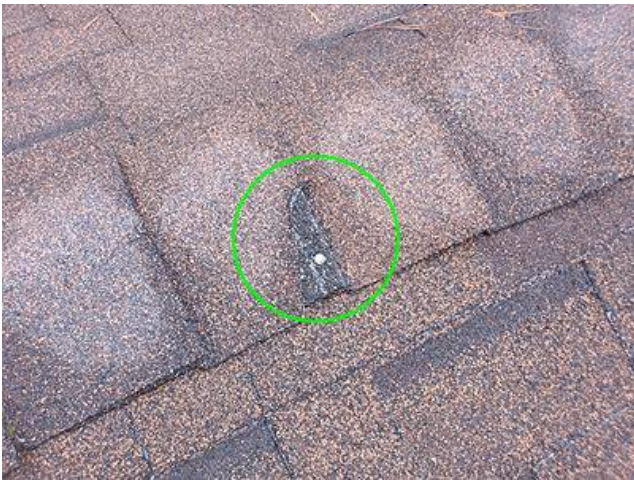
Photo 18-3 Garage peak

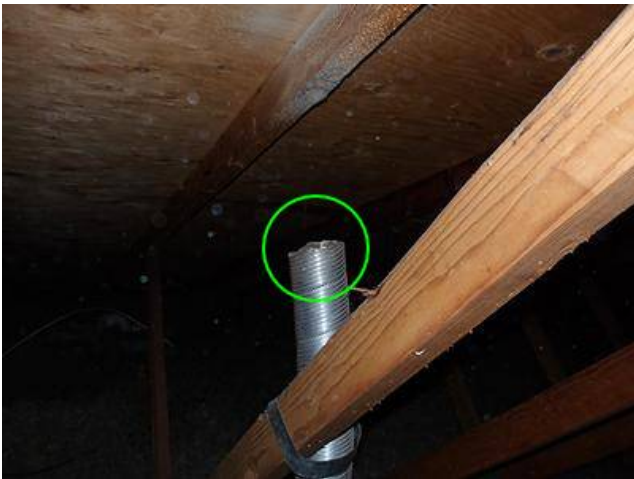
19) 🔧🔍💧 One or more exhaust fan ducts in the attic were not connected to a vent cap. This is a conducive condition for wood destroying insects and organisms due to increased moisture levels in the attic from the exhaust air. A qualified person should evaluate and make permanent repairs as necessary and as per standard building practices, so all exhaust air is vented outside.

Photo 19-1 Hall bathroom exhaust fan duct

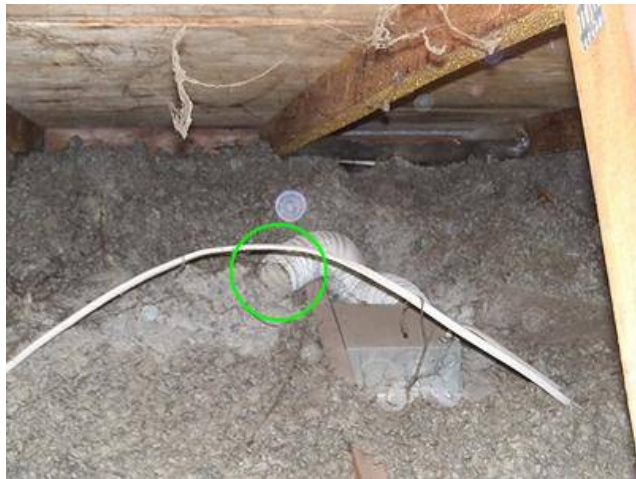
Photo 19-2 Master bathroom exhaust fan & duct

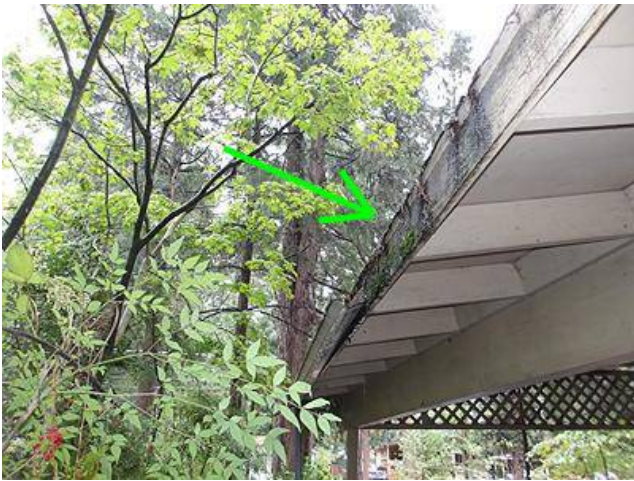
20) 🔧🔍💧 Some gutters were missing. Water may accumulate around the building foundation as a result. A qualified person should evaluate and repair as necessary.

Photo 20-1 Carport

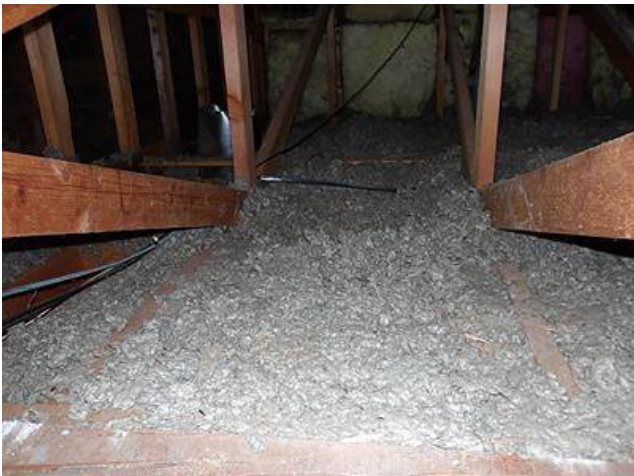
The ceiling insulation's R rating was significantly less than what's recommended for this area (R30 or more). Recommend having a qualified contractor install additional insulation as per standard building practices for better energy efficiency. For more information, visit: <http://www.eere.energy.gov/consumer/tips/insulation.html>

Photo 21-1 Attic insulation

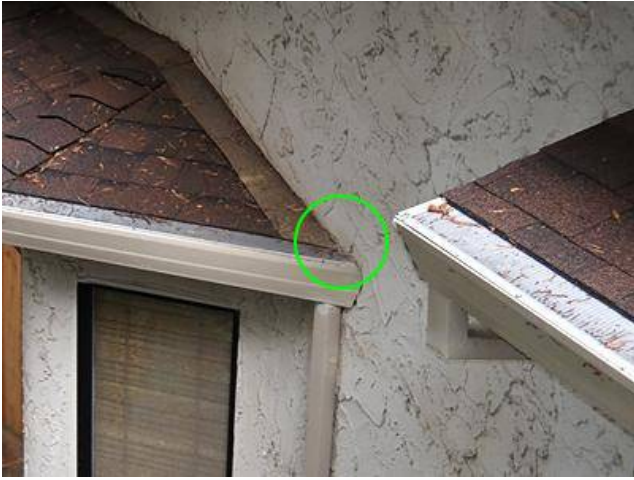
Some roof flashings were missing and/or loose. Leaks may occur as a result. A qualified contractor should evaluate and repair as necessary.

Photo 22-1 South side

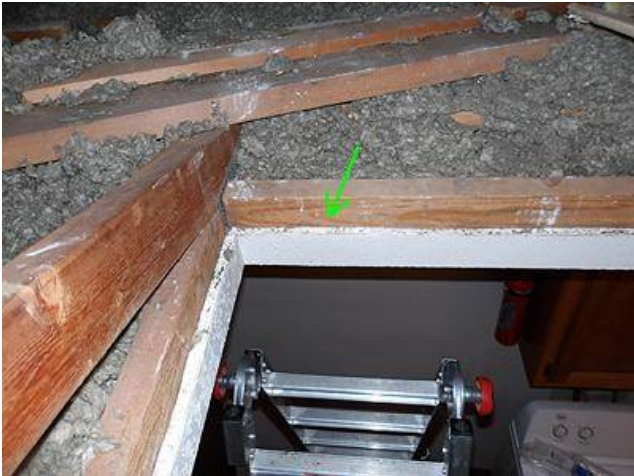
23) 🛠️ 📄 No weatherstrip was installed around the attic access hatch. Weatherstrip should be installed around the hatch to prevent heated interior air from entering attic. For more information, visit: <https://www.reporhost.com/docs/atticaccess.pdf>

Photo 23-1 Attic access

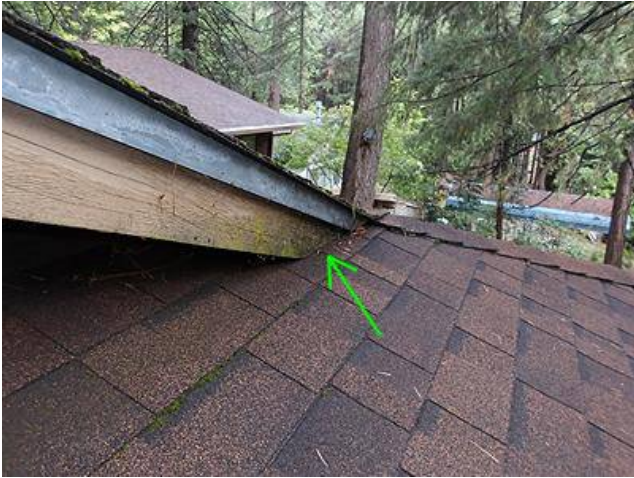
24) 🛠️ 💧 The fascia in one or more areas above lower roof sections was in contact with or had less than a one inch gap between it and the roof surface below. A gap of at least one inch is recommended so water isn't wicked up into the wood fascia from the shingles below, and also to provide room for additional layers of roofing materials when the current roof surface fails. Recommend having a qualified contractor make repairs as necessary, such as trimming fascia, so at least a one inch gap exists between the wood and the roofing below where necessary.

Photo 24-1 NE corner garage

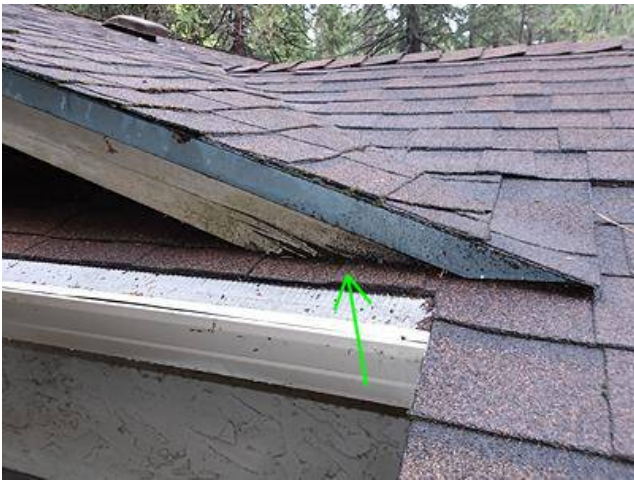
Photo 24-3 South side

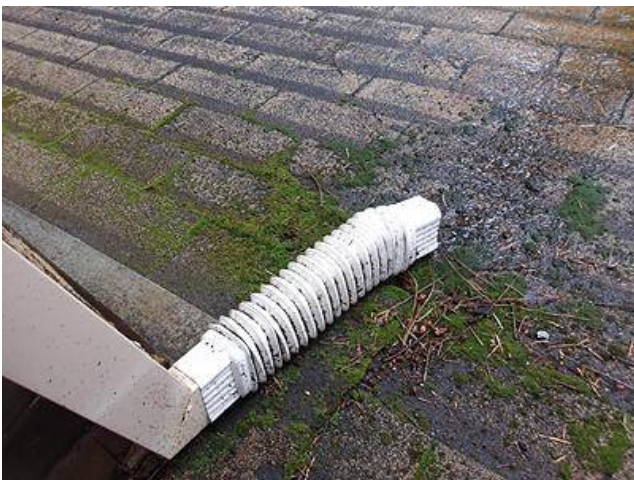
25) 🧰💧 Moss was growing on the roof. As a result, shingles may lift or be damaged. Leaks may result and/or the roof surface may fail prematurely. This is a conducive condition for wood destroying insects and organisms. Efforts should be taken to kill the moss during its growing season (wet months). Typically zinc-based chemicals are used for this, and must be applied periodically. For information on various moss treatment products and their pros and cons, visit:

Photo 25-1 Carport roof

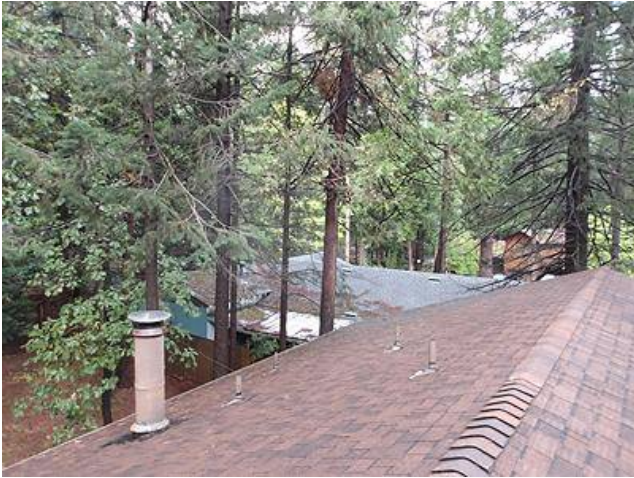
26) 🧰💧 Trees were overhanging roof and were within 10 feet of roof vertically. This is a conducive condition for wood destroying insects and organisms

since organic debris such as leaves or needles are more likely to accumulate on the roof surface. Accumulated debris may cause water to enter gaps in the roof surface and leak into attic and/or interior spaces. Trees should be pruned so they are at least 10 feet above roof, or don't overhang the roof.

Photo 26-1 West side

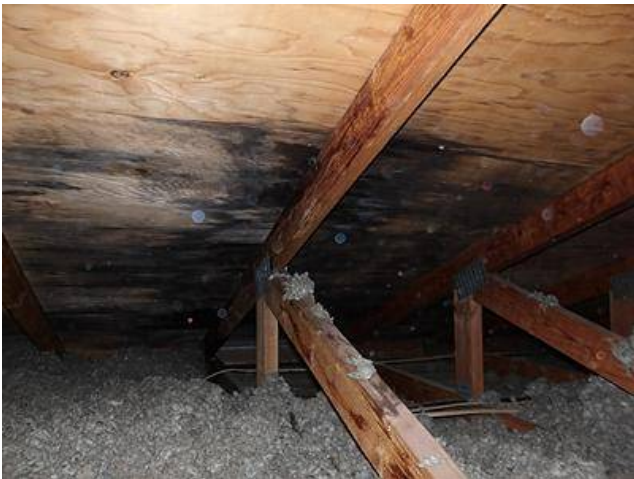
Stains and/or discoloration were visible on the roof structure in one or more areas. These areas were dry at the time of the inspection. The stains may be caused by a past leak. Recommend asking the property owner about past leaks. The client should monitor these areas in the future, especially after heavy rains, to determine if active leaks exist. If leaks are found, a qualified contractor should evaluate and repair as necessary.

Photo 27-1 Above front porch

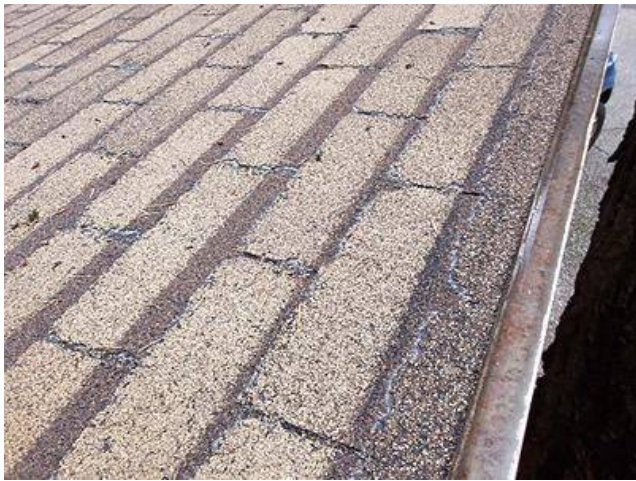
Some sections of the composition shingle roof surface appeared to be near the end of their service life and will likely need replacing in the near future, even with repairs. The client may want to have a qualified roofing contractor evaluate and attempt to issue a year roof certificate.

Photo 28-1 Carport roof

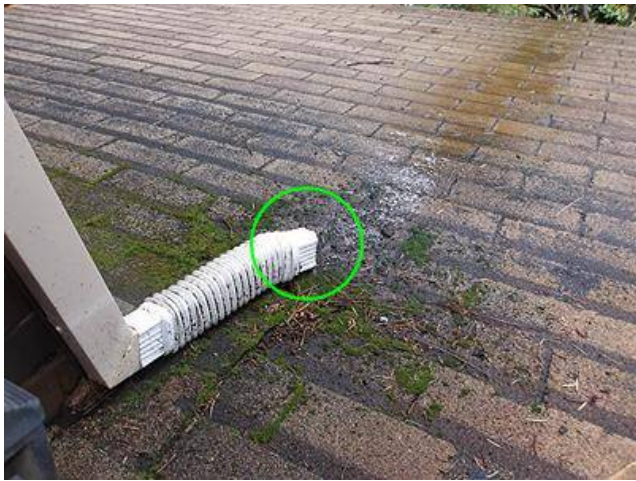
One or more downspouts terminated above roof surfaces rather than being routed to gutters below or to the ground level. This is very common, but it can reduce the life of roof surface materials below due to large amounts of water frequently flowing over the roof surface. Granules typically are washed off of composition shingles as a result, and leaks may occur. Recommend considering having a qualified contractor install extensions as necessary so downspouts don't terminate above roof surfaces.

Photo 29-1 Carport roof

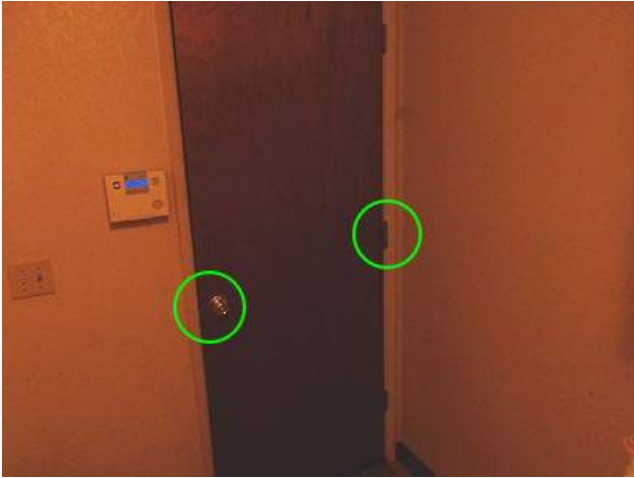
The garage-dwelling door didn't self-latch when it closed with the self-closing device because of damage or deterioration to the hardware. This door is intended to prevent vehicle fumes from entering living spaces and to slow the spread of fire from the garage to living spaces. A qualified person should evaluate and make repairs as necessary.

Photo 30-1 Garage-dwelling door

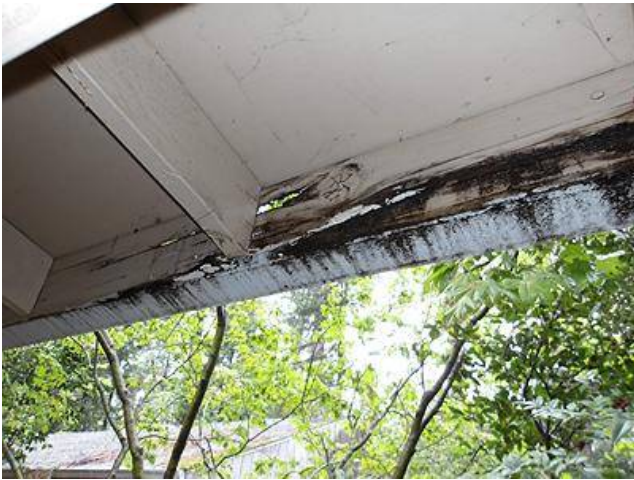
Rot or water damage was found in one or more sections of the carport including trim, rafters and/or fascia. A qualified person should evaluate and repair as necessary. All rotten wood should be replaced.

Photo 31-1 Carport fascia

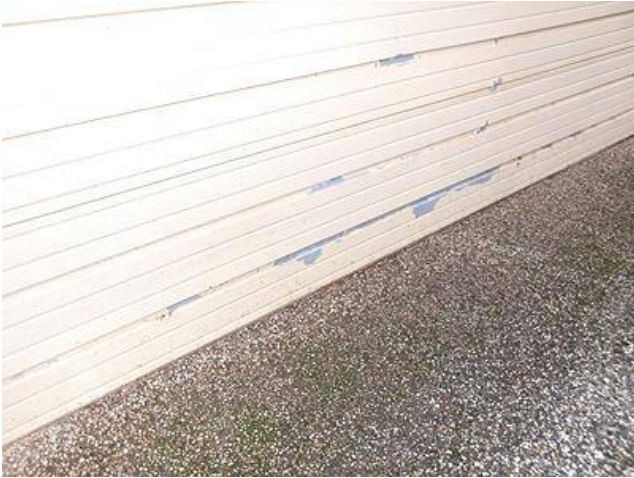
Vehicle door paint was deteriorated. This can lead to rust and corrosion. Paint finish should be maintained as necessary.

Photo 32-1 Vehicle door

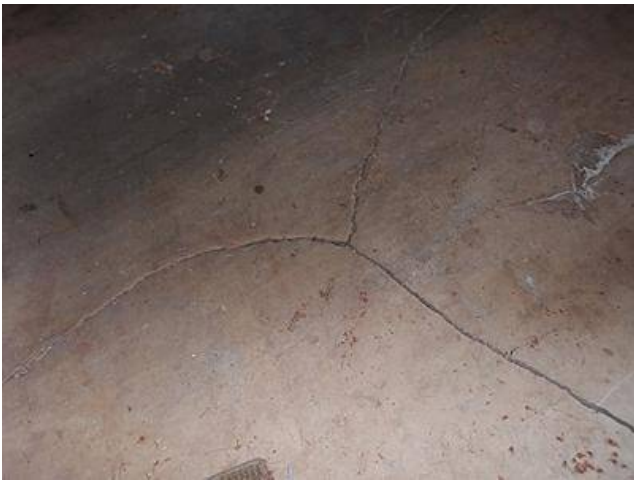
33) ⓘ Minor cracks, heaving and/or settlement were found in one or more sections of slab floors.

Photo 33-1 Garage

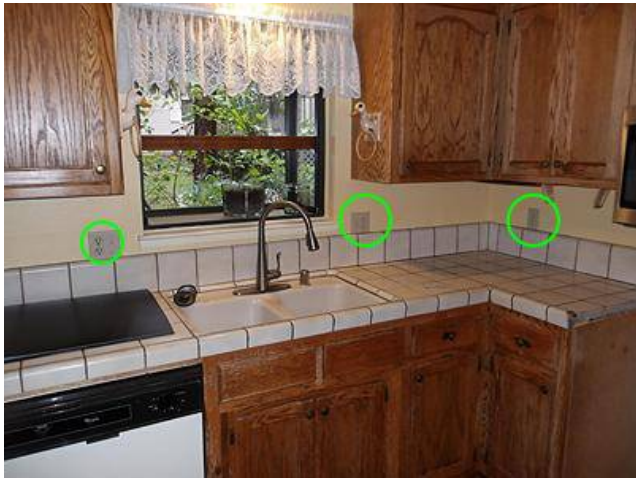
One or more electric receptacles at the following "wet" locations appeared to have no ground fault circuit interrupter (GFCI) protection: kitchen, bathroom(s), garage, exterior and/or crawl space. This is a safety hazard due to the risk of shock. Recommend having a qualified electrician evaluate to determine if GFCI protection exists, and if not, repair as necessary. For more information, visit: http://www.mikeholt.com/documents/nec/pdf/GFCI_requirement_page2.pdf

Photo 34-1 Kitchen

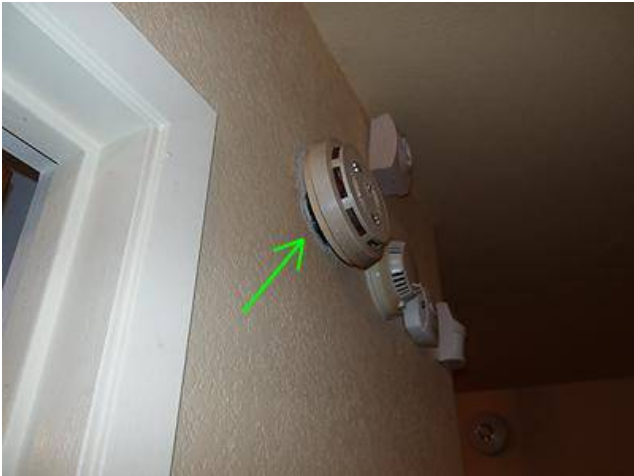
Smoke detectors were loose and/or deteriorated in the following locations: hallways leading to bedrooms. A qualified person should replace smoke detectors or make repairs as necessary. For more information, visit: <http://www.cpsc.gov/cpscpub/pubs/5077.html>

Photo 35-1 Hall

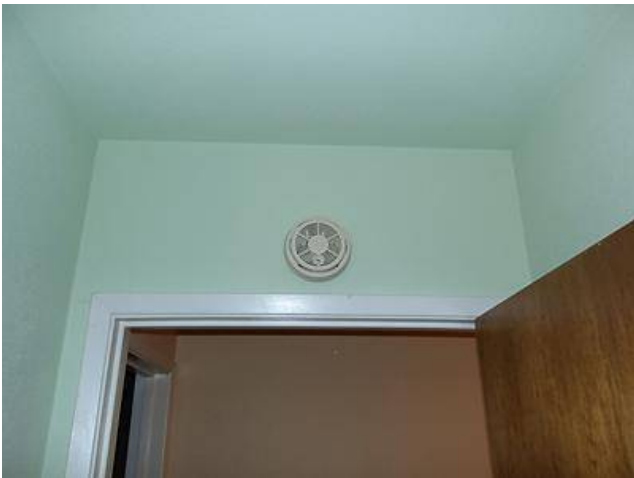
One or more smoke detectors didn't respond when tested. A qualified person should evaluate and replace smoke detectors, replace batteries or make repairs as necessary. For more information, visit <http://www.cpsc.gov/cpscpub/pubs/5077.html>

Photo 36-1 Master bedroom

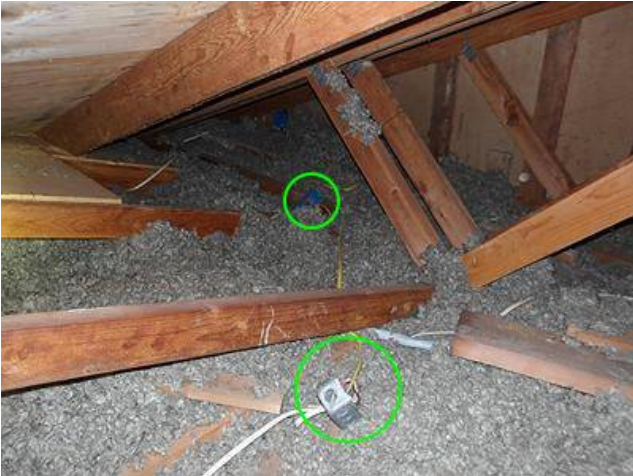
Some junction boxes were loose. This is a potential safety hazard for shock or fire. A qualified person should evaluate and repair as necessary.

Photo 38-1 Attic

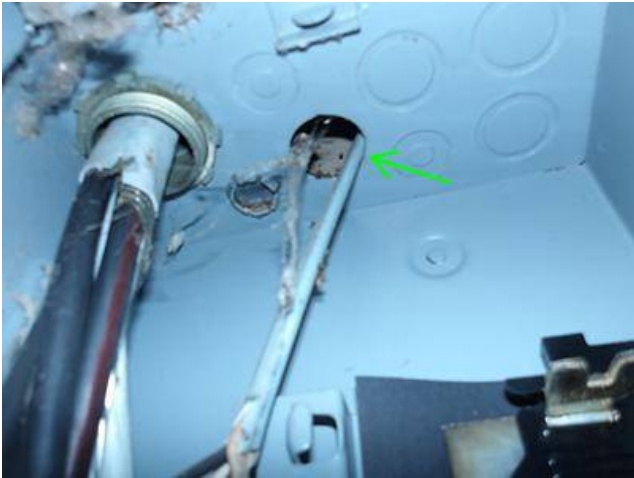
40) 🚨 One or more bushings were missing from where wires enter holes in panel #A. This is a safety hazard since the wiring insulation can be cut or abraded on the metal edge of the hole(s). A qualified electrician should install bushings where missing.

Photo 40-1 Main panel

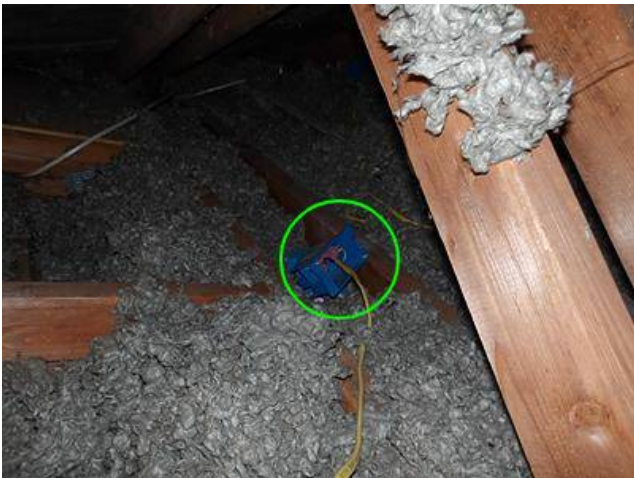
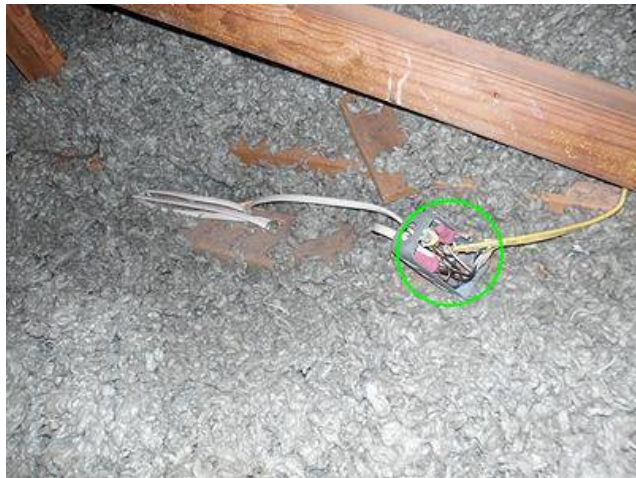
41) 🚨 Some cover plates on junction boxes were missing. They are intended to contain fire and prevent electric shock from exposed wires. This is a safety hazard due to the risk of fire and shock. A qualified person should repair as necessary.

Photo 41-1 Attic

Photo 41-2 Attic

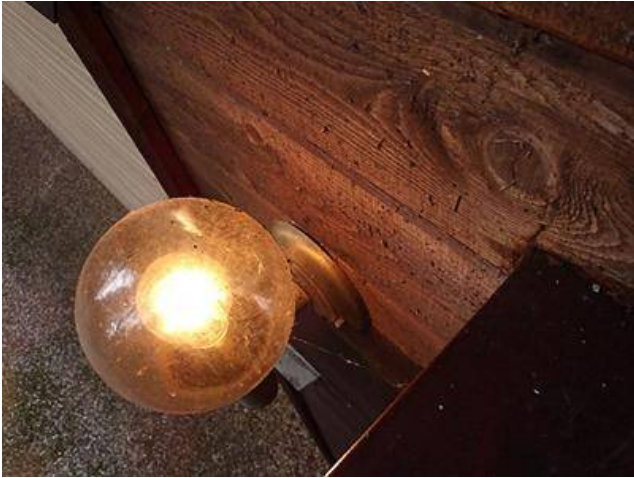
42) 🚨 One or more wall-mounted exterior light fixtures had wiring that's subject to water intrusion due to caulk not being installed around the light fixture's back plate. Caulk should be applied around the perimeter of back plates where missing. A gap should be left at the bottom for condensation to drain out.

Photo 42-1 NW corner garage

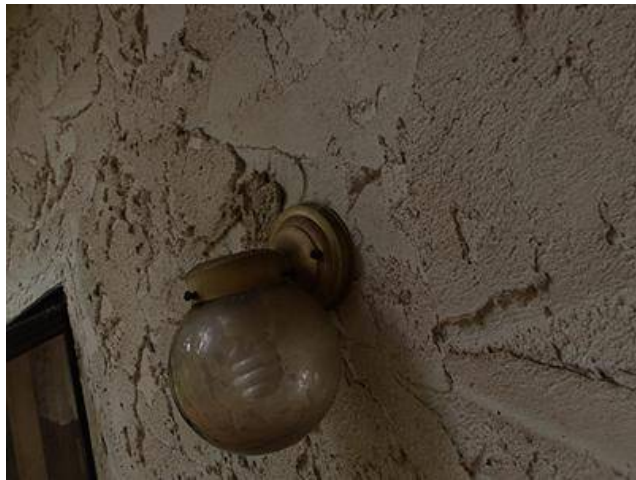
Photo 42-4 South side

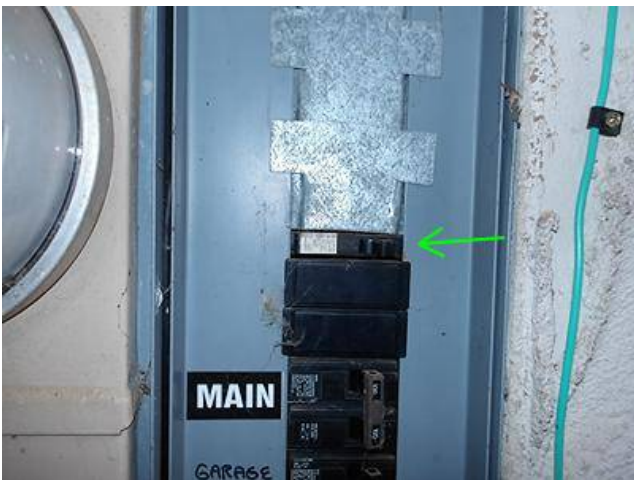
43) 🎁🔍 The legend for overcurrent protection devices (breakers or fuses) in panel #A was substandard. Recommend installing, updating or correcting the legend as necessary so it's accurate. Evaluation by a qualified electrician may be necessary.

Photo 43-1 Main panel

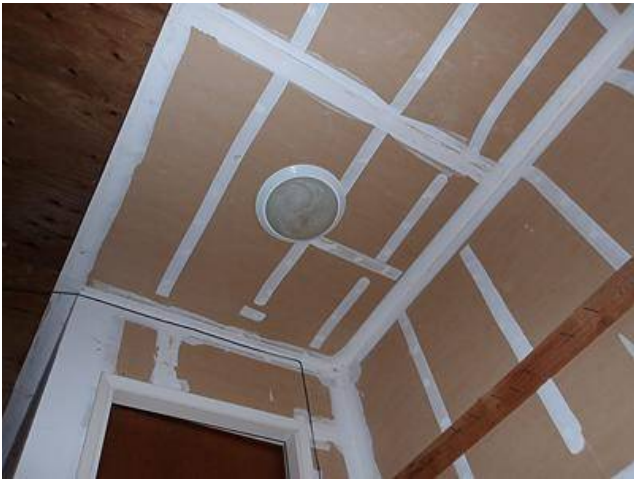
Some light fixtures were inoperable. Recommend further evaluation by replacing bulb(s) and/or consulting with the property owner. Repairs or replacement of the light fixture(s) by a qualified electrician may be necessary.

Photo 45-1 Garage landing

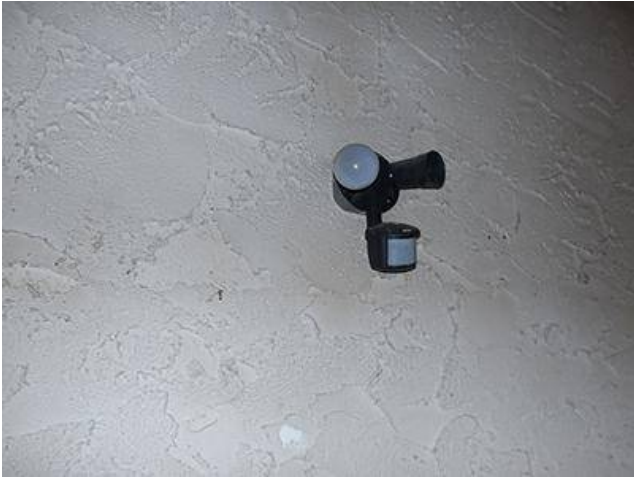
Some bulbs in light fixtures were missing. As a result, some light fixtures couldn't be fully evaluated. Recommend replacing bulbs to fully evaluate fixtures where necessary.

Photo 46-1 North side

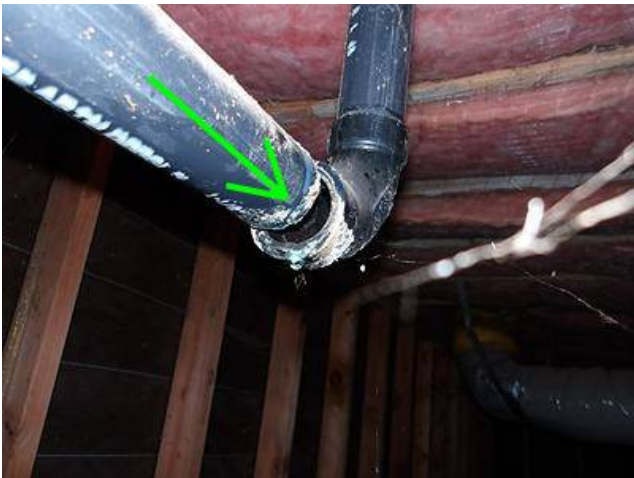
Leaks were found in one or more waste fittings. A qualified plumber should evaluate and repair as necessary.

Photo 48-1 Master bathtub drain line

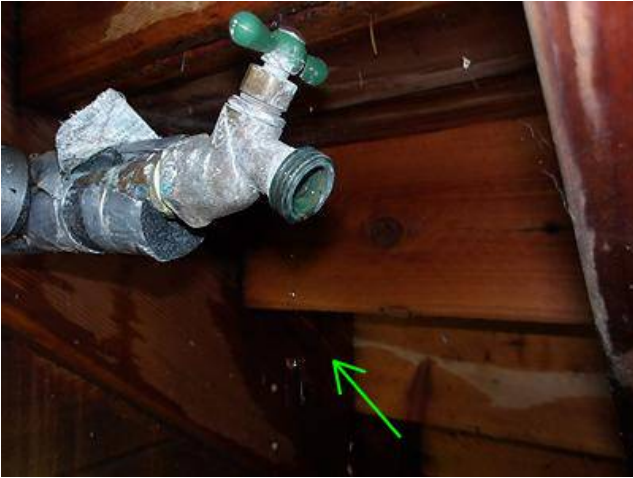
One or more outside faucets were leaking. For example, from the valve stem when turned on or from the spigot when turned off. A qualified plumber should evaluate and repair as necessary.

Photo 50-1 East side below stairs

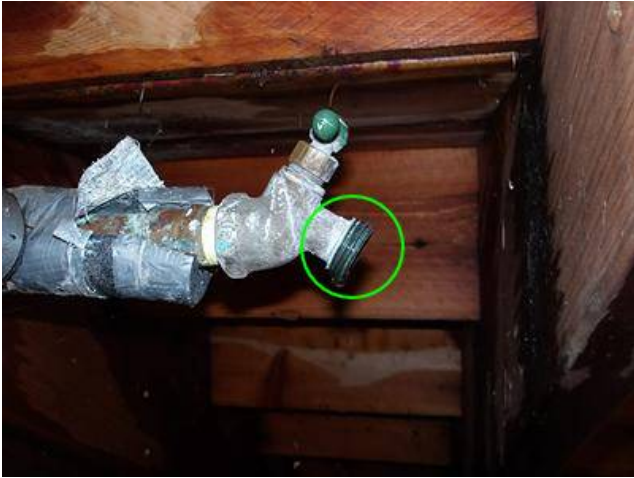
One or more outside faucets were missing [backflow prevention devices](#). These devices reduce the likelihood of polluted or contaminated water entering the potable water supply. This condition can occur when an outside faucet is left in the "on" position with a hose connected and the sprayer head turned off. When pressure in the system fluctuates, water can be drawn back into the water supply pipes from the building. If a chemical sprayer is being used with the hose, those chemicals can enter the water supply pipes.

Photo 51-1 East side below stairs

Recommend installing backflow prevention devices on all exterior hose bibs where missing. They are available at most home improvement stores and are easily installed. For more information, visit: http://edis.ifas.ufl.edu/BODY_AE079

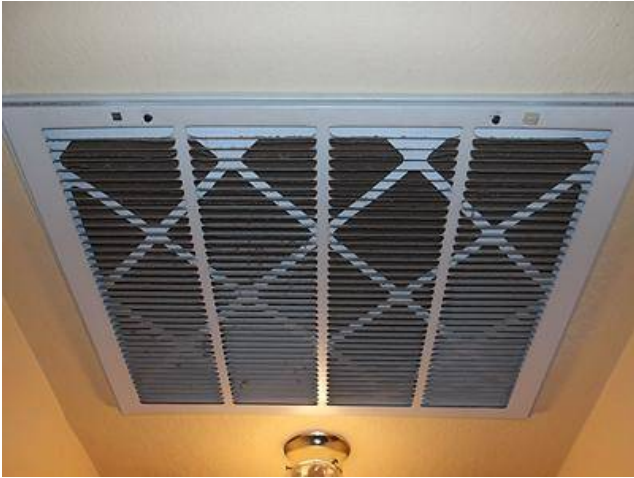
One or more air filters were dirty. A qualified person should replace filter(s) as necessary. Filters should be checked monthly and maintained as necessary in the future.

Photo 54-1 Hall ceiling

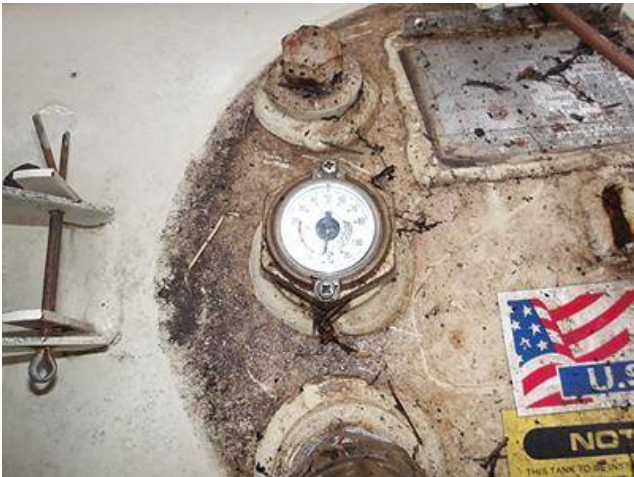
This heating system was not fully evaluated because the following condition(s) existed for the furnace: gas supply turned off. Recommend that a full evaluation be made by a qualified person when conditions have been corrected so the system is operable. Note that as per the standards of practice for NACHI (<http://www.nachi.org>) and ASHI (www.ashi.org), the inspector is not required to operate shut-off valves, pilot lights or overcurrent protection devices, or any controls other than "normal controls".

NOTE: Propane tank empty

Photo 55-1 Propane tank empty

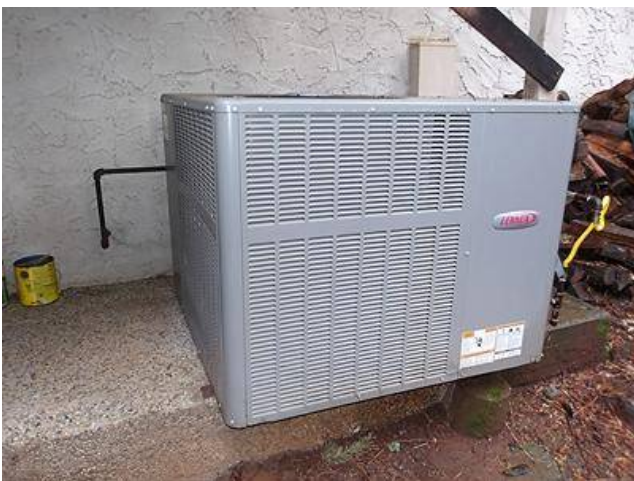
57) ⁱ The outdoor air temperature was below 65 degrees Fahrenheit during the inspection. Because of this, the inspector was unable to operate and fully evaluate the cooling system.

Photo 57-1 HVAC unit

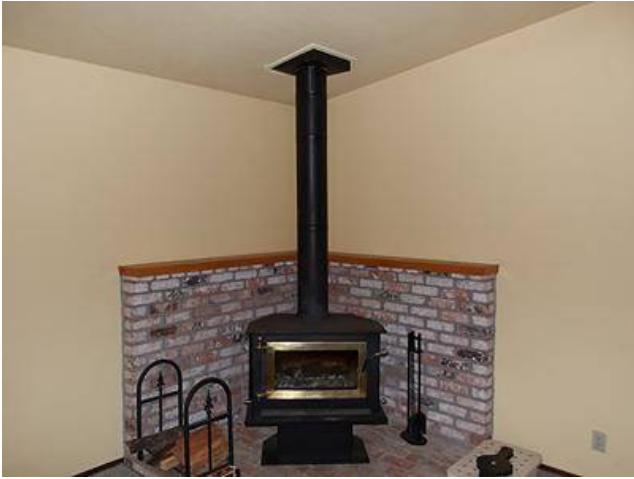
Photo 58-1 Wood stove & chimney

All solid fuel burning appliances (woodstoves and fireplaces, etc.) and their chimneys should be inspected annually by a qualified chimney service contractor, cleaned and repaired as necessary.

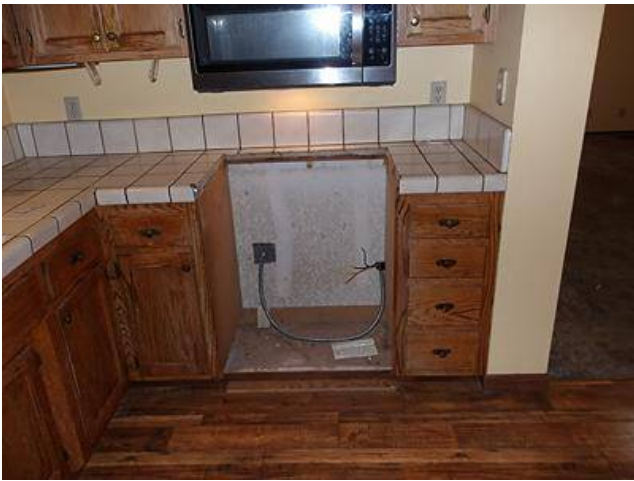
No cooktop or range was installed.

Photo 59-1 Range missing

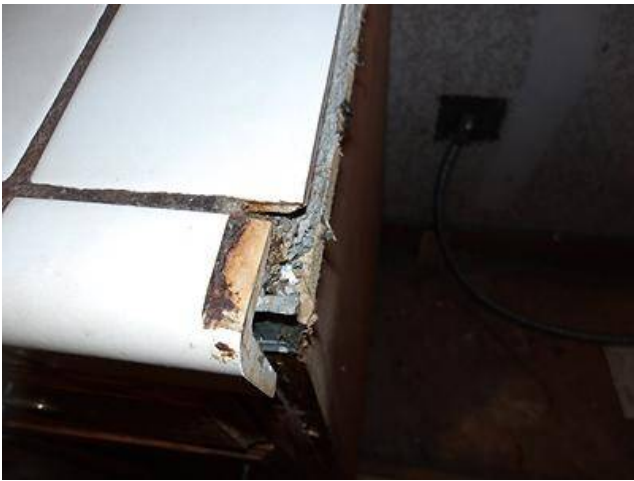
Photo 60-1

60) **i** Some counters showed minor damage.

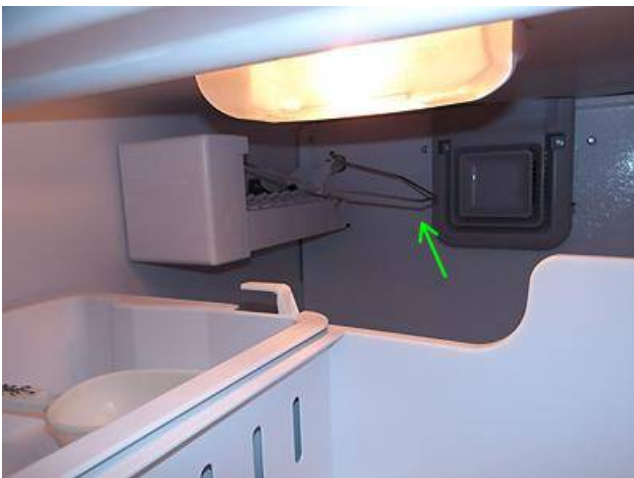
62) **i** The refrigerator ice maker was in the "off" position. The inspector was unable to evaluate this component.

Photo 62-1 Ice maker off

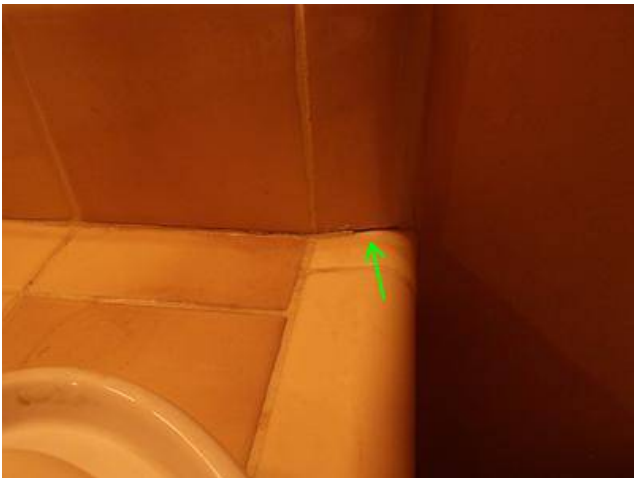
68) **i** Counters showed minor deterioration and/or damage at location #A and B.

Photo 68-1 Hall bathroom
