# Confidential Inspection Report

LOCATED AT:  
3631 Windspun  
Huntington Beach, California

INSPECTED ON:  
Wednesday, March 4, 2026

Inspector: Kevin Switter  
HomeSpec Home Inspections (818) 308 HOME

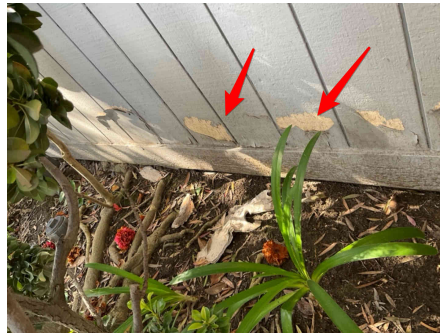
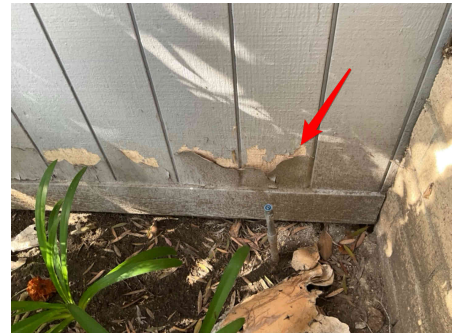
**s-60:** There was damage to the exterior finish noted in one or more areas (assumed from water spraying the structure). We recommend further evaluation and repair as necessary.

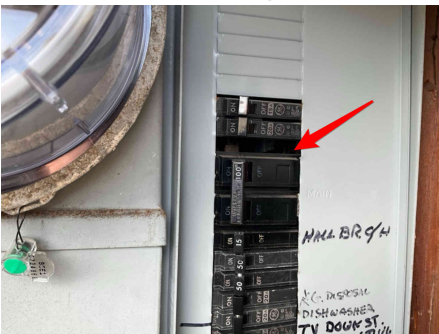
**s-224:** There were one or more open holes/knockouts noted at the box. We recommend they be filled with blanks to avoid potential shocks.

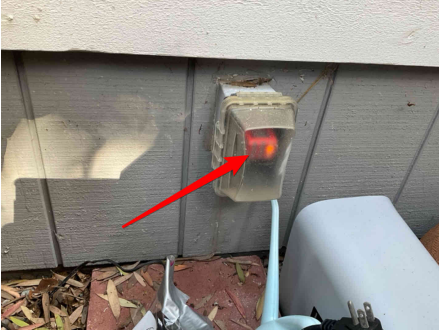
**s-250:** There were one or more receptacles that tested as having a loose, open or bad ground. We recommend ensuring proper grounding and GFCI protection.

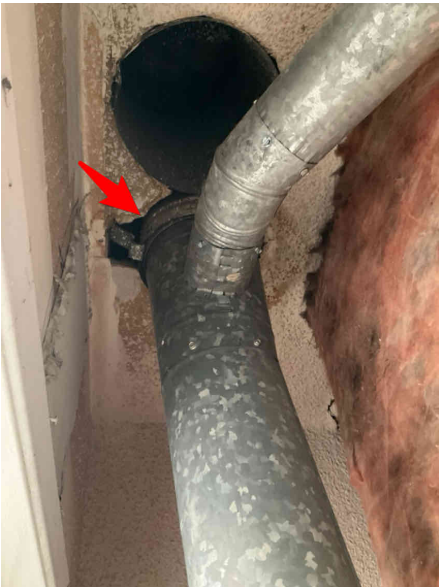
**s-270:** The vent pipe appears to be too close to a combustible material. We recommend approved clearances be provided as per current jurisdictional requirements. Common requirements are 1" from a combustible for double walled pipe and 6" from combustibles for a single walled pipe with a proper adapter plate or thimble installed.

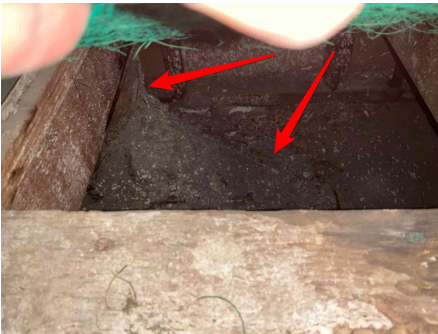
**s-283:** There was debris in the return air compartment as well as fiberglass covered ducting. We recommend all debris be removed and the area be ducted in accordance with current standards to help ensure air purity.

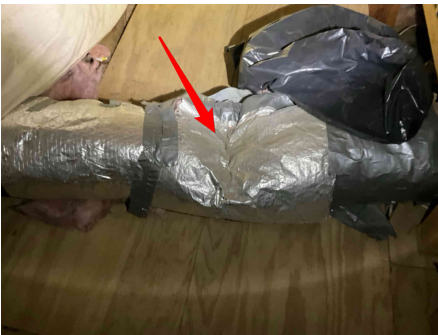
**s-289:** One or more sections of the ducting have been deformed. This condition could affect the air flow and we recommend consulting owner/expert regarding past/future performance .

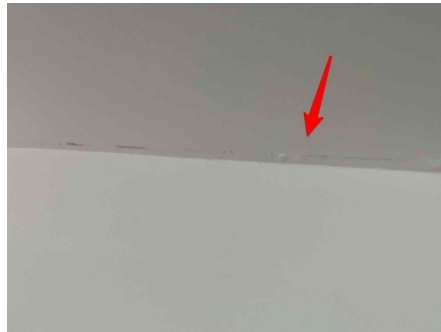
**s-446:** There were cracks, bubbling tape, or seams noted on ceiling. They appear to be cosmetic only at this point and probably a result of patching holes, remodeling or scraping and retexturing the ceilings. However, we recommend consulting the owner or a specialist to confirm this.

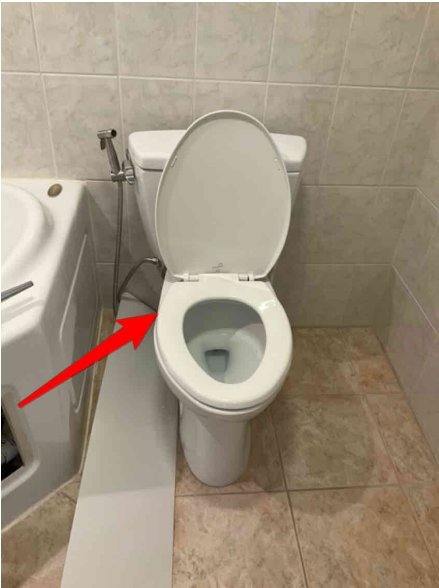
**s-482:** The toilet was not operational at the time of our inspection (shut off at valve). We recommend the reason be determined and the toilet be repaired or replaced as needed.

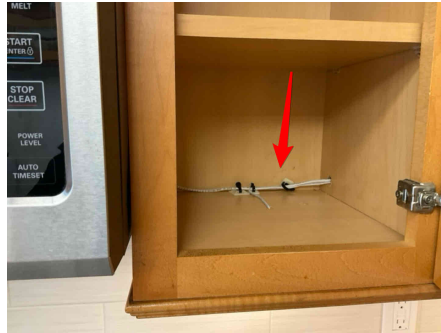
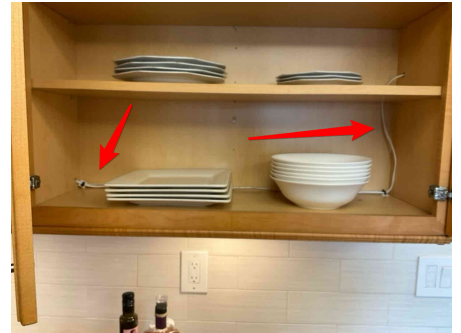
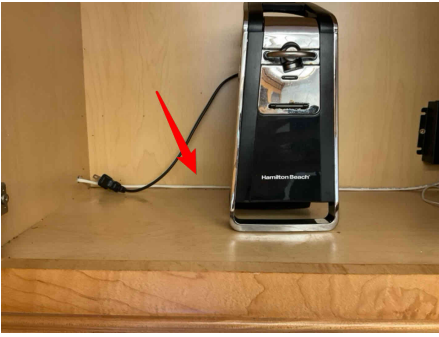
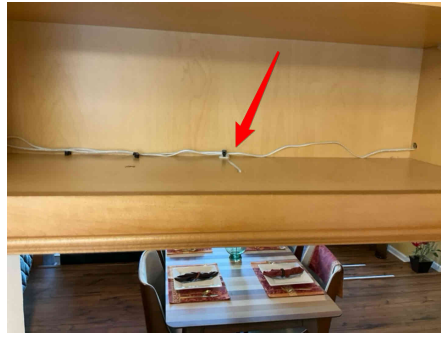
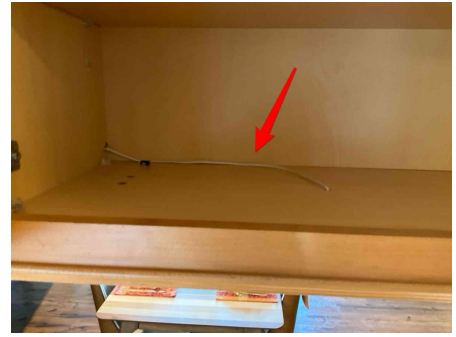
**s-583:** We noted exposed wiring in the cabinets. We recommend all exposed wiring be protected or terminated as necessary in compliance with current jurisdictional requirements.

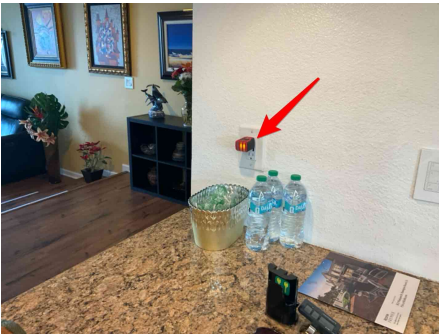
**s-592:** There is not complete Ground Fault Circuit Interrupt (GFCI) protection at all receptacles serving the countertops, which is required by current building standards. We recommend upgrading to current standards for a higher level of safety.

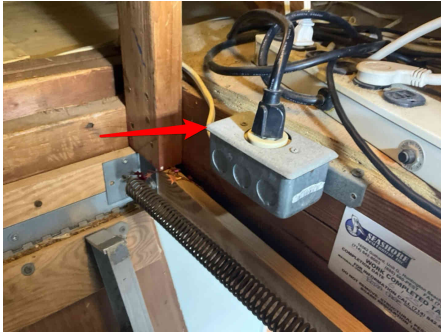
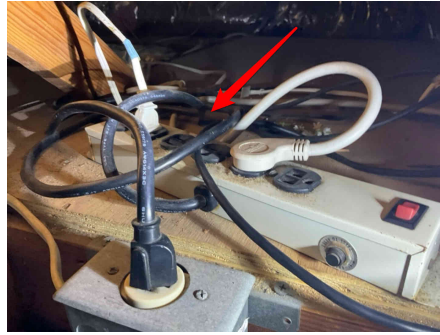
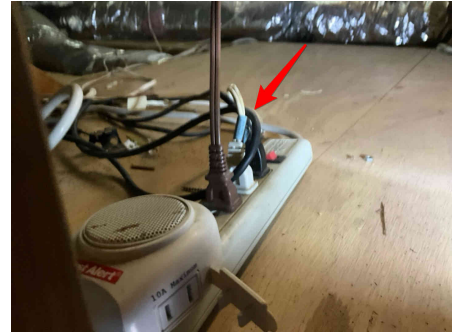
**s-712:** There is loose wiring near the access and a receptacle protruding in the opening. We recommend that all loose wiring be secured to the framing and/or protected from damage in accordance with present standards.

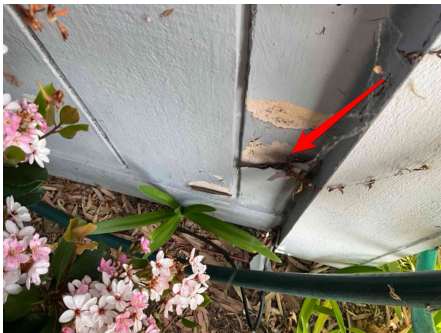
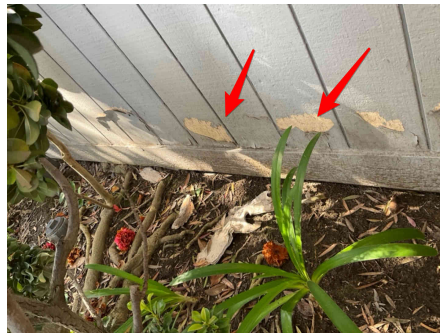
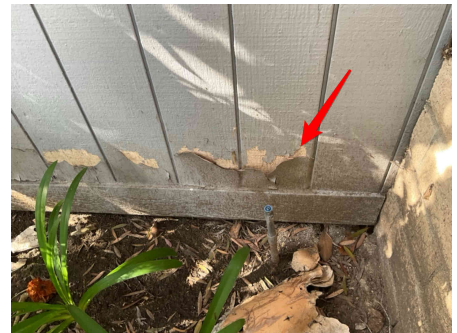
**60:** There was damage to the exterior finish noted in one or more areas (assumed from water spraying the structure). We recommend further evaluation and repair as necessary.

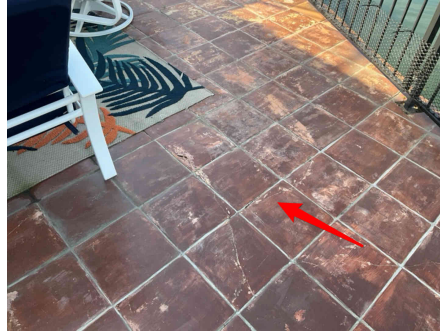
**FEVL 85:** There are cracks noted at a portion of the patio that appear to be atypical, bigger and/or more numerous than what would be considered "normal" or typical. While they appeared to be primarily of a aesthetic issue only, you may wish to get a second opinion or have a specialist comment on them.

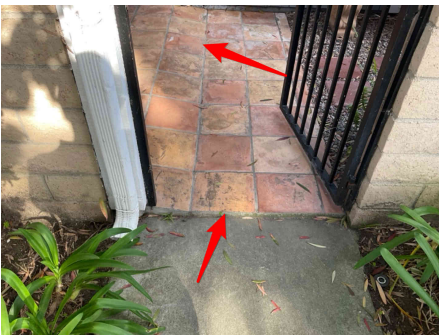
**86:** There are several offsets in the patio that could prove to be trip-hazards.

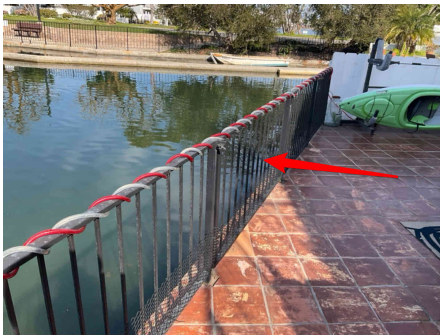
**FEVL 97:** Some of the railings appear low by present standards. We recommend consulting with the local jurisdictional and/or a specialist to ensure railings are safe and, ideally, installed as per current jurisdictional requirements.

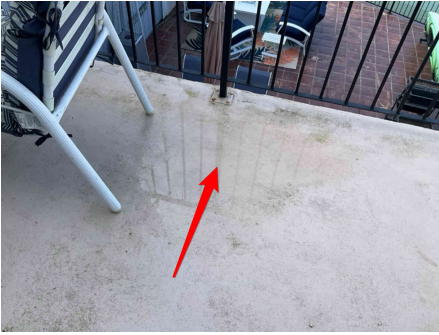
**101:** There was water staining and/or evidence of past ponding noted on the balcony. We recommend consulting owner regarding any past performance issues.

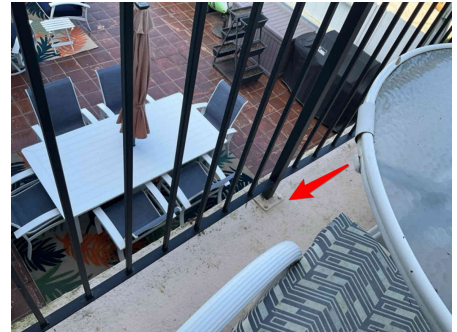
**FTRW** **WARN** **102:** One or more of the balcony railing posts do not appear to be flashed. We were unable to determine if the posts were properly sealed to prevent moisture intrusion. We recommend consulting with the owner regarding any past issues as well as with a waterproofing expert to ensure the integrity of the membrane.

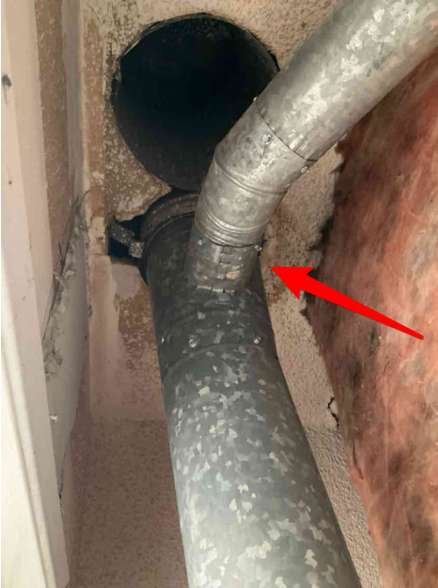
**FTRW** **WARN** **179:** One vent connects to the other vent with a "T" connector. We recommend evaluation to ensure that this type of connection does not hinder the drafting of either, or both, of the units.

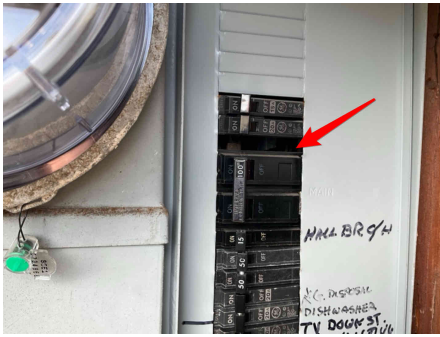
**224:** There were one or more open holes/knockouts noted at the box. We recommend they be filled with blanks to avoid potential shocks.

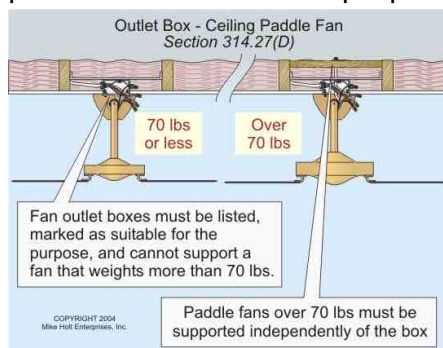
**247:** Due to inaccessibility, we are unable to confirm that the installed ceiling fans have proper support installed. We recommend consulting with the owner regarding any past issues as well as obtaining any pertinent installation receipts/permits.

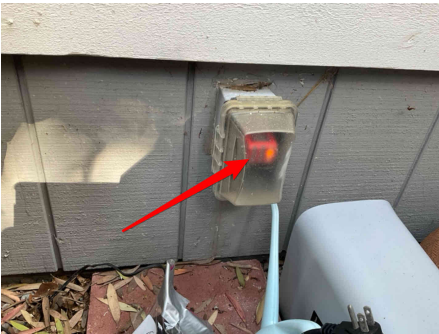
**250:** There were one or more receptacles that tested as having a loose, open or bad ground. We recommend ensuring proper grounding and GFCI protection.

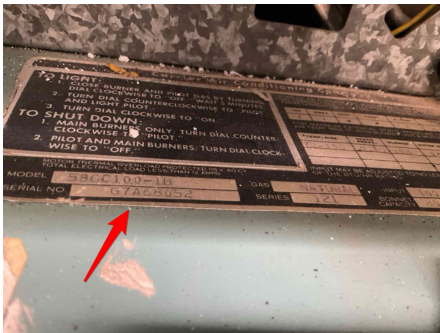
**259:** The furnace appears to be the age of the structure. We recommend it be serviced/evaluated by the appropriate professional.

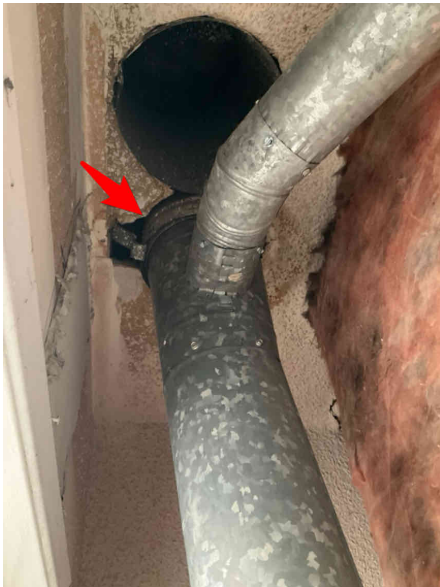
**270:** The vent pipe appears to be too close to a combustibile material. We recommend approved clearances be provided as per current jurisdictional requirements. Common requirements are 1" from a combustibile for double walled pipe and 6" from combustibles for a single walled pipe with a proper adapter plate or thimble installed.

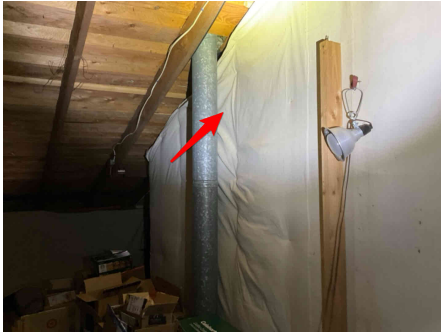
**271:** The vent pipe is in close to or in contact with some combustibile material in the attic. We recommend all contact be eliminated and proper clearances provided to help prevent the possibility of combustion.

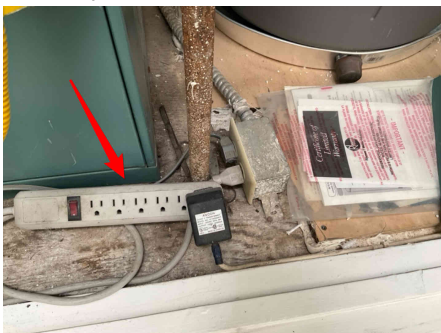
**276:** We found extension cords and/or multi-plug adapters in use. This type of wiring is easy to overload and can be easily damaged. Removal of all extension cords/multi-plugs and replacement with proper circuitry is recommended.

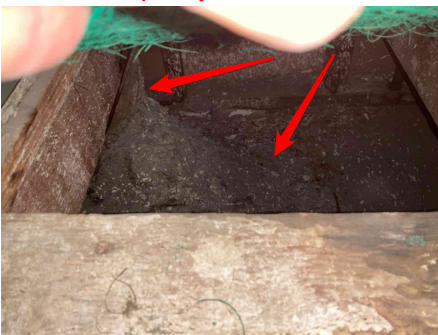
**283:** There was debris in the return air compartment as well as fiberglass covered ducting. We recommend all debris be removed and the area be ducted in accordance with current standards to help ensure air purity.

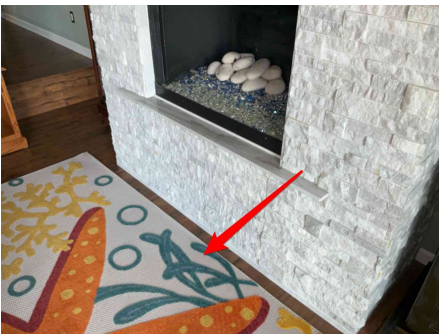
**322:** There is not a proper hearth installed as is the current standard and the adjacent flooring material appears to be combustible. Consideration should be given to the installation of a proper hearth as per current jurisdictional requirements.

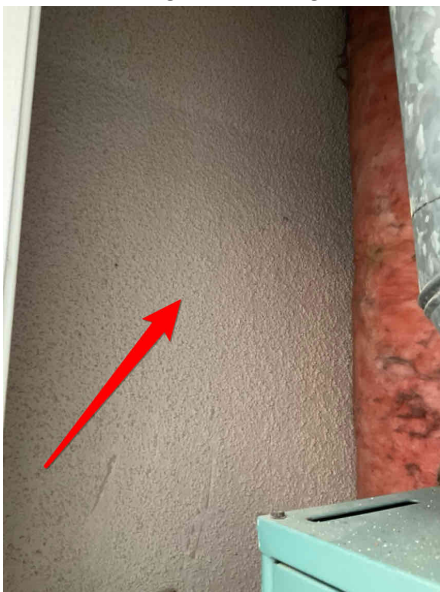
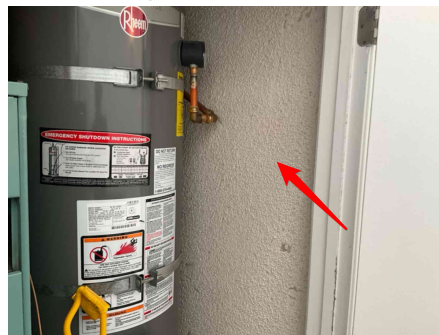
**FEVL** **361:** The original texture appears to still be on the ceiling/walls of the furnace closet. It should be known that, given the age of the structure, it is possible that the texture coating could contain asbestos.

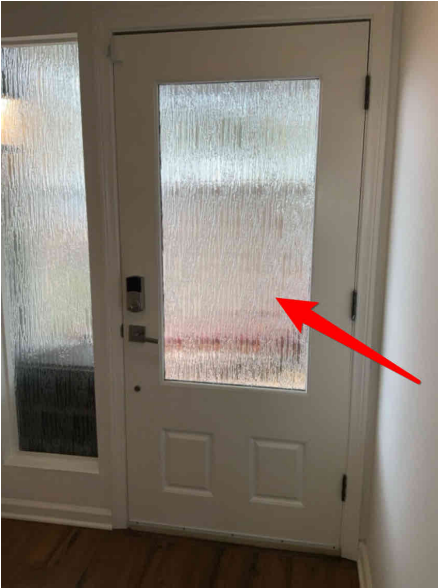
**FEVL 373:** We were unable to determine if the glass in all the panels of the exterior door(s) were completely tempered. The tempered insignia was not visible on one, or both panels. Tempered glass is an important safety feature, especially when there are small children living in the home, and verification of tempered glass or the installation of a proper safety film is recommended.

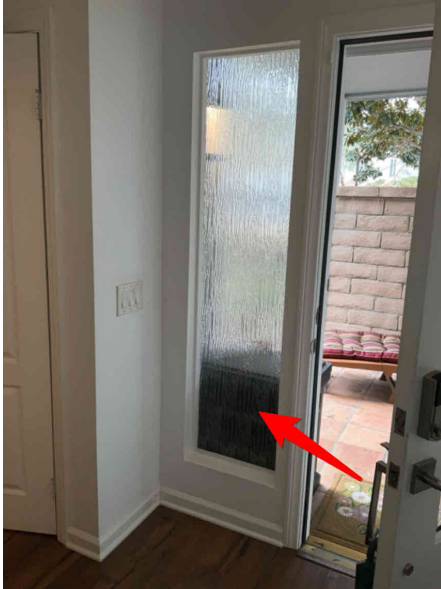
**FEVL 377:** We were unable to determine if the glass in the exterior windows was tempered where currently required. The tempered insignia was not visible. Tempered glass is an important safety feature, especially when there are small children living in the home, and verification of tempered glass or the installation of a proper safety film is recommended.

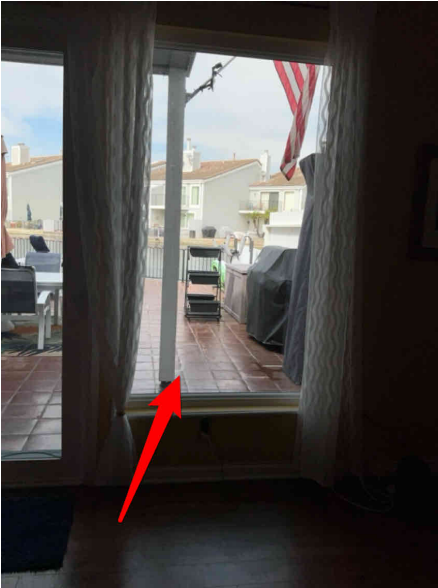
**FTRW SFTY 387:** We were unable to determine if the glass in the exterior windows was tempered where currently required. The tempered insignia was not visible. Tempered glass is an important safety feature, especially when there are small children living in the home, and verification of tempered glass or the installation of a proper safety film is recommended.

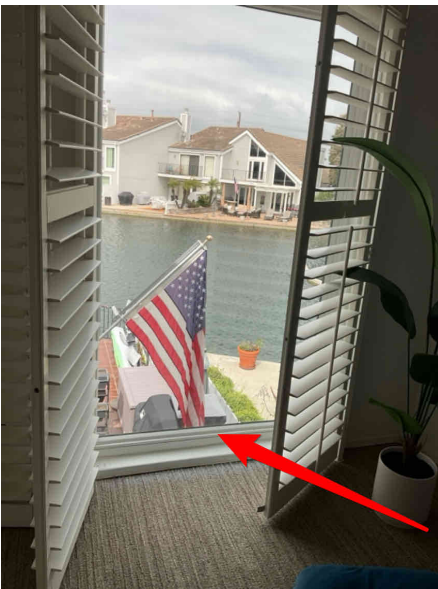
**WARN 411:** We were unable to determine if the glass in all of the exterior windows was tempered. The tempered insignia was not visible to the inspector at the time of the inspection. As a point of reference, tempered glass is currently required in most jurisdictions when a window is less than 18" from the floor or in a high wind or fire area.

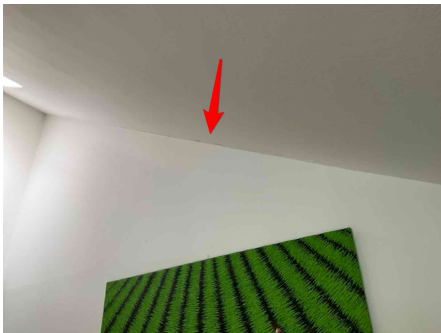
Seam crack/patch
