# WOOD DESTROYING PESTS AND ORGANISMS INSPECTION REPORT

Building No. 3160	Street BIXLER RD	City BRENTWOOD	Zip 94513	Date Of Inspection 7/31/25	Number Of Pages 10
----------------------	---------------------	-------------------	--------------	-------------------------------	-----------------------

General Description:    ONE STORY FRAME, ATTACHED GARAGE, SINGLE FAMILY RESIDENCE	Inspection Tag Posted: IN THE GARAGE  Other Tags Posted: NONE NOTED
---	---

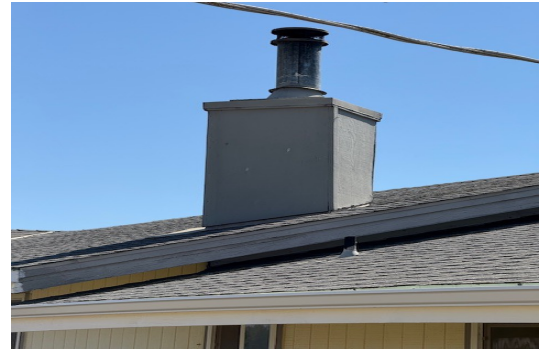
1A

FUNGUS OR DRY ROT

FINDING: THERE IS FUNGUS DAMAGE TO THE SIDING AND TRIM AROUND THE CHIMNEY CHASE.  
RECOMMENDATION: REPLACE DAMAGED SECTIONS OF SIDING AND TRIM AT THE CHASE. IF DAMAGE IS FOUND TO EXTEND BEYOND THIS AREA, A SUPPLEMENTAL REPORT AND ADDITIONAL BID WILL BE ISSUED.

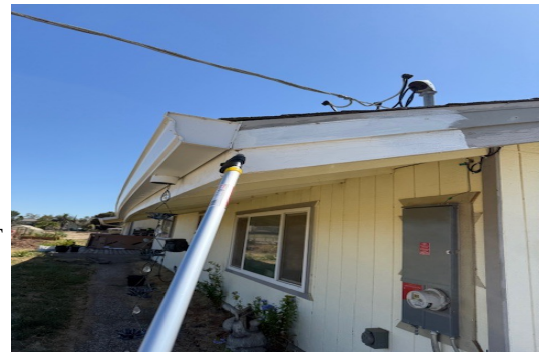
1B

FUNGUS OR DRY ROT

FINDING: FUNGUS DAMAGE IS NOTED TO THE EDGE OF THE ROOF SHEATHING AND TO THE GABLE END RAFTER TAIL IN THE AREAS DESIGNATED.  
RECOMMENDATION: OPEN THE AFFECTED AREAS TO EXPOSE THE EXTENT OF THE DAMAGE REPLACE THE DAMAGED WOOD MEMBERS AS NECESSARY AND PRIME PAINT THE AFFECTED AREAS. SINCE THESE REPAIRS WILL INVOLVE THE ROOF COVERING, WE RECOMMEND THAT INTERESTED PARTIES CONTACT THE PROPER TRADES PERSON TO MAKE APPROPRIATE REPAIRS TO THE ROOFING AFTER WOOD REPAIR IS PERFORMED.

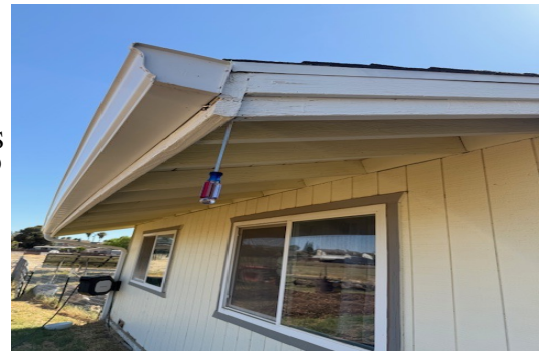
1C

FUNGUS OR DRY ROT

FINDING: THERE IS FUNGUS DAMAGE TO THE GABLE END RAFTER ASSEMBLIES EXTENDING UP SEVERAL FEET AND EXTENDING INTO THE FASCIA BOARDS  
RECOMMENDATION: REPAIR/REPLACE DAMAGED WOOD MEMBERS OF THE ROOF OVERHANG AND THESE MULTIPLE AREAS AS NEEDED TO ELIMINATE THE DAMAGE.  
NOTE: THE PHOTO SHOWS ONE OF MULTIPLE AREAS. PLEASE REFER TO THE DIAGRAM.

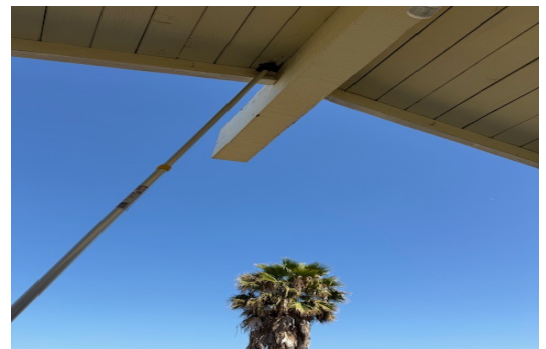
1D

FUNGUS OR DRY ROT

FINDING: THERE IS FUNGUS DAMAGE TO THE LARGE EXTENDED ROOF BEAM, ADJACENT SHEATHING AND TO THE RAFTERS THAT REST ON TOP OF THIS BEAM.  
RECOMMENDATION: RECONSTRUCT THE WOOD MEMBERS OF THE ROOF OVERHANG AS NEEDED TO ELIMINATE THE DAMAGE AND TO MAKE THE AREAS STRUCTURALLY SOUND.  
A ROOFER SHOULD BE CONTACTED TO REPAIR ROOF COVERING AFTER WOOD REPAIRS ARE PERFORMED.

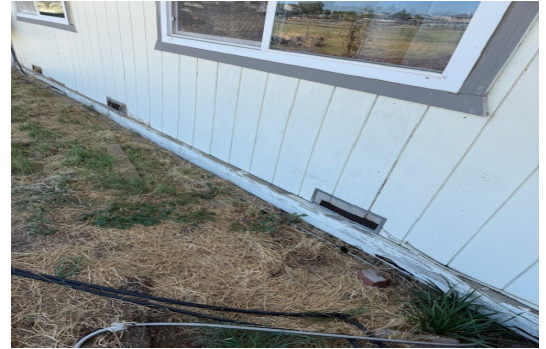
FUNGUS OR DRY ROT

FINDING: THERE ARE EARTH TO WOOD CONTACTS, FUNGUS DAMAGE AND SUBTERRANEAN TERMITE TRACKING ON THE LOWER EXTERIOR WALL PER 1E ON THE DIAGRAM.  
RECOMMENDATION: GRADE SOIL AND REMOVE DAMAGED HORIZONTAL BOARDS ALONG THE BASE OF THE WALL. PERFORM A FURTHER INSPECTION TO DETERMINE IF DAMAGE TRAVELS. IF NO DAMAGE EXTENDS, REPLACE DAMAGED TRIM ALONG THE BASE OF THIS WALL. IF DAMAGE IS FOUND TO EXTEND BEYOND THIS AREA, A SUPPLEMENTAL REPORT AND ADDITIONAL BID WILL BE ISSUED.

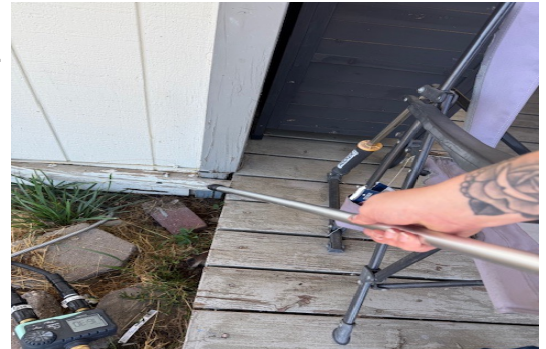
FUNGUS OR DRY ROT

FINDING: THERE IS FUNGUS DAMAGE TO THE CORNER TRIM PER 1F ON THE DIAGRAM AT THE FRONT.  
RECOMMENDATION: REPAIR OR REPLACE DAMAGED SECTIONS. THEN PRIME PAINT AFFECTED AREAS.

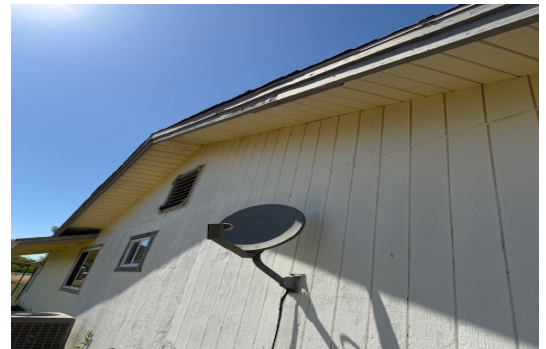
1G

FUNGUS OR DRY ROT

FINDING: THERE IS FUNGUS DAMAGE TO THE GABLE END RAFTER AT THE UPPER SEAM AT THE LEFT SIDE.  
RECOMMENDATION: REPAIR DAMAGED SECTION OF RAFTER.

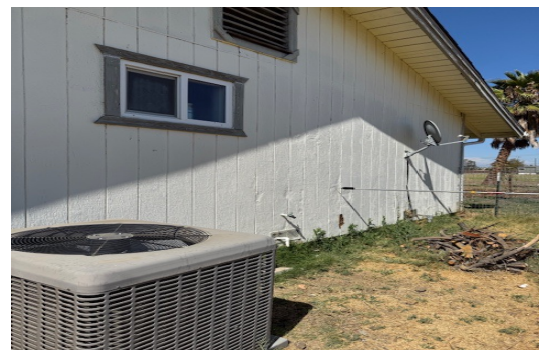
1H

FUNGUS OR DRY ROT

FINDING: THERE IS FUNGUS DAMAGE TO SEVERAL OF THE 9FT X 4FT EXTERIOR SIDING PANELS AT THE LEFT SIDE. SOME EXTENDS TO AREAS SURROUNDING THE WINDOWS AND INTO THE TRIM.  
RECOMMENDATION: REMOVE THE MULTIPLE DAMAGED SIDING PANELS FROM TOP TO BOTTOM AND REMOVE THE TRIM AS NEEDED. FURTHER INSPECT THE FRAMING. IF NO FURTHER DAMAGE IS UNCOVERED, REPLACE DAMAGED SIDING PANELS AND TRIM AND PRIME PAINT AFFECTED AREAS.

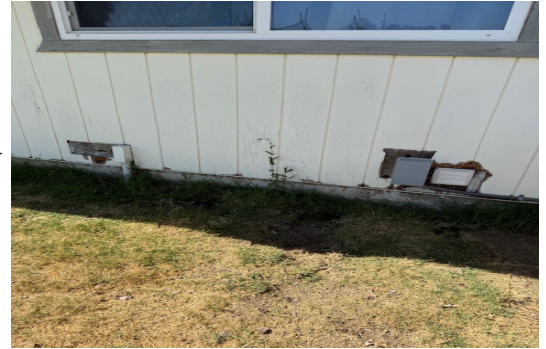
FUNGUS OR DRY ROT

FINDING: THERE IS FUNGUS DAMAGE TO THE BOTTOM TWO FEET (APPROXIMATE) ALONG THE EXTERIOR SIDING DOWN AREAS MARKED 1I ON THE DIAGRAM.  
RECOMMENDATION: TRIM UP THE SIDING ABOUT TWO FEET ALONG THE ENTIRE AREA. INSTALL NEW SIDING BELOW PROPERLY SEALED AT THE SEAM. PRIME PAINT AFFECTED AREAS.

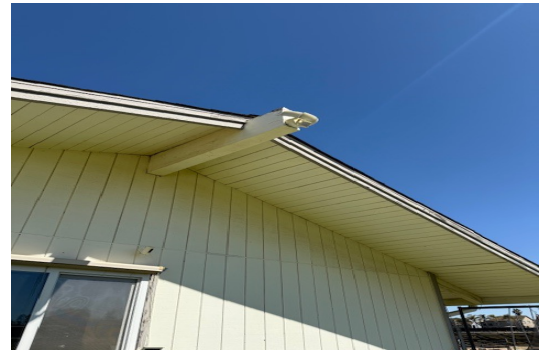
1J

FUNGUS OR DRY ROT

FINDING: THERE IS FUNGUS DAMAGE TO THE END OF THE UPPER EXTENDED ROOF BEAM AT THE BACK.  
RECOMMENDATION: CUT BACK THE BEAM TO ELIMINATE THE DAMAGE AND PRIME PAINT THE END.

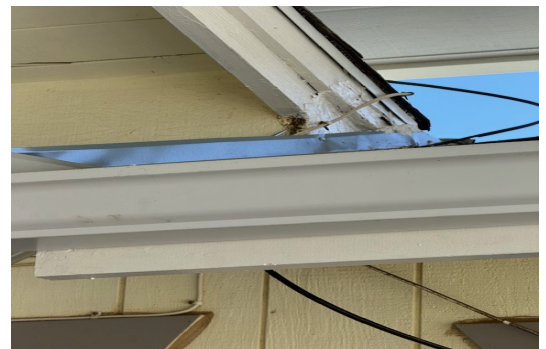
1K

FUNGUS OR DRY ROT

FINDING: THERE IS FUNGUS DAMAGE TO THE UPPER SMALL PORTION OF THE ROOF EDGE AT THE BACK INSIDE CORNER.  
RECOMMENDATION: REPAIR/REPLACE DAMAGED WOOD AND PRIME PAINT AFFECTED AREAS.  
IF DAMAGE IS FOUND TO EXTEND BEYOND THIS AREA, A SUPPLEMENTAL REPORT AND ADDITIONAL BID WILL BE ISSUED.

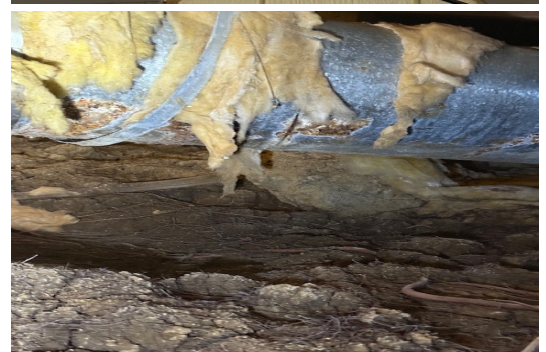
1L

TERMITE INFECTED SCRAP WOOD

FINDING: (SUBTERRANEAN TERMITE) INFECTED SCRAP WOOD DEBRIS IS NOTED ON THE SUBAREA SOIL.  
RECOMMENDATION: REMOVE THE SCRAP WOOD DEBRIS AND ANY OTHER CELLULOSE MATERIAL OF A SIZE THAT COULD BE RAKED.

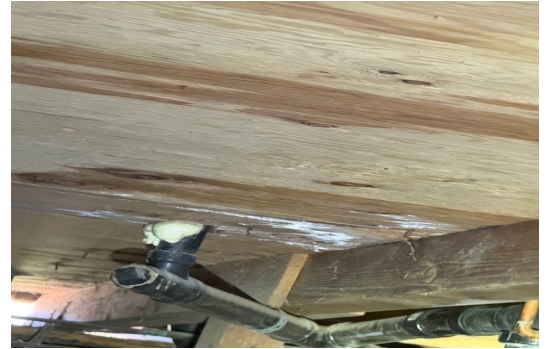
1N

TREAT FOR FUNGUS CONTROL

FINDING: THERE IS SURFACE FUNGUS GROWTH TO THE UNDERPINNING AND TO THE SUBFLOOR UNDER THE BATHROOMS. NO STRUCTURAL DAMAGE IS NOTED.  
RECOMMENDATION: CHEMICALLY TREAT WITH TIMBOR PER LABEL INSTRUCTIONS.

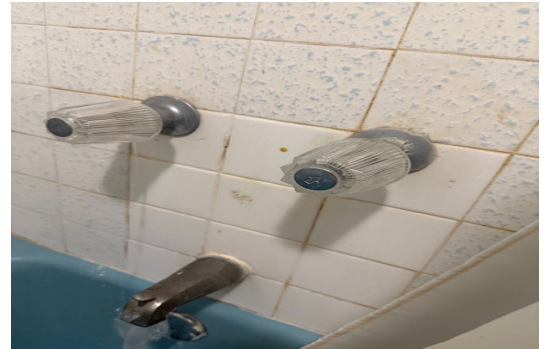
2B

MOISTURE CONDITION

FINDING: THE MASTER BATH TUB SHOWER VALVE ASSEMBLY LEAKS INDICATING WORN RUBBER WASHERS OR DEFECTIVE CARTRIDGES.  
RECOMMENDATION: CONSULT A PLUMBER TO REPAIR.

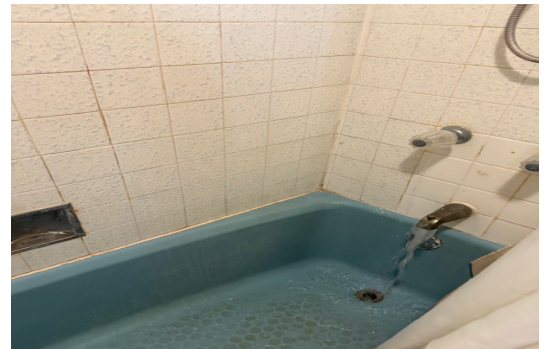
2C

FURTHER INSPECTION UPON REQUEST

FINDING: THE GROUT AND CAULKING ON THE TUB SHOWER AND/OR STALL SHOWER WALLS SHOWS NORMAL WEAR AND DETERIORATION. NO VISIBLE LEAKS ARE NOTED AT THIS DATE.  
RECOMMENDATION: OWNER IS ADVISED TO MAINTAIN THESE AREAS WELL GROUTED AND SEALED TO CONTROL MOISTURE INTRUSION AND TO ALSO HAVE PERIODIC INSPECTIONS. NO APPARENT INFESTATION OF WOOD DESTROYING ORGANISMS WERE NOTED TO THE EXPOSED SURFACES ON THIS DATE. NO REPRESENTATION IS MADE CONCERNING ANY SEALED AREAS UNLESS OPENINGS ARE AUTHORIZED FOR FURTHER INSPECTION.

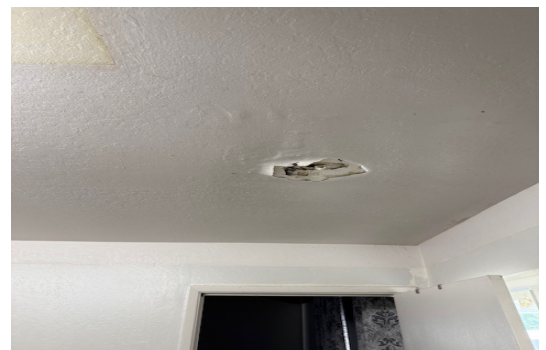
2D

MOISTURE CONDITION

FINDING: THERE IS A STAIN AND DETERIORATION TO THE CEILING IN THE MASTER BATHROOM. CONDITIONS BEHIND ARE UNKNOWN UNLESS OPENED FOR FURTHER EVALUATION. AREAS ABOVE SHOULD BE EVALUATED BY A ROOFER.
