Inspection Report

Ben & Sharon Wagner
8375 Amapoa Avenue
Atascadero, CA 93422

Report Date: 11/14/2025

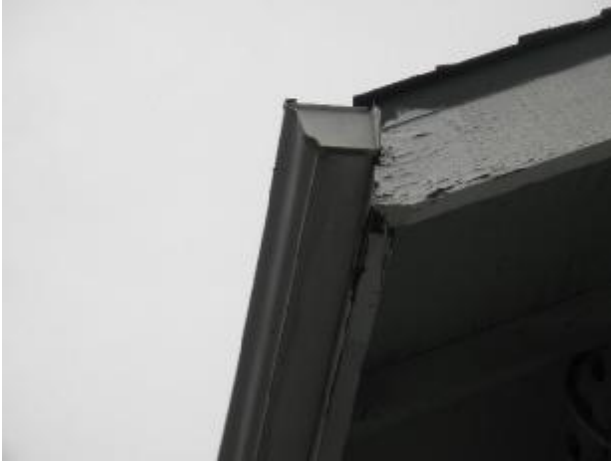
EX

- 1.) There is moisture damage to the fascia boards in the following locations:
 - A.) The fascia board at the base of the second story west facing gable.
 - B.) The fascia board at the inside corner of the eave above the front entry.
 - C.) The fascia board at the second story NE corner of the roof.

Moisture damage at the fascia board.

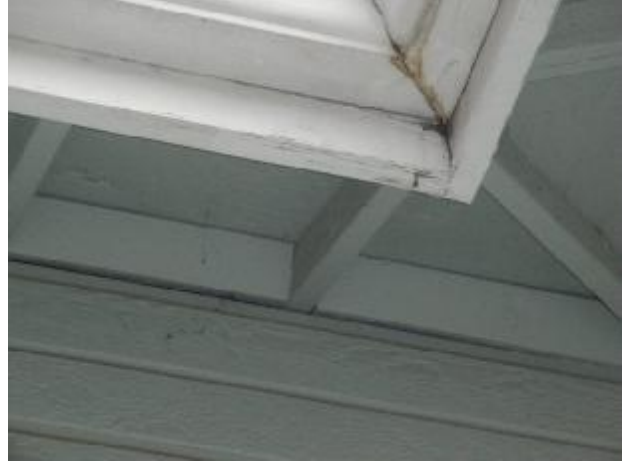
EX

Moisture damage at the fascia board.

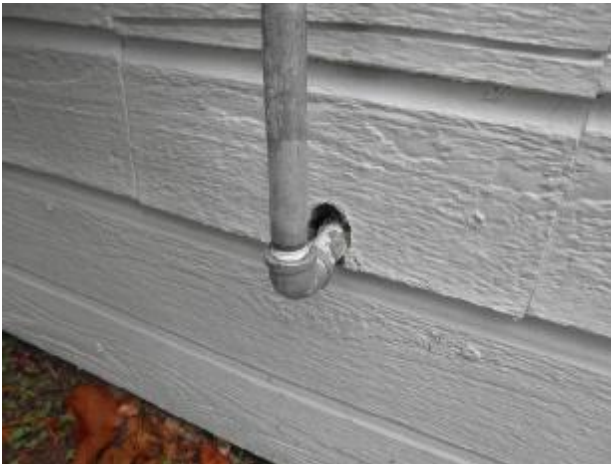
EX

5.) There is a gap where the gas line penetrates the exterior wall at the chimney enclosure. This gap needs to be sealed with caulking to prevent water intrusion.

Seal the gap where the gas line penetrates the exterior wall.

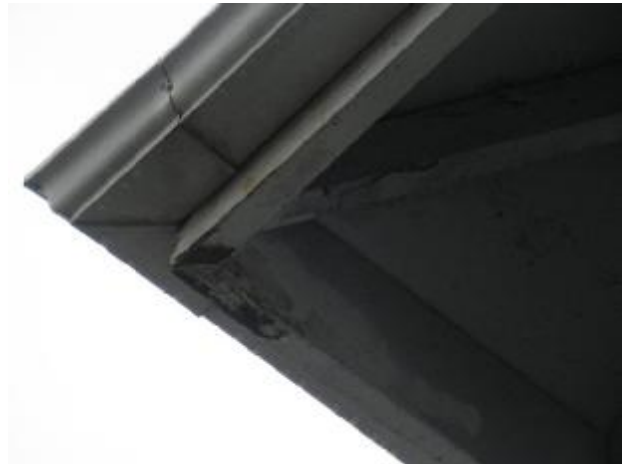
EX

Moisture damage at the fascia board.

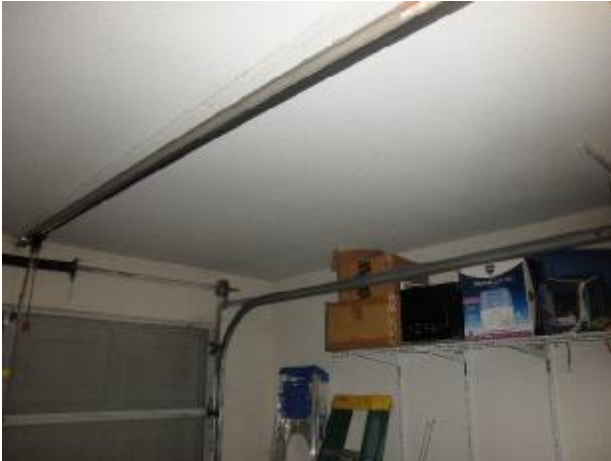
GD

No leaks observed below the water proof deck.

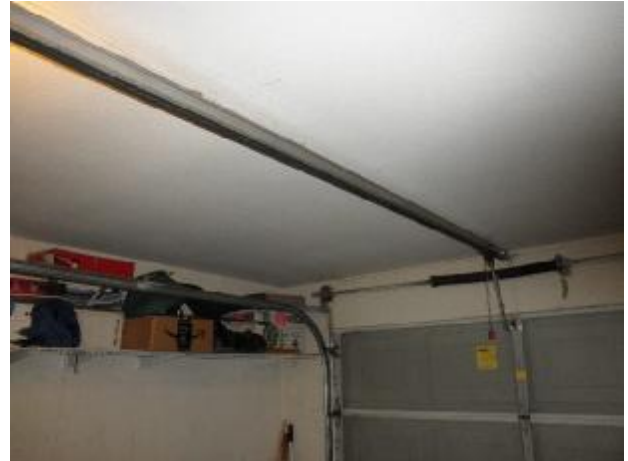
GD

No leaks observed below the water proof deck.

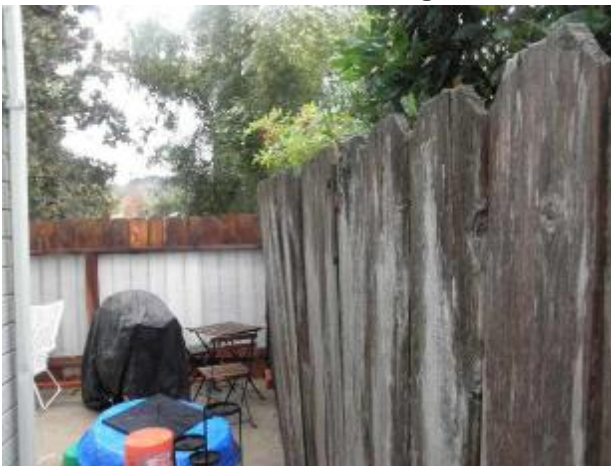
GD

1.) Part of the fence in the backyard is leaning.

Part of the fence in the backyard is leaning.

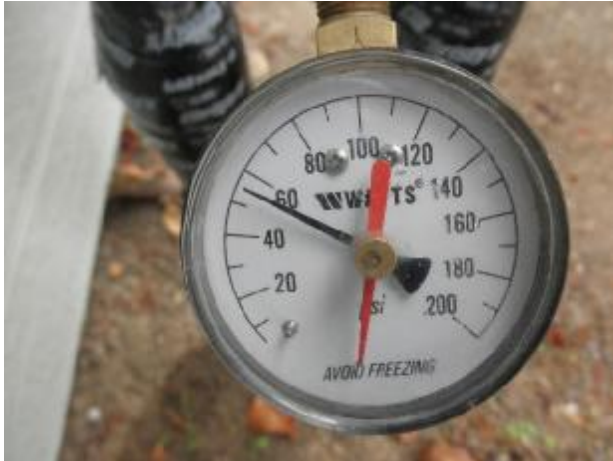
P

Information Note: The water pressure was measured at 55 psi at the time of inspection. This is within a normal and acceptable range. Since the house is equipped with a pressure regulator it should be monitored and retested periodically to ensure that the pressure is below the maximum allowable 80 psi.

The water pressure was measured at 55 psi.

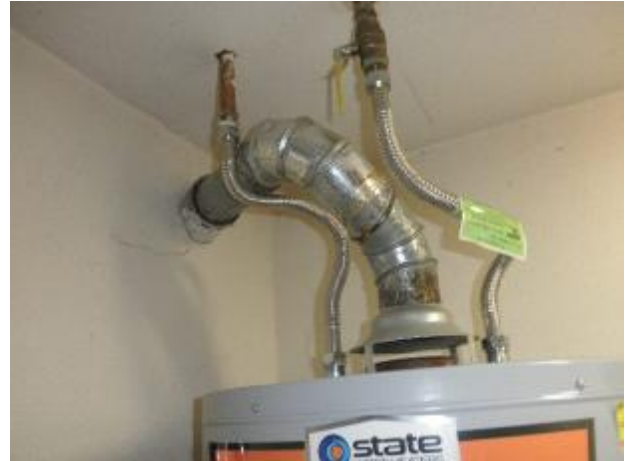
P

Screws missing at the water heater exhaust.

Repair Note: The vent flue sections for the water heater exhaust need to be secured with screws and sealed with foil tape.

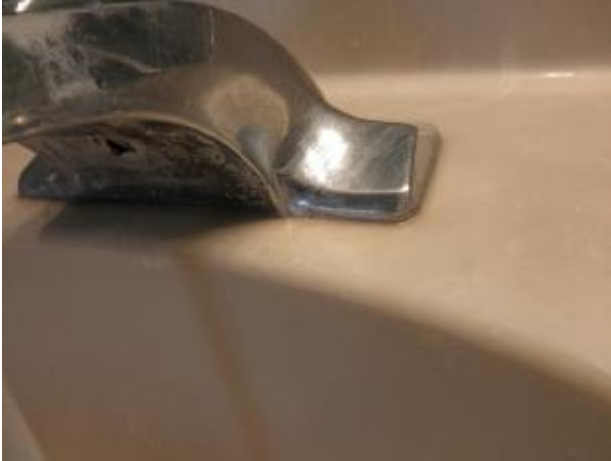
B

1.) There is a leak at the left faucet in the master bathroom.

Leak at the left sink faucet in the master bathroom.

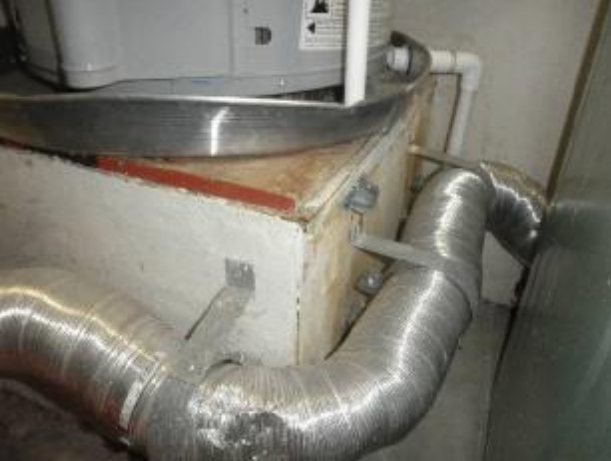
GC

1.) There is minor moisture damage to the water heater platform in the garage.

Minor moisture damage to the water heater platform.
