# Inspection Report

**April Fehrer**  
**519 N Ferrocarril**  
**Atascadero, CA 93422**

Report Date: 1/6/2026

Customer File # 21412
:
: April Fehrer

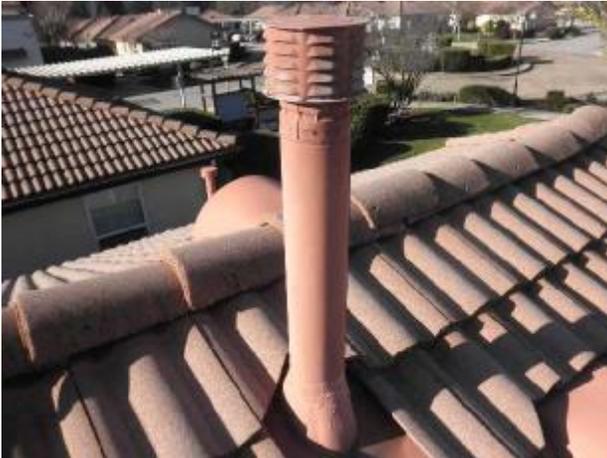
**Roof # R**

1.) The storm collar is missing at the furnace exhaust vent flashing. This may subject this flashing to leaks.

**Missing storm collar at the furnace exhaust vent flashing.**

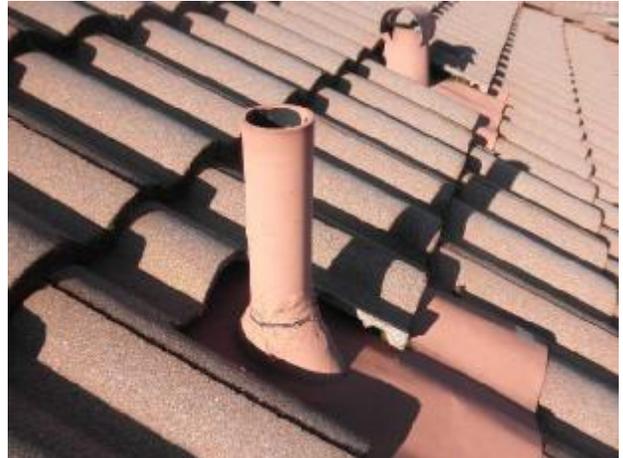
**Roof # R**

**Deteriorated sealant at the vent flashings.**

**Maintenance Note:** The sealant at the flashings has become cracked and deteriorated from exposure to the sun. Recommend resealing the flashings to prevent water intrusion.

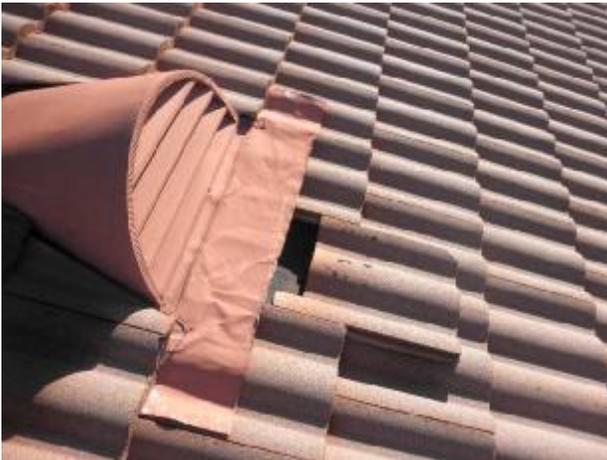
**Roof # R**

2.) There is one displaced roof tile at the west facing slope.

**Displaced roof tile on the west facing slope.**

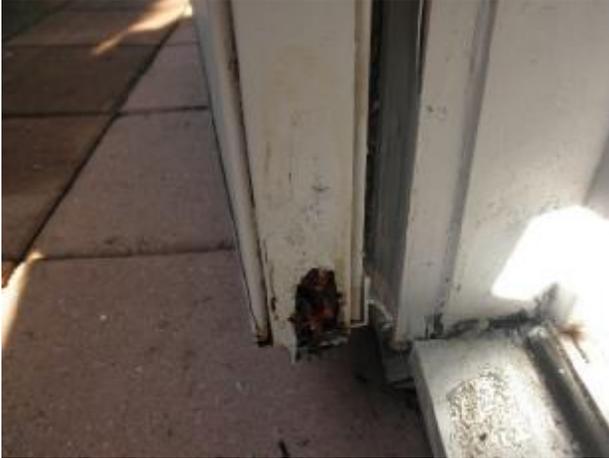
# EX

- 1.) There is moisture damage to the base of the spine at the water heater closet door.

Moisture damage at the base of the water heater closet door.

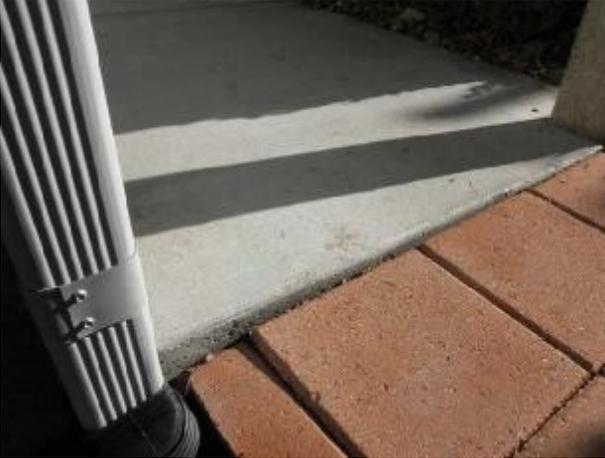
# GD

**Safety Hazard Note: There is a tripping hazard at the interface of the paver walkway and the front concrete patio at the SW corner of the home.**

Tripping hazard at the SW corner of the home.

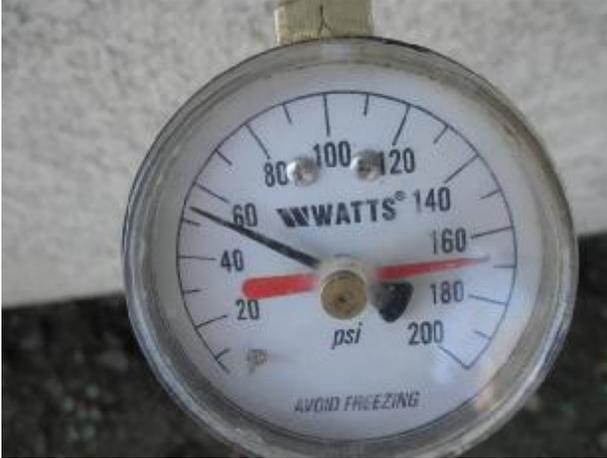
# P

Information Note: The water pressure was measured at 55 psi at the time of inspection. This is within a normal and acceptable range. Since the house is equipped with a pressure regulator it should be monitored and retested periodically to ensure that the pressure is below the maximum allowable 80 psi.

The water pressure was measured at 55 psi.

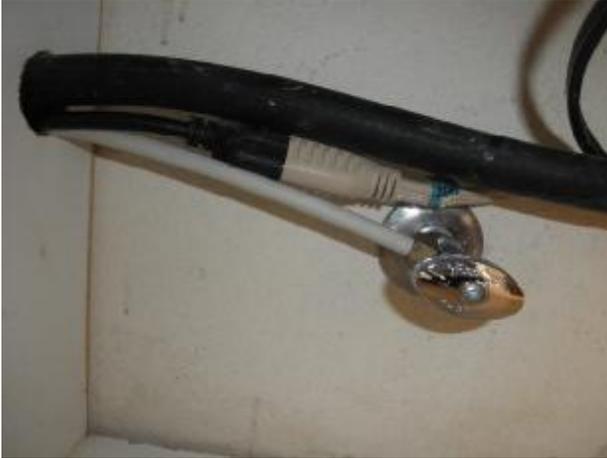
# EL

19 **Safety Hazard Note:** A temporary extension chord is used for power to the dishwasher. This is recommended to be replaced with permanent wiring.

Temporary cord used for the dishwasher.

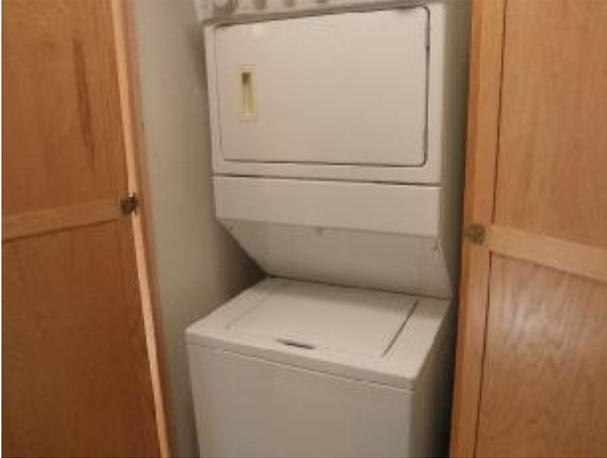
**# K**

**Information Note:** There is no access to the utility connections for the laundry facilities without removal of the machines. These connections were not inspected.

**The laundry units block access to the connections.**
