Key Findings Report

Property Address: 1807 Newport Hills Dr E
Newport Beach CA 92660

Date of inspection: 1/23/2026 **Inspector:** Reid Anderson

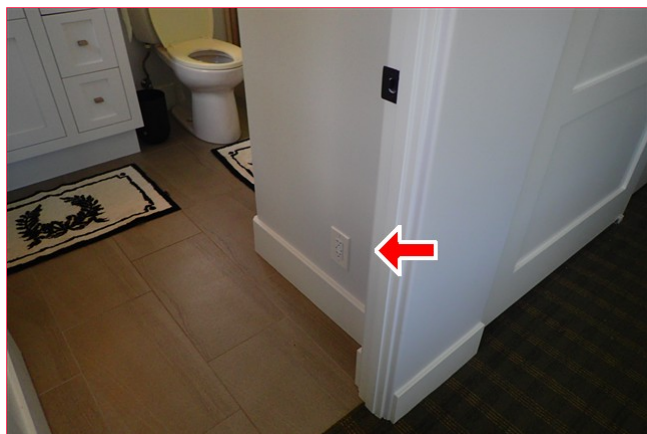
Item 1 - Item 1(Picture)

1. When tested, the GFCI tripped or was already tripped at some Bathroom receptacles near floor . However, despite attempts to do so, the device would not reset. This usually indicates that either the GFCI is defective or is on the same circuit as another GFCI that is tripped.- The seller may know the location of another GFCI on this circuit. If not, a qualified electrician should make repairs as needed. The seller/occupant should take immediate steps to connect any appliance to a functional power source, particularly freezers or refrigerators.

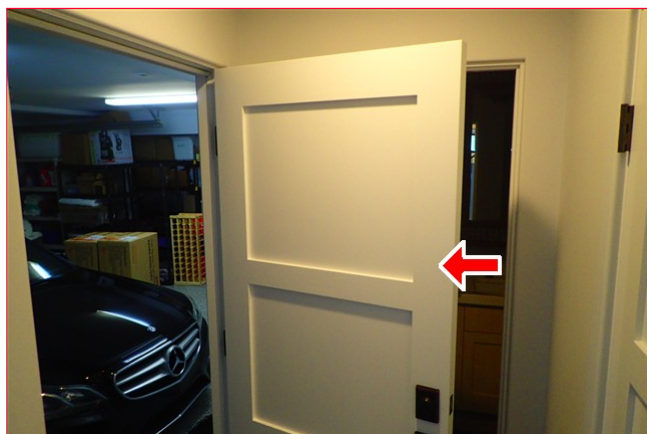
Item 2 - Item 1(Picture)

2. The original manufacturer's label on the fire door between the garage and the house was not visible. We cannot verify that this raised panel door is a fire-rated door.
 - We recommend the fire rating of this door be verified, or that the door be replaced with an approved fire-rated door.

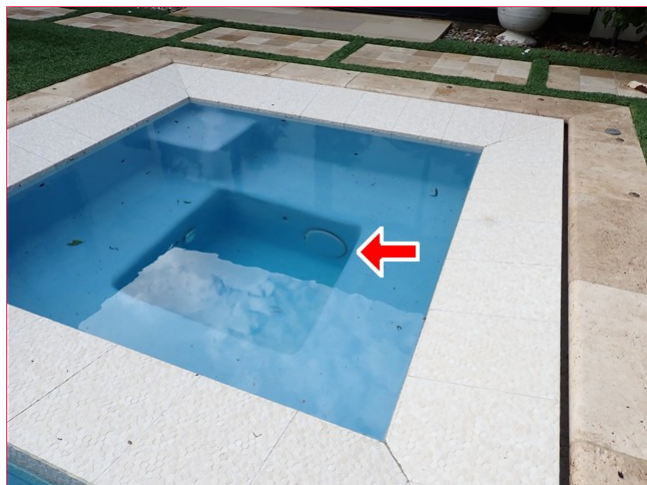
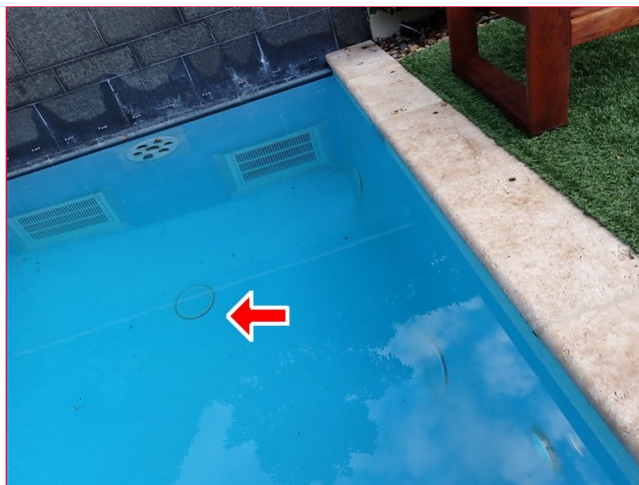
5. The existing drain covers were not verified to be the anti-entrapment style as now required since December 2008. Anti-entrapment drains help prevent drownings and bodily injury. - For these safety reasons, a qualified pool technician should install proper drain covers where needed that are compliant with the Virginia Graeme-Baker Pool and Spa Safety Act (ASME/ANSI A112.19.8-2007).

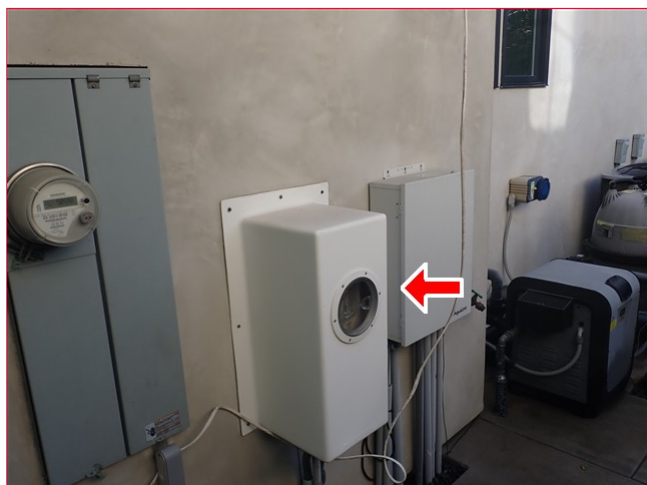
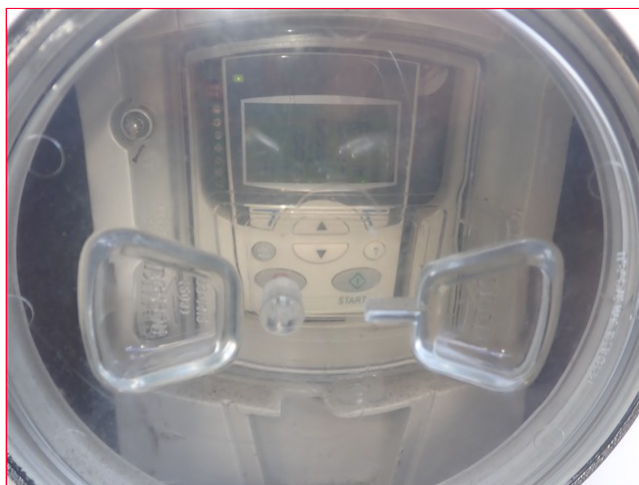
- 6. (1) The swim spa jets were not tested. - We recommend having the seller demonstrate the operation of the swim spa system.

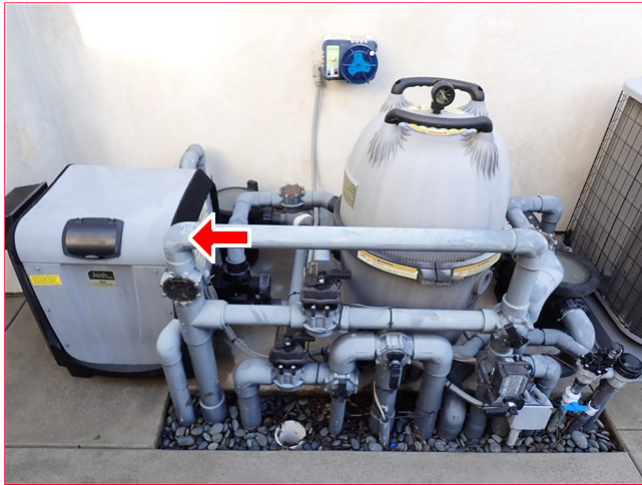
Item 7 - Item 1(Picture)

- 7. The pool/spa heater did not respond to normal user controls at the pool panel. The remote control inside the house may override the control panel.
- Ask the owner to demonstrate operation of the heater. If necessary, a qualified technician should evaluate the system to determine what corrective action may be necessary to restore proper function.

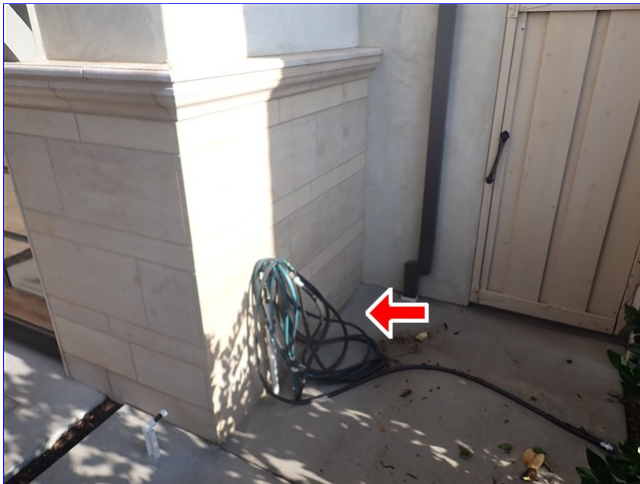
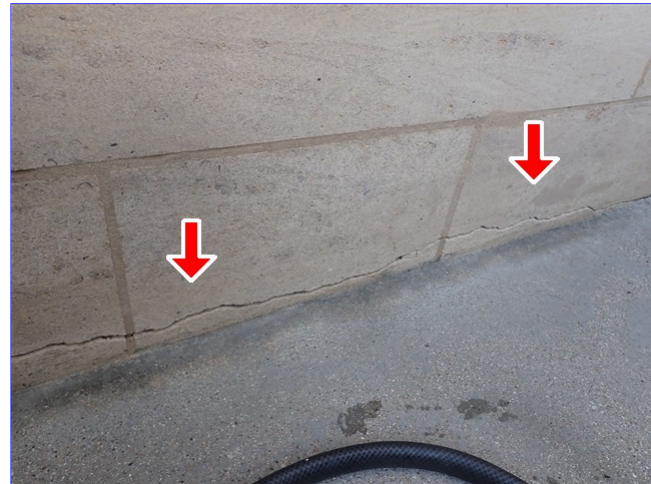
- 8. (1) Cracks are present at the right front of the building. - We recommend review by a qualified specialist to determine if repairs are needed.

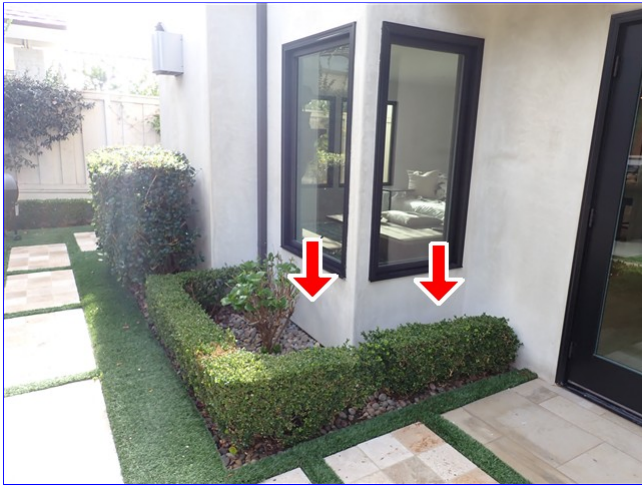
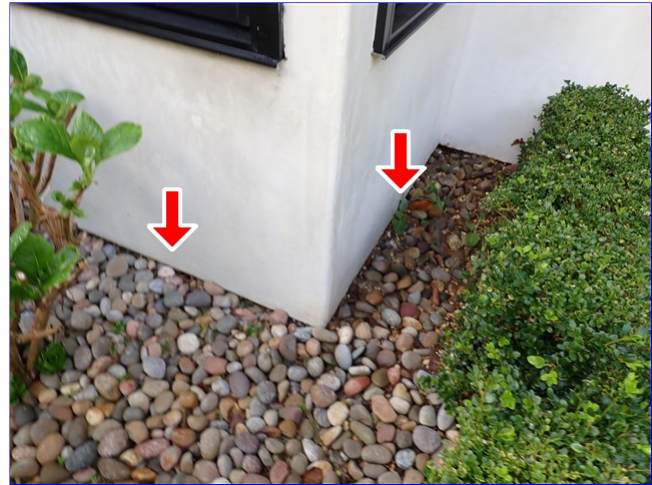
- 9. (2) Soil is at or above the weep screed at the right rear of the building. The weep screed is designed to allow the water absorbed by the stucco to drain at the base of the wall. When soil block the weep screed, this can promote water retention in the wall and potential damage.
- We recommend adequate clearances be provided in accordance with current standards. The stucco areas should be monitored for any moisture related conditions and repaired or modified by a qualified technician if problems are noted.

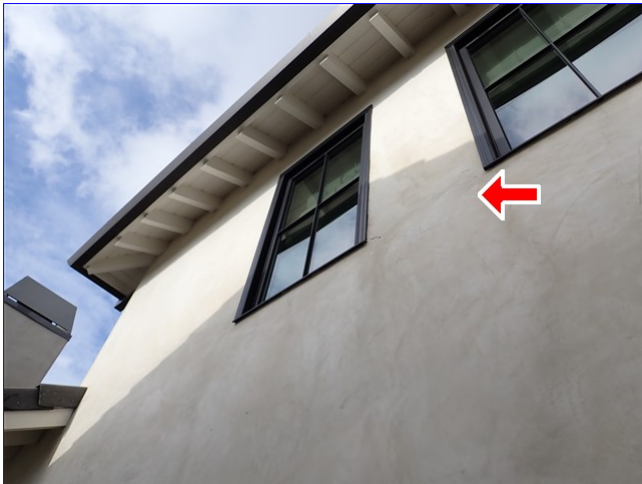
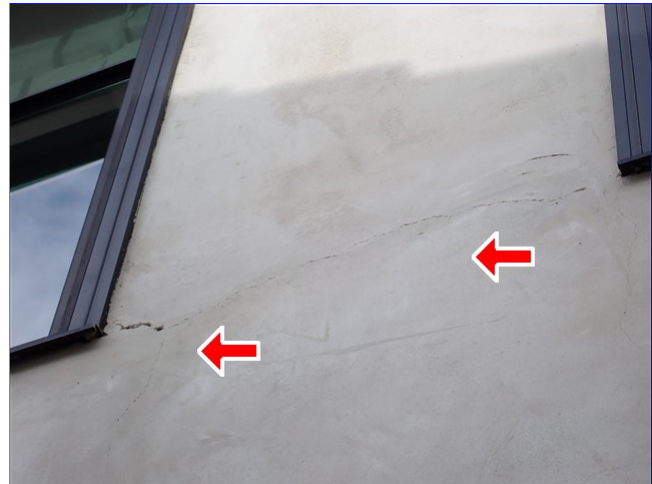
10. (3) Stucco cracks are present on the left side of the building. The most common cracks radiate out diagonally from the corner of doors and windows. - The cracked surfaces can be patched as part of normal maintenance. If the cracks re-open, we recommend examination and review by a qualified specialist.

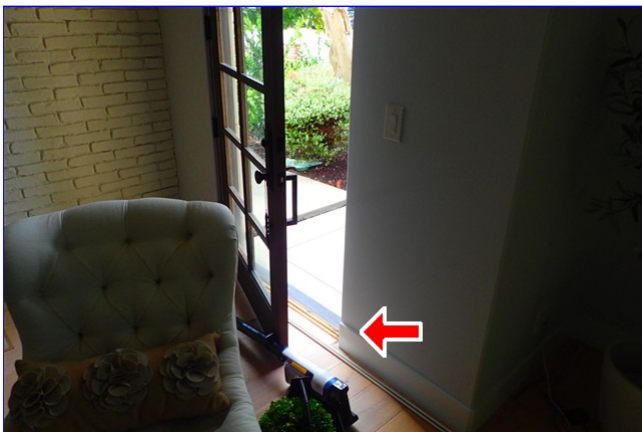
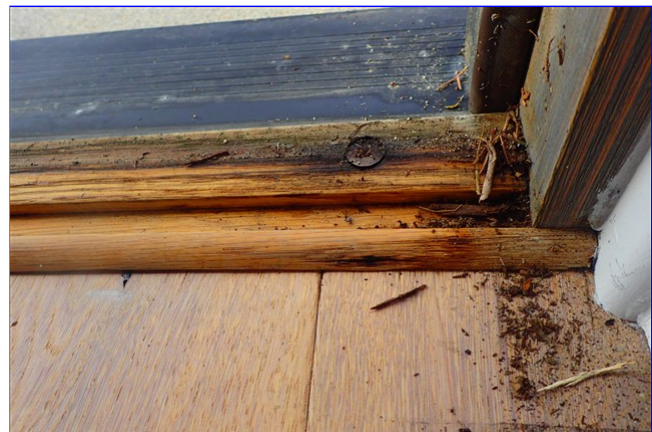
11. (1) A door at the rear patio has evidence of water intrusion. The wall was not wet when tested with a moisture meter. The threshold may not have a proper slope to shed water. Standing water can wick into the nearby materials. - A qualified specialist should eliminate the source of the water intrusion and make repairs as needed.

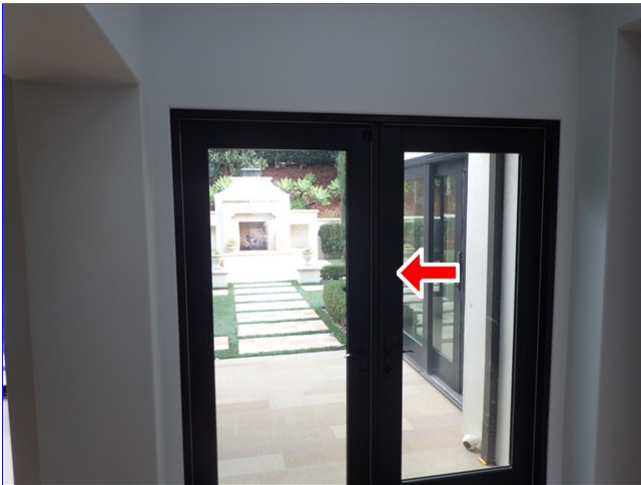
Item 12 - Item 1(Picture)

12. (2) An exterior door at the rear patio binds on the jamb or threshold. - Have a qualified technician adjust the door to restore proper operation.

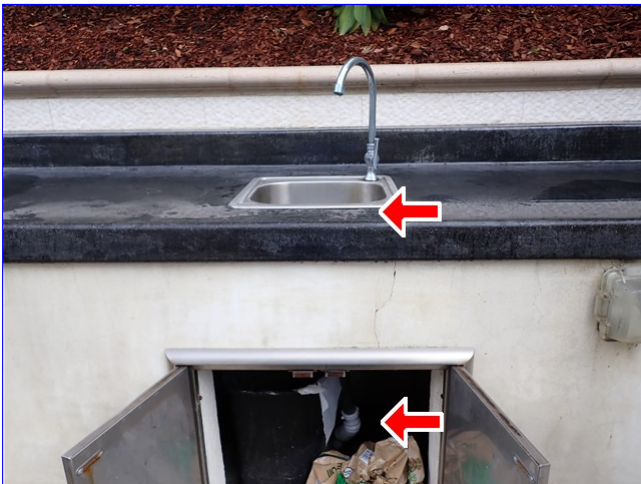
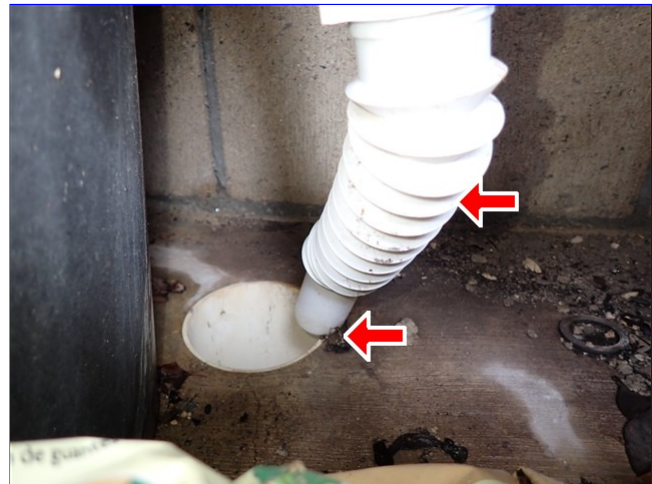
13. The exterior patio sink drain has no trap and does not appear to be connected to the house drain system. The sink likely drains to the street. Washing any harmful food bacteria or other products down this drain is not recommended. - This condition should be reviewed and repaired by a qualified plumber.

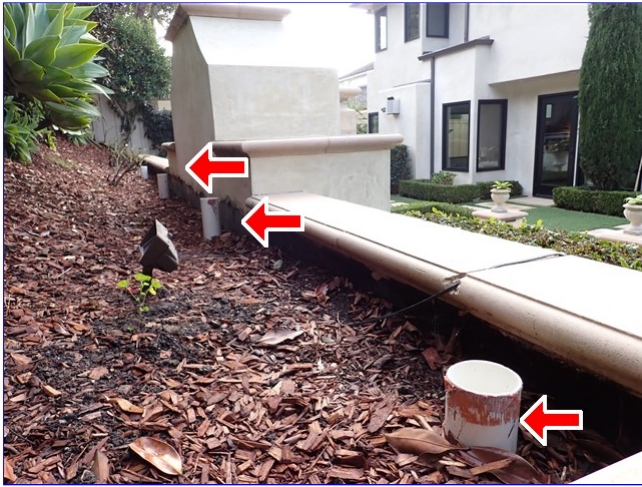
Item 15 - Item 1(Picture)

14. (1) All landscape drainage systems require ongoing maintenance to ensure proper function. Tree debris, roots and other materials can collect in drains or catch basins and clog the drainage system. - The drains should be checked and cleaned periodically.
(Testing the yard drains with water to verify the condition of the drains is beyond the scope of this inspection. We recommend asking the seller about the past performance of the drains.)
15. (2) One or more of the drain system inlets on the rear exterior of the building is above grade level. This will prevent the drainage system from functioning as intended. A qualified technician should make repairs or modifications as necessary.

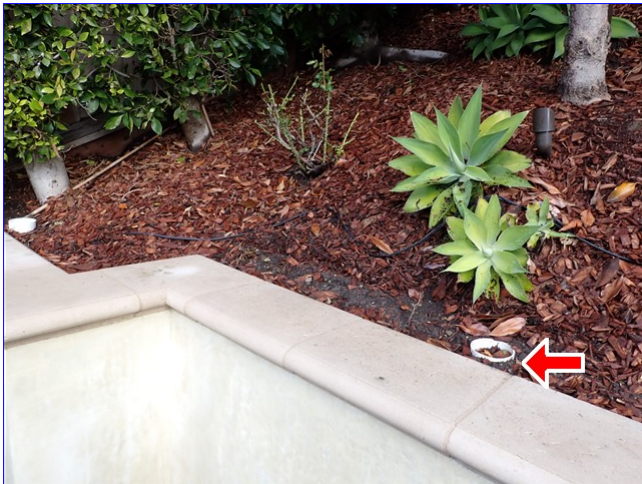
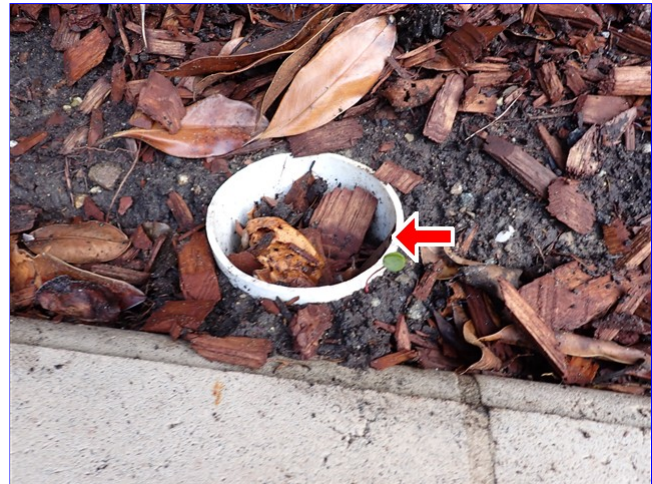
16. (3) One or more of the subsurface drains is clogged at the left rear, and may be ineffective in a heavy rain. - Debris should be cleaned from the drains by a qualified technician to ensure proper operation of the system.

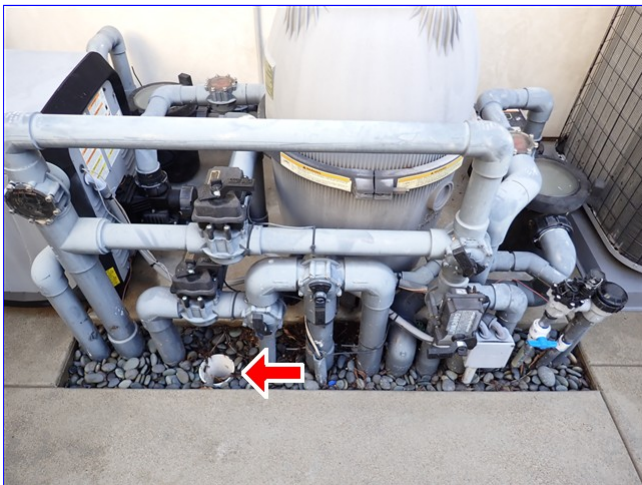
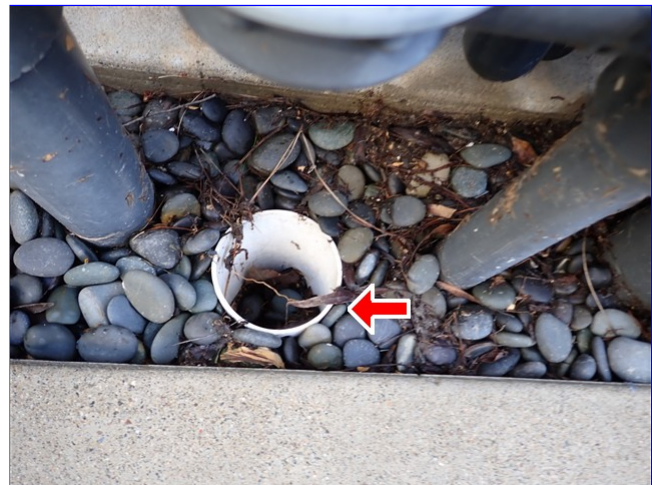
17. (4) One of the drainage system inlet screen covers on the left side exterior of the building is missing. This could allow debris to enter and create a blockage in the drainage system. We recommend installation of screened covers on all drain openings.

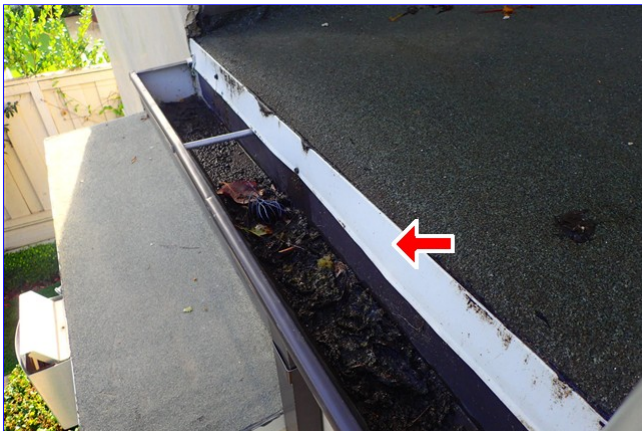
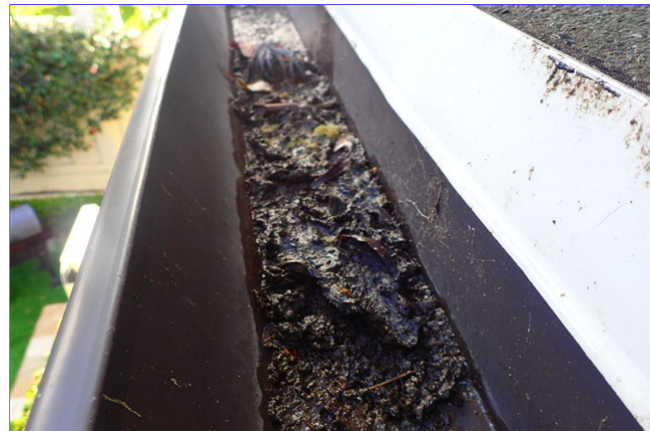
19. The gutters have accumulated debris. - We recommend the gutters be cleaned and evaluated by a qualified technician as part of normal maintenance.

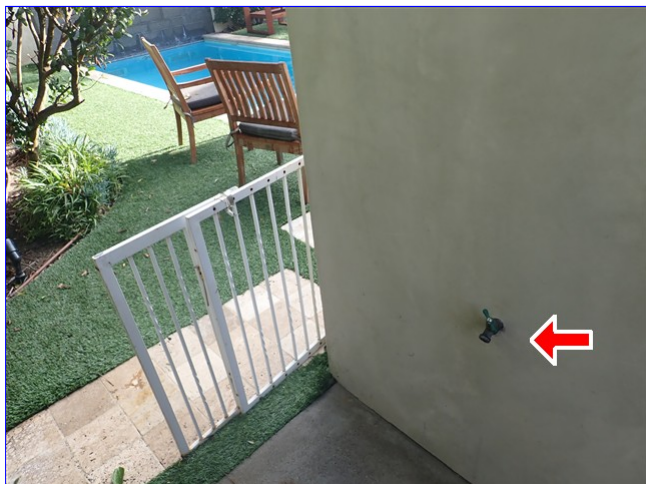
Item 21 - Item 1(Picture)

21. Backflow prevention devices are now required on exterior hose bibbs to prevent contamination of the domestic water supply. This is a one way valve that prevents water from being siphoned into the supply piping through a hose in a pool of water (in the event of negative pressure as would happen when working on the municipal water service.) - Upgrading the hose bibbs by installing backflow devices is especially important for house with pool/spa, ponds, and/or water features.

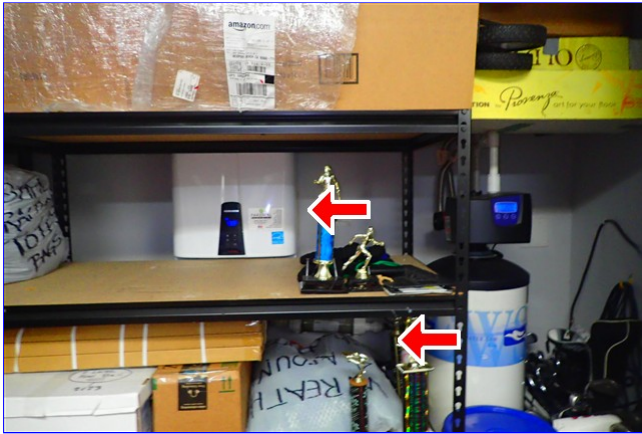
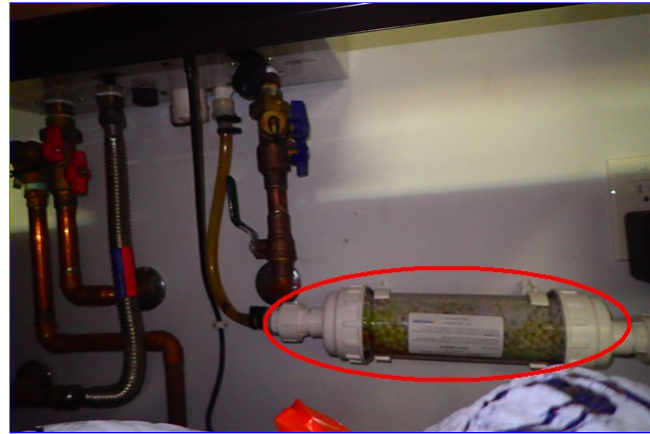
22. Maintenance Note: Tankless water heaters should be de-scaled on a regular basis to keep them operating at peak efficiency. White vinegar (or similar) should be recirculated through the water heater by a qualified technician to flush out the mineral deposits. - We recommend asking the seller when the water heater was last had a de-scaling treatment.

(A pre-filter has been installed before the water heater to reduce the frequency for de-scaling maintenance. The filter should be changed on a regular basis. Consult a qualified plumber for further information.)

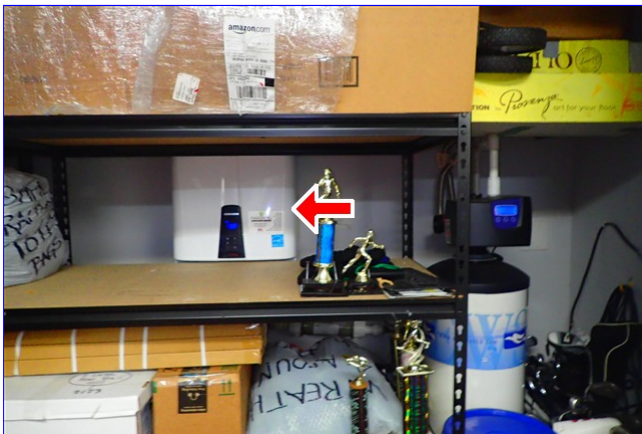
Item 23 - Item 1(Picture)

23. There is evidence that the water heater has been upgraded or replaced (the unit was manufactured in 2013). We recommend checking with the owner or the local building department regarding necessary permits and any warranty information that may be available.

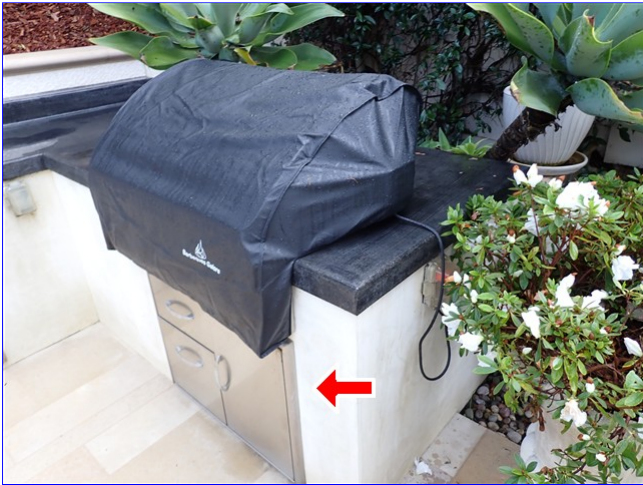
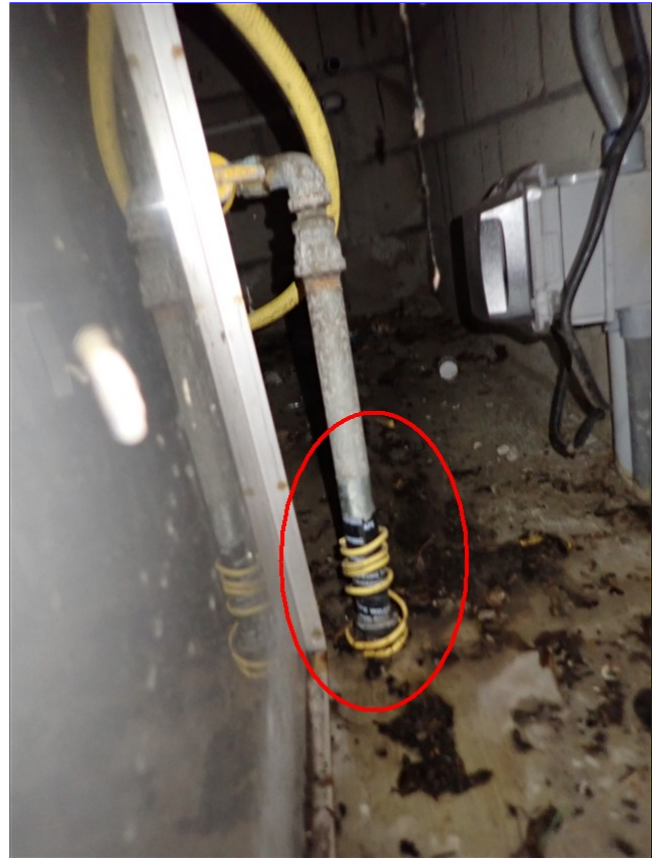
25. (1) The gas lines at the furnace and water heater were installed without a sediment trap. Gas valves installed on such appliances should be protected by a drip leg that is installed just before the appliance valve to capture any debris or moisture that might be in the gas line. - Consult a qualified gas plumbing contractor for further recommendations and repairs. (Home warranty companies may use the lack of such traps as a reason to deny repairs due to the gas appliances not being installed to "code".)
26. (2) The gas piping material for the built-in barbecue was not verified to be approved for underground installation by current standards. The installation may have been approved at the time of installation. The pipe is subject to corrosion and leakage if it is not the proper pipe.
- Consult a qualified plumbing contractor for evaluation of this condition and any required repairs.

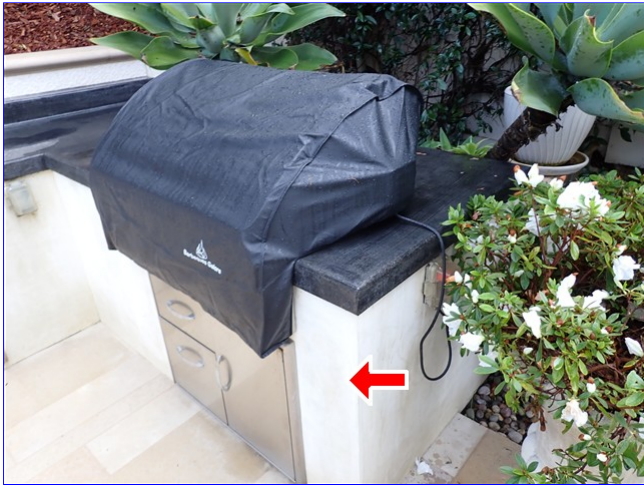
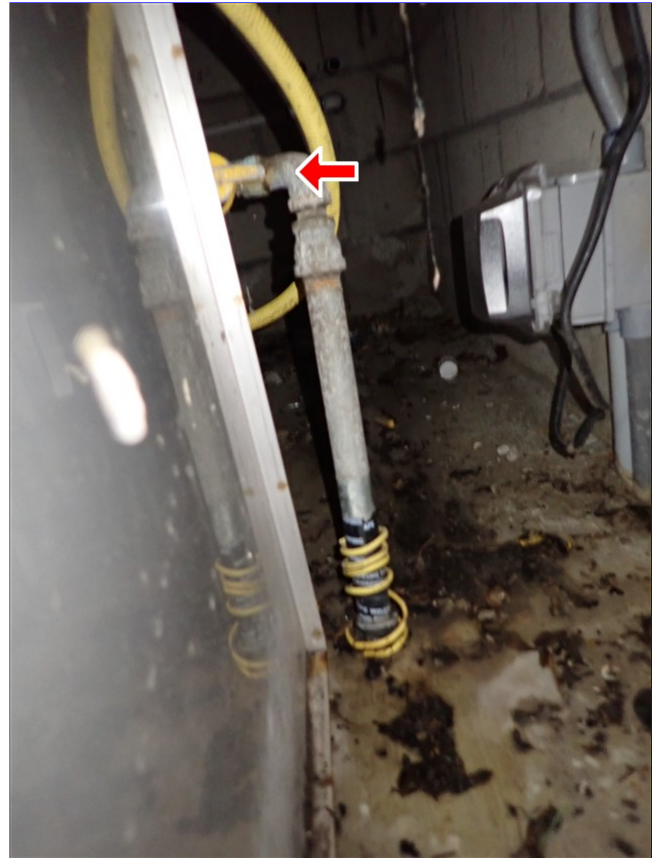
27. (3) A gas appliance has a shut off valve with poor access. All gas appliances should have a **readily accessible** shut valve within six feet of the appliance, for safety and for servicing the appliance. - A qualified, licensed plumbing contractor should make repairs or modifications as needed.

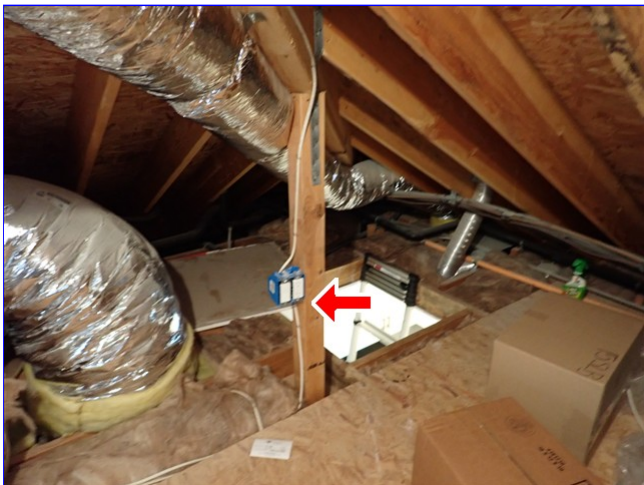
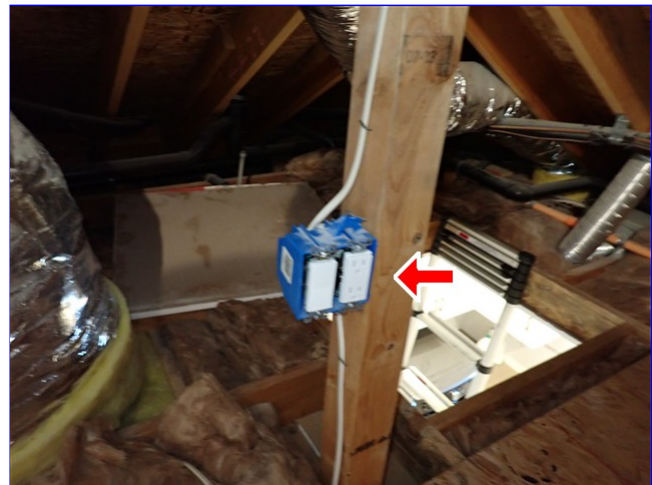
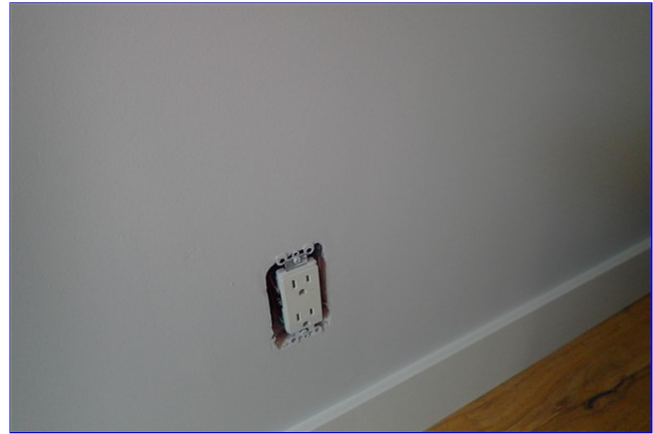
- 30. (1) One or more cover plates for receptacles and/or switches are missing and/or damaged in the building. This can be a shock hazard. All missing or damaged cover plates should be replaced with new cover plates.

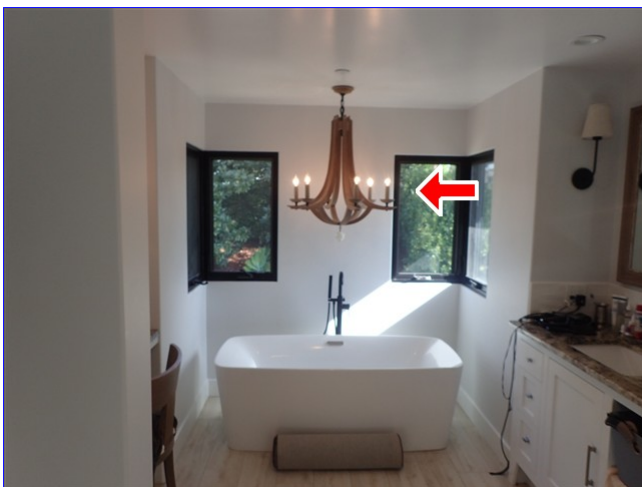
Item 31 - Item 1(Picture)

31. (2) The light fixture cover over the Master Bathroom bathtub and/or shower is not approved for damp locations. - The existing trim should be replaced with a cover rated for damp locations.

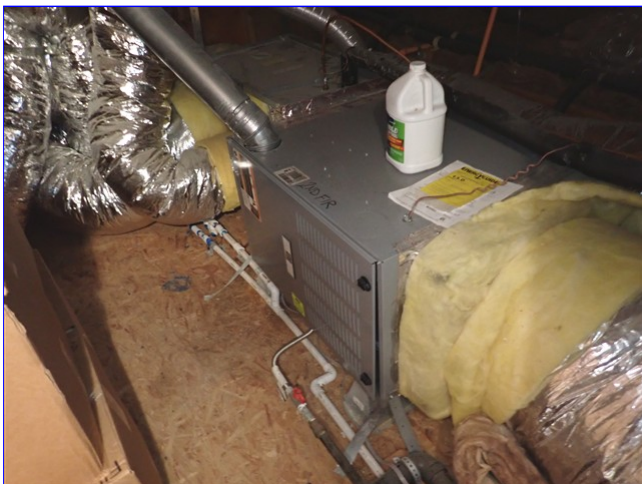
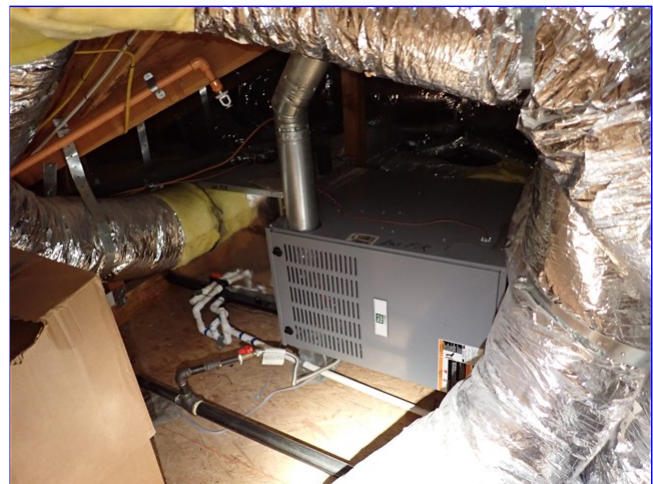
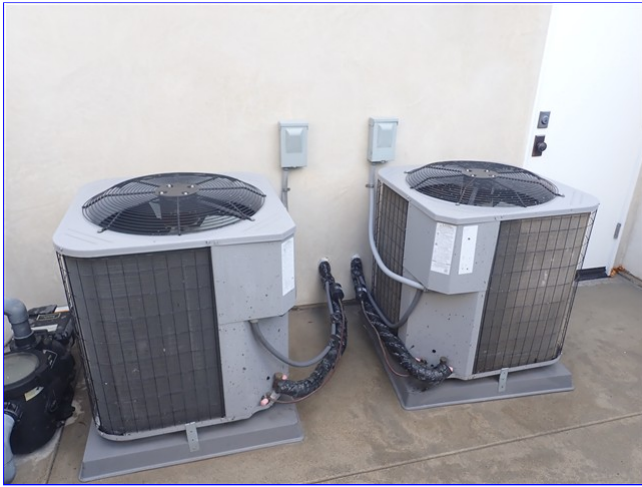
32. There is evidence that the heating and cooling system has been upgraded or replaced (the furnaces were built in 2013 and the condensing units were built in 2014). We recommend checking with the owner or the local building department regarding necessary permits and any warranty information that may be available.

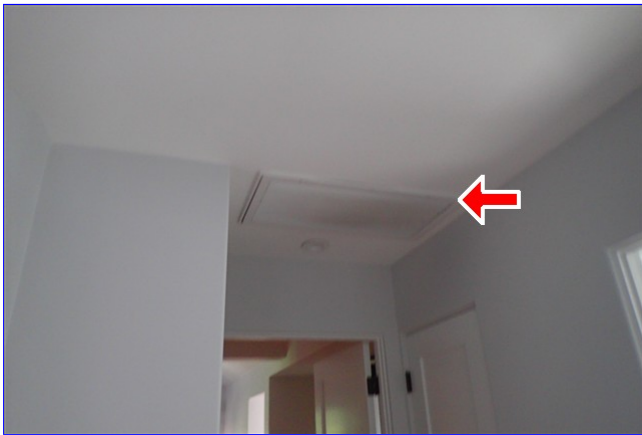
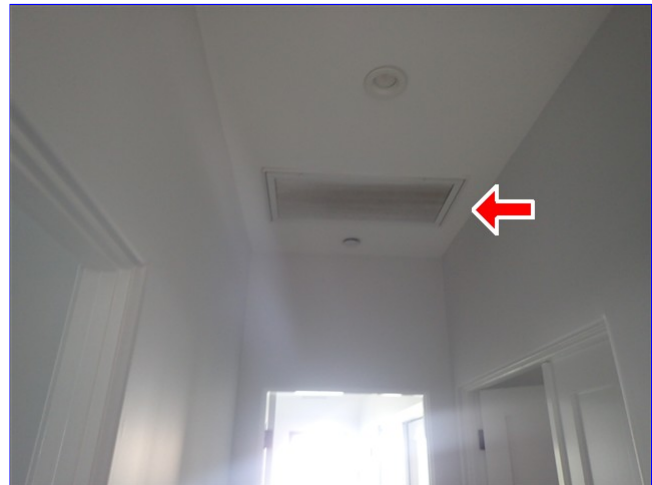
- 33. The filter(s) were dirty. This decreases the effectiveness of the filter and blocks airflow, making the blower work harder. - Replace (or clean washable) filters now, and at regular intervals thereafter.

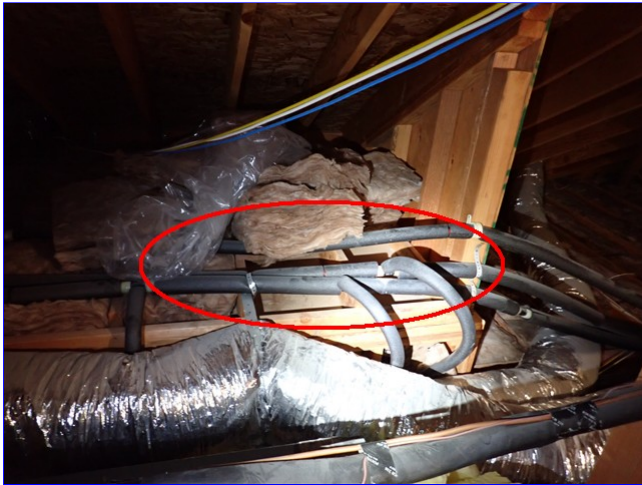
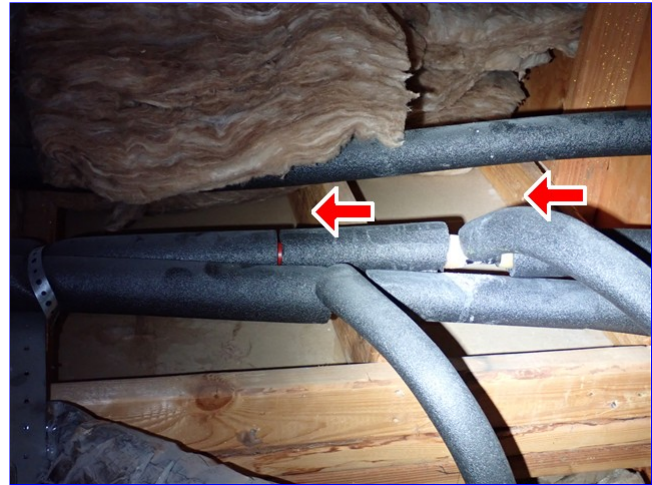
- 34. Some of the insulation in the attic is displaced or missing. Where insulation is missing, new insulation should be installed. Where insulation is out of place, it should be put back into place. A qualified technician should do the work.

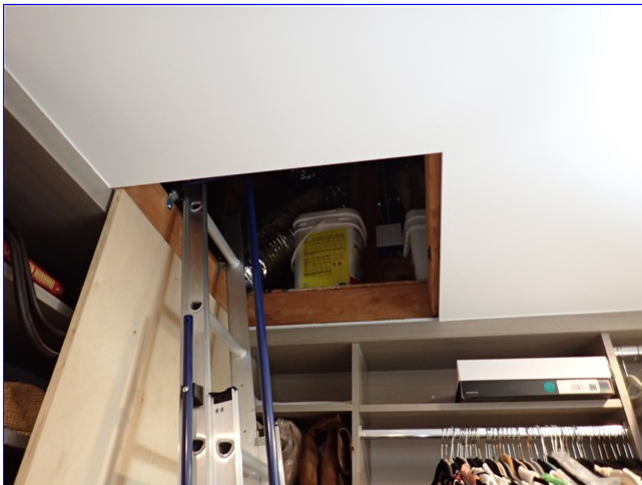
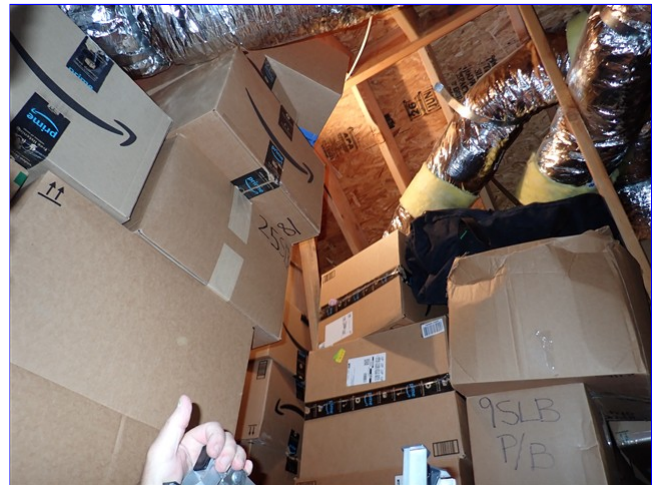
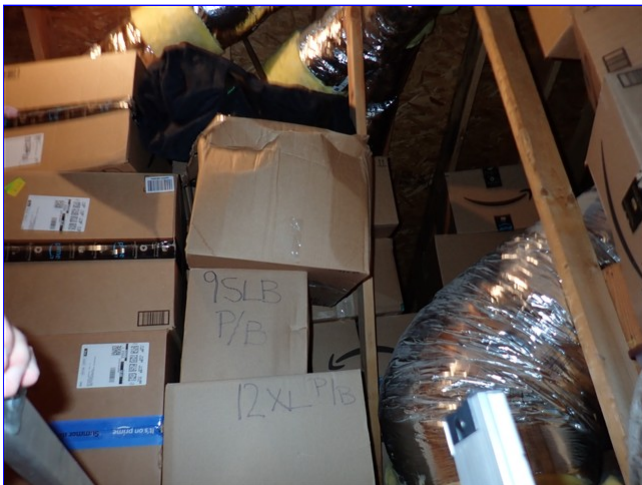
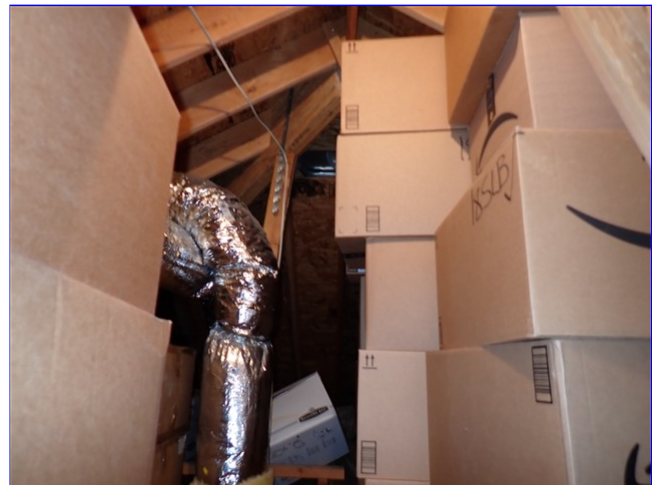
- 35. Stored items are present in the attic. This can compress the insulation and/or prevent a full inspection of the attic. - We recommend removing any stored items.

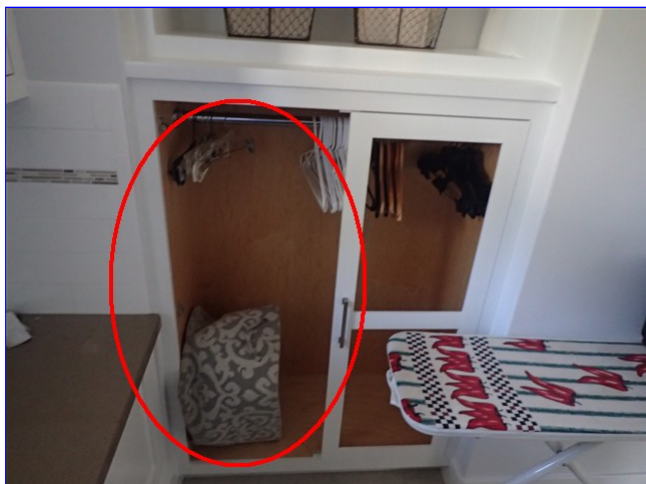
Item 40 - Item 1(Picture)

- 40. One or more closet doors have been removed. - All removed doors should be re-hung in their original locations as needed.

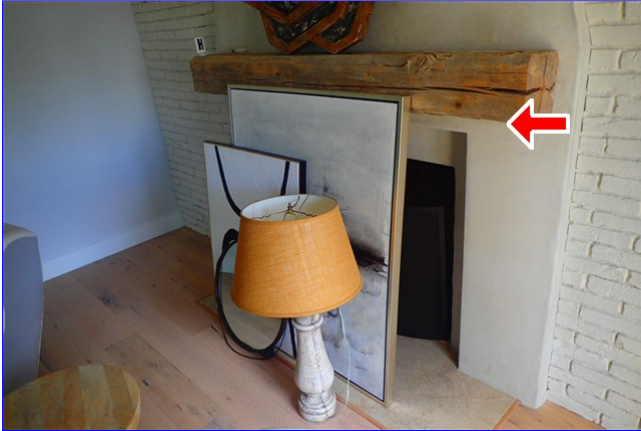
Item 41 - Item 1(Picture)

41. (1) The mantle is too close to a firebox opening and/or projects too far out by current standards. - No damage was noted at this time, however we recommend modifying the mantel for improved fire safety.

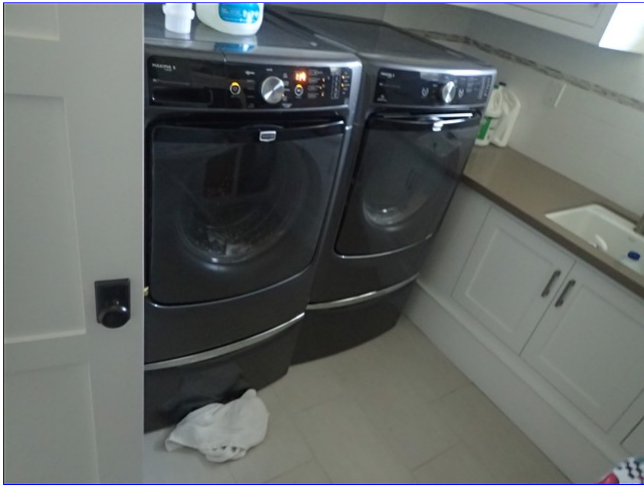
Item 43 - Item 1(Picture)

43. No floor drain is visible and no clothes washer overflow pan is present in the laundry. Because of the location of this laundry area over wood flooring or finished space on the floor below, a pan connected to a drain in good repair is advised. We recommend installation of a drained catch pan under the washing machine, as an upgrade and preventive measure.

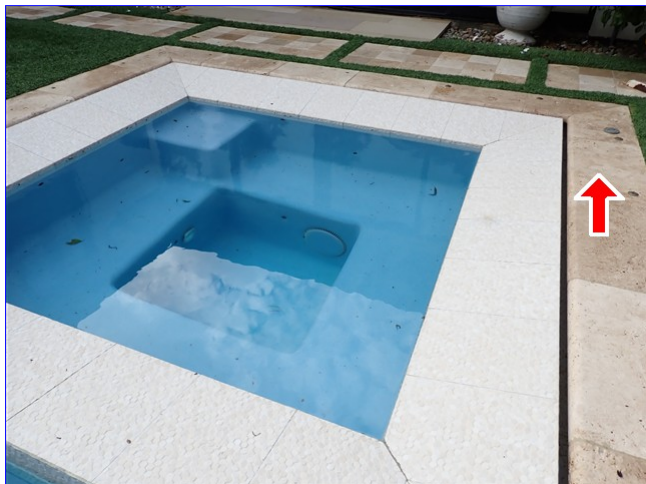
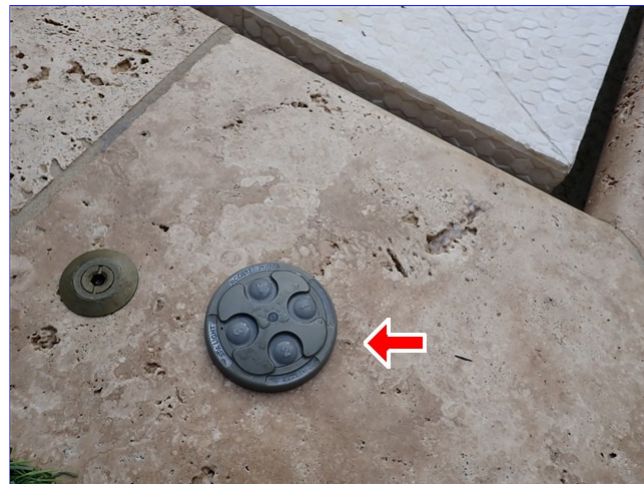
- 46. (2) The air switch at the edge of the spa was not operational during this inspection. The buttons had no response when tested. - The seller should demonstrate the operation of the switches or a qualified technician should evaluate the system and determine what repairs may be necessary.

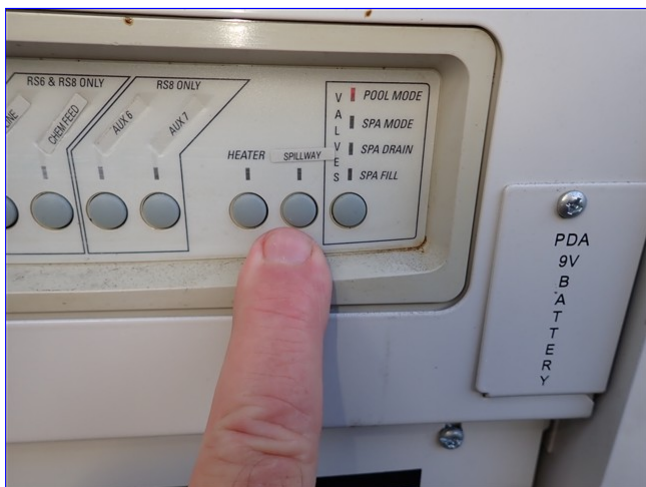
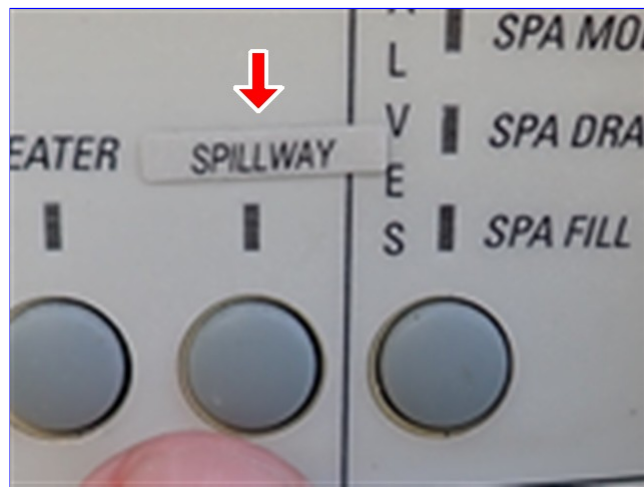
- 47. (3) The spillway was not tested. There was no response when tested at the pool panel. - We recommend having the seller demonstrate the operation of the spillway. If necessary, a qualified pool technician should evaluate the system and make any needed repairs.

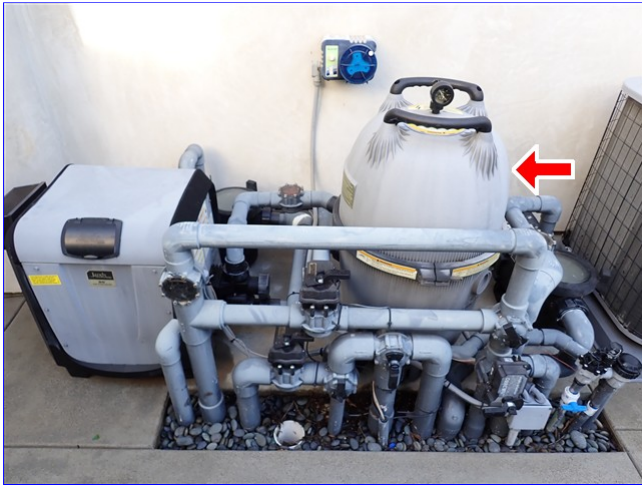
Item 48 - Item 1(Picture)

- 48. The diatomaceous earth filter should be backwashed on a regular basis. - We recommend asking the seller (or the pool service provider if applicable) when the filter was last backwashed. If it is unknown, the filter should be serviced by a qualified technician.
