### *Inspection Report*

Address: 710 Los Osos Valley Rd Los Osos, California

2/16/23

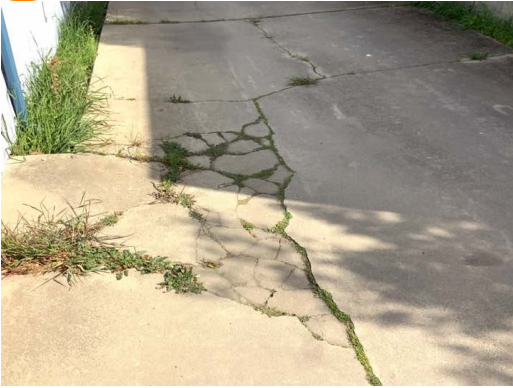
**FI 14:** Some typical, common and moderate cracks found in areas of the driveway.

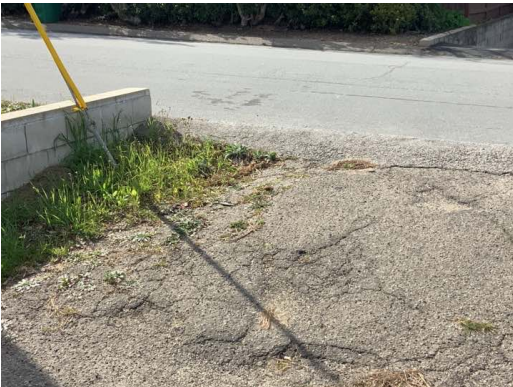
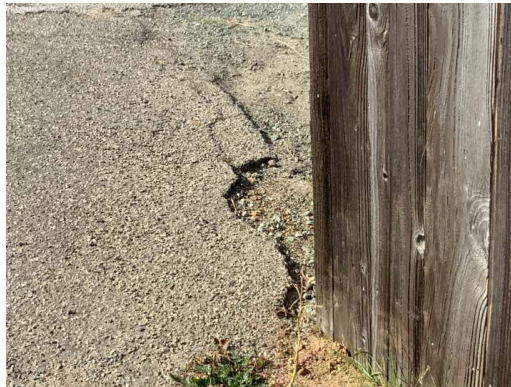
**MR FI 17:** Eroded or damaged asphalt found in some areas of the driveway. Maintenance or repairs are recommended.

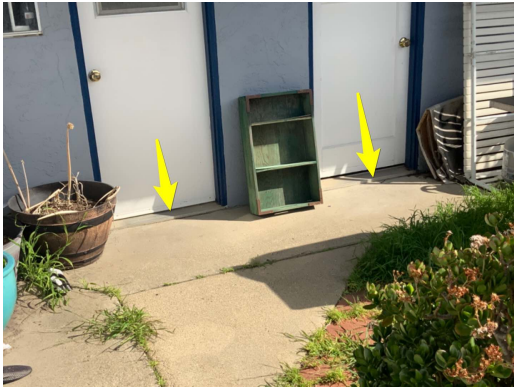
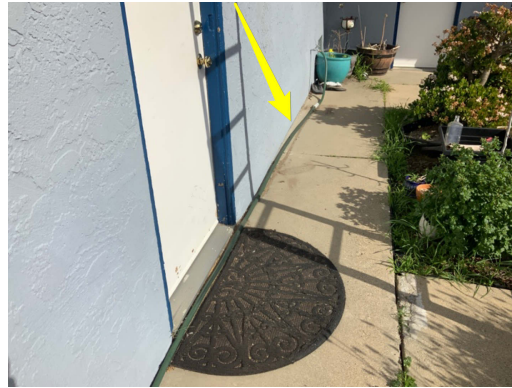
**FI DS 23: Disclosure:** Areas of the exterior walkways found to be installed high at or above exterior interior floor level, and some exterior door thresholds. This does not allow for moisture which can collect behind the exterior siding or trim to properly drain and can build up moisture inside the wall cavity. Refer to the Termite Report for additional comments and recommendations.

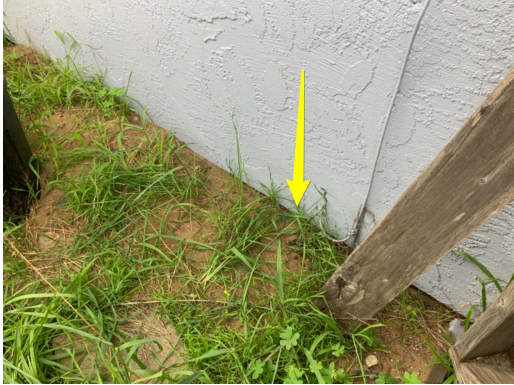
**E&C MR 30:** Soil level found high at areas of the foundation. (Recommend 4 inches from the bottom of the exterior stucco siding to dirt, rock, mulch or wood chips).

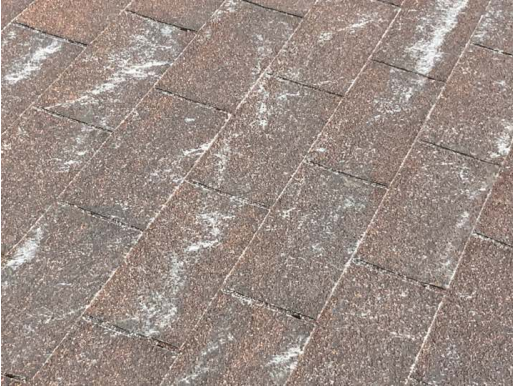
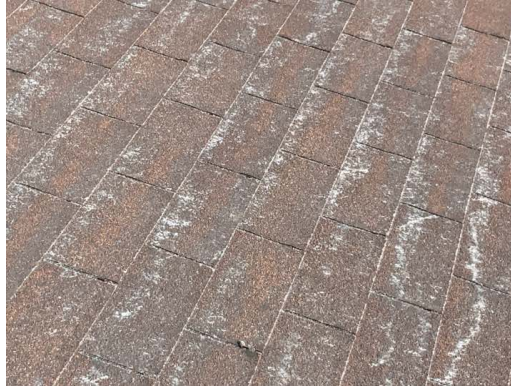
**E&C 38:** Areas of the Asphalt composition roofing appears to be at the end of its useful life. Recommend contacting a licensed roofing contractor for an estimate for replacement.

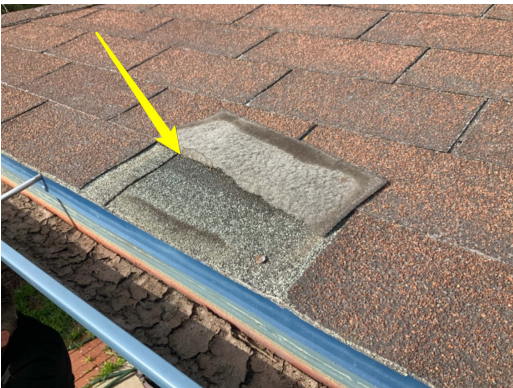
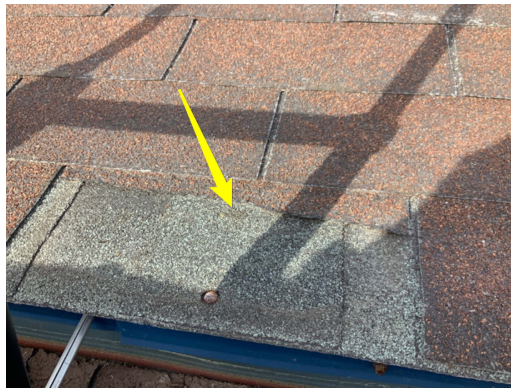
**E&C 39:** Some damaged and missing roof shingles noted at areas of the roof. Corrections are needed. Contact a qualified roofer to evaluate the roof and make the appropriate recommendations and repairs as needed.

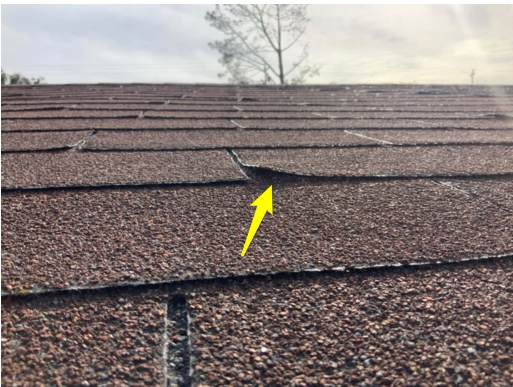
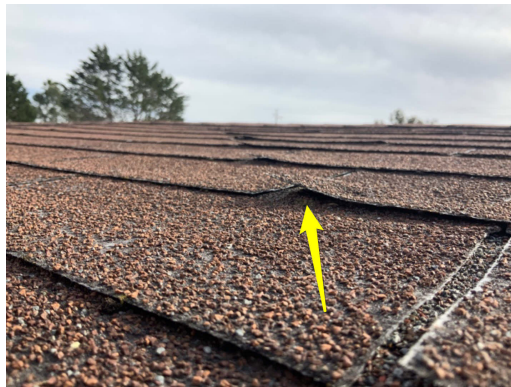
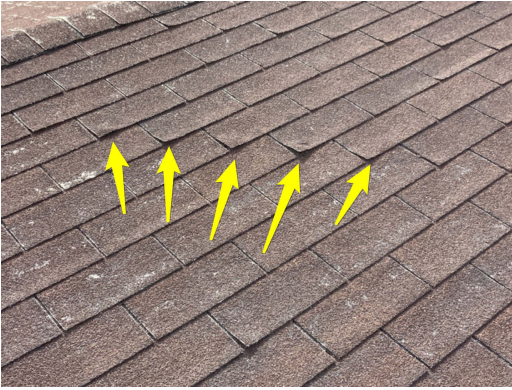
**MR FI 40:** Some loose and lifting roof shingles found at areas of the asphalt composition roof. Maintenance and/or repairs Recommended.

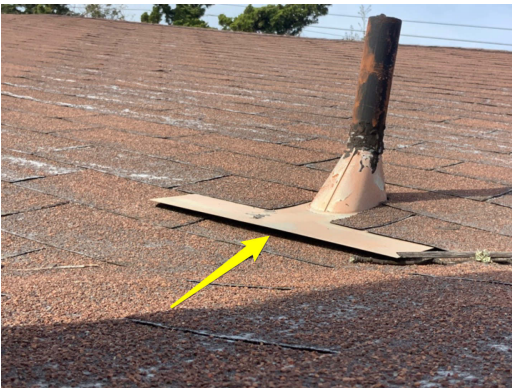
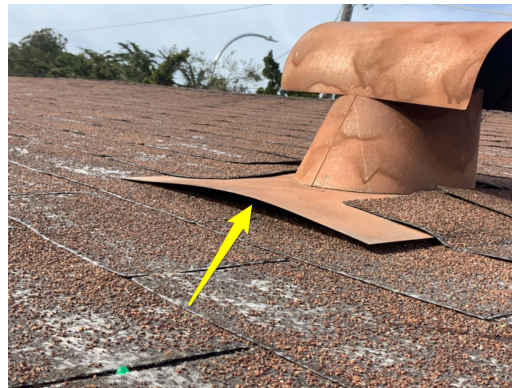
**E&C MR 43:** Some Loose / Lifting roof flashings. Corrections, maintenance or repairs are recommended to help prevent water intrusion and/or roof leakage from windy wet weather.

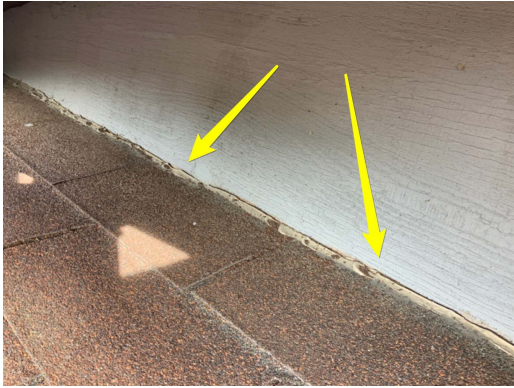
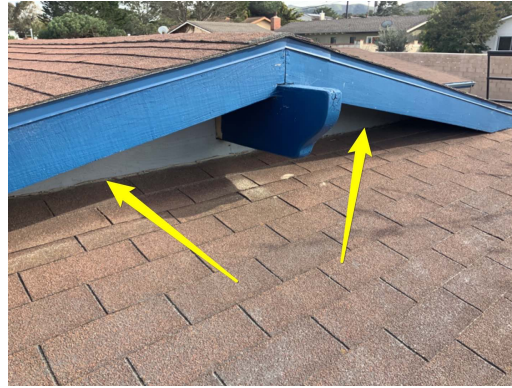
**44:** No visible head wall flashings under the California hips.

No exposed metal flashing

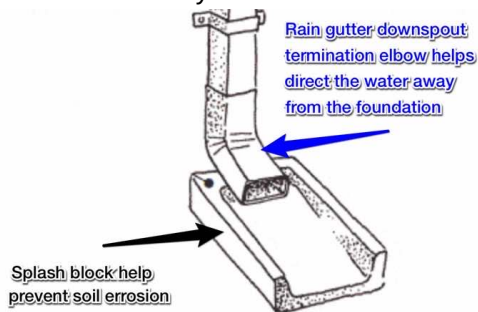
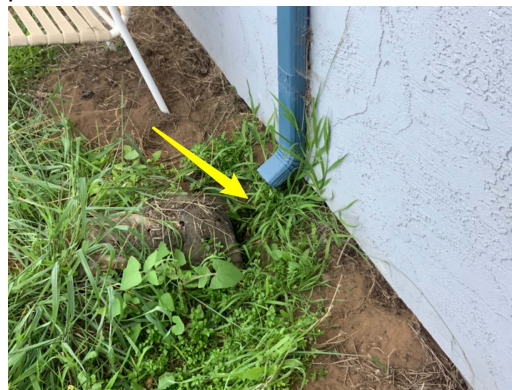
**MR 45:** Recommend splash blocks and diverting the rain gutter downspouts at the bottom to assist in proper flow of roof water away from the house and to help prevent soil erosion where not installed.

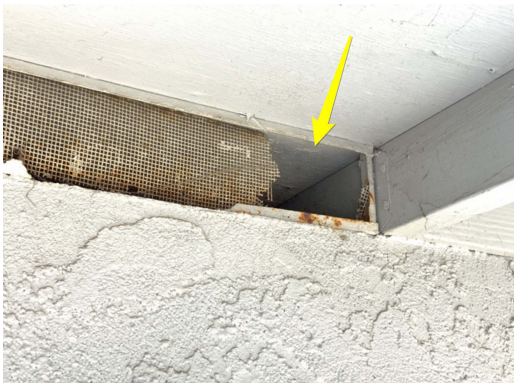
**E&C** **MR** 51: Some damaged attic eave vent screens found on areas of the exterior at the roof overhangs. Repair or replacement recommended to help prevent critter intrusion into attic areas.

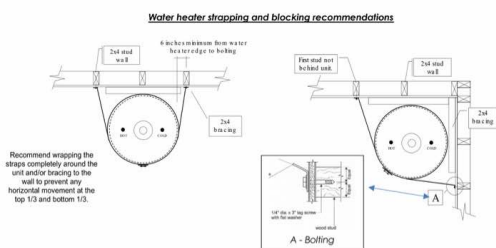
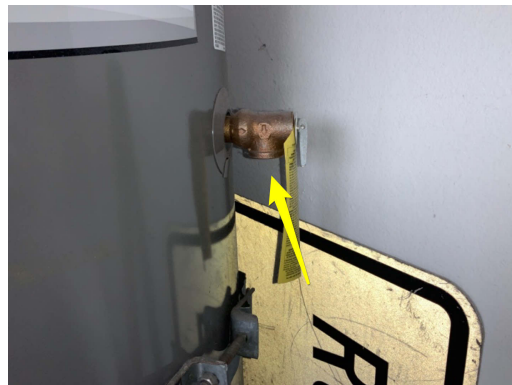
**E&C 66: Water heater is improperly and loosely strapped & not secured well - moves when pushed.**

Recommend adding the proper **STRAPPING and/or BRACING OR BLOCKING** to the wall to properly secure the tank per Uniform Plumbing Code and State Architect Requirements. Recommended further review and repairs by a certified or licensed professional familiar with the minimum installation requirements.

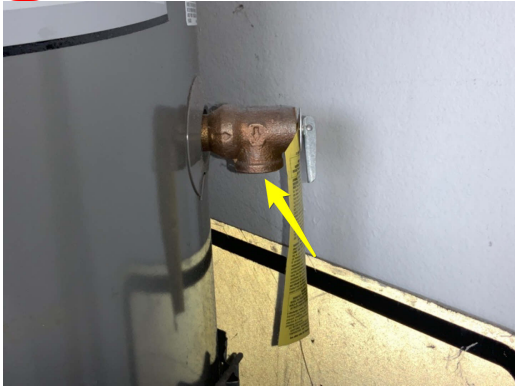
**SC 67:** Water heater TPR (temperature pressure relief) pipe is missing / not installed.

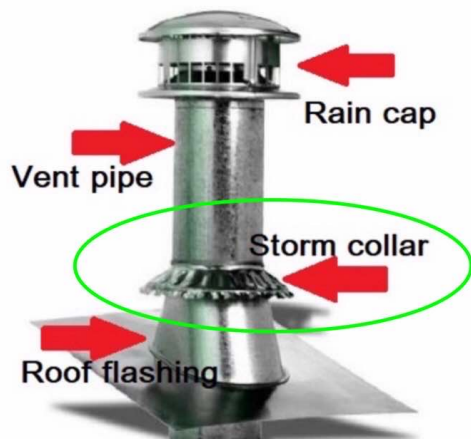
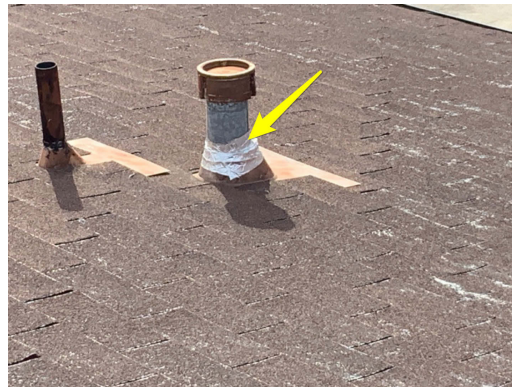
**E&C 68:** Missing / Recommend a proper storm collar per standards at the water heater vent pipe at the roof termination.

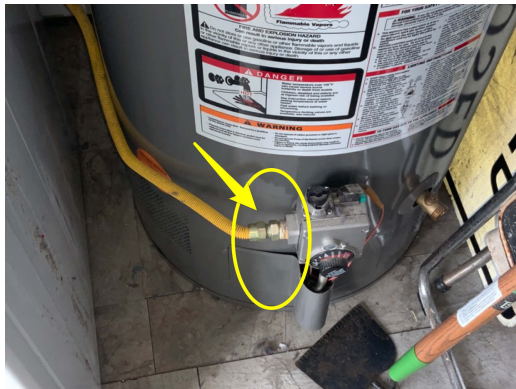
**E&C 70:** Recommend the installation of the missing sediment trap / drip leg at the WATER HEATER gas piping at flex connection by a certified or licensed plumbing professional familiar with minimum requirements.

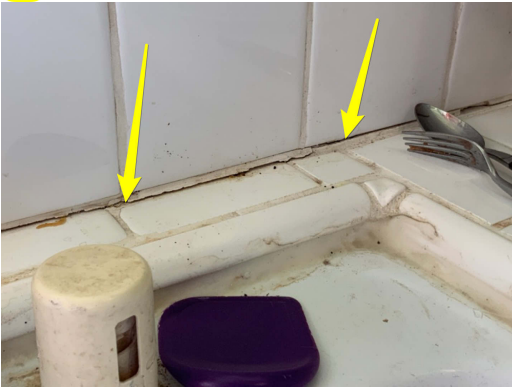
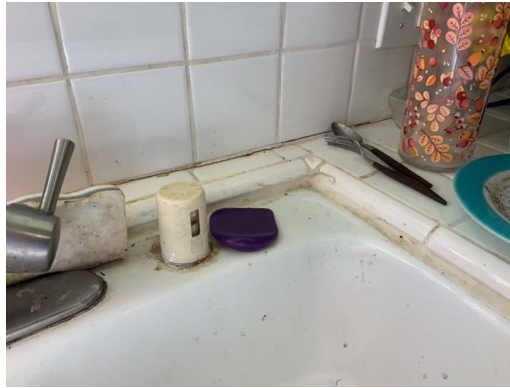
**MR 76:** Recommend sealing the kitchen sink at counter connection and /or the counter top to backsplash.

This can allow water to flow into the cabinetry below

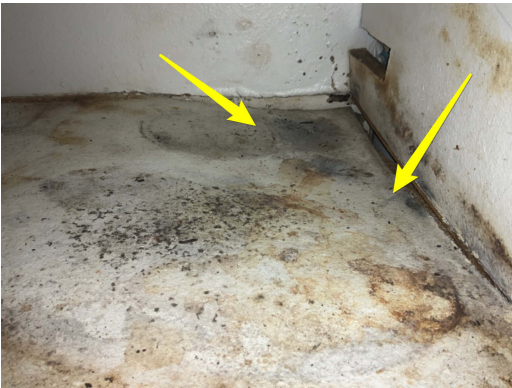
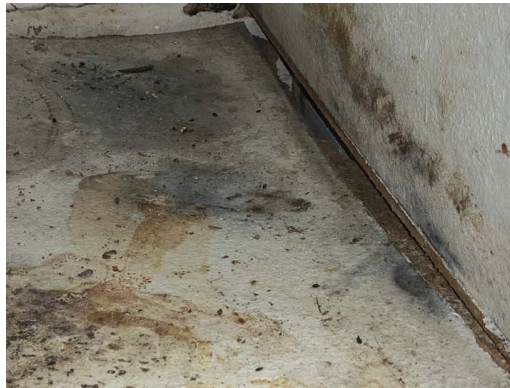
**SC FI 77:** Moisture stains and damage in the cabinet below the kitchen sink. Some visible mold growth noted on areas of the drywall and/or cabinetry. Recommend additional review by a qualified remediation professional.

Heavy water damage

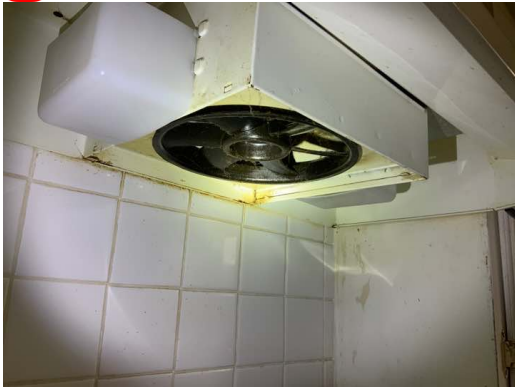
**E&C 86:** Kitchen cook top exhaust hood FAN found non-operational or not operating properly.

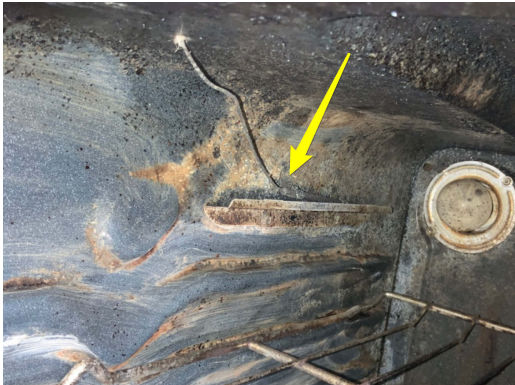
**MR 89:** The thermostat in the oven found loose and not properly sitting in its hanger which can negatively affect the temperature settings in the oven. Maintenance or repair recommended.

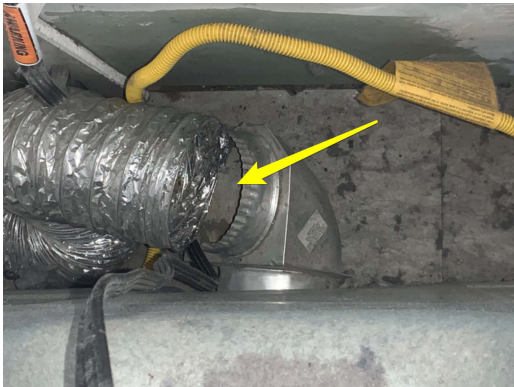
**E&C** **97:** The laundry dryer vent pipe found disconnected at the dryer connection inside the laundry room. Correction needed for safety.

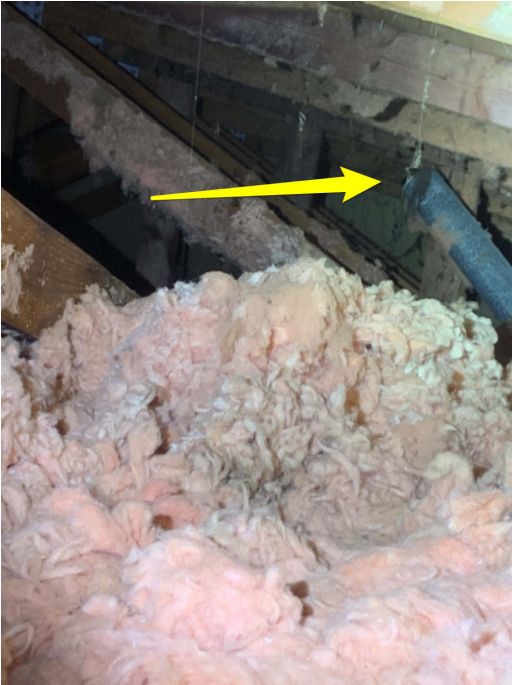
**E&C 107:** The HALLWAY BATHROOM and PRIMARY BEDROOM BATHROOM exhaust fan vent pipe found improperly terminating in the attic. Proper termination to the exterior is recommend per standards.

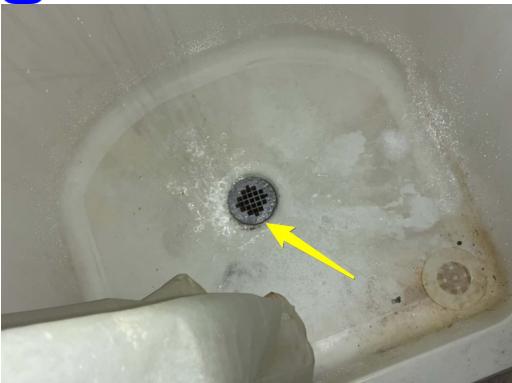
**SU 110:** The drain cover found loose in the primary bedroom bathroom shower

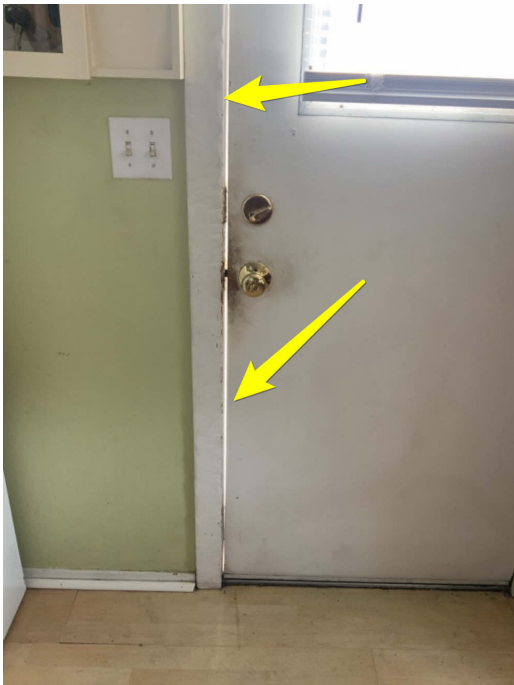
**MR 116:** Visible daylight noted around some of the exterior doors. Adjustment and/or repair of the weather stripping is recommended to help prevent water and critter intrusion.

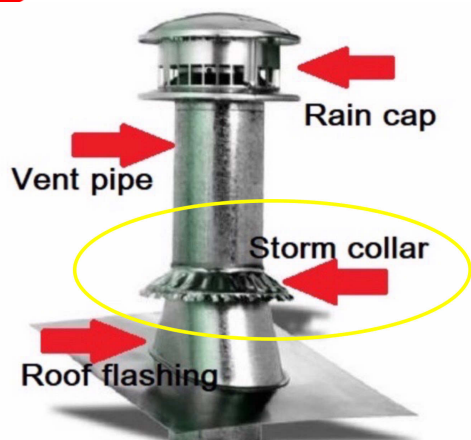
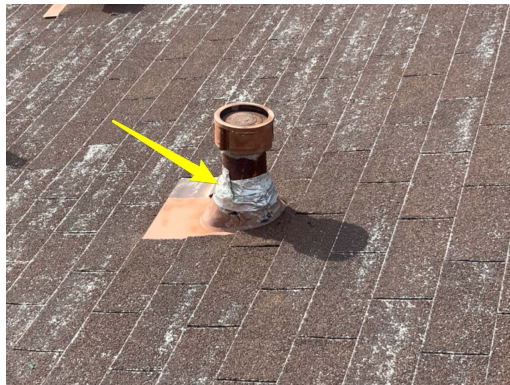
**E&C 136:** Missing / Recommend a proper storm collar per standard at the furnace vent pipe at the roof termination.

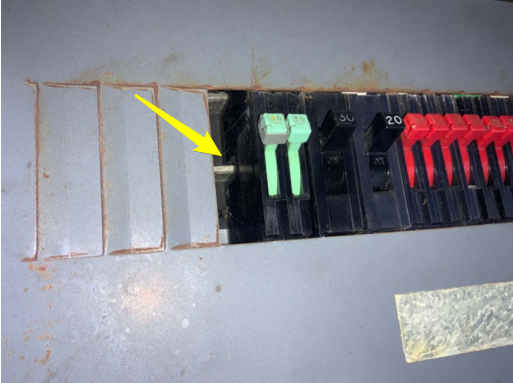
**SC 141:** Improper and unsafe openings in the dead front cover inside the MAIN ELECTRICAL PANEL. Openings are needing to be plugged or sealed for safety per standards.

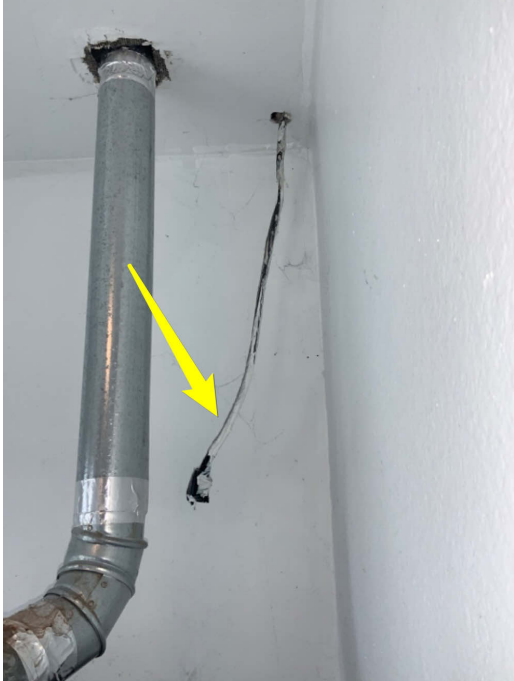
In the laundry room above the water heater

**SC 146:** Improper electrical wiring. Exposed electrical splices / wires not protected in a box with a cover in the laundry room above the water heater.

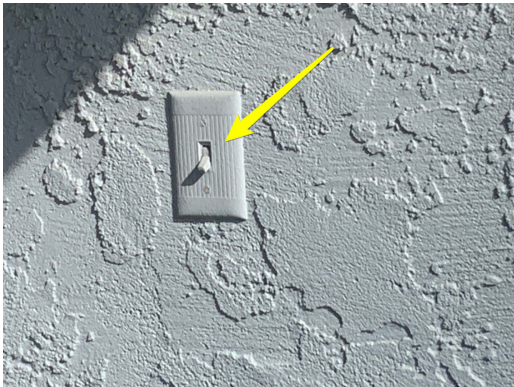
**SC 147:** Exterior electrical LIGHT SWITCH found without a proper weather tight box or cover for the exterior light on the FRONT OF THE GARAGE.

Switch needs a proper weather tight cover

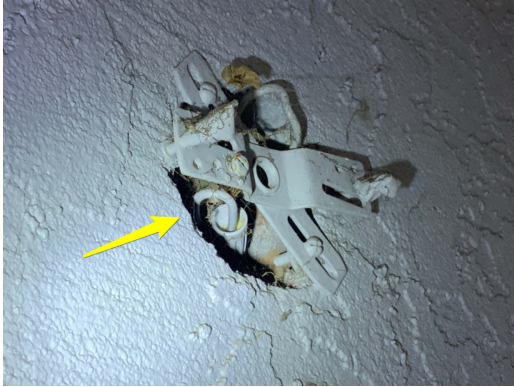
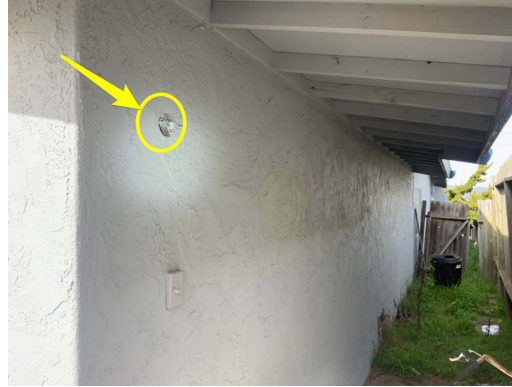
**SC 148:** Light fixture is missing, exposed wiring: AT THE GARAGE EXTERIOR LIGHT ON THE SOUTHEAST CORNER ON THE SIDE OF THE GARAGE.
