# Home Inspection Report

Prepared for: Walter Gularte

715 Shannon Hill dr.  
Paso Robles, CA 93446

Inspected by:  
Tom Myers  
Myers Home Inspection LLC  
805-470-9191

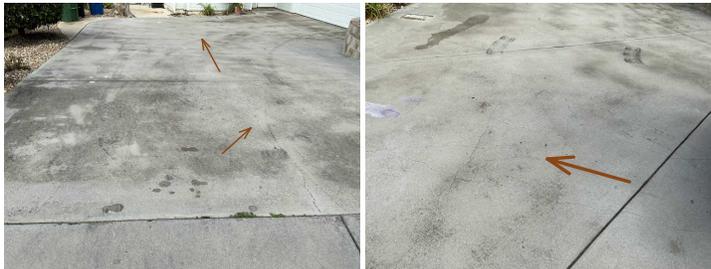
Driveway: Concrete - **Recommend monitoring.**

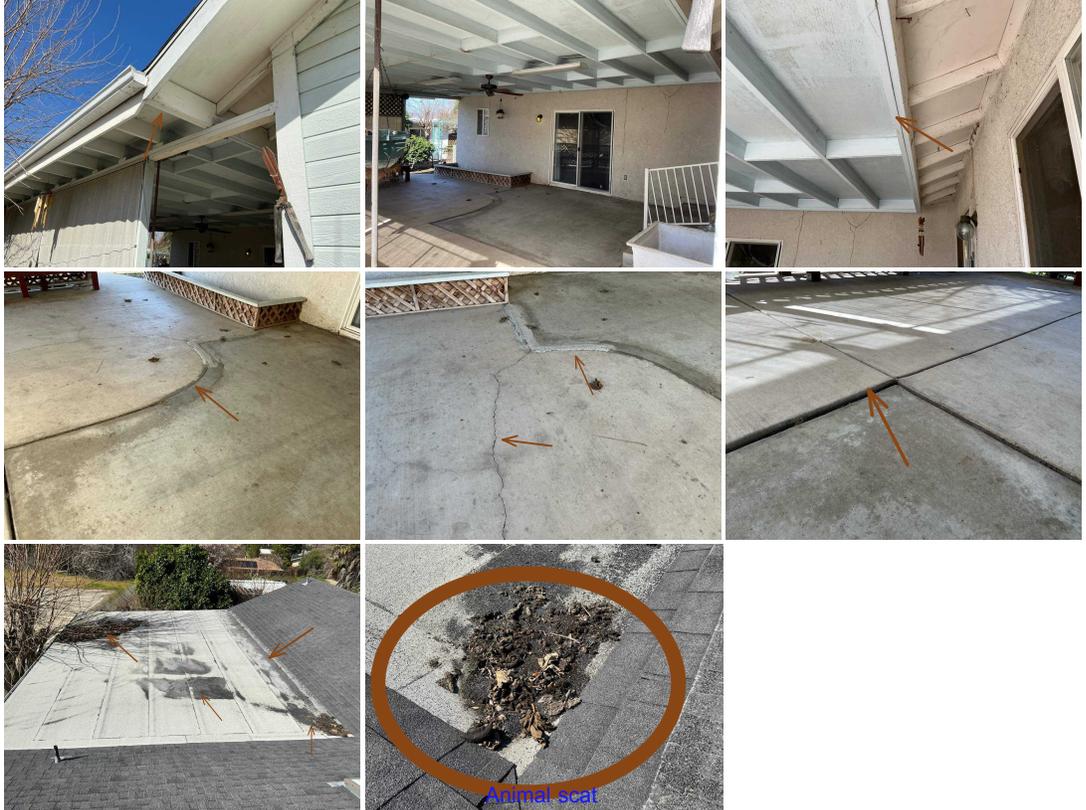
, Evidence of poor drainage, Heavily cracked and unevenly settled causing trip hazard. Pergola attached to house fascia . , A qualified contractor is recommended to evaluate and estimate repairs. Animal excrement on roof

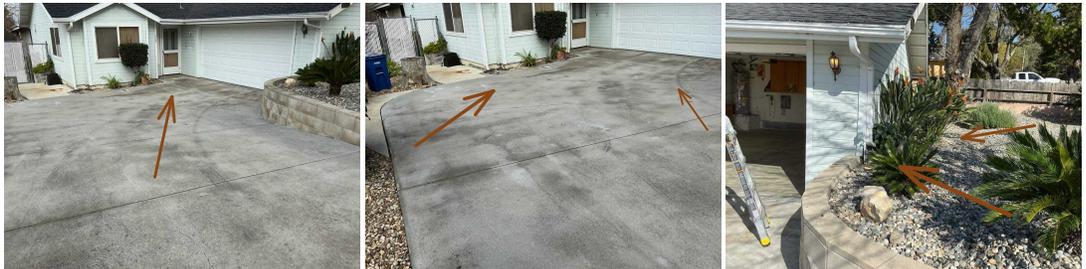
Grading: Negative slope, Moderate slope - **MAINTENANCE:**, Landscape grading should be sloped away from Garage, house and foundation. Recommend a licensed landscaper to correct grading issues. Hidden moisture damage may be present., Driveway Grading has negative slope and water is pooling and running against the foundation. Water can cause foundation settling and erosion problems.. drainage needed at garage.

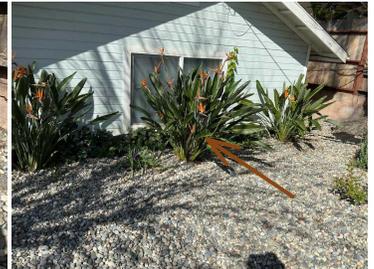
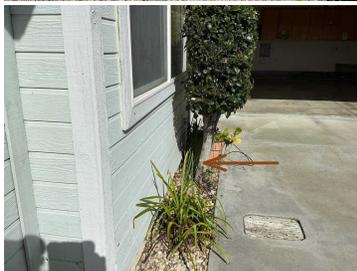
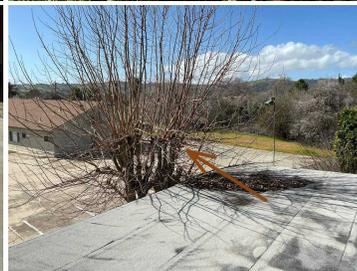
10. Maintenance required Vegetation: Trees and shrubs - MAINTENANCE: Planting should be maintained away from exterior of structure. , Tree limbs over hang the roof and should be cut back

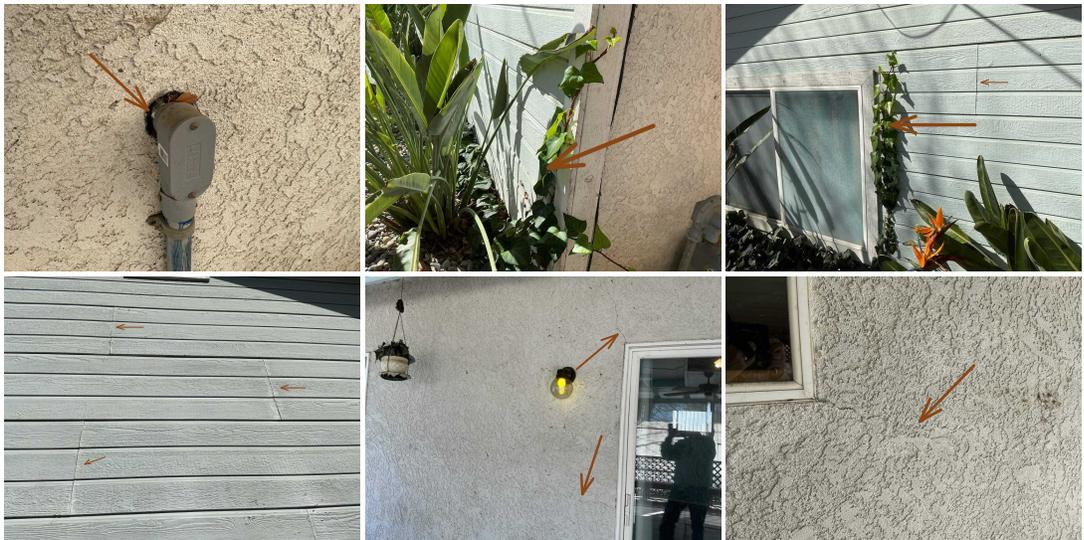
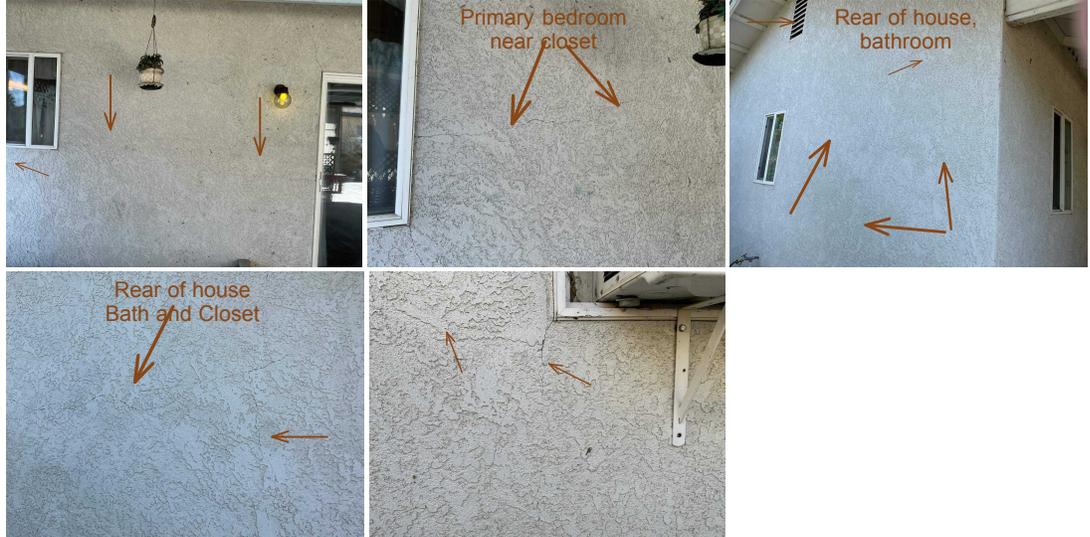
, Visible settling, Gaps not properly sealed at through wall fittings and fiber siding. Moisture stains present. No flashing or caulking at wall intersection, Recommend sealant or caulking be replaced and painted by a stucco contractor. Stucco has many horizontal and vertical cracks an may allow water intrusion into wall especially at rear of house. Recommend stucco siding contractor address all noted concerns as well as others they find. , Recommend siding and painting contractor for fibrous siding and all wood trim repairs and further evaluation. This is a visual inspection only and Hidden damage may be present.

Recommend further evaluation by a licensed, qualified Stucco and siding contractor for all needed repairs to stucco, fibrous siding and wood trim. Assess possible water intrusion into structure walls. Assess possibility of mold and advise. Repair and paint as needed. This is a visual inspection only and Hidden damage may be present.

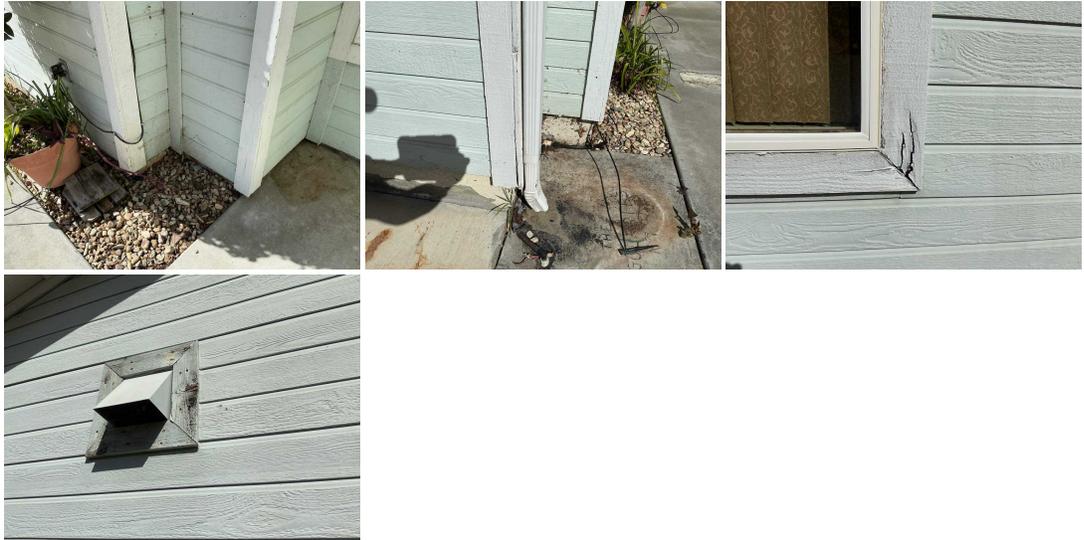
, Wood rot, Damaged, Also, Refer to pest report for further information., Repair and/or painting needed

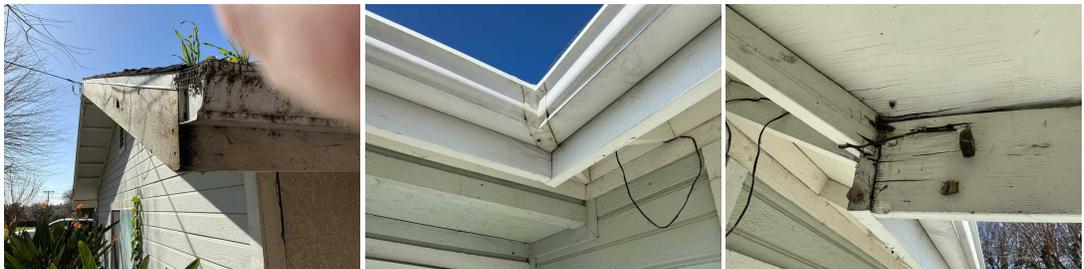
, Areas of Moisture, Wood rot or pest damage noticed., A qualified contractor is recommended to evaluate and estimate repairs, Also, Refer to pest report for further information.

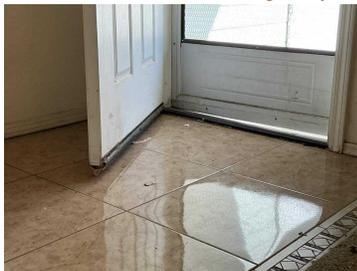
6. Maintenance required Entry Doors: Wood with glass - **MAINTENANCE:**  
, Recommend sealing to prevent water or pest entrance. , Loose or missing threshold

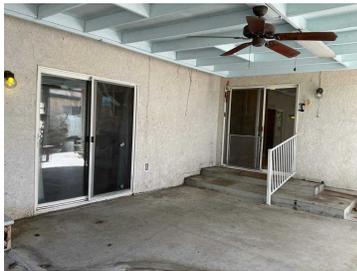
7. Maintenance required Patio Door: Vinyl sliding - **MAINTENANCE:**  
Damaged lock in kitchen

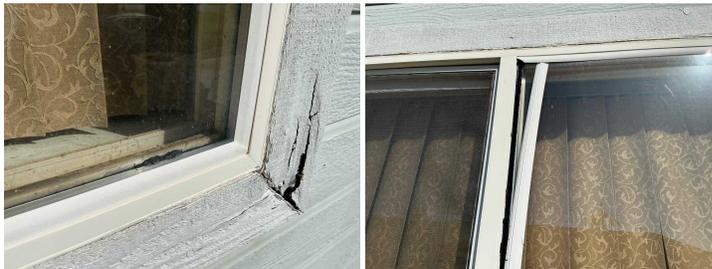
8. Maintenance required Windows: Vinyl slider - Maintenance, See individual room notes, Window seal broken or damaged. Due to time of day, not all windows will show fogging of broken seal.

Recommend further evaluation by a licensed, qualified glazer for repair of windows and sliding door as needed. Assess

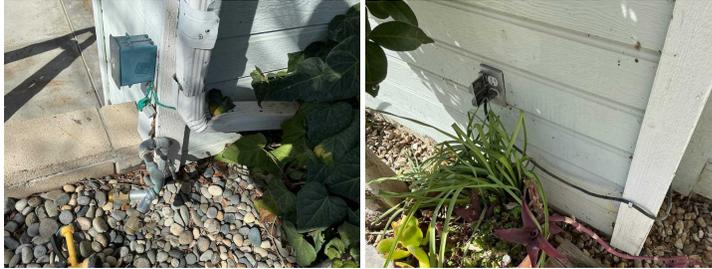
Exterior Electric Outlets: 110 VAC - **MARGINAL:**  
, Exposed wiring present, Loose or missing moisture cover, Non-GFCI outlet, Improper wiring for exterior application, Review by an electrician suggested.

Recommend further evaluation by a licensed, qualified electrician to assess dual 100amp breakers in main panel and repair as needed. Repair or replace any non GFCI outlets and exterior weather covers as needed.

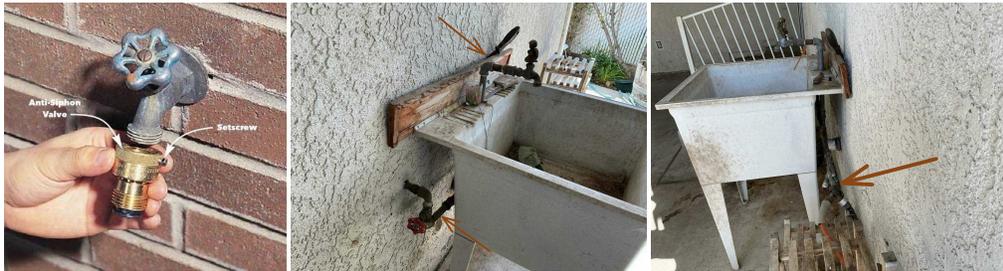
Hose Bibs: Rotary - **MAINTENANCE:**, Install of anti siphon device recommend at all exterior hose bibs to prevent reverse water contamination.. leaking spigots. Loose pipes need secured. , Exterior PVC pipe are not UV protected and need wrapped and supported to prevent damage., Note: Valves are not operated as part of this inspection, any reference to any valve inspected is visual only unless otherwise noted., A licensed plumber is recommended to evaluate and estimate repairs

Recommend further evaluation by a licensed, qualified plumber to repair leaking spigots, faucets and water line connections in house and exterior. See individual room notes. Adjust water pressure to between 60-80psi. Secure water lines and pipes as needed.

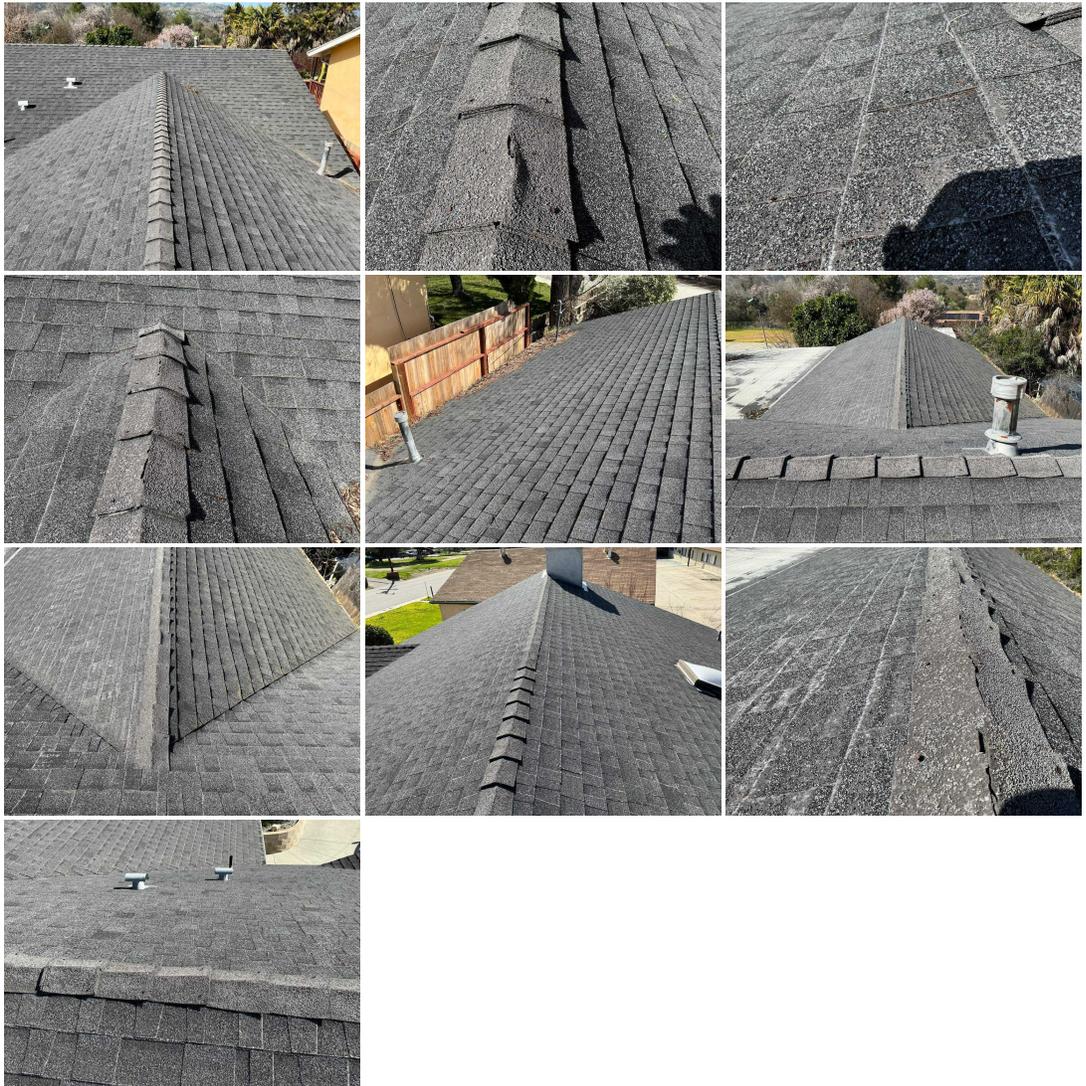
, Loose or damaged shingles, Shingles nailed improperly or nails loose. This can lead to water intrusion. , Signs of cracking, Roof near end of useful life, Algae growth noted and should be cleaned to prevent deterioration. , A qualified roofing contractor is recommended to evaluate and estimate repairs

Recommend further evaluation by a licensed, qualified roofing contractor for repair of Damaged shingles, ridge caps, pergola roof holding water and pergola roof connection to house. Further evaluation to remaining material life span. Repair gutters and downspouts to move water away from foundation. Seal all penetrations at vents, skylight and flashing as needed.

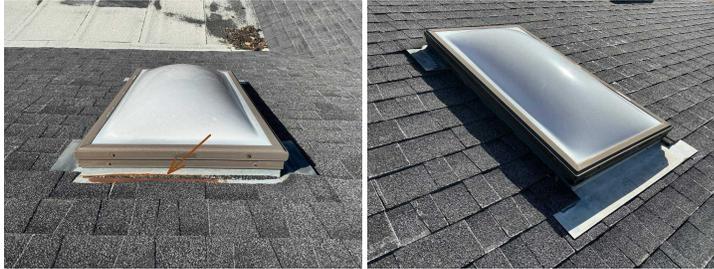
, Skylights are visually inspected only and not water tested., Hidden damage may be present. Recommend a contractor investigate as necessary to determine the full extent of damage and make proper repairs.

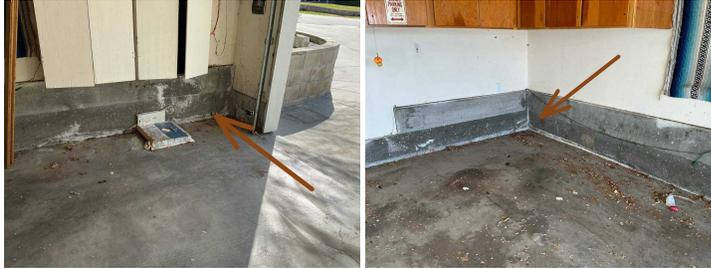
9. Maintenance required Floor/Foundation: Poured concrete - **MAINTENANCE:**  
, Efflorescence is a white powdery substance of minerals left behind from moisture intrusion.

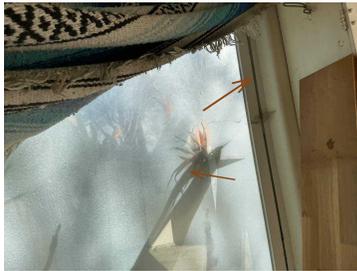
, The window will not open, Current or previous water damage present. Recommend windows be review and repaired by a qualified glazer or contractor. Hidden damage may be present.

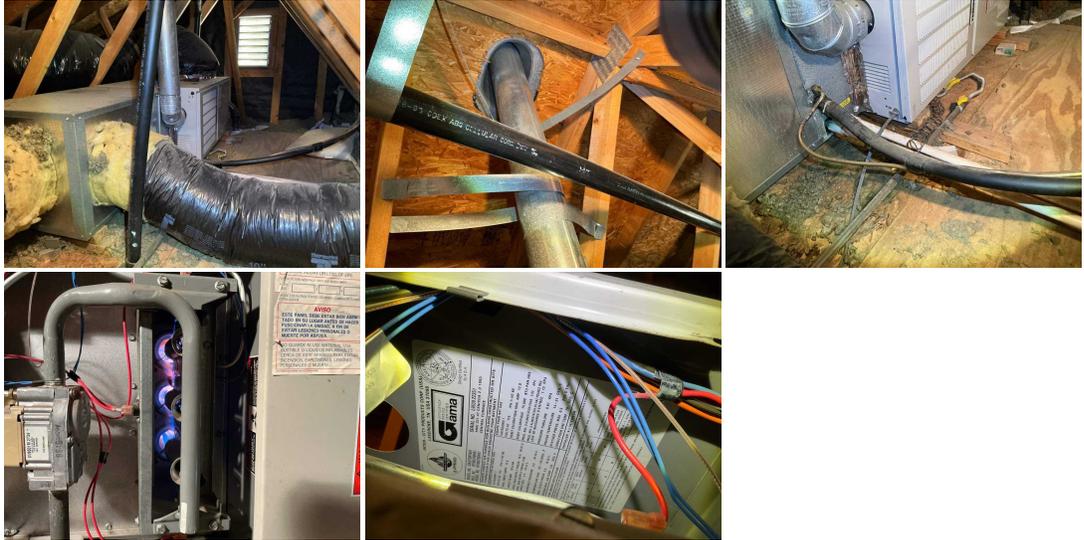
- 1. Maintenance required Heating System Operation: Appears functional - **MAINTENANCE:**  
Service recommended

Recommend further evaluation by a licensed, qualified HVAC contractor to service and repair AC exterior unit and Heater in attic as needed. Advise to life expectancy.

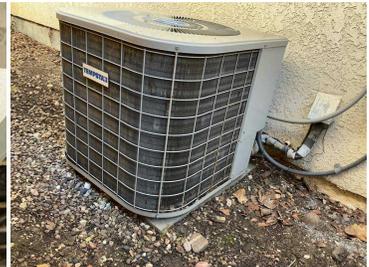
- 1. Acceptable A/C System Operation: Appears serviceable
- 2. Acceptable Condensate Removal: PVC
- 3. Maintenance required Exterior Unit: Pad mounted - **MAINTENANCE:**  
, Not properly supported, sitting out of level. Exterior box has excessive rust. Recommend service.

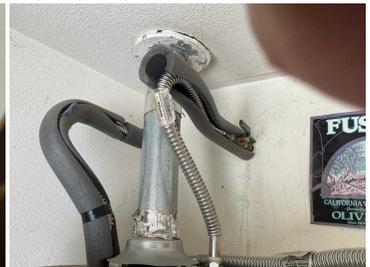
8. Maintenance required Water Heater Operation: Adequate - **MAINTENANCE:**  
, Earthquake support straps and or blocking missing or not properly installed

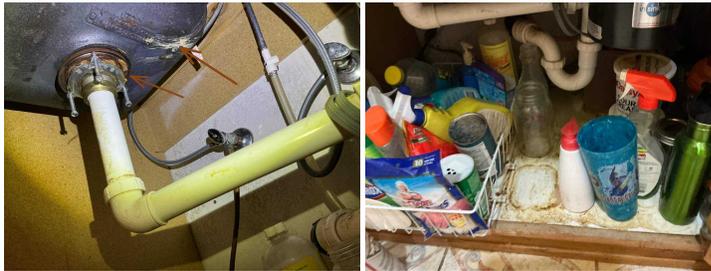
9. Maintenance required Sink: Porcelain Coated - MAINTENANCE:  
, Pitting stem, Leaking, recommend plumber repair  
Stains under sink. No standing water at time of inspection

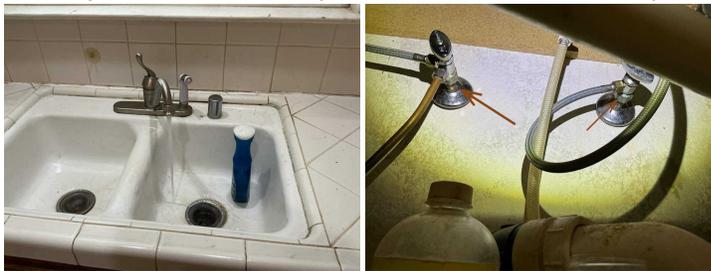
11. Maintenance required Plumbing/Fixtures: Metal and PVC - MAINTENANCE:  
, The supply piping under the sink is corroded. It may be desirable to replace it before leaks develop., Recommend a plumber evaluation and repairs.

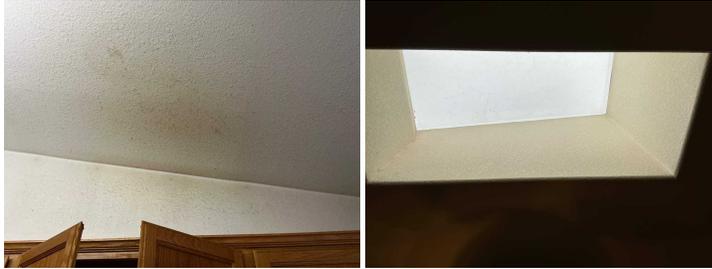
15. Maintenance required Ceiling: Paint - MAINTENANCE:  
Exhaust stains present from oven vent

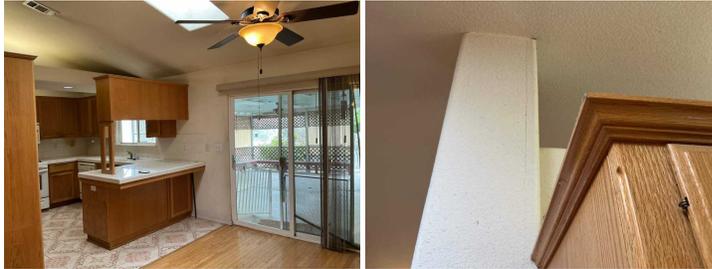
16. Maintenance required Walls: Paint - MAINTENANCE: clearing needed  
Normal Cracks present

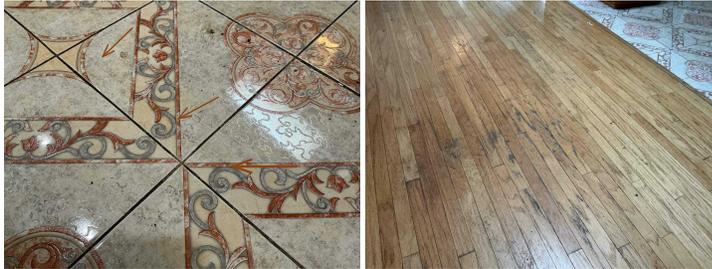
17. Maintenance required Floor: Tile, Wood - MAINTENANCE:  
Tile cracks present , Water damage

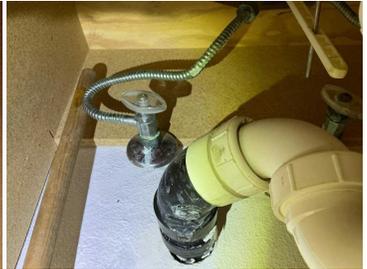
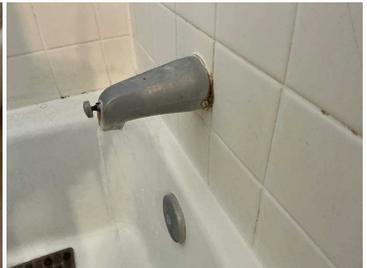
10. Maintenance required Faucets/Traps: Metal with PVC trap - **MAINTENANCE:**  
**, Leaking supply line, Shower diverter not functioning properly, all water is not flowing to showerhead, Build up found in aerator of fixtures possibly caused by deteriorated water., Missing or faulty drain stopper, Recommend a plumber evaluate, check for hidden damage, eliminate source of moisture and properly repair all deteriorated components.**

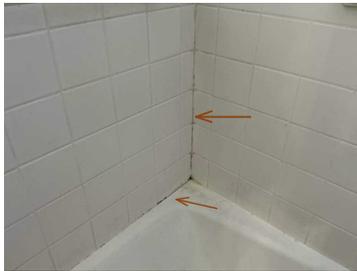
11. Maintenance required Tub/Surround: Porcelain tub and ceramic tile surround - **MAINTENANCE:**  
, Loose grout, Recommend caulking to prevent water intrusion

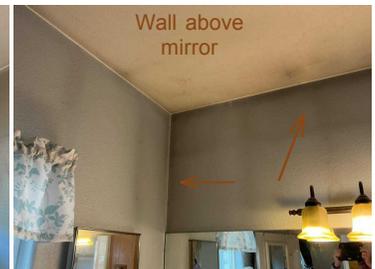
19. Marginal Walls: Paint - **MARGINAL:**  
, Evidence of past or present water leakage, Moisture or current water present on drywall from exterior . Recommend a contractor investigate and repair as needed. Possible mold, recommend a specialist review and mitigate if needed. This is a visual inspection only and Hidden damage may be present.

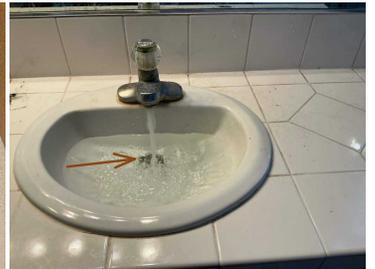
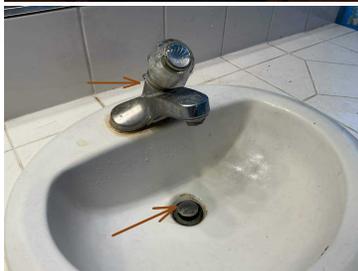
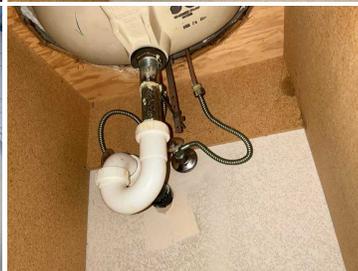
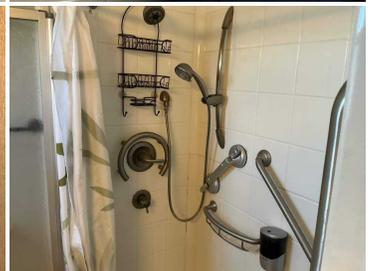
, Build up found in aerator of fixtures possibly caused by deteriorated water., Missing or faulty drain stopper

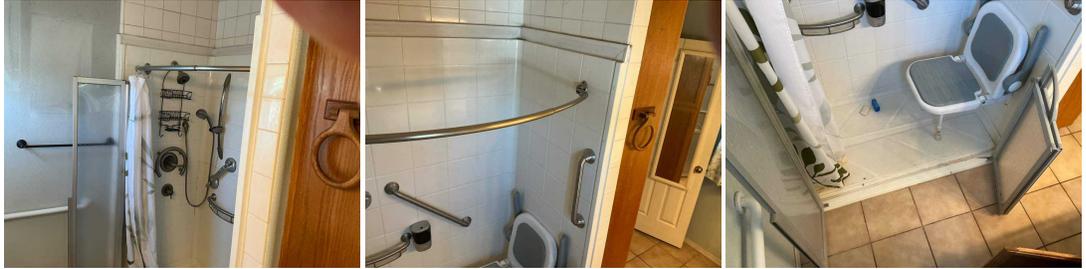
28. Maintenance required Shower/Surround: Fiberglass pan and fiberglass surround - MAINTENANCE:  
, Recommend chalking to prevent water intrusion, custom install may need further review,  
ask owner for warranty information

Recommend plumber assess added shower installation in primary bathroom.

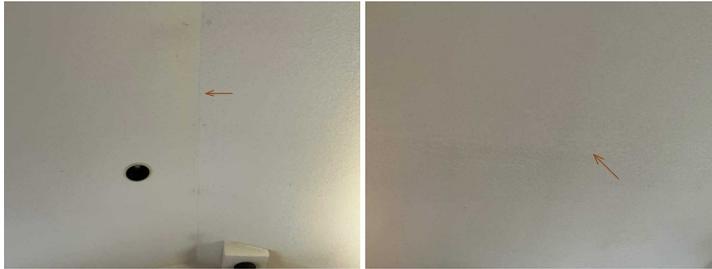
2. Maintenance required Ceiling: Paint - MARGINAL:  
, Cracks present

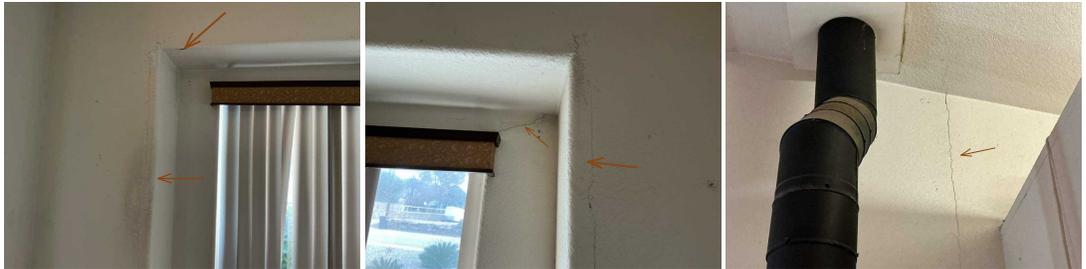
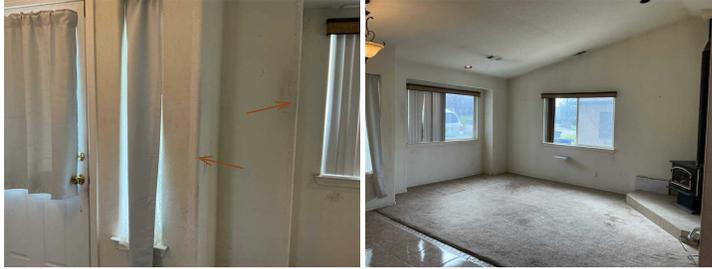
3. Maintenance required Walls: Paint - MAINTENANCE:  
, Cracks present, Evidence of past or present water leakage, A qualified contractor is  
recommended to evaluate and estimate repairs, This is a visual inspection only and Hidden  
damage may be present.

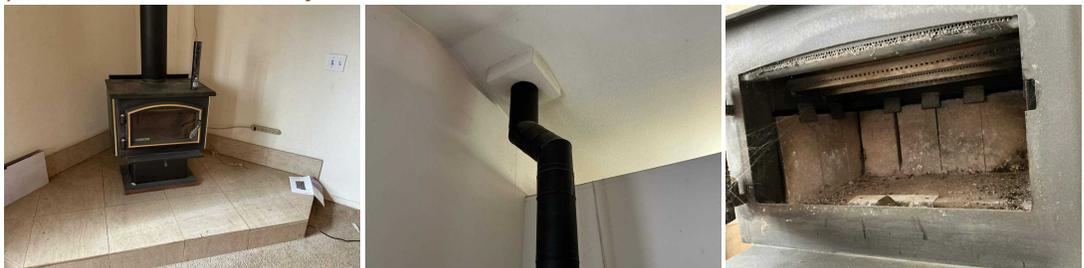
- 1. Maintenance required Freestanding Stove: Wood burning - Maintenance, Recommend cleaning and inspection  
    prior to use and Annually.

A wood stove was present, which operates at high temperatures and should only be installed and operated in complete accordance with the manufactures instructions. Be sure to keep children well away from the stove when in use. All wood stoves should be cleaned and inspected by a qualified chimney sweep prior use and the start of each season. Repair exterior chimney and clean flue as needed.

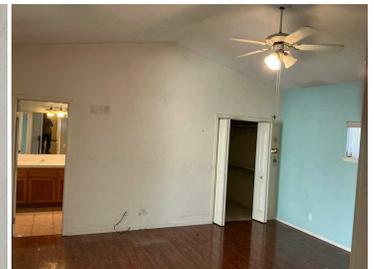
, Evidence of past or present water behind drywall near and in closet., A qualified contractor is recommended to evaluate and estimate repairs and check for water damage. This is a visual inspection only and Hidden damage may be present.

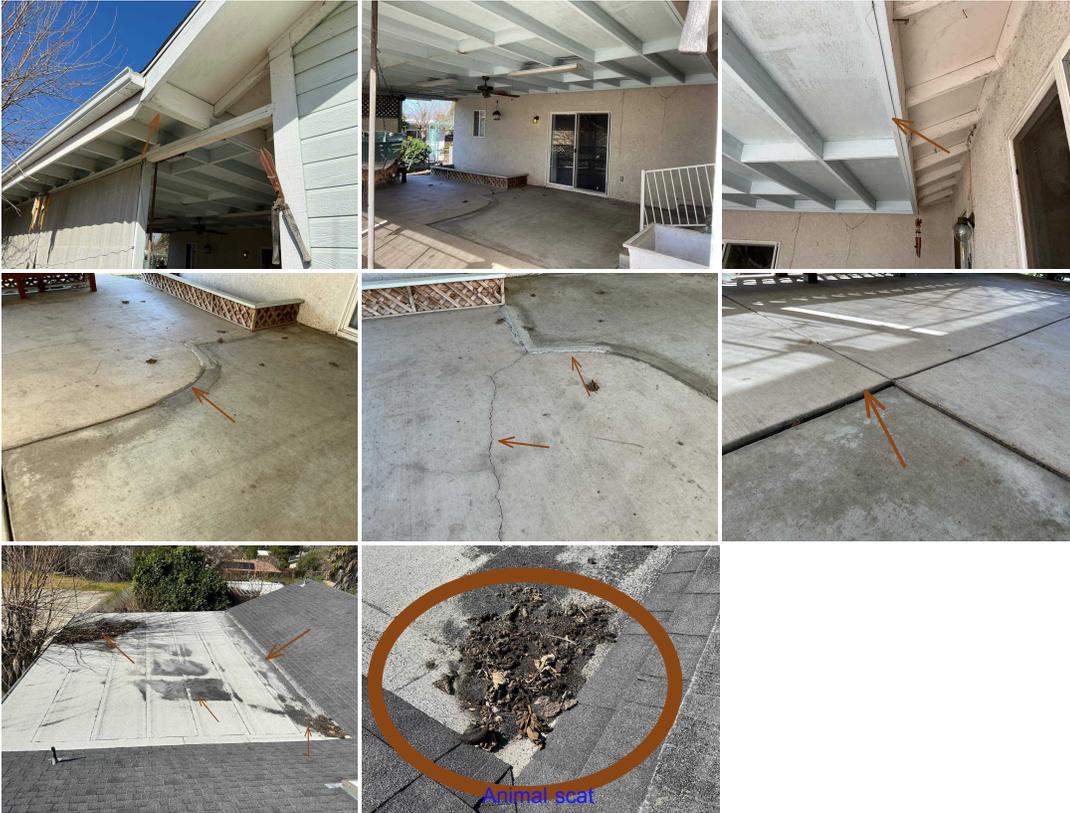
, Evidence of poor drainage, Heavily cracked and unevenly settled causing trip hazard. Pergola attached to house fascia . , A qualified contractor is recommended to evaluate and estimate repairs. Animal excrement on roof

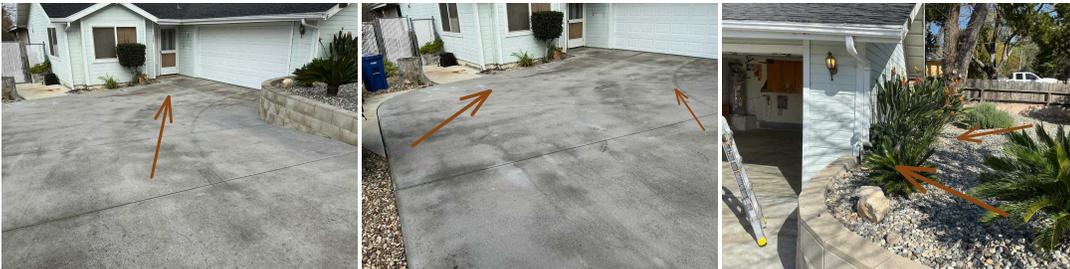
#### 2. Grading: Negative slope, Moderate slope - MAINTENANCE:, Landscape grading should be sloped away from Garage, house and foundation. Recommend a licensed landscaper to correct grading issues. Hidden moisture damage may be present., Driveway Grading has negative slope and water is pooling and running against the foundation. Water can cause foundation settling and erosion problems.. drainage needed at garage.

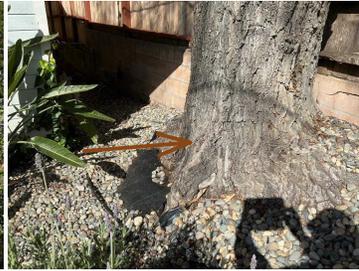
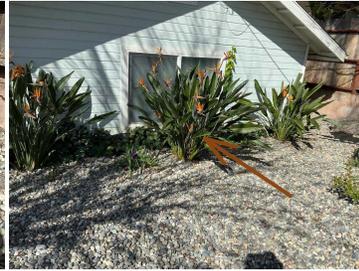
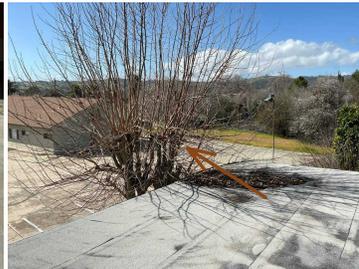
3. Vegetation: Trees and shrubs - **MAINTENANCE:**, Planting should be maintained away from exterior of structure. , Tree limbs over hang the roof and should be cut back

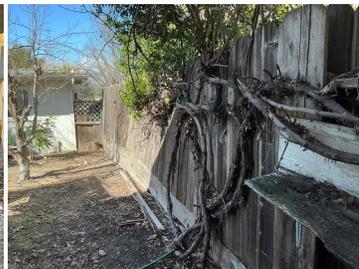
5. Fences: Wood, Chain link - **MAINTENANCE:**  
, Damaged, Wood rot or pest damage. Falling over into neighbor. A qualified contractor is recommended to evaluate and estimate repairs

Repair of fences needed

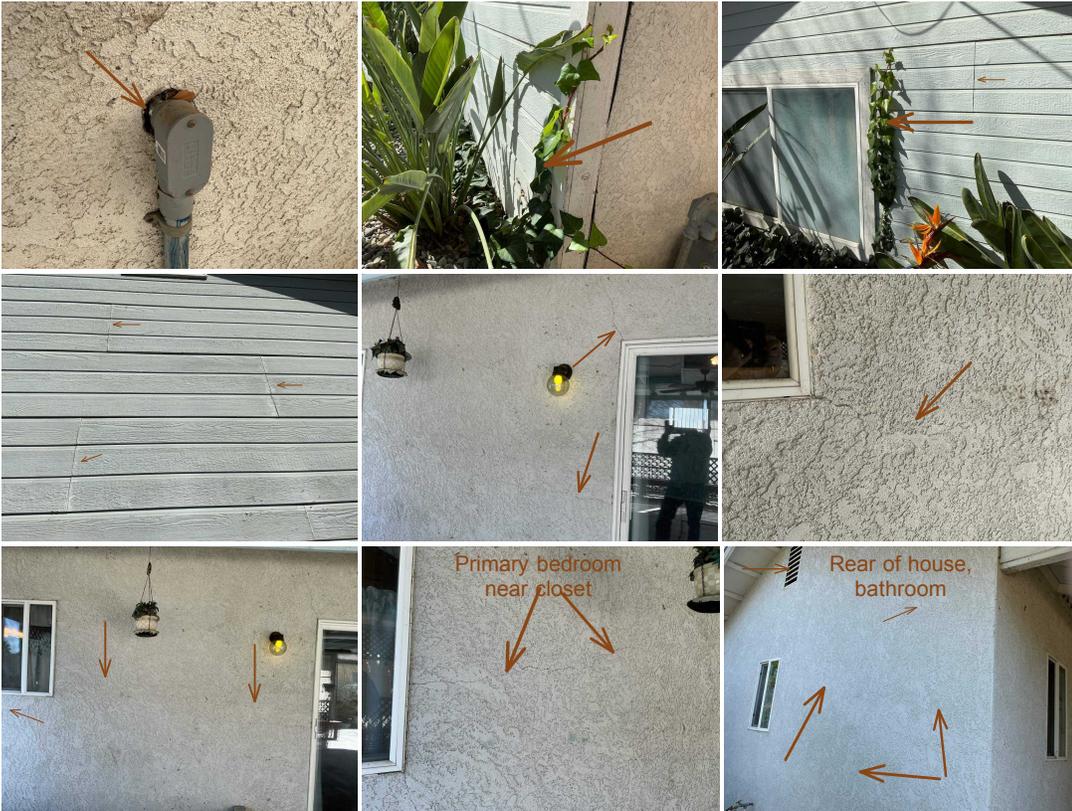
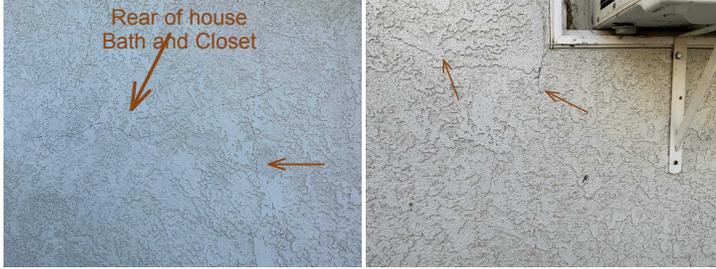
6. Main house Exterior Surface Type: Fibrous, Stucco - MAINTENANCE:  
, Visible settling, Gaps not properly sealed at through wall fittings and fiber siding. Moisture stains present. No flashing or caulking at wall intersection, Recommend sealant or caulking be replaced and painted by a stucco contractor. Stucco has many horizontal and vertical cracks an may allow water intrusion into wall especially at rear of house. Recommend stucco siding contractor address all noted concerns as well as others they find. , Recommend siding and painting contractor for fibrous siding and all wood trim repairs and further evaluation. This is a visual inspection only and Hidden damage may be present.

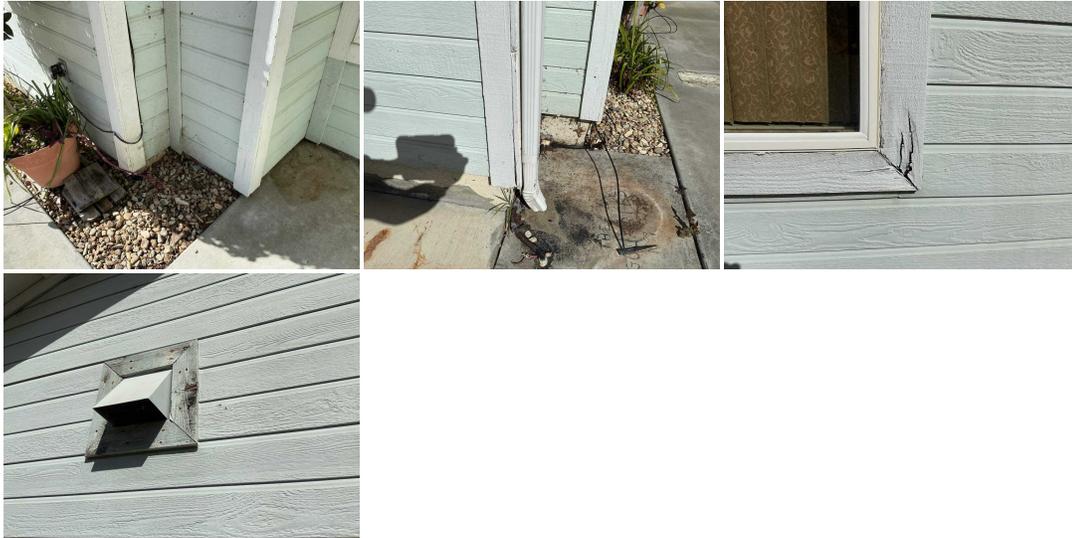
7. Trim: Wood - MAINTENANCE:  
, Wood rot, Damaged, Also, Refer to pest report for further information., Repair and/or painting needed

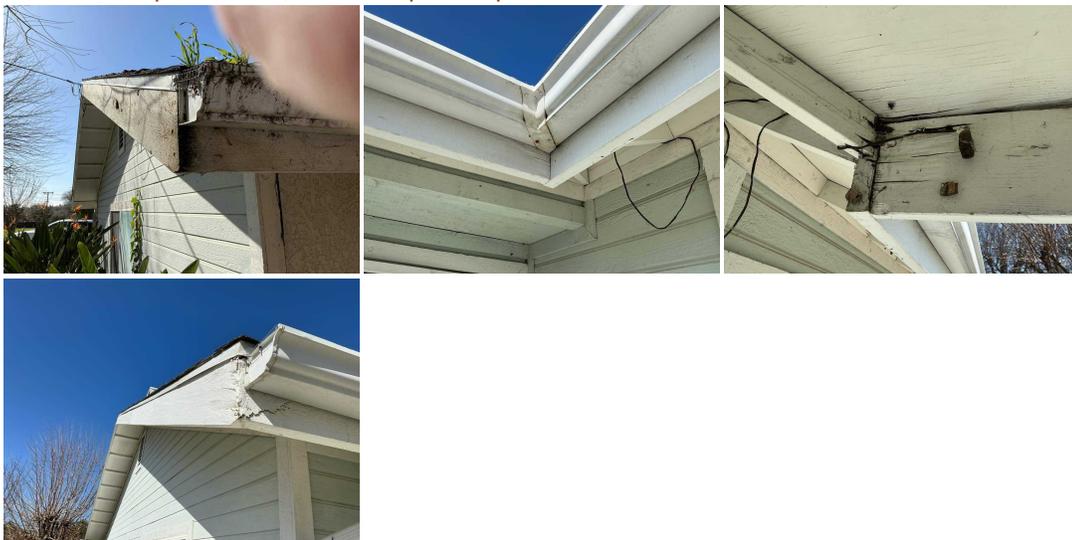
8. Fascia: Wood - MAINTENANCE:  
, Areas of Moisture, Wood rot or pest damage noticed., A qualified contractor is recommended to evaluate and estimate repairs, Also, Refer to pest report for further information.

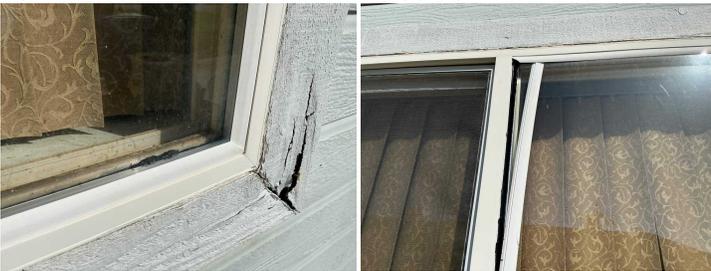
12. Windows: Vinyl slider - **Maintenance,** See individual room notes, Window seal broken or damaged. Due to time of day, not all windows will show fogging of broken seal.

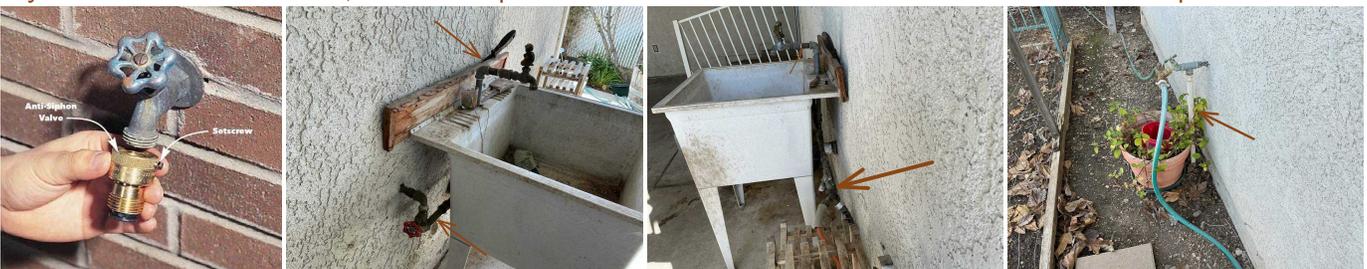
Loose pipes need secured. , Exterior PVC pipe are not UV protected and need wrapped and supported to prevent damage., Note: Valves are not operated as part of this inspection, any reference to any valve inspected is visual only unless otherwise noted., A licensed plumber is recommended to evaluate and estimate repairs

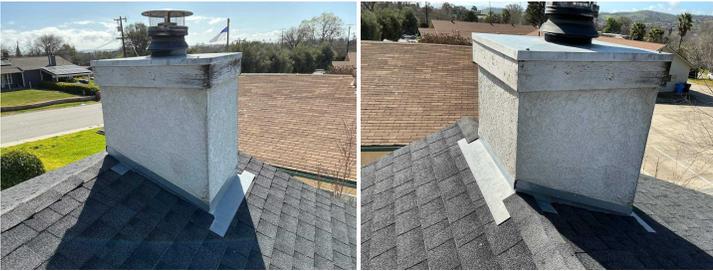
21. Front of house Chimney Chimney: Framed - **MAINTENANCE:**  
, Recommend a contractor evaluate, check for hidden damage, eliminate source of moisture and properly repair all deteriorated components.

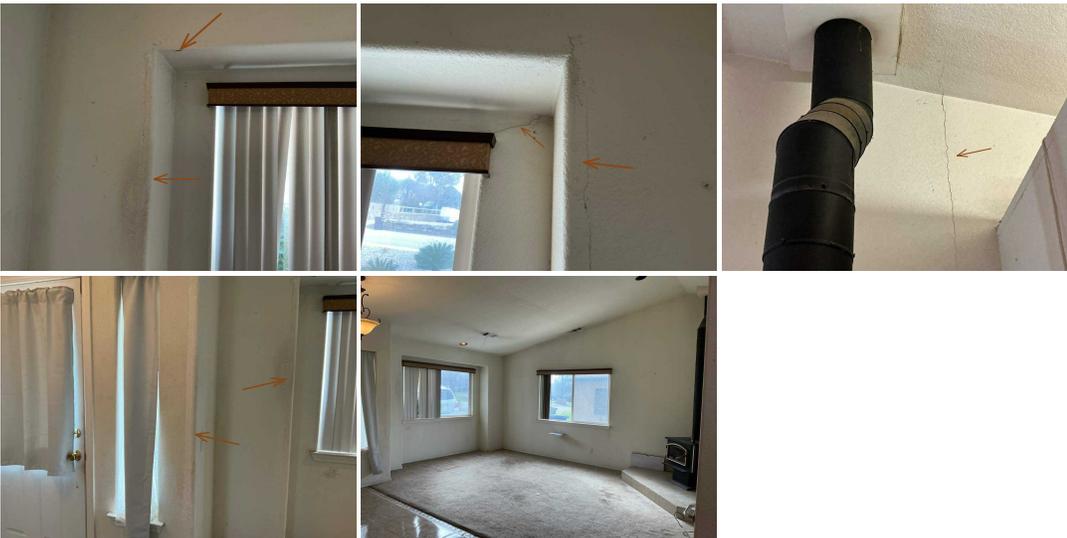
56. Living Room Living Space Walls: Paint - **MAINTENANCE:**  
, Cracks present, Evidence of past or present water leakage, A qualified contractor is recommended to evaluate and estimate repairs, This is a visual inspection only and Hidden damage may be present.
