# PROPERTY INSPECTION REPORT

**FOUR POINT**  
HOME INSPECTION INC.

**1545 Park St**  
**Inspection Prepared For: Jim Gates**  
**Agent: -**

**Date of Inspection: 10/24/2023**  
**Year Built: 1900 Size: 1290**  
**Weather: Mild/Dry**

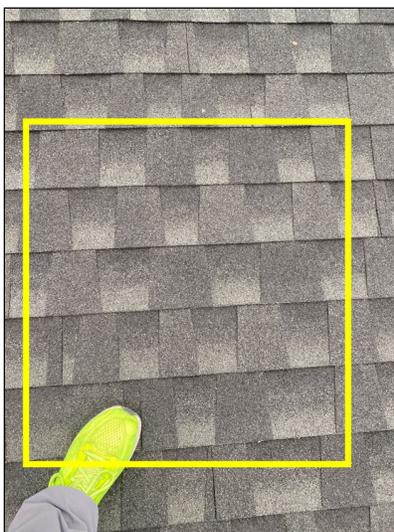
Asphalt shingles covering the roof of this home exhibited minor general deterioration that appeared to be commensurate with the age of the roof. Appeared to be adequately protecting the underlying home structure at the time of the inspection.

Asphalt shingles covering the roof of this home exhibited minor general deterioration that appeared to be commensurate with the age of the roof.

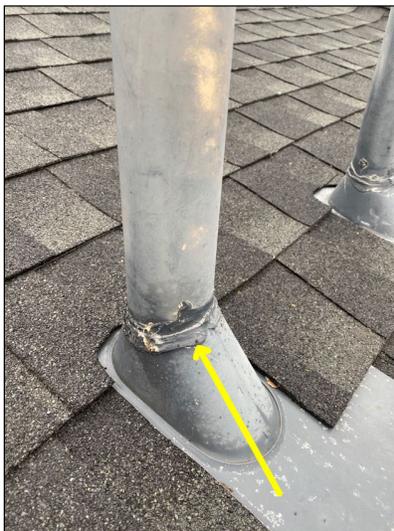
**Routine Maintenance:** Plumbing vent flashings are mastic covered and will start to show signs of mastic deterioration from sun exposure over time.

**Routine Maintenance:** Plumbing vent flashings are mastic covered and will start to show signs of mastic deterioration from sun exposure over time. Recommend re-sealing all through the roof vents and projections as a part of routine maintenance to prevent unwanted moisture intrusion.

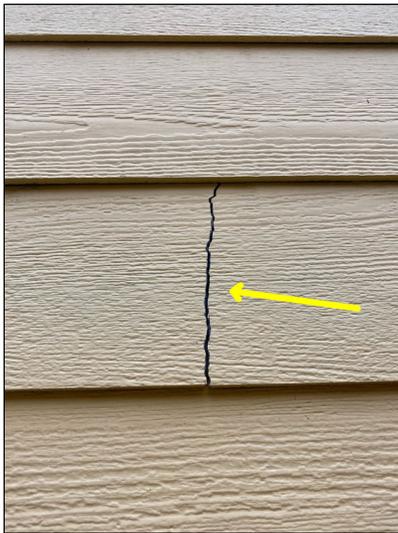
**Routine Maintenance:** Gaps at joints of the siding more than 1/4 inch (ca. 10 cm) should be sealed to keep unwanted moisture out.

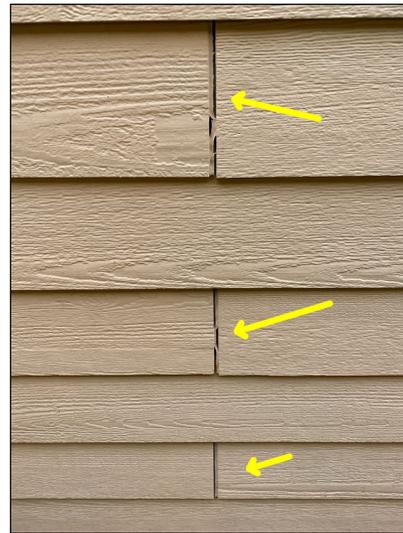
**Routine Maintenance:** Gaps at joints of the siding more than 1/4 inch (ca. 10 cm) should be sealed to keep unwanted moisture out.

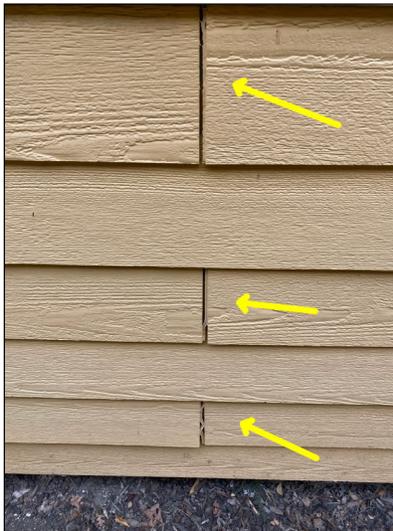
**Routine Maintenance:** Gaps at joints of the siding more than 1/4 inch (ca. 10 cm) should be sealed to keep unwanted moisture out.

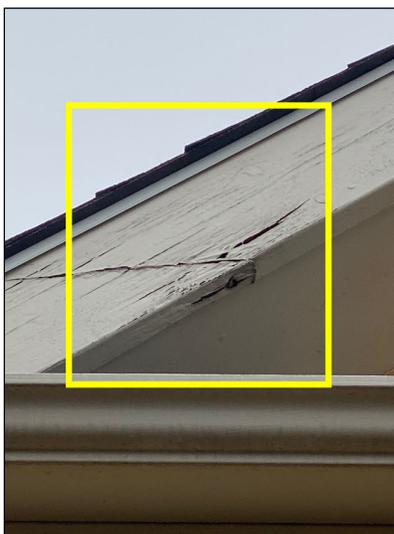
Page 14 Item: 2	Soffits & Fascia	Moisture damage, wood rot, observed. Refer to pest report for further details and repair damage as needed.

**Moisture damage, wood rot, observed. Refer to pest report for further details and repair damage as needed.**

Moisture damage, wood rot, observed.

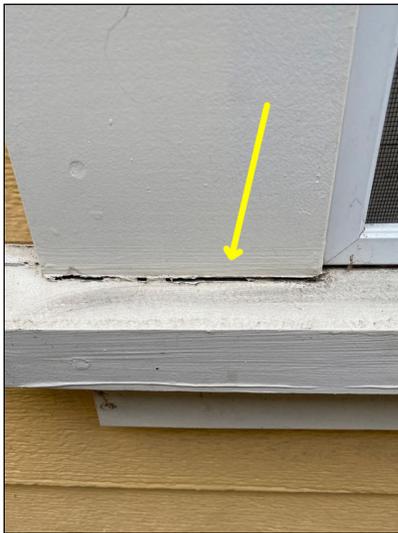
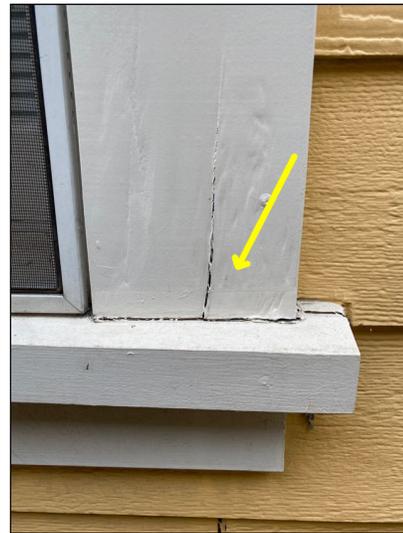
**Maintenance Needed:** Trim had gaps that should be filled with an appropriate sealant by a qualified contractor to help prevent moisture and insect entry.

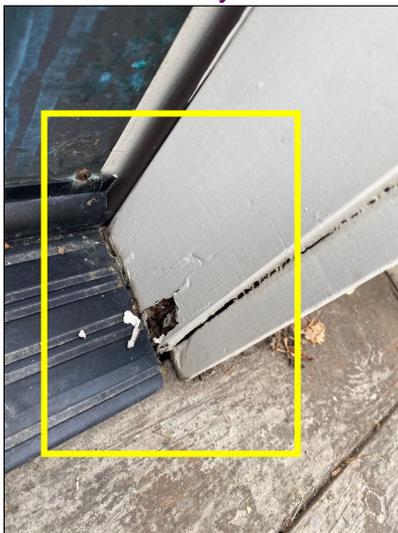
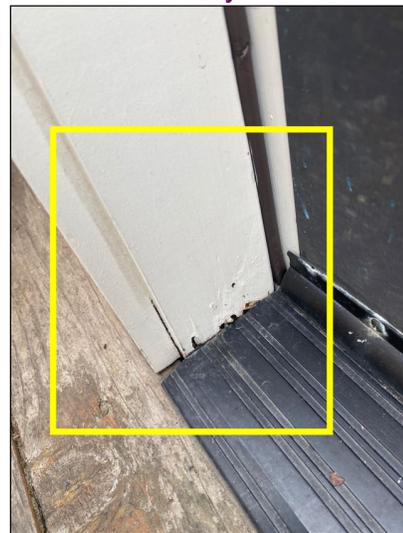
Page 14 Item: 3	Trim Condition	• Moisture damage, wood rot, observed. Refer to pest report for further details and repair damage as needed.
Crawlspace Foundation

Moisture damage, wood rot, observed.

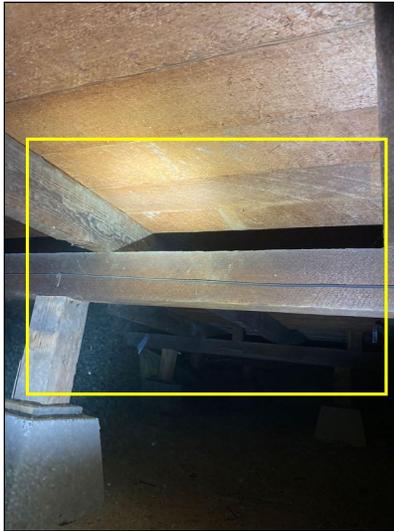
**Improvement:** No insulation was installed in the unheated crawlspace. Insulation of insulation will help reduce heating costs.

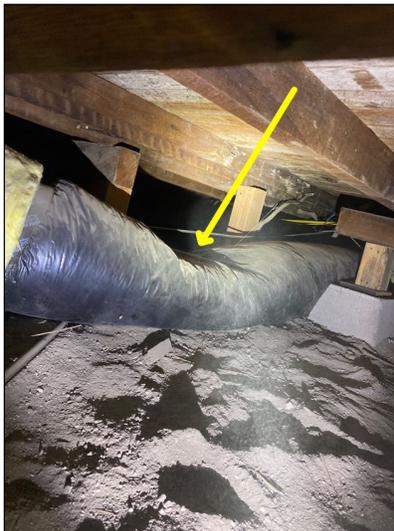
Page 20 Item: 11	Ducting	• Ducts in the crawlspace were visibly damaged and should be repaired/replaced by a qualified HVAC contractor.
Grounds

• Ducts in the crawlspace were visibly damaged and should be repaired/replaced by a qualified HVAC contractor.

Ducts in the crawlspace were visibly damaged and should be repaired/replaced by a qualified HVAC contractor.

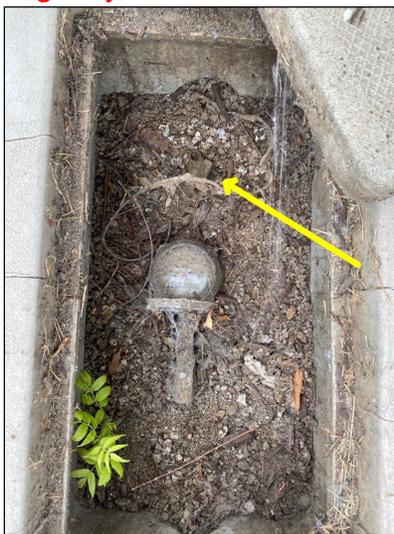
Main water shut of to the home

**Safety Improvement:** The main water supply shut-off valve was difficult to access. Consider having a more accessible main water supply shut-off valve installed by a qualified plumbing contractor for use during an emergency.

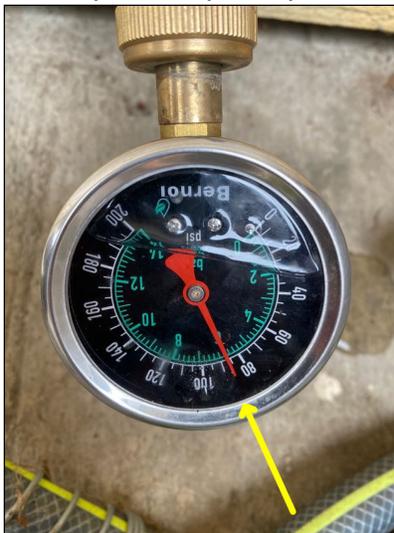
- **Monitor:** High pressure: Home water supply pressure exceeded the 80 pounds per square inch (PSI) limit considered the maximum allowable by generally-accepted current standards. Excessively high water pressure is likely to cause leaks. The Inspector recommends service by a qualified plumbing contractor.
- Recommend 40-80 PSI.
- Home water pressure measured 85 pounds per square inch (psi) at the time of the inspection.

Home water pressure measured 85 pounds per square inch (psi) at the time of the inspection.

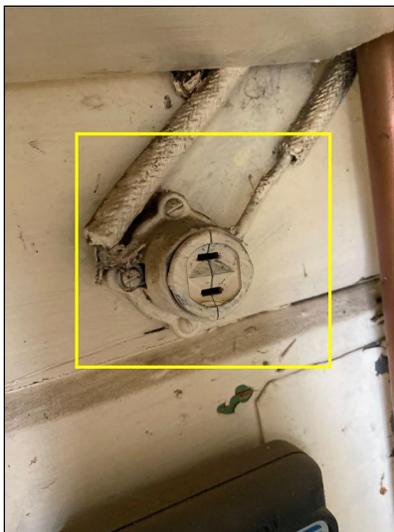
Page 23 Item: 8	Exterior Outlets/GFCI	<b>Safety:</b> The home contained outdated, ungrounded 2-prong electrical receptacles. Although this condition may have been commonly considered safe or acceptable at the time the home was originally constructed, as general knowledge of safe building practices has improved with the passage of time, building standards have changed to reflect current understanding. For safety reasons, the Inspector recommends that receptacles are replaced with grounded receptacles by a qualified contractor.

**Safety:** The home contained outdated, ungrounded 2-prong electrical receptacles. Although this condition may have been commonly considered safe or acceptable at the time the home was originally constructed, as general knowledge of safe building practices has improved with the passage of time, building standards have changed to reflect current understanding. For safety reasons, the Inspector recommends that receptacles are replaced with grounded receptacles by a qualified contractor.

**Safety:** The home contained outdated, ungrounded 2-prong electrical receptacles. (inside the water heater closet)

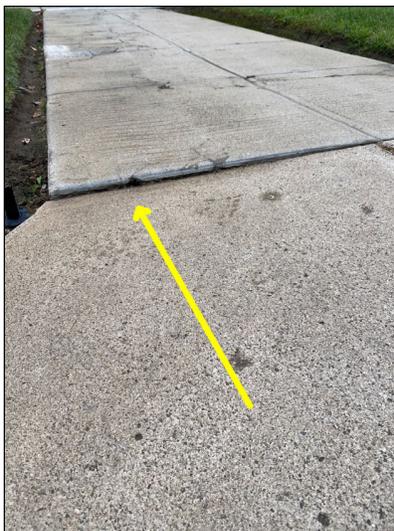
**Safety:** Uneven transitions noted at the walkways during inspection. This is a potential tripping hazard.

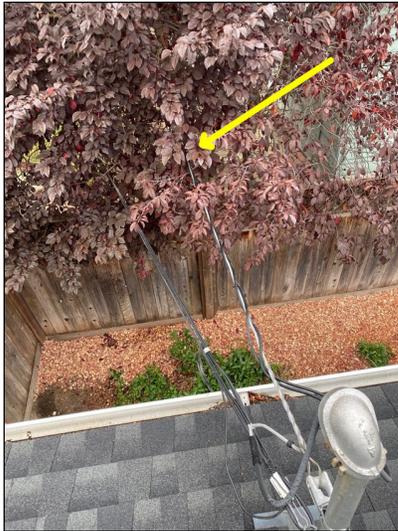
Page 26 Item: 1	Cable Feed Condition	<p><b>-CLEARANCE- TREES</b></p> <p>The overhead service-drop conductors had inadequate clearance from tree branches. This condition should be corrected by a qualified contractor or the utility service provider to avoid abrasion and damage to the conductors. Work around the service conductors should be performed by a qualified personnel only. Injury or death may result from attempts at correction by those without proper qualifications.</p> <p><b>-SERVICE MAST</b></p> <p>The electrical service mast was bent and should be replaced by a properly supported mast by a qualified electrical contractor.</p>

The overhead service-drop conductors had inadequate clearance from tree branches.

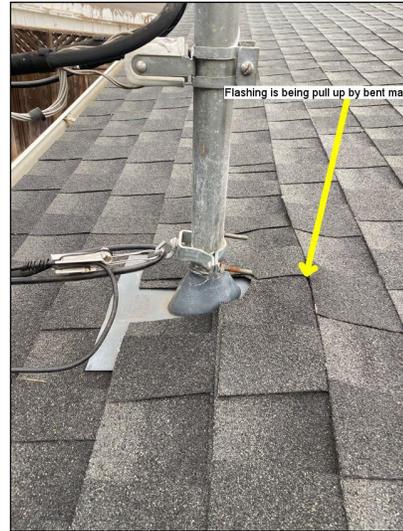
The electrical service mast was bent and should be replaced by a properly supported mast by a qualified electrical contractor.

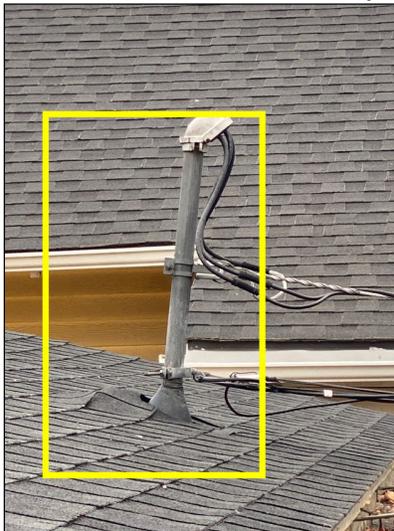
The electrical service mast was bent and should be replaced by a properly supported mast by a qualified electrical contractor.

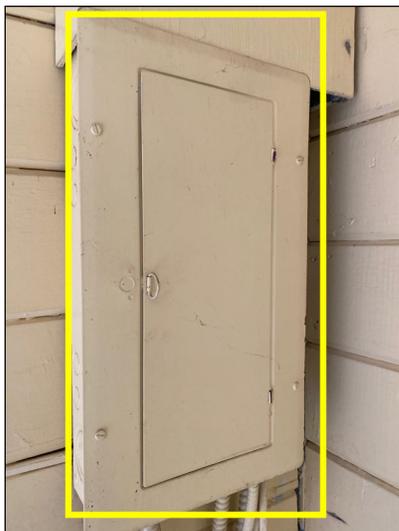
**Safety:** The sub panel cabinet was a type 1, rated for indoor use only primarily to provide a degree of protection against limited amounts of airborne dirt.

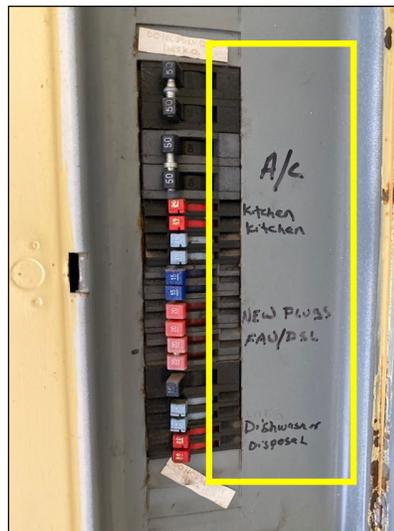
**Safety Improvement:** The Circuit Directory label identifying individual electrical circuits was not complete in the service panel, not all breakers are labeled.

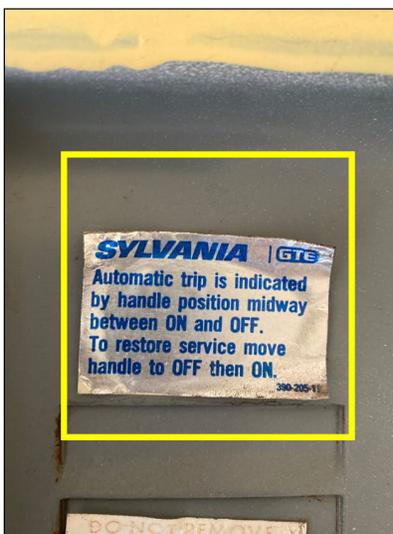
Page 28 Item: 2	Electrical Panel	<p><b>-BAD BRANDS</b></p> <p>The service sub panel brand was Sylvania. Sylvania service panels are reputed to have a high rate of circuit breaker failure which can result in a fire or shock/electrocution. The Inspector recommends that before the expiration of your Inspection Objection Deadline, you consult with a qualified electrical contractor concerning the necessity for replacing this service panel. Information about defective Sylvania service panels is widely available on the internet.</p>

The service sub panel brand was Sylvania. Sylvania service panels are reputed to have a high rate of circuit breaker failure which can result in a fire or shock/electrocution. The Inspector recommends that before the expiration of your Inspection Objection Deadline, you consult with a qualified electrical contractor concerning the necessity for replacing this service panel. Information about defective Sylvania service panels is widely available on the internet.

The service sub panel brand was Sylvania.

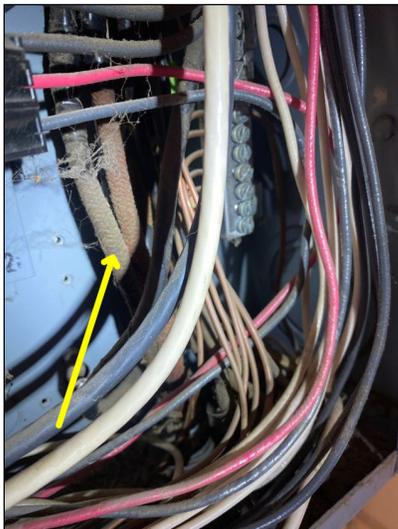
Page 30 Item: 4	Panel Wiring	<p><b>Safety:</b> Electricity in the home was distributed through old wiring insulated with cloth insulation. Due to its age, this wiring should be evaluated by a qualified electrical contractor.</p> <p>Electrical wires visible inside the electrical panel were improperly terminated. Although they were not energized at the time of the inspection, these wires may have the potential to become energized and should be correctly terminated by a qualified contractor.</p>

**Safety:** Electricity in the home was distributed through old wiring insulated with cloth insulation.

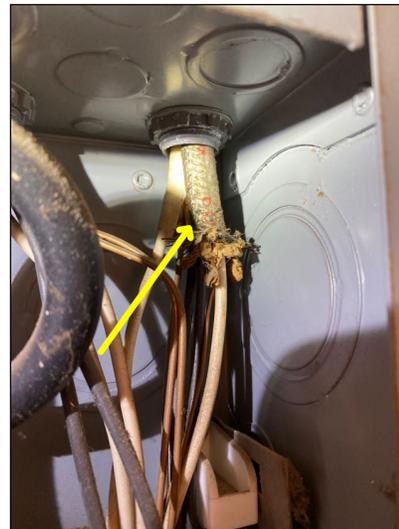
**Safety:** Electricity in the home was distributed through old wiring insulated with cloth insulation.

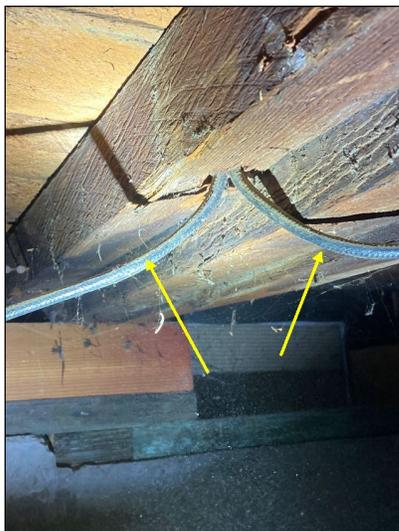
**Safety:** Electricity in the home was distributed through old wiring insulated with cloth insulation.

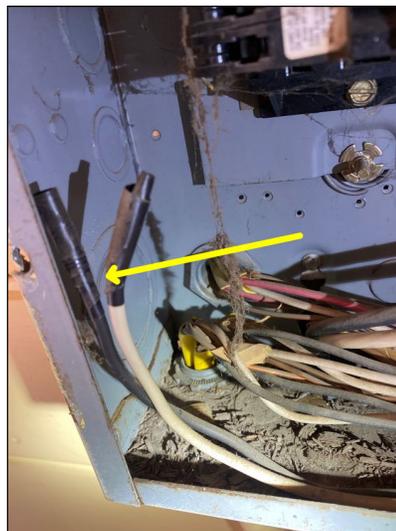
Electrical wires visible inside the electrical panel were improperly terminated. Although they were not energized at the time of the inspection, these wires may have the potential to become energized and should be correctly terminated by a qualified contractor.

Electrical wires visible inside the electrical panel were improperly terminated.

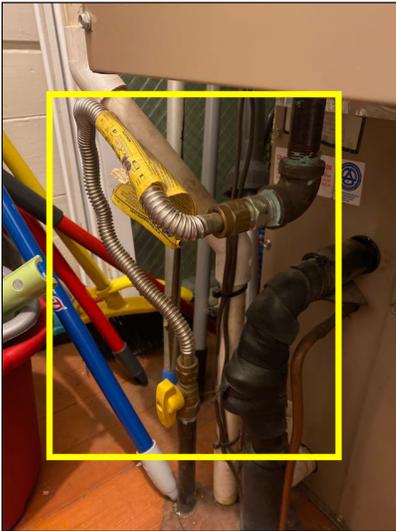
- ✓ • At the time of the inspection, the Inspector observed no deficiencies in the condition of the shut off valve or visible gas supply pipes.
- **Improvement:** The gas supply pipe contained no sediment trap. A sediment trap is generally recommended but not always required, depending on the local Authority Having Jurisdiction (AHJ). The purpose of a sediment trap is to prevent sediment or debris particulates from entering and clogging the heaters gas valve, which can cause the heater to shut down. You may wish to consult with local contractor concerning the advisability of installing a sediment trap in the gas line.

**Improvement:** The gas supply pipe contained no sediment trap.

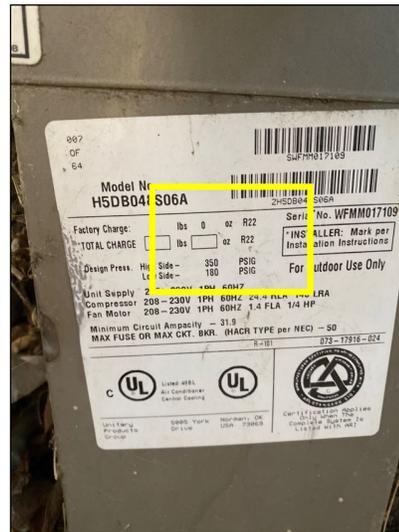
**Monitor R22 Refrigerant:** The AC unit uses R-22 refrigerant

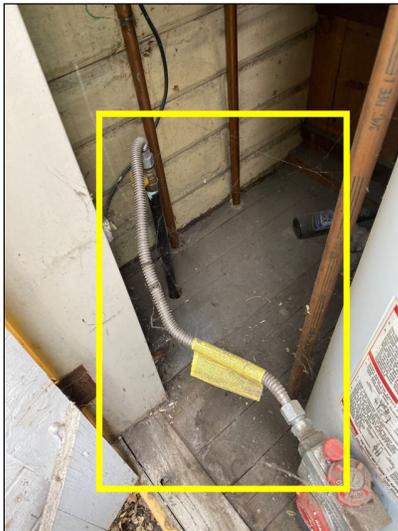
- ✓ • At the time of the inspection, the Inspector observed no deficiencies in the condition of the shut off valve or visible gas supply pipes.
- **Improvement:** The gas supply pipe contained no sediment trap. The purpose of a sediment trap is to prevent sediment or debris particulates from entering and clogging the water heater gas valve, which can cause the water heater to shut down. You may wish to consult with local contractor concerning the advisability of installing a sediment trap in the gas line.

**Improvement:** The gas supply pipe contained no sediment trap.

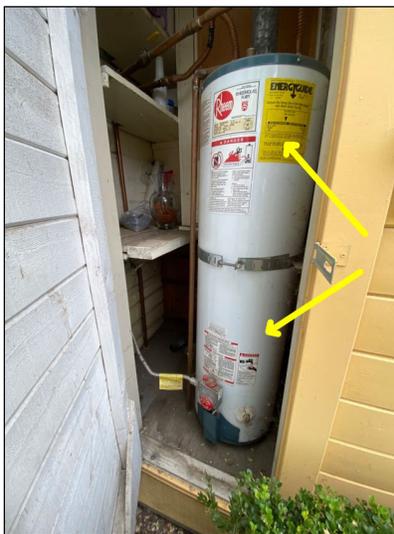
Page 40 Item: 9	Strapping	<ul style="list-style-type: none"> <li>The water heater is missing one strap. Requires two 1 1/2" steel straps 16 gauge, 1/3 from the top and the bottom and blocked to prevent any movement of the unit. The Inspector recommends correction by a qualified contractor.</li> </ul>
<b>Interior Areas</b>

• The water heater is missing one strap. Requires two 1 1/2" steel straps 16 gauge, 1/3 from the top and the bottom and blocked to prevent any movement of the unit. The Inspector recommends correction by a qualified contractor.

The water heater is missing one strap.

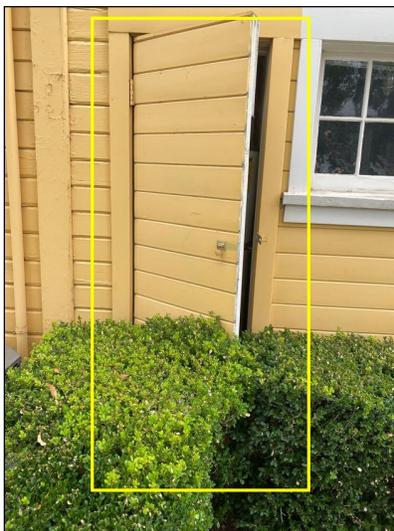
**Observations:** *Safety Improvement:* The water heater was difficult to access due to overgrown vegetation. Recommend having the vegetation cut back to make the main valve more accessible for use during an emergency.

*Safety Improvement:* The water heater was difficult to access due to overgrown vegetation.

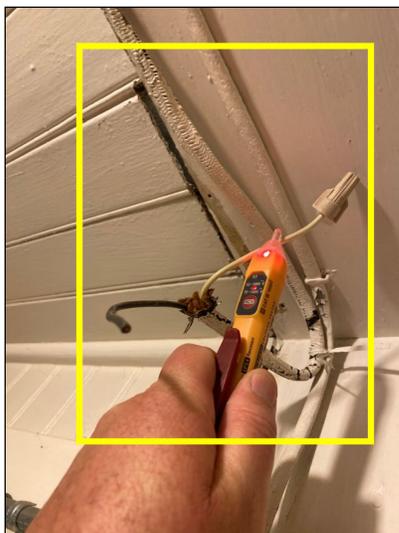
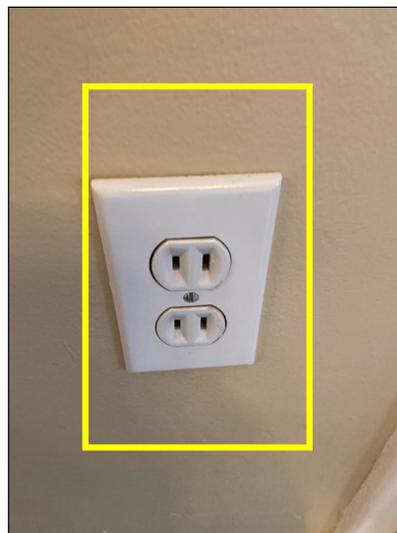
Page 42 Item: 2	Electrical	<p>Energized electrical splices not contained within a junction box and exposed to touch were visible in the interior at the time of the inspection. Electrical splices should be contained within an approved junction box with a cover plate installed. This condition is a shock/electrocution and potential fire hazard and should be corrected by a qualified electrical contractor.</p> <p><b>Safety:</b> The home contained outdated, ungrounded 2-prong electrical receptacles. Although this condition may have been commonly considered safe or acceptable at the time the home was originally constructed, as general knowledge of safe building practices has improved with the passage of time, building standards have changed to reflect current understanding. For safety reasons, the Inspector recommends that receptacles are replaced with grounded receptacles by a qualified contractor.</p>

Energized electrical splices not contained within a junction box and exposed to touch were visible in the interior at the time of the inspection. (closet)

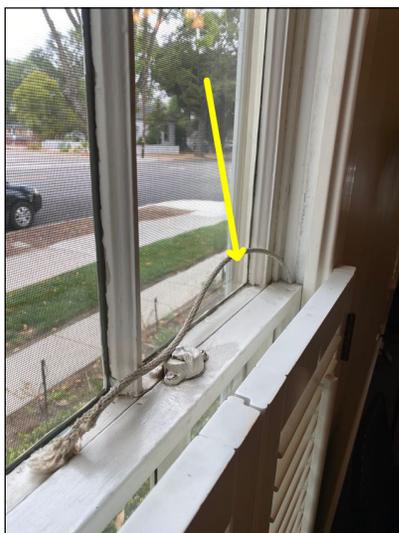
Page 43 Item: 7	Window Condition	<p><b>-SINGLE-HUNG</b></p> <p>The lower sash of a single-hung window in the Living Room would not stay up when lifted and released due to damaged/missing sash ropes. The Inspector recommends service by a qualified contractor.</p>

The lower sash of a single-hung window in the Living Room would not stay up when lifted and released due to damaged/missing sash ropes. The Inspector recommends service by a qualified contractor.

The lower sash of a single-hung window in the Living Room would not stay up when lifted and released due to damaged/missing sash ropes.

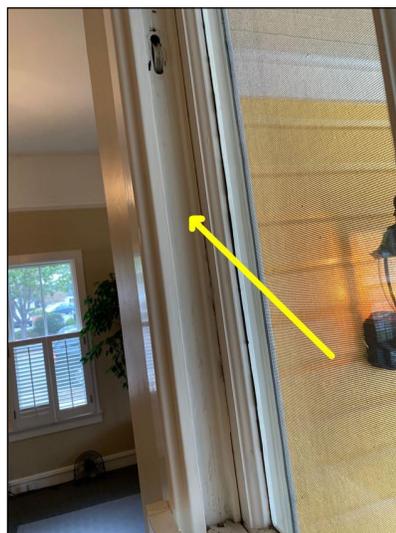
The lower sash of a single-hung window in the Living Room would not stay up when lifted and released due to damaged/missing sash ropes.

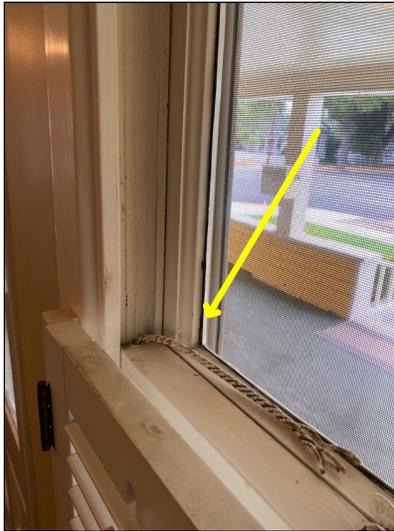
The lower sash of a single-hung window in the Living Room would not stay up when lifted and released due to damaged/missing sash ropes.

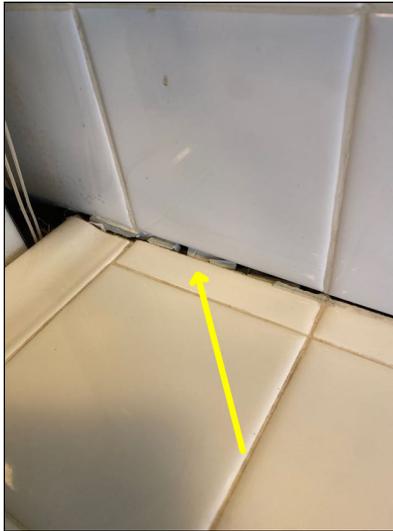
Grout lines of the tiled kitchen countertops exhibited moderate deterioration.

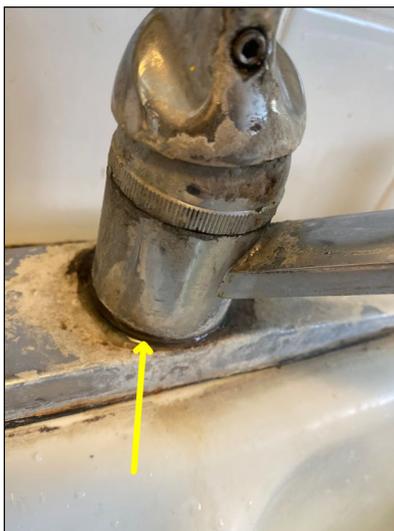
Page 47 Item: 6	Sinks	The kitchen faucet base leaked when water was turned on. The Inspector recommends service by a qualified plumbing contractor.

The kitchen faucet base leaked when water was turned on. The Inspector recommends service by a qualified plumbing contractor.

The kitchen faucet base leaked when water was turned on.

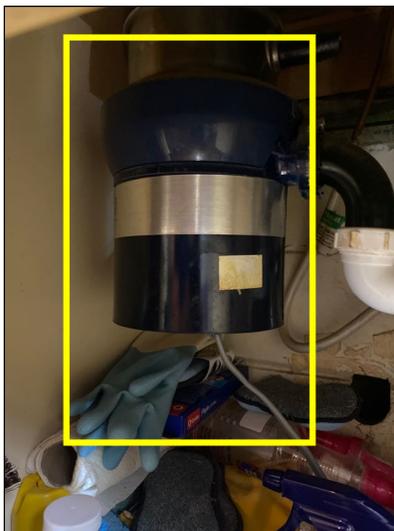
Page 47 Item: 7	Garbage Disposal	• The garbage disposal appeared to be inoperable at the time of the inspection. The Inspector recommends that before the expiration of your Inspection Objection Deadline you consult with a qualified contractor to discuss options and costs for repair or replacement.

The garbage disposal appeared to be inoperable at the time of the inspection.

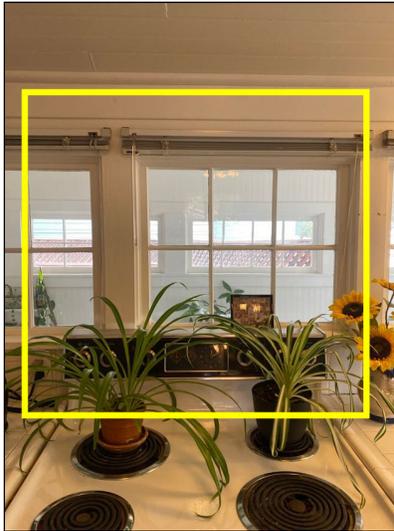
**Safety Improvement:** The Inspector recommends that an exhaust hood or air filtration system be installed to prevent possible moisture damage and grease accumulation on walls and ceiling adjacent to the range.

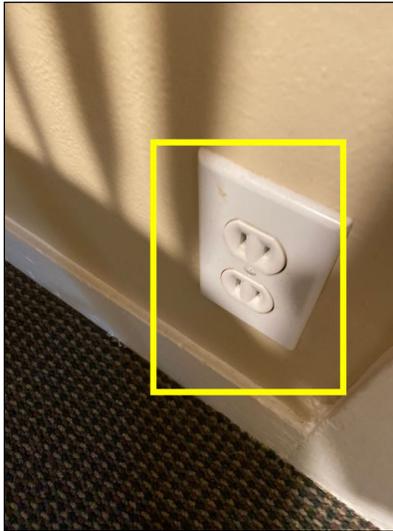
Page 52 Item: 2	Electrical	<b>Safety:</b> This bedroom contained outdated, ungrounded 2-prong electrical receptacles. Although this condition may have been commonly considered safe or acceptable at the time the home was originally constructed, as general knowledge of safe building practices has improved with the passage of time, building standards have changed to reflect current understanding. For safety reasons, the Inspector recommends that receptacles are replaced with grounded receptacles by a qualified contractor.

**Safety:** This bedroom contained outdated, ungrounded 2-prong electrical receptacles.

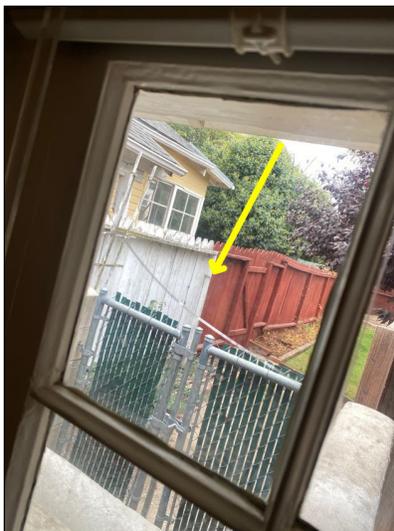
Page 54 Item: 11	Window Condition	A window at the Bedroom of the home had a cracked or broken pane.
Bedroom #2

A window at the Bedroom of the home had a cracked or broken pane.

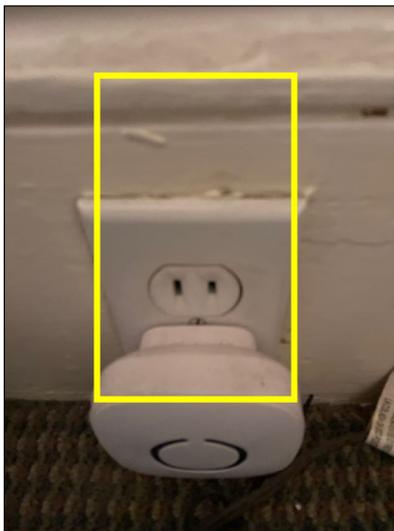
Page 55 Item: 2	Electrical	<b>Safety:</b> This bedroom contained outdated, ungrounded 2-prong electrical receptacles. Although this condition may have been commonly considered safe or acceptable at the time the home was originally constructed, as general knowledge of safe building practices has improved with the passage of time, building standards have changed to reflect current understanding. For safety reasons, the Inspector recommends that receptacles are replaced with grounded receptacles by a qualified contractor.

**Safety:** This bedroom contained outdated, ungrounded 2-prong electrical receptacles.

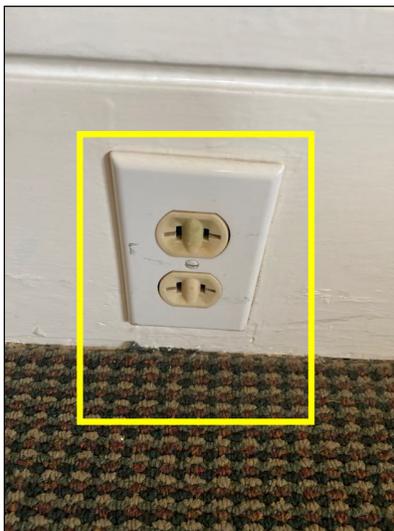
Page 56 Item: 2	Electrical	<b>Safety:</b> This bedroom contained outdated, ungrounded 2-prong electrical receptacles. Although this condition may have been commonly considered safe or acceptable at the time the home was originally constructed, as general knowledge of safe building practices has improved with the passage of time, building standards have changed to reflect current understanding. For safety reasons, the Inspector recommends that receptacles are replaced with grounded receptacles by a qualified contractor.

**Safety:** This bedroom contained outdated, ungrounded 2-prong electrical receptacles.

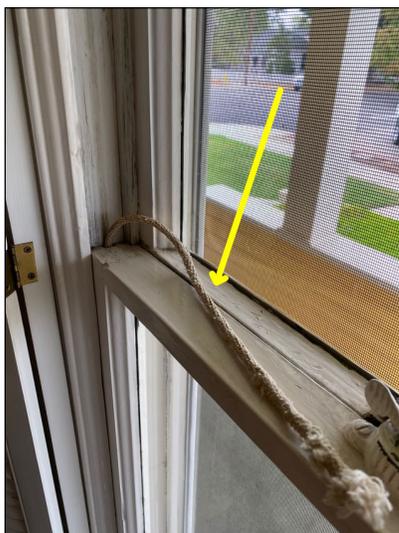
Page 58 Item: 11	Window Condition	<b>-SINGLE-HUNG</b> The lower sash of a single-hung window in the Bedroom would not stay up when lifted and released due to damaged/missing sash rope. The Inspector recommends service by a qualified contractor.

The lower sash of a single-hung window in the Bedroom would not stay up when lifted and released due to damaged/missing sash rope.

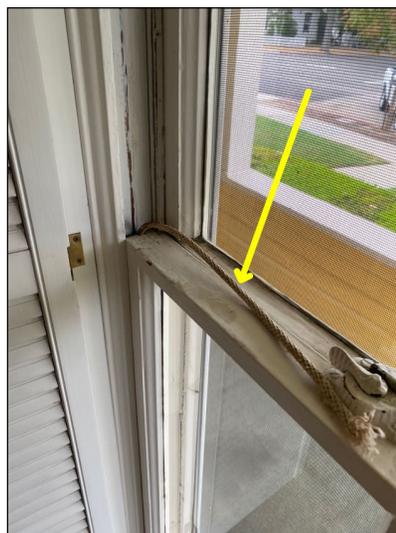
The lower sash of a single-hung window in the Bedroom would not stay up when lifted and released due to damaged/missing sash rope.
