SEARCHLIGHT
HOME INSPECTIONS

Confidential Inspection Report

LOCATED AT:
16483 Hwy. 67 Ramona, Ca.
Ramona, CA 92065

INSPECTED ON:
Sunday, December 7, 2025

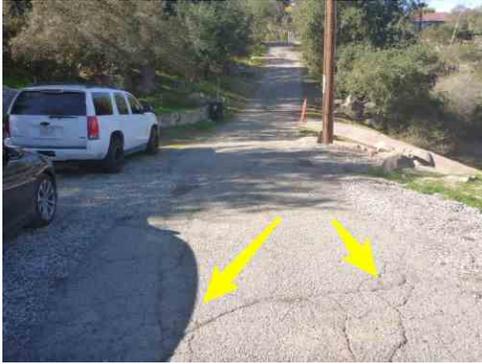
CR 49: The asphalt driveway is weathered/damaged/deteriorated. Continued use without repairs may require replacement.

Deteriorated/Cracked Driveway Asphalt Needs Repair

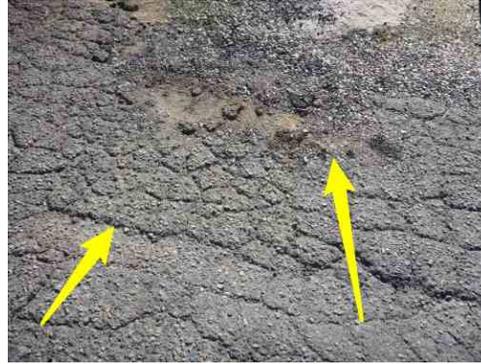
Deteriorated/Cracked Driveway Asphalt Needs Repair

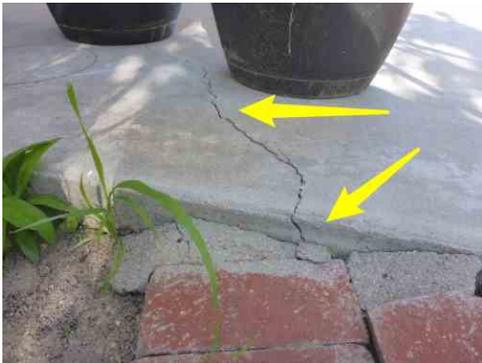
SC 50: There are cracks and heaving or settling of the patio(s). These conditions pose a trip hazard. We recommend correcting any trip hazard conditions. The brick to concrete transitions have offsets that are a trip hazard and need repair. The patio to balcony transitions are uplifted with damage and need evaluation and repair by a specialist and to improve site drainage to minimize soil movement and settling issues.

Patio Concrete Cracked & Offsets at Transition to Bricks is a Trip Hazard

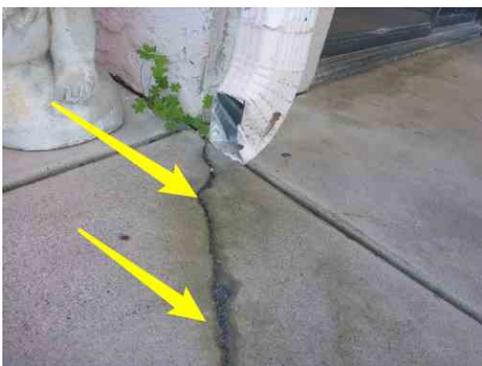
Cracked Concrete Patio w/ Downspout Discharging at Cracked Concrete

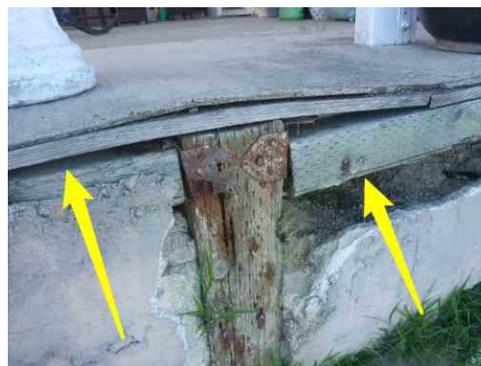
Patio To Deck Transition Damaged/Uplifted Needs Evaluation & Repair

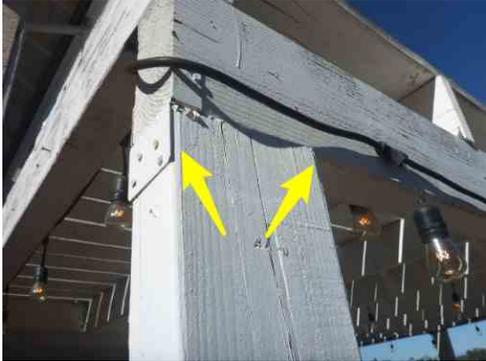
CR 51: The patio cover is not structurally sound with loose post connections at the top and the base of the posts are in contact with the soils and need evaluation & repair by a general contractor. The posts are loose and have improper metal brackets installed that are not secure at the connection points and need repair by a general contractor along with any costs for your budgeting purposes prior to close of contingencies. Unpainted wood sections at the patio cover also need sanding, sealing, and repainting to protect the wood from further deterioration.

Loose Patio Cover Posts Not Secured Properly at Top

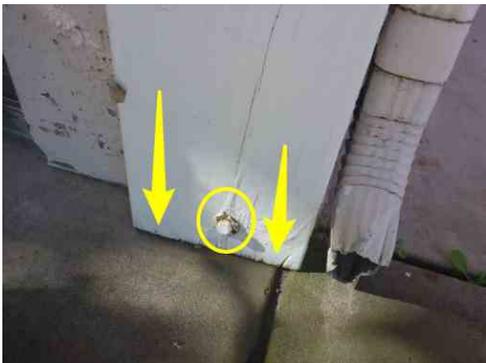
Patio Cover Support Posts Not Elevated Above Grade w/ Metal Brackets in Places Subject to Wood Rot

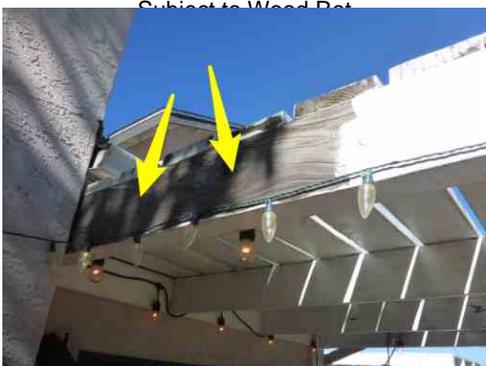
Patio Cover Not Fully Painted to Protect Wood From Damage

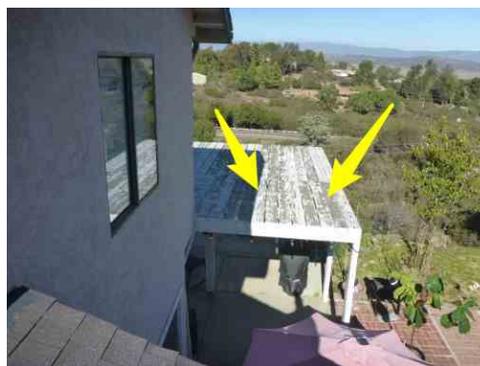
Patio Cover Needs Repainting & Repair

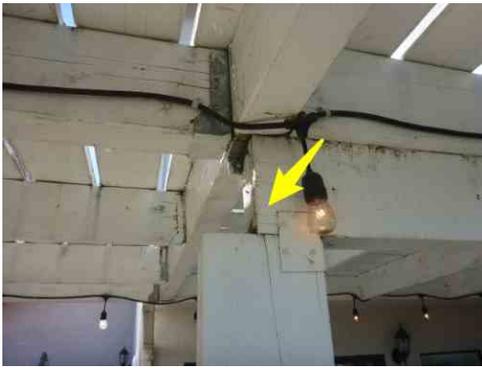
Patio Cover Beams Not Fully Supported at Post Connection Points

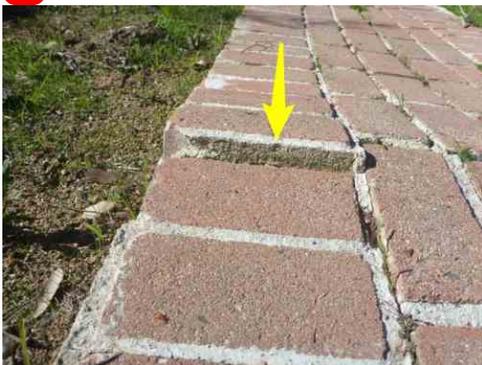
SC 52: Uneven sections in the walkway surface(s). This condition is a trip hazard.

Uneven Walkways w/ Offsets Are a Trip Hazard & Need Repair

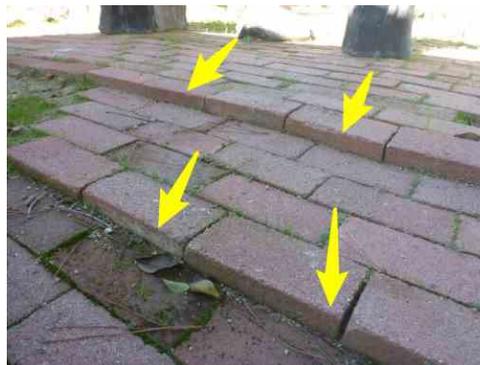
Uneven Walkways w/ Offsets Are a Trip Hazard & Need Repair

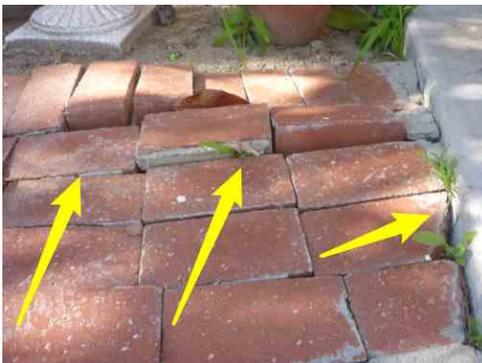
Uneven Brick Walkways Need Repair to Prevent Any Trip Hazards

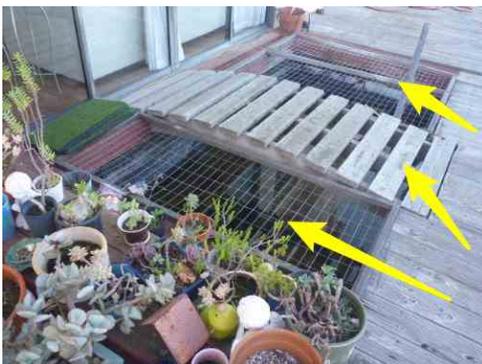
The abandoned rear deck pond is a trip hazard and is covered with light metal rolled fencing material that will not support the weight of a child or person and needs repair as this is part of a walkway outside the sliding glass door. This needs repair to prevent a trip and fall hazard.

Open Gaps at Abandoned Pond Is a Trip & Fall Hazard

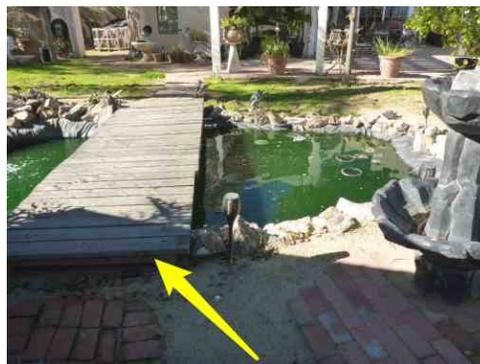
Walkway Offsets Are a Trip & Fall Hazard & No Guardrails at Ponds

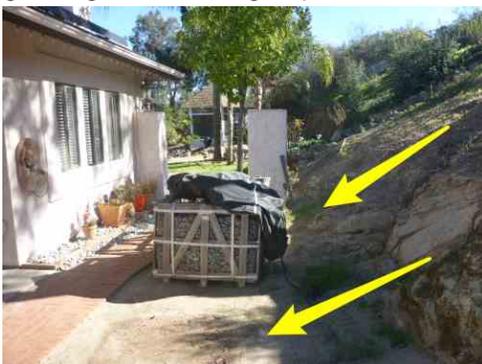
Front Side Lacks Drainage to Control Excess Water Run Off Away From Structure/Foundation

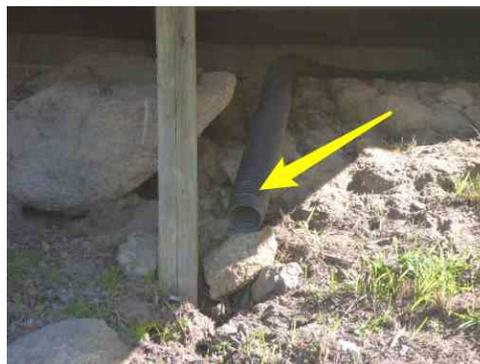
The corrugated drain line terminates under the balcony deck and is draining on a support post for the balcony deck and needs to be extended further away from the post at the base to prevent water damage as this can cause settling of the support framework for the balcony deck. Have further evaluation by a grading and drainage specialist.

Corrugated Drain Line Under Balcony Deck Terminates Next to the Support Post & Needs To Be Extended Further Away

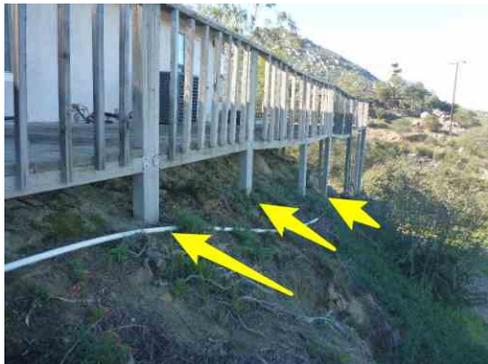
SC s-57: The balcony deck is not structurally sound and needs further evaluation by a deck specialist for costs of replacement as it is not safe for access in its current condition. The deck framing is not secure or safe as posts are set on rocks, framing is sagging, guardrails are missing balusters with wide openings and posts are not secured and lack metal brackets for secure connections. Wood deck planks are loose with raised nails and are a trip hazard. Have further evaluation by a balcony deck specialist for costs of repair/replacement prior to close of contingencies.

Balcony Posts In Contact w/ Soils Not Secure w/ Sagging Framing

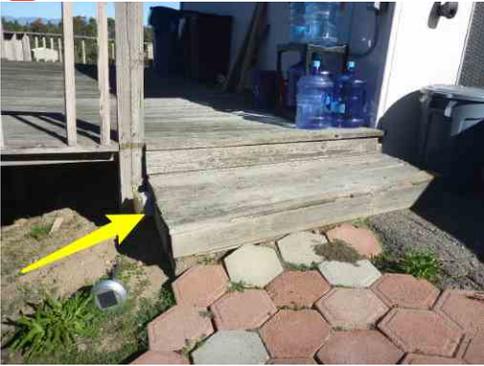
SC 58: One or more of the stair steps are loose at the balcony deck and need to be level and secured.

Loose Wood Step to Balcony Needs Repair

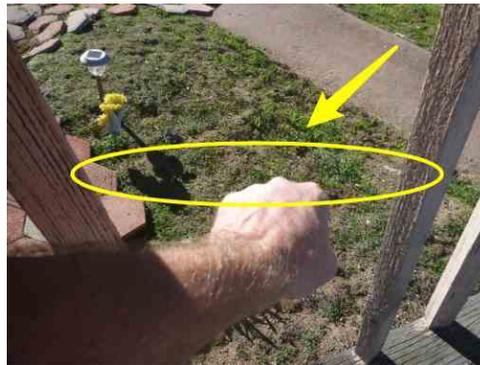
CR s-60: The balcony guard railings are not secure and/or not sturdy. We recommend the railings be reinforced or replaced in accordance with present standards.

Balcony Guardrails Loose w/ Missing Wide Open Spaces Not Safe

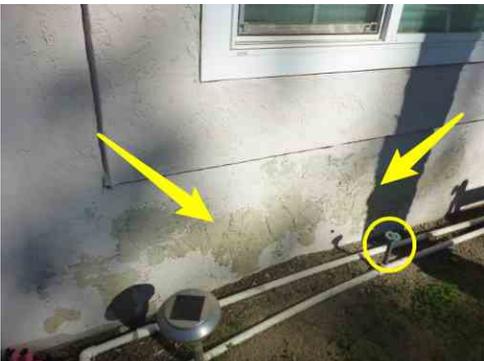
FE 61: The stucco siding has past repairs. We recommend inquiring about the condition(s) documented. Check that the sprinklers are not spraying up against the house and patch and repair as necessary after redirecting them away from the structure.

Stucco Past Patching Repairs Check Sprinklers Aren't Spraying on Stucco

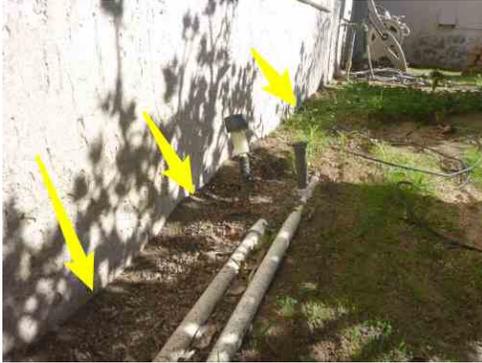
FE 63: The stucco weep screed material along the bottom of the stucco siding needs 2" of clearance to concrete or 4" clearance to earth. Clear soils at the base and slope away at 1/4" per foot to drain away towards area drains to control any excess water run off away from the structure and perimeter foundation areas to an appropriate location as per local jurisdiction.

Clear Soils at Base of Stucco by 4" to Drain Properly

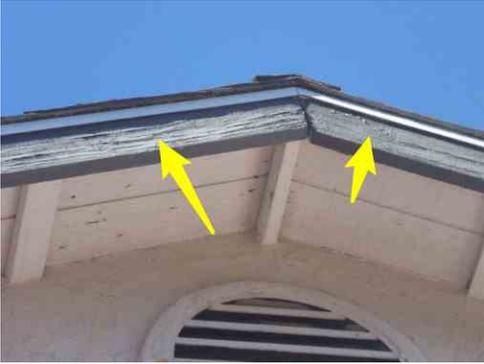
CR 67: The visible fascia materials appeared worn/weathered/aging and needs further evaluation by a termite specialist for any costs of repair.

Worn Fascia Boards Need Further Evaluation
by a Termite Specialist for Any Costs of
Repair

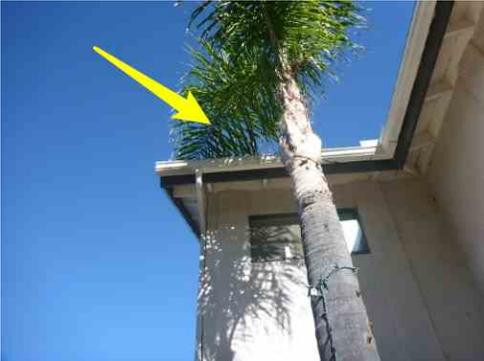
CR 68: Trees are touching or over-hanging the roof. We recommend they be trimmed to prevent damage to the roofing surface, and allow free flow of roof runoff.

Keep Palms Trimmed Off Structure/Roof To
Prevent Damage & Pest Access

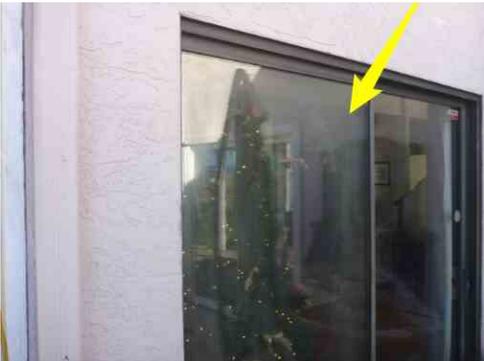
CR 69: Condensation/stains are visible between the exterior sliding glass door panes between the thermal glass panes. We recommend having all of the thermal doors and windows evaluated by an appropriate professional in the appropriate trade. This was noted for the sliding glass door in the living room. Check all glass panes for any failed hermetic seals and replace as necessary.

Fogged Sliding Glass Door Panes at Exterior
Doors Need Evaluation/Repair

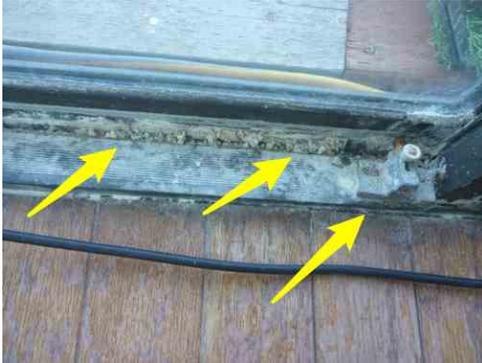
CR 70: The exterior sliding glass doors are corroded at the base of the metal tracks and are difficult to open and others are stuck shut and need hardware service to open and close easily for egress. Some of the sliding glass door screens are missing and need replacement. Have further evaluation and repair by a door specialist.

Corroded Sliding Glass Door Frames/Tracks are Stuck or Hard to Open & Need Repair for Egress

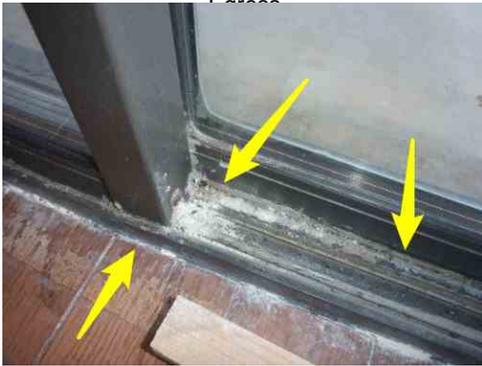
Corroded Metal Sliding Glass Door Frames & Tracks Need Evaluation/Repair To Open Easily

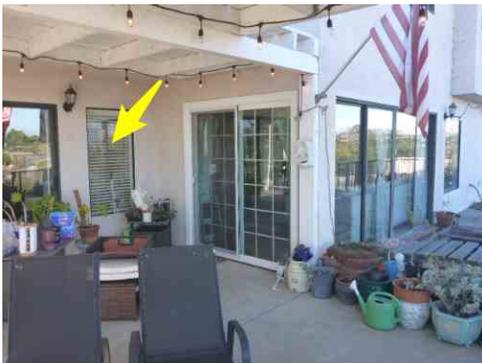
FE 71: Condensation/stains are visible between the glass panes in the thermal window(s). We recommend having all of the thermal doors and windows evaluated by an appropriate professional in the appropriate trade. This was noted for the dining room fixed window left of the sliding glass door.

Fogged Fixed Window Next to Sliding Glass Door in Dining Rm

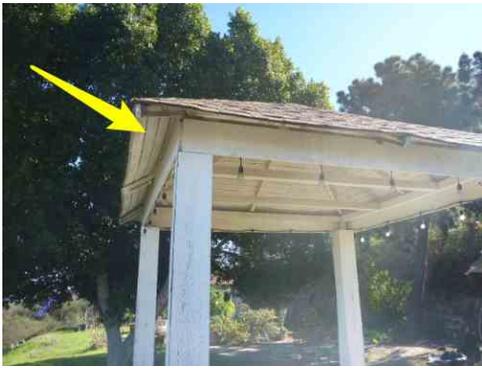
CR 74: The gazebo has damaged wood and is not structurally sound. Have further evaluation by a termite specialist for costs of repair or removal prior to close of contingencies.

Gazebo is Not Structurally Sound w Wood Damage & Needs Repair/Replacement

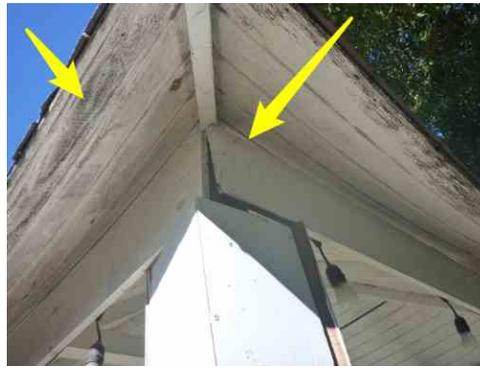
Loose Posts w/ Wood Rot Damage at Gazebo Not Structurally Sound

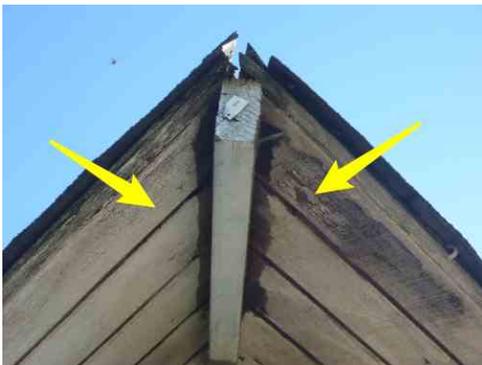
Roof Rot Damage at Gazebo Not Structurally Sound

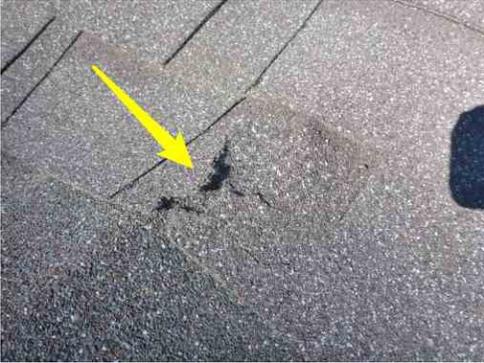
CR 82: The ridge cap shingle is damaged at one area noted in the report photo and needs repair to replace the torn shingle section. Have serviced by a roofer as regular maintenance to prevent any leaks.

Replace Torn Roof Shingle Near Ridge Cap
To Prevent Leaks

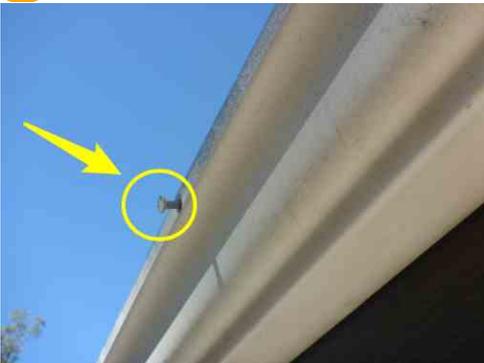
CR 83: The rain gutters are loose from the building and need to be secured.

Loose Nails That Support the Rain Gutters
Need to be Secured Properly

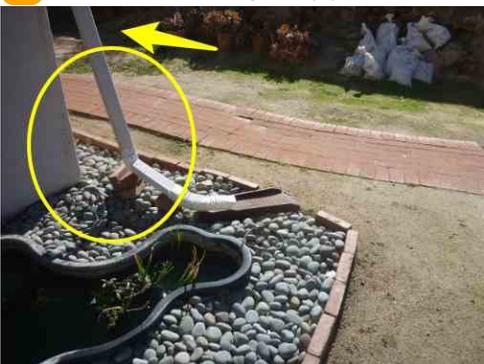
CR 84: The downspout(s) are loose from the building.

Loose Downspouts Not Secured & Need
Service to Be Secured & Extended Away
From House

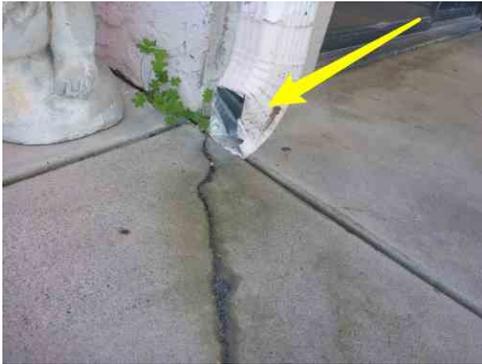
CR 85: Runoff water from the roof discharged next to the building. We recommend the downspouts be routed sufficiently away from the building to prevent ponding, pooling, and saturation of the soil at the foundation.

Extend Downspouts Away From Structure & Foundation Areas

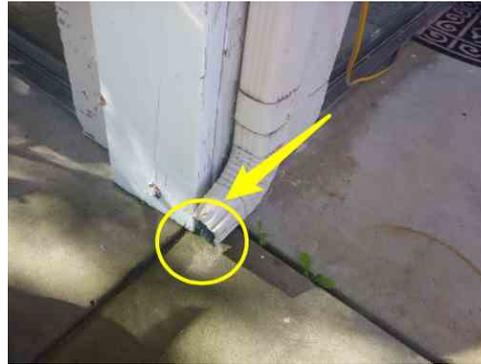
Extend Downspout Away From Structure To Prevent Ponding at Foundation

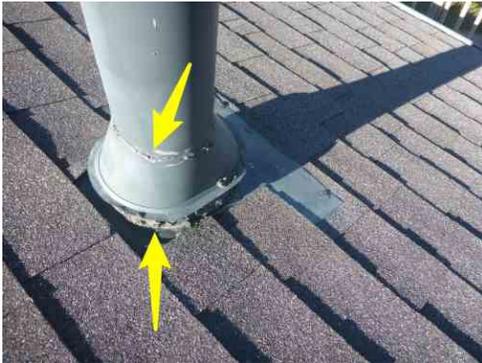
CR 87: The roof penetrations are not sealed at several locations. We recommend correcting the condition(s) using approved methods as noted for the old furnace vent pipe penetration that has moisture stains around the pipe in the attic space above the garage.

Abandoned Furnace Vent Pipe Penetration Needs Resealing

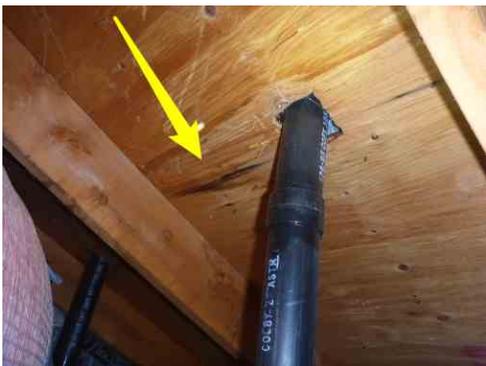
FE 96: Moisture stains visible on the plywood sheathing around the roof penetrations. These moisture stains appear to be prior to the re roof and should be confirmed by the seller. Further evaluate the roof penetrations and reseal any penetrations as necessary.

Attic Moisture Stains Around the ABS Vent Penetrations Prior to Re Roof

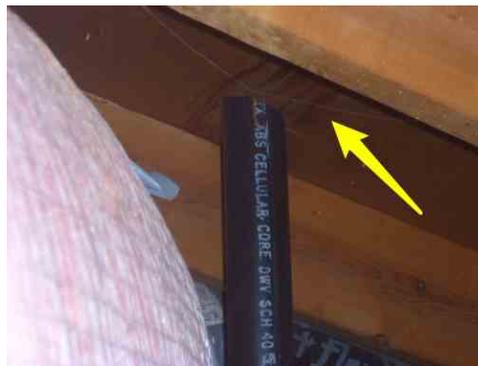
Old Attic Moisture Stains Around ABS Vent Penetrations Prior to Re Roof

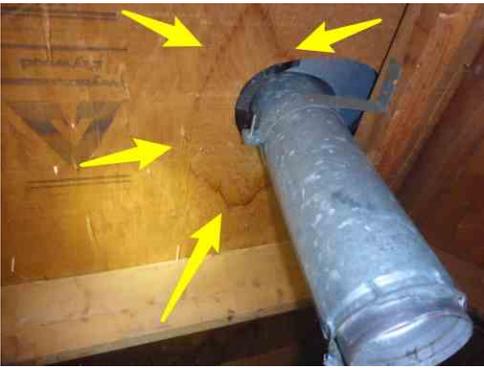
Attic Moisture Stains at Furnace Vent Pipe
Penetration Needs Resealing at Roof

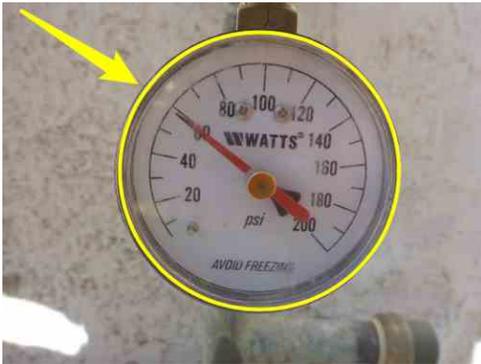
109: The pressure at an exterior hose faucet tested at 60 psi. which is in the acceptable range between 40-80 PSI and should be checked annually. A pressure regulator was not seen at the main valve and is not required if the pressure is in the acceptable range between 40-80 psi but is recommended to be installed if one does not exist in the system.

Water Pressure Was Good at 60 PSI during inspection. Check Annually

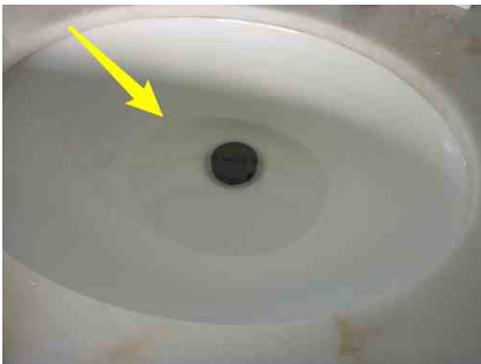
Downstairs Guest Suite Bath Sink Drain Slow & Needs Line Cleared

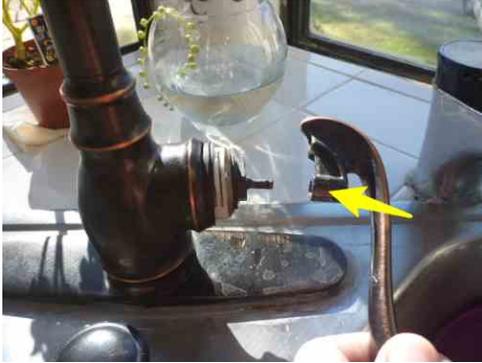
CR 114: The kitchen sink faucet has missing parts and the handle is loose and missing the set screw to secure it in place and needs service.

Kitchen Sink Faucet Missing Parts & Handle
Not Secured

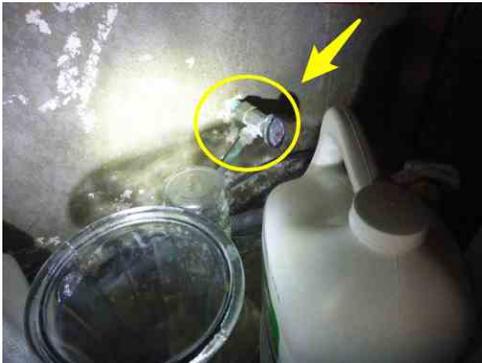
CR 116: Old style gate valves and plastic supply lines are present at the sinks and or toilets. I recommend updating older gate valves and plastic lines to newer style angle stop ball valves with stainless steel braided lines to prevent leaks by a plumber.

Old Style Corroded Gate Valves at Kitchen
Sink Recommend Upgrading w/ Angle Stop
Ball Valves & SS Braided Hoses

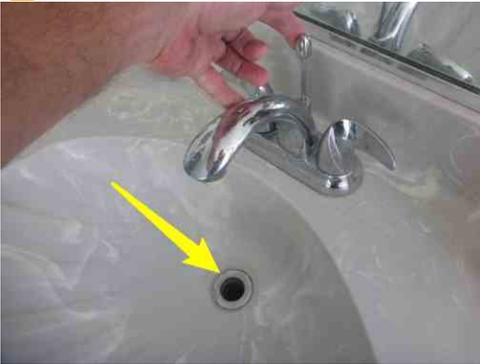
CR 118: Upper hall bathroom sink stopper mechanism is missing parts and needs repair service.

Upper Hall Bath Sink Stopper Missing Parts & Needs Service

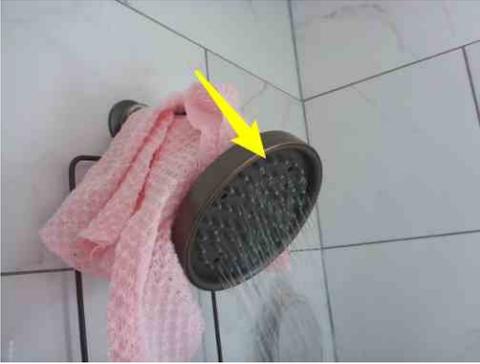
CR 124: The downstairs guest suite shower has lower flow on the hot side and needs the scald protection adjusted for full flow rate as noted in the report photo.

Downstairs Guest Suite Bathroom Shower
Needs Scald Protection Adjusted for Better

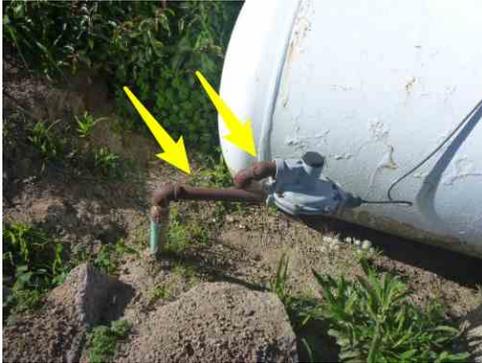
CR 128: Areas of the visible gas piping are rusted/corroded by the propane tank as seen in the report photo. These should be kept sealed and need sanding and painting or to be replaced as necessary. Check with the company that leases the tank for service and repair as necessary.

Rusted Gas Line at Propane Tank Needs Service to Prevent Leaks

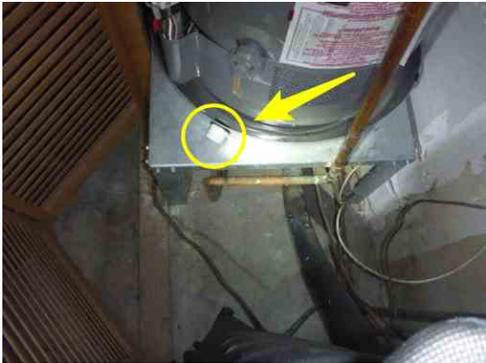
CR 144: The drain line in the drain pan under the water heater does not extend to the exterior and is recommended to be installed to prevent water damage at the interior.

Water Heater Drain Pan Discharge Line Not Extended to Exterior

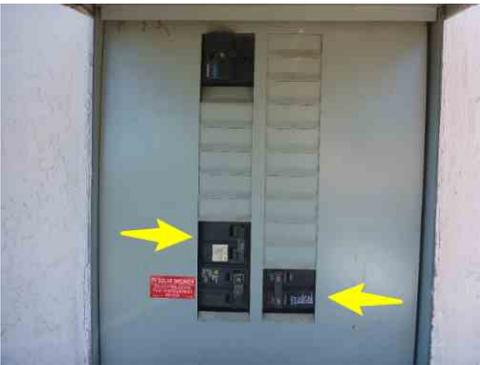
CR 159: A number of breakers are not labeled. We recommend they be accurately labeled to allow individual circuits to be shut off for maintenance or emergency needs.

Main Electrical Panel Circuit Breakers Not Labeled

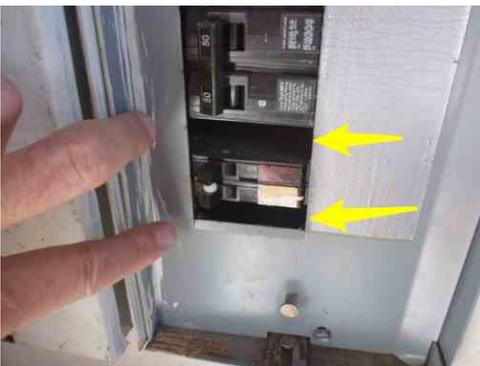
SC 166: There are at least 5 missing twist-outs/unused breaker slots in the garage sub panel. This condition is a safety hazard and needs plastic inserts installed to prevent any shock hazards.

At Least 5 Missing Knockouts Need Plastic Inserts Installed at Garage Sub Panel

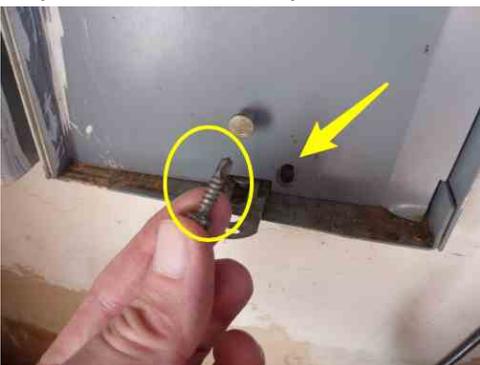
SC 167: The garage sup panel cover screws are the improper/pointed type. The sharp pointed screws can penetrate the wiring posing a safety hazard and need to be replace with blunt ended machine screws as per manufactures specs.

Wrong Type of Pointed Screw at Garage Sub Panel Front Cover

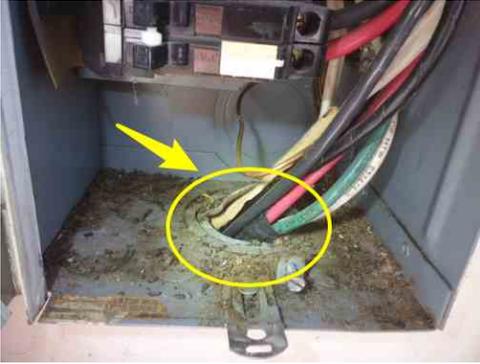
SC s-168: Circuit wires/cables are missing strain relief clamps/devices where the wires enter the garage sub panel and needs repair by an electrician.

No Strain Relief Clamp at Garage Sub Panel
Where Wires Enter at Base

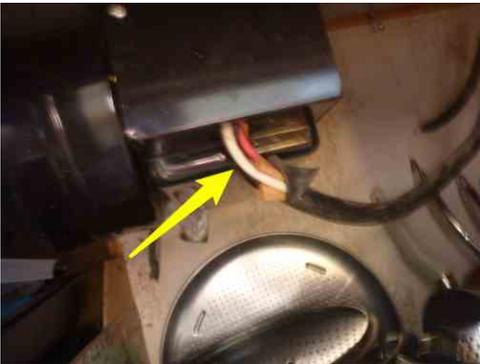
The kitchen cabinet has open spliced wires that lack conduit and a junction box and need service as noted in the report photos. The kitchen pantry light is also improperly wired and has exposed wiring that needs repair. Have further evaluation and repair by an electrician along with any costs of repair prior to close of contingencies.

Loose Exposed Wires In Kitchen Cabinet Lack Conduit & Need Service

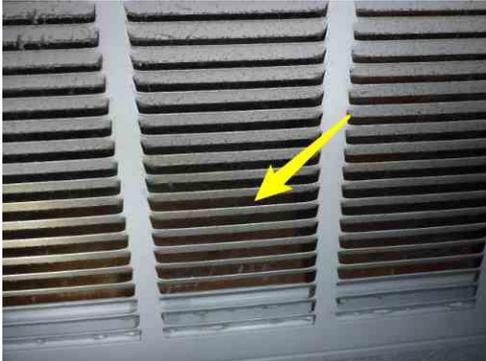
No Furnace Filter at the Hallway Filter Grill Cover & Needs Installation

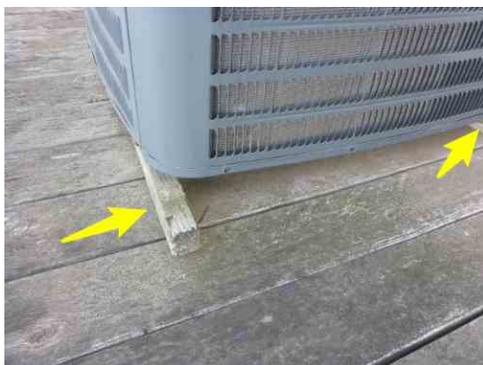
AC Condensing Unit On Loose Wood Rails & Needs to be Leveled & Secured at the Base

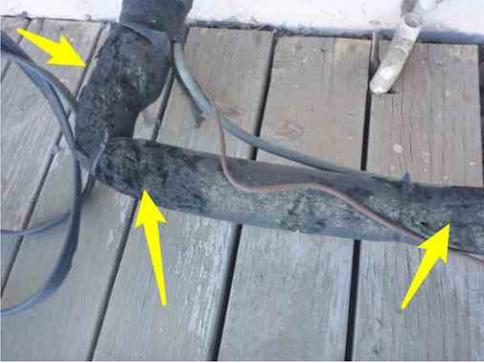
Worn Insulation on AC Condensing Unit
Needs Repair & Cover For Mice

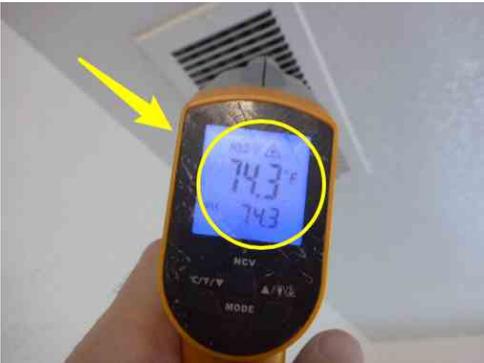
AC Unit Not Cooling During Inspection &
Needs Evaluation For Costs of Repair

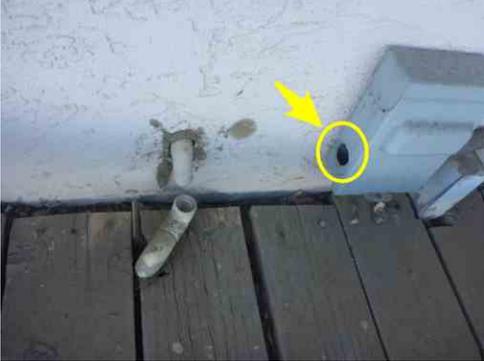
Install Plastic Insert Cover at AC Disconnect
Hole on Rear Balcony Deck

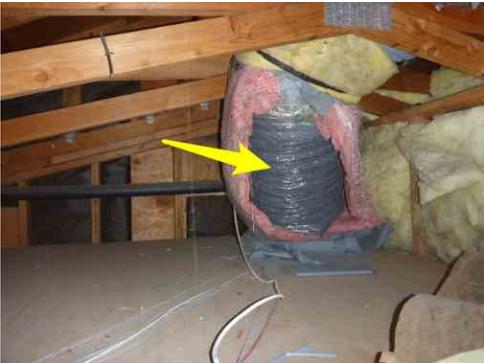
Attic Ducts w/ UV Damaged Outer Plastic
Cover Need Repair/Replacement

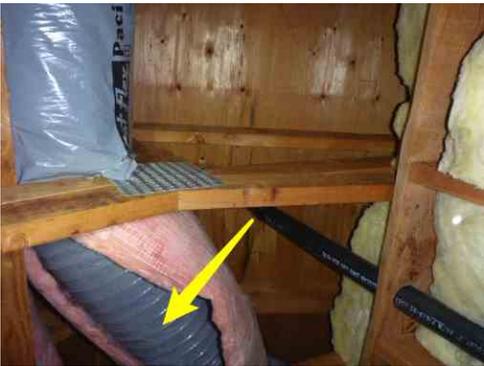
Attic Ducts w/ UV Damaged Outer Plastic
Cover Need Repair/Replacement

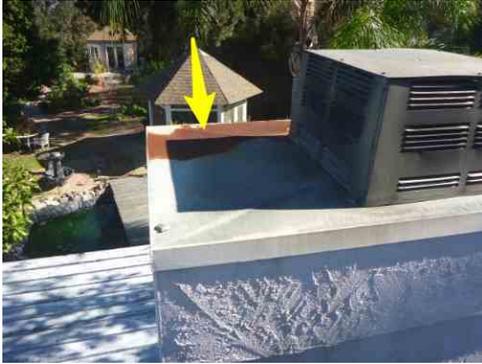
Rusted/Sunken Metal Chimney Cap Needs Proper Slope to Drain

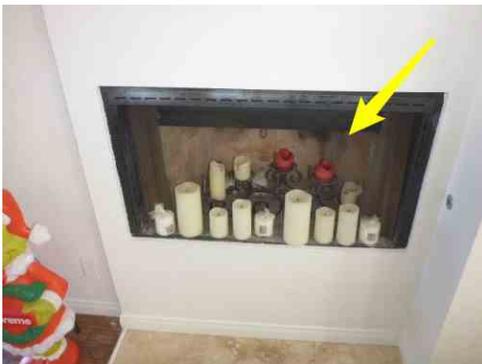
Living Room Fireplace Missing Glass Doors

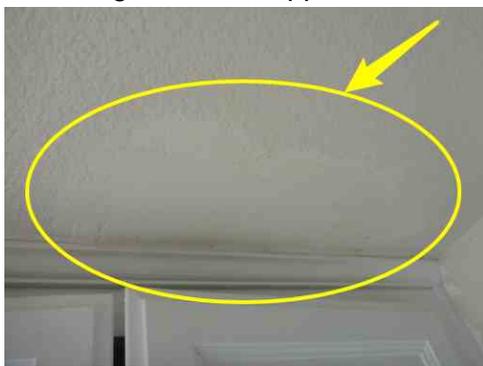
Ask Sellers About Ceiling Patch at Laundry Rm & Repair Paperwork

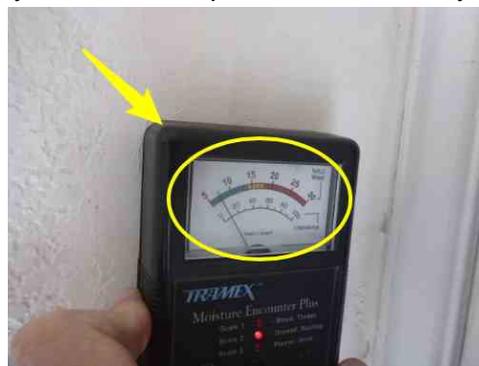
Laundry Room Ceiling Patch Dry w/ Moisture Meter Test at Inspection

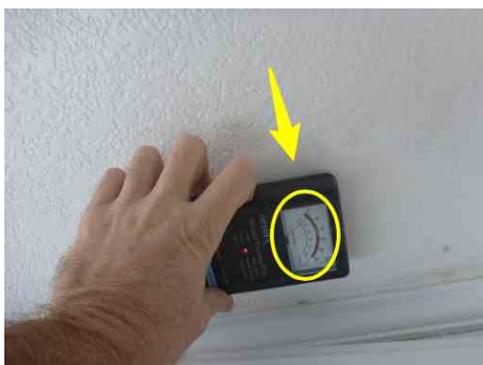
Laundry Room Ceiling Patch Dry w/ Moisture Meter Test at Inspection

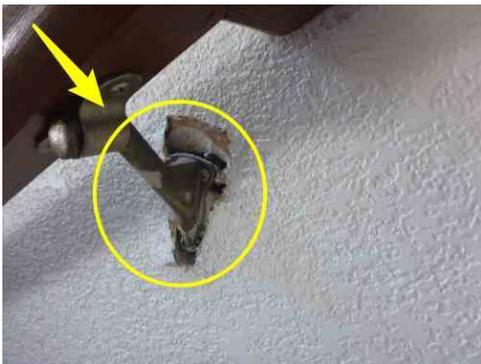
SC s-238: The stair handrail(s) are not properly secured and needs service for the top handrail bracket as noted in the report photo.

Stair Handrail Loose at Top Bracket Needs Service

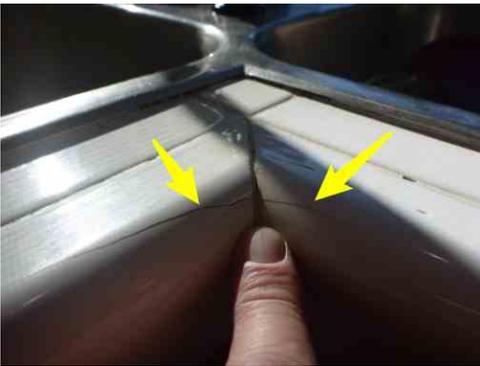
Cracked Kitchen Countertop Tiles by the Sink
Need Repair

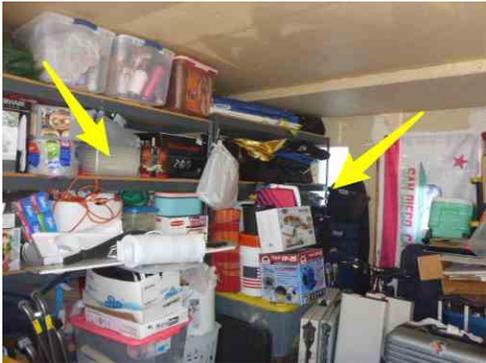
Garage Too Full of Personal Items To See Much or the Floor

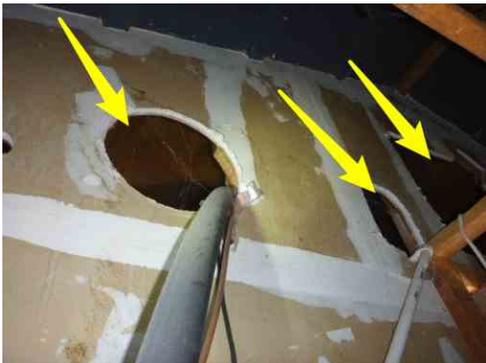
Holes in Garage Firewall Need Repair to Maintain Fire Separation
