PROJECT NAME :
HOUSE STRUCTURAL EVALUATION REPORT.

ADDRESS : 15215 JENKINS DR., WHITTIER, CA 90604

SCOPE OF WORK :
HOUSE STRUCTURAL EVALUATION REPORT

DATE: 10/18/2025

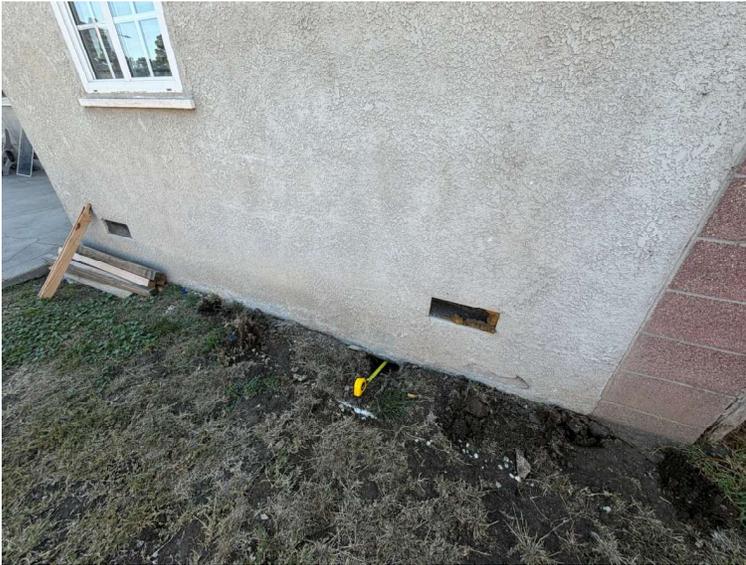
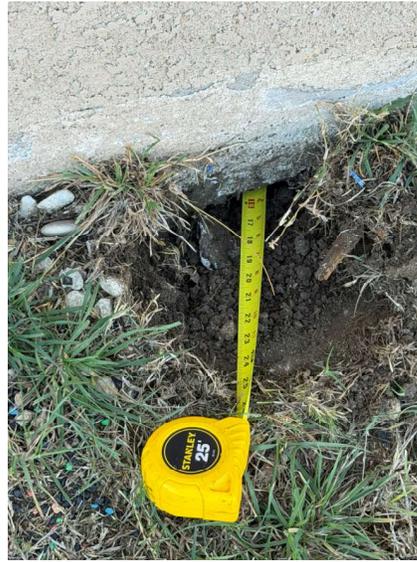
Pictures description:
Current pictures taken at the backyard. There is no continues footing under exterior wall .

3. SOIL GRADE LEVEL AROUND THE HOUSE SHALL BE SLOPED 2% AWAY FROM THE HOUSE WALL FOR THE CORRECT DRAINAGE PURPOSES;
4. CURRENT OLD HOUSE OF 71 YEARS OLD WAS BUILT UNDER QUALITY LEVEL, INSPECTED AND APPROVED DURING CONSTRUCTION. CURRENT BUILDING CODE CBC 2022 WON'T ALLOW THAT TYPE OF FOUNDATION FOR CURRENT CONDITIONS. HOUSE REQUIRED FOR VOLUNTARY UPGRADE OF THE OWNER'S OPTION. UNDERPIN METHODE CAN BE USED FOR MODIFICATIONS OF THE EXSITING FOUNDATION SYSTEM AND SHALL BE DESIGNED BY PROFFESIONAL ENGINEER AND APPROVED BY THE CITY AUTHORITIES.

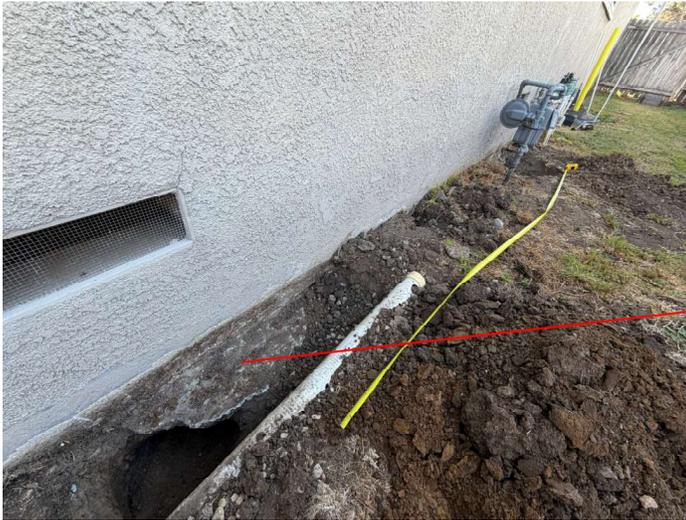
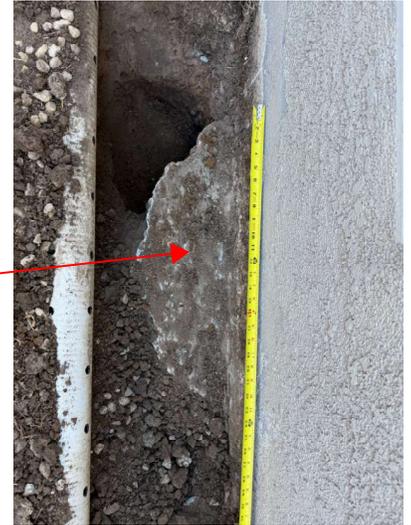
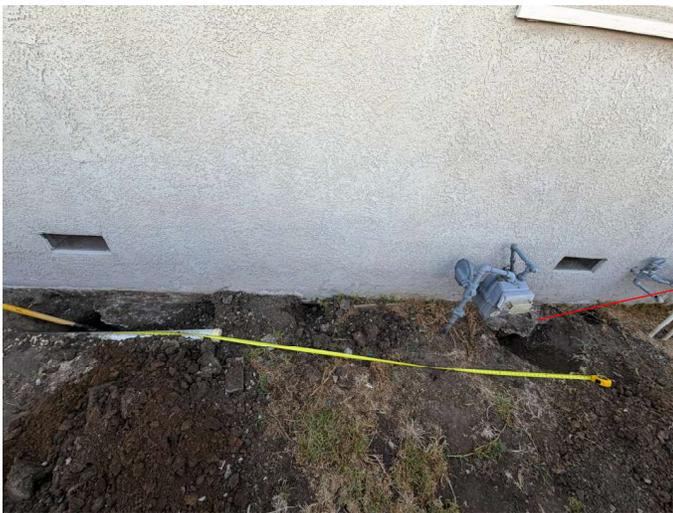
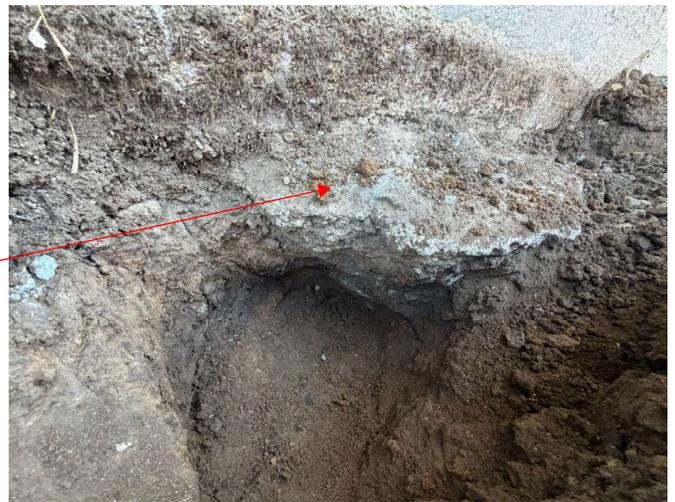
Pictures description:
Current pictures taken at the side yard ,West house wall. There is no continues footing under exterior wall but found pad footings spaced ~ 9 ft.

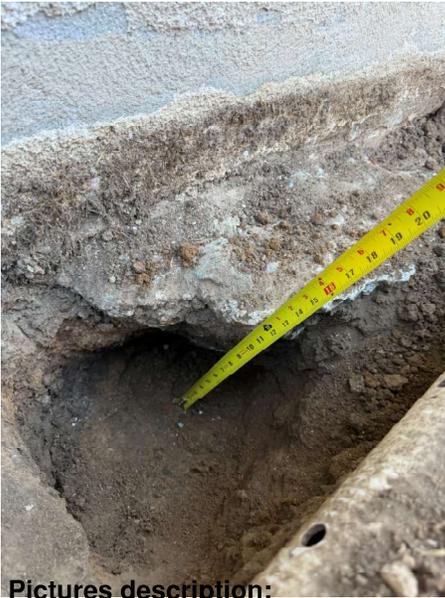
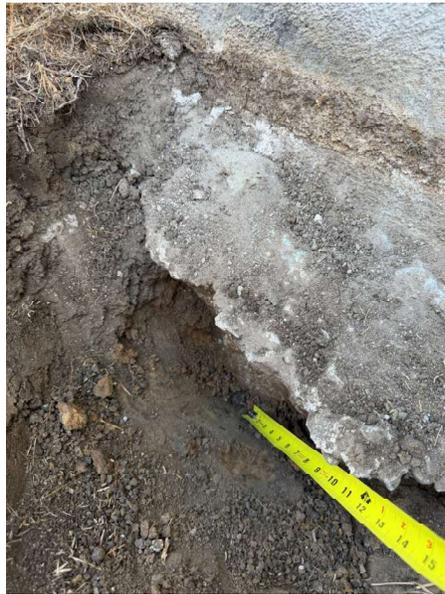
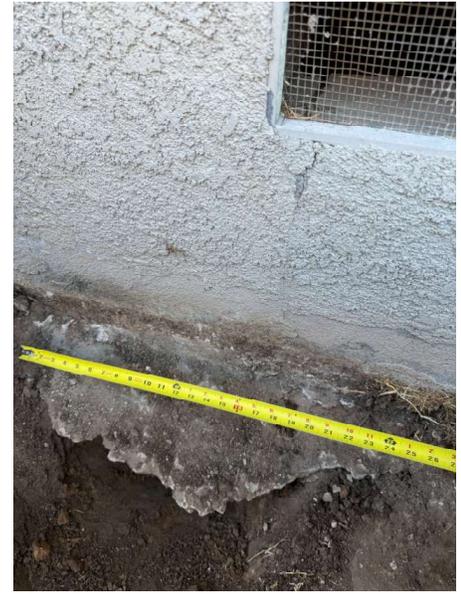
Current pictures taken at the side yard ,West house wall. There is no continues footing under exterior wall but found pad footings spaced ~ 9 ft and ~16" min. in depth and ~24" wide,

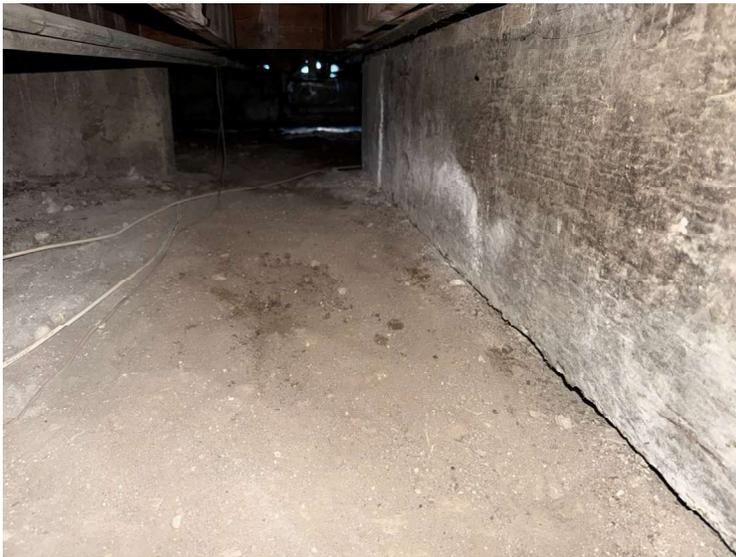
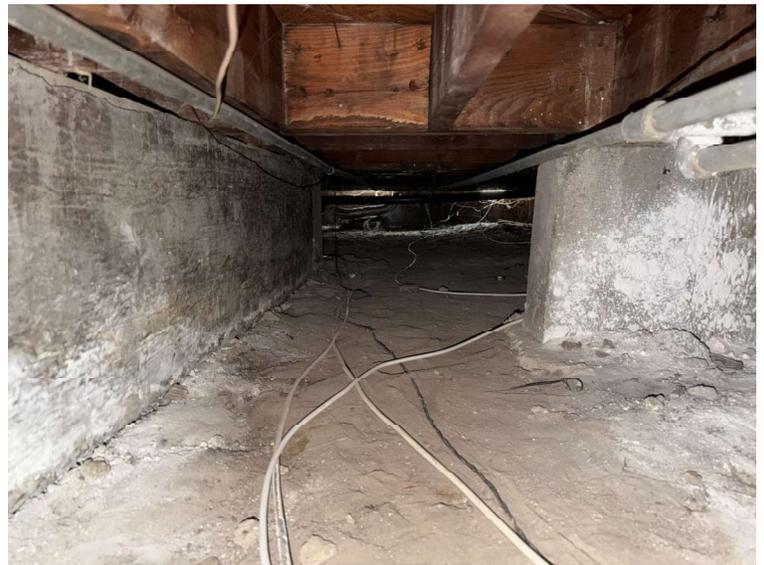
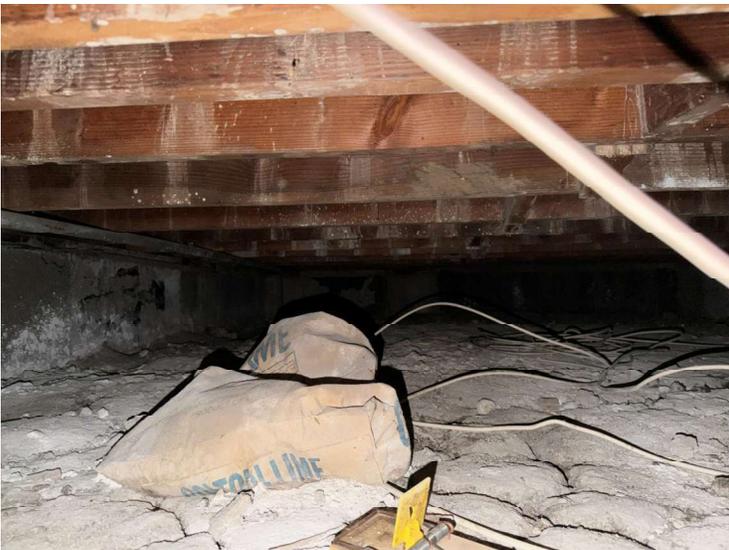
Current pictures taken at the crawl space area , no continues footing observed under the stem wall. Bottom of the stem wall is straight and flat.

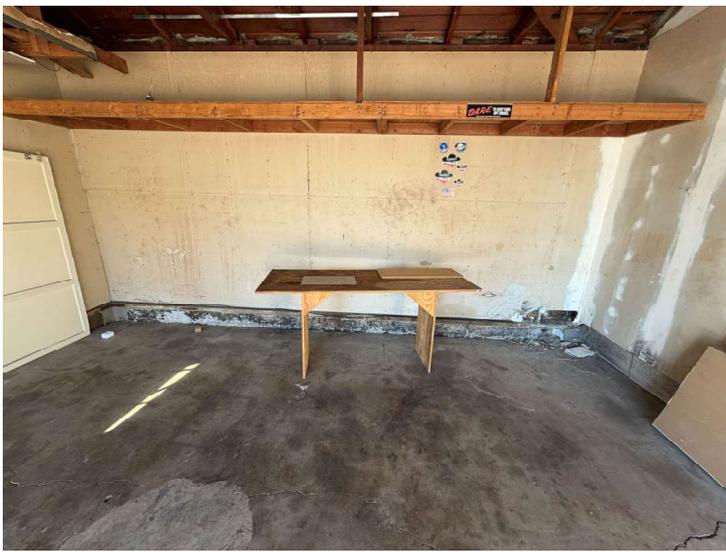
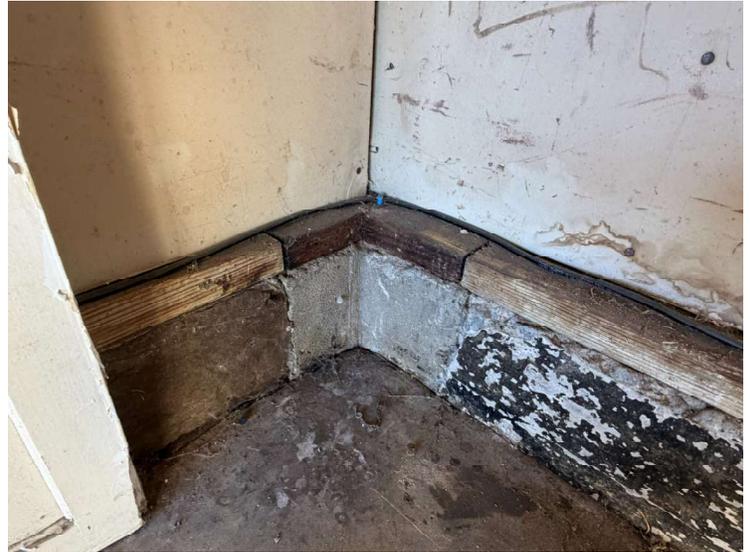
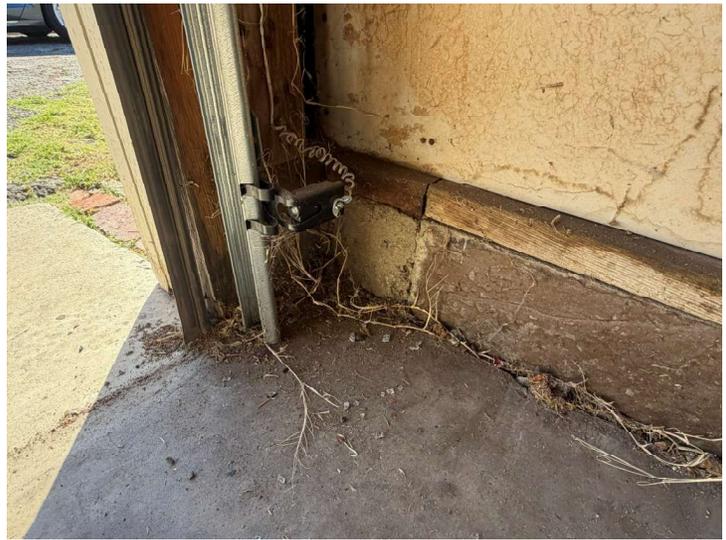
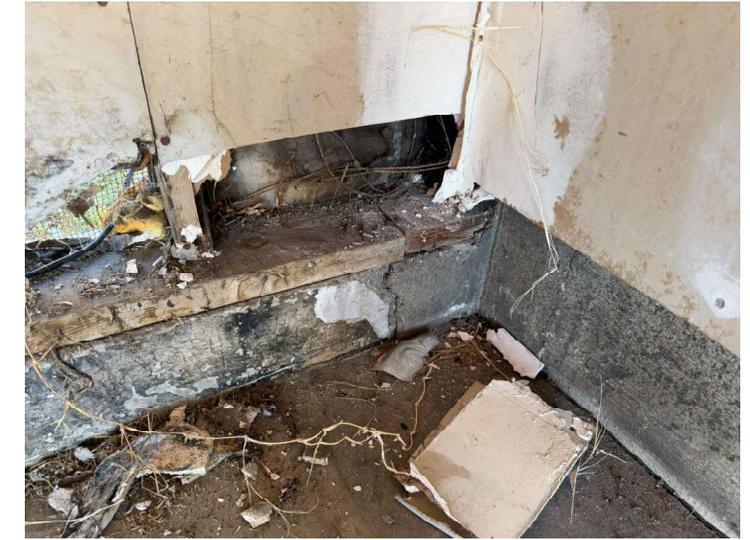
Current pictures taken at the attached two car garage , no continues footing observed under the stem wall. Each corner of the garage has original inserts which follow the same pattern for the foundation system discovered for the house.

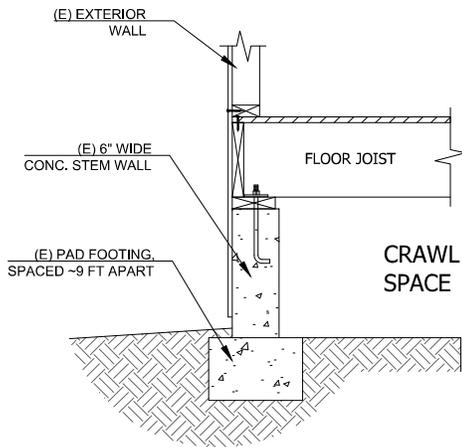
1 (E) FOUNDATION DETAIL
NTS

1. MOST OF THE CRACKS ARE RELATED WITH THE MAINTENANCE ISSUES IN 71 OLD HOUSE AND HAS NO SAFETY OR STRUCTURAL ISSUES;
2. EXISTING TYPE OF FOUNDATION IS NOT CONVENTIONAL FOR THAT TYPE OF TRACK HOME AND LOCATION. RAISED FOUNDATION WITH CONCRETE STEM WALL (POSSIBLY PRECAST SECTIONS AND INSTALLED IN THE FILED) SUPPORTED BY CONCRETE PAD FOOTINGS WHICH SPACED APART. CURRENT TYPE OF FOUNDATION CAN BE USED IF DESIGNED AND BUILT PROFESSIONALLY. SEE PAGE 5 DETAIL #1 FOR MORE INFORMATION.
