# Inspection Report

**Property Address:**  
51 Quinta Court  
Paso Robles CA 93446

1/15/2026

**Harper Homes: Home Inspection Services**

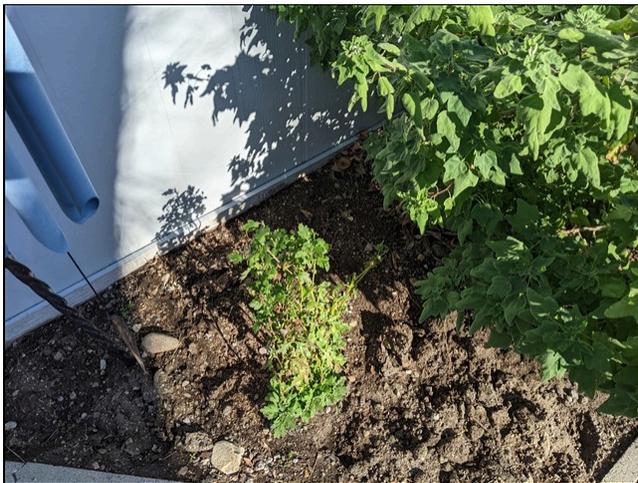
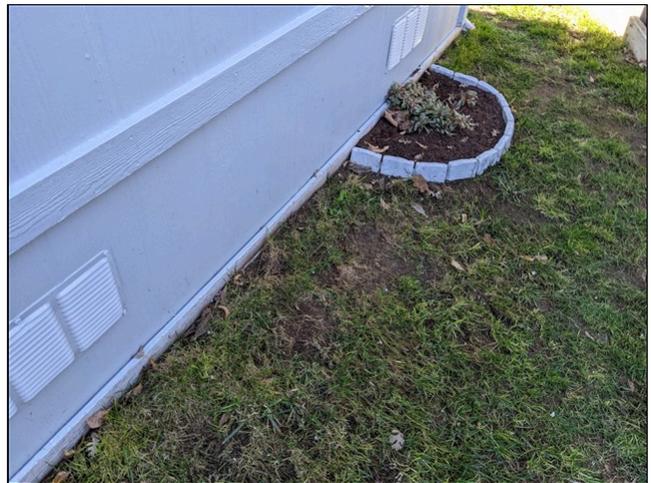
Soil or landscape materials pushed up against the wood siding at the front and rear exterior. No moisture damage was noted. Refer to the pest report for more information on this condition and have material removed to prevent earth to wood contact while allowing drainage to remain effective.

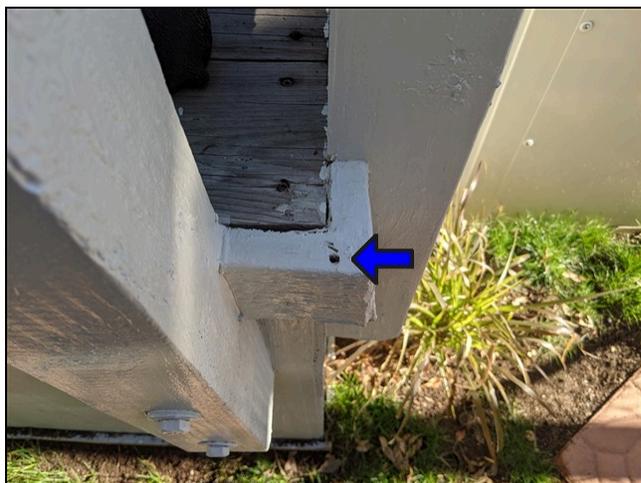
1.1 Item 1(Picture)

Moisture damage noted left deck. Recommend further evaluation by a structural pest control operator and make repairs as prescribed.

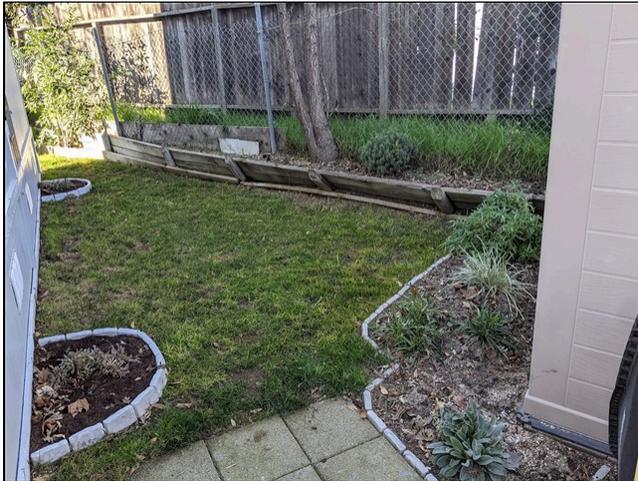
1.5 Item 1(Picture)

Landscape retaining wall at the rear exterior is leaning slightly and can be altered or re-installed, as needed.

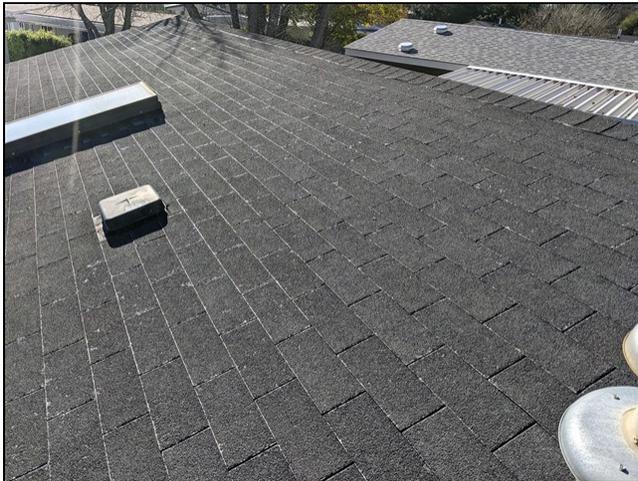
2.0 Item 1(Picture)

Areas of the roofing material are weathered and showing signs of age. No leaks were noted in the attic or interior. Recommend further evaluation with cost to replace and remaining life determined by a licensed roofing contractor.

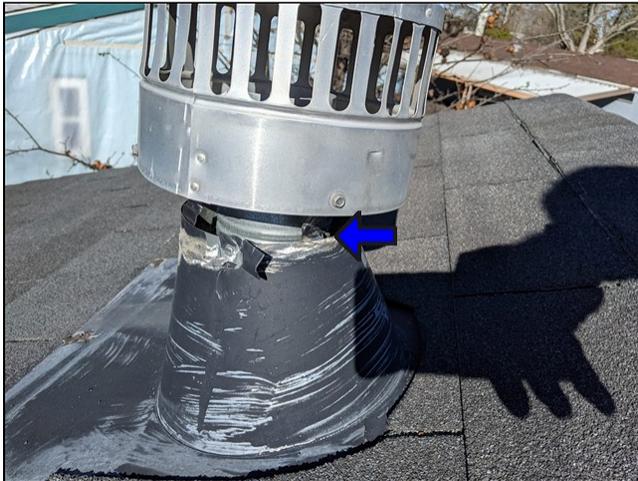
2.2 Item 1(Picture)

The water heater vent is gaped and should be properly sealed or a storm collar installed to prevent moisture intrusion.

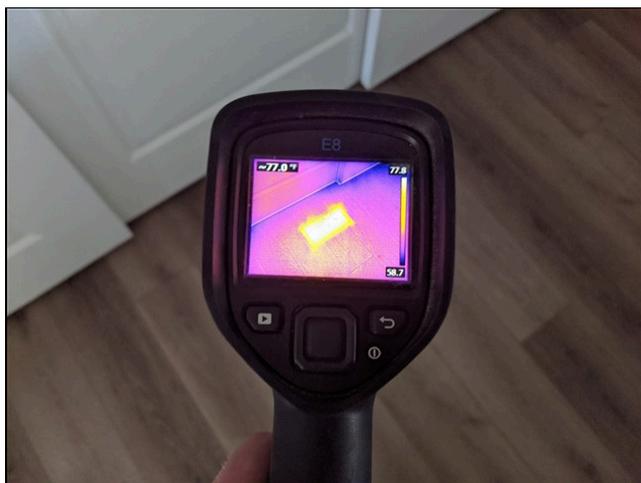
3.0 Item 1(Picture)

The furnace appears to be in working condition, but is over 20 years. Recommend service performed by a qualified HVAC contractor to help conserve the remaining life of the unit and have replaced as necessary.

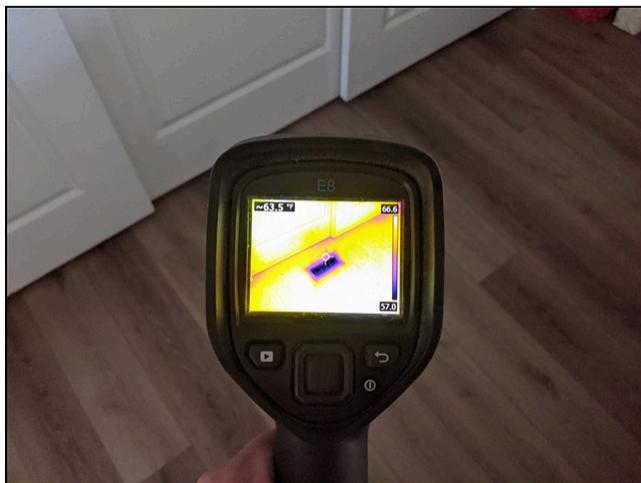
3.4 Item 1(Picture)

The cooling system was tested and functional at the time of the inspection.

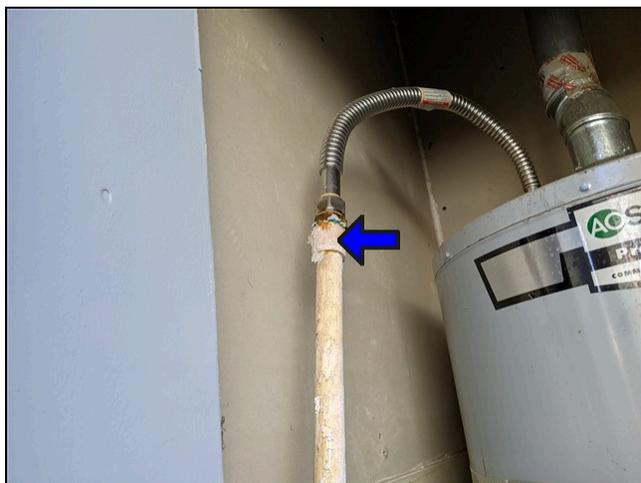
4.2 Item 1(Picture)

Supply line leak noted at water line in the water heater closet and should be repaired to prevent further deterioration and water waste.

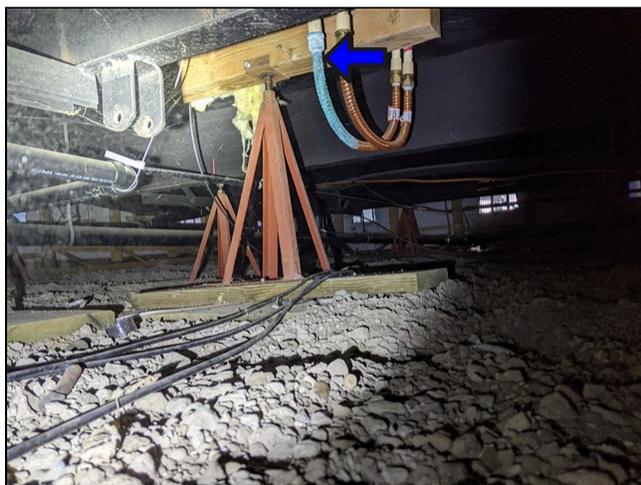
4.2 Item 2(Picture)

A moderate amount of corrosion was noted at the fitting in the sub area. No leaks were noted. Recommend cleaning all corrosion off of the pipes as needed and monitor for leaks.

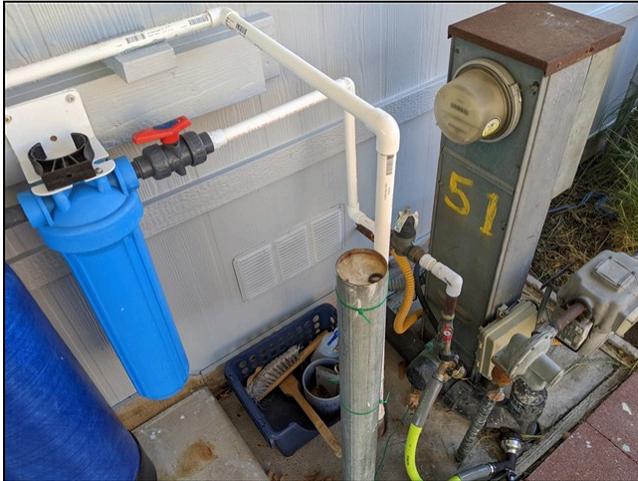
4.2 Item 3(Picture)

Water supply lines need complete insulation at the main entrance to the building to help prevent damage in freezing weather.

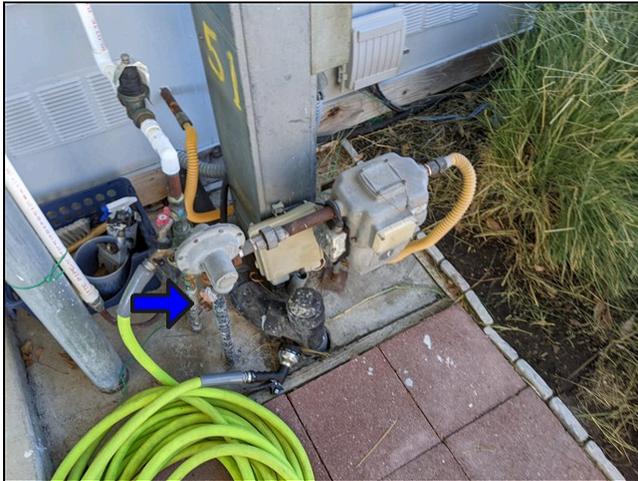
4.3 Item 1(Picture)

The gas shutoff is located at the right exterior of the home. To turn the gas off turn the valve perpendicular to the piping.

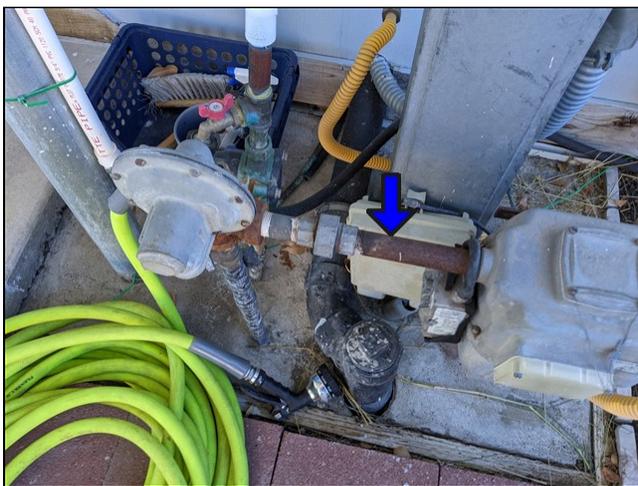
4.3 Item 2(Picture)

Steel gas line is rusted at the right exterior and should have loose rust removed and painted with proper corrosion inhibiting paint to prevent further deterioration.

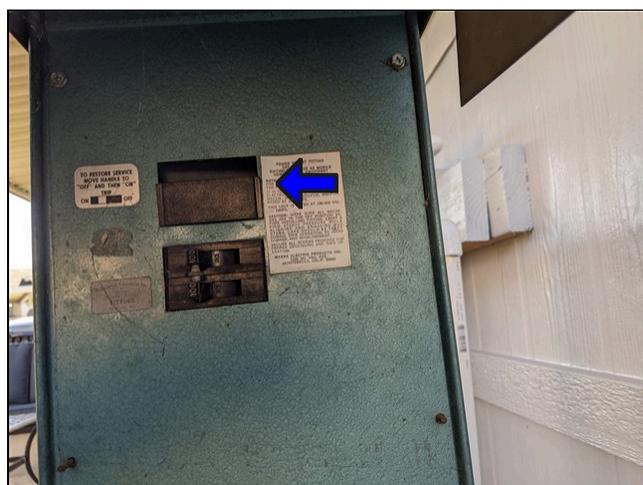
5.1 Item 1(Picture)

Unused breaker slot remains exposed at the main panel and needs the appropriate breaker slot cover installed.

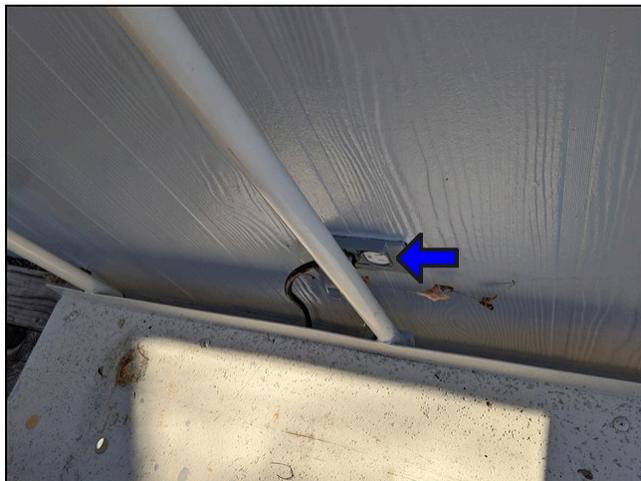
5.6 Item 1(Picture)

Weather cover for the exterior receptacle at the left exterior is damaged and needs replaced to insure intended safety.

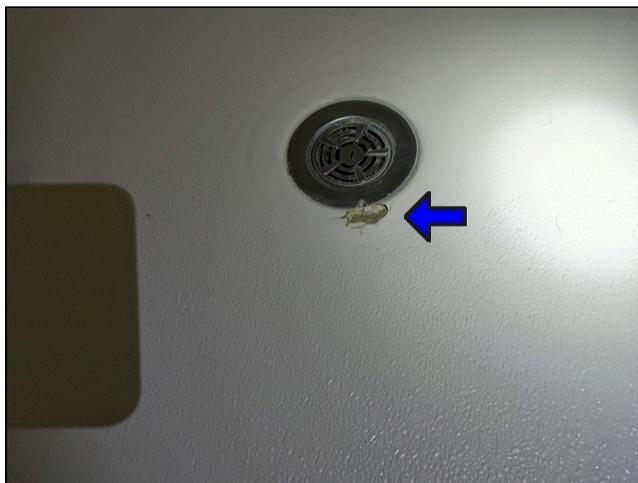
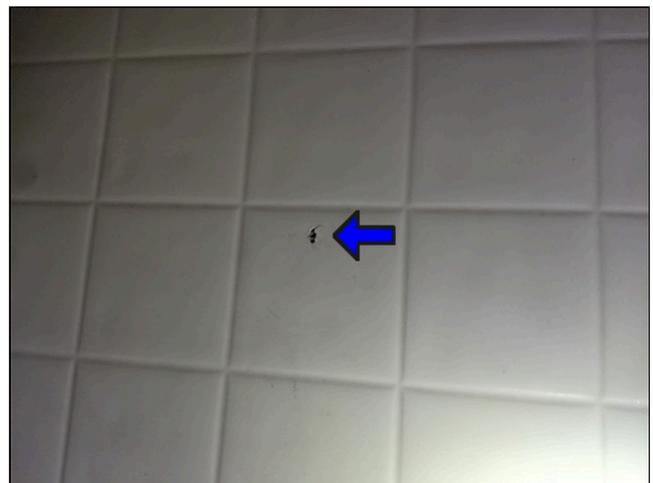
Fiberglass tub/shower is damaged and needs repaired to prevent further deterioration and a possible leak behind the shower wall.

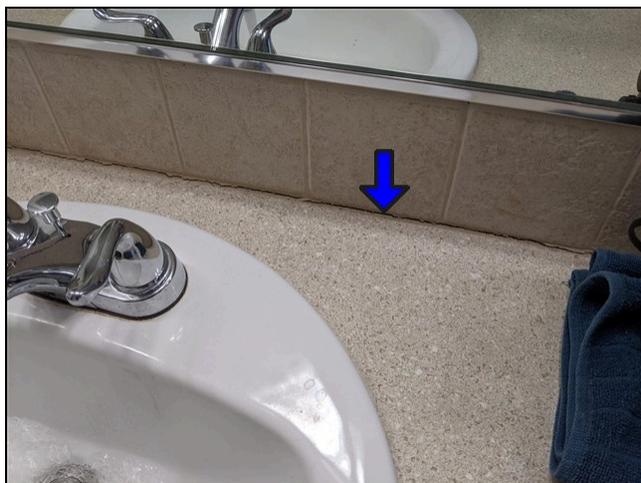
6.6.A Item 1(Picture)

Grout needs improved at the countertop backsplash area. Recommend color matched grout caulk for these areas.

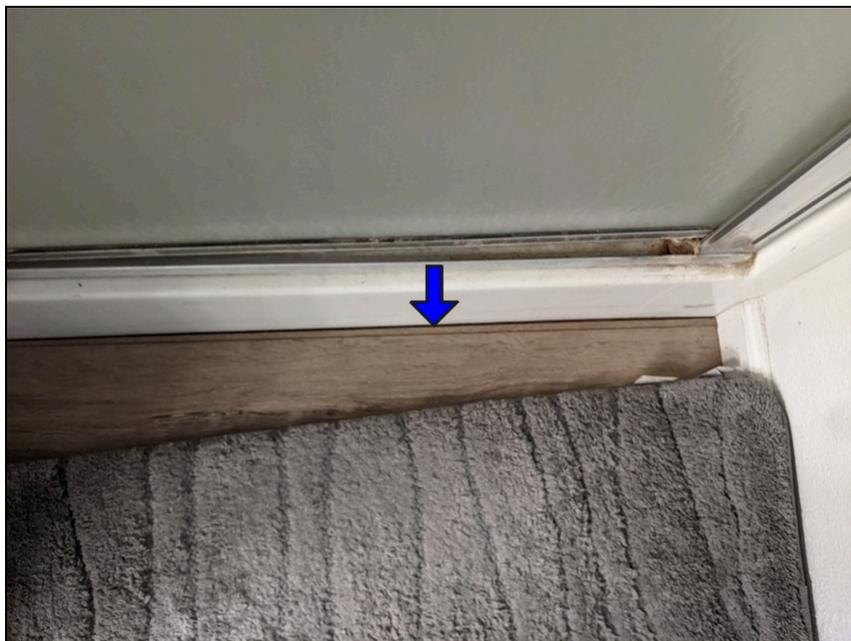
6.6.A Item 2(Picture)

Caulking needs improved where the shower meets the bathroom floor.

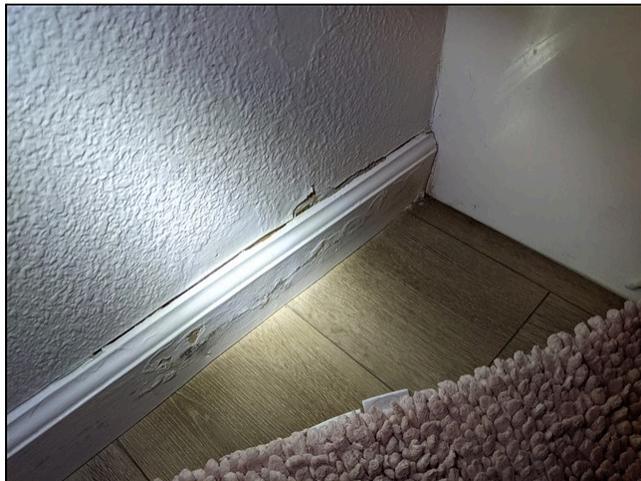
6.5.B Item 1(Picture)

Slight moisture damage noted at the baseboard near the shower/tub edges due to probable typical shower splash and misuse of the shower curtain. Cosmetic repairs can be made at the baseboard, as needed, and moisture exposure avoided.
