A-OK Home Inspection Service
(530) 321-5355
aokinspections.com

Real Estate Inspection Report

27 Inglewood Dr, Oroville,
CA 95966

Inspected On Sat, Feb 28, 2026 at 10:30 AM

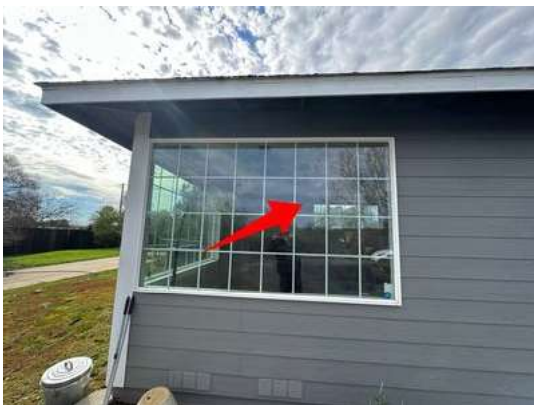
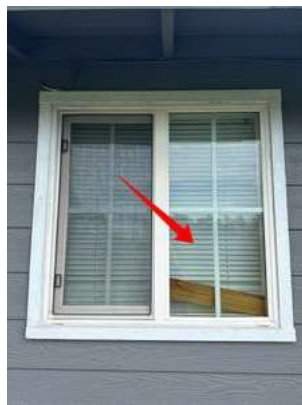
Comment 3
Deficiency / Evaluation / Repair

Broken living room fixed window. Broken garage window.

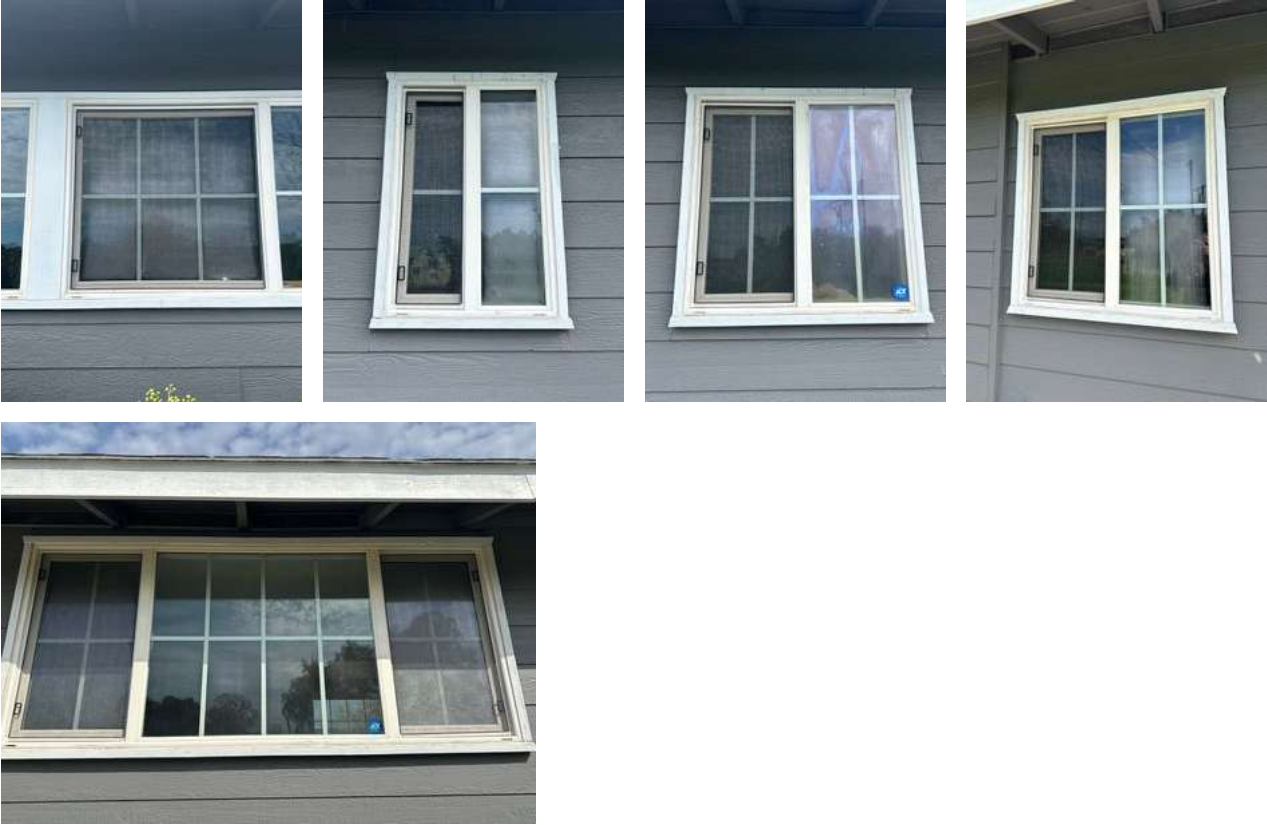
Comment 4

Window(s) noted with a moisture barrier breach. Northeast elevation, southwest elevation bathroom, southwest elevation guest bedroom, southwest living room fixed.

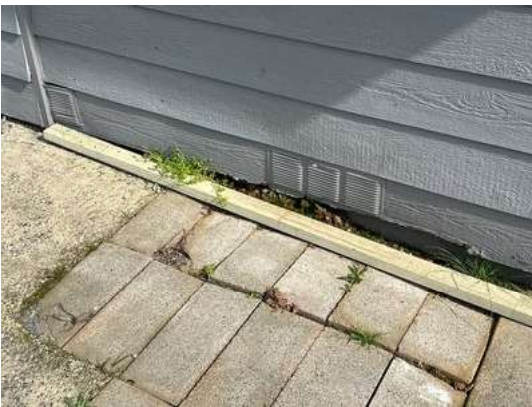
Comment 5

Damaged siding along ground level, southwest elevation. Recommend review for repair.

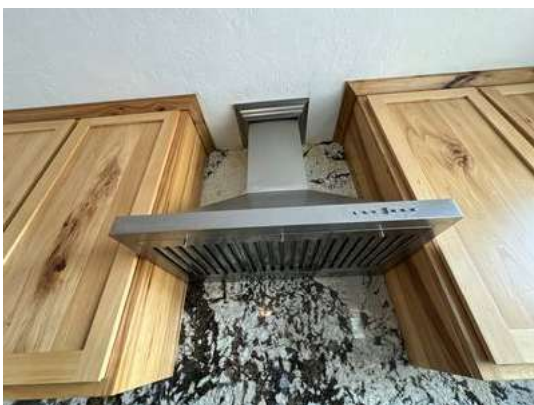
Comment 12

Vent hood inoperable. Recommend review for repair.

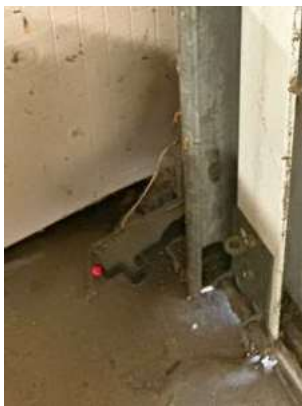
Comment 16

Unable to open garage door, error light on eye beam. Recommend review for repair.

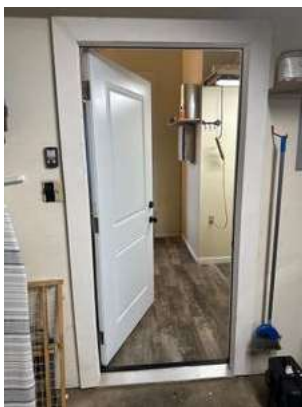
Comment 17

A house to garage fire door is required along with a working auto closure device. Closure device not present.

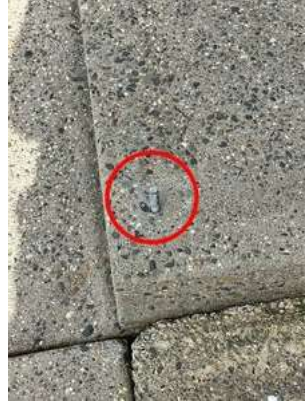
Comment 20

Exposed anchor bolts at side concrete pad. Potential trip hazard noted. Recommend removing.

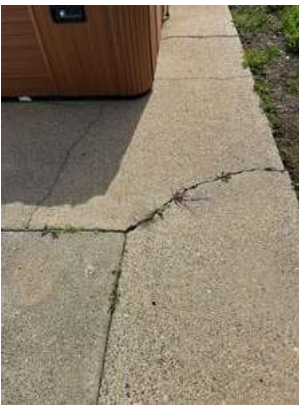
Comment 21

Predictable settling cracks on concrete walkway surfaces noted.

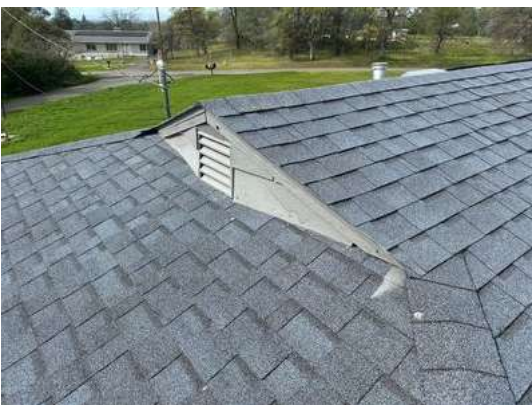
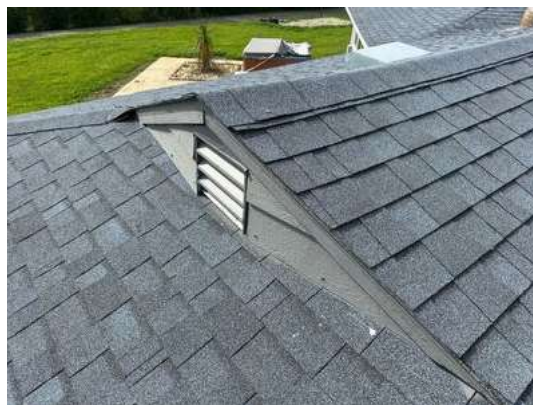
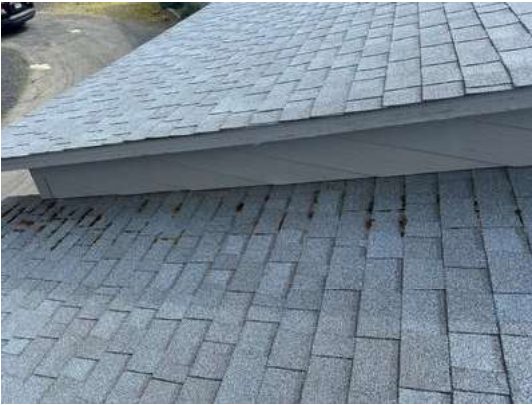
Siding at roof gables in contact with roof material. Recommend 1" clearance above roof surface to prevent deterioration.

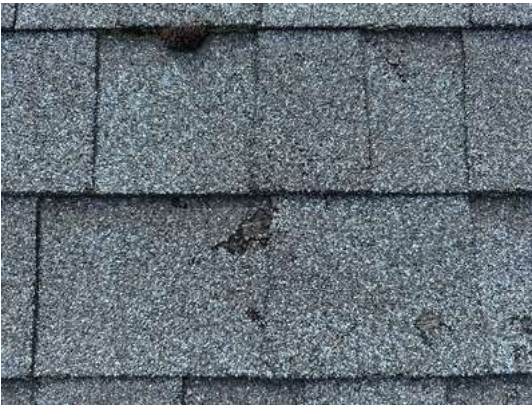
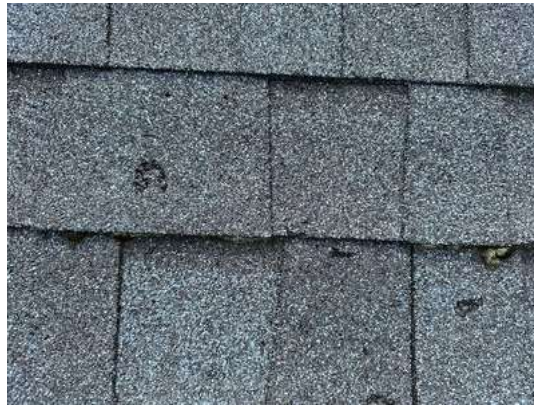
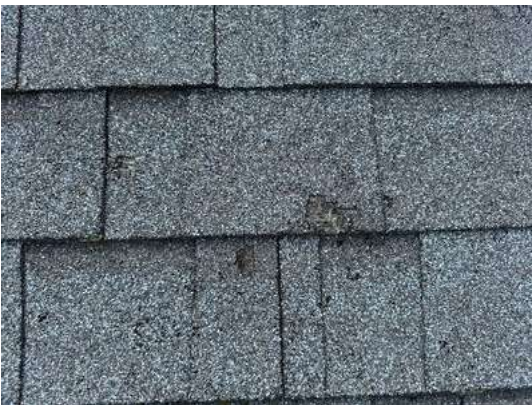
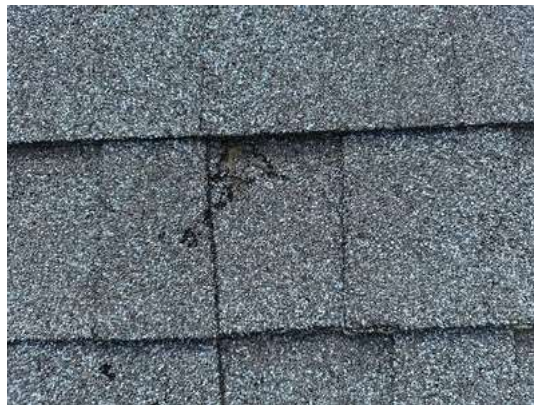
Comment 31

Damaged singles noted. Recommend further review by a roofing contractor for estimated serviceable life.

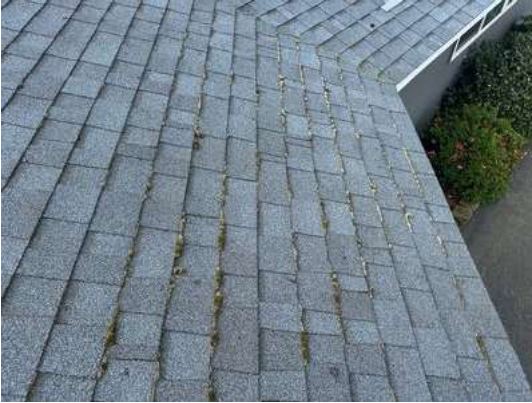
Comment 32

Moss on roof. This can lead to the premature failure of the roof and subsequent leaks. Recommend treating moss during its growing season (wet months) with a moss killer. For information on various moss treatment products and their pros and cons, visit <http://bryophytes.science.oregonstate.edu/page24.htm>

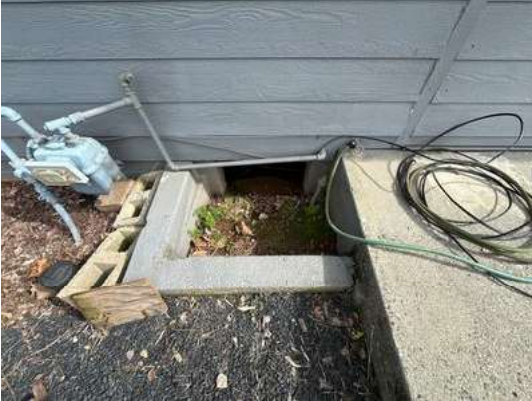
Comment 36
Information

Moisture/ mud in crawlspace, presumably from recent rains. Did not enter crawlspace.
