Inspection Report

Walda Williams
2424 Traditions Loop
Paso Robles, CA 93446

Report Date: 2/10/2026

Inspection location: 2424 Traditions Loop
Paso Robles, CA 93446

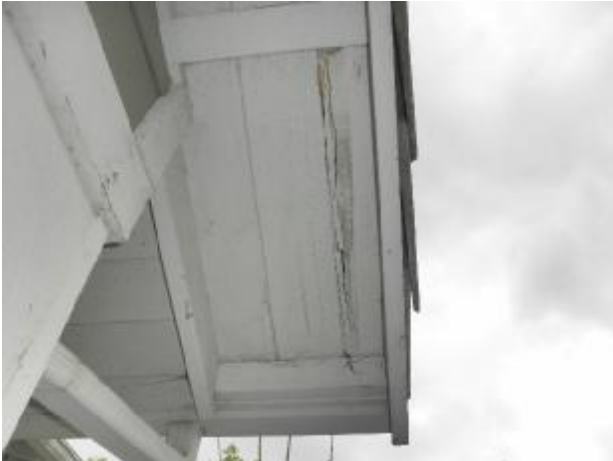
Roof # R

1.) There is evidence of a roof leak with moisture damage to the eave at the outside corner of the front entry roof overhang.

Evidence of a leak with moisture damage to the eave.

- 1.) There is evidence of a roof leak with moisture damage to the eave at the outside corner of the front entry roof overhang.
- 2.) There are three cracked and displaced roof tiles on the north facing slope.
- 3.) There is one broken roof tile on the east facing slope above the front entry area.

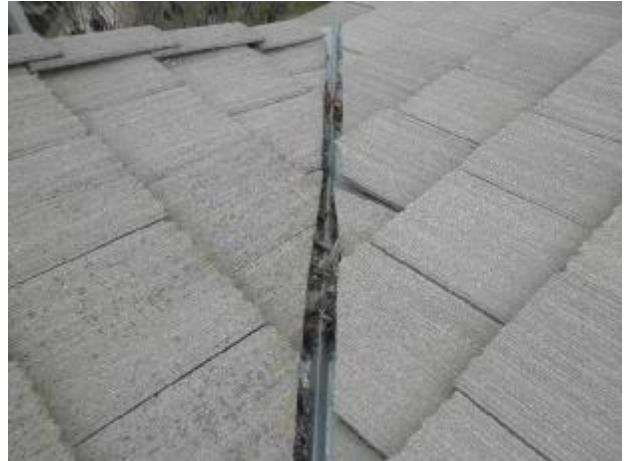
Roof # R

The leaves and debris need to be cleared out of the valleys.

Maintenance Note: The leaves and foliage debris needs to be cleared from the roof to promote positive drainage. This is particularly important at the valley(s) where water damming can cause leakage and premature deterioration of the roof materials.

Maintenance Note: The leaves and foliage debris needs to be cleared from the roof to promote positive drainage. This is particularly important at the valley(s) where water damning can cause leakage and premature deterioration of the roof materials.

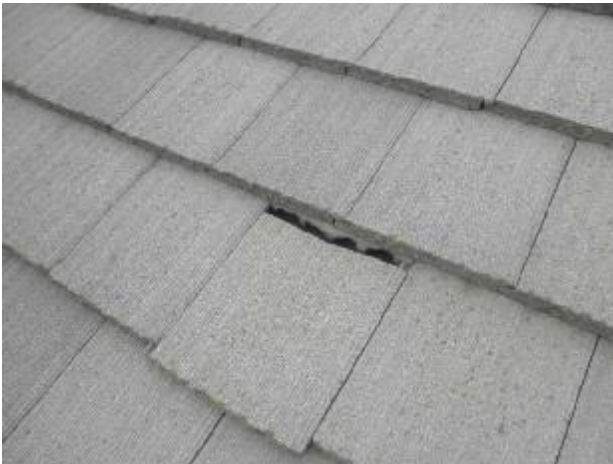
Roof # R

2.) There are three cracked and displaced roof tiles on the north facing slope.

Cracked and displaced tiles on the north facing slope.

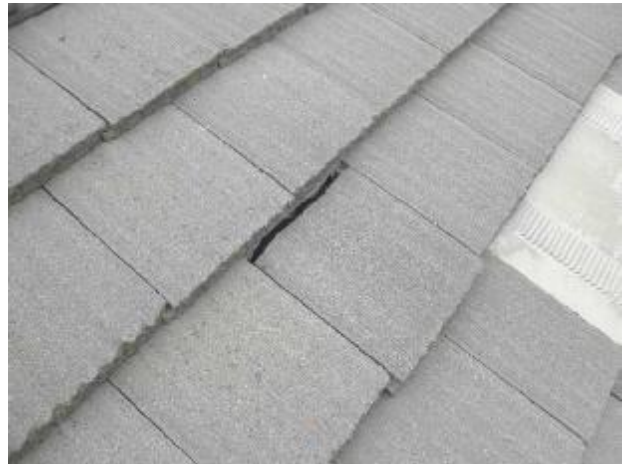
Roof # R

Cracked and displaced tiles on the north facing slope.

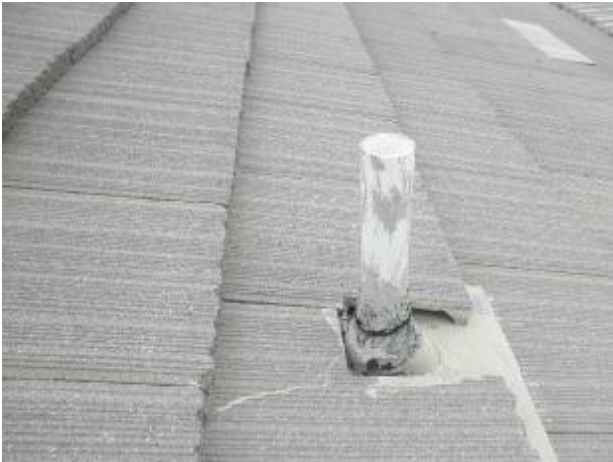
Roof # R

Deteriorated sealant at the vent flashings.

Maintenance Note: The sealant at the flashings has become cracked and deteriorated from exposure to the sun. Recommend resealing the flashings to prevent water intrusion.

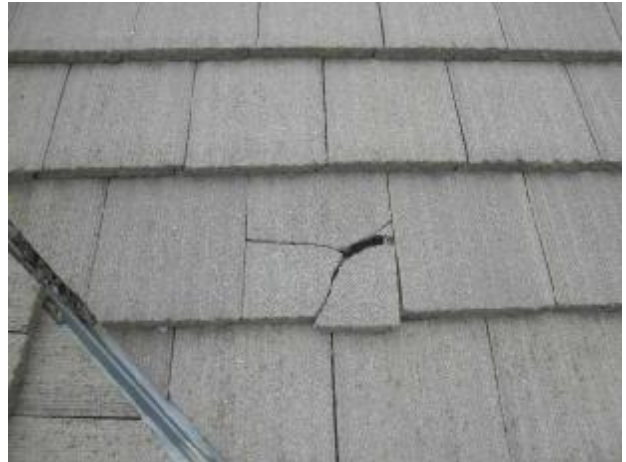
Roof # R

3.) There is one broken roof tile on the east facing slope above the front entry area.

Broken tile on the east facing slope.

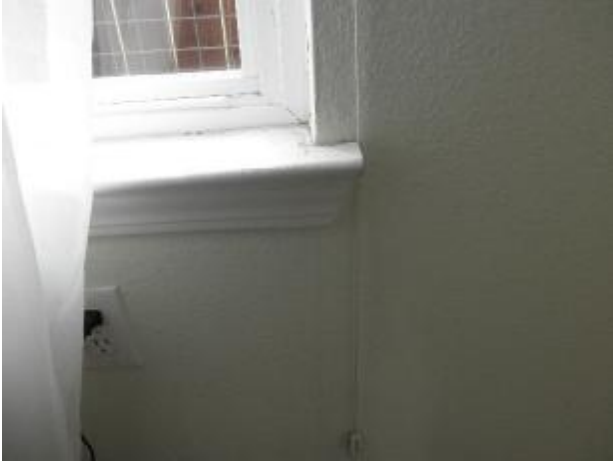
EX

Evidence of a leak at the single hung window in the master bedroom.

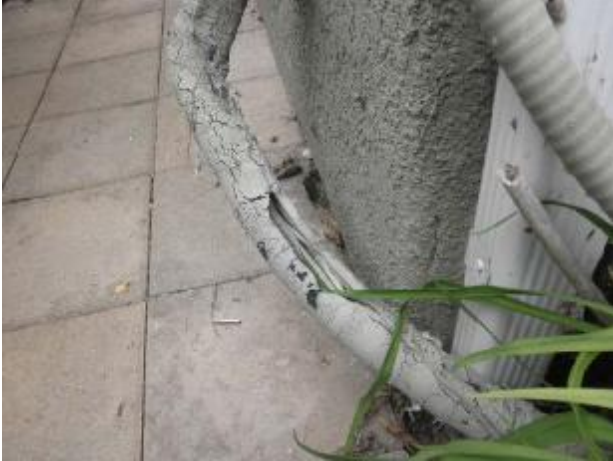
HC

1.) The insulation is partially deteriorated and in need of replacement at the low-pressure line adjacent to the A/C condenser unit.

Deteriorated insulation at the A/C low-pressure refrigerant line.

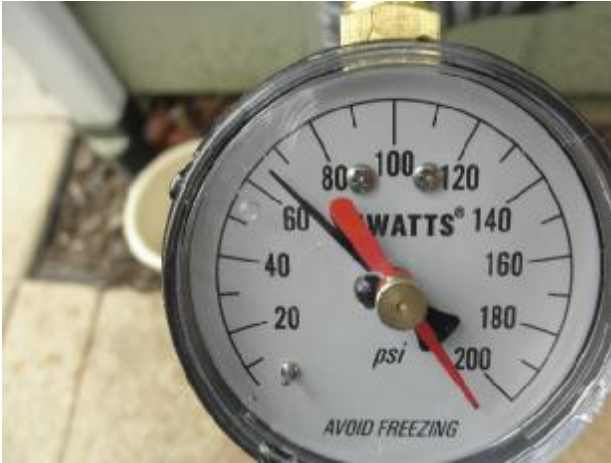
P

Information Note: The water pressure was measured at 65 psi at the time of inspection. This is within a normal and acceptable range. Since the house is equipped with a pressure regulator it should be monitored and retested periodically to ensure that the pressure is below the maximum allowable 80 psi.

The water pressure was measured at 65 psi.
