Address of Property: 2073 Sand Point Rd, Discovery Bay CA 94505
 Inspection Date: 8/29/2023
 Report #: 18783
 Title Co. & Escrow #:

WOOD DESTROYING PESTS AND ORGANISMS INSPECTION REPORT

Inspection Report

Property Address:
2073 Sand Point Road
Discovery Bay CA 94505

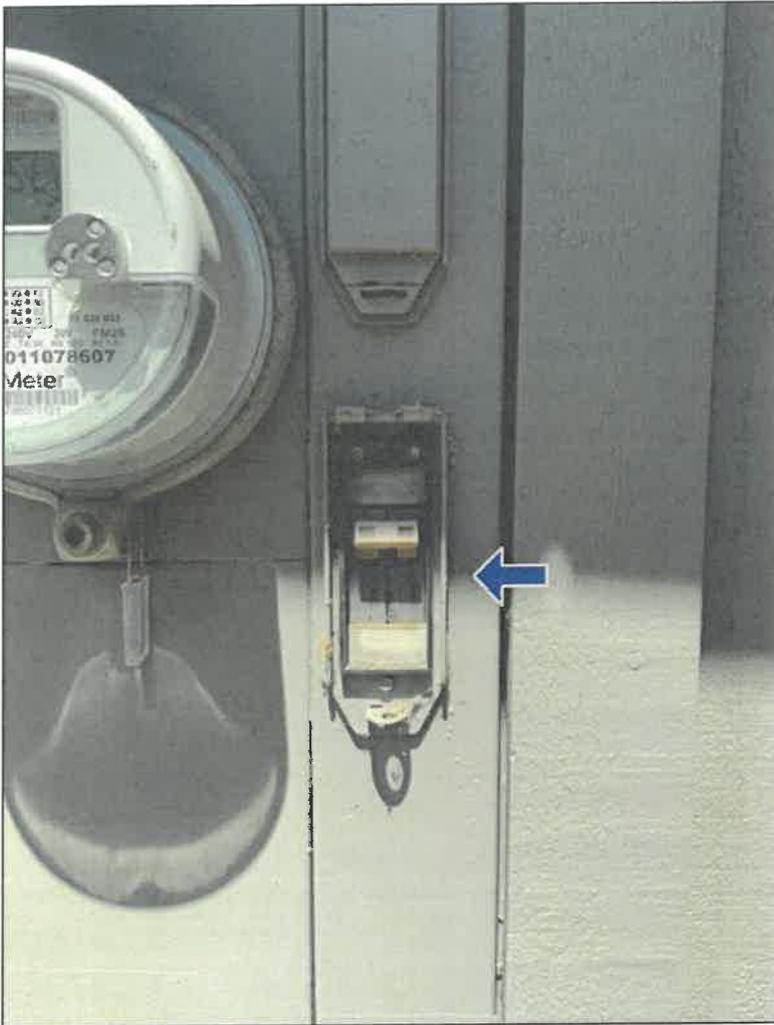
1.1 Item 2(Picture) exterior weather cover for the main electrical panel breaker is missing/broken

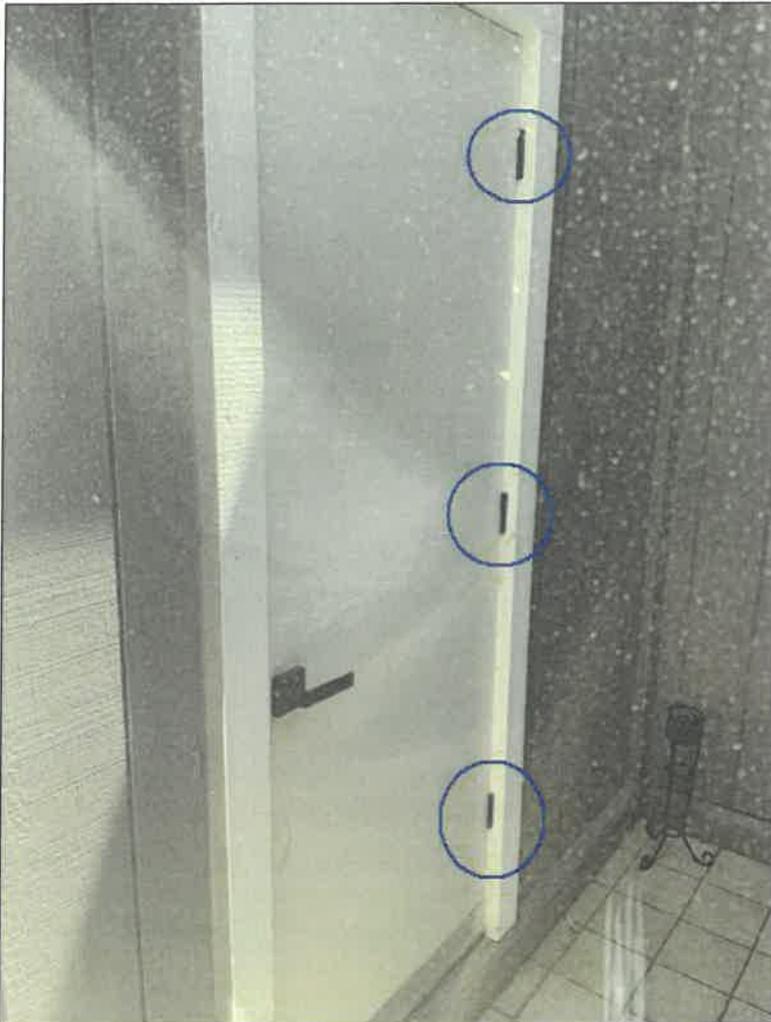
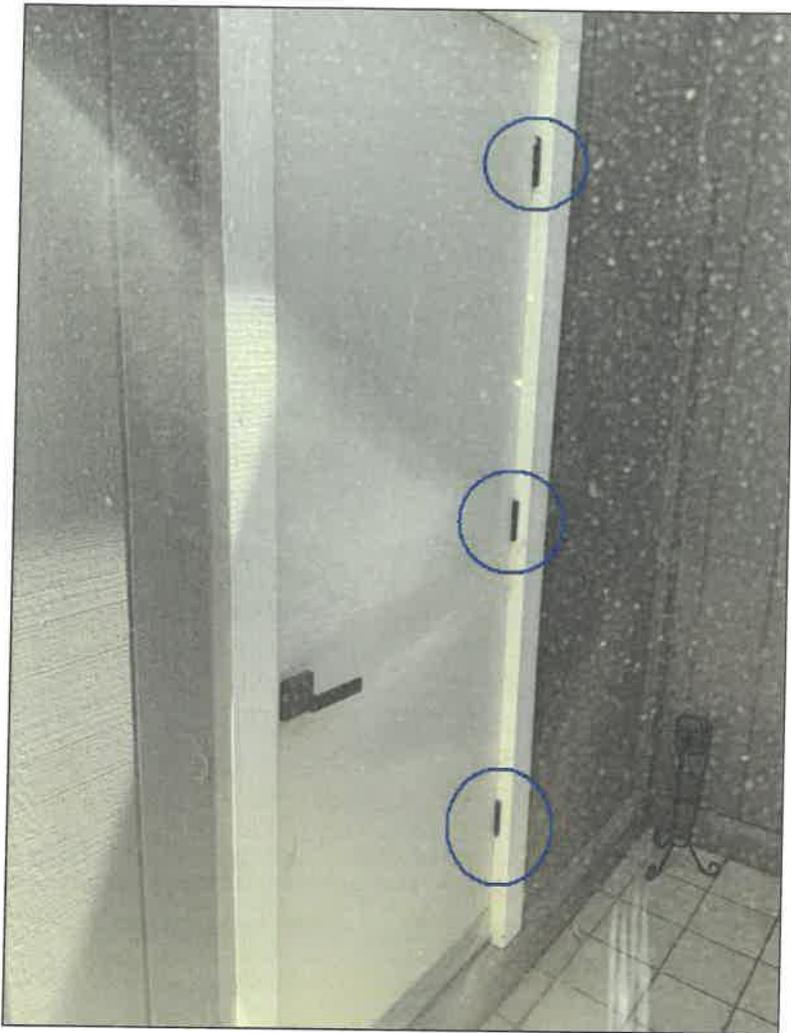
2.1 Item 1(Picture) exterior entry door hinges are installed incorrectly, they have been installed on the exterior of the structure

(1) **The exterior entry door hinges are installed incorrectly, they have been installed on the exterior of the structure. These hinges need to be installed inside the structure for safety reasons. The inspector recommends consulting with a qualified tradesman for proper installation of the hinges for safety reasons.**

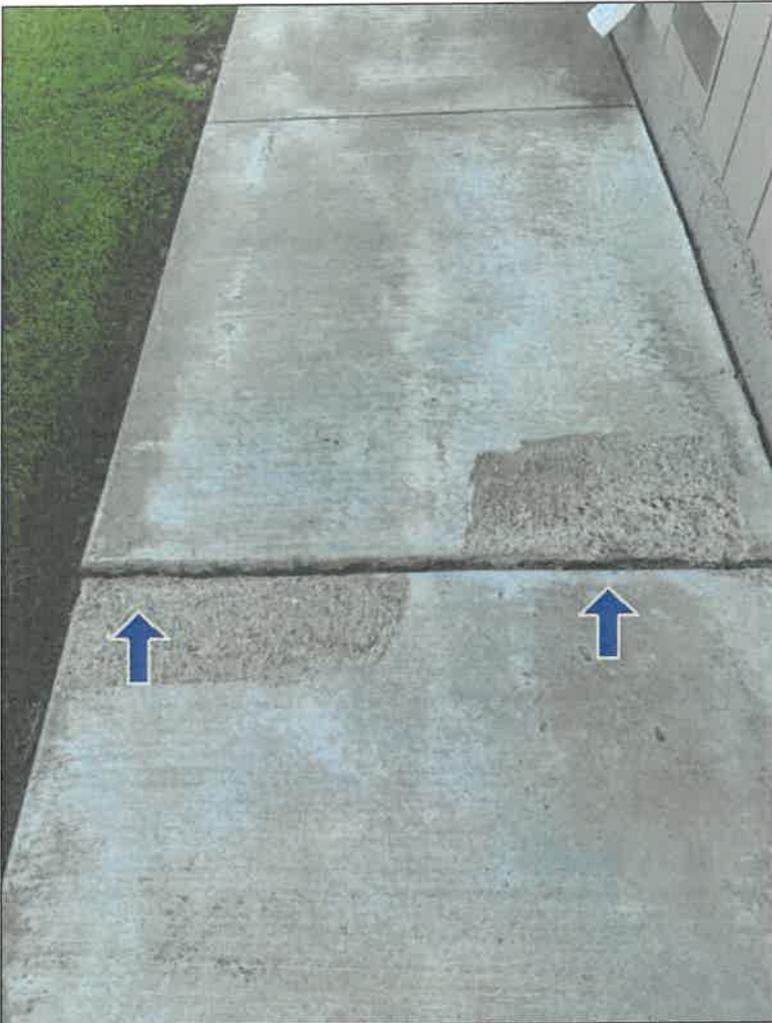
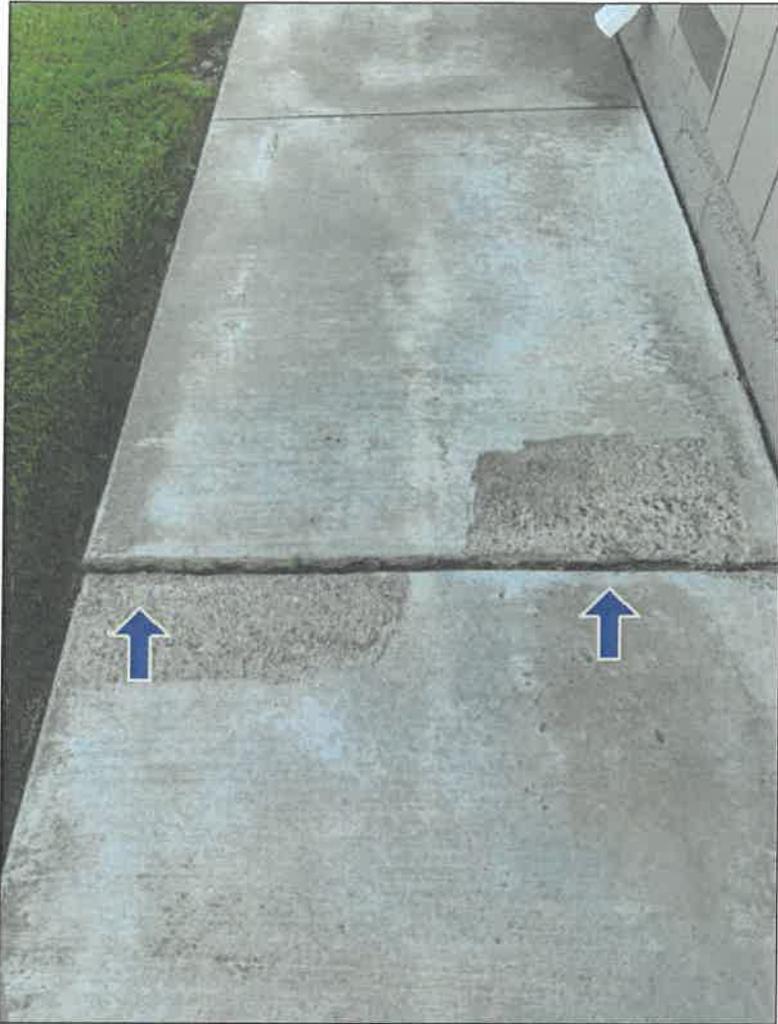
2.3 Item 1(Picture) Trip hazard

There are raised/settled areas of concrete walkways around the structure. These areas are a trip hazard and should be repaired for safety reasons.

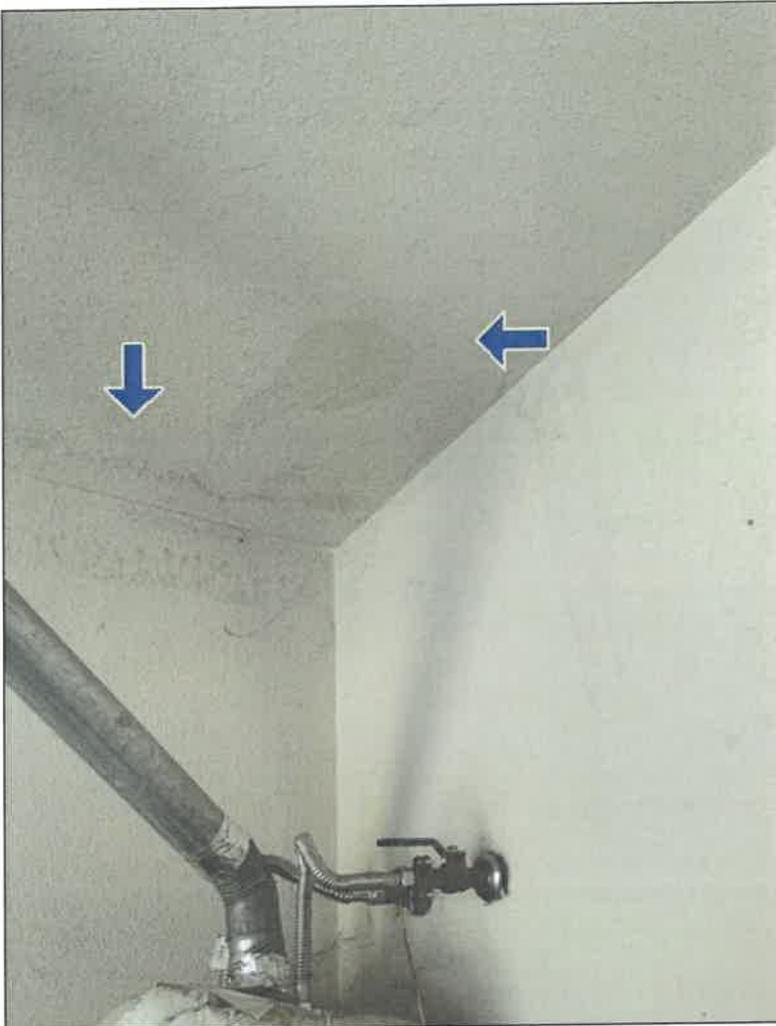
3.0 Item 1(Picture) Stains in the garage ceiling

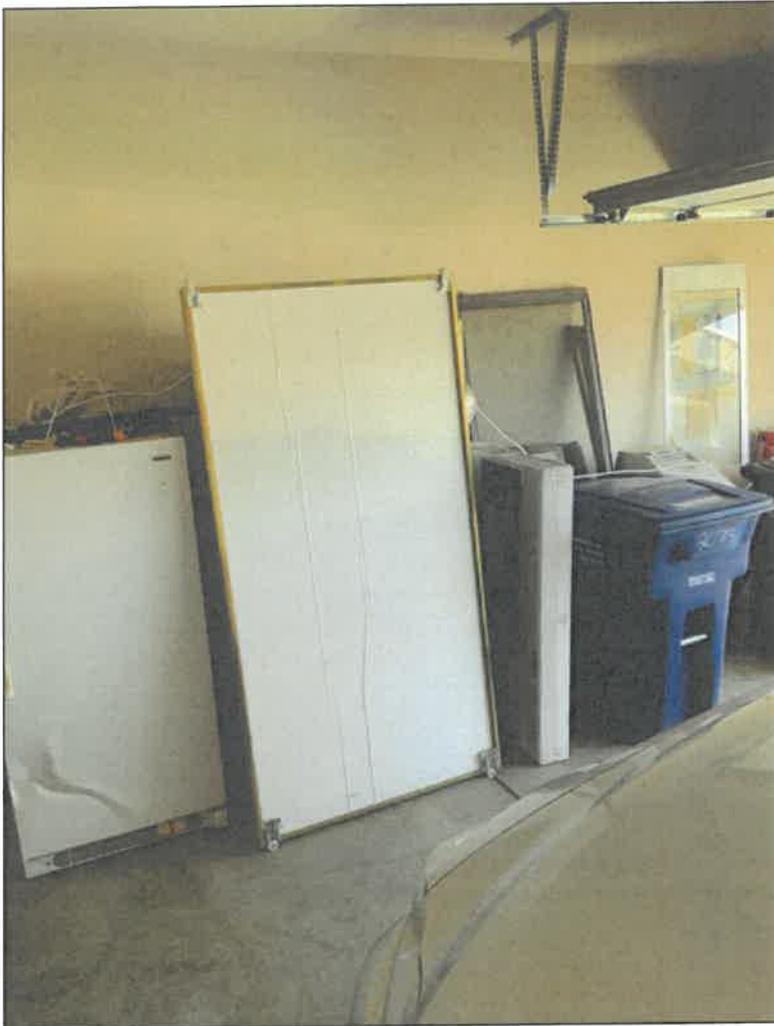
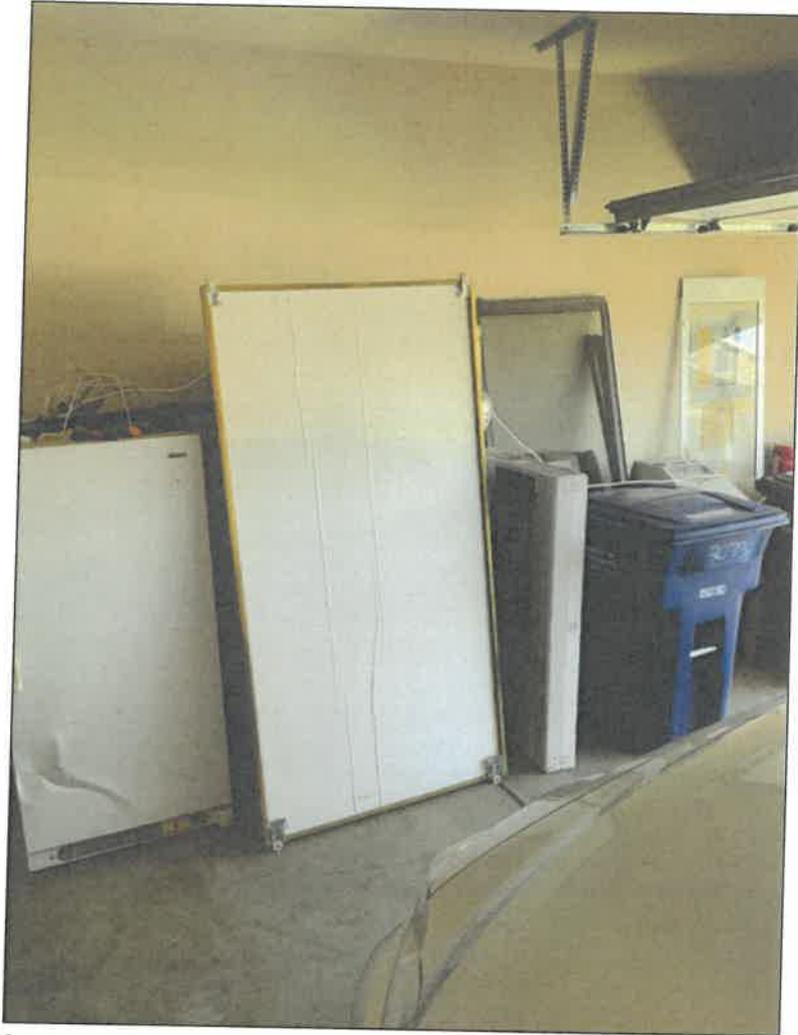
3.1 Item 1(Picture) Stored items in the garage

(1) There are stored items in the garage that prevent the inspector from inspecting the entire garage. The inspector recommends doing a thorough walk-thru before the close of escrow.

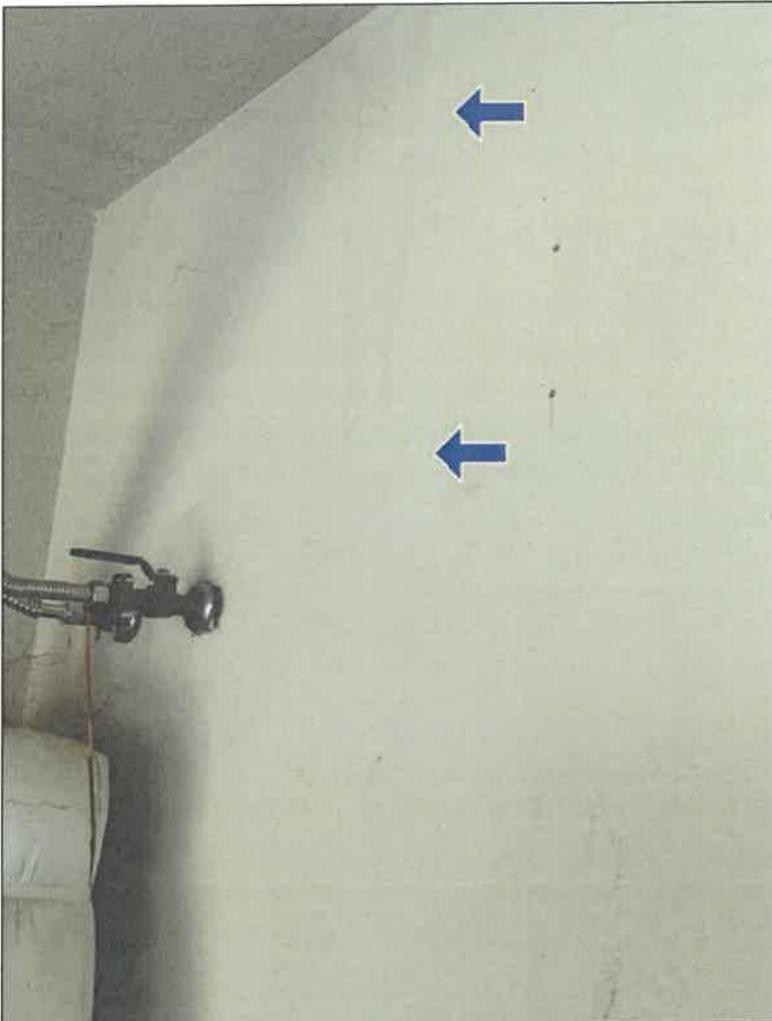
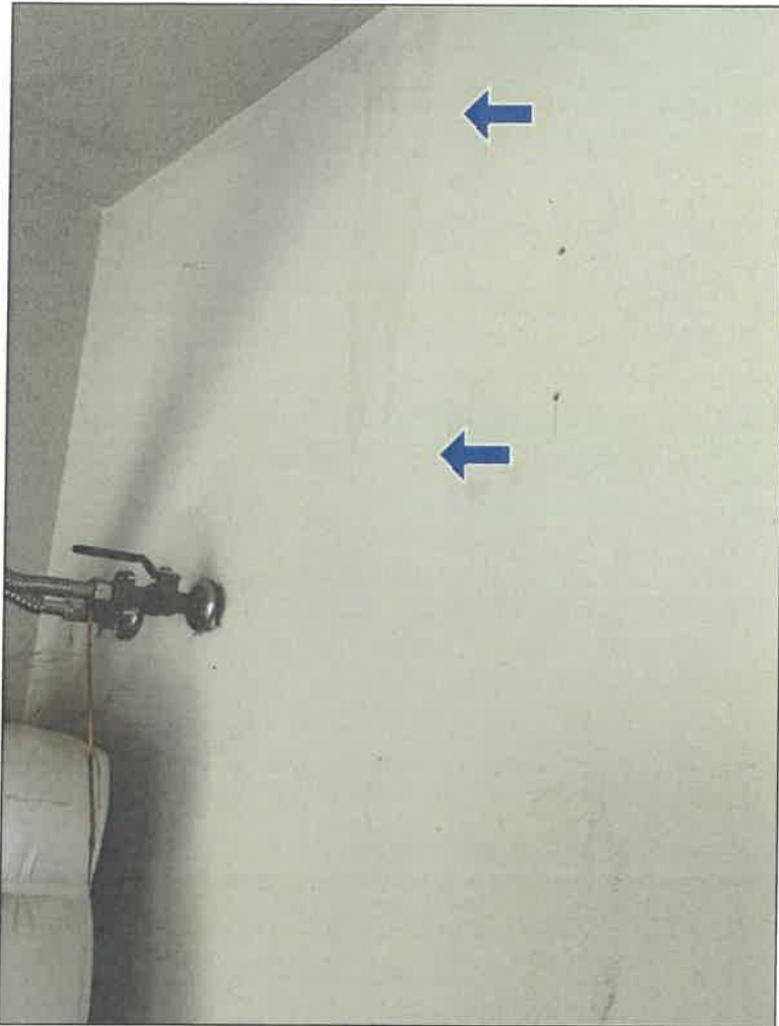
3.1 Item 2(Picture) Stains in the garage walls

There are stains in the garage sheetrock. These stains were tested with a moisture meter and found to be dry at the time of inspection. The inspector recommends consulting with a qualified tradesman for further evaluation and repairs.

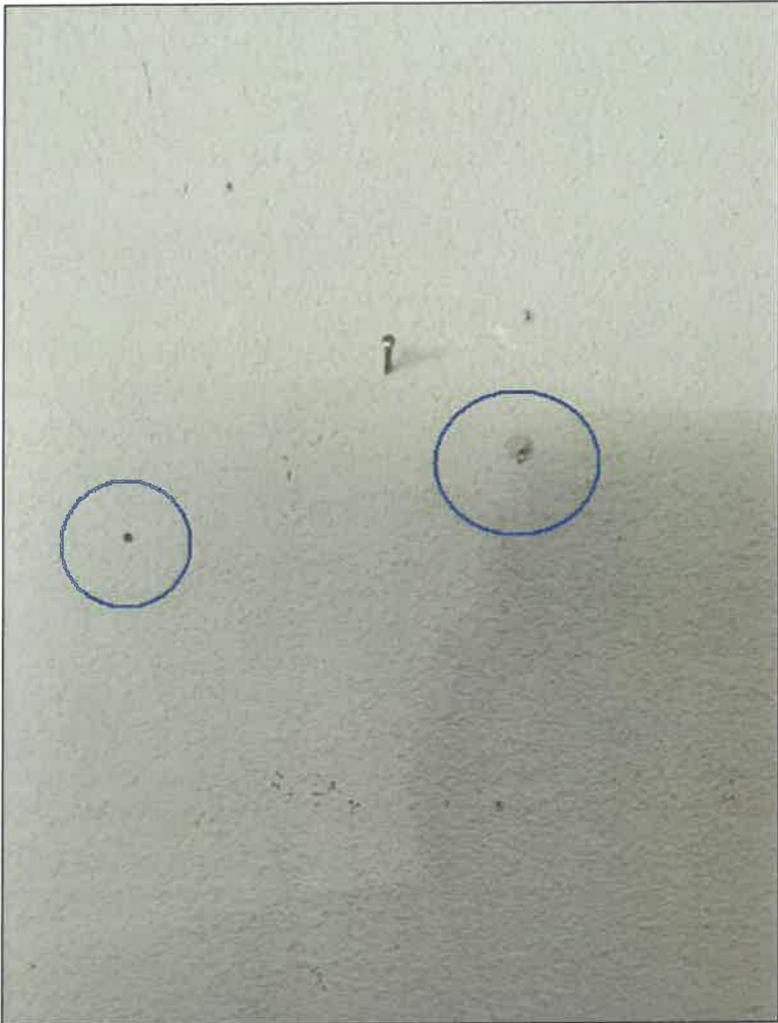
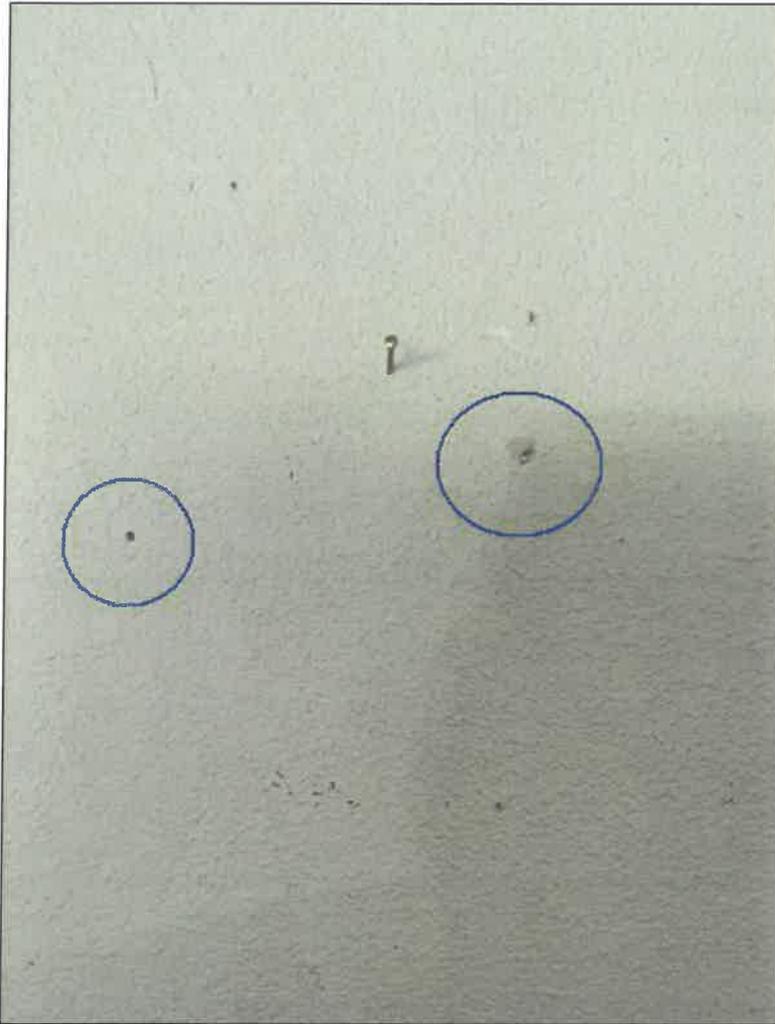
3.1 Item 3(Picture) Holes/gaps garage firewall

There are holes/gaps in the garage firewall. This is a void in the firewall protection. These areas should be properly repaired for safety reasons. The inspector recommends consulting with a qualified tradesman for further evaluation and repairs.

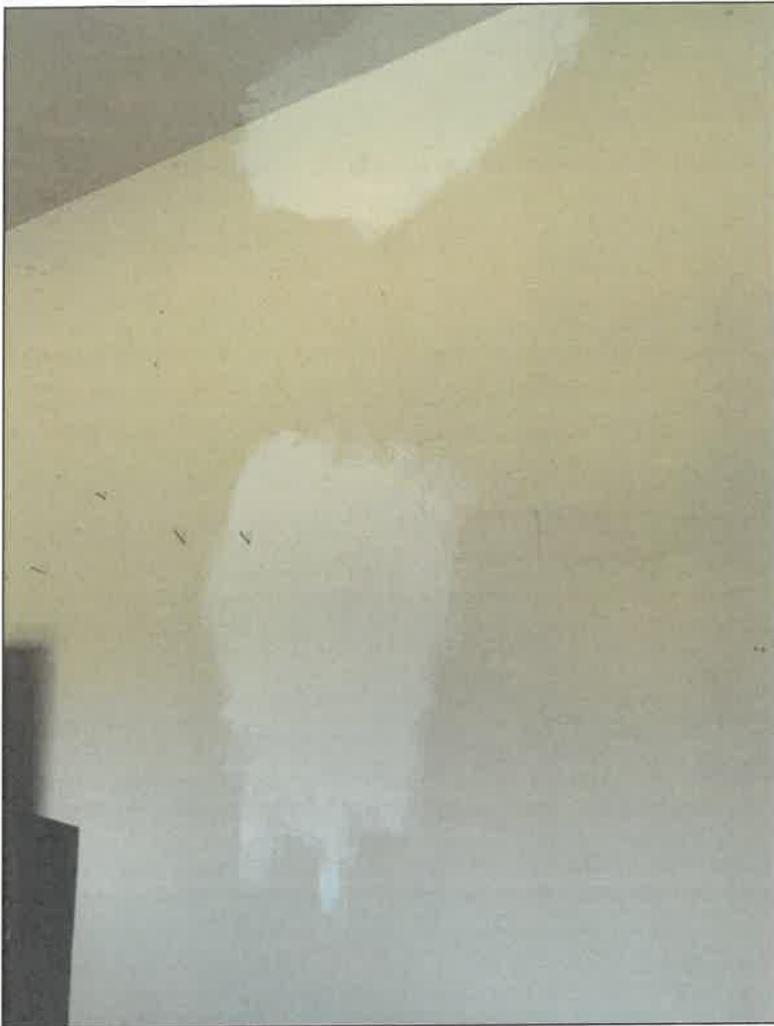
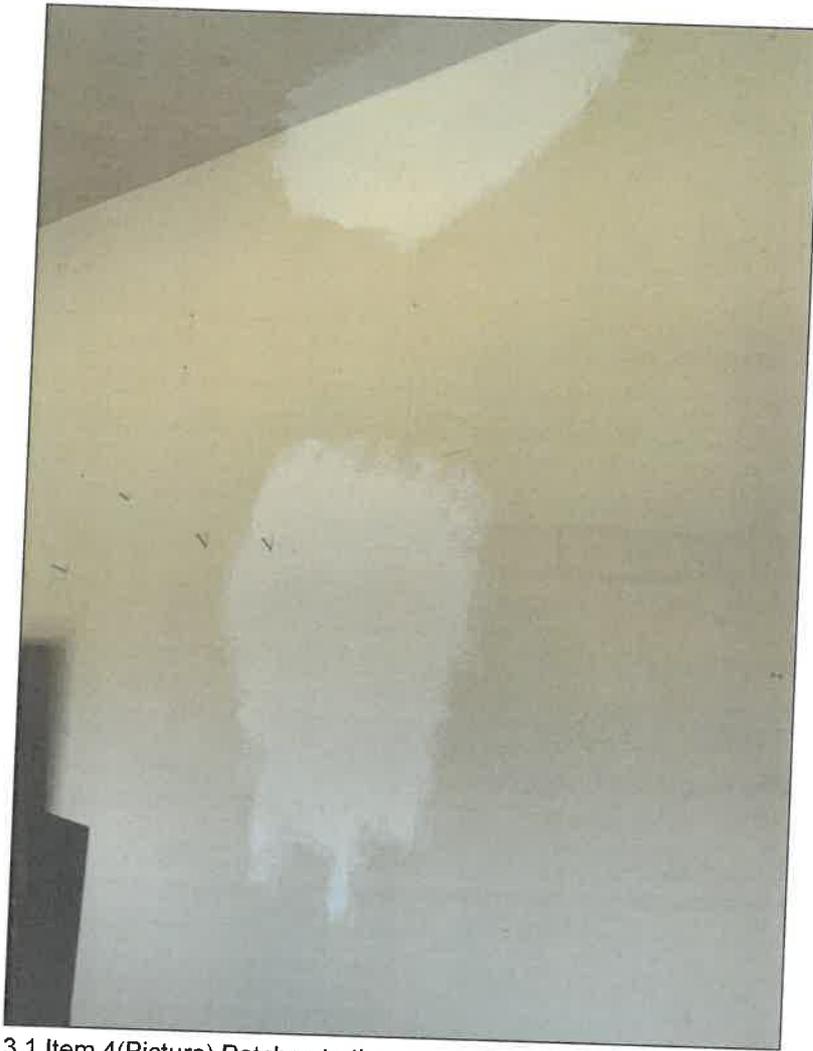
3.1 Item 4(Picture) Patches to the garage firewall

(2) There are patches in the garage firewall. These patches were not identified as fire rated sheetrock. The inspector recommends consulting with the seller for more information.

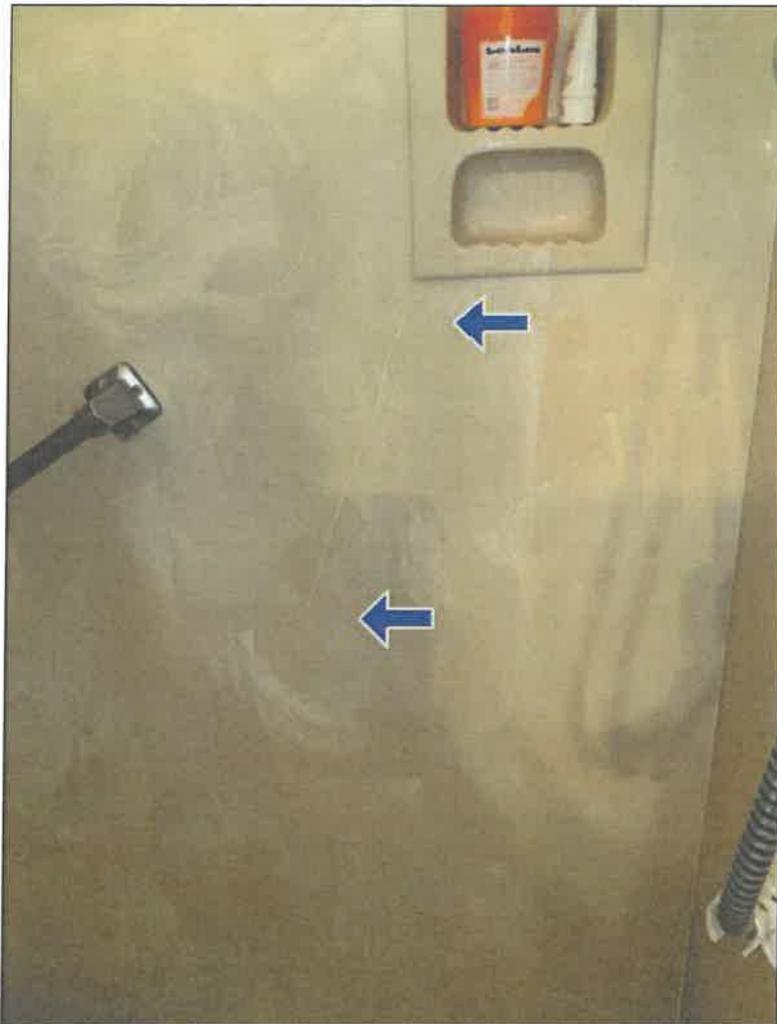
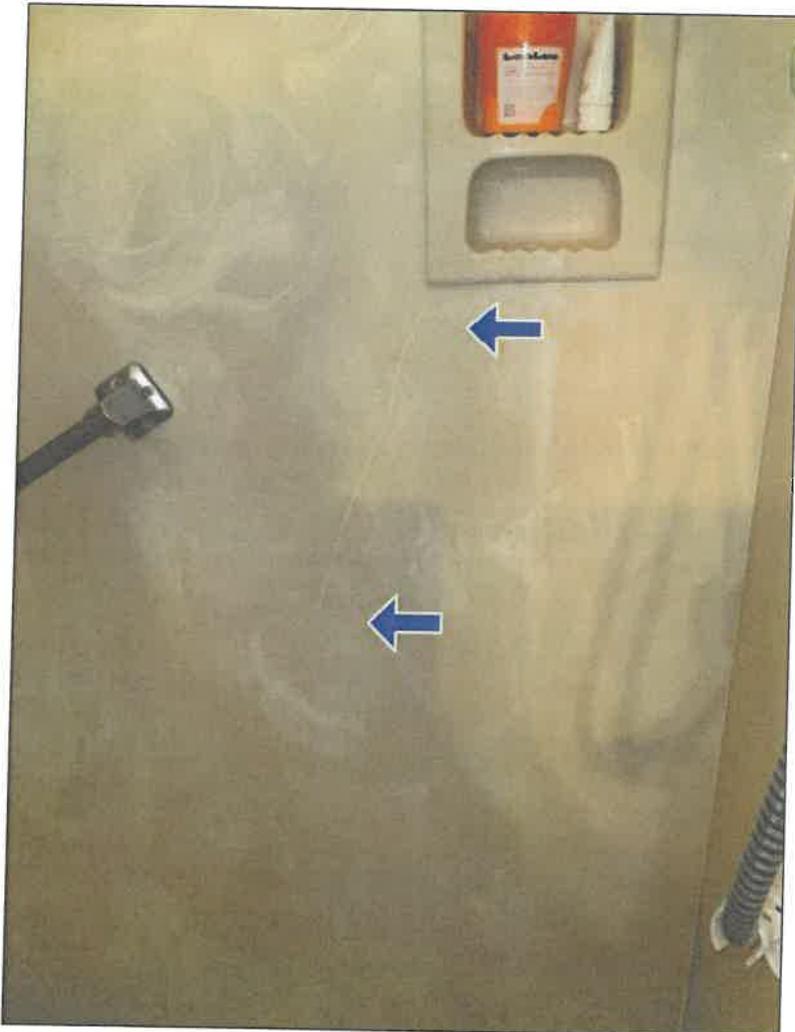
6.3 Item 1(Picture) cracks inside the master shower enclosure

There are cracks inside the master shower enclosure. The inspector recommends review of the most current pest report. Recommend consulting with a qualified tradesman for repairs.

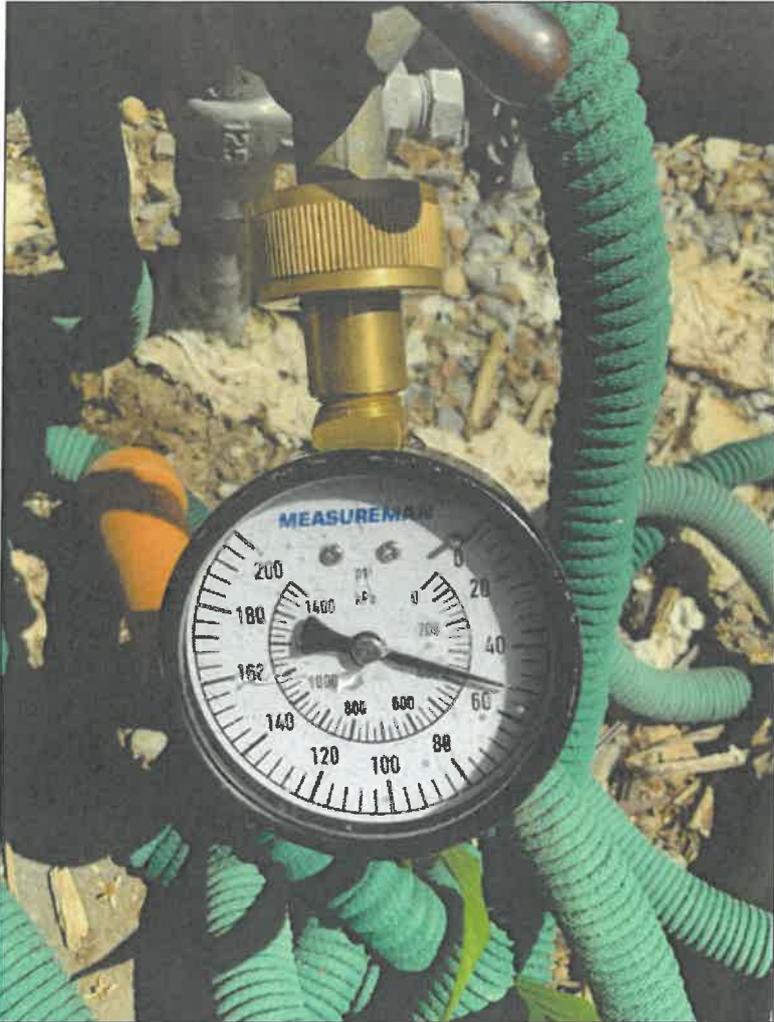
7.3 Item 1(Picture) Water pressure is approx. 55 LBS when taken at the main spigot.

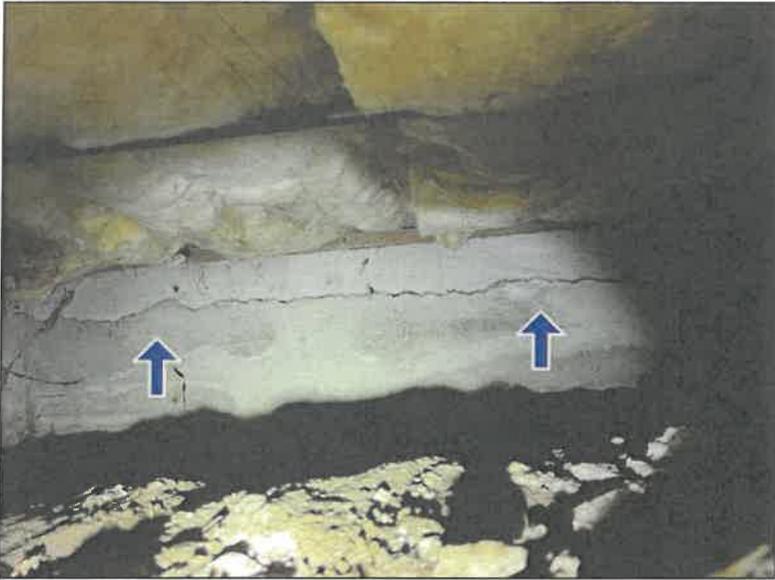
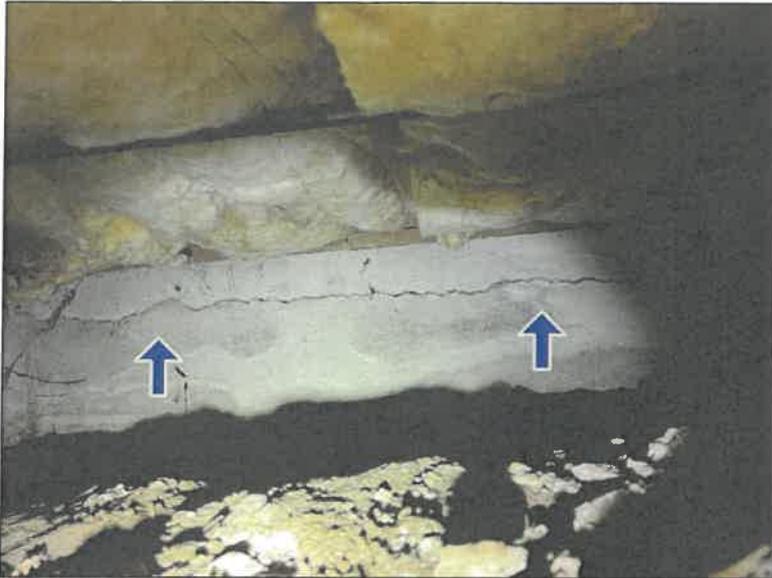
9.0 Item 1(Picture) Cracks to the foundation

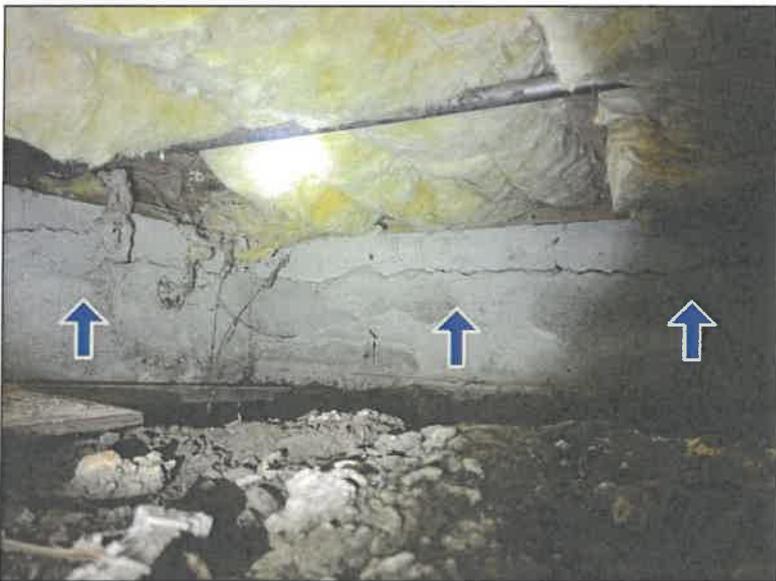
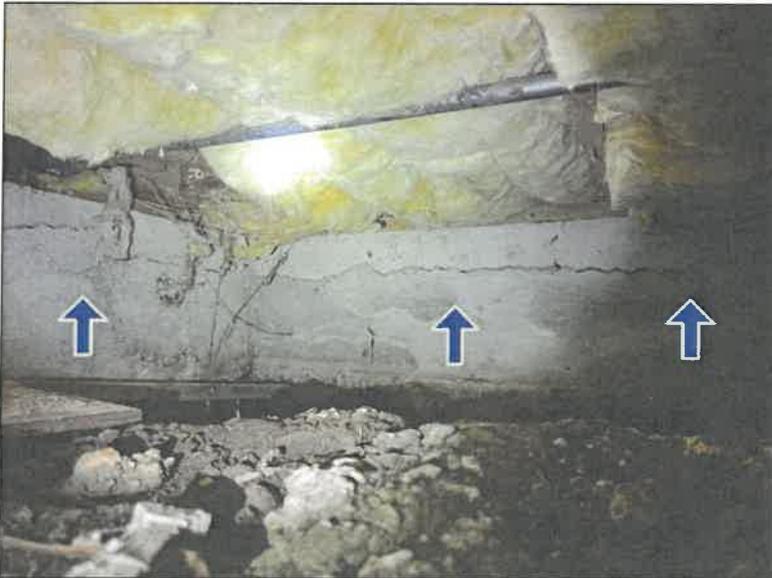
9.0 Item 2(Picture) Cracks to the foundation

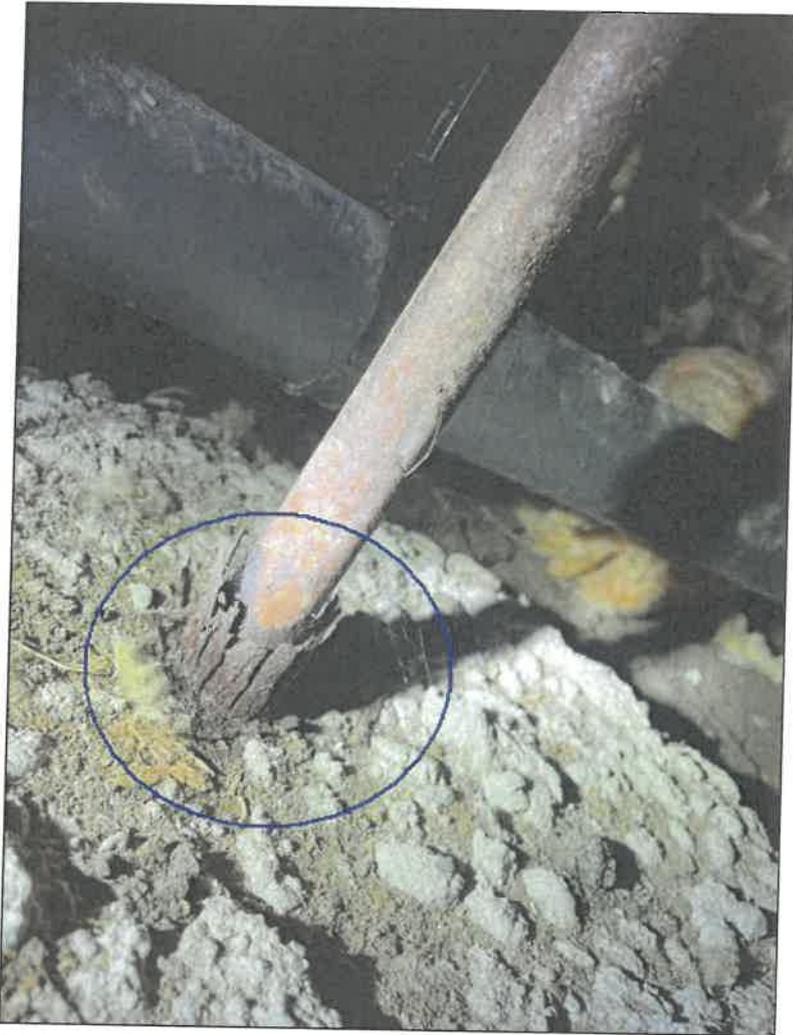
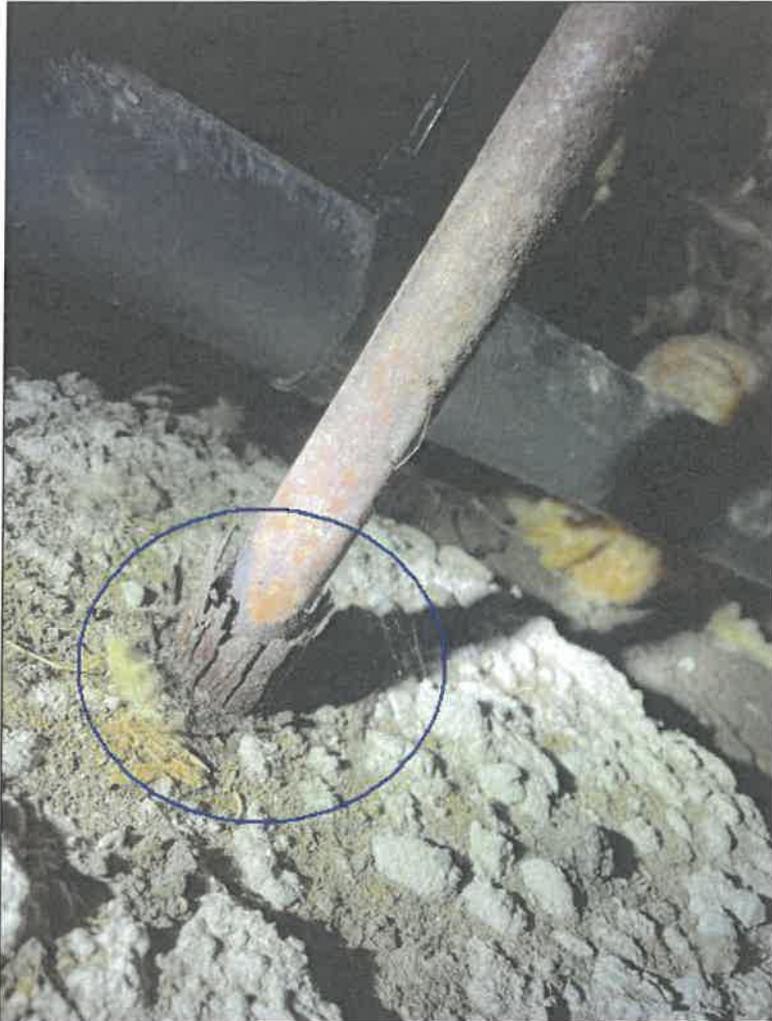
9.2 Item 1(Picture) screw jacks for this structure are rusty/corroded and damaged

The floor joists for this structure are supported by adjustable metal screw jacks. These screw jacks are made of metal and do require periodic maintenance to prevent rust and damage. The screw jacks for this structure are rusty/ corroded and damaged. The inspector recommends consulting with a qualified tradesman for further evaluation of the screw jacks and needed repairs/replacement.
