Accurate Inspection Team LLC
Property Inspection Report

336 Rosemont Blvd, San Gabriel, CA 91775
Inspection prepared for: Kingman Family Trust & Mary Vega Trustee
Real Estate Agent: Pete Whan - Pete Whan & Associates

Date of Inspection: 1/28/2026 Time: 10:00 am
Age of Home: 1941 Size: 1,484 sqft
Weather: Sunny & Warm

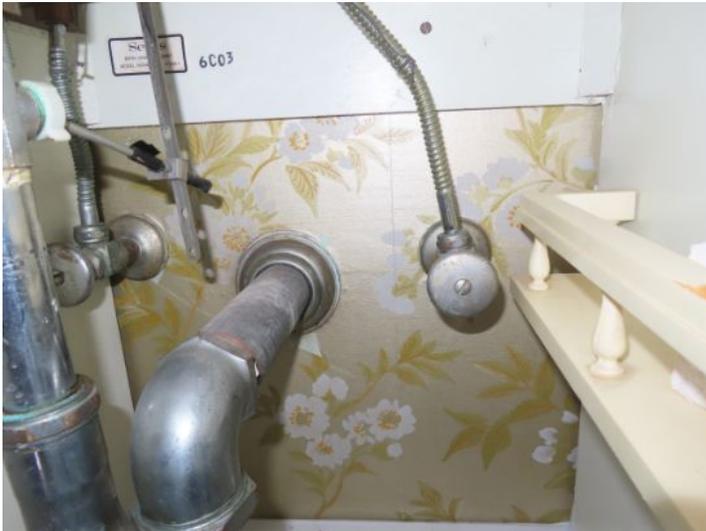
frozen shut off handles

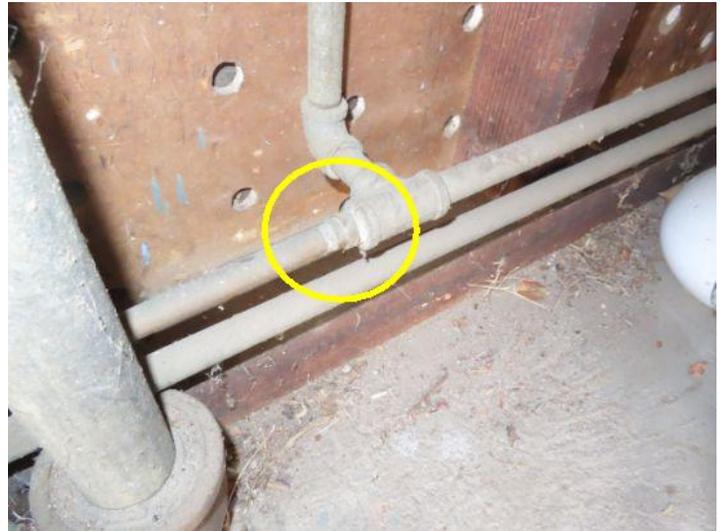
copper to galvanized missing proper connections at the garage bathroom

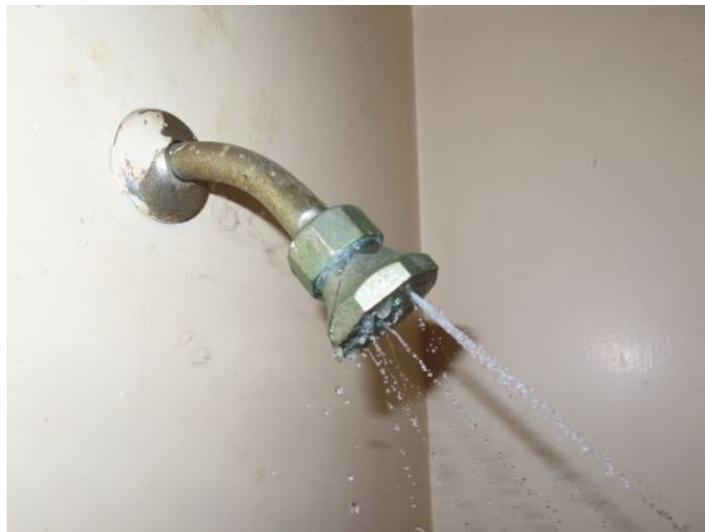
clogged shower head

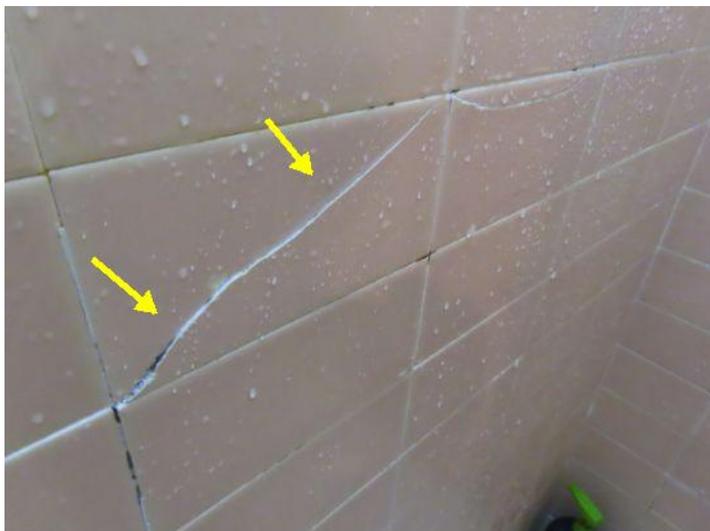
cracked tile

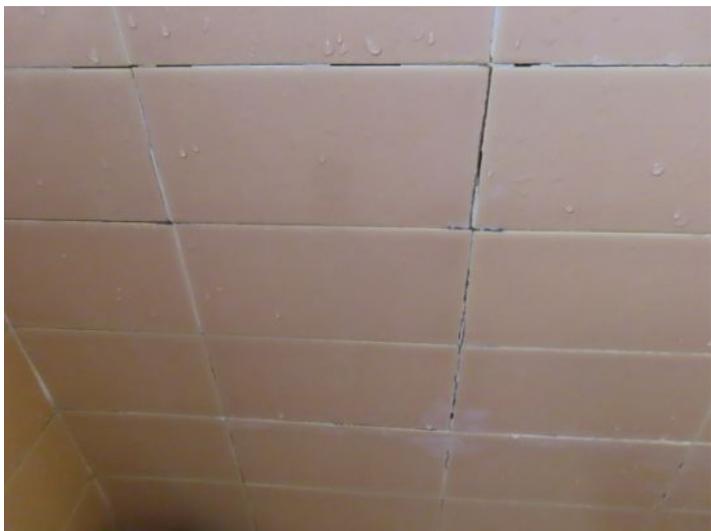
missing grout

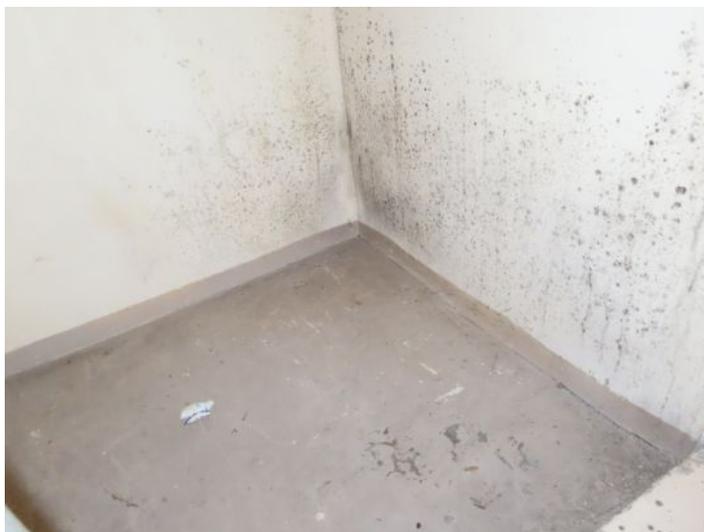
mold stains present at the garage bathroom

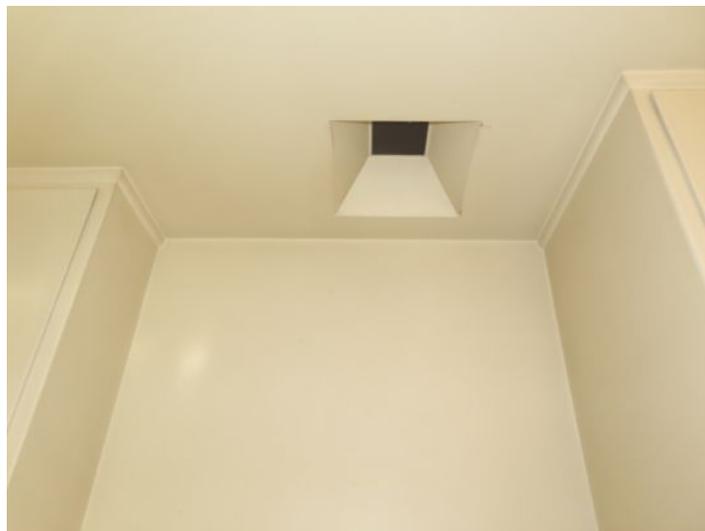
none, recommend installing an exhaust vent

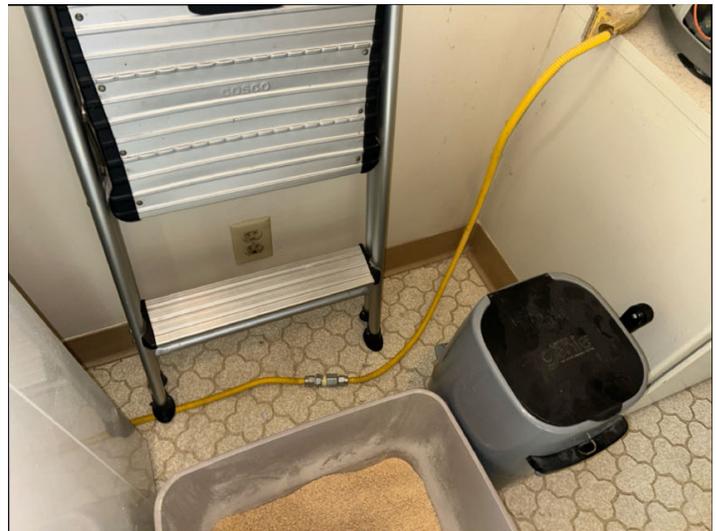
unsecured gas line

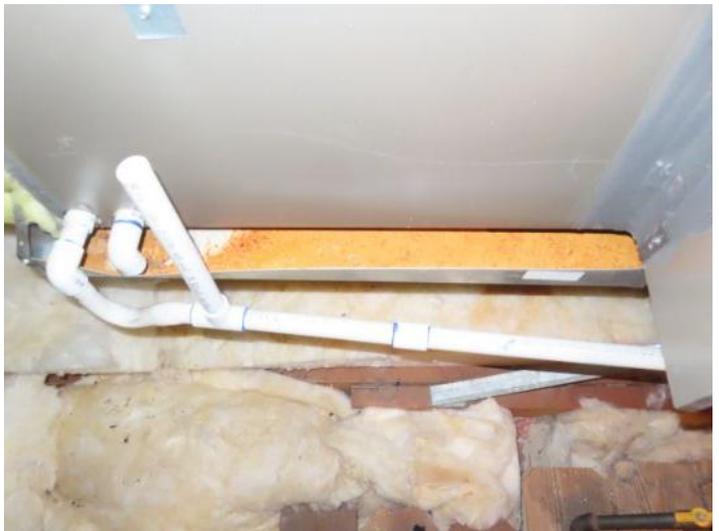
rusted drip pan

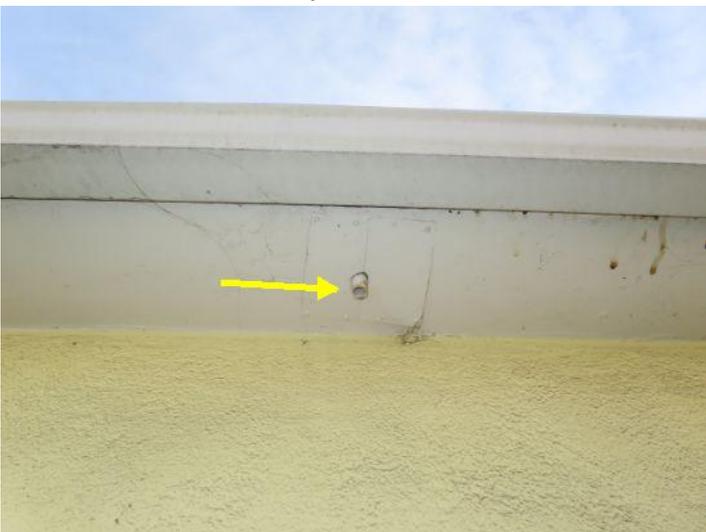
signs of leaking at the secondary condensation line

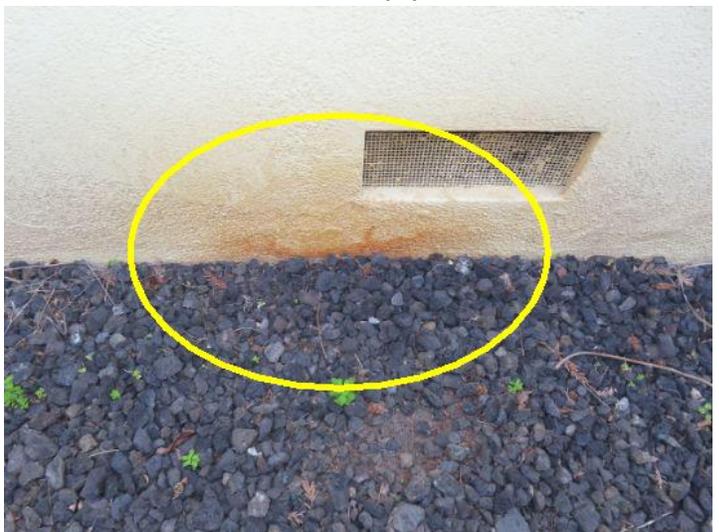
signs of leaking at the secondary condensation line

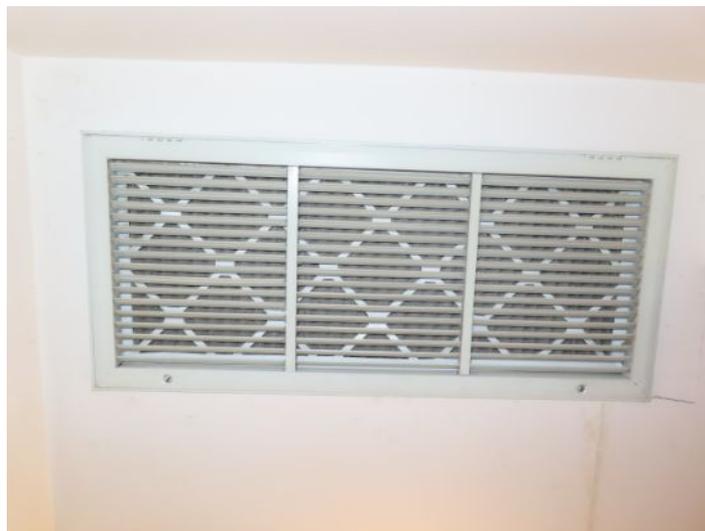
dirty filter, recommend replacement

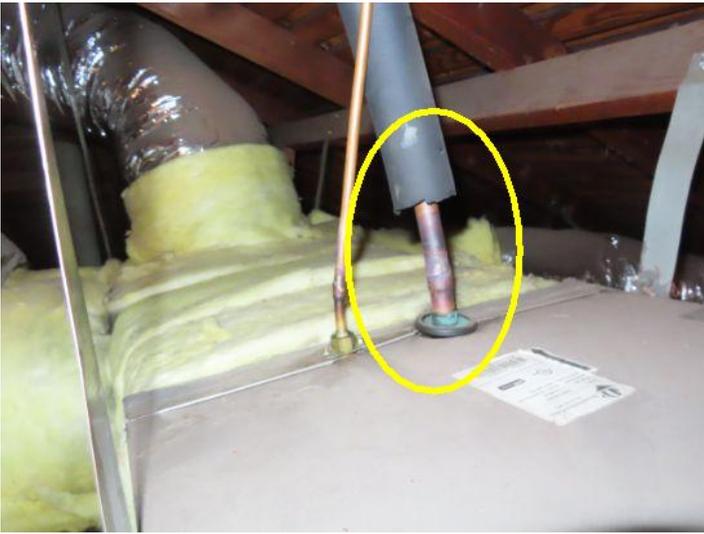
missing insulation in the attic area

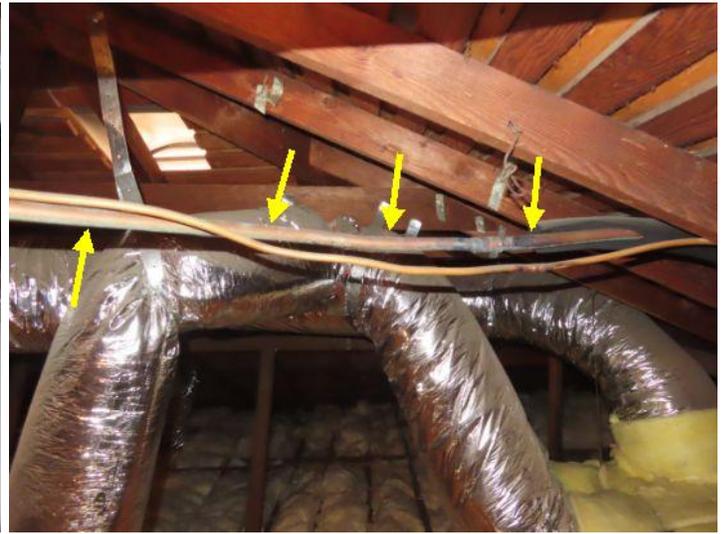
missing insulation in the attic area

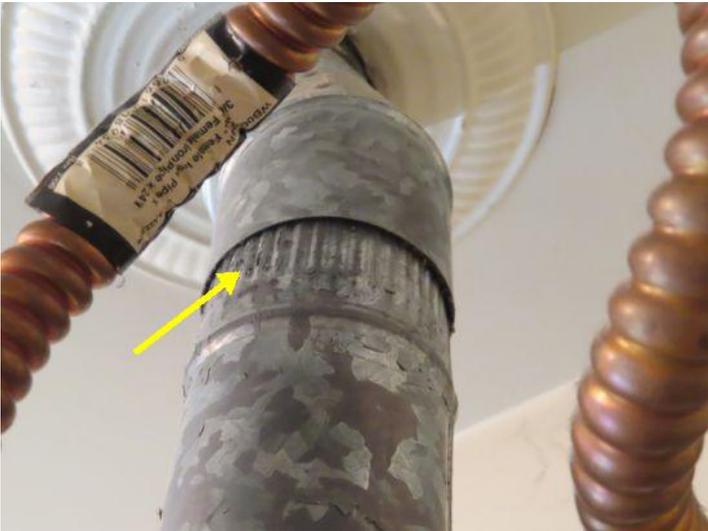
loose connections

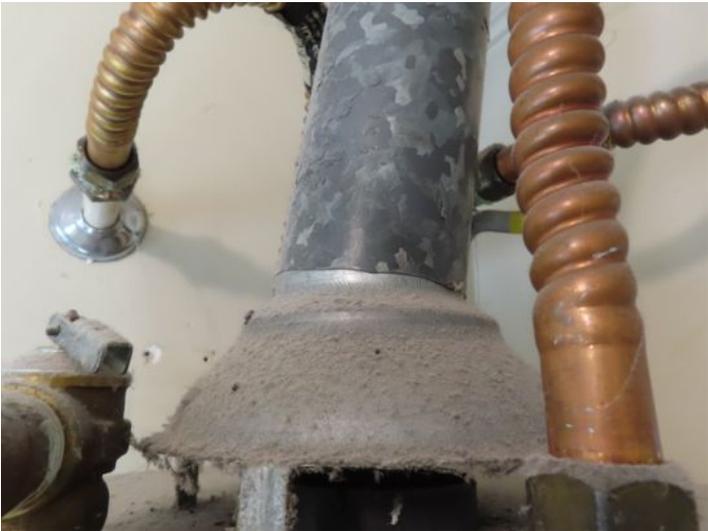
missing screws at connections

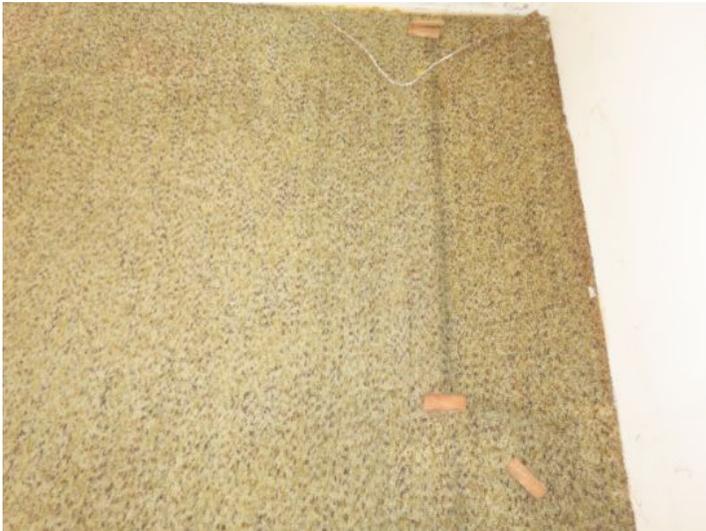
deteriorated areas

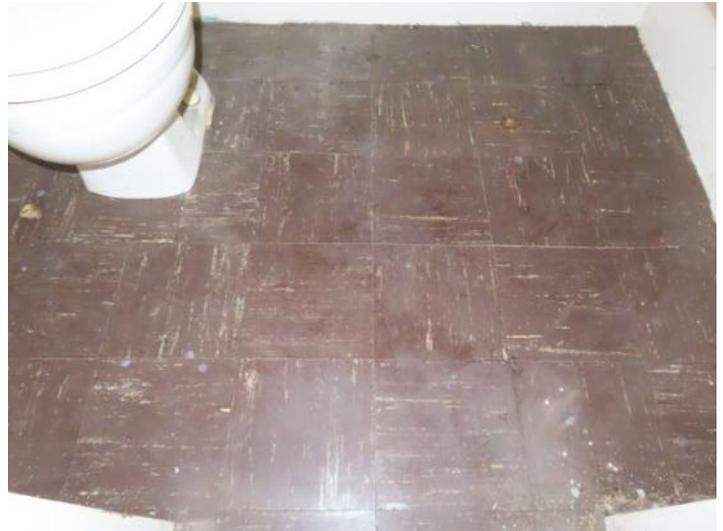
vinyl squares may contain asbestos

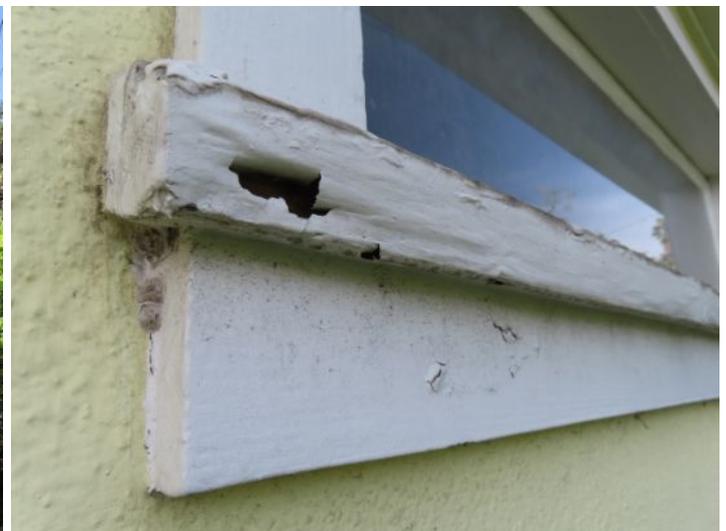
deteriorated wood window frames

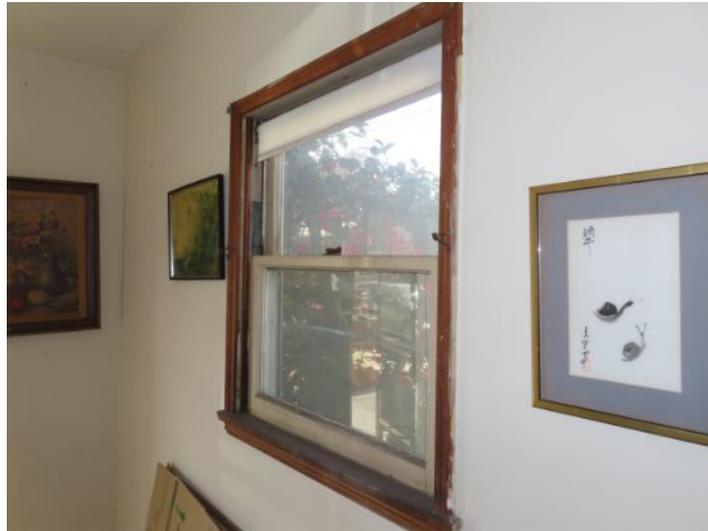
did not latch or lock

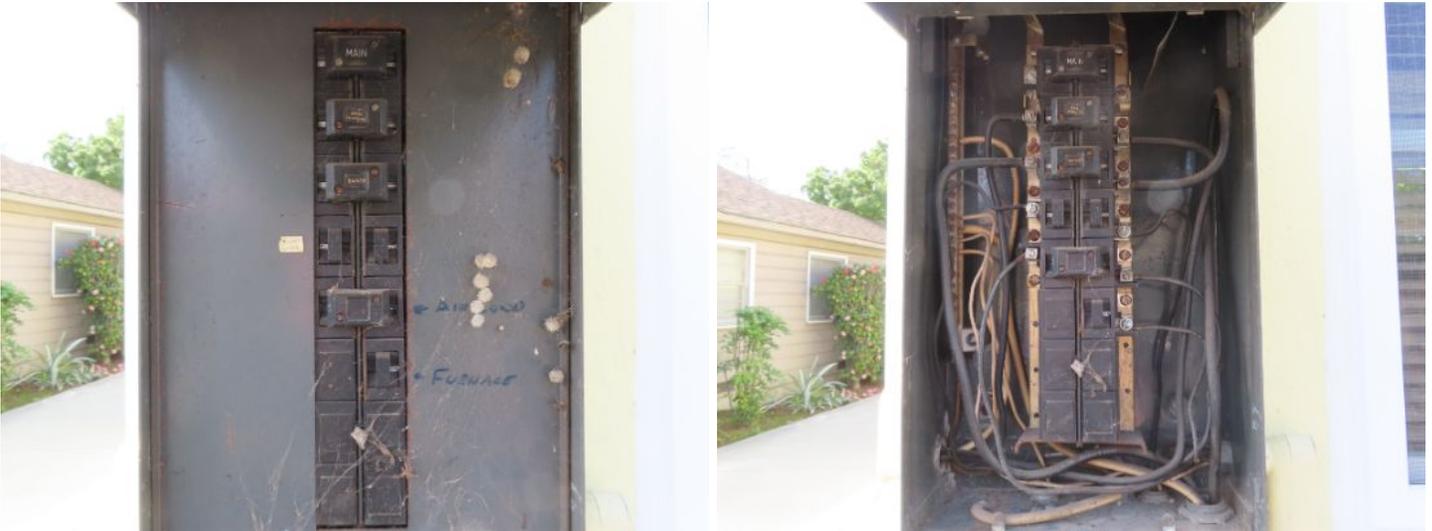
Observations: functional, push button type breakers present, **no labels present, worn breakers**

push button type breakers present

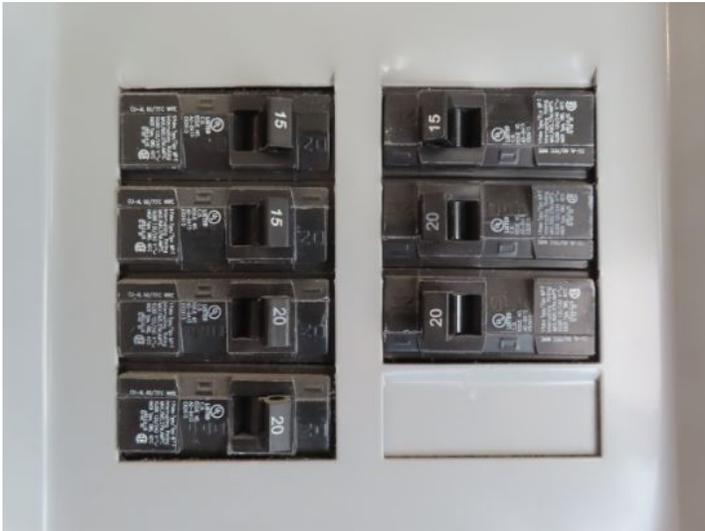
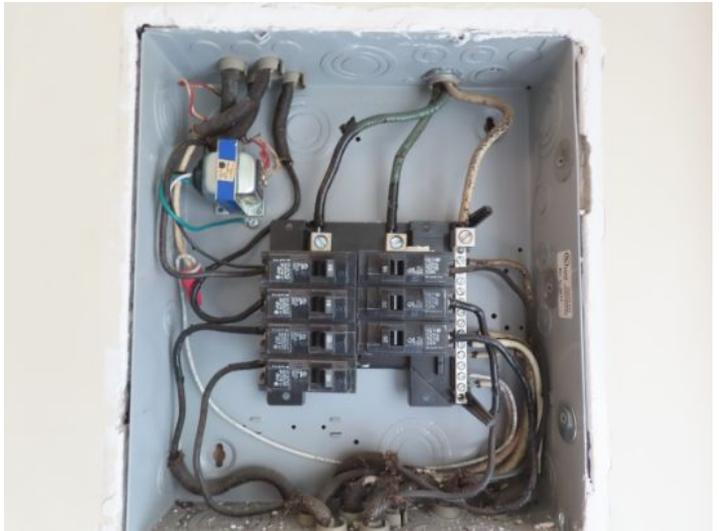
aluminum wiring present, recommend further evaluation

two wires to one breaker, recommend further evaluation by a licensed electrician

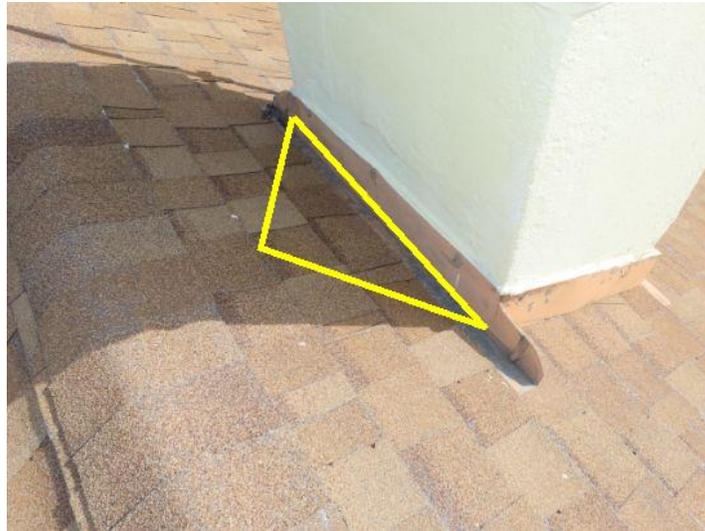
recommend a cricket flashing at chimney

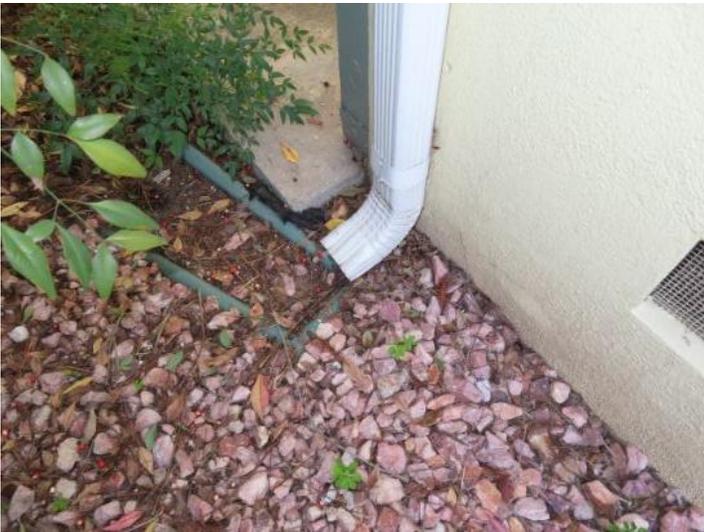
gutters do not divert water away from structure

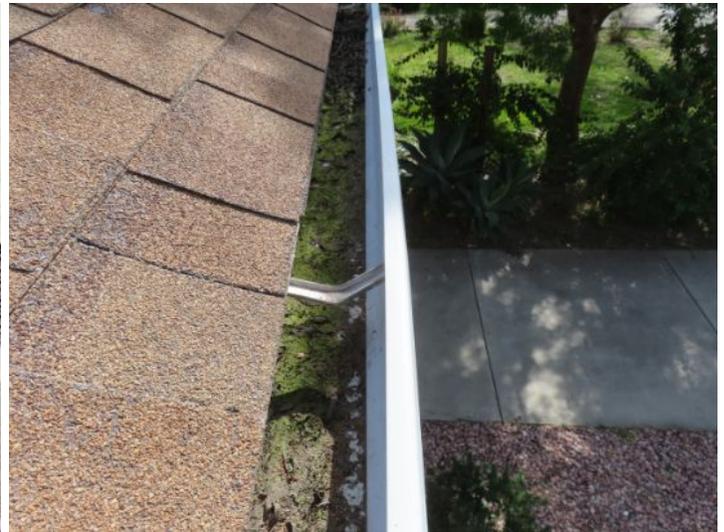
gutters are restricted by debris, recommend cleaning

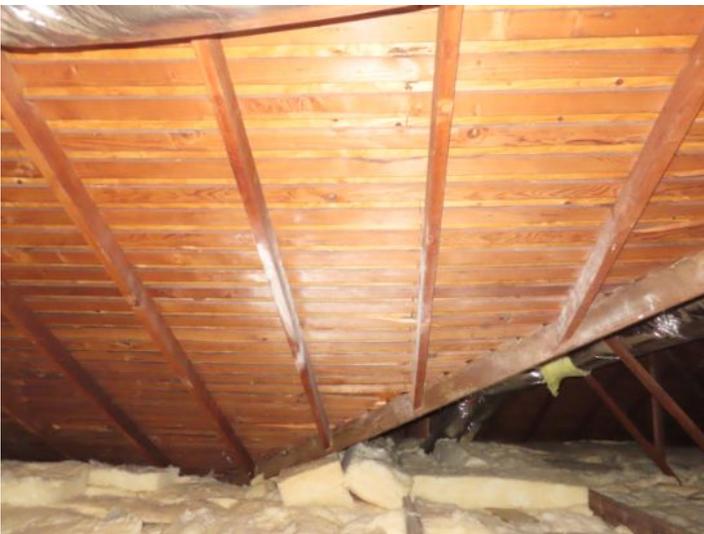
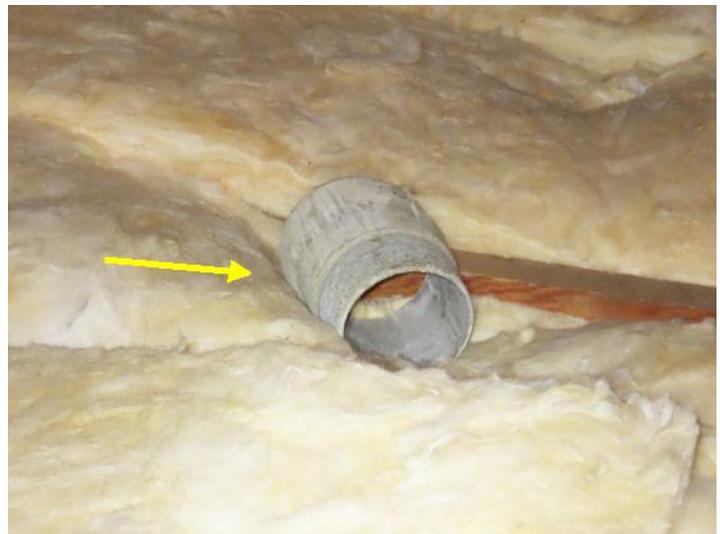
old asbestos transite pipe present, recommend removal

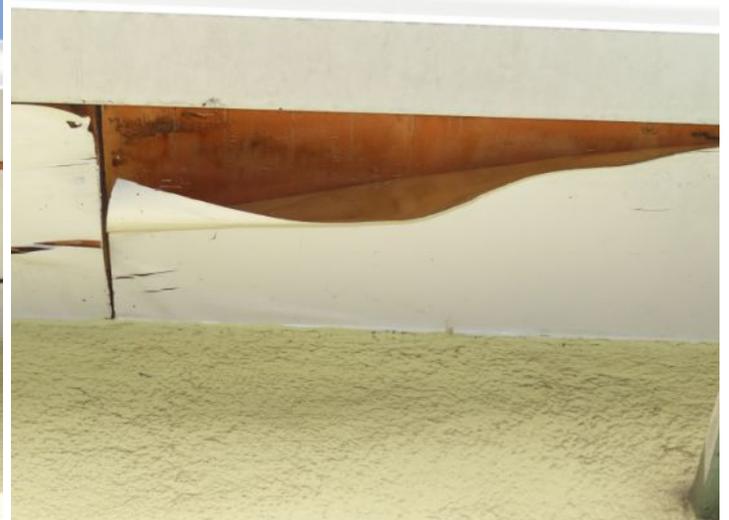
leaking at the eaves

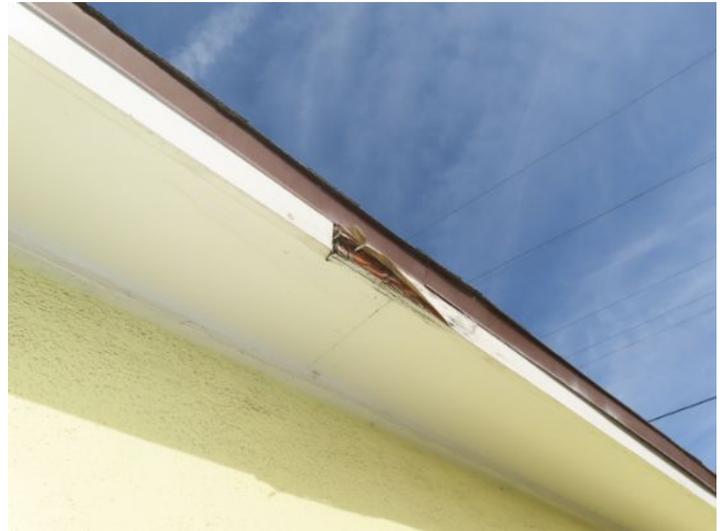
deteriorated wood

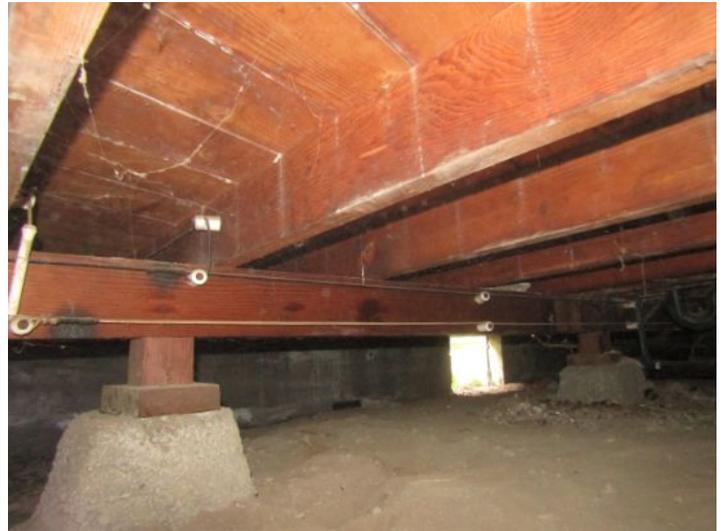
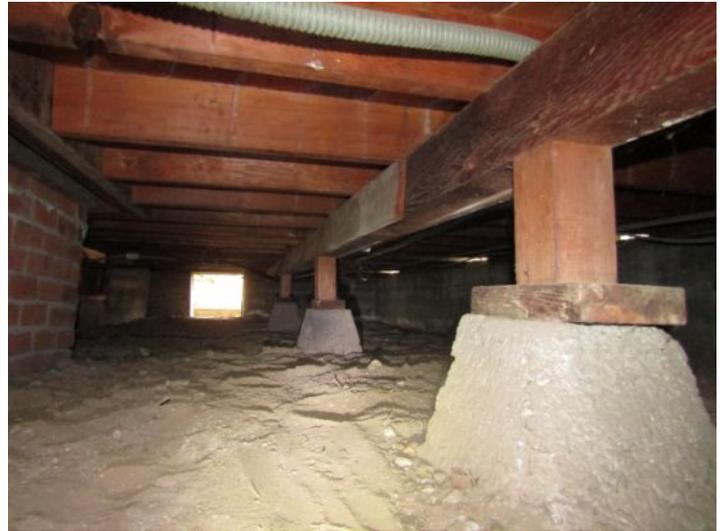
recommend T-Straps at the post and girders

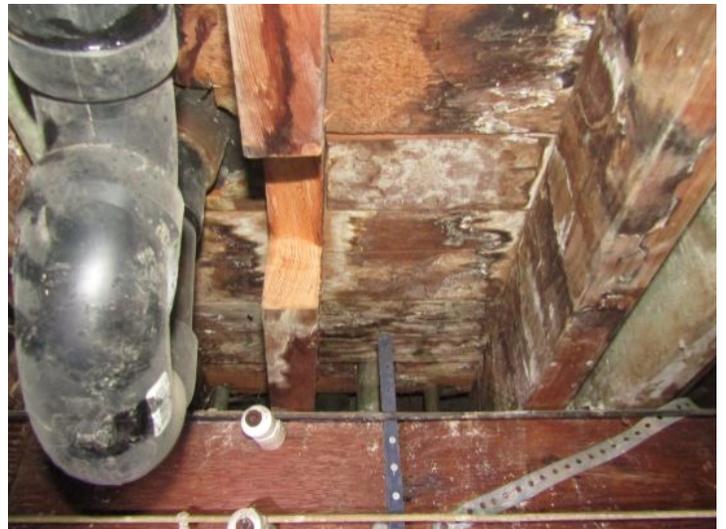
stained in areas

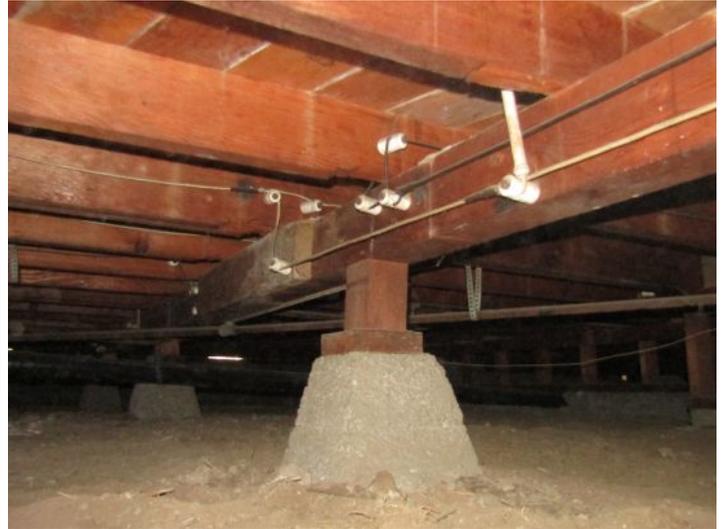
knob and tube present

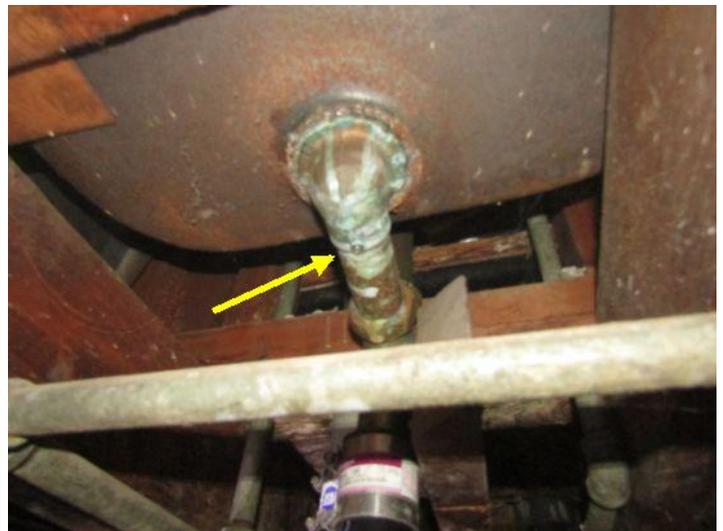
visible leaking under the hall bathroom bathtub

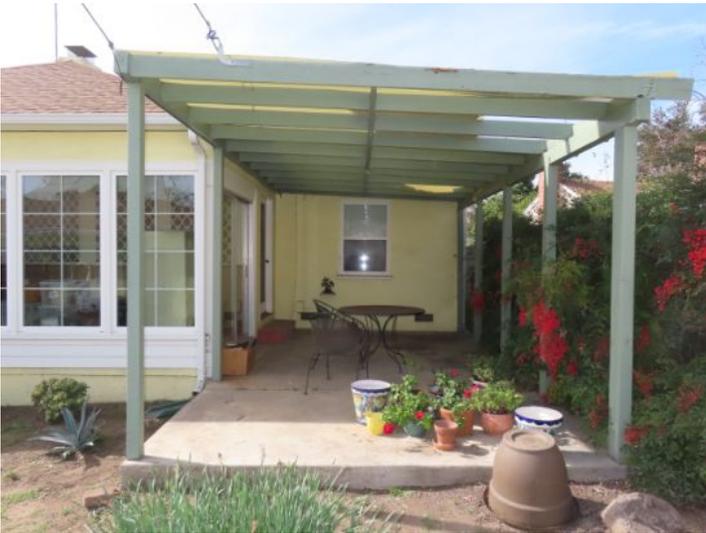
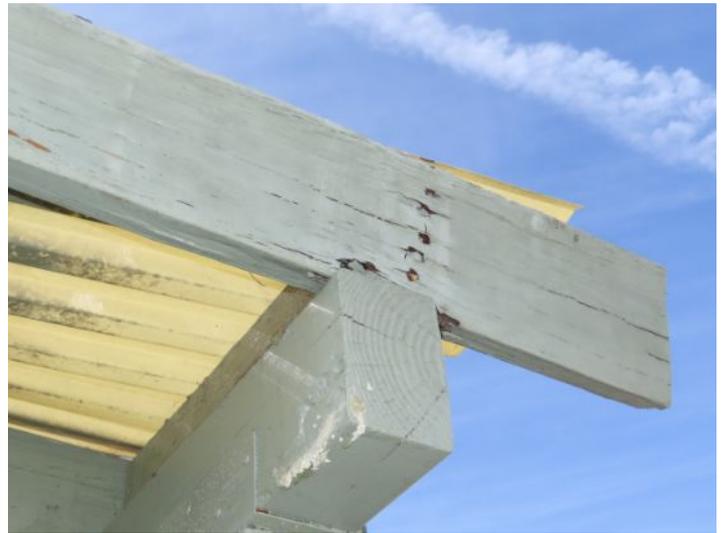
deteriorated wood

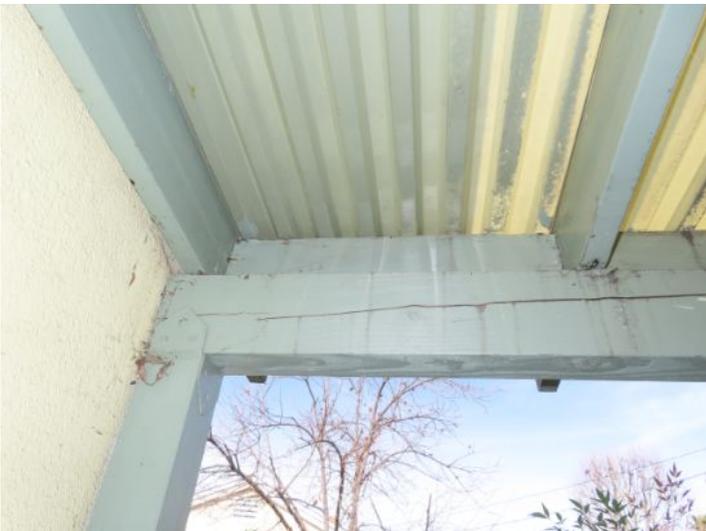
deteriorated wood

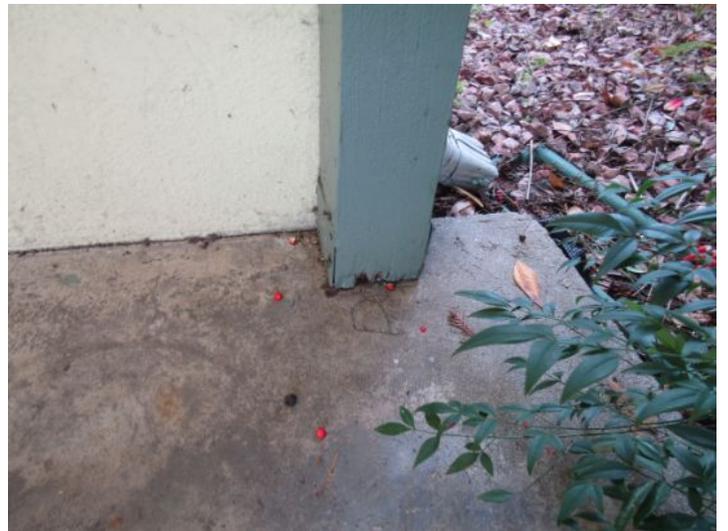
earth to wood contact

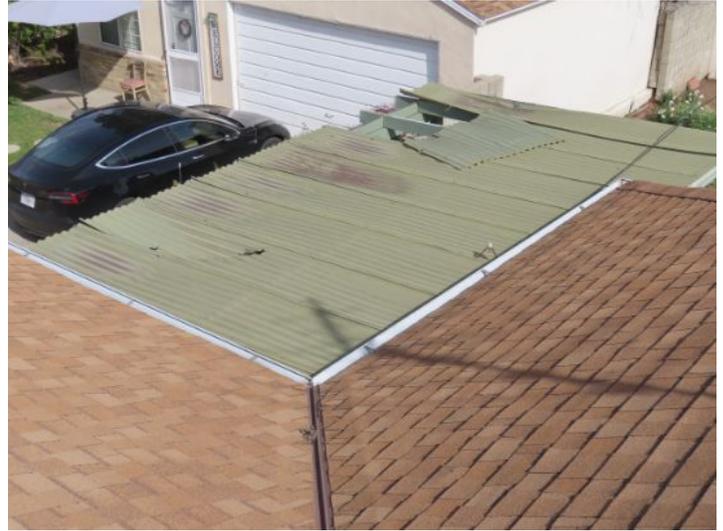
damaged and missing

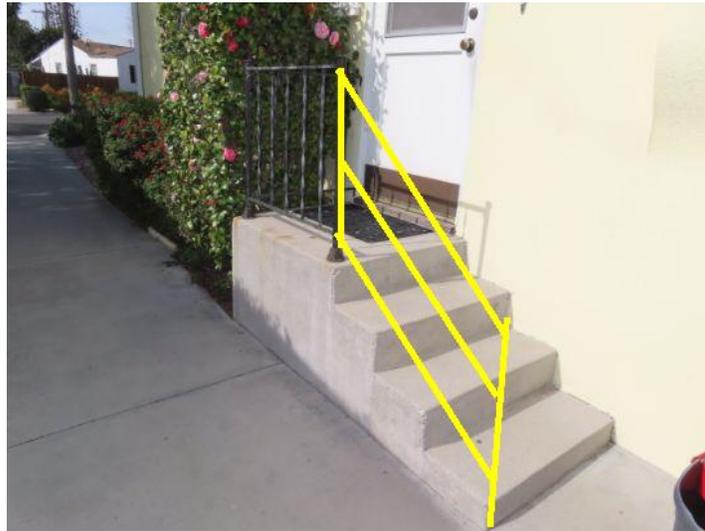
recommend hand rails

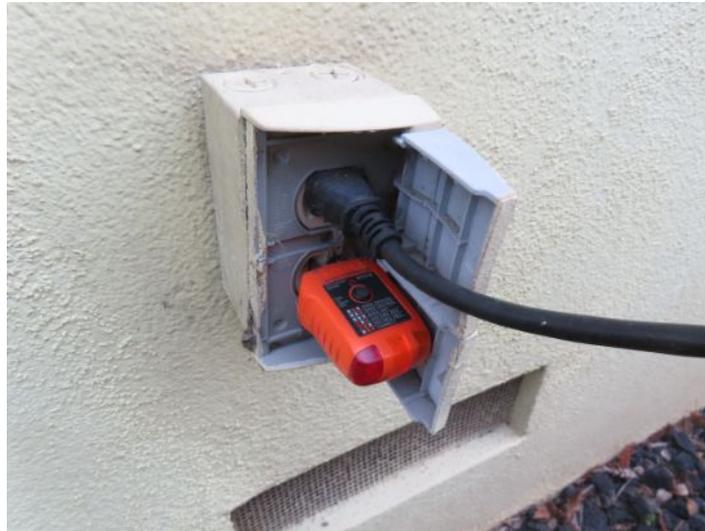
recommend -GFCI on all exterior outlets

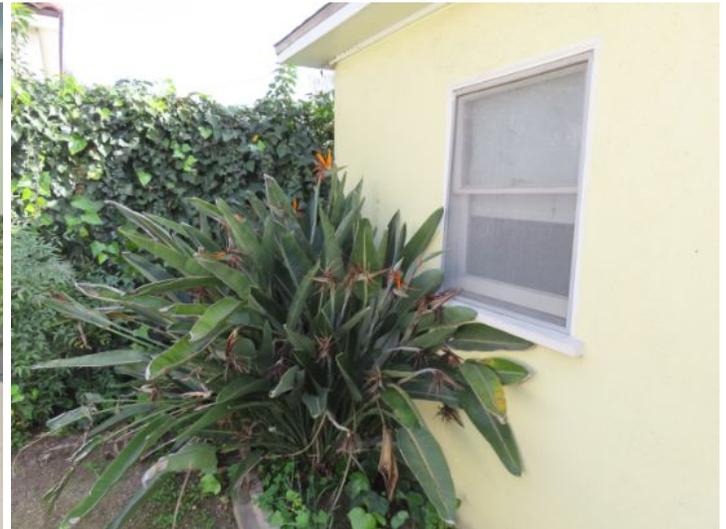
recommend trimming all shrubs that are touching the structure
