Inspection Report

Property Address:
770 Beverly Drive
Nipomo CA 93444

2/18/2026

Harper Homes: Home Inspection Services

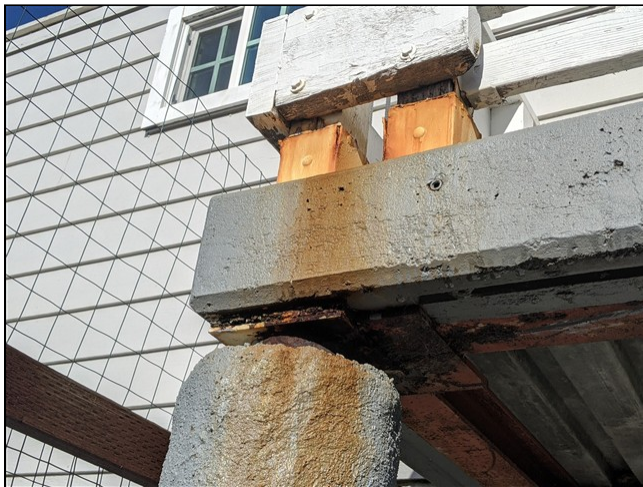
1.1 Item 1(Picture)

The metal support brackets at the front concrete patio show signs of rust and corrosion. Surface rust can lead to further deterioration if not addressed over time. Recommend cleaning and painting the brackets with an appropriate rust-inhibiting coating to help protect the metal and slow further deterioration.

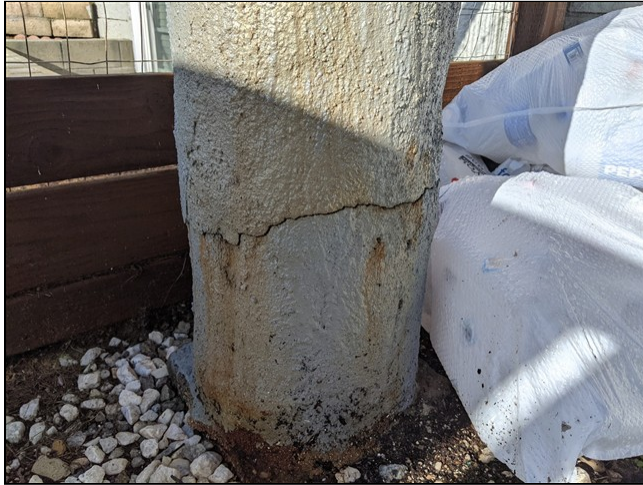
1.1 Item 3(Picture)

Cracking was noted in the concrete at the base of the front support post. In many installations, a metal post extends through the center and provides the primary structural support, with the surrounding concrete mainly

serving as a protective or stabilizing surface. Recommend sealing or repairing the cracked concrete as needed to help prevent moisture intrusion and further deterioration.

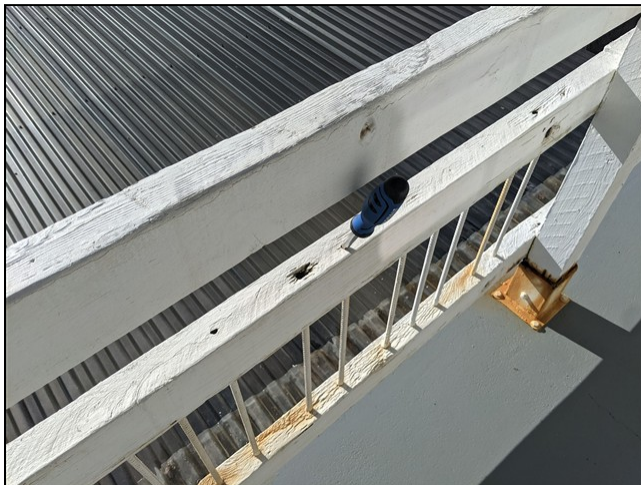
1.1 Item 4(Picture)

Moisture damage noted at the front deck. Recommend further evaluation by a structural pest control operator and make repairs as prescribed.

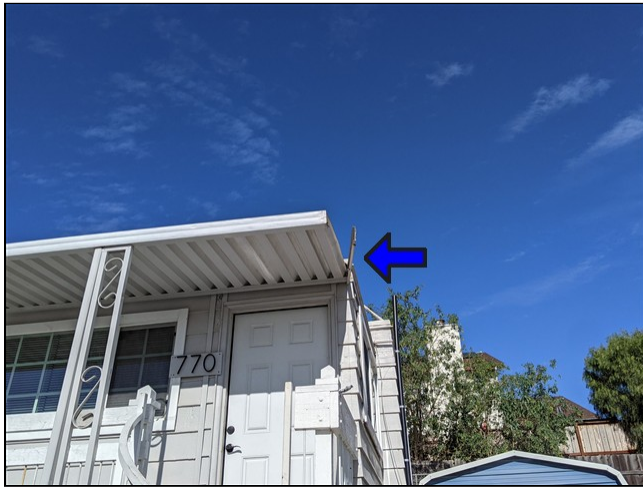
1.1 Item 6(Picture)

The front patio cover trim is separating and needs to be properly reattached.

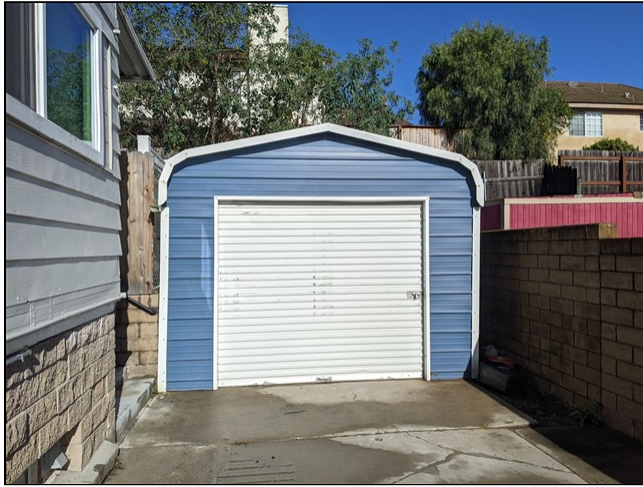
1.4 Item 1(Picture)

Sheds are outside the scope of a standard home inspection. Recommend further evaluation is made as needed.

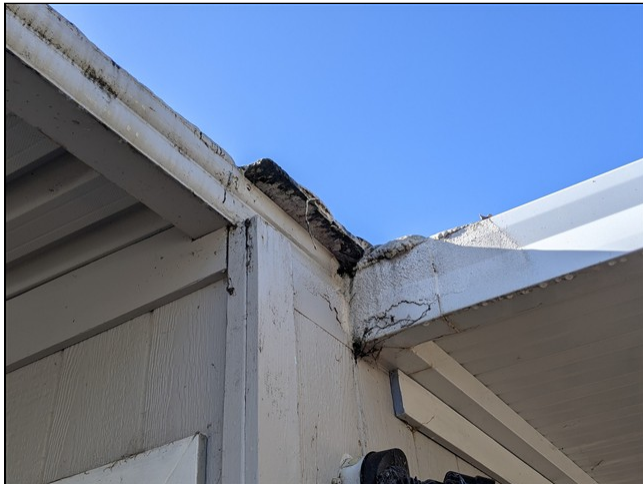
2.0 Item 1(Picture)

Roof sheathing contains moisture damage under the eave at the rear exterior. Refer to the pest report for further information on this condition and make repairs as prescribed. Roofing materials should be further evaluated and repaired in these areas to prevent continued deterioration.

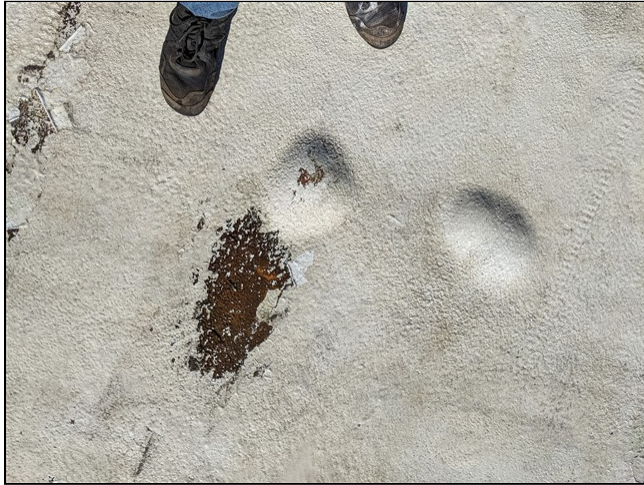
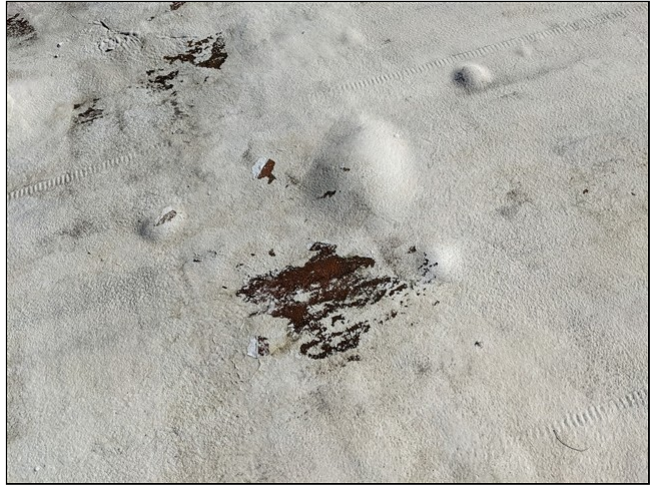
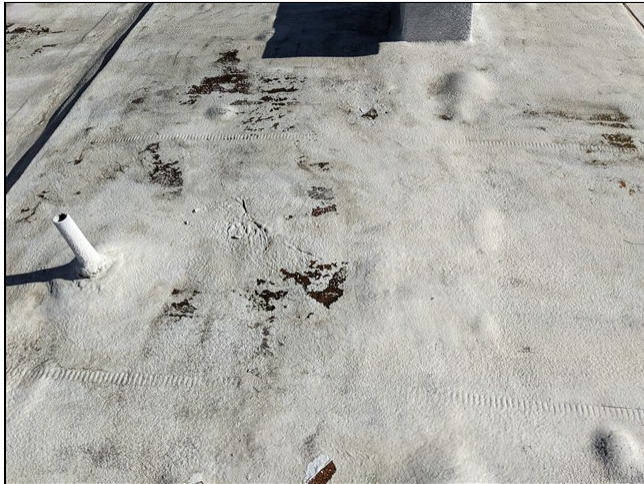
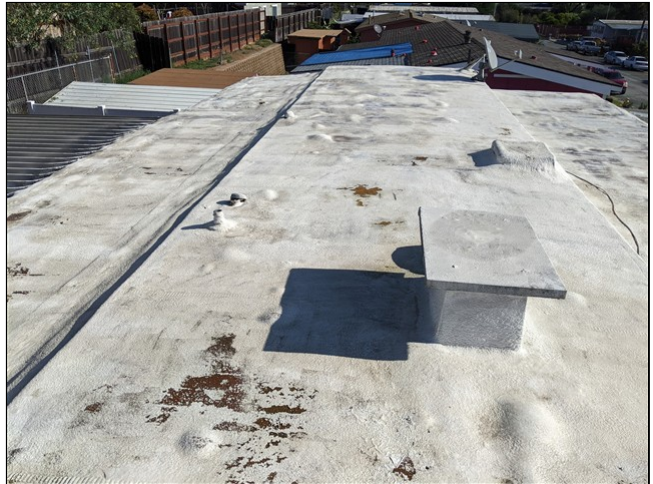
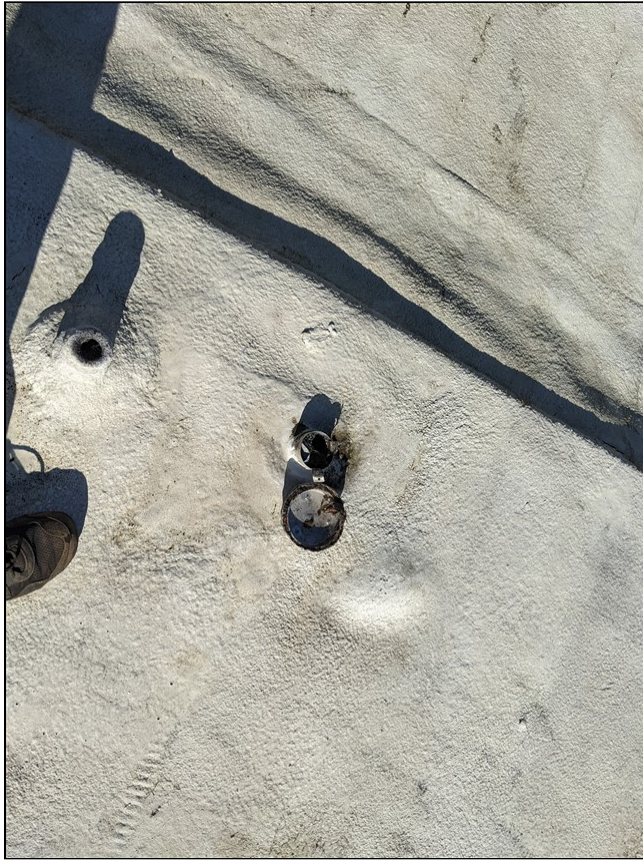
The flat roof on the mobile home appears aged and is showing bubbling and visible signs of deterioration. These conditions are commonly associated with wear and breakdown of roofing materials and can reduce the roof's ability to properly shed water over time. Repairs or replacement of the affected roofing sections are

recommended to help maintain proper performance and prevent further deterioration. Evaluation by a qualified roofing contractor is advised.

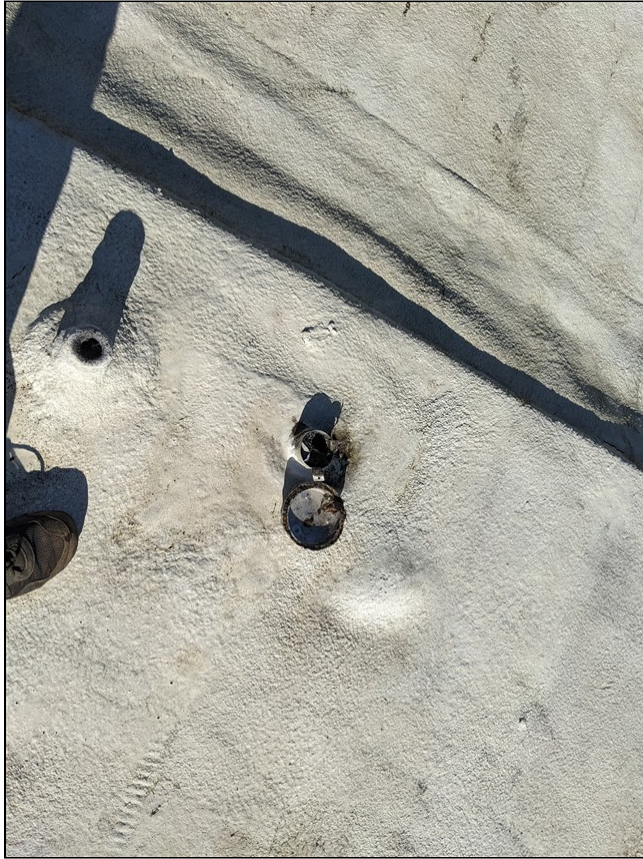
2.2 Item 1(Picture)

Exhaust vent cap is missing vent and should be installed immediately to prevent moisture or debris from entering the exhaust vent.

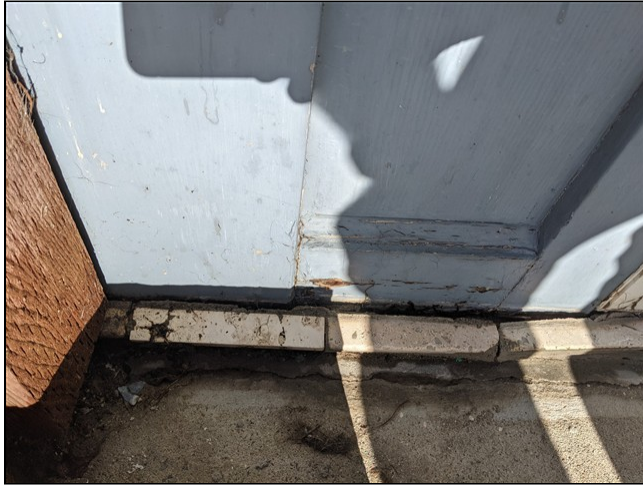
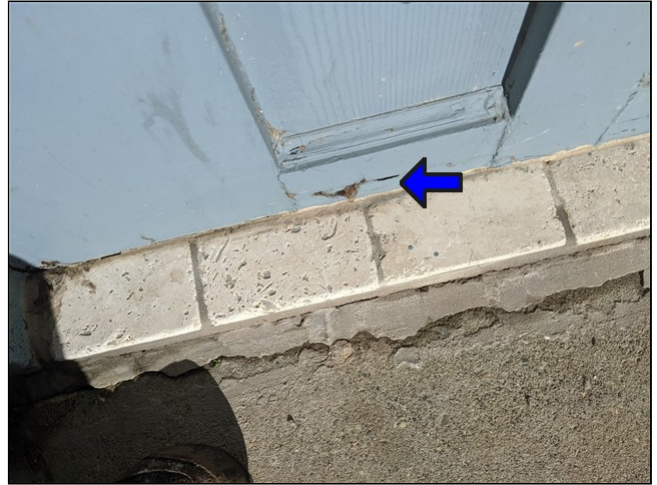
Moisture damage noted at the trim. Recommend further evaluation by a structural pest control operator and make repairs as prescribed.

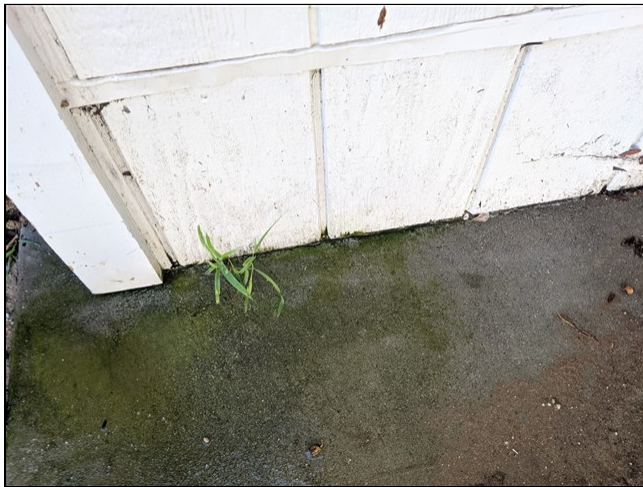
2.4 Item 3(Picture)

Siding and trim is in contact with concrete noted at the rear exterior. Recommend wood materials be cut back from contacting the concrete to help prevent further moisture intrusion.

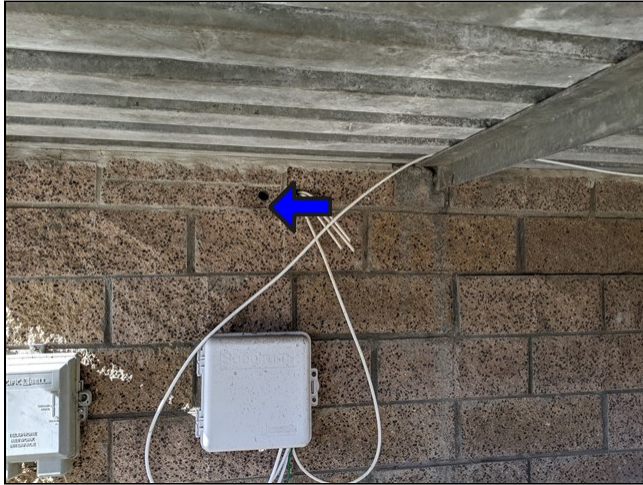
2.4 Item 4(Picture)

Perforations in the siding at the right exterior should be patched or repaired to prevent pest or moisture intrusion.

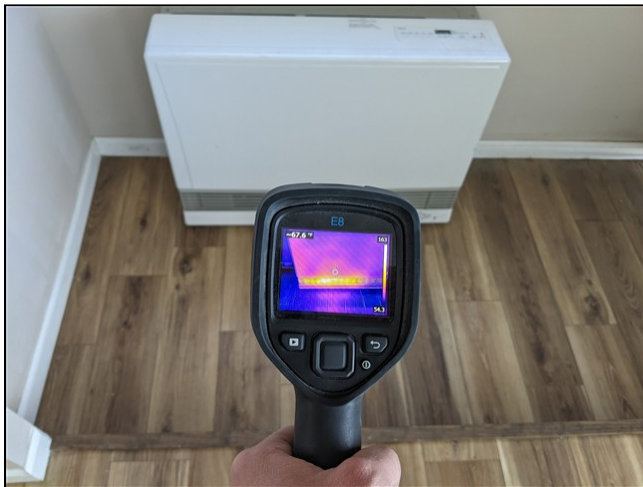
3.0 Item 1(Picture)

The wall heaters were tested and functional at the time of the inspection.

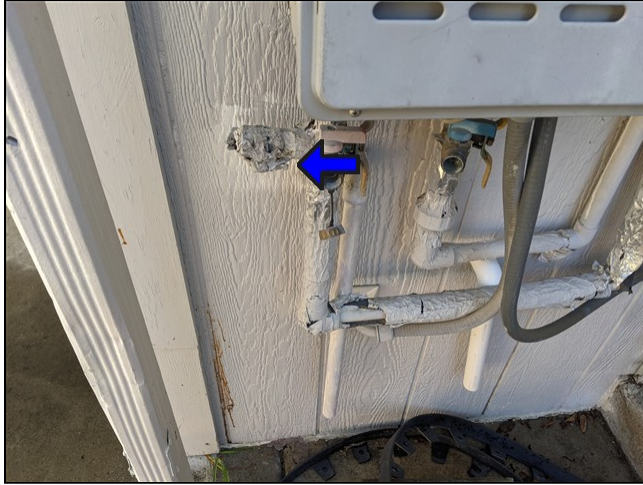
4.0 Item 1(Picture)

Water heater safety valve piping missing and needs properly installed to prevent an unsafe condition if the TPR is activated.

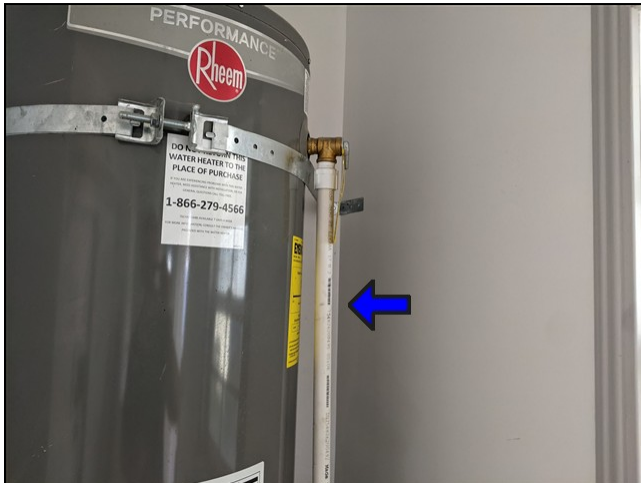
4.0 Item 2(Picture)

Water heater safety valve piping is improper material and needs properly re-installed to prevent an unsafe condition if the TPR is activated.

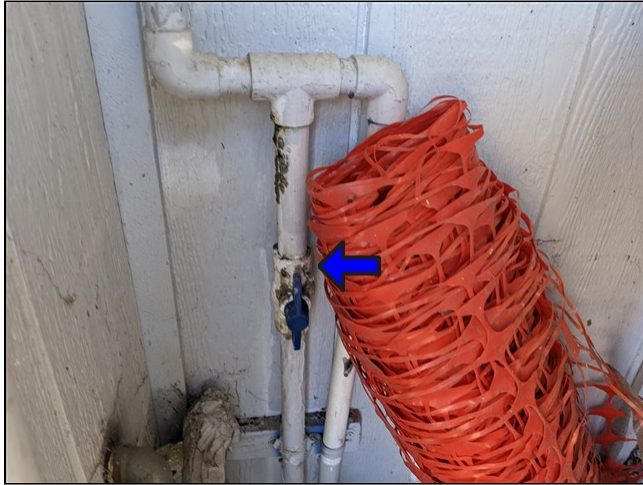
4.2 Item 1(Picture)

Supply line leak noted at the rear exterior and should be repaired to prevent further deterioration and water waste.

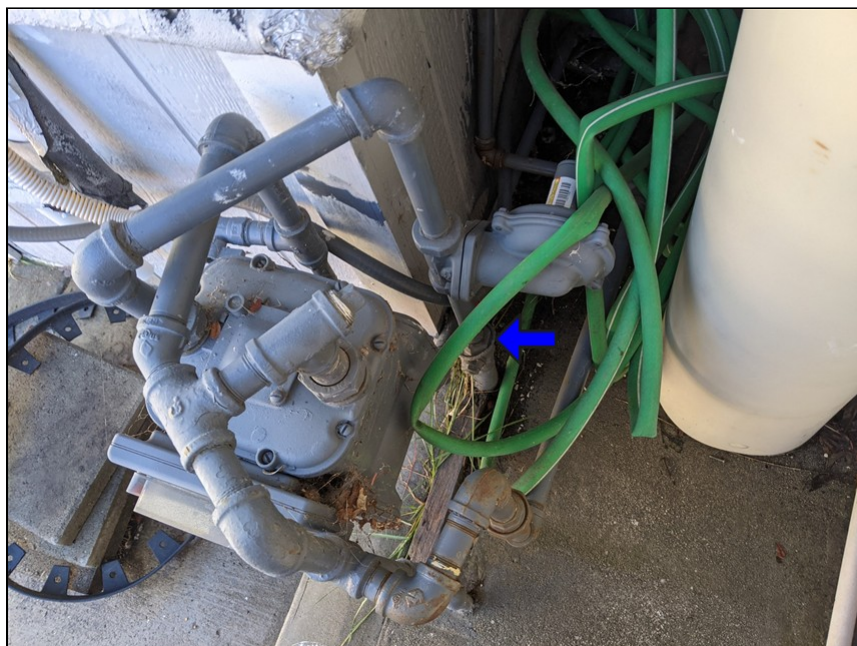
4.3 Item 1(Picture)

The gas shutoff is located at the rear exterior of the home. To turn the gas off turn the valve perpendicular to the piping.

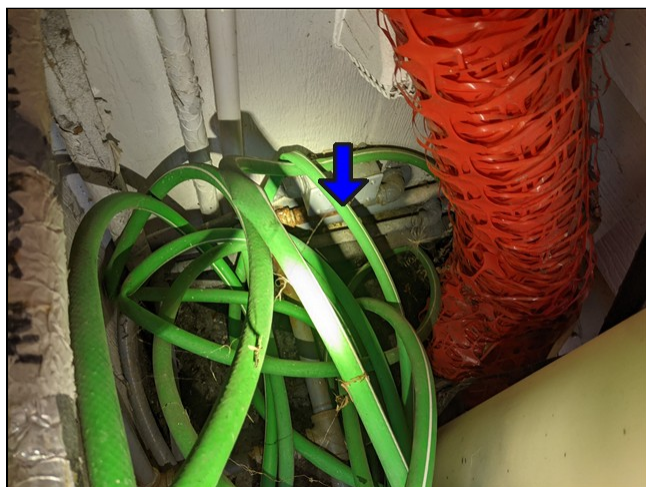
4.3 Item 2(Picture)

Steel gas line is rusted at the rear exterior and should have loose rust removed and painted with proper corrosion inhibiting paint to prevent further deterioration.

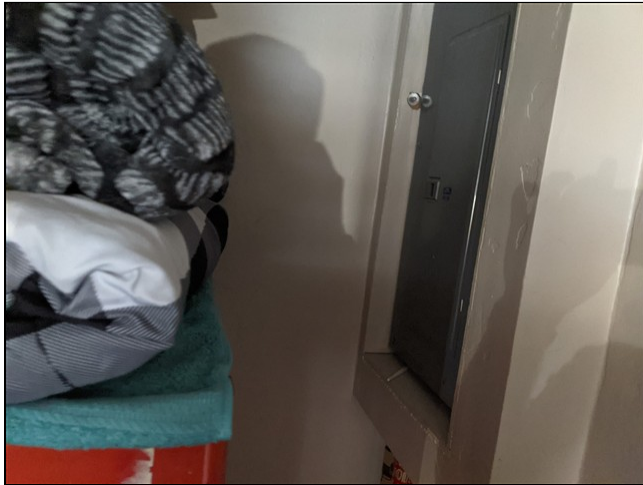
5.1 Item 1(Picture)

The bus bar where the breakers connect to the upstairs bedroom sub panel is loose. This condition should be further evaluated and repaired by a licensed electrician to ensure the safety of the home.

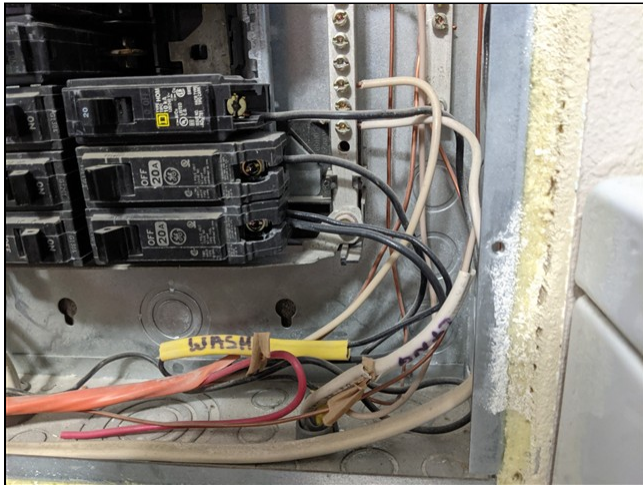
5.2 Item 1(Picture)

Double wires improperly installed on a breaker in the downstairs laundry room sub panel. Alteration or repairs should be made to prevent an unsafe condition.

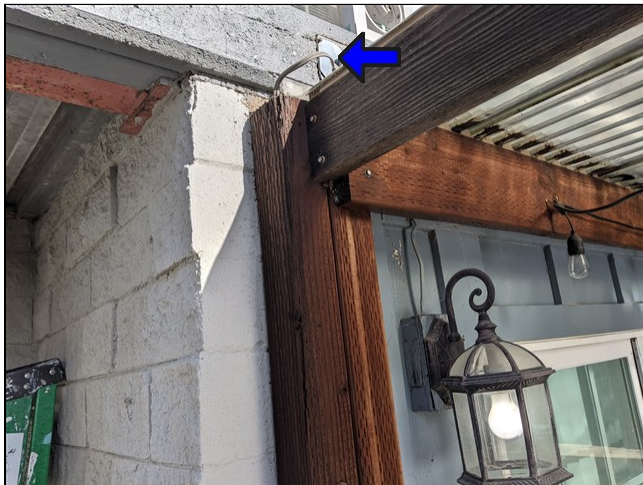
5.3 Item 1(Picture)

Wiring installed improperly and exposed where damage could occur, noted at the front exterior. Recommend the wiring be installed inside conduit or behind walls.

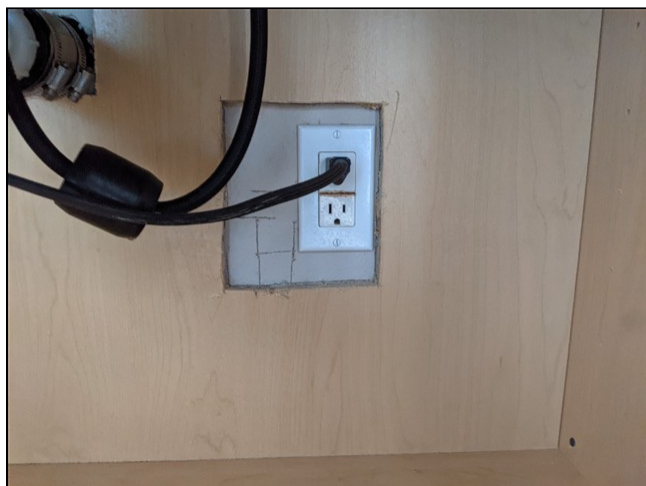
5.6 Item 1(Picture)

Receptacle is damaged at the cabinet under the upstairs kitchen sink and should be replaced before further use.

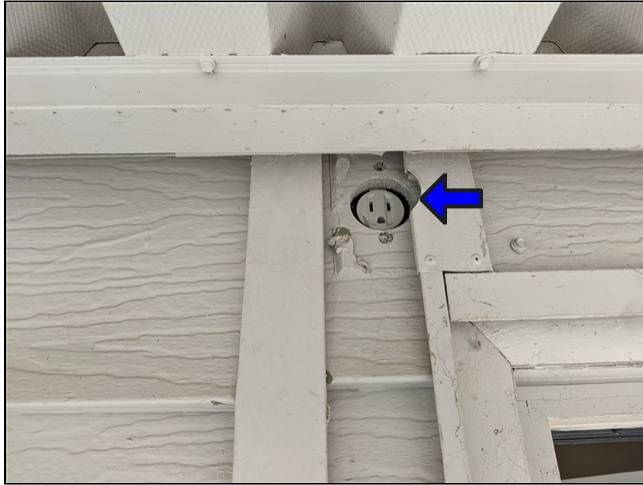
5.6 Item 2(Picture)

Exterior receptacle without a weather cover noted at the front exterior. Installation is needed to insure full safety of this system.

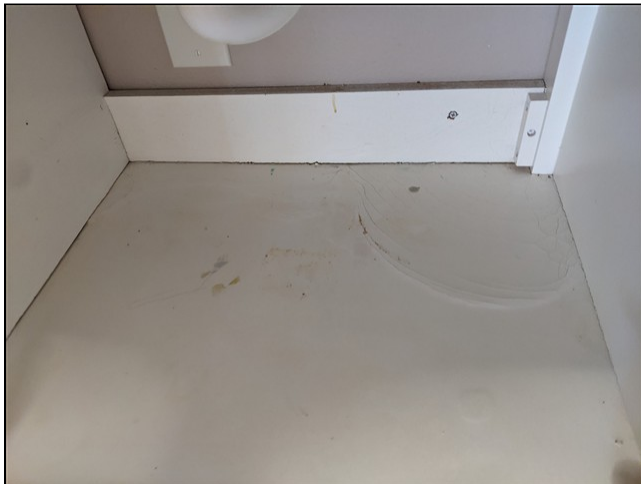
6.3.A Item 1(Picture)

Slight moisture damage noted to the cabinet under the sink. No leaks noted at the time of inspection. Cosmetic repairs can be made as needed.

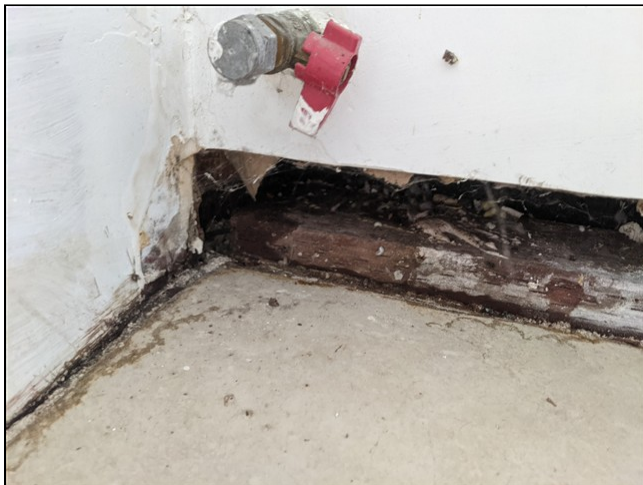
7.0 Item 1(Picture)

Signs of moisture intrusion and possible microbial growth was noted in the laundry room. Recommend further evaluation and repairs are made at this location to prevent further moisture intrusion.

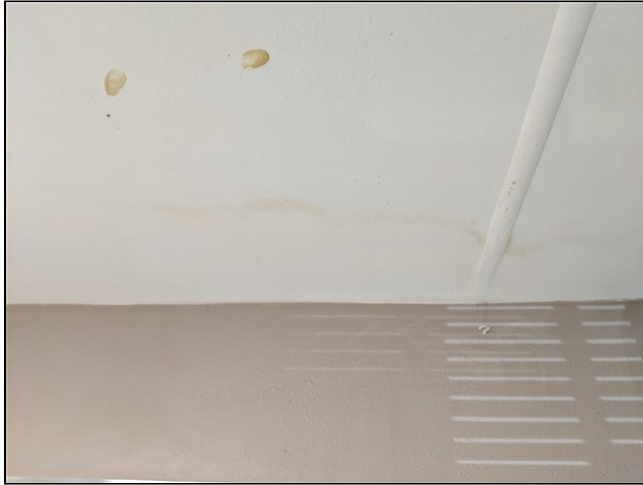
7.0 Item 2(Picture)

Moisture stains noted on the ceiling and walls bathroom ceiling. Recommend the roof and flashings be further evaluated in these areas to determine the cause and remedy of this moisture intrusion.

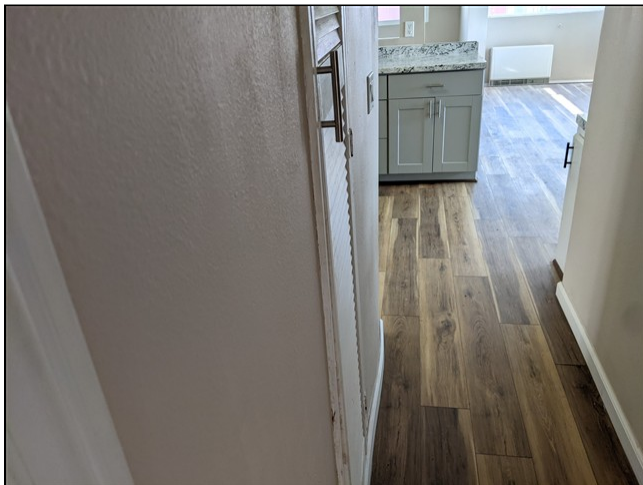
7.0 Item 3(Picture)

A bowed or uneven section of wall was observed in the upstairs hallway. The cause and extent of this condition could not be determined during the inspection. Recommend further evaluation is made as needed.

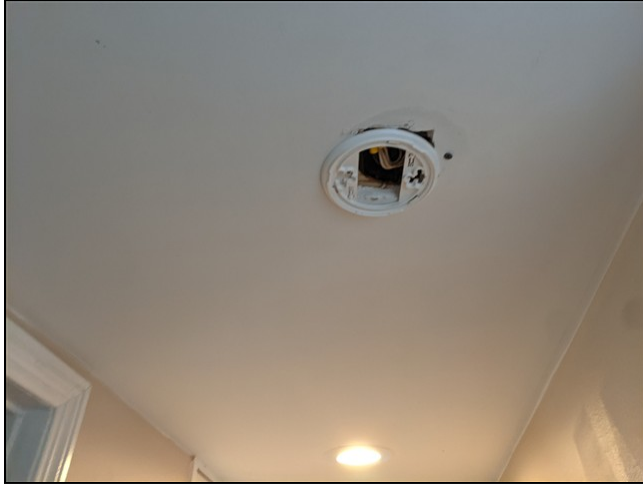
7.4 Item 1(Picture)

Smoke alarm has been removed from upstairs hallway and should be replaced to ensure intended safety of the home.

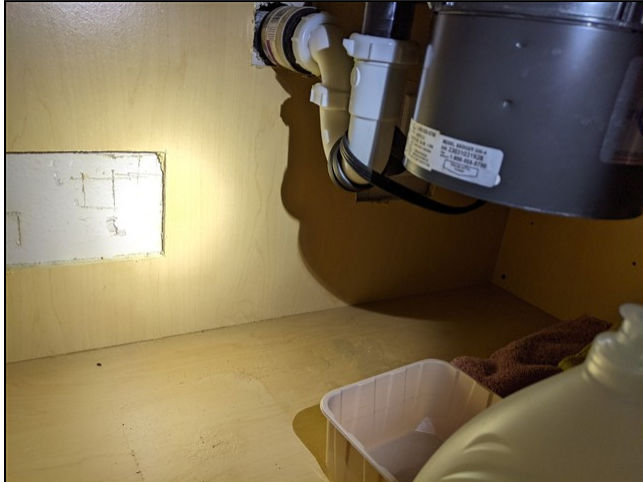
8.4.A Item 1(Picture)

Drain line leak noted under the sink. Recommend repairs made before further use of the sink.

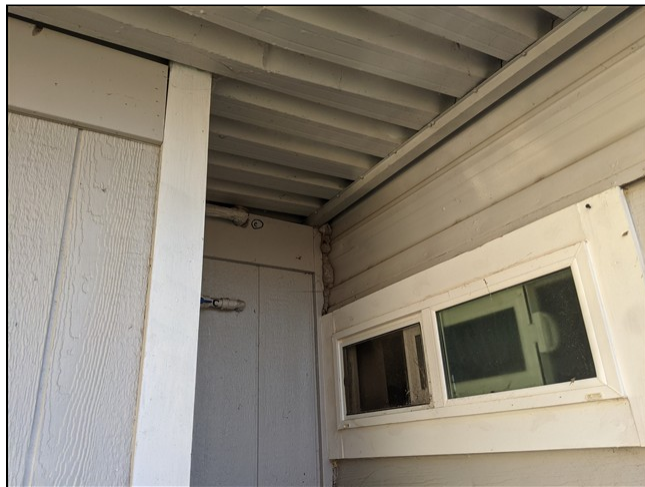
9.1 Item 1(Picture)

The rear laundry room is permanently attached to the main structure of the modular home. The attaching of additional structures to a manufactured home is typically not approved by the manufacturer. Recommend further evaluation of this portion of the home by a qualified contractor to determine if alterations or improvements are needed.
