THE REAL ESTATE
INSPECTION COMPANY

HOME INSPECTION

11493 Nantucket Pkwy
San Diego, CA 92130

02/10/2026

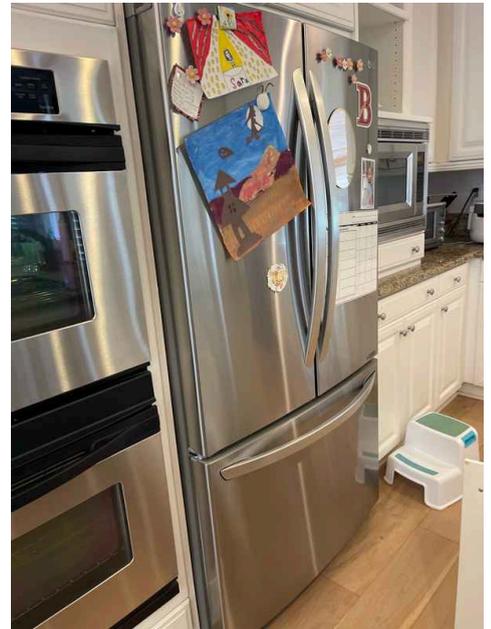
KITCHEN

Refrigerator was not inspected or commented on. If in fact the refrigerator does convey and you are concerned about its serviceability and functionality we recommend further evaluation by a licensed appliance contractor.

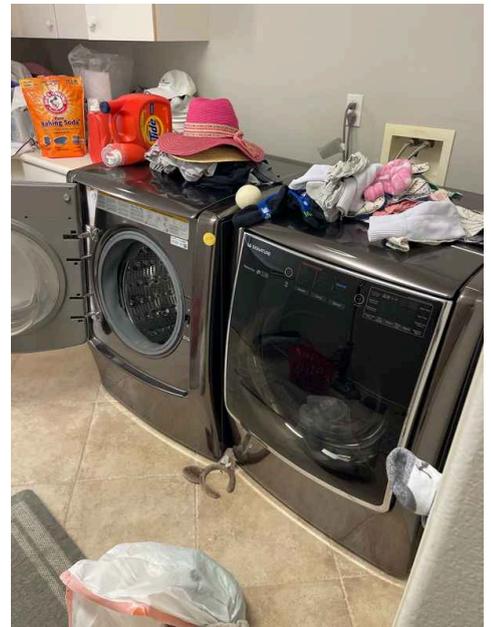
LAUNDRY ROOM

WASHER/DRYER - NOT TESTED

The clothes washer and dryer were not inspected or commented on. If in fact the machines do convey and you are concerned about their serviceability and functionality we recommend further evaluation by a licensed appliance contractor.

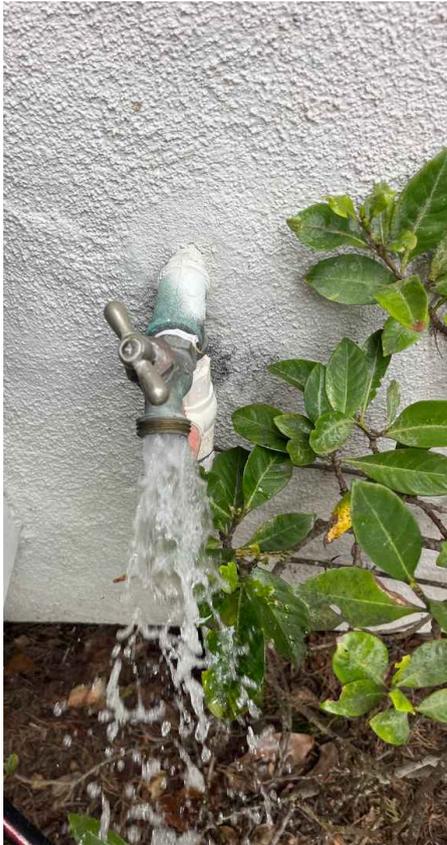
A representative number of hose spigots were tested and operational. This is not an exhaustive test and hose spigots may leak when a hose or other device is connected due to back pressure.

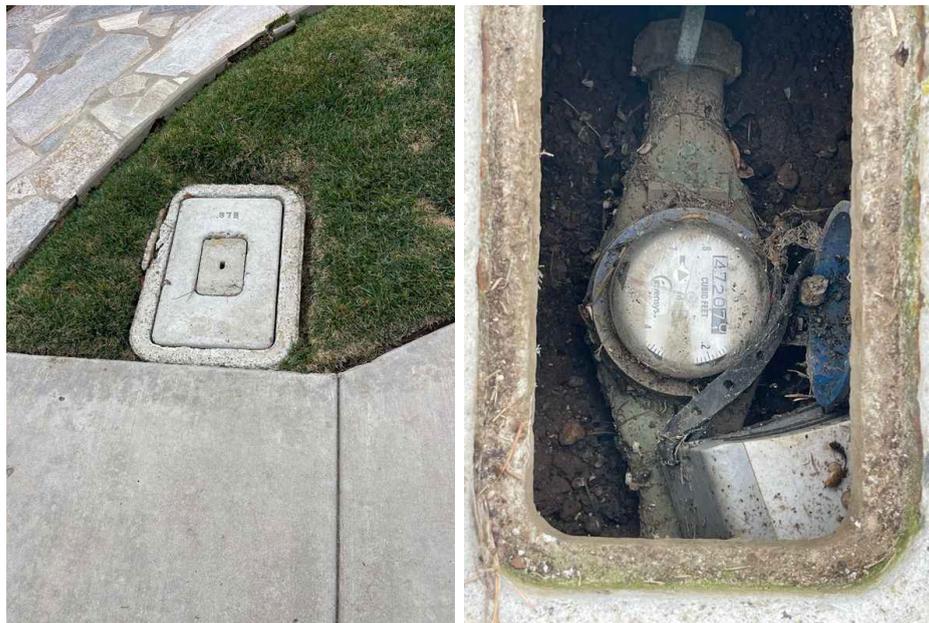
Front Exterior

Note: The water meter was observed for an extended period of time with plumbing fixtures, washing machine, dishwasher, sprinkler system, and any other water-using systems, devices and fixtures turned off. No movement of the water meter was observed.

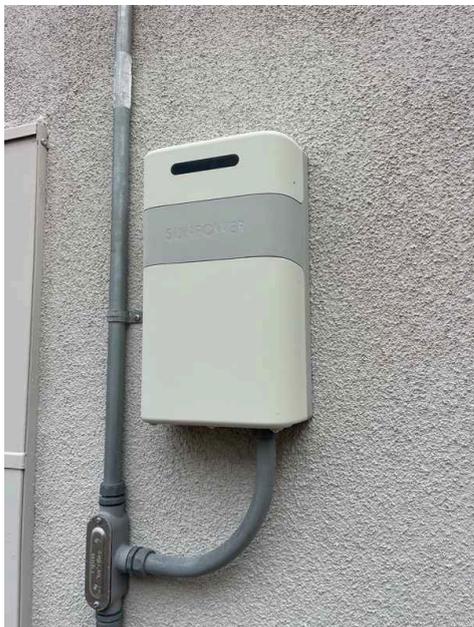
ROOF/RIGHT EXTERIOR

Although the inspector may make comments on obvious deficiencies of the photovoltaic system, an adequate inspection lies beyond the scope of the Home Inspection and the expertise of the Inspector. We recommend that you have the system inspected by a qualified contractor to ensure that it is in safe operating condition.

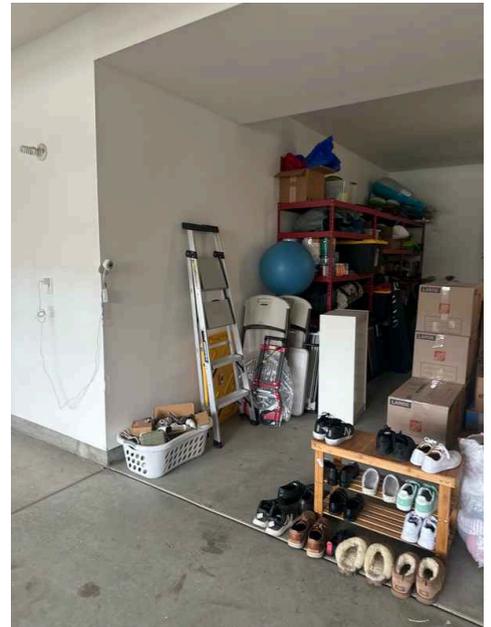
GARAGE

Due to occupants personal items, not all areas were visible. We recommend a careful evaluation during final walk-through.

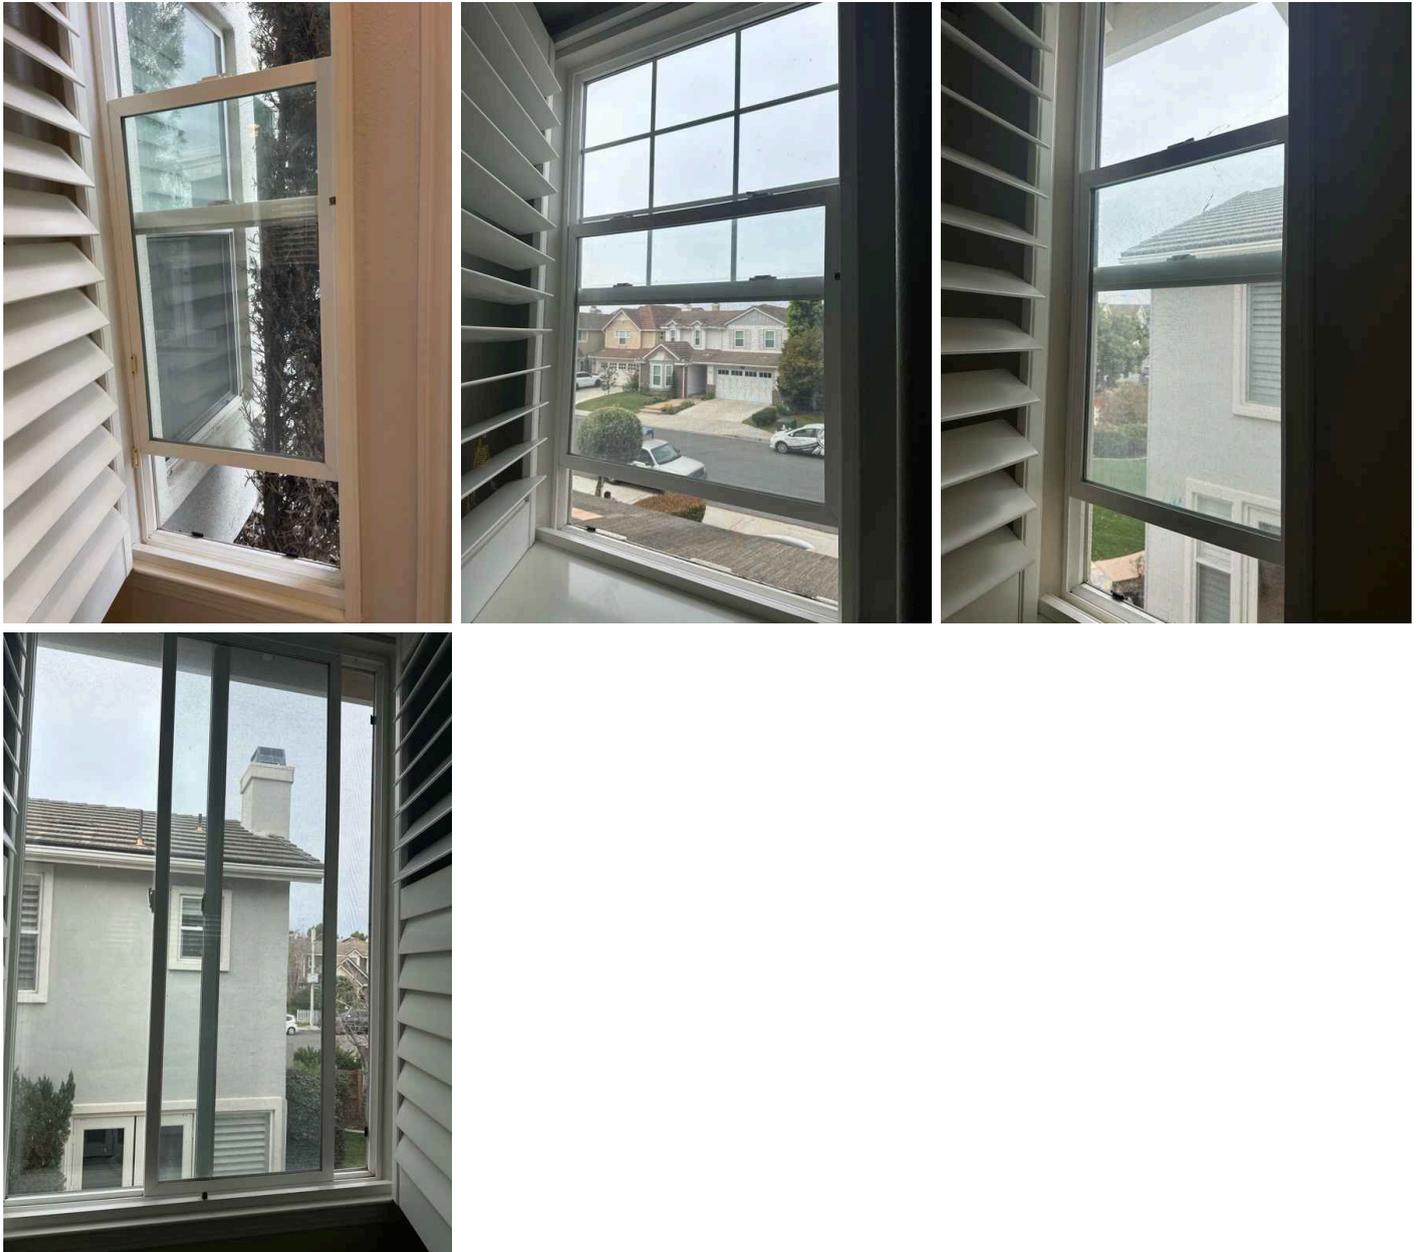
Only a representative number of accessible windows are checked for operation during this inspection in accordance with the standards of practice of a home inspection. In some instances, the inspector may not be able to disclose the exact condition of every window. This includes reporting on the condition of the locks, springs, counter-balance mechanisms, or evidence of leaking if furniture, personal items or window coverings prevent access to windows and surrounding areas.

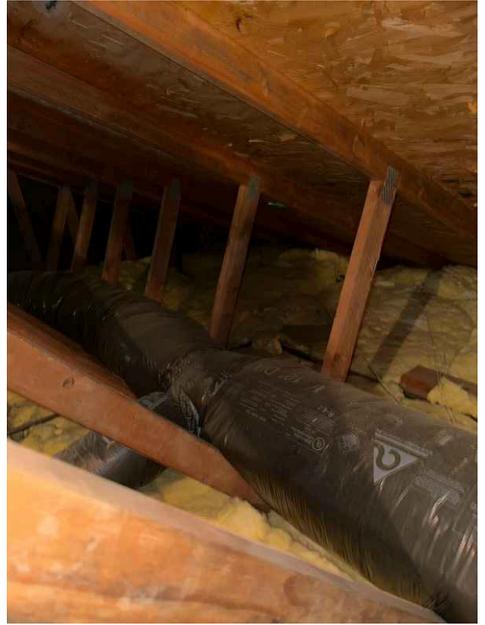
Attic

Due to the structure of the roof/framing, some areas of the attic could not be inspected.

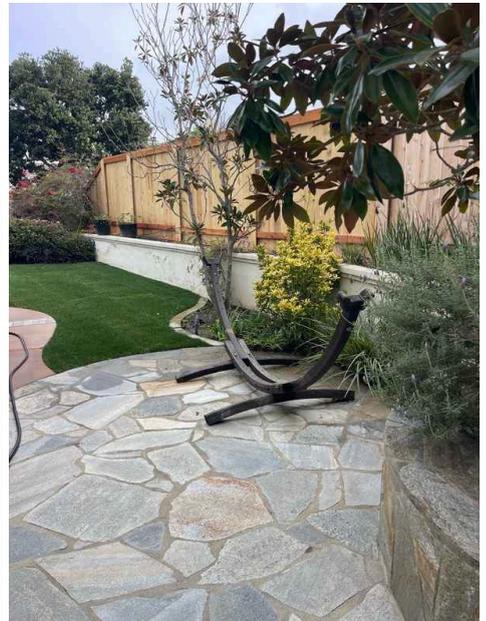
Rear Exterior

Retaining wall present. Wall appears to be in serviceable condition. Note: Confirming that the retaining wall was properly installed, with the required reinforcement and drainage, is not possible within the limited scope of a home inspection.

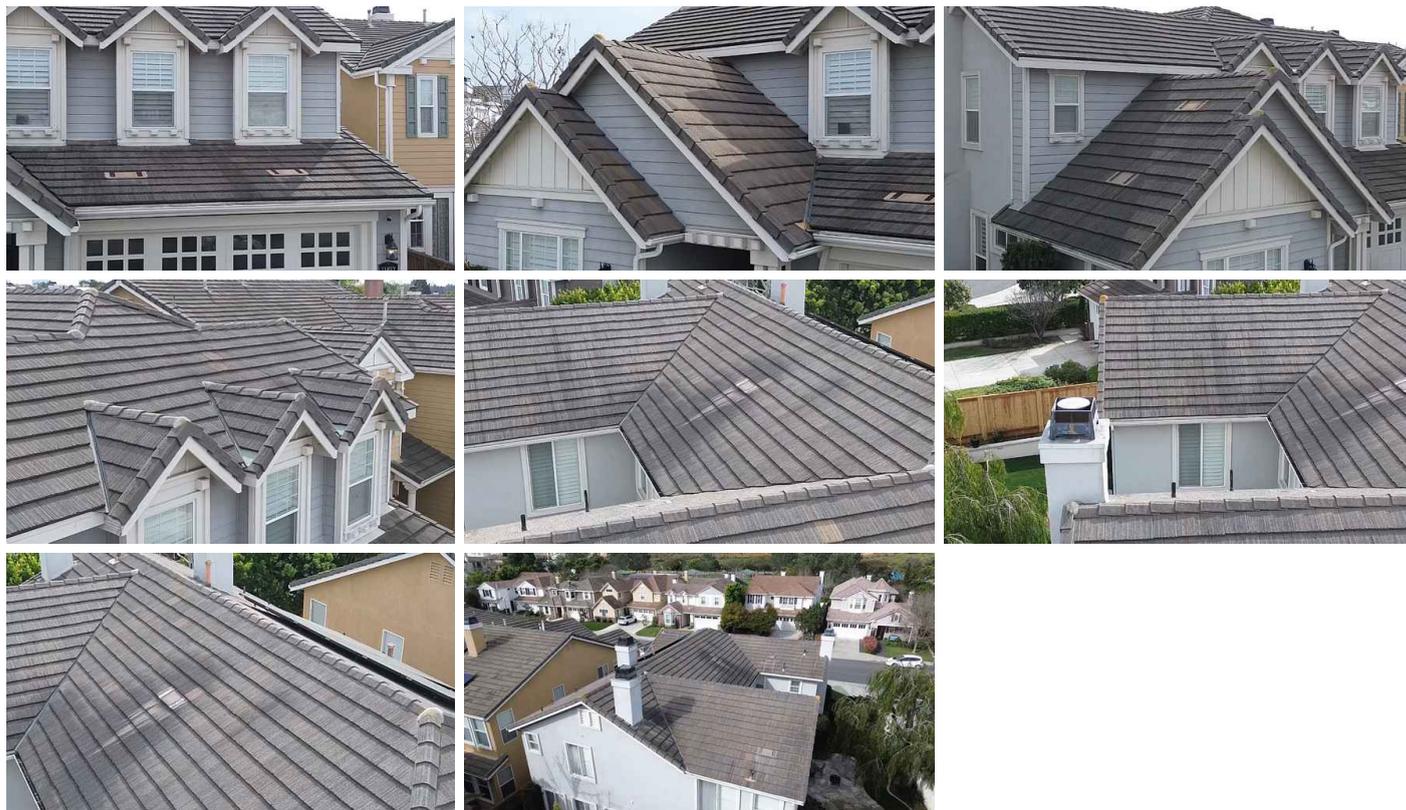
Roof

The roof shows normal wear for its age and type; appears to be in serviceable condition. Notable exceptions will be listed below.

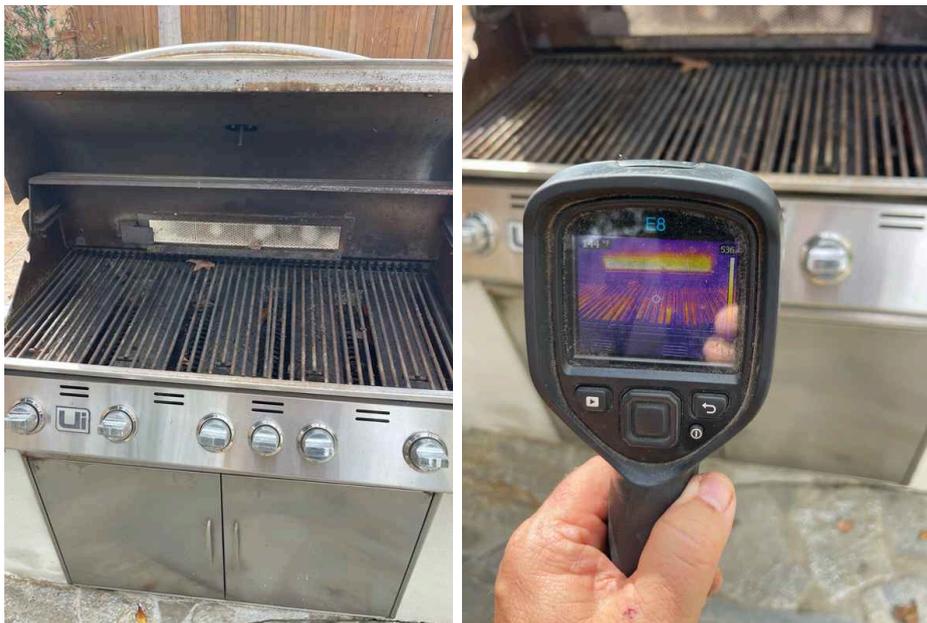
Rear Exterior

The home was equipped with an outdoor grill/bbq. The grill/bbq was operable at the time of the inspection. This test is not exhaustive and does not confirm the performance, accuracy, or effectiveness of the grill/bbq. We recommend review of this system with the seller if a more detailed evaluation is desired.
