# Inspection Report

**Debra Trout  
345 Black Hawk  
Nipomo, CA 93444**

Report Date: 2/20/2026

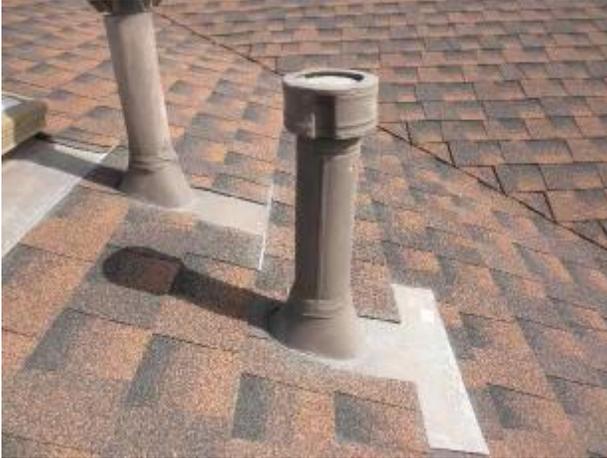
# R

1.) The storm collar is missing at the water heater exhaust vent flashing. This may subject this flashing to leaks.

Missing storm collar at the water heater exhaust vent flashing.

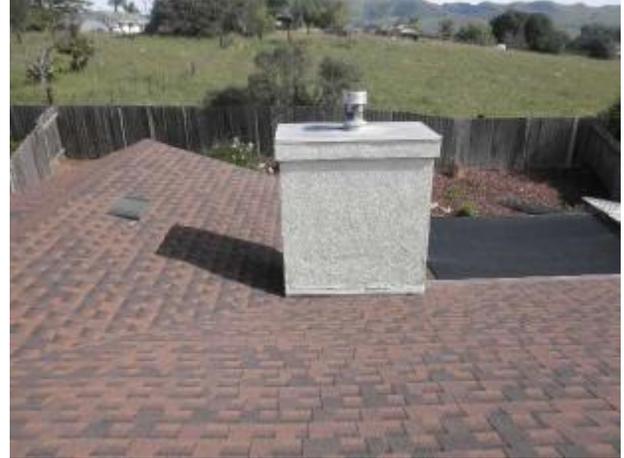
# R

**Repair Note:** There is no cricket flashing installed at the chimney enclosure. This is required when the enclosure is greater than 30 inches wide. This may render this area to potential leaks.

Missing cricket at the chimney enclosure.

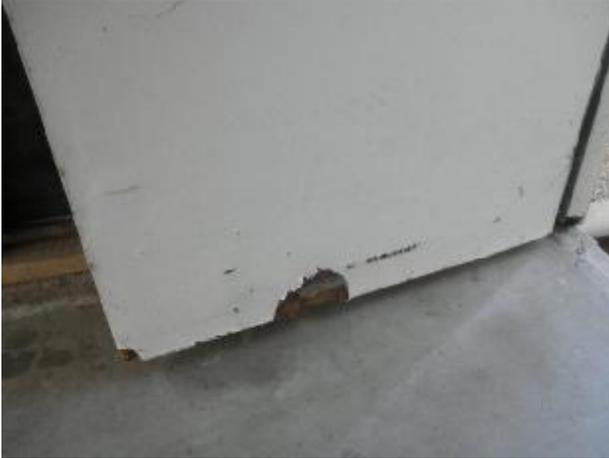
# EX

Moisture damage to the base of the rear entry door to the garage.

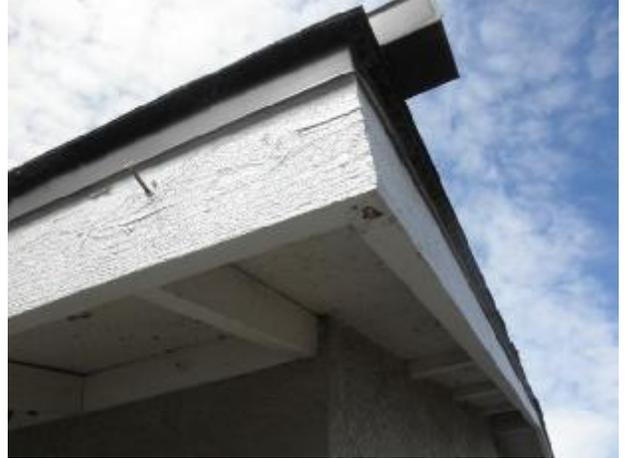
# EX

Moisture damage to the fascia board at the SE corner of the master bedroom.

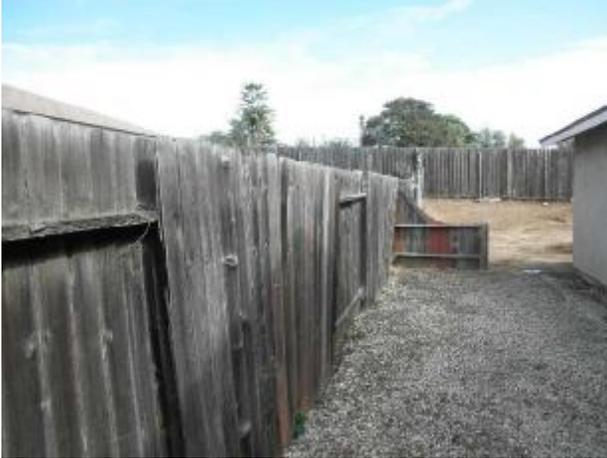
# GD

**Maintenance Note: Part of the fencing is leaning in the north side yard and the fence gate at the center of the backyard is damaged and laying on the ground.**

Part of the fence is leaning in the north side yard.

**Maintenance Note:** Part of the fencing is leaning in the north side yard and the fence gate at the center of the backyard is damaged and laying on the ground.

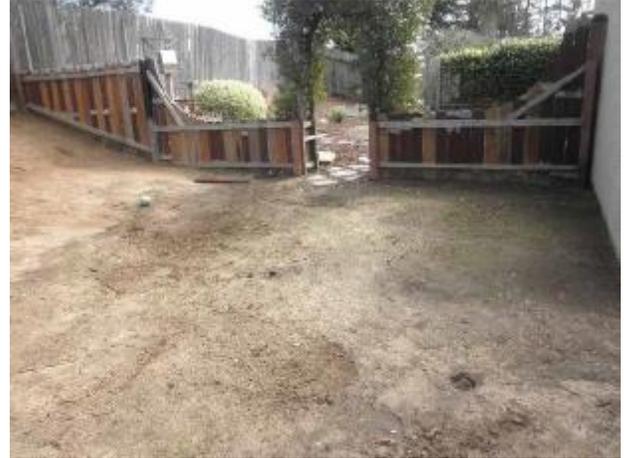
# GD

Parts of the backyard have sluggish drainage.

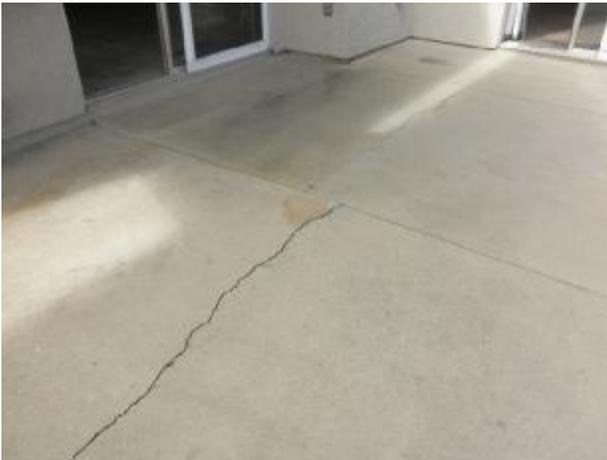
# GD

1.) There is a general settlement crack in the backyard concrete patio.

General settlement crack in the concrete patio.

- 1.) There is a general settlement crack in the backyard concrete patio.

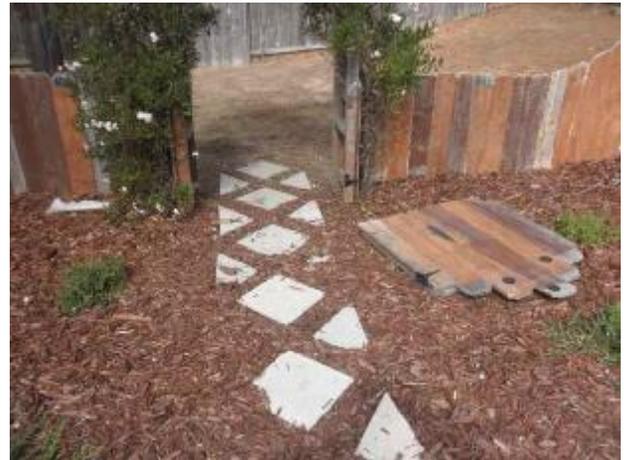
# GD

Damaged fence gate in the backyard.

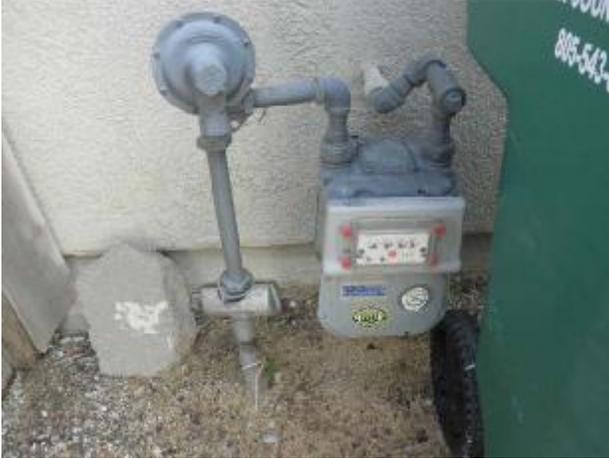
# HC

**Information Note: The gas meter was locked off at the time of inspection therefore, I was unable to test the gas furnace(s). Recommend performing a supplemental inspection when the gas service is restored.**

The gas meter was locked off at the time of inspection.

**Information Note:** The gas meter was locked off at the time of inspection therefore, I was unable to test the gas furnace(s). Recommend performing a supplemental inspection when the gas service is restored.

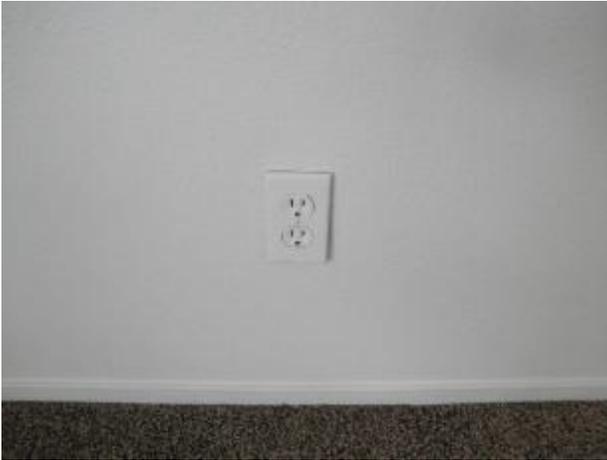
# EL

1.) There is no power to the top half of the outlet on the north wall in the front bedroom. There was still no power even after the light switch in the room was switched on and off. The outlet itself is loose and the cover plate is broken.

Outlet loose, cover plate broken and no power to the top half in the front bedroom.

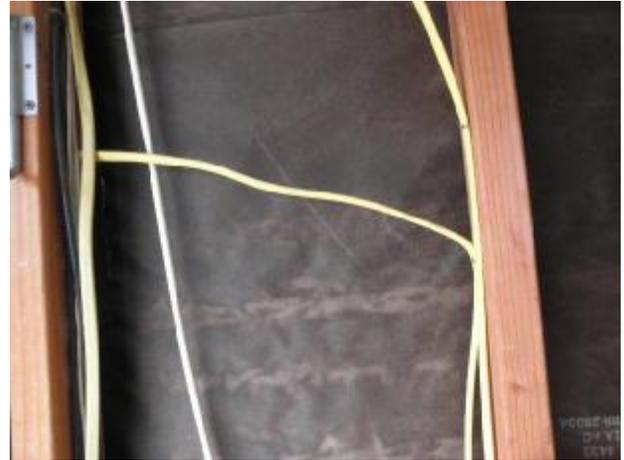
# EL

**Safety Hazard Note:** There is horizontal wiring installed in the garage which is less than seven feet off the ground. This is required to be installed in conduit or have a wall surface installed over it for physical protection.

Horizontal wiring in the garage less than seven feet.

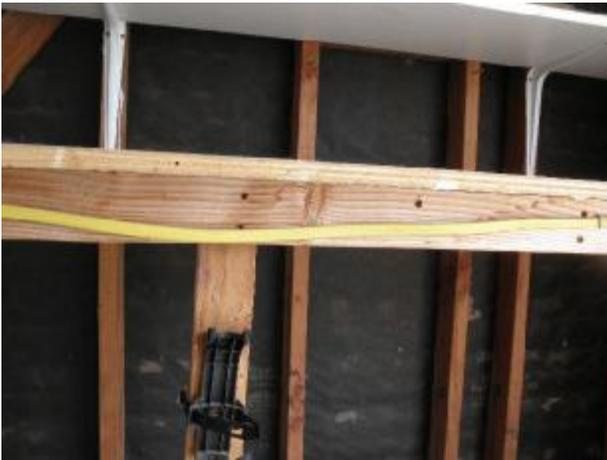
# EL

19 **Safety Hazard Note:** There is surface mounted wiring installed in the garage. This is required to be installed in conduit or have a wall surface installed over it for physical protection.

Surface mounted wiring in the garage.

**Safety Hazard Note:** There is surface mounted wiring installed in the garage. This is required to be installed in conduit or have a wall surface installed over it for physical protection.

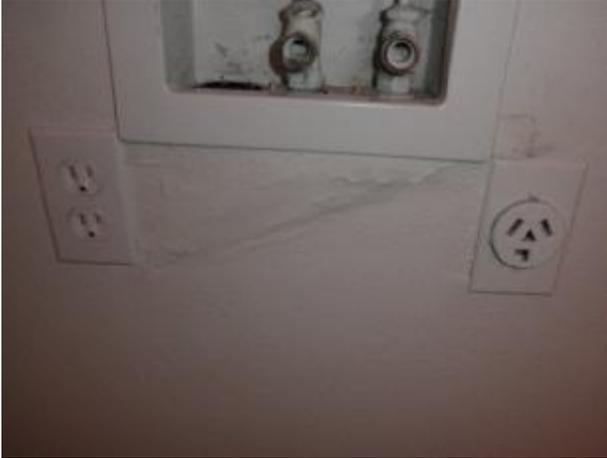
# K

2.) There is moisture damage below the water lines in the laundry room. Also, a portion of the drywall was cut out directly below this. Suggest reviewing with the seller of any past leaks.

Moisture damage to the wall below the water lines in the laundry room.

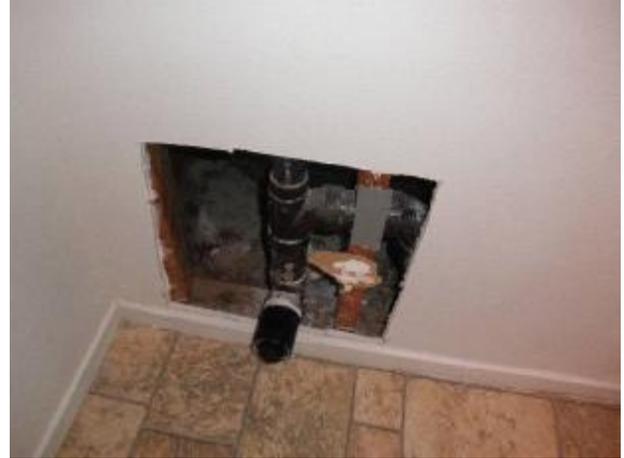
# K

Drywall opened in the laundry room.

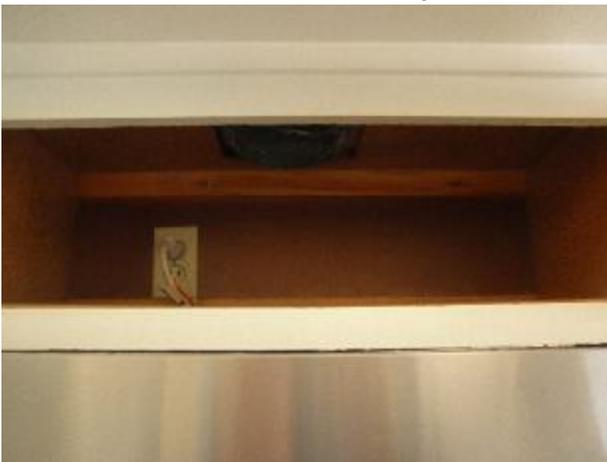
# K

Microwave vent to the outside was not connected.

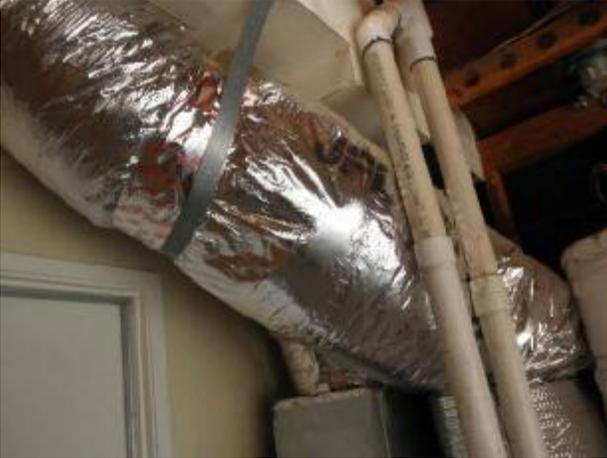
# GC

**Fire Safety Hazard Note:** There are nonmetallic heating ducts in the garage above the furnace. This compromises the firewall separation required between the house and the garage. This ducting is required to be solid sheet metal when inside the garage space.

Flexible duct installed in the garage.
