Inspection Report

Property Address:
4115 Orinda Ct
Atascadero CA 93422

1/9/2026

Harper Homes: Home Inspection Services

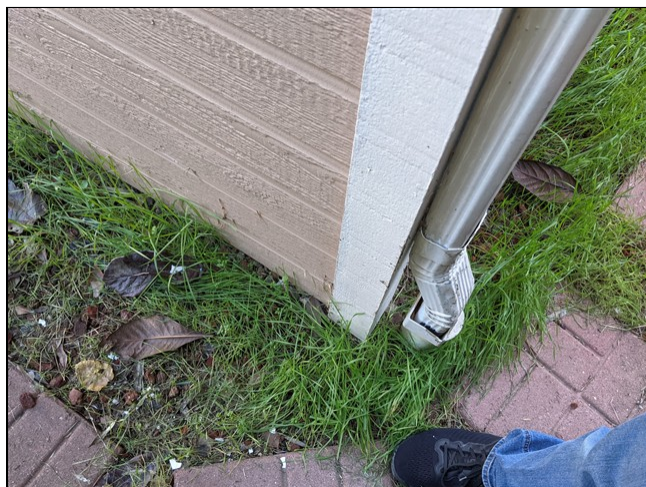
1.0 Item 1(Picture)

Soil or landscape materials pushed up against the wood siding at front right corner. No moisture damage was noted. Refer to the pest report for more information on this condition and have material removed to prevent earth to wood contact while allowing drainage to remain effective.

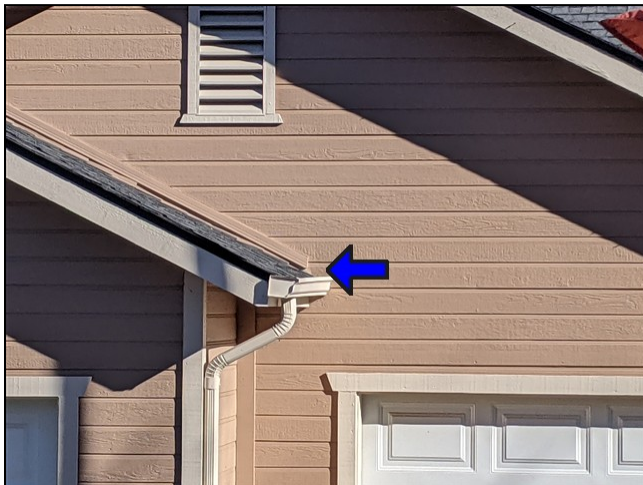
2.1 Item 1(Picture)

Kick out flashing not installed at the front exterior where the roof returns back into the siding. Recommend kick out flashing be properly installed to prevent moisture intrusion at the siding in this area.

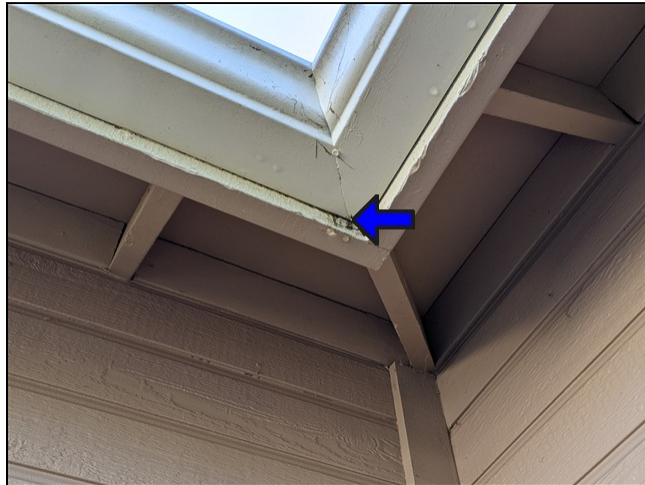
2.3 Item 1(Picture)

Gutter seams show signs of leaking. Recommend cleaning and sealing the seams with gutter sealant to prevent continued moisture exposure at the fascia.

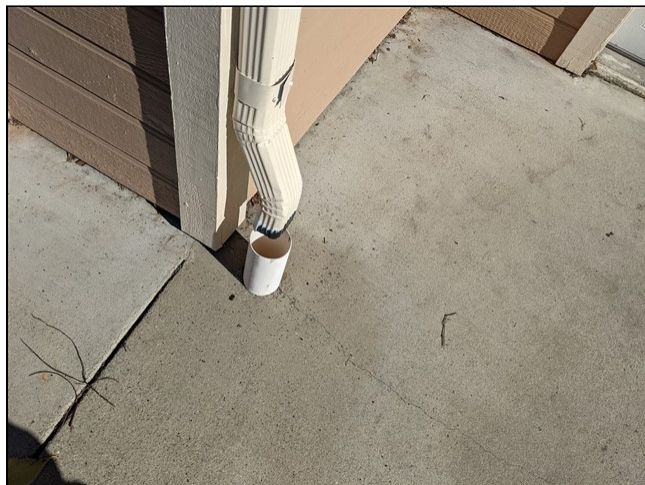
2.3 Item 2(Picture)

Downspout extensions should be installed into the underground drain lines to promote functional drainage of rain water into the drains.

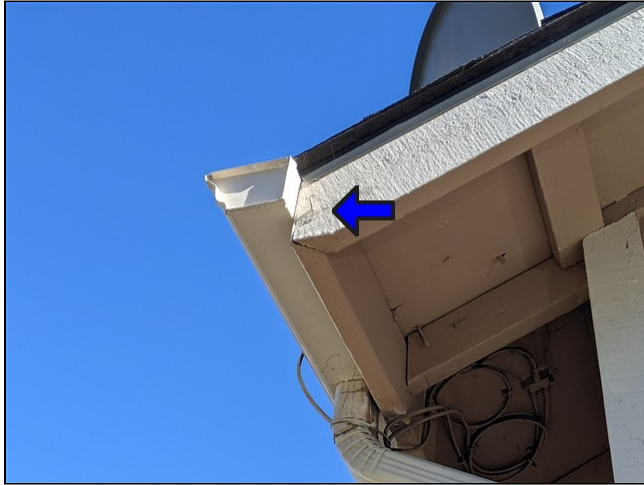
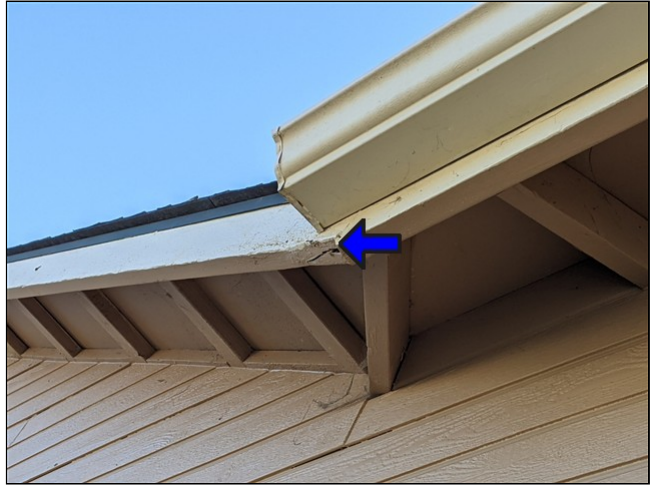
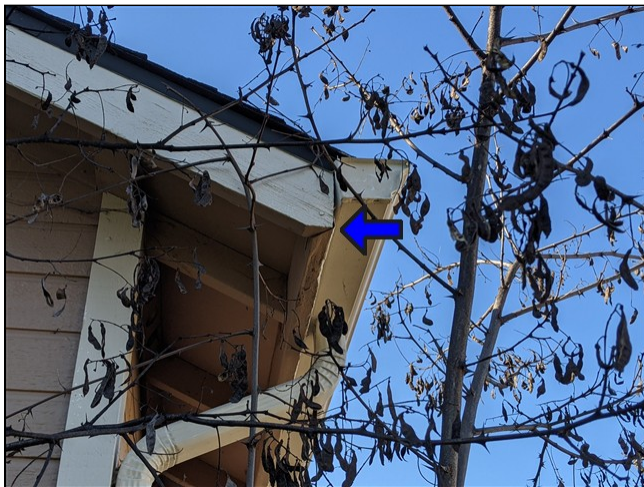
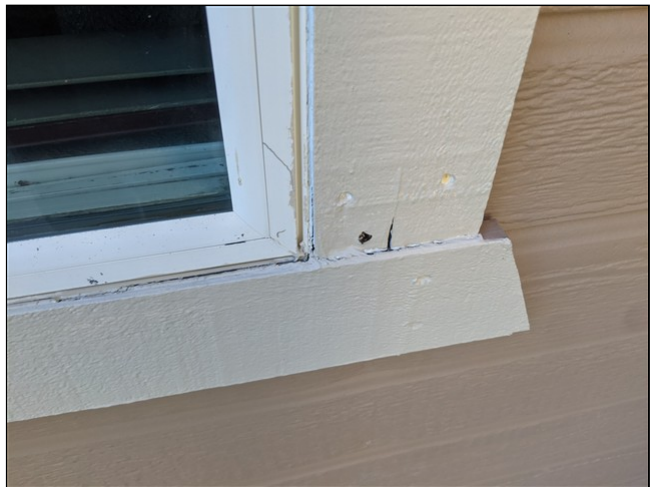
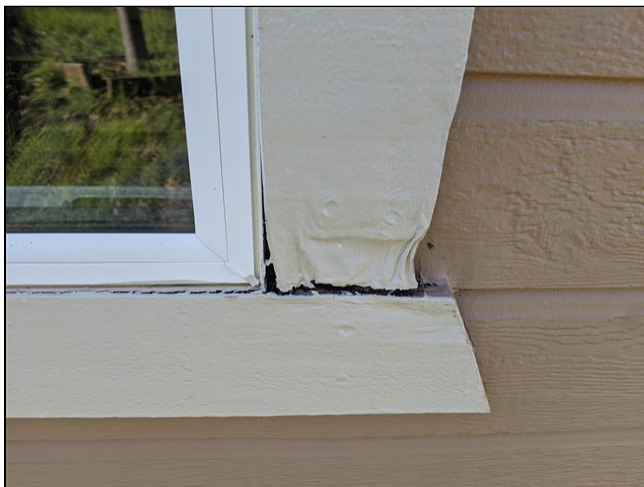
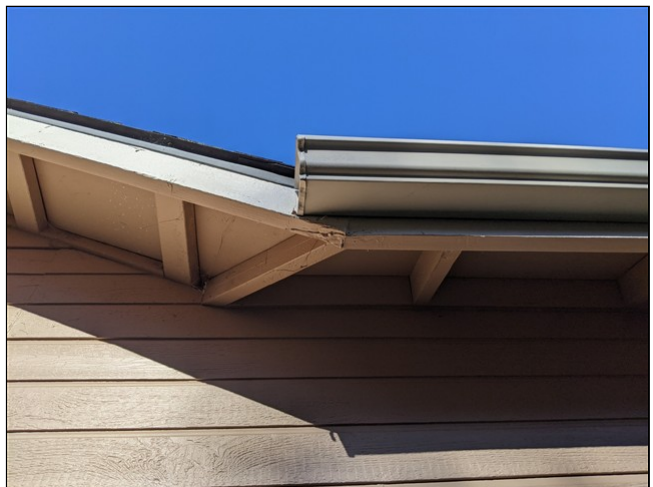
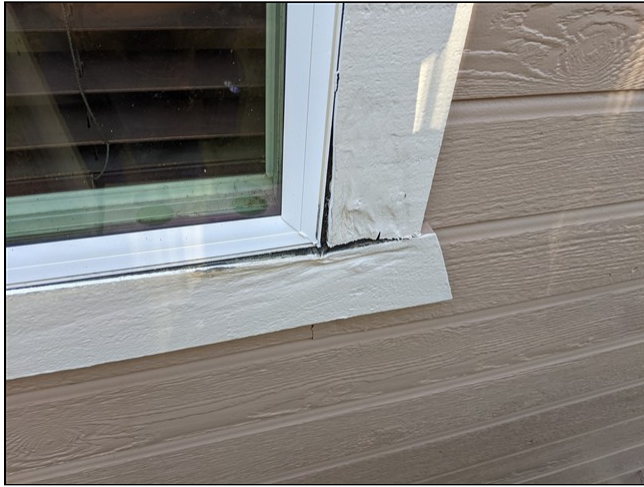
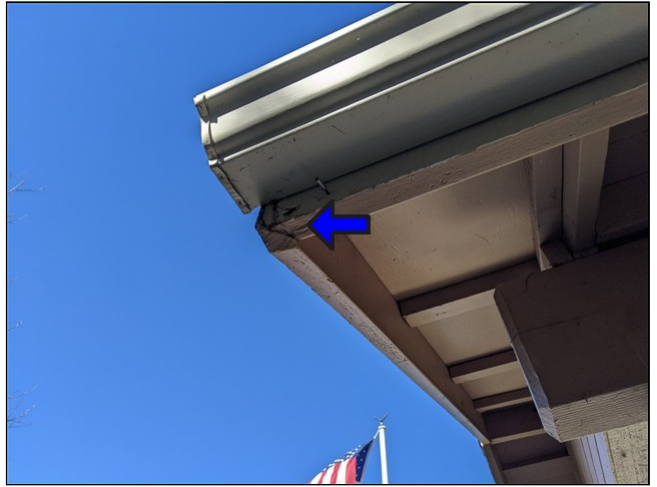
Moisture damage noted at the fascia and trim. Recommend further evaluation by a structural pest control operator and make repairs as prescribed.

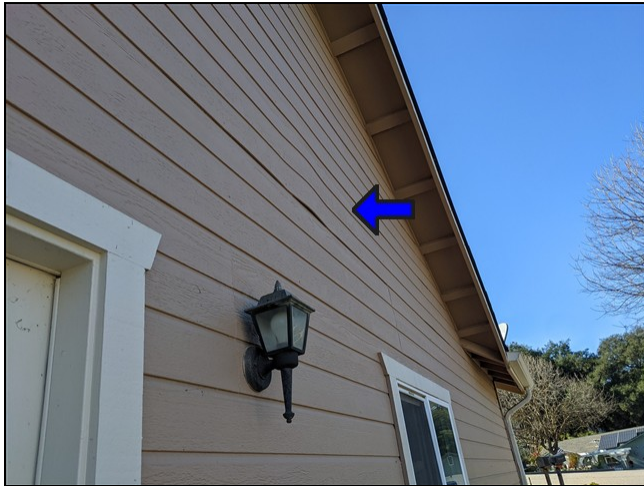
2.4 Item 9(Picture)

Wood siding is buckling in areas. Probable moisture absorption at the siding due to left exterior has caused the siding to expand and push outward between connection points. Not of structural concern. Recommend replacement of the siding as needed.

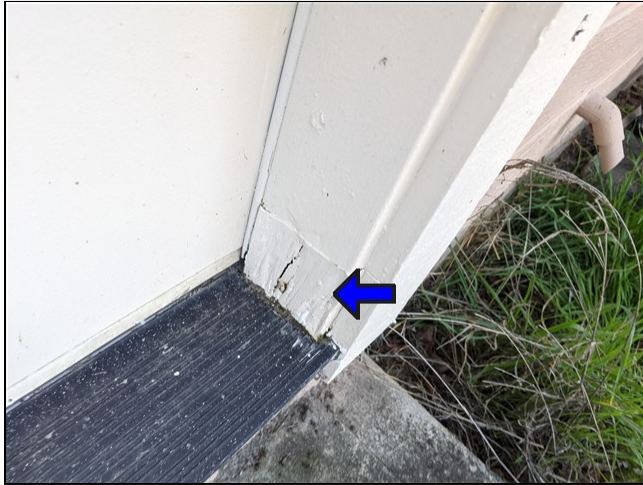
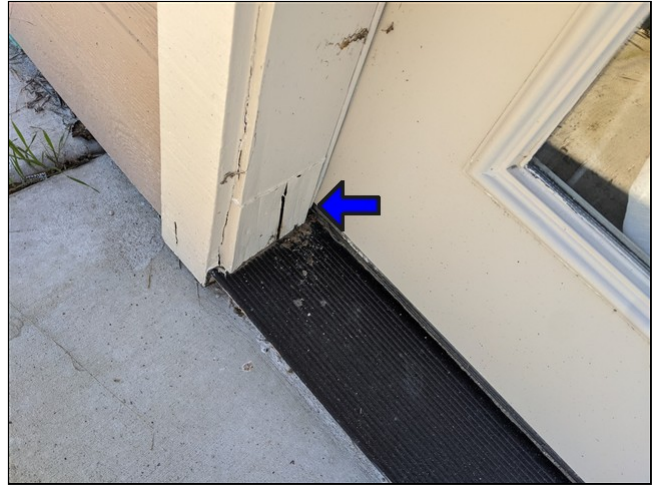
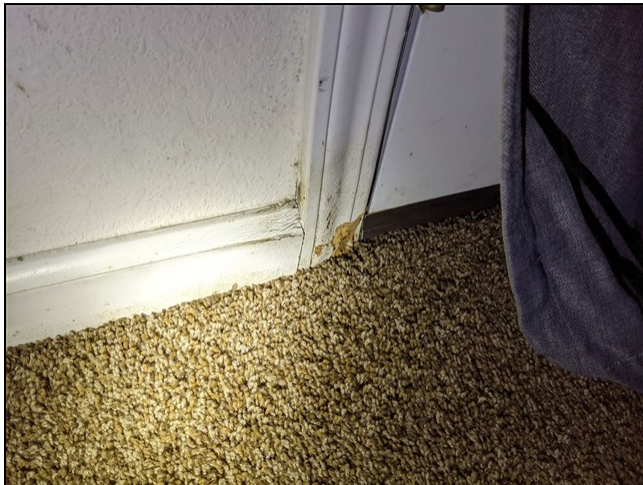
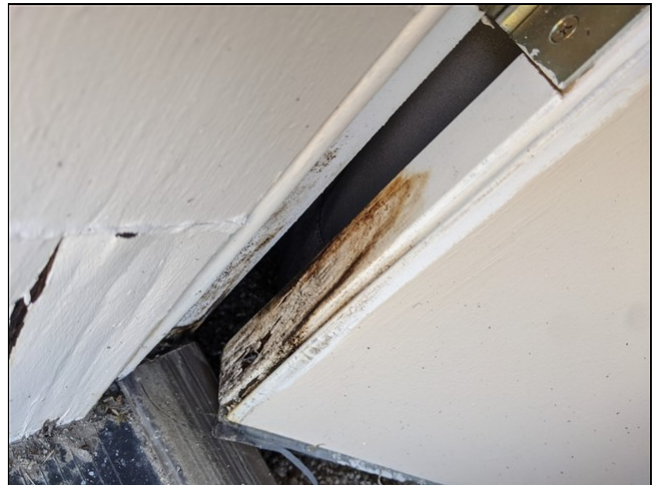
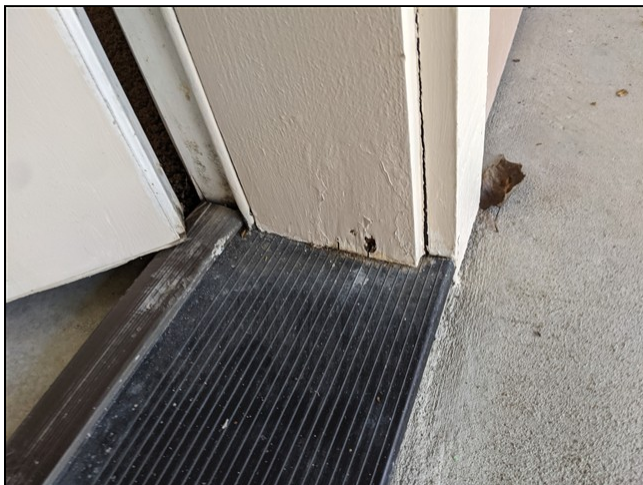
Moisture damage noted on the door and jamb material at the left garage door, rear living room door and rear master bedroom door. Refer to the pest report for further information on this condition and make repairs as prescribed.

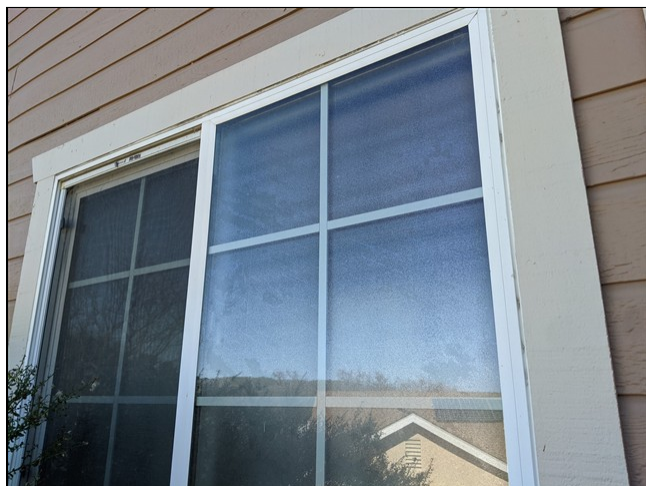
2.6 Item 1(Picture)

Failed seals in dual pane windows, noted at the left master bathroom window and condensation build up or stains were noted within the window. Recommend windows repaired or replaced to ensure full insulation capabilities and improve aesthetics.

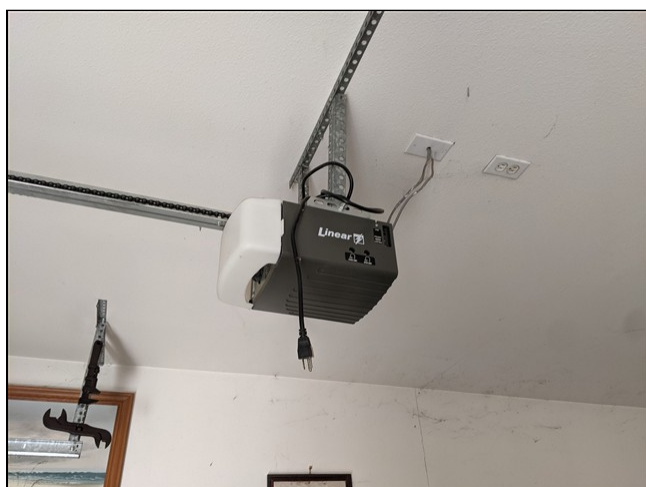
2.7 Item 1(Picture)

The left garage door was unplugged and appeared inoperable at the time of the inspection. Recommend further evaluation and repairs are made as needed to allow for proper function of the garage door.

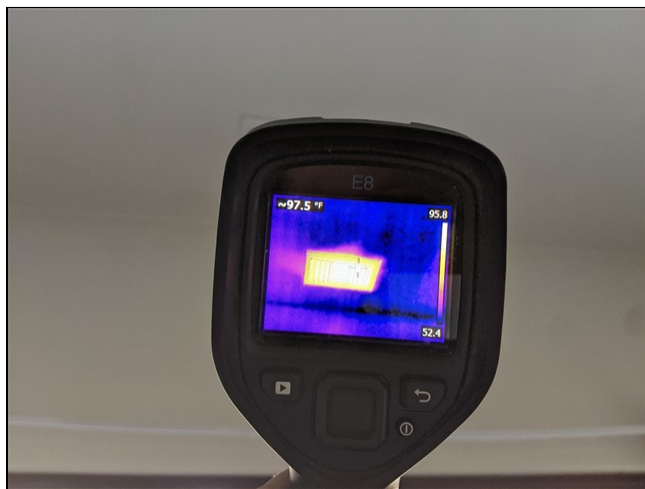
4.0 Item 1(Picture)

The furnace appears to be in working condition, but is over 23 years old and at or near the end of it's serviceable life. Recommend service performed by a qualified HVAC contractor to help conserve the remaining life of the unit and have replaced as necessary.

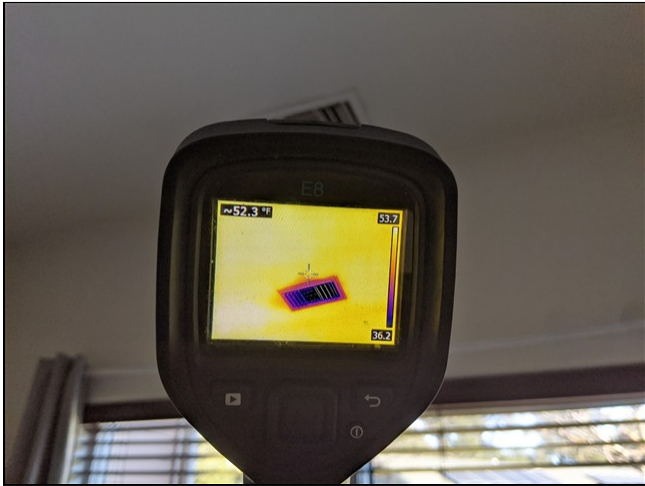
4.4 Item 1(Picture)

REPAIR AS NEEDED
Air conditioner is functioning as intended but over 23 years old and may be near the end of it's serviceable life. Recommend replacement, as necessary, by a qualified HVAC contractor.

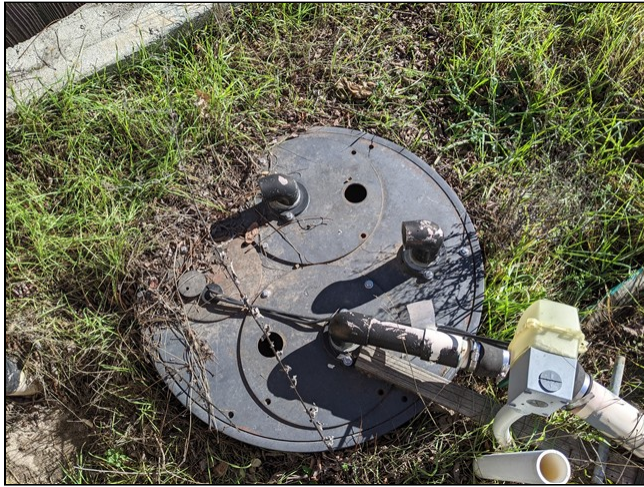
5.1 Item 1(Picture)

A pump was observed at the rear left corner of the property. Pumps and related components are specialized systems and are outside the scope of a standard home inspection. The pump was not evaluated for proper operation or condition. Further evaluation and servicing by a qualified technician is recommended as needed.

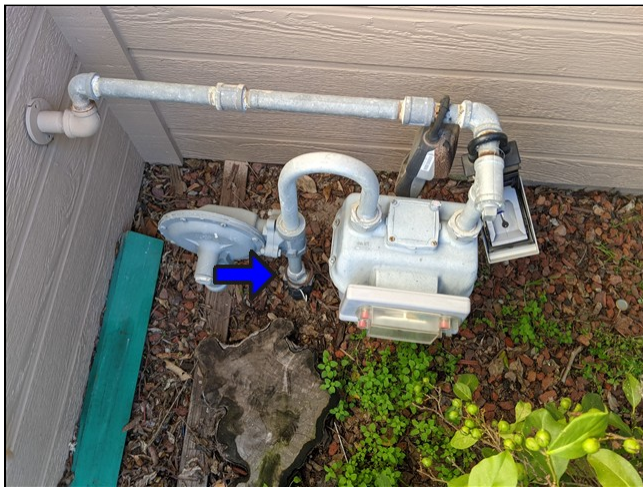
5.3 Item 1(Picture)

The gas shutoff is located at the front exterior of the home. To turn the gas off turn the valve perpendicular to the piping.

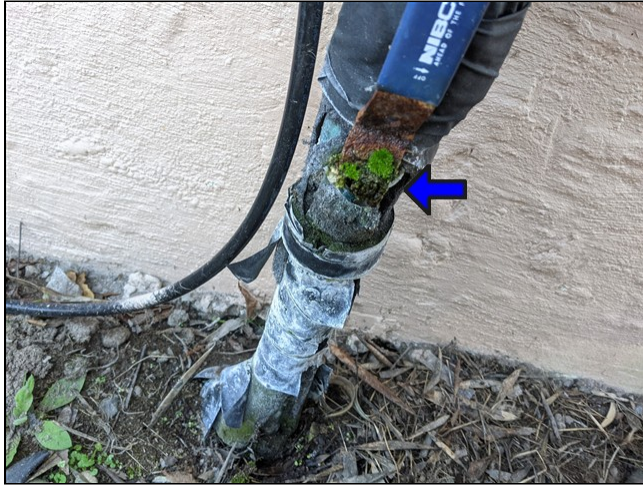
5.4 Item 1(Picture)

Main water shutoff valve leaks and should be repaired or replaced to prevent moisture saturation in the area and water waste.

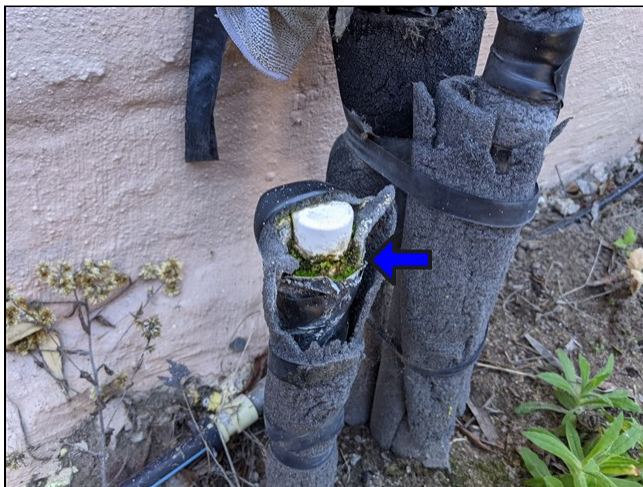
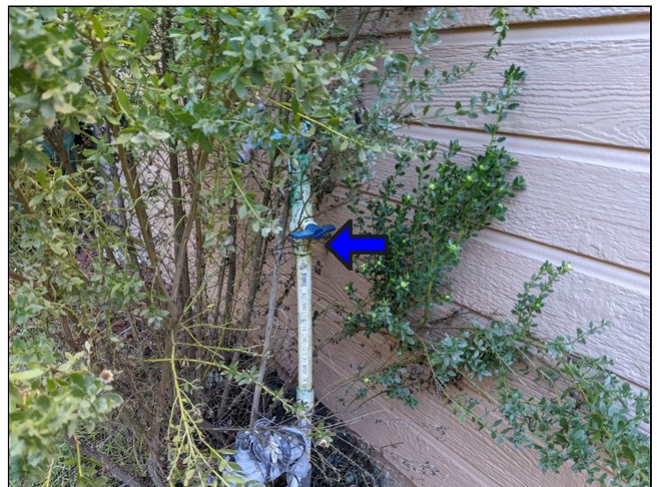
Leak noted on the supply line for the irrigation at the left and right exterior and repairs should be made to prevent further deterioration, soil saturation, and water waste.

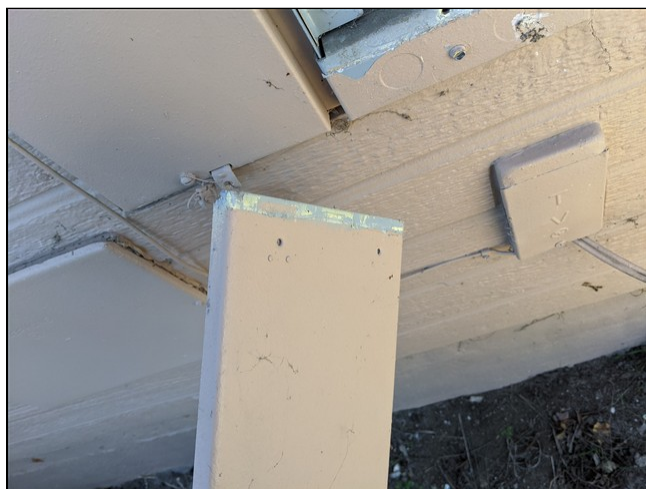
6.1 Item 1(Picture)

Main panel hinge is missing on the front cover. Recommend reinstallation of the proper hinge to insure the panel cover remains in place.

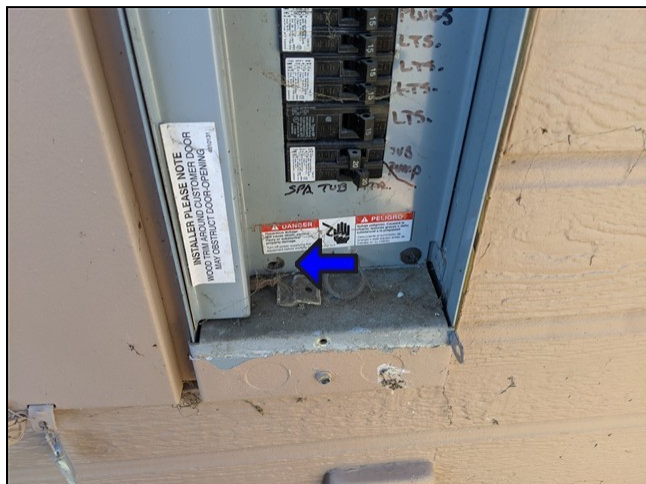
6.1 Item 2(Picture)

Front cover screw missing at the main panel and needs to be installed to prevent a possible unsafe condition.

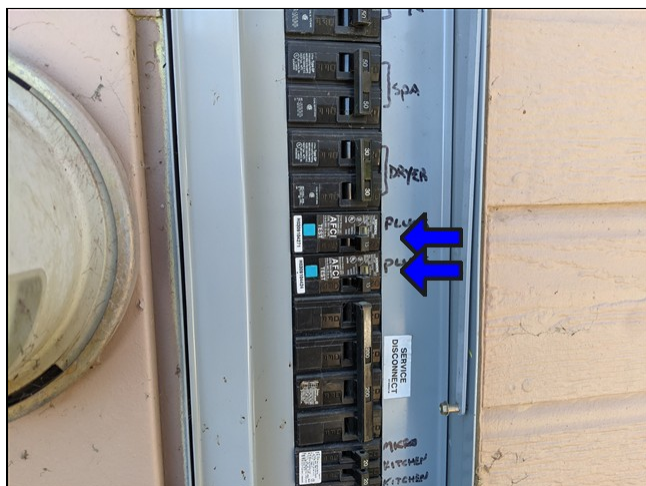
6.2 Item 1(Picture)

The ARC fault breaker for the bedrooms receptacles did not trip when tested at the main panel. Recommend replacement of the breaker to insure intended safety.

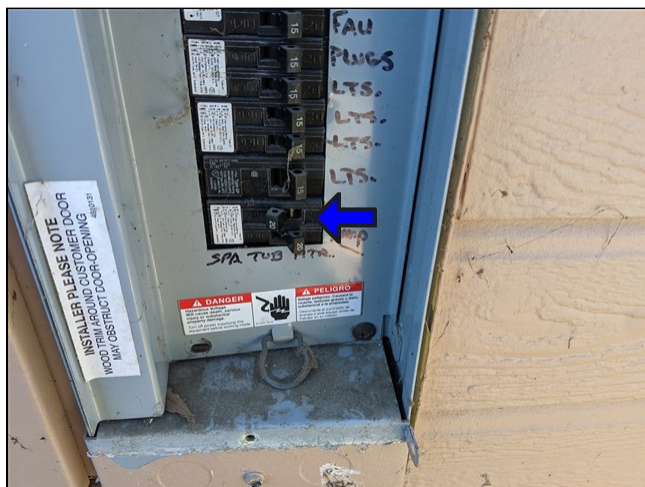
6.2 Item 2(Picture)

The breaker at the bottom of the panel was off at the time of the inspection and when operated showed signs of overheating. It is recommended this condition is further evaluated and repairs made by a licensed electrician.

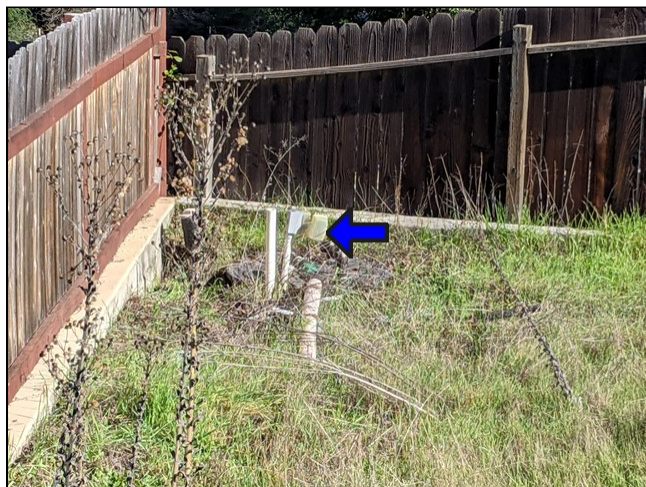
6.6 Item 1(Picture)

The receptacle at the rear left corner of the home where the pump is located was inoperative at the time of inspection and repairs are needed.

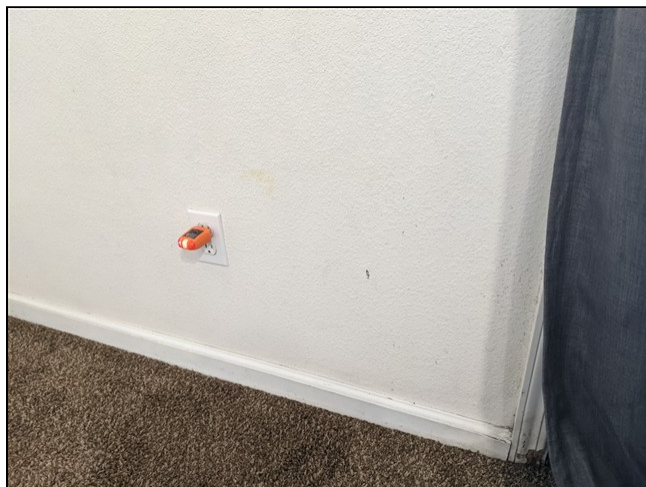
6.6 Item 2(Picture)

Hot and neutral connections reversed on a receptacle to the left of the rear master bedroom door. This can create an unsafe condition or cause damage to an appliance, and should be re-installed to prevent damage and/or an unsafe condition.

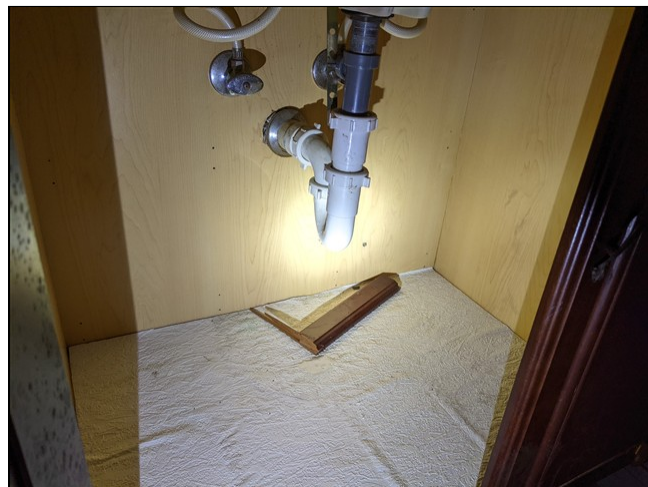
7.2.A Item 1(Picture)

Leak noted on the drain line in the cabinet under the right sink and repairs should be made before further use.

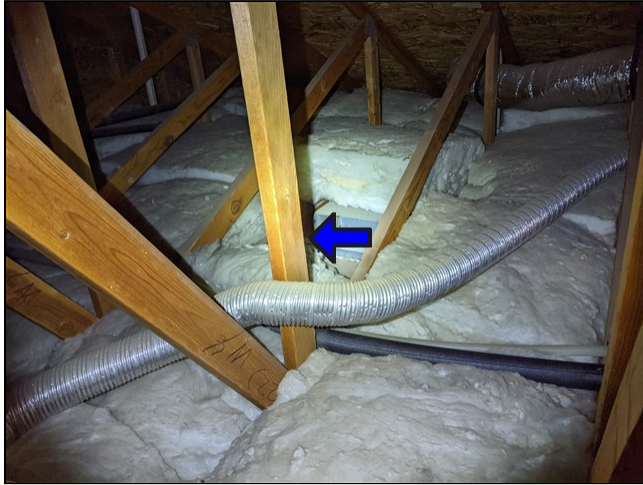
7.4.A Item 1(Picture)

Exhaust fan terminates in the attic space and should be extended out to a proper screen covered vent terminal location. This will prevent moist air exposure in the attic.

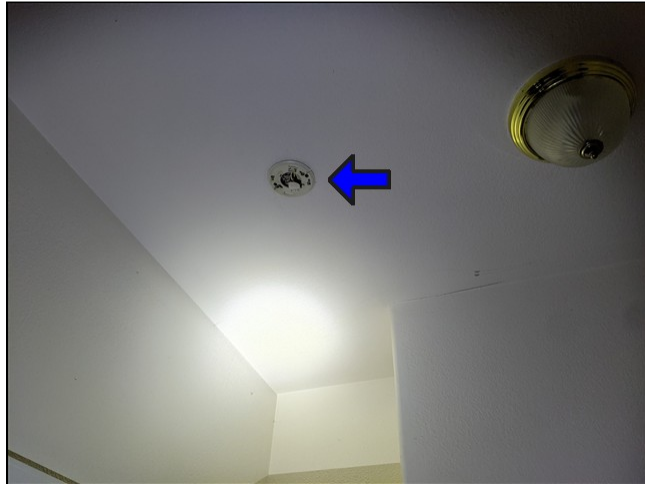
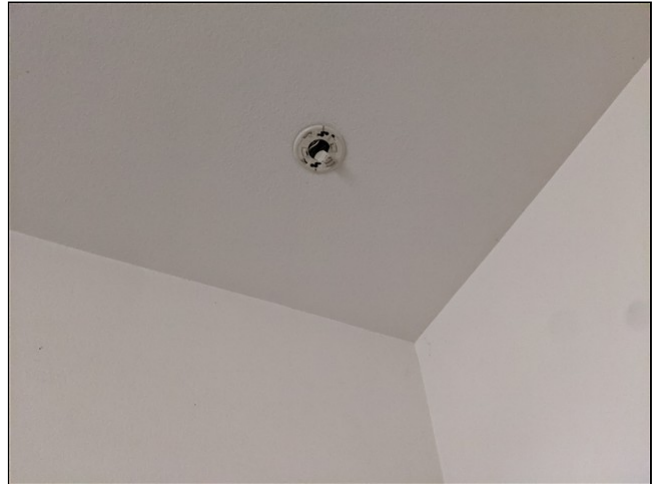
Smoke alarm has been removed from hallway and middle right bedroom and should be replaced to ensure intended safety of the home.

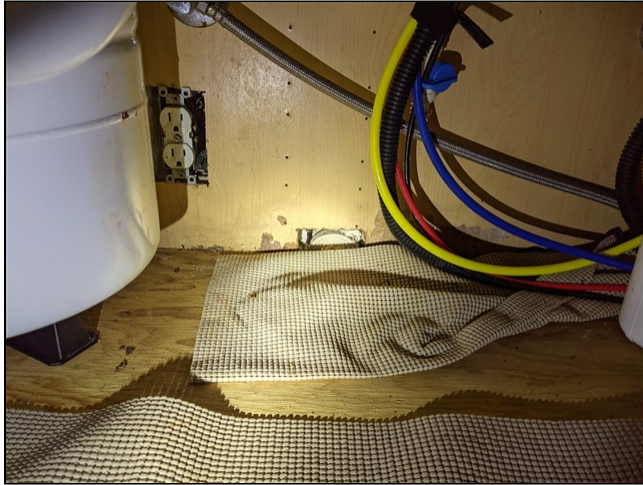
9.3 Item 1(Picture)

Slight moisture damage noted to the cabinet under the sink. No leaks noted at the time of inspection. Moisture damage may extend into the enclosed areas, and should be further evaluated and repaired, as needed.

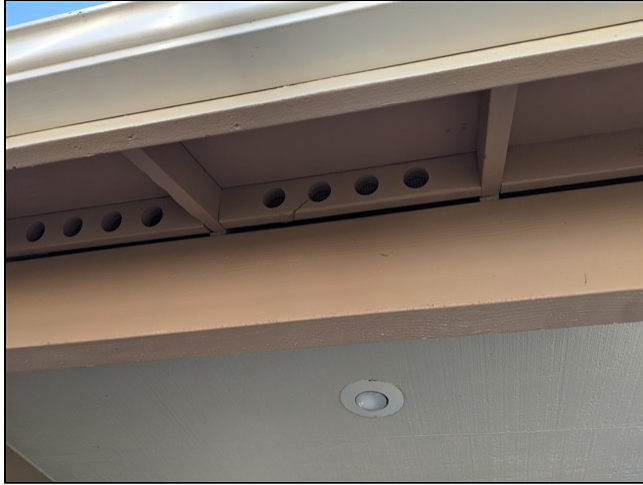
10.2 Item 1(Picture)

Rafter blocking is gaped at the eaves above the front entryway, allowing pest or rodent intrusion into the attic space. Recommend gaps sealed or screened to prevent pest intrusion.
