HOME INSPECTION

4422 Point Degada
Oceanside, CA 92058

02/11/2026

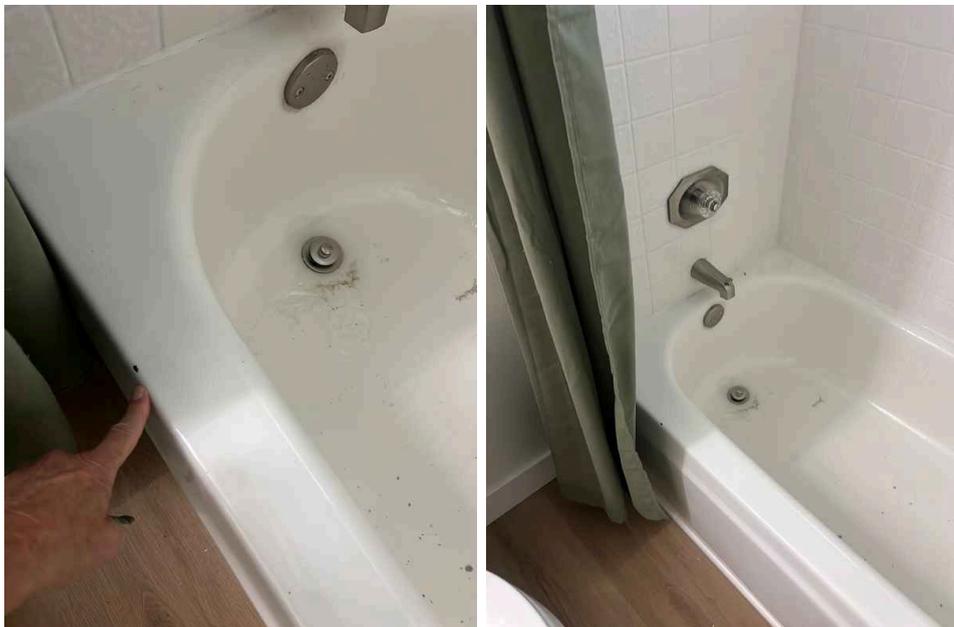
3.3.1 FAUCETS, VALVES AND CONNECTED FIXTURES

The tub has a small chip(s) in the enamel coating. We recommend patching the chip to prevent additional rusting.

Recommendation

Contact a qualified professional.

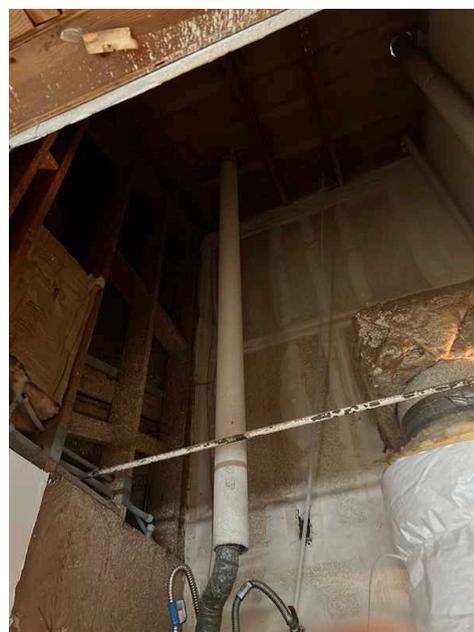
3.7.1 WATER HEATER(S), FLUES AND VENTS

A cementitious-type flue was present which may contain asbestos and other hazards. The only way to confirm the presence or absence of asbestos is through lab testing. In addition, this type of flue can deteriorate over time causing blockage inside the flue which is a Carbon Monoxide hazard. We recommend removal by a qualified contractor.

Recommendation

Contact a qualified professional.

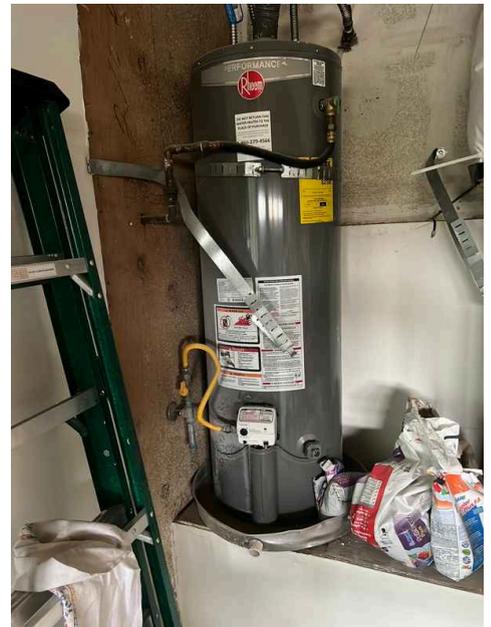
3.9.1 WATER HEATER STRAPPING, BRACING AND PLATFORM

The water heater is improperly strapped. Seismic strapping is required to be installed 4 inches above the controls, and at the top 1/3 of the water heater. We recommend installation of a seismic strap kit by a qualified person. Proper installation can be found by visiting http://www.seismic.ca.gov/HOG/waterheaterbracing_08-11-04.pdf

Recommendation

Contact a qualified professional.

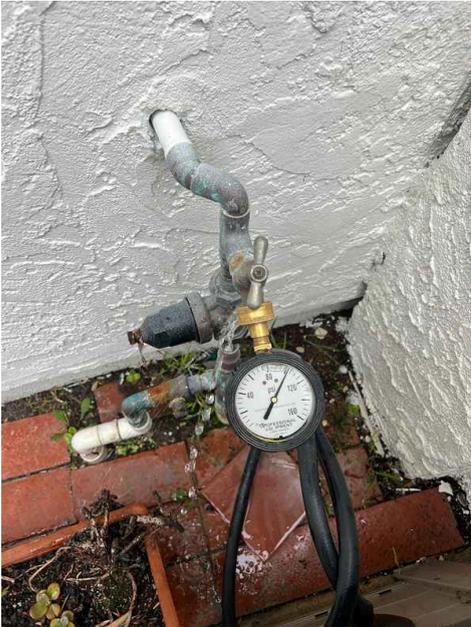
3.10.1 WATER PRESSURE AND REGULATOR

High water pressure noted. This can cause water lines, faucets and water supplied appliances to fail and leak. We advise having a licensed plumber repair or install a new pressure regulator, to allow a PSI range of 50-70.

Recommendation

Contact a qualified plumbing contractor.

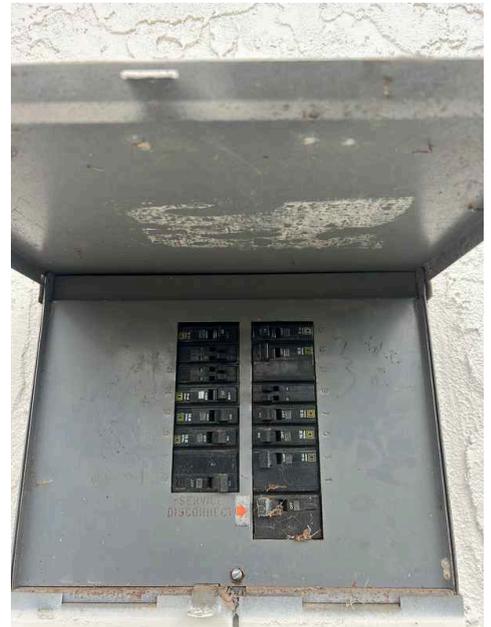
The breakers are not labeled. We recommend properly labeling the breakers for safety.

Recommendation

Contact a qualified professional.

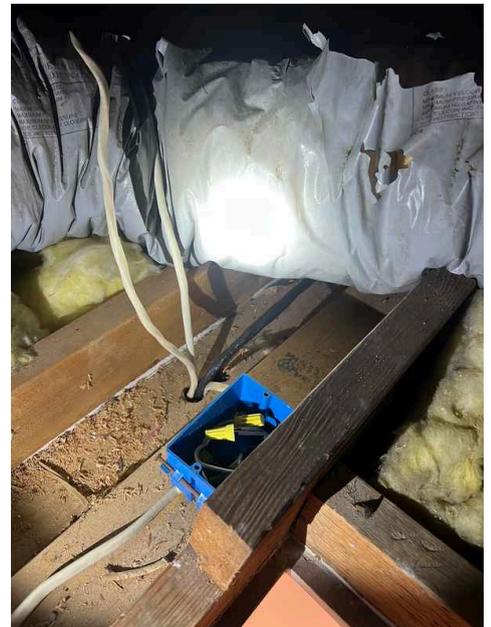
4.6.1 JUNCTION BOXES

Open junction box noted. Whenever wires are joined together the junction box must have a cover for safety. We advise installing an approved cover plate for safety.

Recommendation

Contact a qualified electrical contractor.

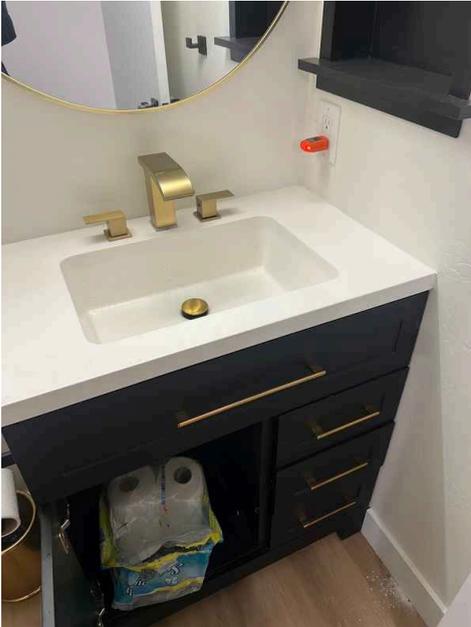
4.10.1 OPERATION OF GFCI
(GROUND FAULT CIRCUIT
INTERRUPTERS)

No GFCI receptacle was found in the bathroom. We recommend that a duplex GFCI outlet be installed.

Recommendation

Contact a qualified electrical contractor.

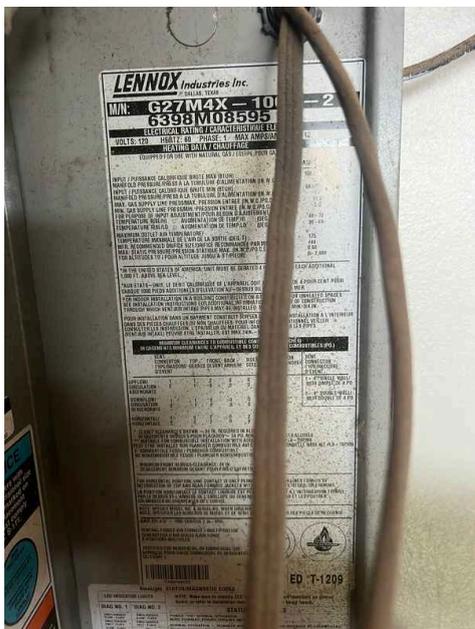
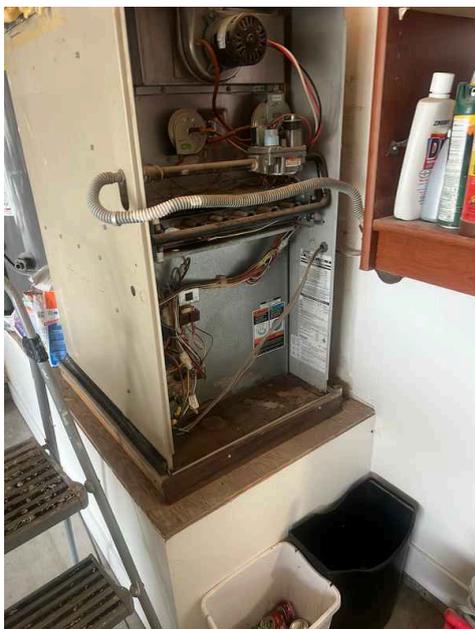
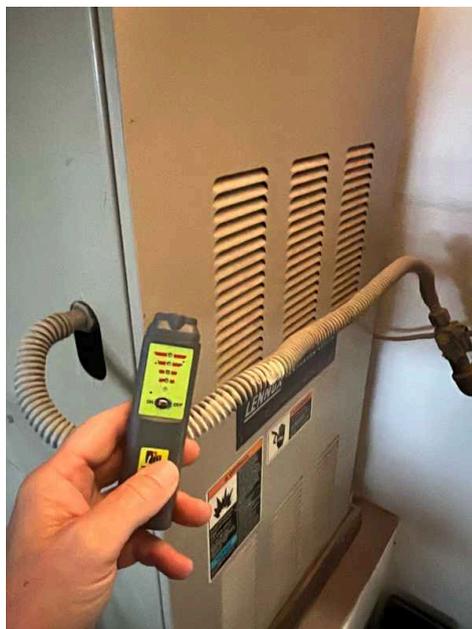
5.2.1 HEATING EQUIPMENT

The furnace is an older unit which may be nearing the end of its useful life. Most furnace contractors recommend replacing a furnace when it becomes 20 years old ([Table of Life Expectancy](#)). Since Southern California has a mild climate, furnaces can last longer than industry standards. Since this furnace is aged, we recommend having a licensed furnace contractor inspect the furnace for safety and provide an estimate of life remaining and cost of replacement prior to the end of your contingency period so that you may budget accordingly. Note: We specifically disclaim cracks in furnace heat exchangers because proper evaluation requires invasive, technically exhaustive measures that exceed the scope of the General Home Inspection.

Recommendation

Contact a qualified heating and cooling contractor

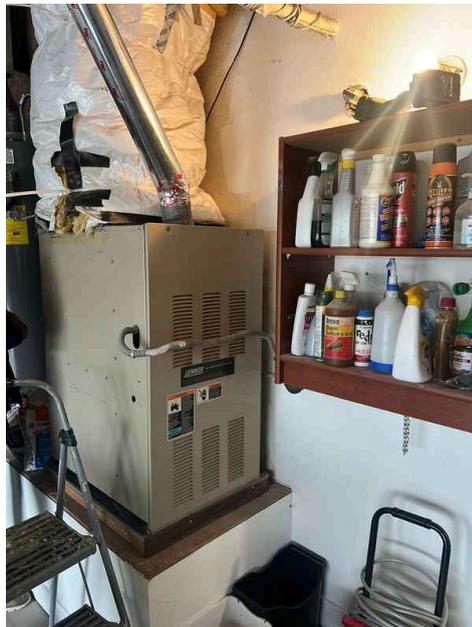
5.2.2 HEATING EQUIPMENT
CYCLING

The heating unit is cycling on and off. We recommend further evaluation and repair by a licensed heating contractor.

Recommendation

Contact a qualified heating and cooling contractor

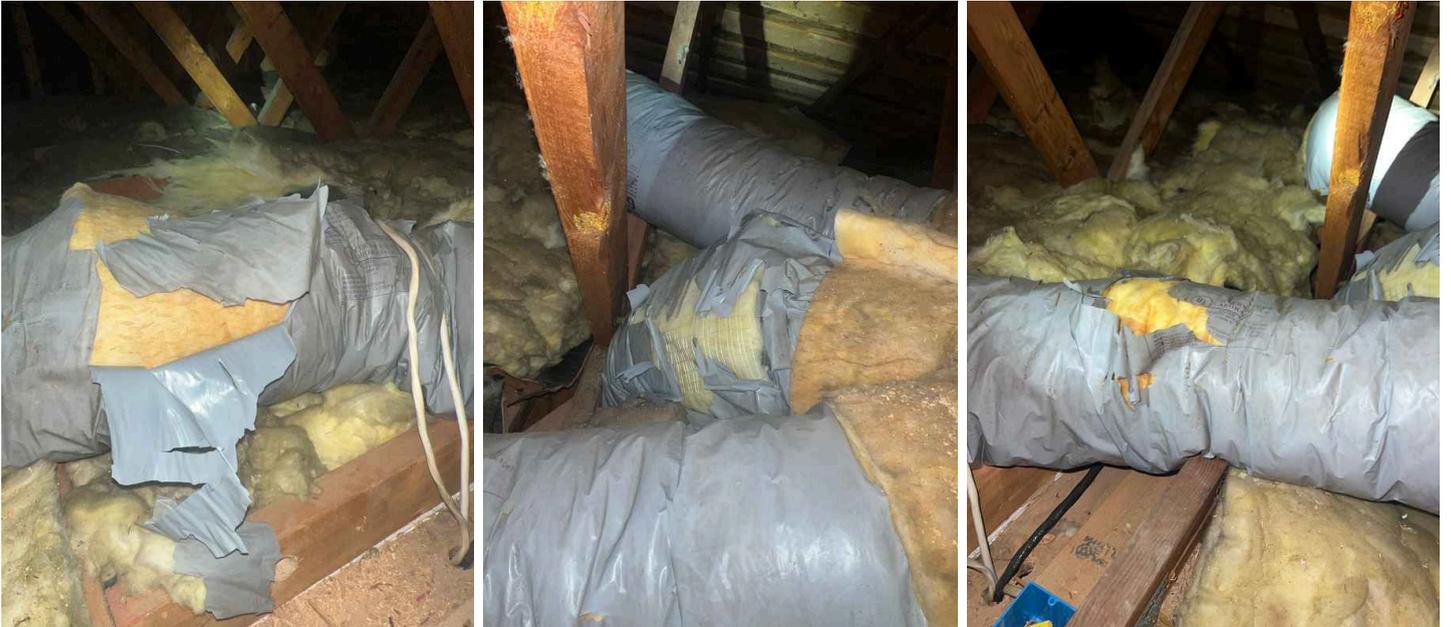
5.5.1 DISTRIBUTION SYSTEMS (including ducts and piping, with supports, insulation, air filters, registers)

DUCT - UV DAMAGE

Some of the ductwork has been damaged by exposure to UV rays (sunlight) through the roof vents. UV rays deteriorate the plastic sleeve around the duct allowing the insulation layer to fall away from the duct, reducing efficiency. We recommend further evaluation and repair by a licensed HVAC contractor.

Recommendation

Contact a qualified heating and cooling contractor

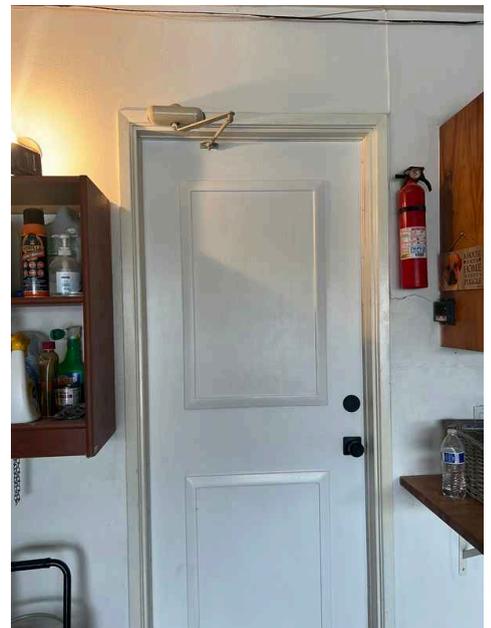
8.3.1 AUTO CLOSER (GARAGE DOOR)

CLOSER - INADEQUATE

The auto closer at the fire door did not adequately close the door, and requires adjustment or replacement. The auto closer must close the door within 3 seconds with enough force to latch the door.

Recommendation

Contact a qualified professional.

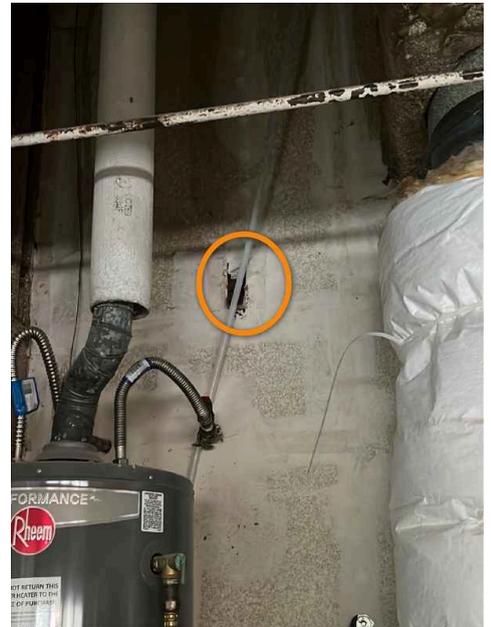
8.4.1 FIRE WALL

Hole (s) in the fire wall was observed in the garage. Wherever the garage shares a wall with adjacent living space, a fire-rated drywall must be installed and intact for fire resistive performance. We recommend having the holes patched with fire-rated drywall by a qualified person.

Recommendation

Contact a qualified professional.

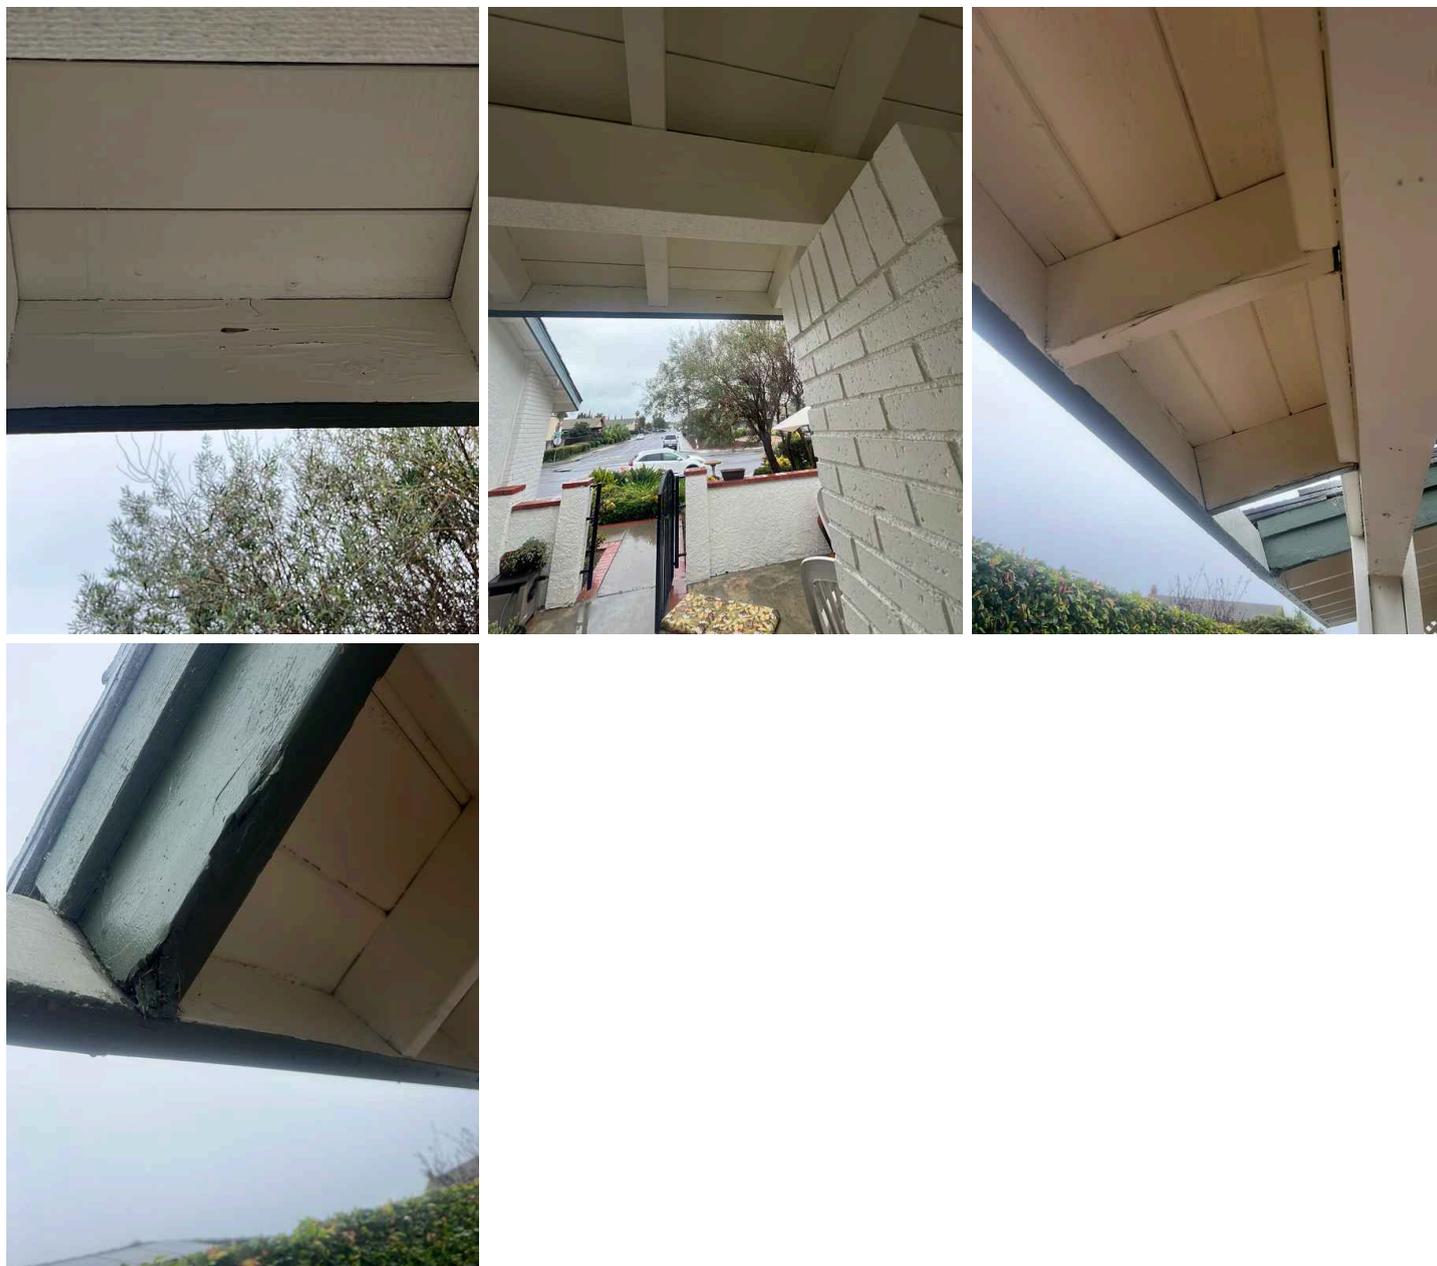
10.9.1 EAVES, SOFFITS AND FASCIAS

FASCIA/EAVES - TERMITES/ROT

Recommendation

Contact a qualified pest control specialist.

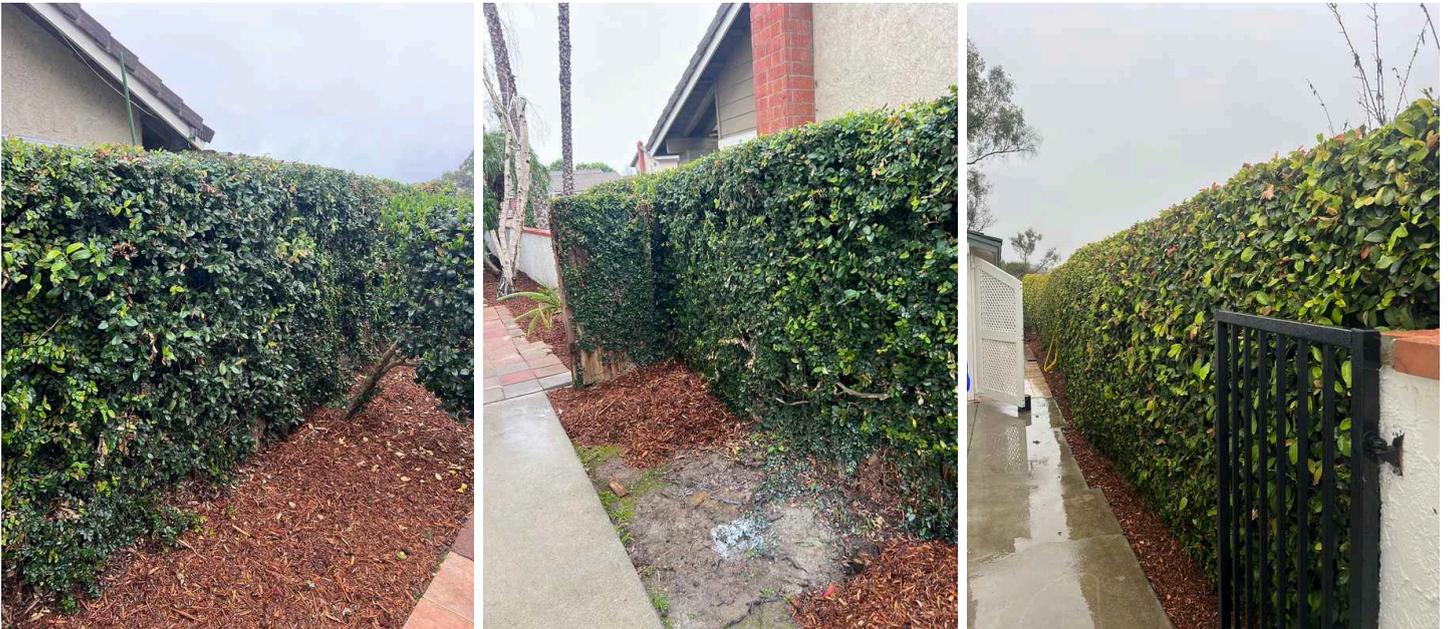
10.10.1 FENCE, LANDSCAPE WALLS, BOUNDARY WALLS

FENCE VEGETATION

Recommendation

Contact a qualified landscaping contractor
