WOOD DESTROYING PESTS AND ORGANISMS INSPECTION REPORT

Building No. 2	Street Lanai Ct.	City Chico	ZIP 95973	Date of Inspection 03/11/2025	Number of Pages 3
-------------------	---------------------	---------------	--------------	----------------------------------	----------------------

HOUSE DETECTIVE TERMITE CONTROL INC

Report # : 16047
Registration # : PR5960
Escrow # :
 CORRECTED REPORT

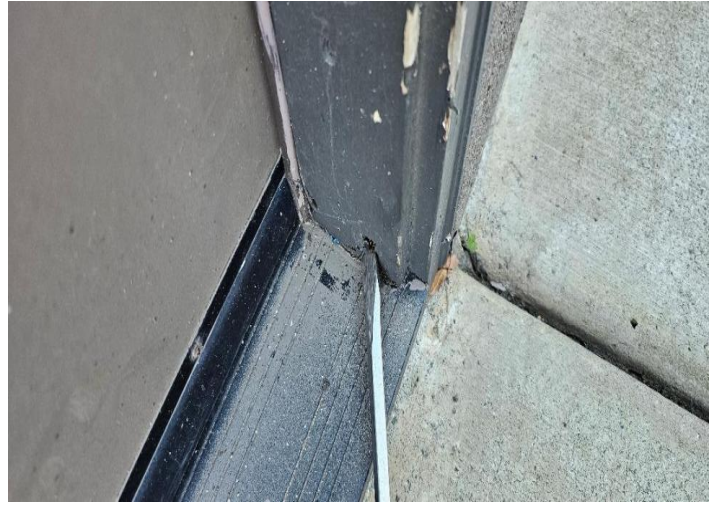
FINDING: Fungus damage was found to the side garage door jamb.

3A - Damaged side garage door jamb.

RECOMMENDATION: Remove the damaged wood members and replace with new material. Prime paint only.

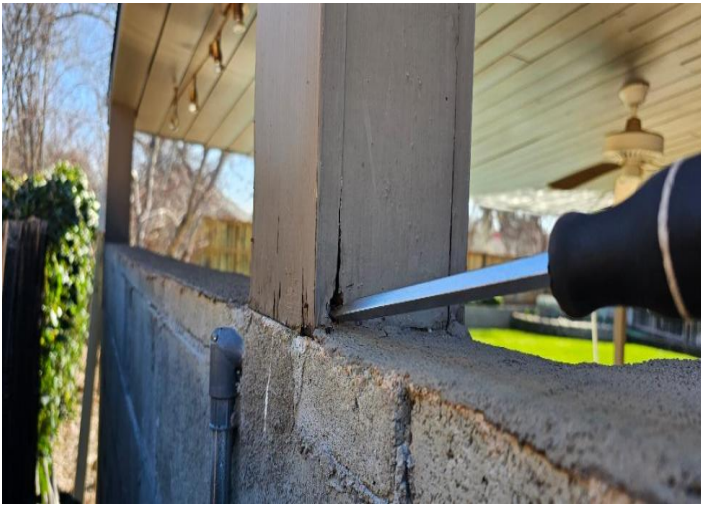
FINDING: Fungus damage was found to a support post for the patio overhang where indicated.

3B - Damaged support post.

RECOMMENDATION: Remove the damaged wood members and replace with new material. Prime paint only.

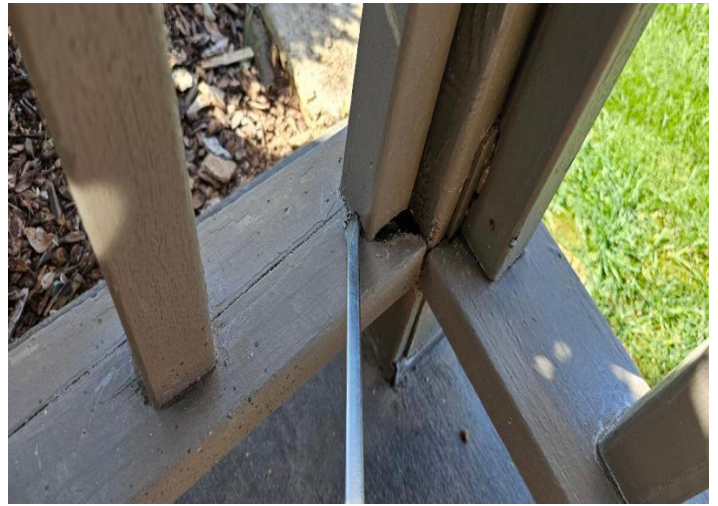
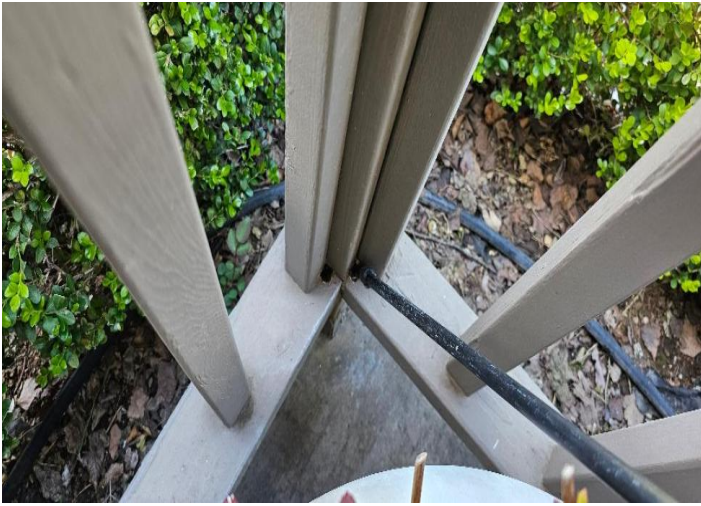
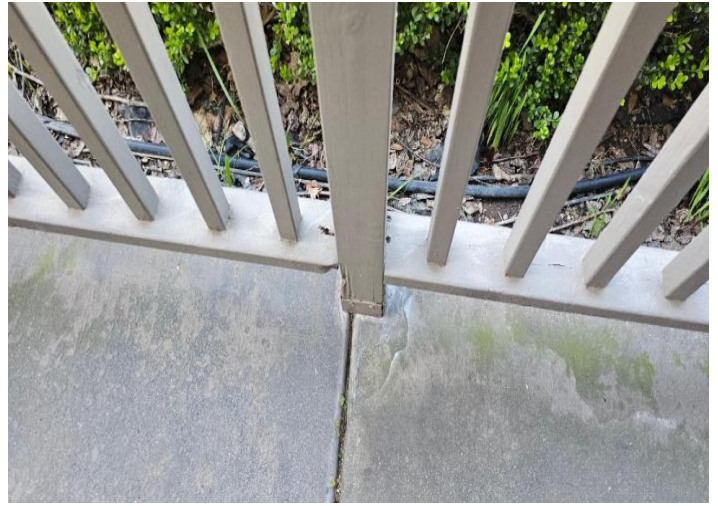
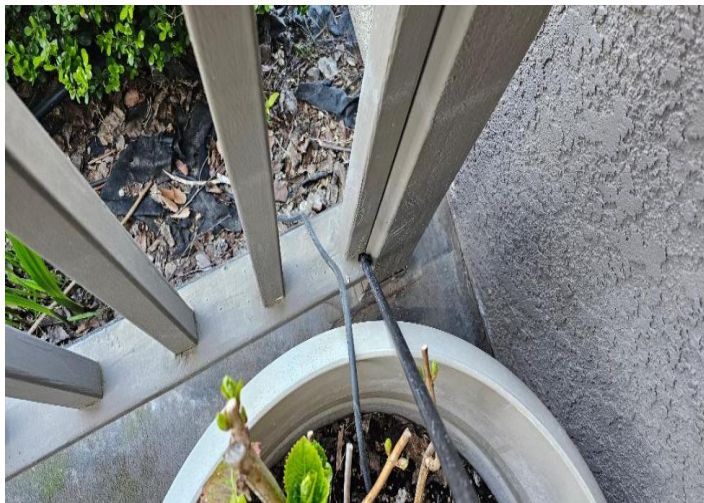
FINDING: Fungus damage was found to sections of lower handrail and pickets on the front handrail system.

3C - Damaged handrail members.

RECOMMENDATION: Remove the damaged wood members and replace with new material. Prime paint only.
