## **Property Inspection Report**

**2505 Basin St, Oceano, CA 93445**

**Date of Inspection: 2/12/2026 Time: 9:00 AM**

**Inspector: Greg Hines**

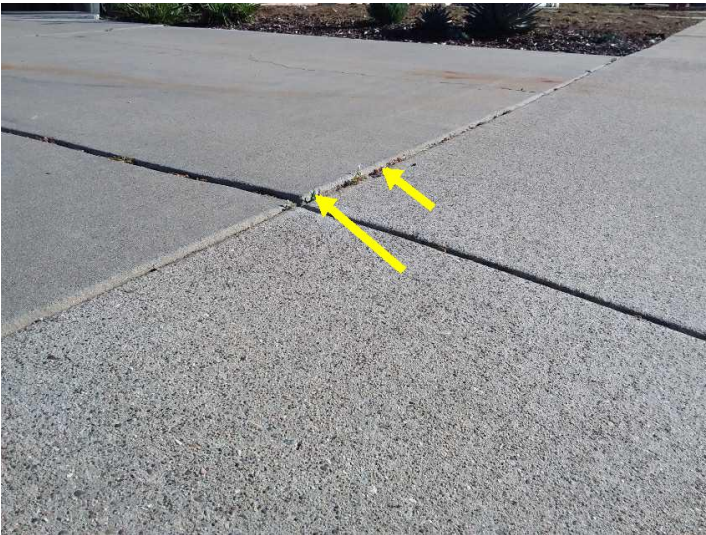
There is one or more offsets in the driveway that could prove to be trip-hazards.

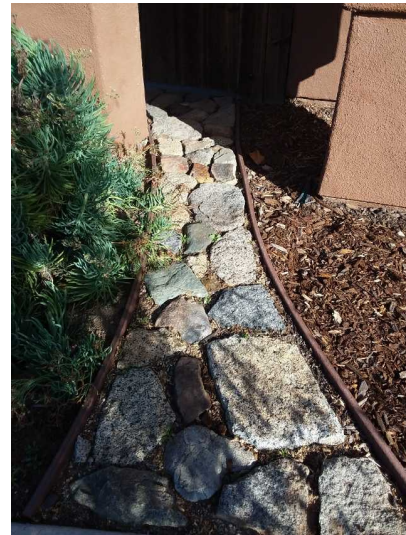
The paver patio or walkway has multiple offsets. This may be due to unsuitable soil below the pavers.

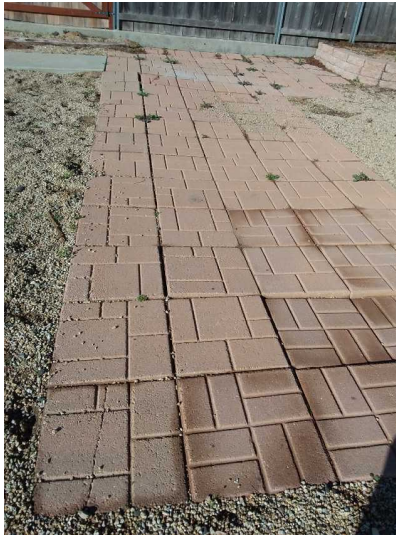
The paver patio or walkway has multiple offsets. This may be due to unsuitable soil below the pavers.

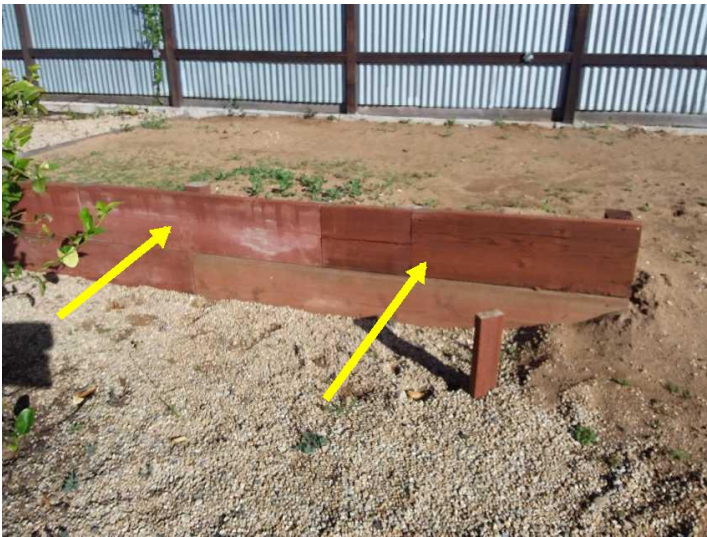
10.3. The wooden planks at the rear of the property have no structural value, and are intended to inhibit surface soil movement, and should be periodically monitored for damage or stability.

The wooden planks at the rear of the property have no structural value, and are intended to inhibit surface soil movement, and should be periodically monitored for damage or stability.

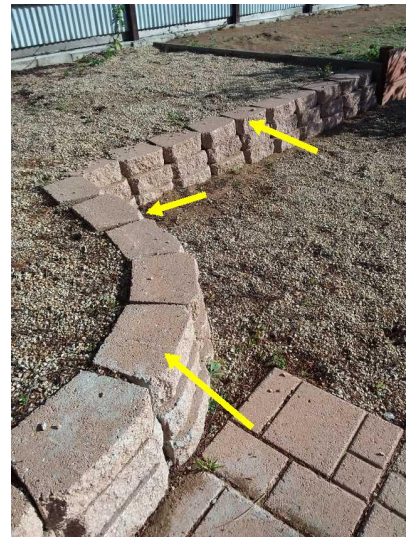
10.2. Some of the planter block-caps are loose or missing and should be serviced.

Some of the planter block-caps are loose or missing and should be serviced.

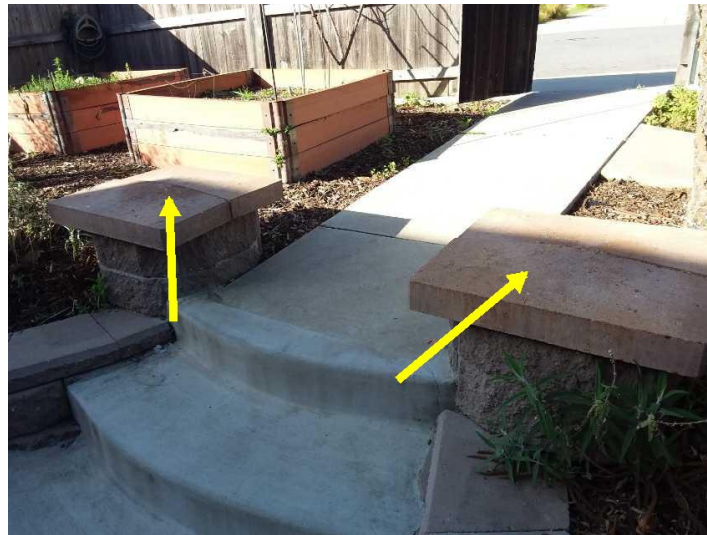
Some of the planter block-caps are loose or missing and should be serviced.

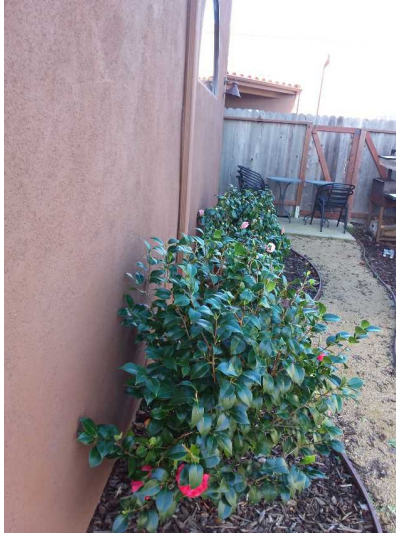
11.2. Vegetation is encroaching on the structure, and should be kept a minimum of twelve inches away for the general welfare of the walls and foundation.

Vegetation is encroaching on the structure, and should be kept a minimum of twelve inches away for the general welfare of the walls and foundation.

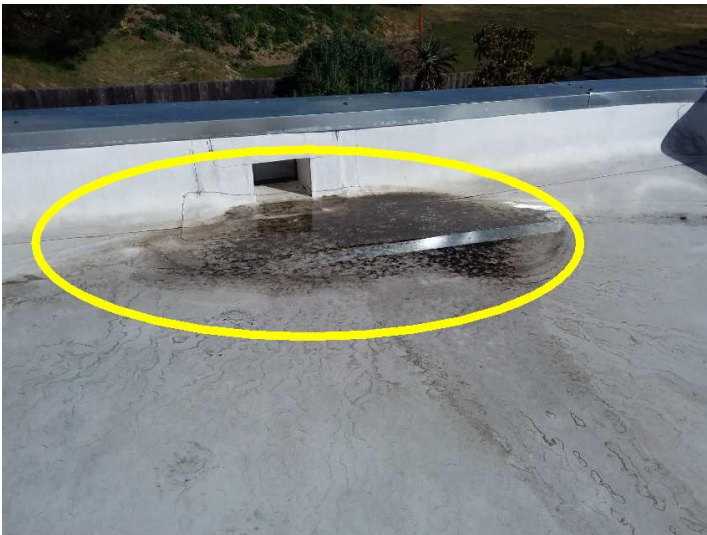
3.5. There are areas of the roof that are sunken or bellied and is holding water which should be evaluated and serviced by a licensed roofing contractor.

There are areas of the roof that are sunken or bellied and is holding water which should be evaluated and serviced by a licensed roofing contractor.

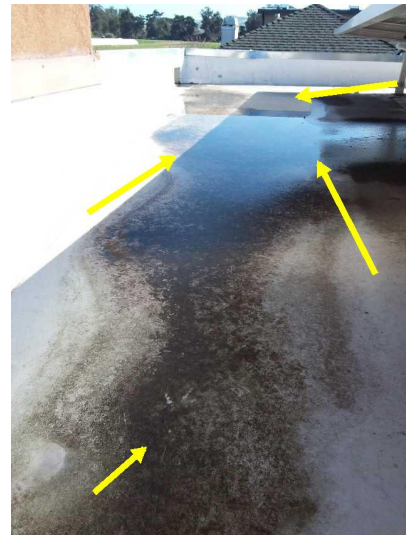
There are areas of the roof that are sunken or bellied and is holding water which should be evaluated and serviced by a licensed roofing contractor.

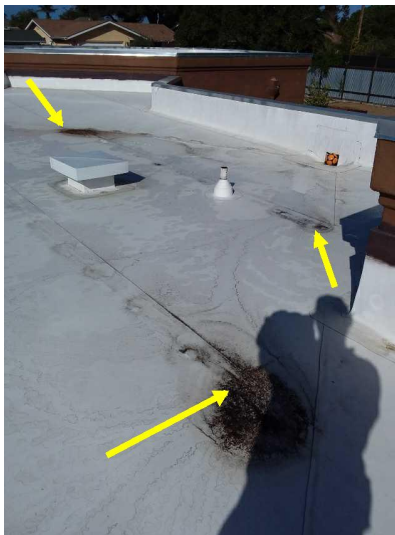
There are areas of the roof that are sunken or bellied and is holding water which should be evaluated and serviced by a licensed roofing contractor.

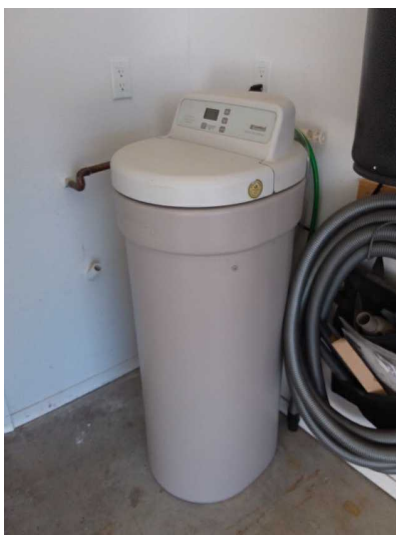
A water softener is present that we do not have the expertise to evaluate except for visible leaks. We recommend you ask the sellers if the unit was professionally installed and its service history.

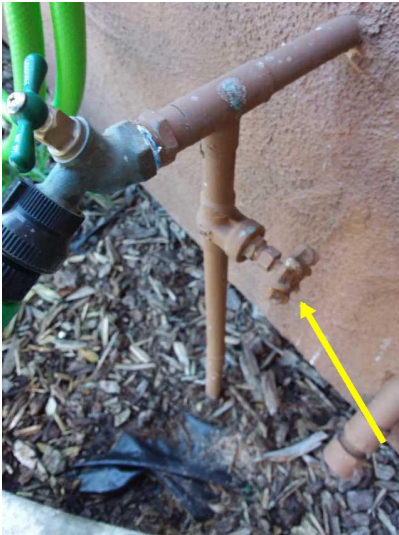
The main water shutoff valve is an older "Gate" style valve. This older valve may no longer properly function. We recommend it be upgraded to a newer "Ball" valve.

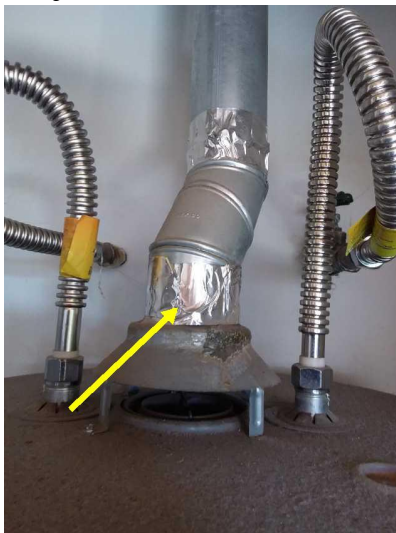
The vent pipe is not properly connected. It is required to have a minimum of 3 fasteners where the pipe connects to the draft hood or other single wall vent pipes.

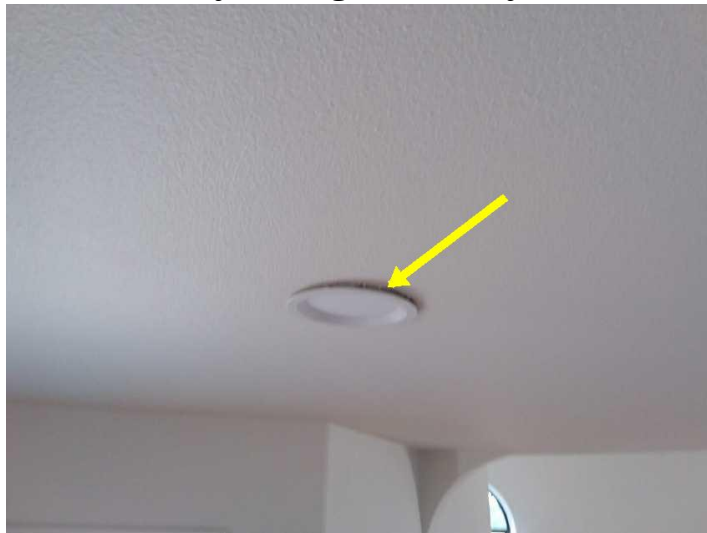
A ceiling light is not fully secure which should be serviced.

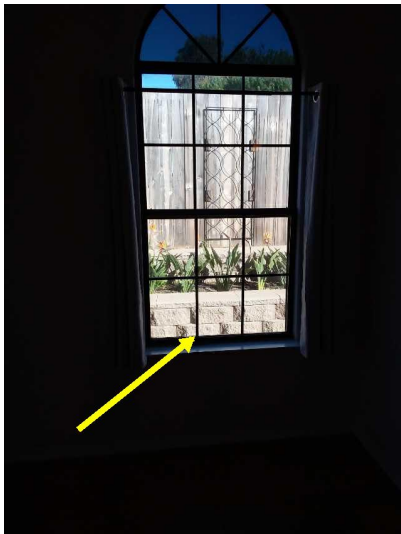
A window is stuck or painted shut, and should be serviced.

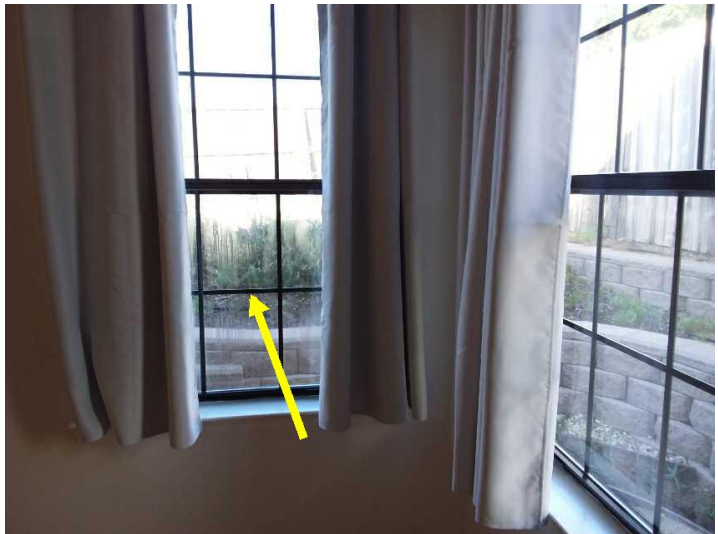
4.5. A window(s) may have a broken hermetic seal which you may wish to have replaced. This is evident from fogging, or condensation forming between the panes of glass that confirm that the seal has failed.

A window(s) may have a broken hermetic seal which you may wish to have replaced. This is evident from fogging, or condensation forming between the panes of glass that confirm that the seal has failed.

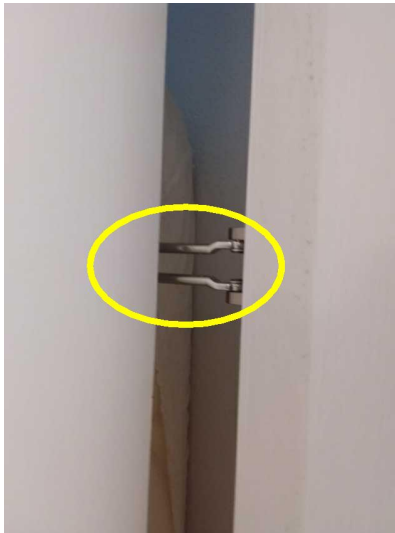
A secondary lock has been installed higher than 48 inches which could impede the exit of a child or short person.

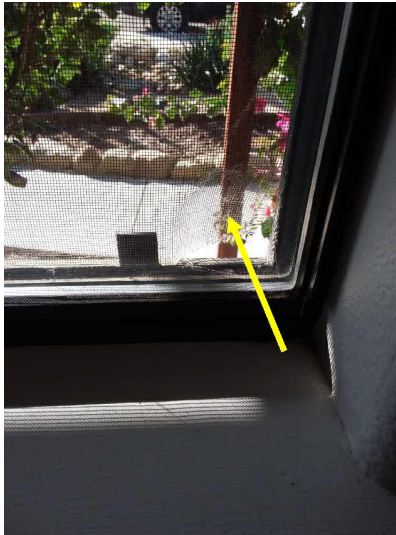
One or more window screens are damaged, which you may wish to have repaired.

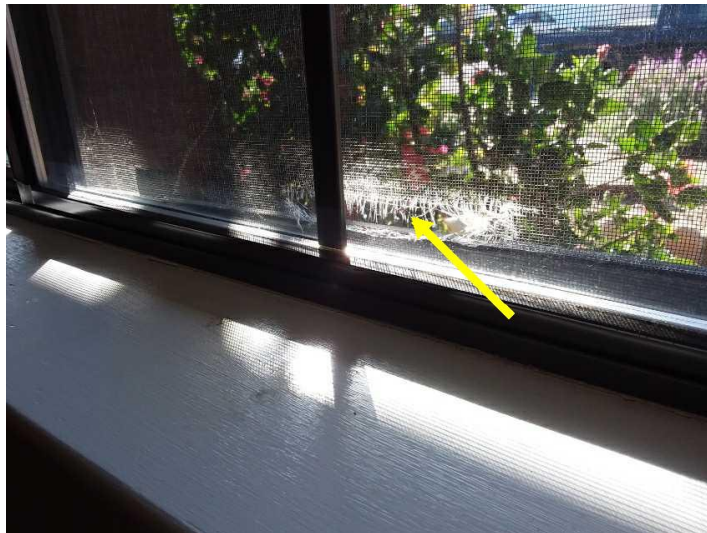
One or more window screens are damaged, which you may wish to have repaired.

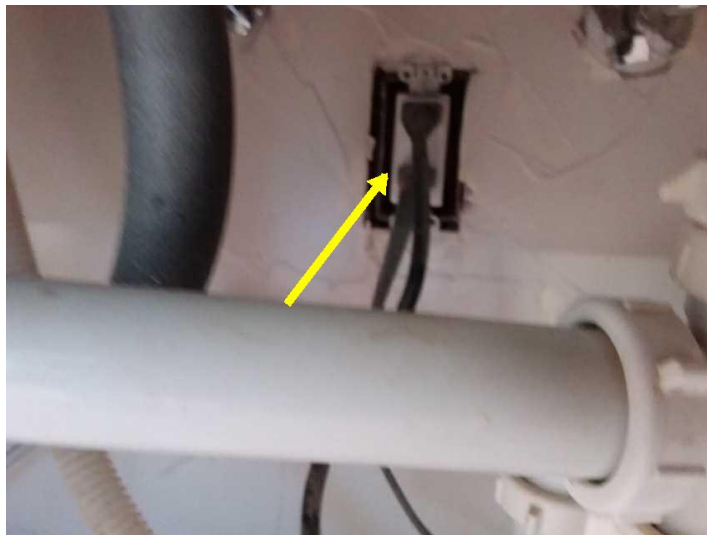
4.3. One or more outlet covers is missing or broken and should be serviced.

One or more outlet covers is missing or broken and should be serviced.

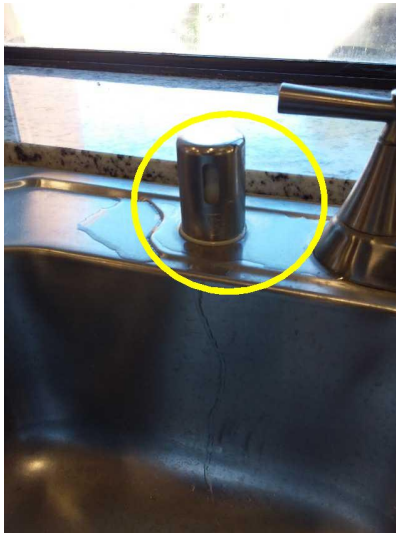
The dishwasher is functional but discharges water through the anti-siphon valve, which indicates a partial obstruction in the discharge hose. Removing and cleaning the hose where it attaches to the garbage disposal should correct this problem.

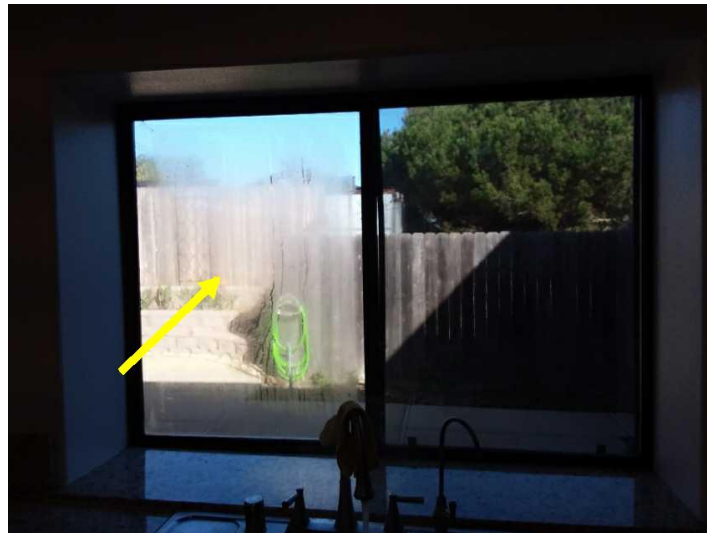
10.1. A window(s) may have a broken hermetic seal which you may wish to have replaced. This is evident from fogging, or condensation forming between the panes of glass that confirm that the seal has failed.

A window(s) may have a broken hermetic seal which you may wish to have replaced. This is evident from fogging, or condensation forming between the panes of glass that confirm that the seal has failed.

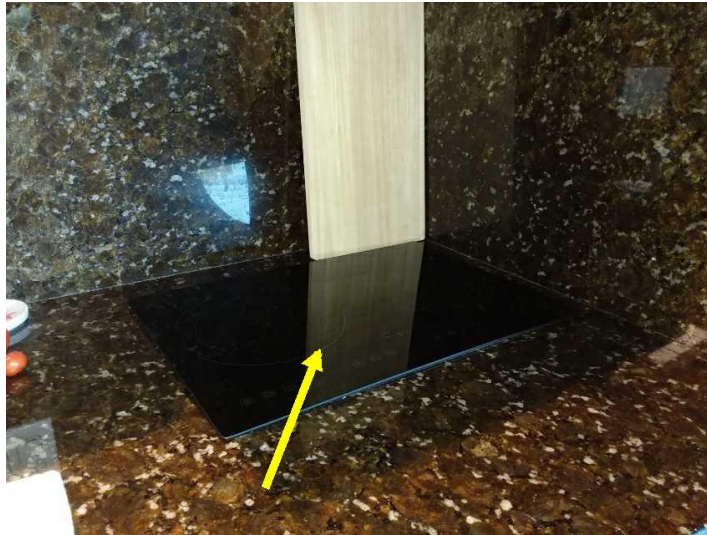
7.1. One or more of the electrical cook top burners did not respond, and should be serviced or demonstrated as functional.

One or more of the electrical cook top burners did not respond, and should be serviced or demonstrated as functional.

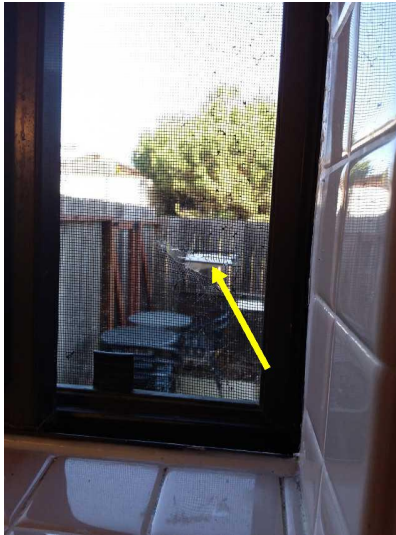
One or more window screens is damaged, which you may wish to have repaired.

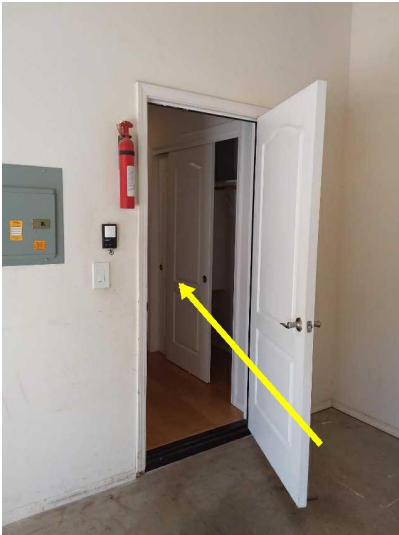
The house entry door is not a fire rated, self-closing and latching door, which should be serviced.

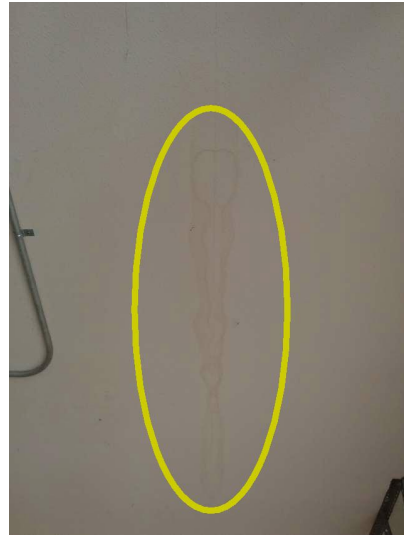
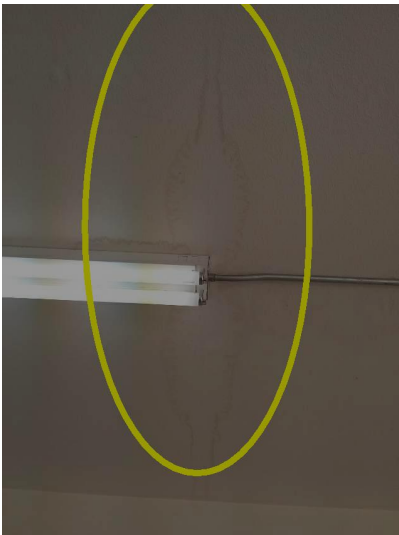
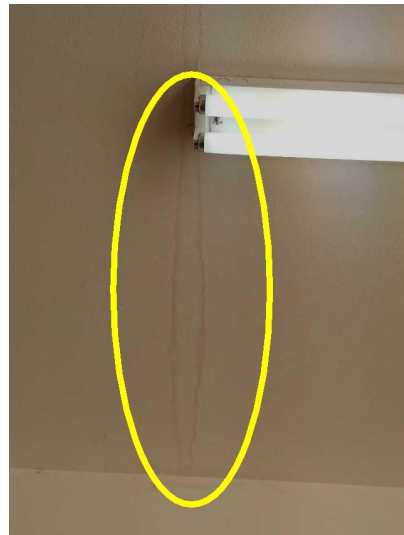
There is a moisture stain on the garage ceiling, the cause of which should be explained or explored further. However, we not unable to confirm that is being caused by an active leak.

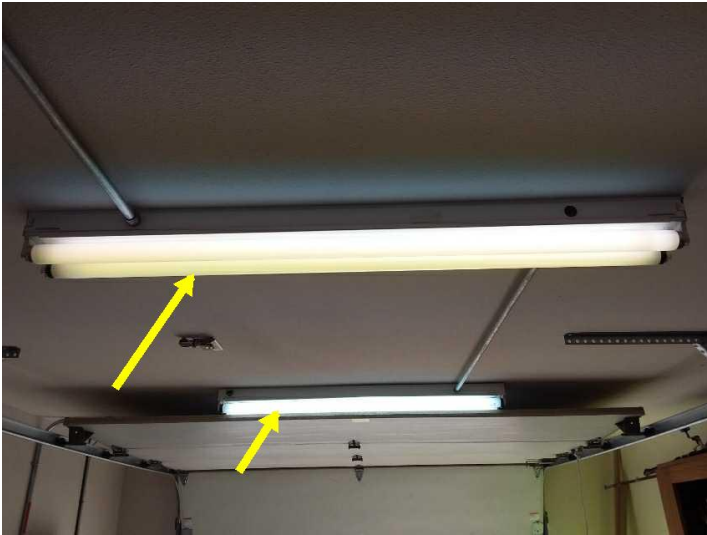
A light is missing its globe or cover and should be serviced.

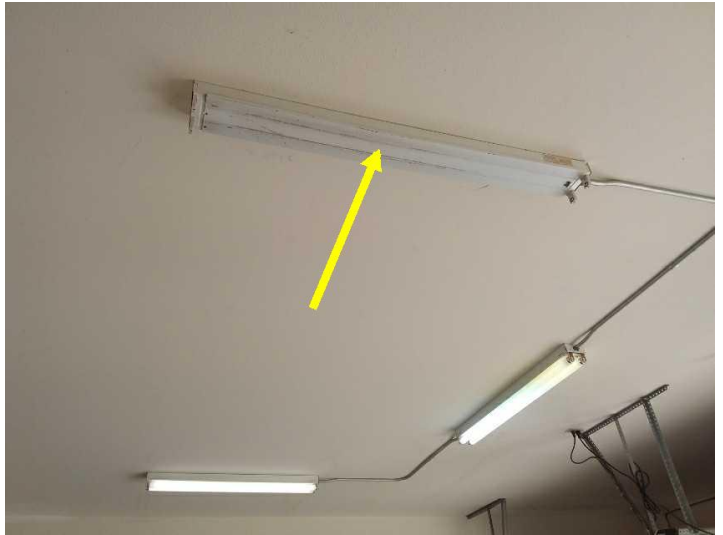
A ceiling light does not respond, and should be serviced.

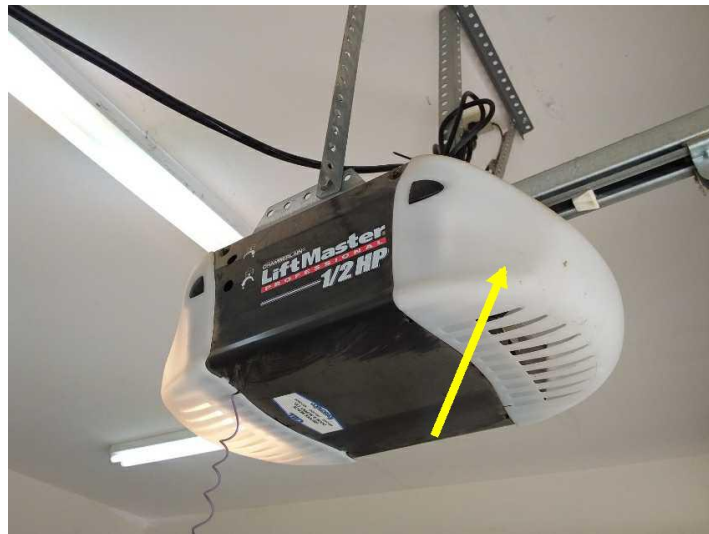
The garage door opener front light did not respond when the auto-reverse mechanism when activated which should be serviced. This is important because it typically is the only light on when pulling into the garage at night.
