SEWER SCOPE REPORT

8104 Arrington Ave., Pico Rivera, CA 90660

Inspection Date: 3/14/2026
Report Number: 2026031401KL
Real Estate Agent: Joe Napoli
Home Inspector: Kenny Lu

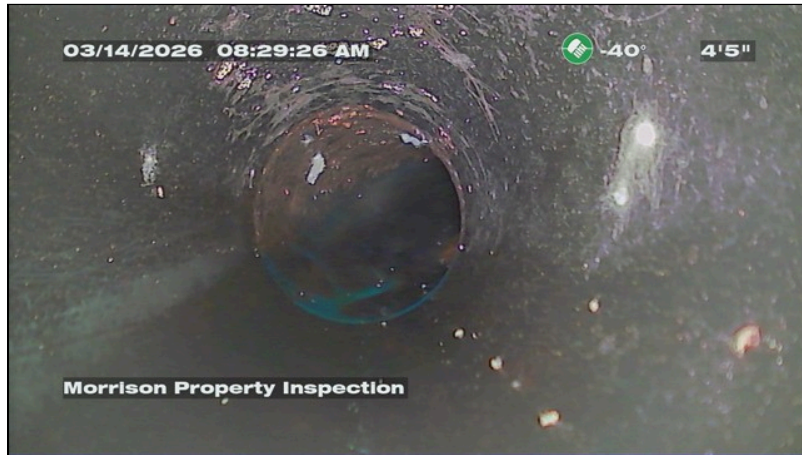
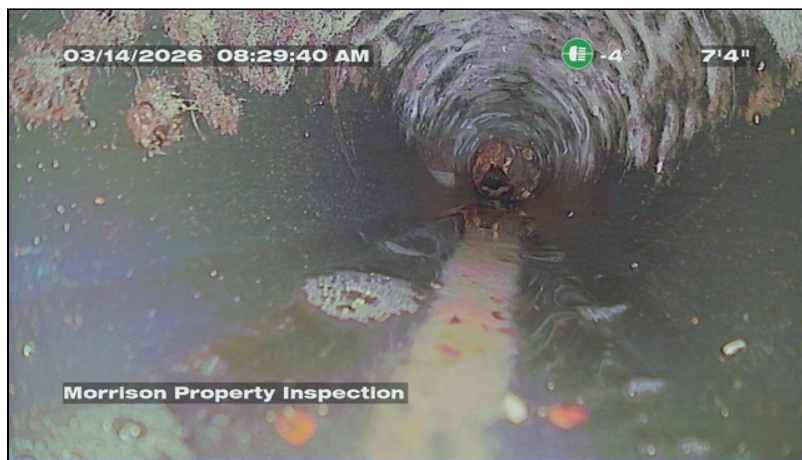
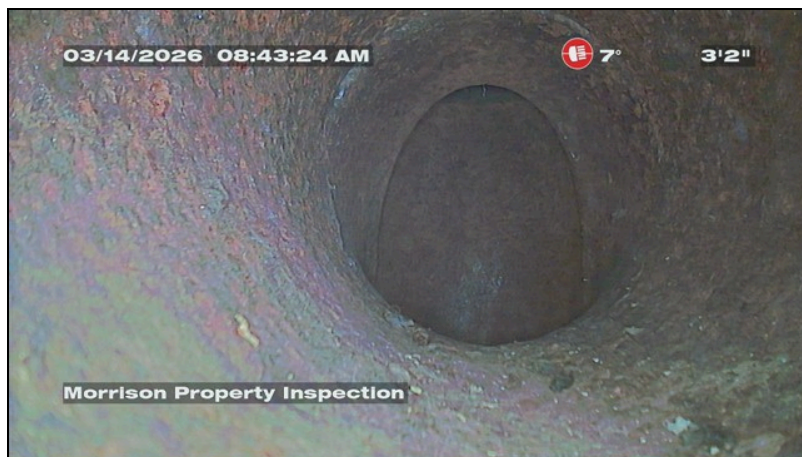
(1) Acrylonitrile-Butadiene-Styrene (ABS) piping was observed for a portion of the drain line. ABS is made from a thermoplastic resin. This is considered a modern building material. The estimated service life of ABS is 50+ years, depending on site conditions. Due to the flexible nature of ABS

pipings, bellies in the line can develop from inadequately compacted soil. ABS drain lines should be checked annually for any changes in condition.

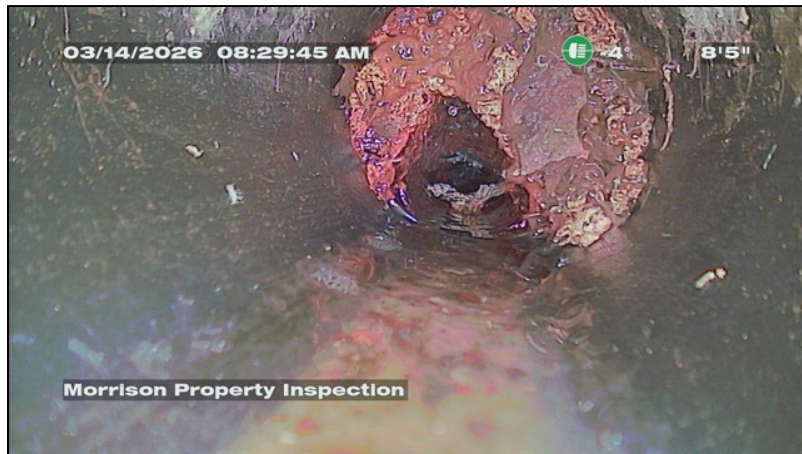
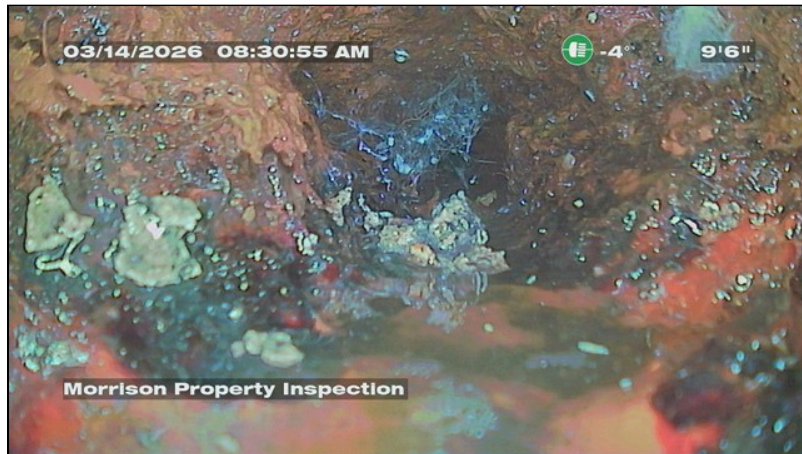
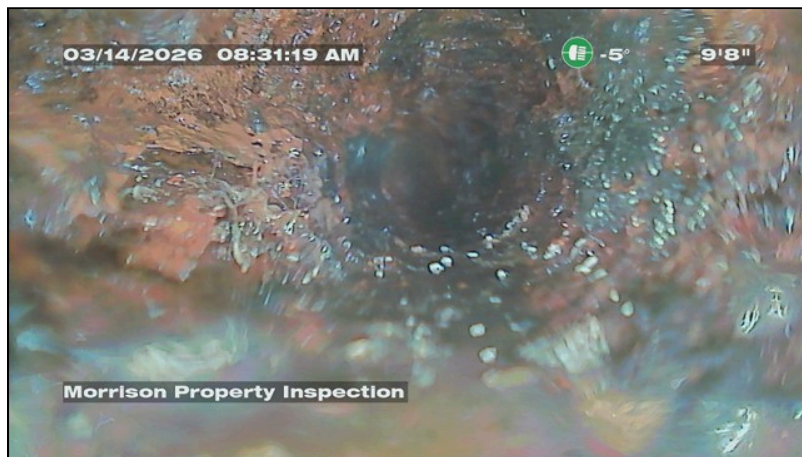
(2) Scaling observed at cast iron drain lines. Scaling may prevent us from determining if there is a crack or leak from the exterior side of the line. Scaling was not causing blockage at the time of inspection.

To help preserve the condition and function of your sewer line, we recommend periodic hydrojetting as part of a preventive maintenance plan. This service uses high-pressure water to remove grease, scale, and debris that naturally accumulate over time—helping to prevent future clogs, improve flow, and extend the lifespan of the pipe. It's a simple and cost-effective way to protect your system before problems arise.

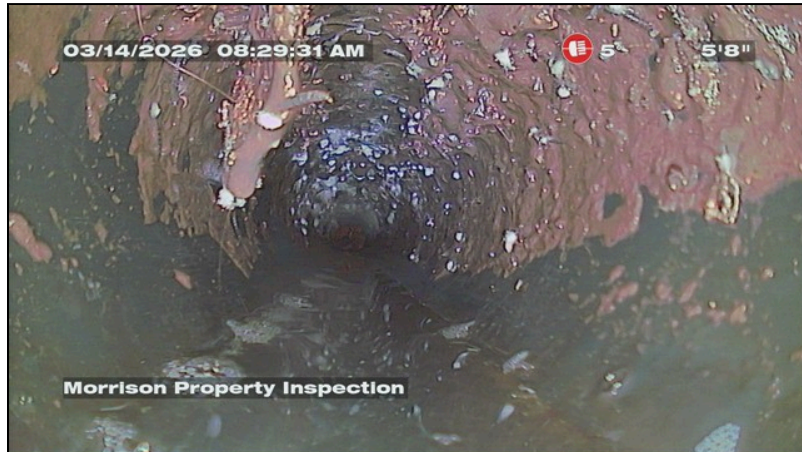
1.2 Item 7 (Picture)

(3) Grease build up observed within the sewer line. Excessive grease build up can cause slow draining and/or clogging of the main line. No blockages were observed at the time of inspection. Suggest monitoring and maintenance as needed.
