Cornerstone Inspection

Property Inspection Report

3229 Violet St, San Luis Obispo, CA 93401

Date of Inspection: 2/26/2026 Time: 9:00 AM

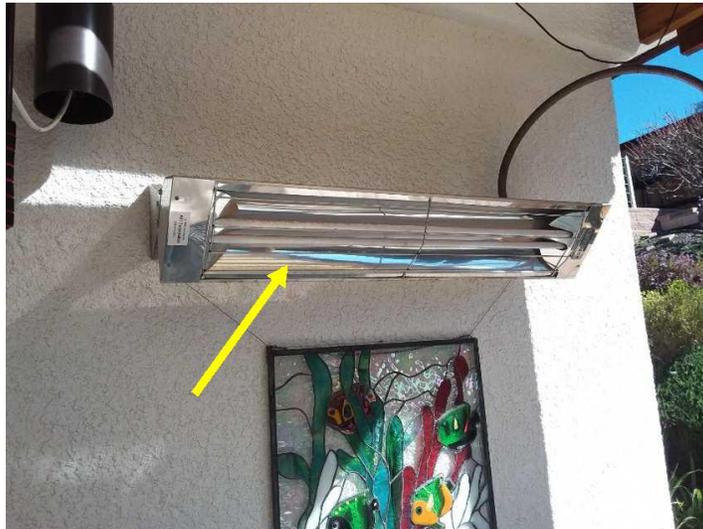
1.5. There is a gas light or heater in the yard that we do not have the expertise to evaluate.

There is a gas light or heater in the yard that we do not have the expertise to evaluate.

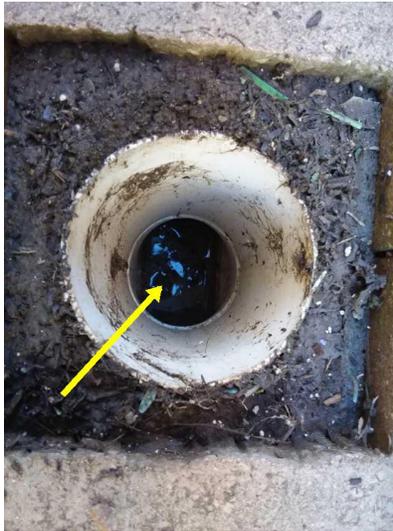
2.6. There is standing water or debris visible within the area drains, which could be indicative of at least a partial blockage. The tendrils of roots may have invaded the drains, but silt also tends to become trapped within the drain pipes and hardens during the summer months to the consistency of wet concrete and creates an impediment that commonly leads to a full blockage. Therefore, we recommend that the lines be flushed through to the street or to their termination point.

There is standing water or debris visible within the area drains, which could be indicative of at least a partial blockage. The tendrils of roots may have invaded the drains, but silt also tends to become trapped within the drain pipes and hardens during the summer months to the consistency of wet concrete and creates an impediment that commonly leads to a full blockage. Therefore, we recommend that the lines be flushed through to the street or to their termination point.

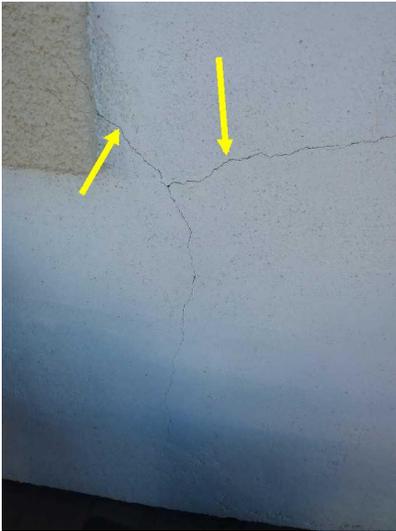
3.4. There are typical cracks in the stucco, which you should view for yourself. Most cracks result from movement, and are structural in that respect, but the vast majority of them have only a cosmetic significance. You may wish to have this confirmed by a specialist.

There are typical cracks in the stucco, which you should view for yourself. Most cracks result from movement, and are structural in that respect, but the vast majority of them have only a cosmetic significance. You may wish to have this confirmed by a specialist.

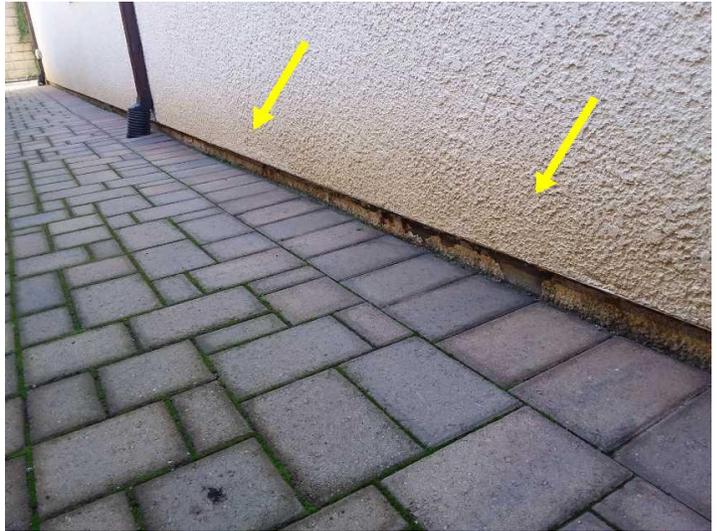
There are stains present that may be difficult to remove.

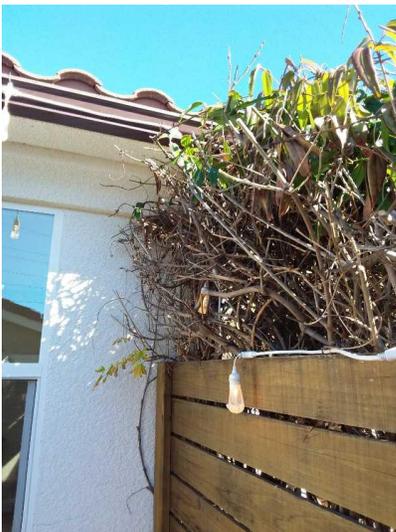
Vines, shrubs or bushes are growing on the house walls and although they are attractive they can introduce pests and rodents and accelerate deterioration. Therefore, you may wish to consider having them removed or cut back to 12 inches away from the home.

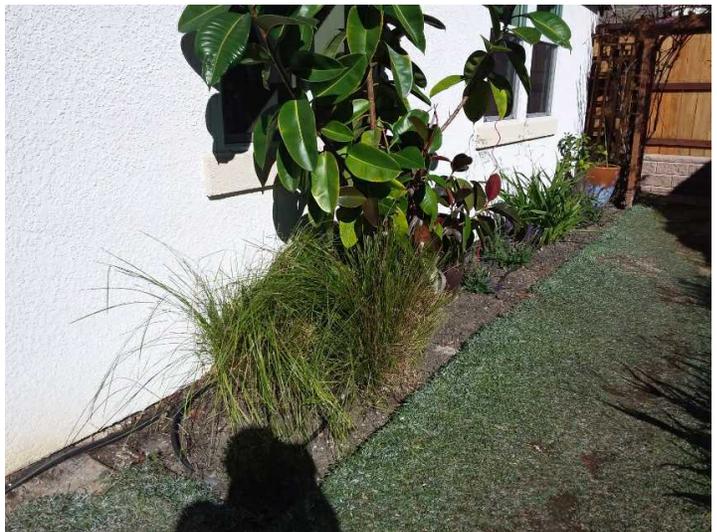
Vines, shrubs or bushes are growing on the house walls and although they are attractive they can introduce pests and rodents and accelerate deterioration. Therefore, you may wish to consider having them removed or cut back to 12 inches away from the home.

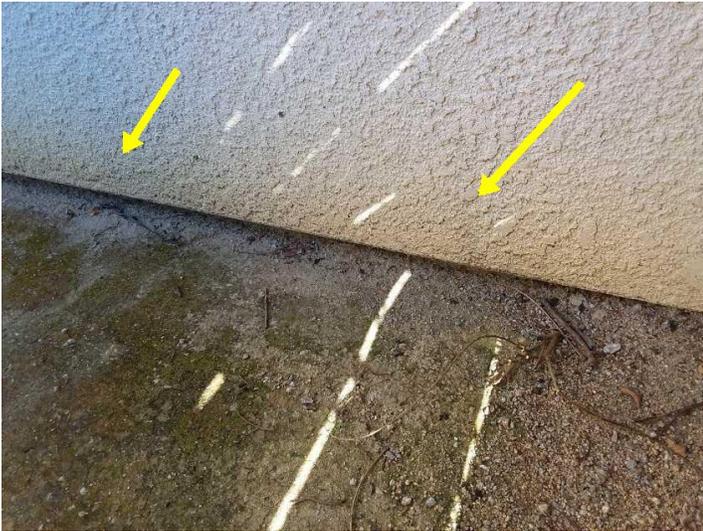
There are stains present that may be difficult to remove.

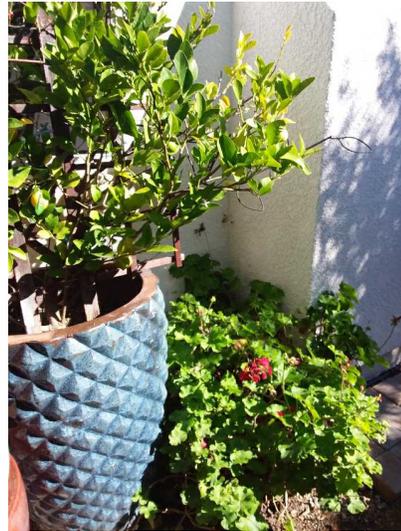
Vines, shrubs or bushes are growing on the house walls and although they are attractive they can introduce pests and rodents and accelerate deterioration. Therefore, you may wish to consider having them removed or cut back to 12 inches away from the home.

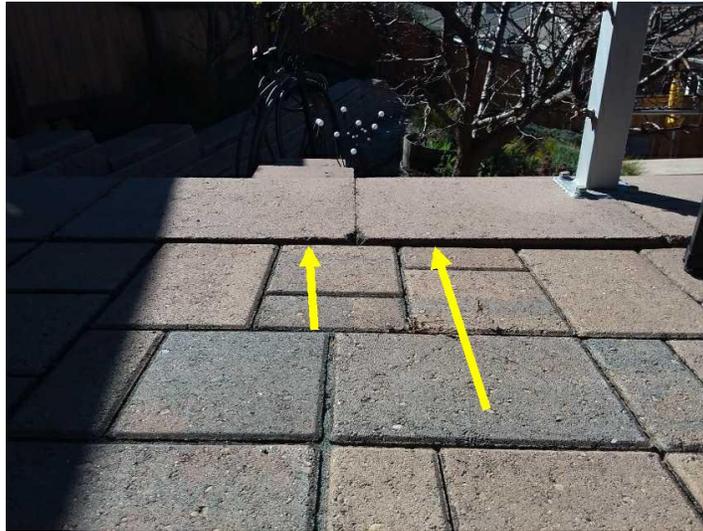
There is one or more offsets in the walkways that could prove to be trip-hazards.

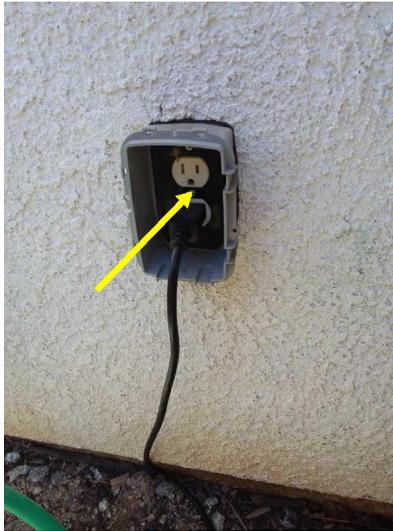
6.2. Some of the exterior electrical outlets do not have a weather rated cover or the cover is damaged and should be serviced.

Some of the exterior electrical outlets do not have a weather rated cover or the cover is damaged and should be serviced.

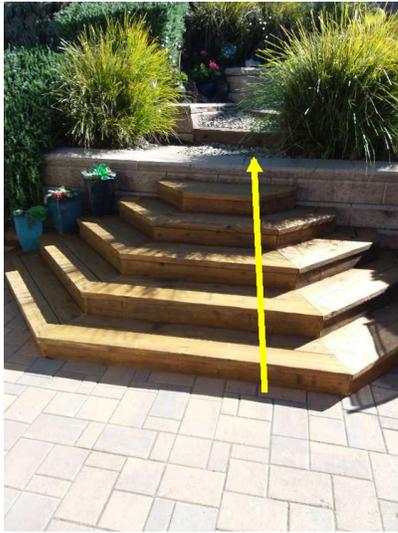
Current building standards require handrails to be installed on steps which have 4 or more risers, and particularly if children or the elderly visit or occupy this property.

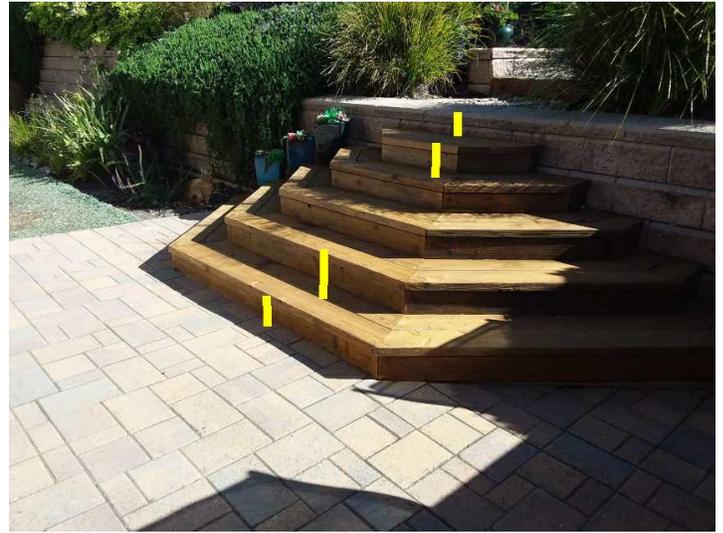
9.1. Some of the steps have unequal treads or risers. Steps are required to be uniform to prevent trip-hazards. The rise of any step should be no less than four inches and no greater than seven inches, and the run should be no less than eleven inches. Also, the dimensions of the largest step should not exceed that of the smallest by more than three-eighths of an inch.

Some of the steps have unequal treads or risers. Steps are required to be uniform to prevent trip-hazards. The rise of any step should be no less than four inches and no greater than seven inches, and the run should be no less than eleven inches. Also, the dimensions of the largest step should not exceed that of the smallest by more than three-eighths of an inch.

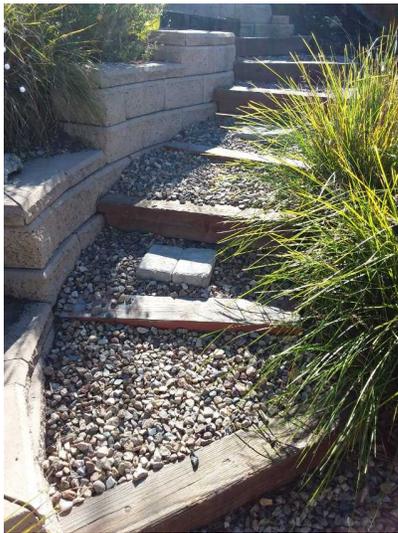
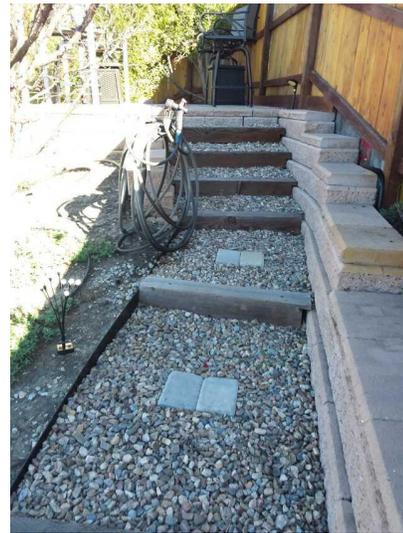
9.3. The railroad-tie steps are landscape components and would not conform to common standards requiring certain dimensions, handrails, guardrails, et cetera.

The railroad-tie steps are landscape components and would not conform to common standards requiring certain dimensions, handrails, guardrails, et cetera.

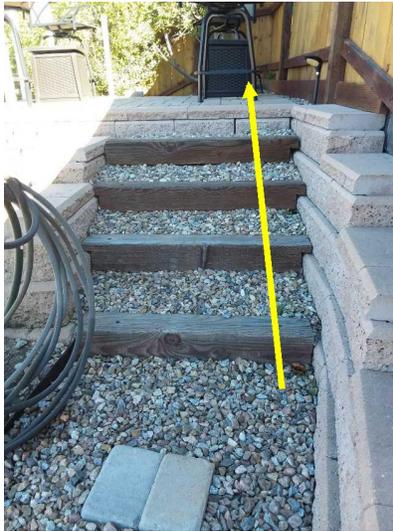
Current building standards require handrails to be installed on steps which have 4 or more risers, and particularly if children or the elderly visit or occupy this property.

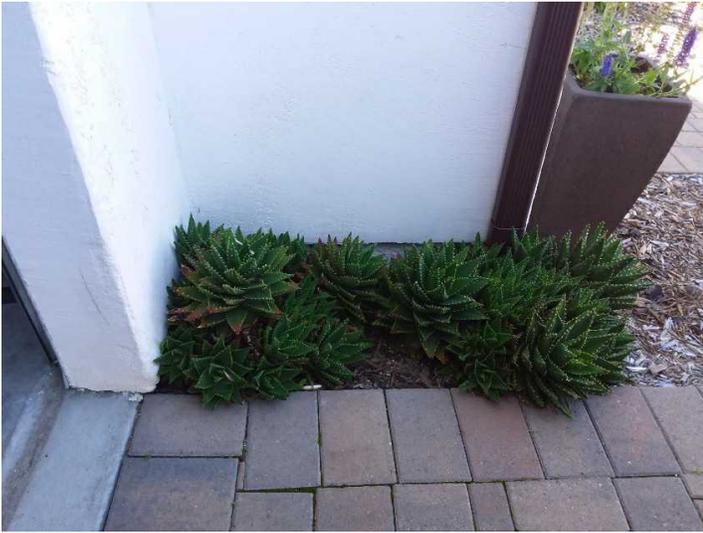
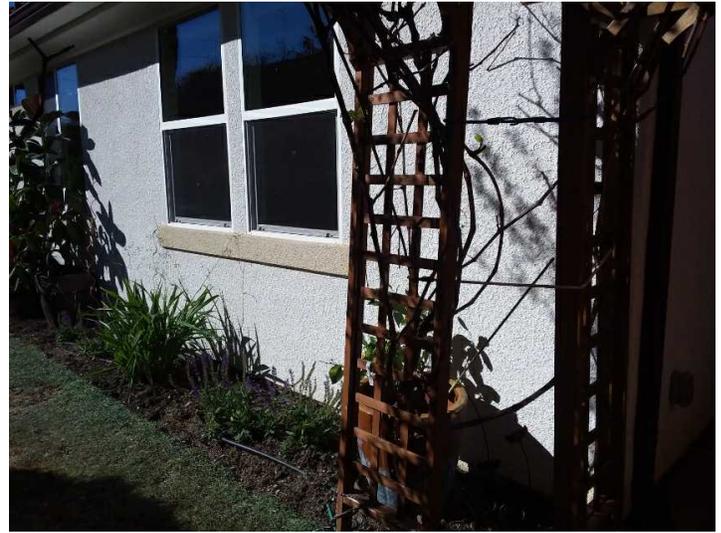
12.2. Vegetation is encroaching on the structure, and should be kept a minimum of twelve inches away for the general welfare of the walls and foundation.

Vegetation is encroaching on the structure, and should be kept a minimum of twelve inches away for the general welfare of the walls and foundation.

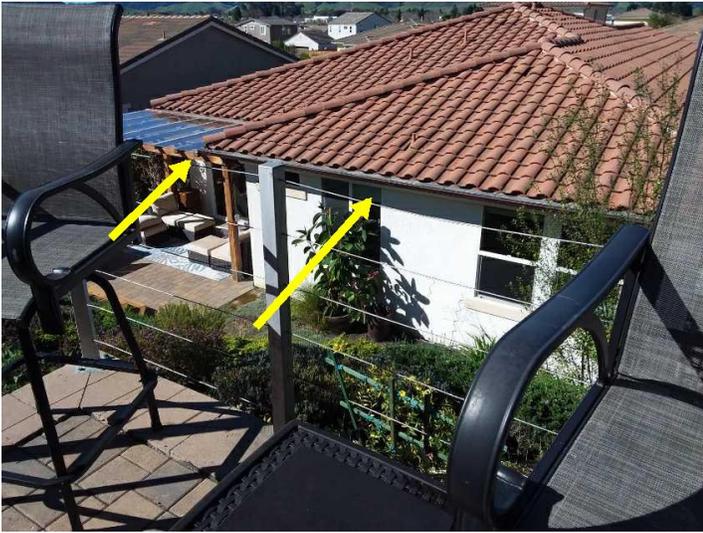
The balcony/yard guardrail does not conform to common safety standards. Common safety standards require them to be a minimum of 42 inches high when the standing surface is 30" or more above grade.

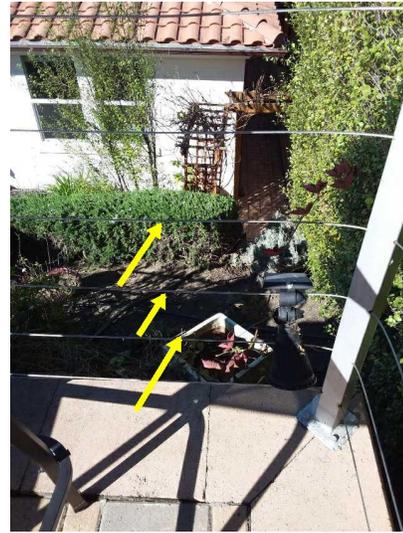
The balcony/deck guardrail is climbable, and therefore not child-safe. If children occupy or visit this property appropriate precautions should be taken to make the area more secure.

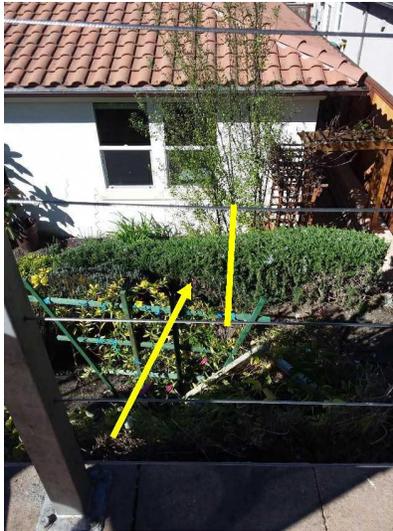
The balusters in the guardrail are more than 4" apart and are not child safe. Therefore, you may wish to add a protective barrier.

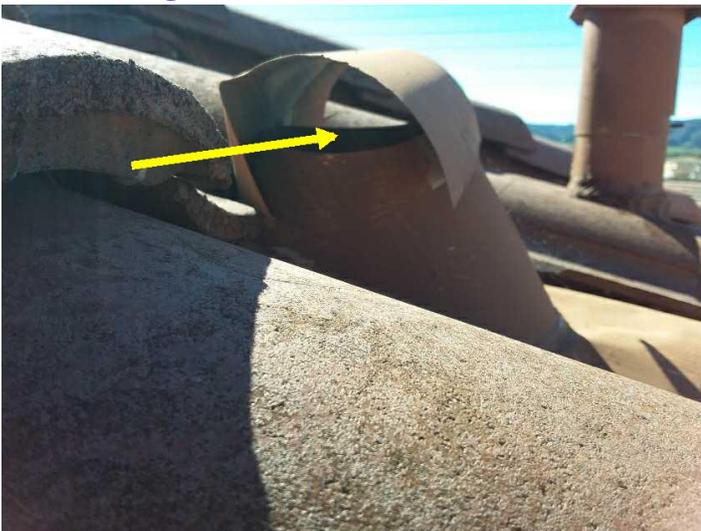
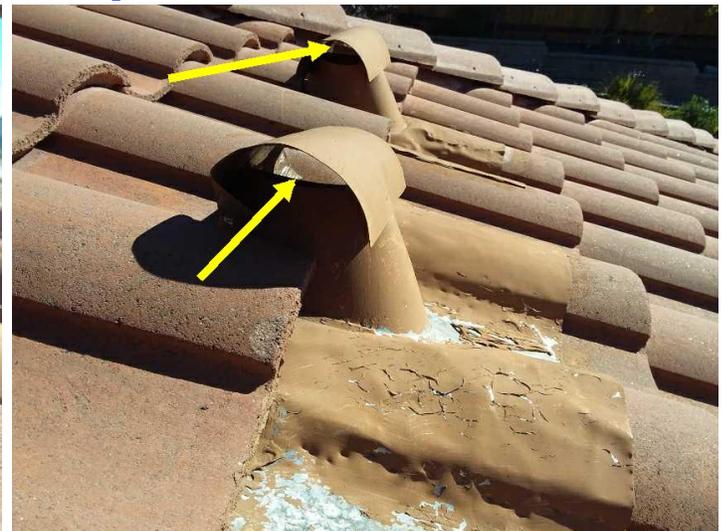
2.5. Some of the roof flashing needs to be sealed or serviced. They are comprised of metal that seals valleys and vents and other roof penetrations, and are the most common point of leaks. This is particularly true of the flashing's on a layered roof, which are covered by the roofing material and which are even more susceptible to leaks.

Some of the roof flashing needs to be sealed or serviced. They are comprised of metal that seals valleys and vents and other roof penetrations, and are the most common point of leaks. This is particularly true of the flashing's on a layered roof, which are covered by the roofing material and which are even more susceptible to leaks.

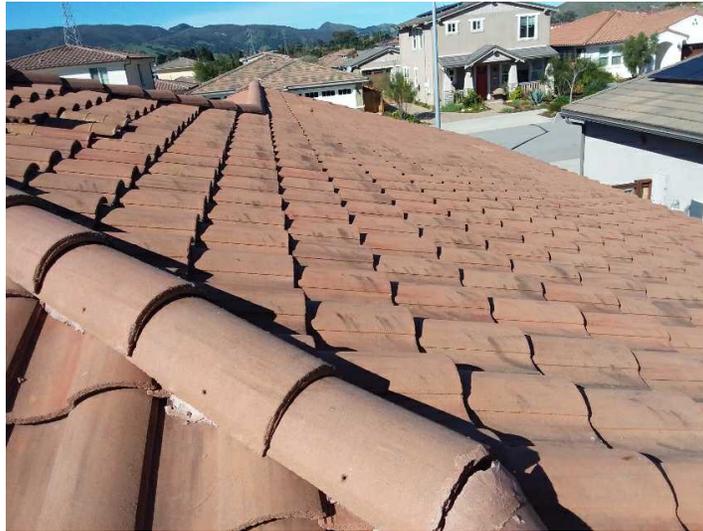
The roof is in acceptable condition, but this is not a guarantee against leaks. For a guarantee, you would need to have a roofing company perform a water-test and issue a roof certification.

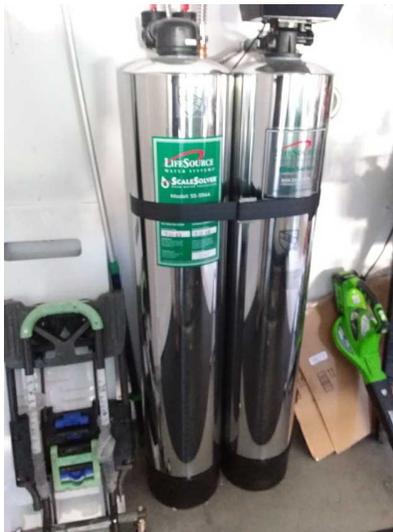
A water softener is present that we do not have the expertise to evaluate except for visible leaks. We recommend you ask the sellers if the unit was professionally installed and its service history.

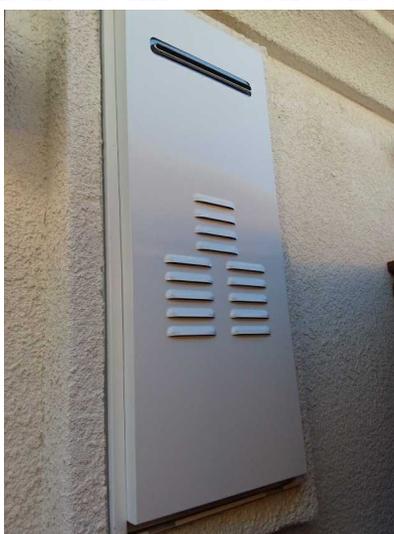
5.10. The condensate drainline is not connected and should be serviced.

The residence is served by a tankless water heater located in the left exterior side of the home..

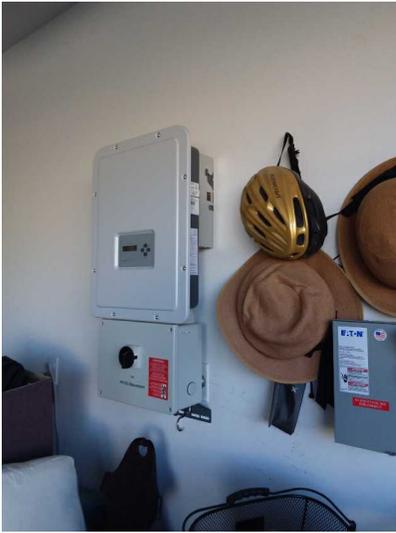
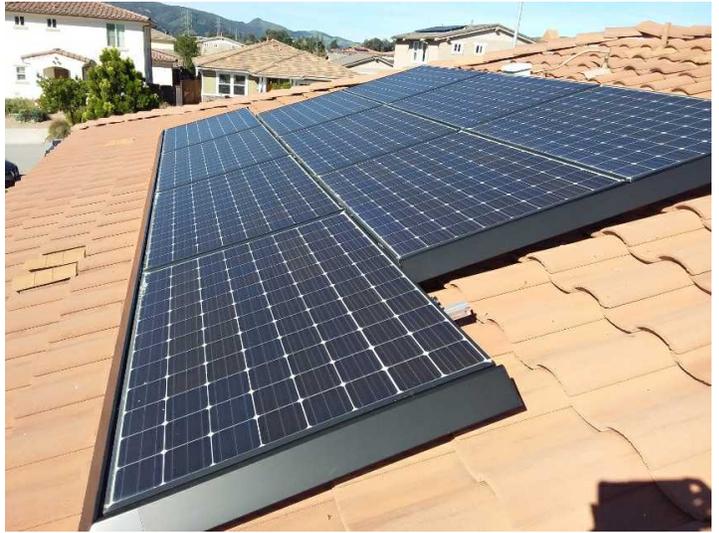
A photovoltaic solar system has been installed that we do not have the expertise to evaluate. We recommend the sellers provide information regarding its installation, operation and maintenance history, otherwise your may want to have it evaluated by a licensed specialist

10 panels on roof

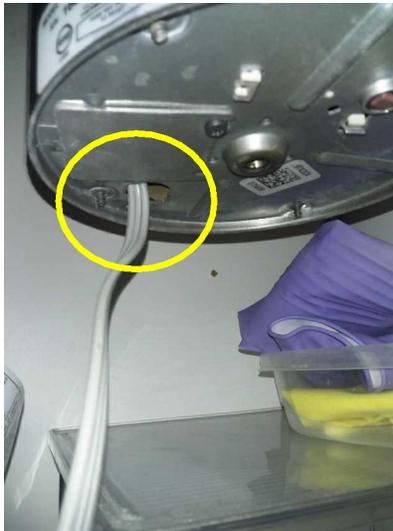
<i>Kitchen</i>		
Page 28 Item: 7	Garbage Disposal Comments	7.2. The electrical connection to the garbage disposal is substandard. The approved appliance cord is missing its protective clamp.

The electrical connection to the garbage disposal is substandard. The approved appliance cord is missing its protective clamp.

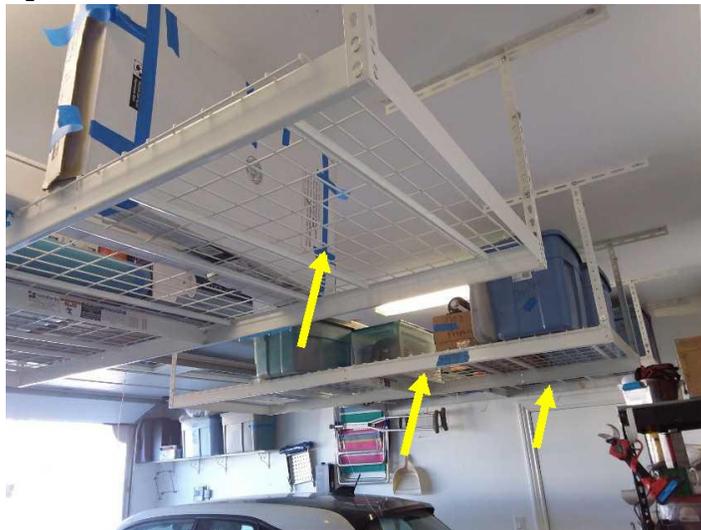
The storage space may have been added without the benefit of a permit, which could stress the roof framing. You may wish to verify this with the sellers. Regardless, you should limit the storage to lightweight items.
