WOOD DESTROYING PESTS AND ORGANISMS INSPECTION REPORT

BUILDING NO. 1805	STREET, CITY, STATE, ZIP Sunberg Avenue, San Leandro CA 94577	Date of Inspection 2/12/2026	No. of Pages 10
-----------------------------	---	--	---------------------------

General Description: Single family wood frame structure with stucco and brick veneer exterior.	Inspection Tag Posted: Subarea
	Other Tags Posted:

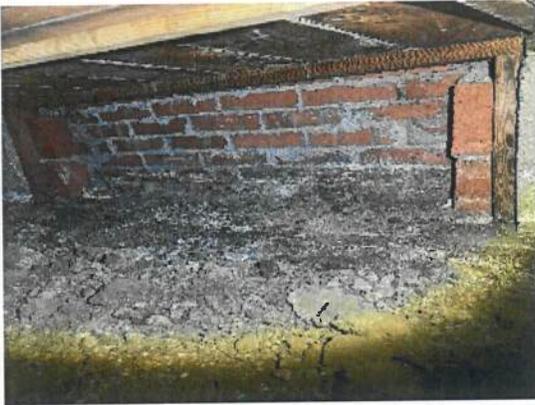
- ITEM 1A Fungus damage was found to the *support piers below the fireplace* at the area indicated on the diagram.
REC: Remove the damaged wood members and replace with new material as necessary.
NOTE: THIS REPAIR WILL BE ATTEMPTED FROM BELOW. IF THIS REPAIR CANNOT BE COMPLETED IN THIS MANNER OR IF DAMAGE EXTENDS INTO ANY ADJACENT AREA, A SUPPLEMENTAL REPORT WILL BE ISSUED STATING FINDINGS, RECOMMENDATIONS AND ADDITIONAL COST.

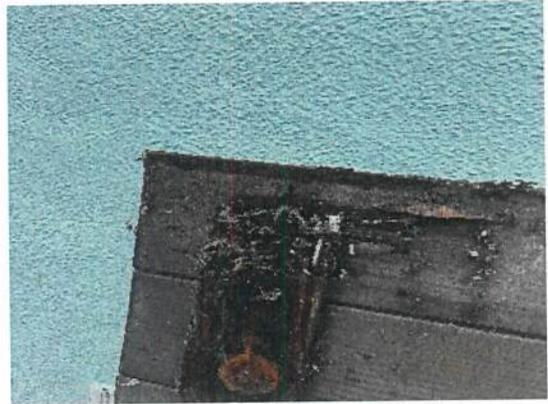
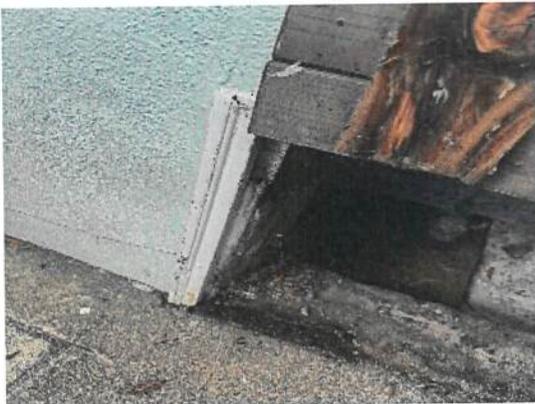
***** This is a Section 2 Item *****
- ITEM 1C The sub-area access door and/or framing is fungus damaged.
REC: Remove the damaged wood and replace with new materials as necessary. One coat primer. No painting included.
NOTE: IF DAMAGE EXTENDS INTO ANY ADJACENT AREA, A SUPPLEMENTAL REPORT WILL BE ISSUED STATING FINDINGS, RECOMMENDATIONS AND ADDITIONAL COST.

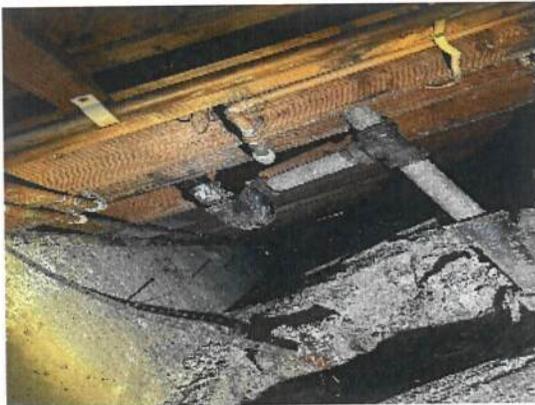
***** This is a Section 1 Item *****
- ITEM 1B Evidence of a plumbing leak was noted at the *hall bathroom tub drain*.
REC: The owner should contact a plumbing contractor to inspect the area and make necessary repairs.

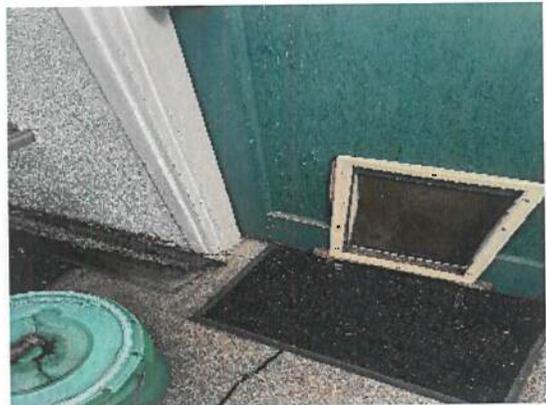
- ITEM 8A The pedestrian garage door is fungus damaged.
REC: Remove the door and replace with a new pre-hung door. One coat primer.
No painting included.
If new hardware is required, an additional quote will be given at that time.
NOTE: IF DAMAGE EXTENDS INTO ANY ADJACENT AREA, A SUPPLEMENTAL REPORT WILL BE ISSUED WITH OUR FINDINGS, RECOMMENDATIONS AND ADDITIONAL COSTS.

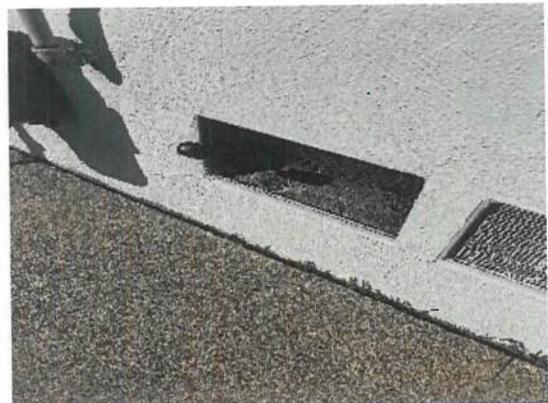
***** Information Item *****
- ITEM 11G The *vent framing* at the area(s) indicated on the diagram is fungus damaged.
REC: Remove the damaged wood members and replace with new material as necessary to eliminate fungus infection.
One coat primer only. No painting included.
NOTE: IF DAMAGE EXTENDS INTO ANY ADJACENT AREA, A SUPPLEMENTAL REPORT WILL BE ISSUED WITH OUR FINDINGS, RECOMMENDATIONS AND ADDITIONAL COSTS.

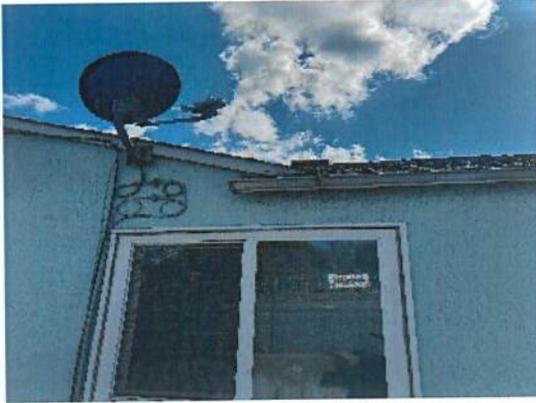
11J,11K

***** This is a Section 2 Item *****
- ITEM 11J The *barge rafter* is fungus damaged at the areas indicated on the diagram.
REC: Remove damaged wood members and replace with new materials as necessary to eliminate fungus infection. One coat primer only. No painting included. Our job quotation for this item does not include patching the disturbed areas of the roof covering/gutters or re-installing gutters removed to facilitate repairs, if any.
NOTE: UPON COMPLETION OF WOOD REPAIR, OWNER TO ENGAGE A LICENSED ROOFER/GUTTER FIRM TO REPAIR OR REPLACE DISTURBED ROOF COVERING OR GUTTERS, IF ANY.
NOTE: IF DAMAGE EXTENDS BEYOND ADJACENT AREAS, A SUPPLEMENTAL REPORT WILL BE ISSUED STATING FINDINGS, RECOMMENDATIONS AND ADDITIONAL COST.

***** This is a Section 1 Item *****
- ITEM 11K The *sheathing* is fungus damaged at the areas indicated on the diagram.
REC: Remove damaged wood members and replace with new materials as necessary to eliminate fungus infection. One coat primer only. No painting included. Our job quotation for this item does not include patching the disturbed areas of the roof covering/gutters or re-installing gutters removed to facilitate repairs, if any.
NOTE: UPON COMPLETION OF WOOD REPAIR, OWNER TO ENGAGE A LICENSED ROOFER/GUTTER FIRM TO REPAIR OR REPLACE DISTURBED ROOF COVERING OR GUTTERS, IF ANY.
NOTE: IF DAMAGE EXTENDS BEYOND ADJACENT AREAS, A SUPPLEMENTAL REPORT WILL BE ISSUED STATING FINDINGS, RECOMMENDATIONS AND ADDITIONAL COST.

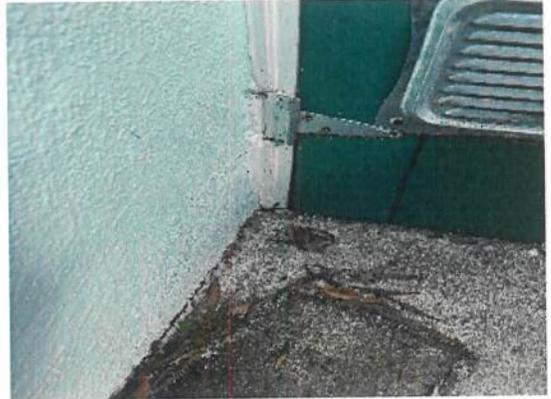
***** Information Item *****
- ITEM 11M The *door trim at the water heater closet* at the area(s) indicated on the diagram is fungus damaged.
REC: Remove the damaged wood members and replace with new material as necessary to eliminate fungus infection.
One coat primer only. No painting included.
NOTE: IF DAMAGE EXTENDS INTO ANY ADJACENT AREA, A SUPPLEMENTAL REPORT WILL BE ISSUED WITH OUR FINDINGS, RECOMMENDATIONS AND ADDITIONAL COSTS.
