Inspection Report

This home inspection report prepared specifically for:

Debra Reinier & Russell Mathis
9290 Carmel Road
Atascadero, CA 93422

Inspection location: 9290 Carmel Road
Atascadero, CA 93422

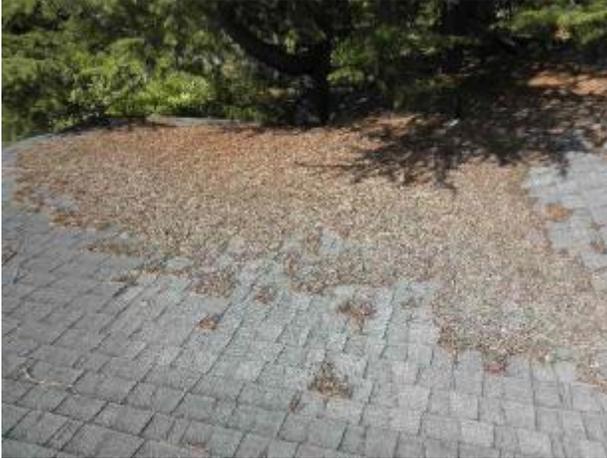
R

Maintenance Note: The leaves and foliage debris needs to be cleared from the roof to promote positive drainage. This is particularly important at the valley(s) where water damming can cause leakage and premature deterioration of the roof materials.

The leaves and debris need to be cleared off the roof.

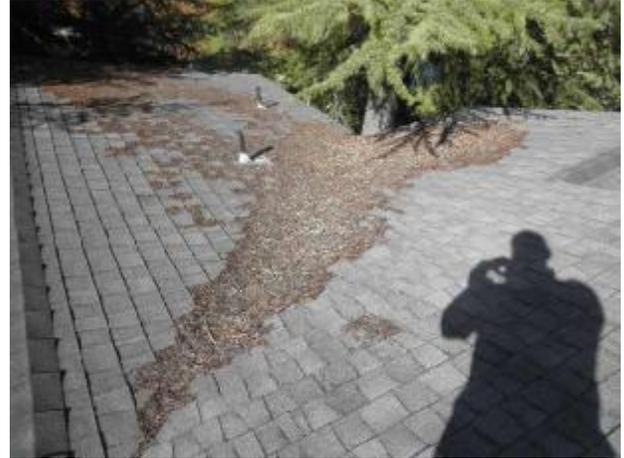
R

The leaves and debris need to be cleared off the roof.

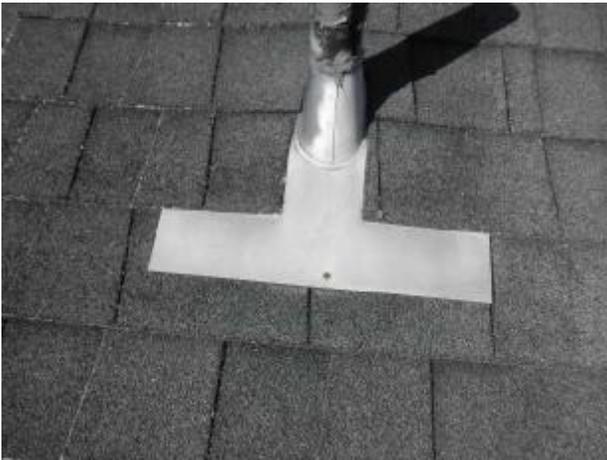
R

Maintenance Note: The exposed nails at the base of the roof flashings need to be sealed.

The exposed nails in the roof flashings need to be sealed.

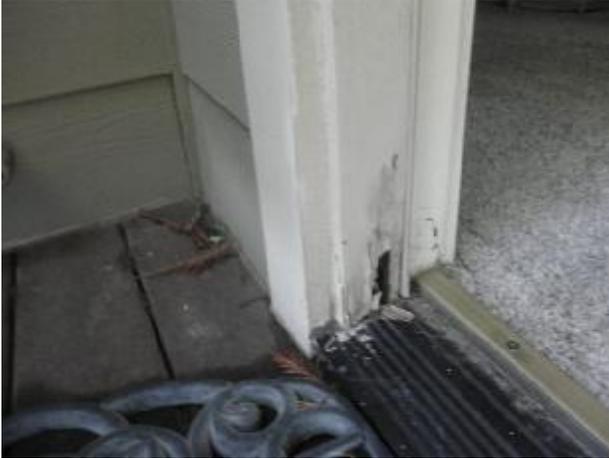
EX

1.) There is moisture damage to the base of the jambs at the exterior door in the master bedroom.

Moisture damage at the base of the jambs at the exterior door in the master bedroom.

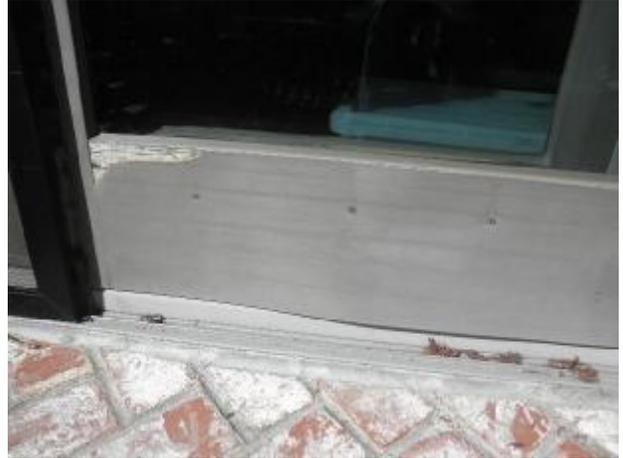
EX

2.) There is some damage to the bottom face plate at the fixed half of the sliding glass door in the guest bedroom.

Damaged face plate at the sliding glass door.

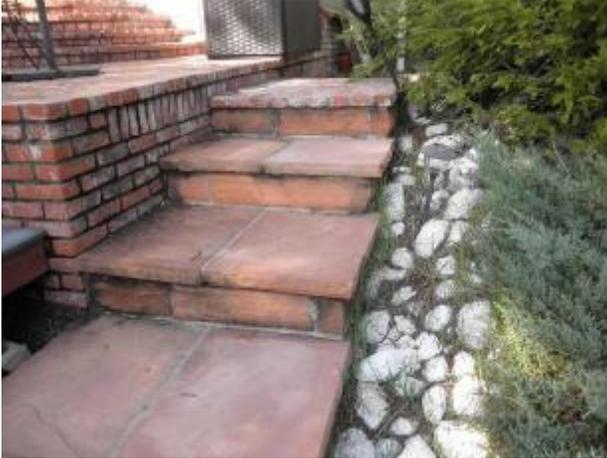
GD

Safety Hazard Note: There are no railings installed at the brick stairs at the backyard patio and the masonry stairs by the spa. This can be a falling hazard.

Missing railing at the masonry stairs.

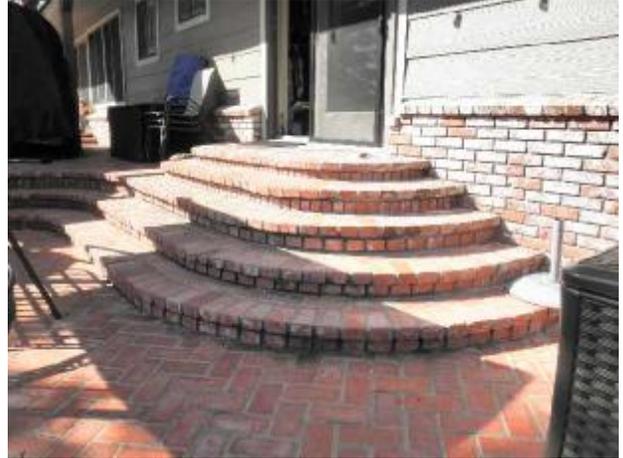
GD

Missing railing at the brick stairs.

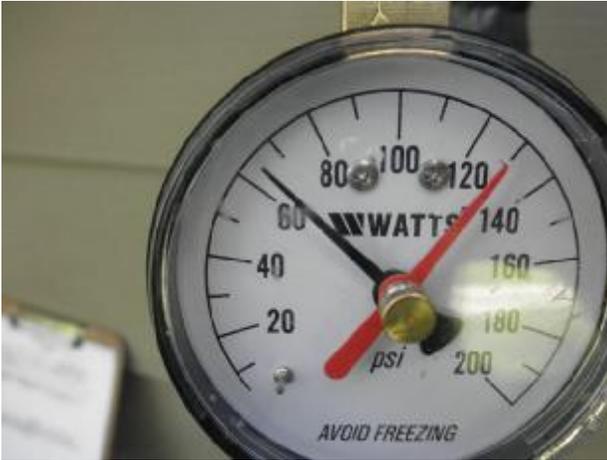
P

The water pressure was measured at 65 psi.

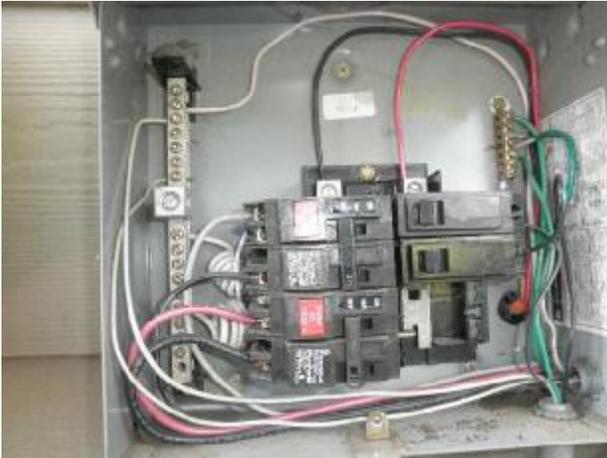
EL

Safety Hazard Note: The inside dead front cover is missing with exposed electrical components at the subpanel on the exterior SE wall.

Missing inside dead front cover at the electrical subpanel.

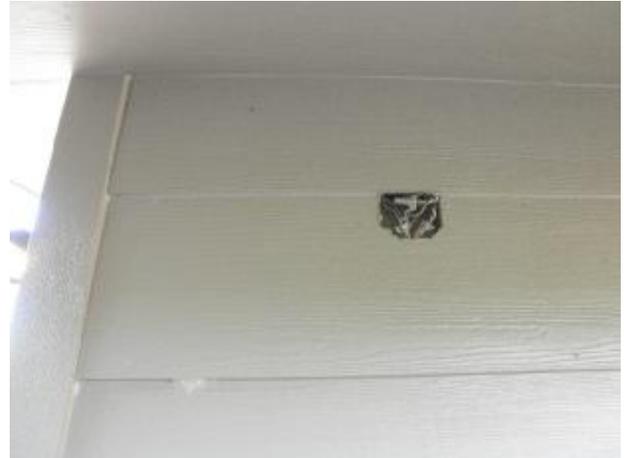
EL

Safety Hazard Note: There is an open junction box with exposed wiring at the exterior SW wall. This box needs to be sealed with a cover plate.

Open junction box at the exterior SW wall.

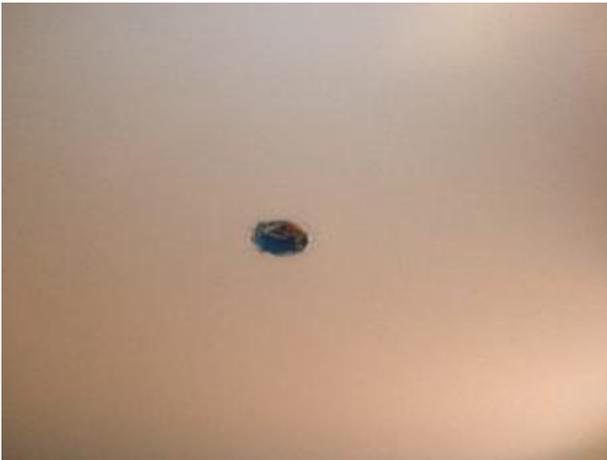
EL

1.) There is a missing light above the kitchen.

Missing light above the kitchen.

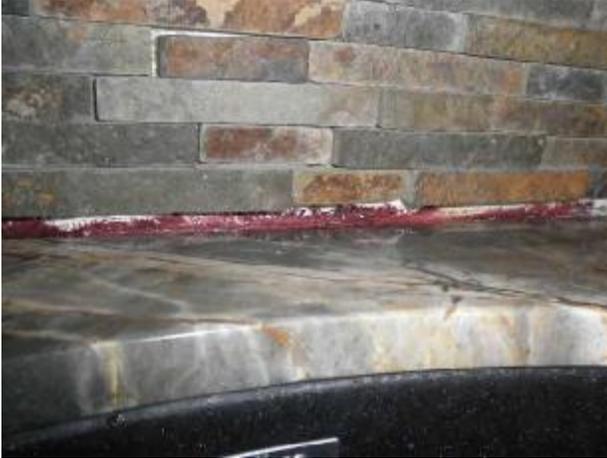
K

Large gap between the back splash and kitchen counter.

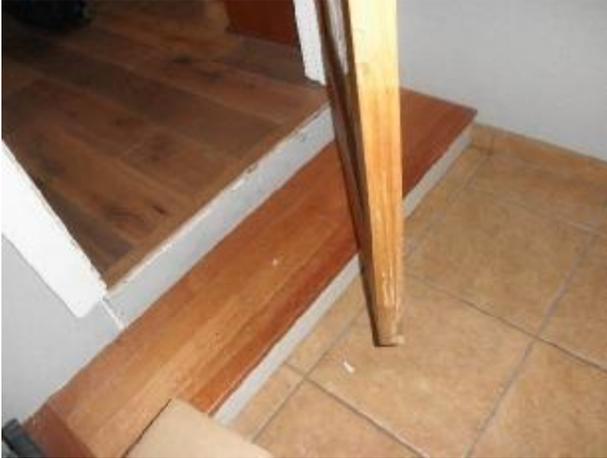
IR

Safety Hazard Note: The common door between the kitchen and the laundry room swings outward over the interior stairs. This is not permitted and is considered a potential falling hazard. A landing of minimum 36" in width is required or the door should be reconfigured to swing towards the interior of the home.

Door swings over stairs leading into the laundry room.

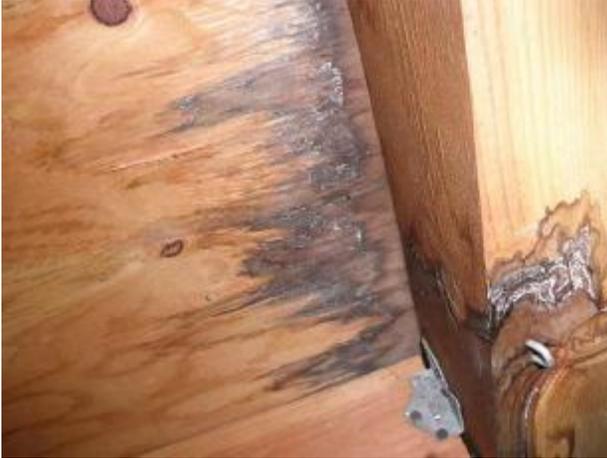
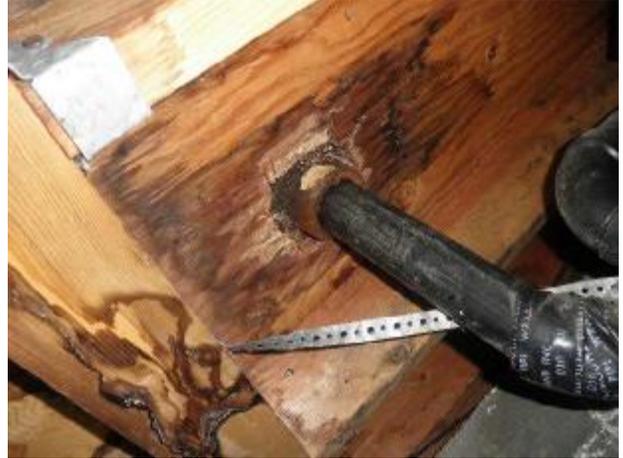
F

1.) There is an evidence of a leak with surface fungus and fungus damage to the framing below the toilet in the guest bathroom as seen from the substructure area.

Evidence of a leak and damage to the below the guest bathroom on the SE side of the substructure.
