Inspection Report

770 Beverly Drive
Nipomo CA 93444

2/18/2026

Harper Homes: Home Inspection Services

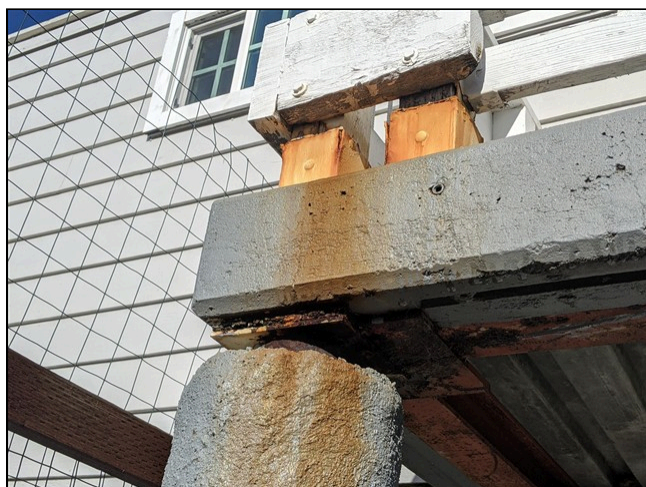
1.1 Item 1(Picture)

The metal support brackets at the front concrete patio show signs of rust and corrosion. Surface rust can lead to further deterioration if not addressed over time. Recommend cleaning and painting the brackets with an appropriate rust-inhibiting coating to help protect the metal and slow further deterioration.

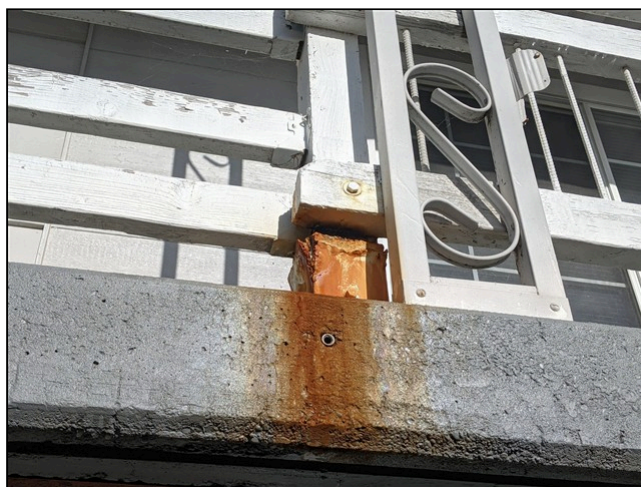
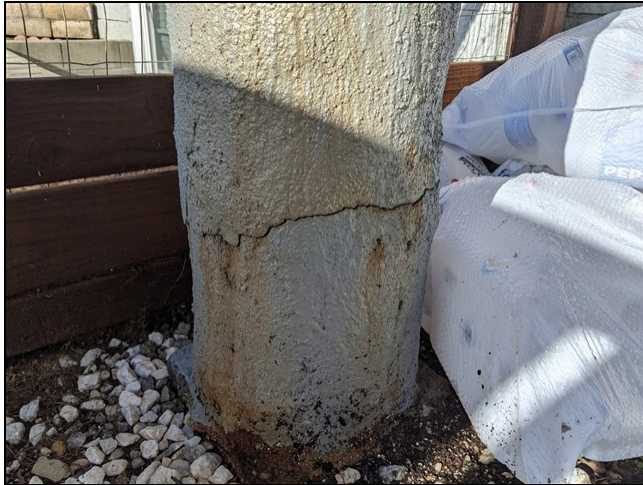
1.1 Item 2(Picture)

Cracking was noted in the concrete at the base of the front support post. In many installations, a

metal post extends through the center and provides the primary structural support, with the surrounding concrete mainly serving as a protective or stabilizing surface. Recommend sealing or repairing the cracked concrete as needed to help prevent moisture intrusion and further deterioration.

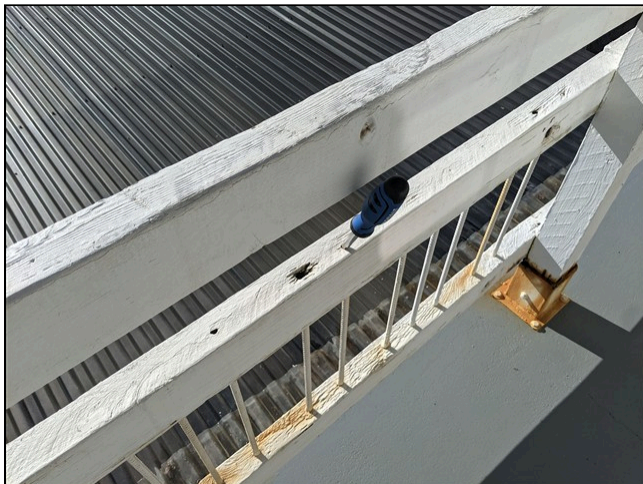
1.1 Item 4(Picture)

Moisture damage noted at the front deck. Recommend further evaluation by a structural pest control operator and make repairs as prescribed.

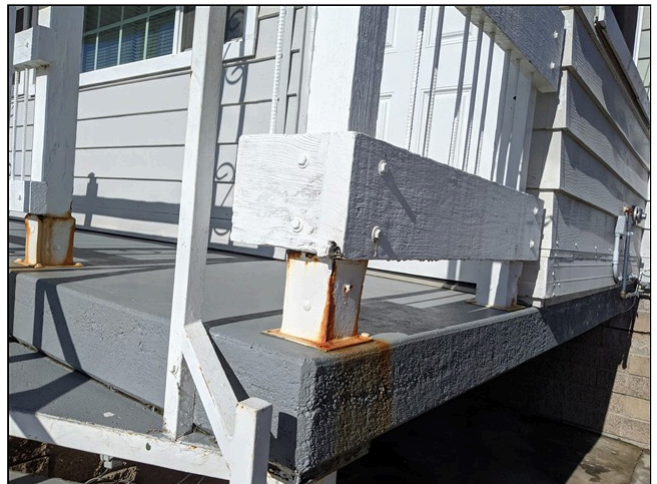
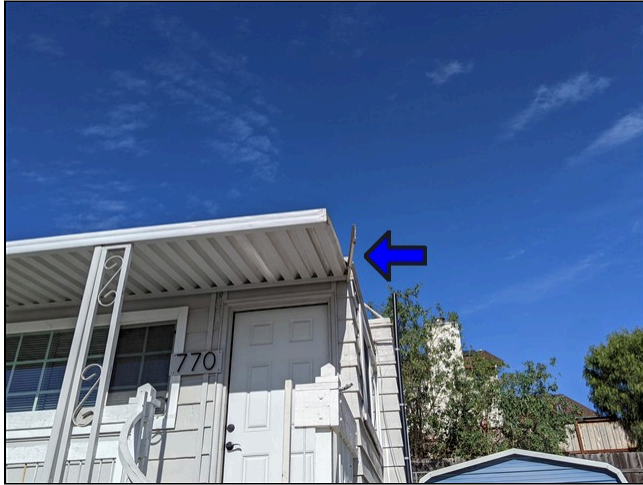
1.1 Item 5(Picture)

The front patio cover trim is separating and needs to be properly reattached.

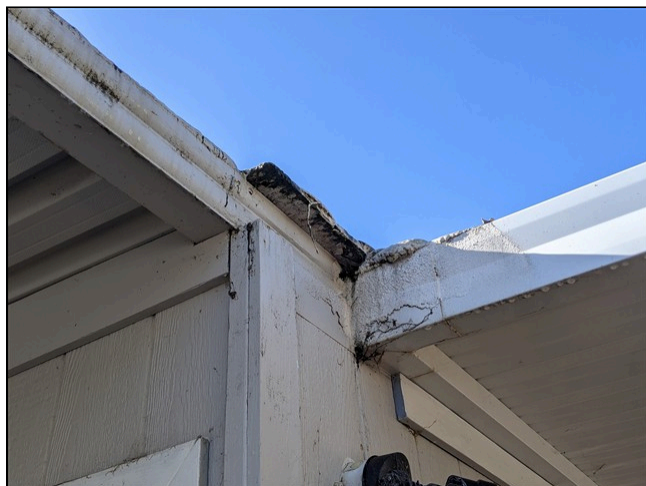
2.0 Item 1(Picture)

Roof sheathing contains moisture damage under the eave at the rear exterior. Refer to the pest report for further information on this condition and make repairs as prescribed. Roofing materials should be further evaluated and repaired in these areas to prevent continued deterioration.

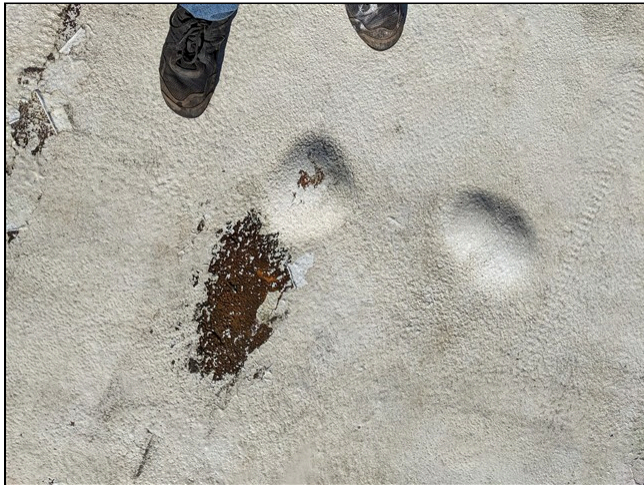
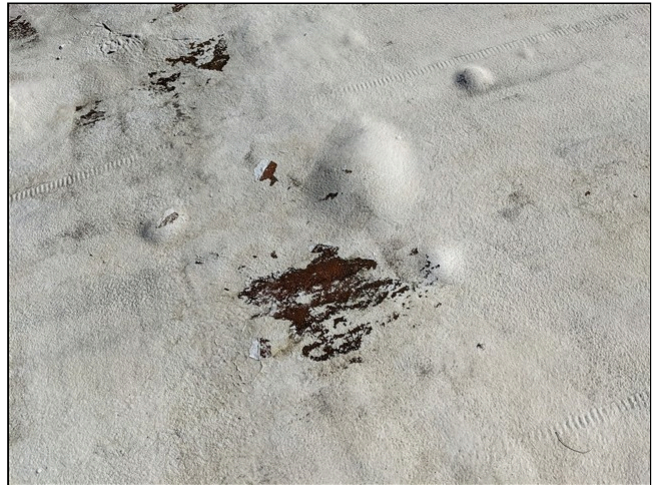
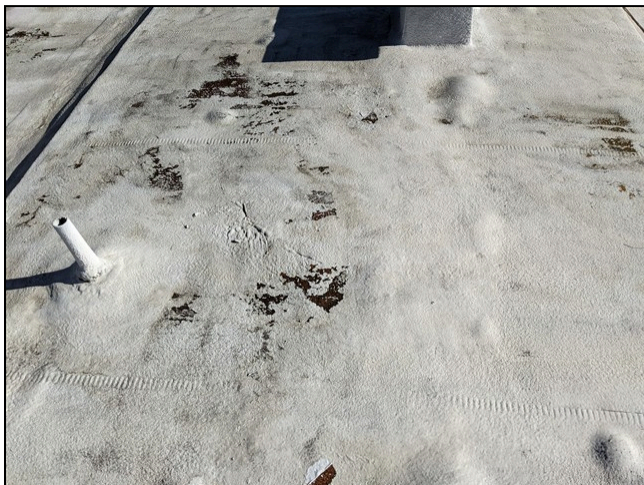
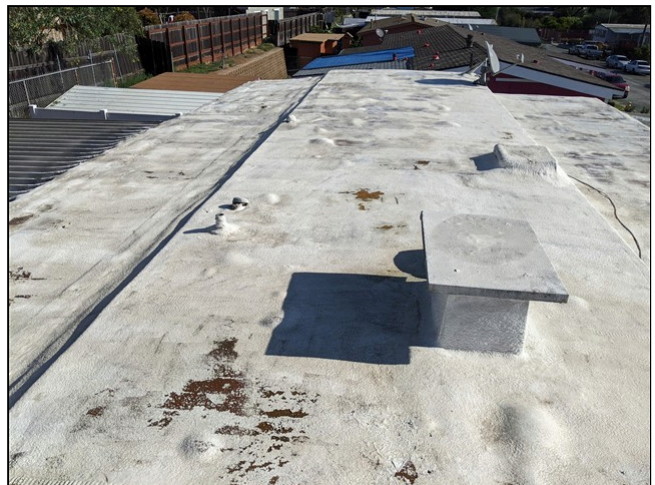
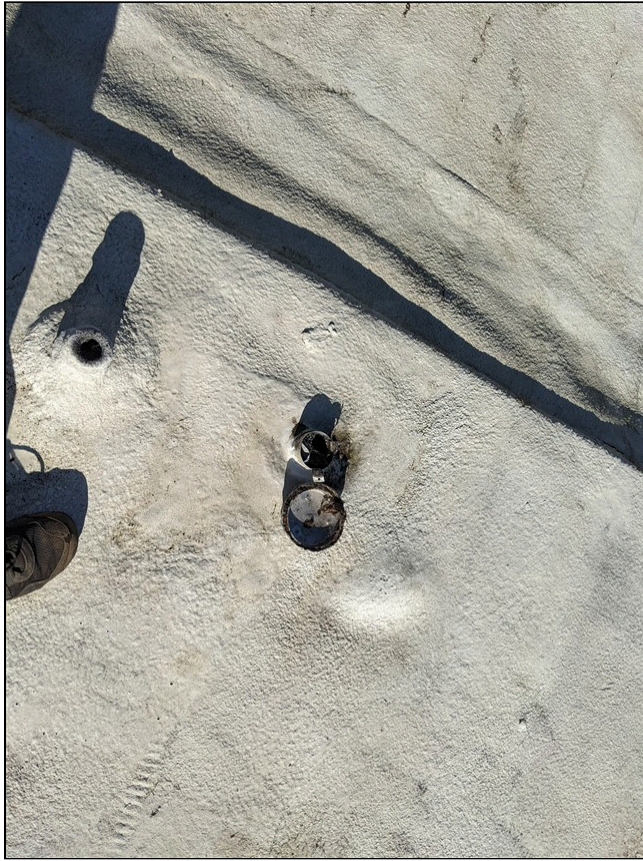
2.0 Item 2(Picture)

The flat roof on the mobile home appears aged and is showing bubbling and visible signs of deterioration. These conditions are commonly associated with wear and breakdown of roofing materials and can reduce the roof's ability to properly shed water over time. Repairs or replacement of the affected roofing sections are recommended to help maintain proper

performance and prevent further deterioration. Evaluation by a qualified roofing contractor is advised.

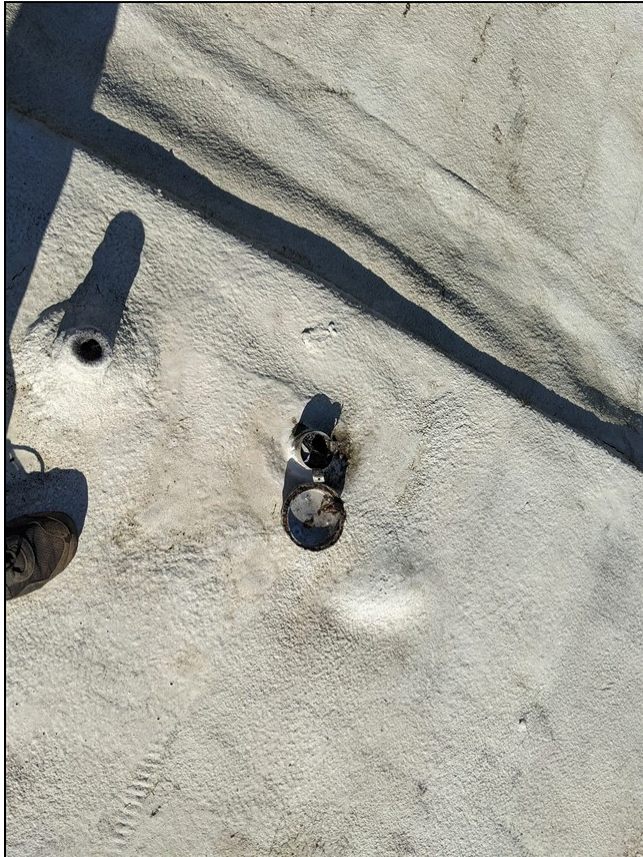
2.2 Item 1(Picture)

Exhaust vent cap is missing vent and should be installed immediately to prevent moisture or debris from entering the exhaust vent.

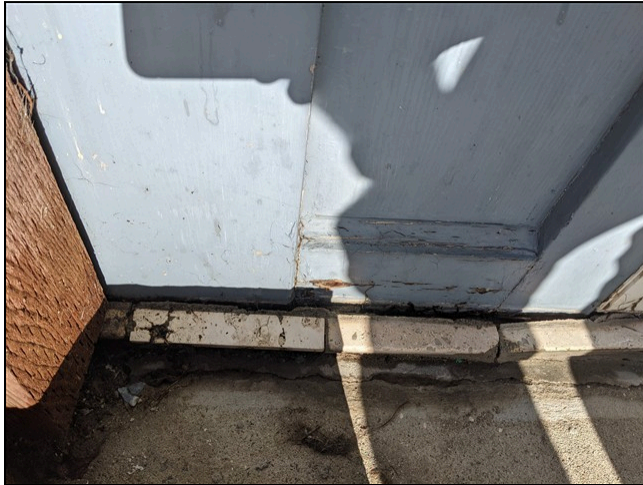
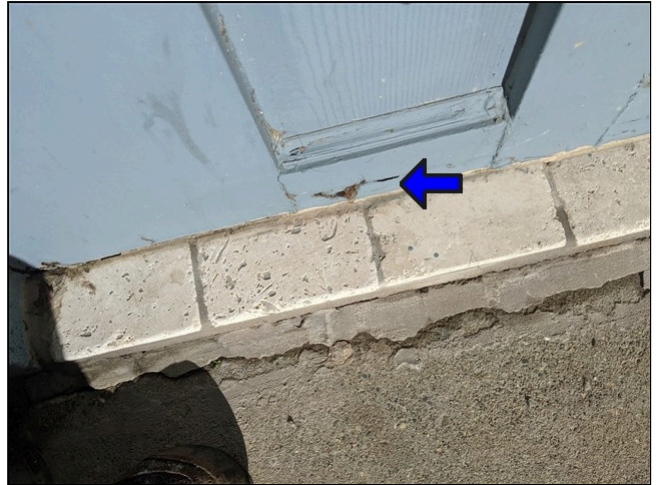
2.4 Item 1(Picture)

Moisture damage noted at the trim. Recommend further evaluation by a structural pest control operator and make repairs as prescribed.

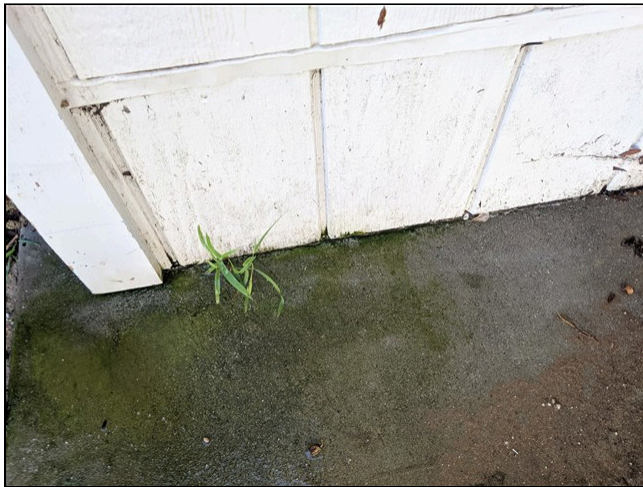
2.4 Item 3(Picture)

Siding and trim is in contact with concrete noted at the rear exterior. Recommend wood materials be cut back from contacting the concrete to help prevent further moisture intrusion.

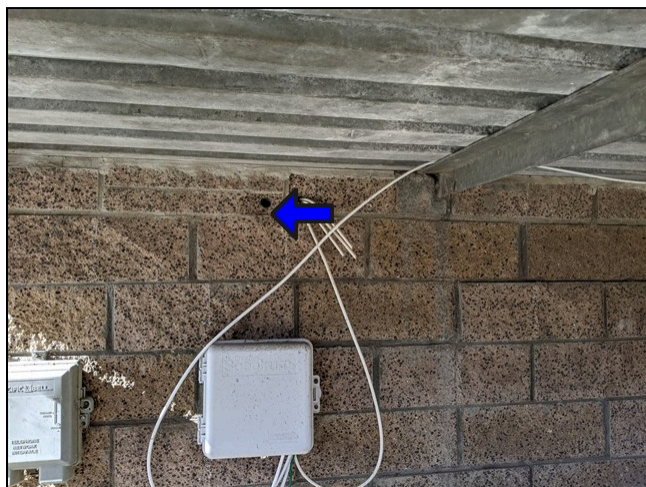
2.4 Item 4(Picture)

Perforations in the siding at the right exterior should be patched or repaired to prevent pest or moisture intrusion.

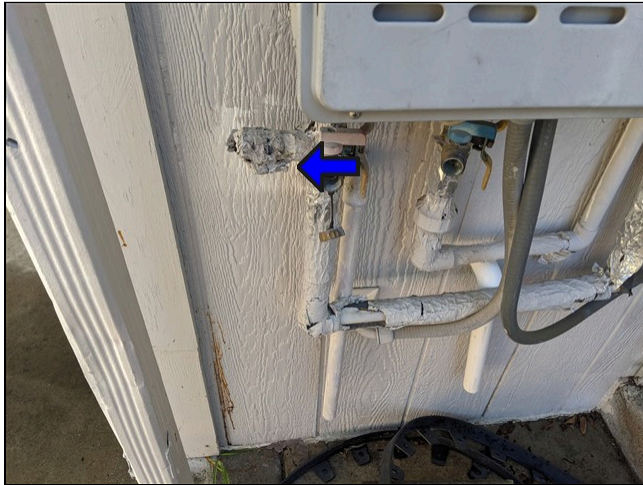
4.0 Item 1(Picture)

Water heater safety valve piping missing and needs properly installed to prevent an unsafe condition if the TPR is activated.

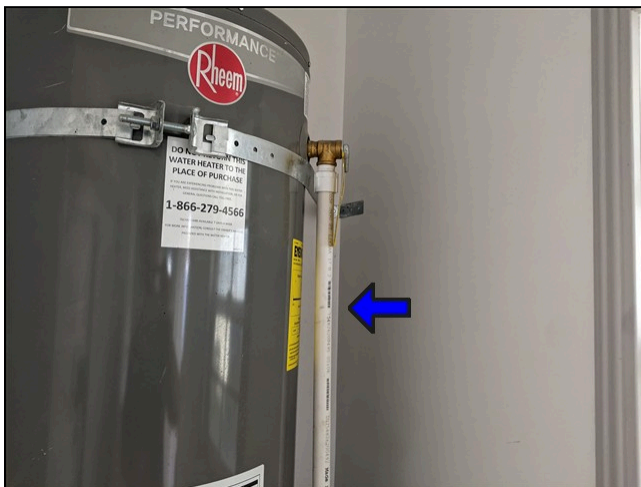
4.0 Item 2(Picture)

Water heater safety valve piping is improper material and needs properly re-installed to prevent an unsafe condition if the TPR is activated.

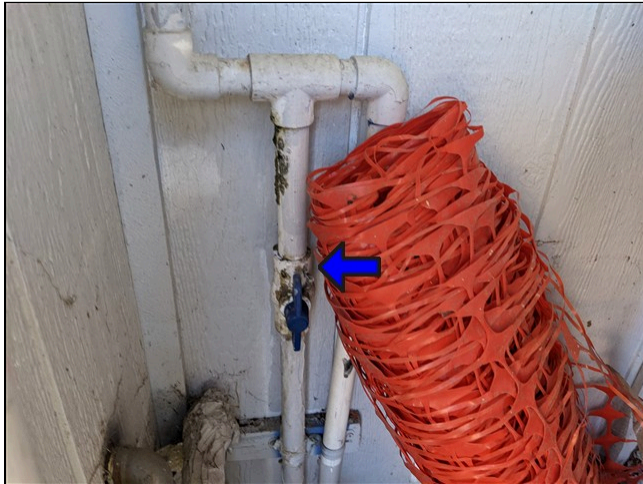
4.2 Item 1(Picture)

Supply line leak noted at the rear exterior and should be repaired to prevent further deterioration and water waste.

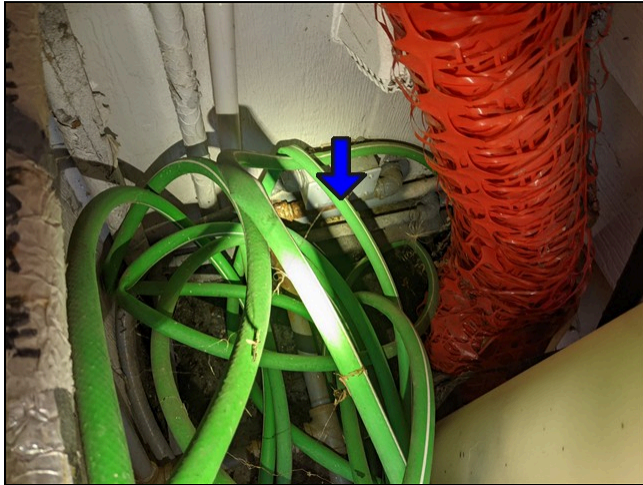
4.3 Item 2(Picture)

Steel gas line is rusted at the rear exterior and should have loose rust removed and painted with proper corrosion inhibiting paint to prevent further deterioration.

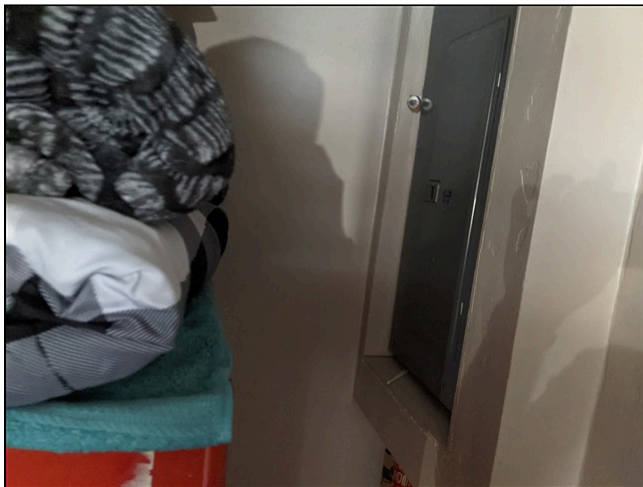
5.1 Item 1(Picture)

The bus bar where the breakers connect to the upstairs bedroom sub panel is loose. This condition should be further evaluated and repaired by a licensed electrician to ensure the safety of the home.

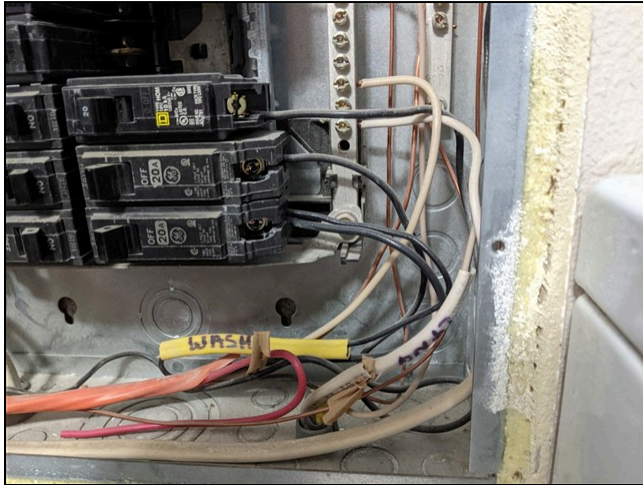
5.2 Item 1(Picture)

Double wires improperly installed on a breaker in the downstairs laundry room sub panel. Alteration or repairs should be made to prevent an unsafe condition.

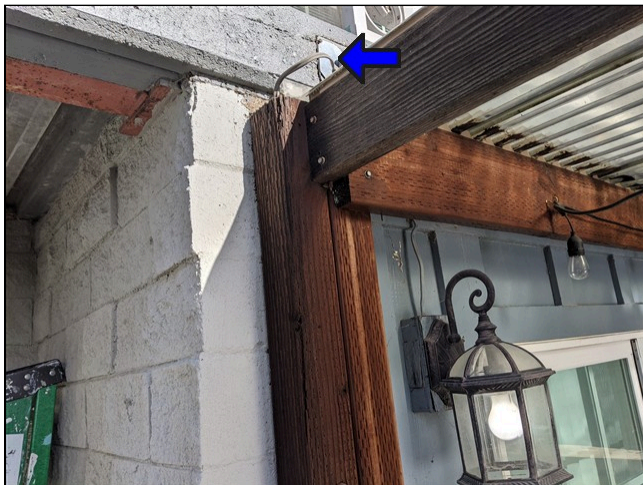
5.3 Item 1(Picture)

Wiring installed improperly and exposed where damage could occur, noted at the front exterior. Recommend the wiring be installed inside conduit or behind walls.

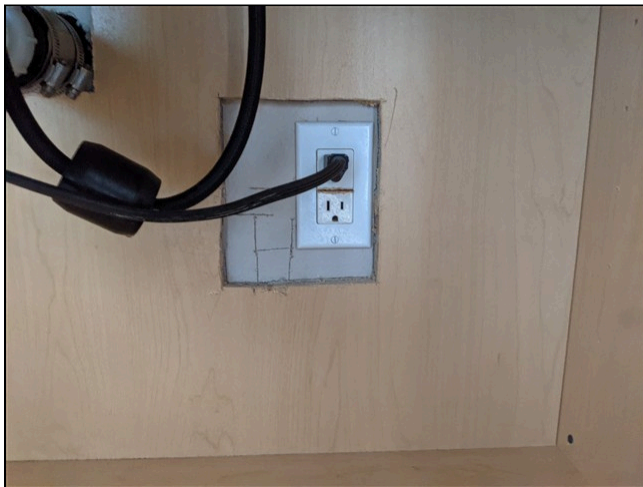
5.6 Item 1(Picture)

Receptacle is damaged at the cabinet under the upstairs kitchen sink and should be replaced before further use.

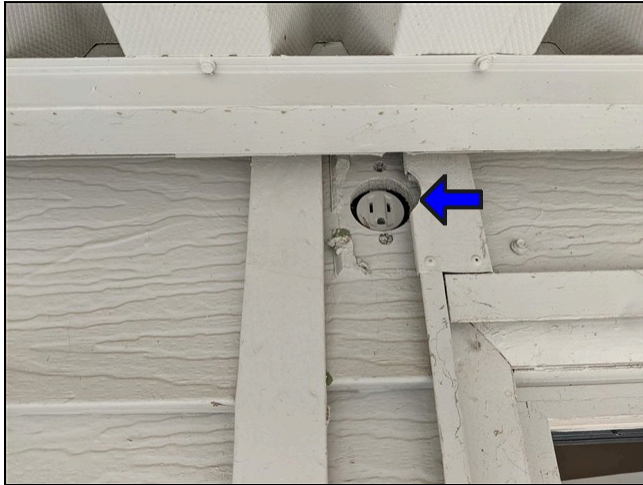
5.6 Item 2(Picture)

Exterior receptacle without a weather cover noted at the front exterior. Installation is needed to insure full safety of this system.

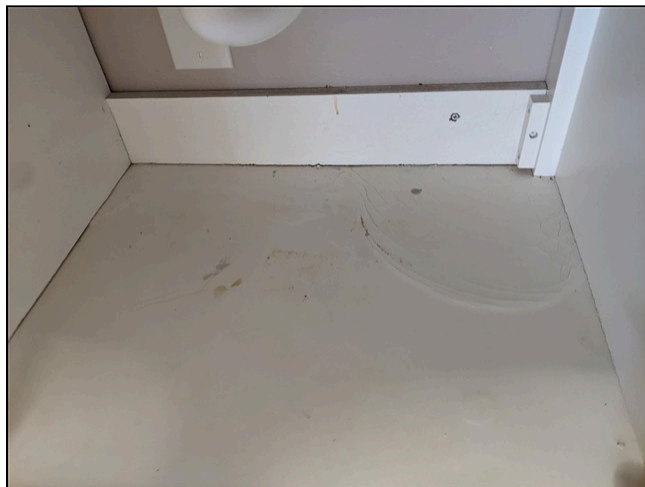
6.3.A Item 1(Picture)

Slight moisture damage noted to the cabinet under the sink. No leaks noted at the time of inspection. Cosmetic repairs can be made as needed.

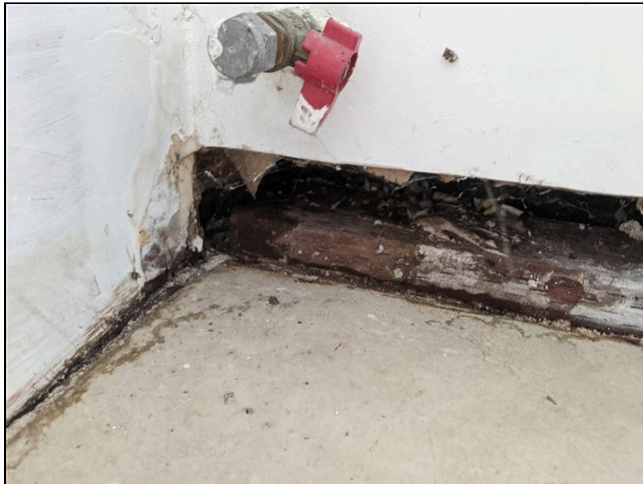
7.0 Item 1(Picture)

Signs of moisture intrusion and possible microbial growth was noted in the laundry room. Recommend further evaluation and repairs are made at this location to prevent further moisture intrusion.

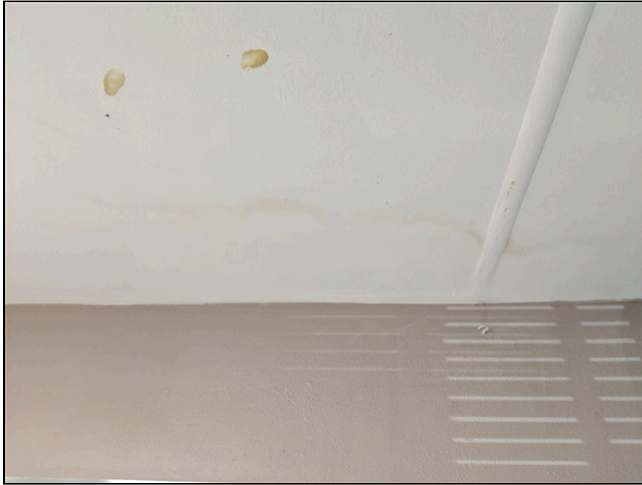
7.0 Item 2(Picture)

Moisture stains noted on the ceiling and walls bathroom ceiling. Recommend the roof and flashings be further evaluated in these areas to determine the cause and remedy of this moisture

intrusion.

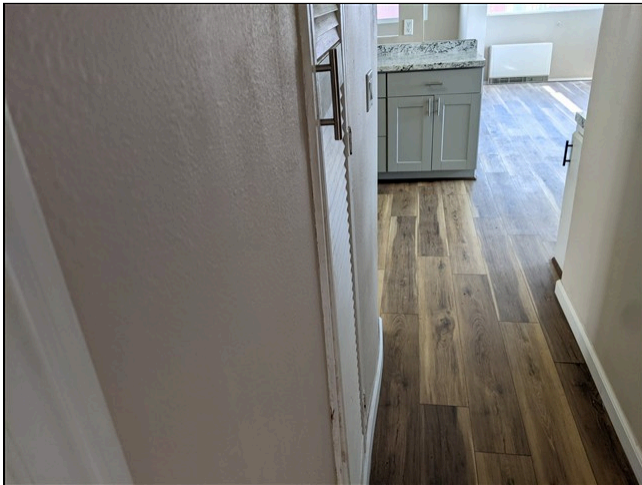
7.0 Item 3(Picture)

A bowed or uneven section of wall was observed in the upstairs hallway. The cause and extent of this condition could not be determined during the inspection. Recommend further evaluation is made as needed.

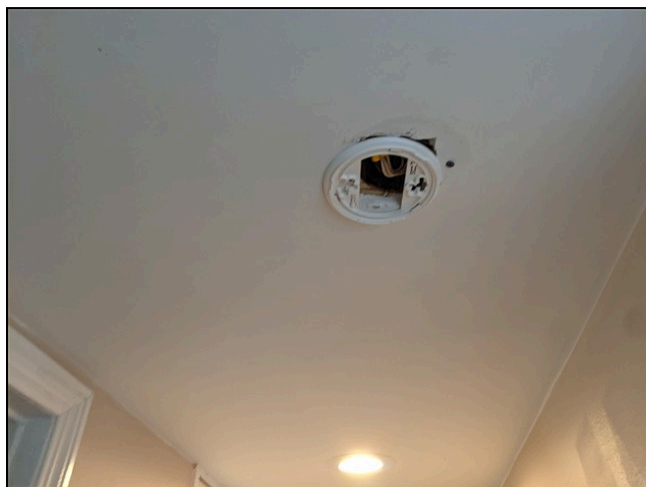
7.4 Item 1(Picture)

Smoke alarm has been removed from upstairs hallway and should be replaced to ensure intended safety of the home.

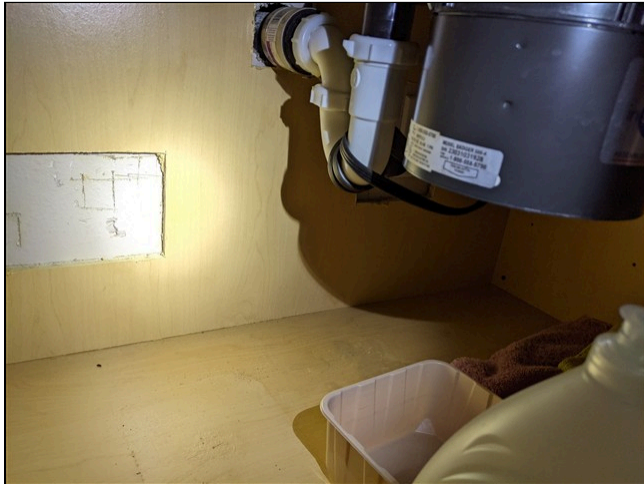
8.4.A Item 1(Picture)

Drain line leak noted under the sink. Recommend repairs made before further use of the sink.

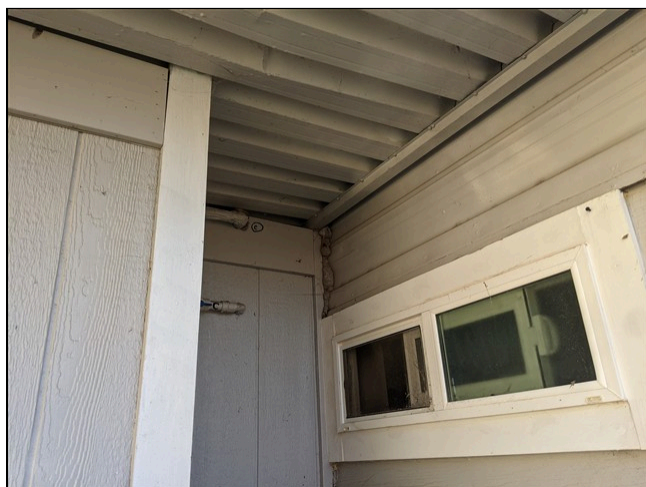
9.1 Item 1(Picture)

The rear laundry room is permanently attached to the main structure of the modular home. The attaching of additional structures to a manufactured home is typically not approved by the manufacturer. Recommend further evaluation of this portion of the home by a qualified contractor to determine if alterations or improvements are needed.
