Inspection Report

Address: 46 Via Santa Barbara Paso Robles, CA 93446

01/15/2026

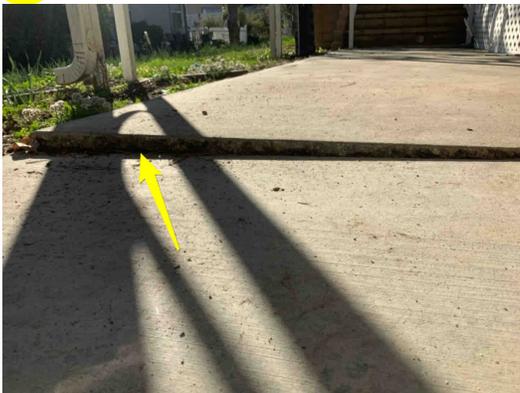
Example

SU 18: Areas of the walkways are uneven with potential trip hazards.

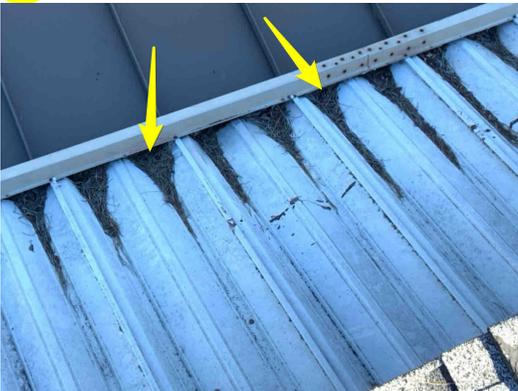
Example

MR 24: Debris has collected on portions of the Aluminum Awnings. Maintenance recommended

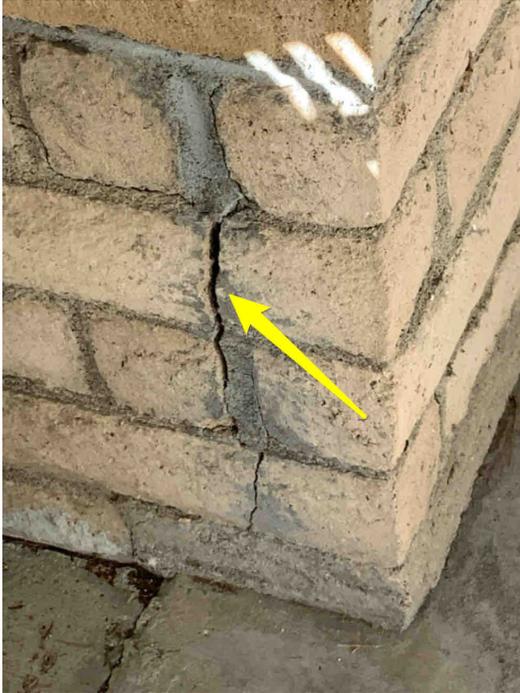
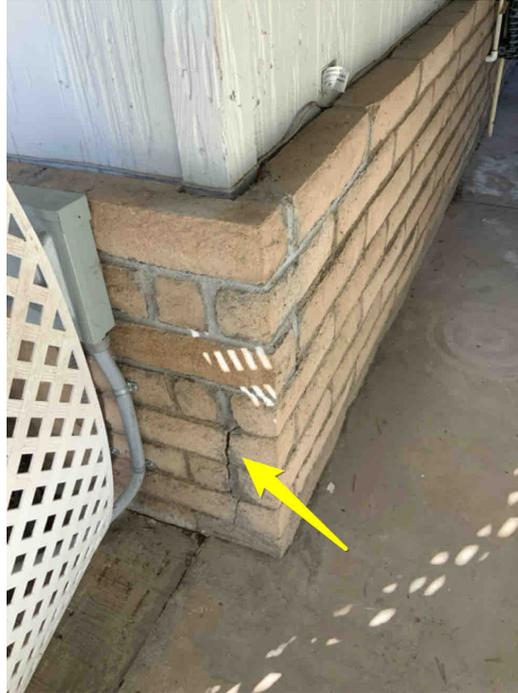
FI **MR** **DS** 30: Some visible cracking and separations noted in areas of the exterior brick veneer. Example - On the southeast corner near the air conditioner condenser.

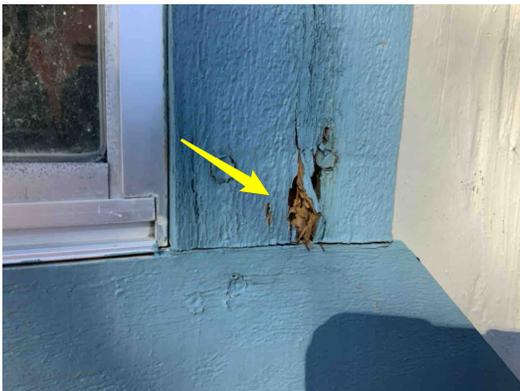
Example

E&C 33: Some moisture and/or bug type damage & deterioration found at exterior areas such as eaves, fascia and/or trim. Refer to the termite report for locations and extent.

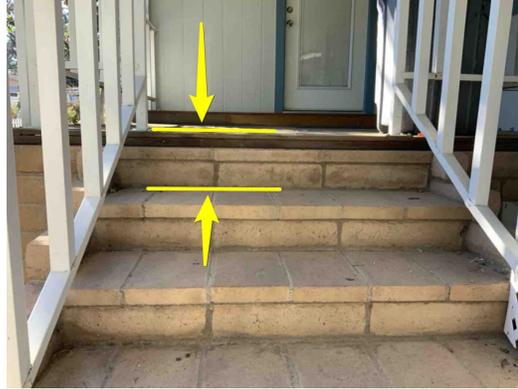
SC 39: Caution. The top step is taller than the rest. Uneven step tread rise, step heights are not all the same, at the exterior stairway off the OFF THE BACKYARD WOOD DECK. Potential trip or fall hazard.

Top step is taller than all the rest

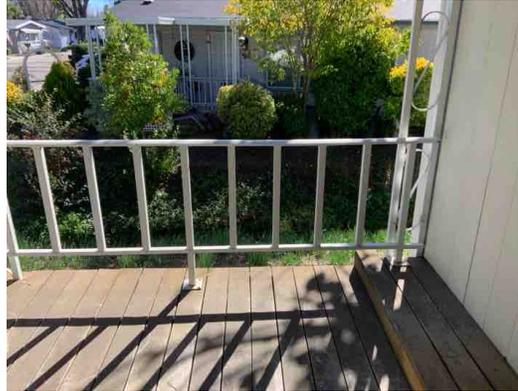
SU 49: *Openings between spindles and the height of the deck railings at the BACKYARD DECK do not meet current standards. Upgrades Recommended for safety.*

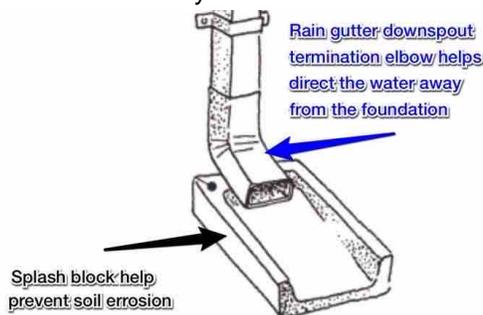
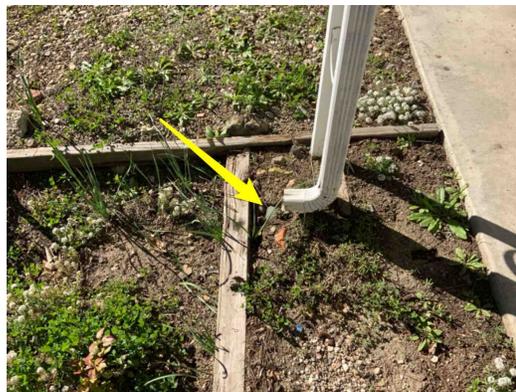
Example

MR 67: Recommend splash blocks and diverting the rain gutter downspouts at the bottom to assist in proper flow of roof water away from the house and to help prevent soil erosion where not installed.

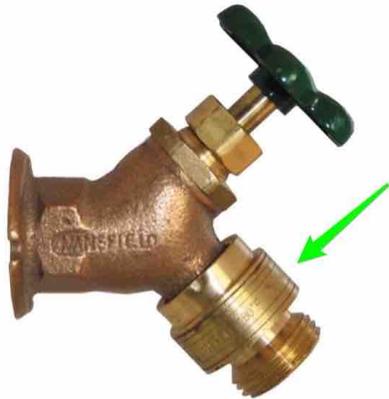
UPG 79: Anti-siphon valves recommended on exterior hose faucets where not installed.

Example of an anti-siphon valve on a hose faucet

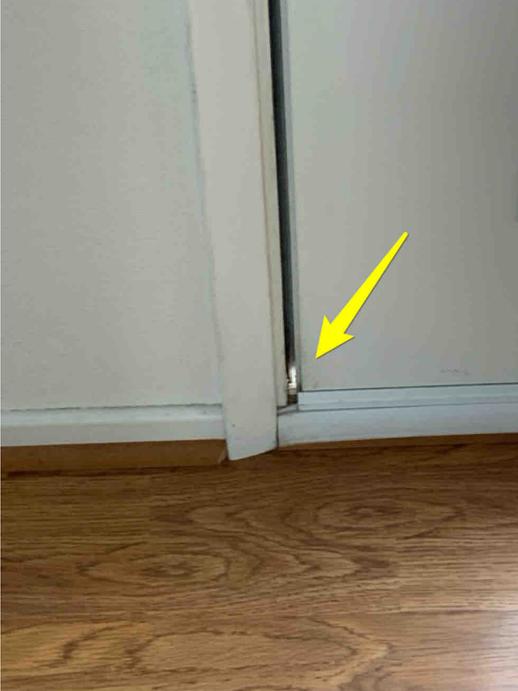
Example

MR UPG 128: Visible daylight noted around some of the exterior doors. Adjustment and/or repair of the weather stripping is recommended to help prevent water and critter intrusion.

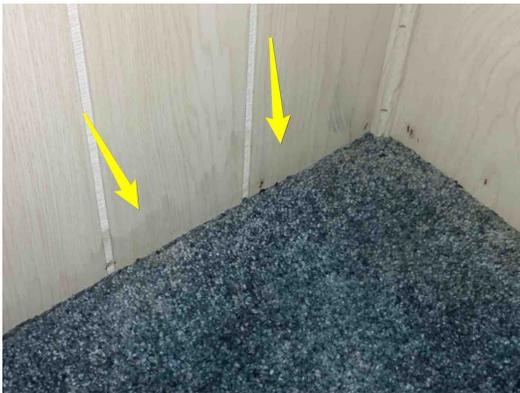
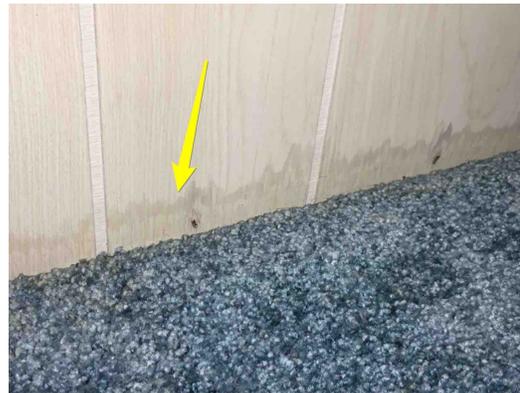
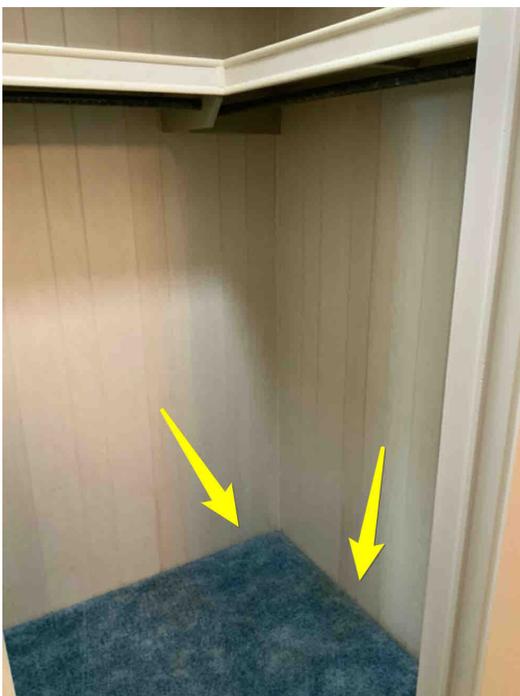
Example locations

FI 144: Evidence of moisture stains and/or damage at the walls in the BEDROOM-1 CLOSET - opposite the old water heater enclosure. Recommend further review of the water stains to determine the cause, the current condition and if repairs are needed.

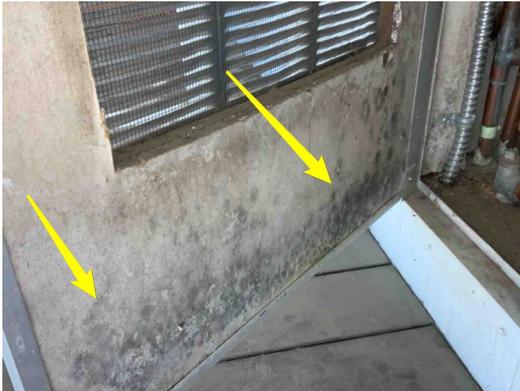
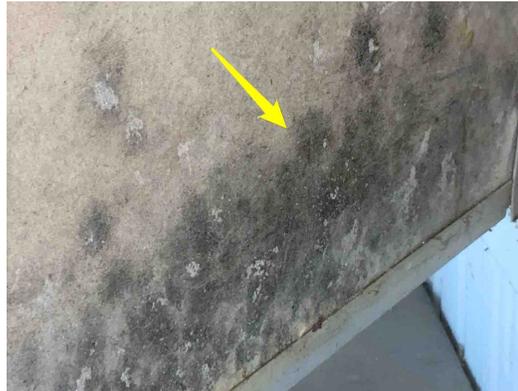
Example

FI 145: Evidence of past moisture stains & damage with some visible mold growth on areas of the drywall: INSIDE THE EXTERIOR FURNACE ENCLOSURE. Recommend additional review by a qualified remediation professional. Recommend further review to determine if stains are current or old and if repairs are needed.

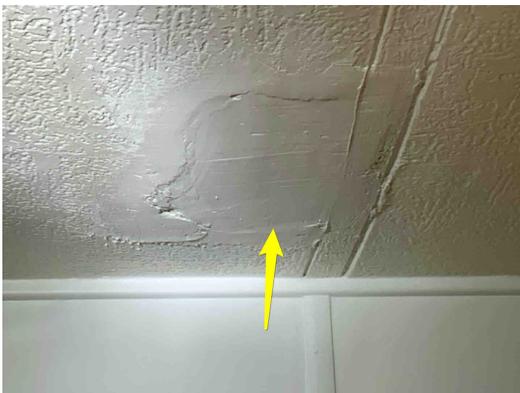
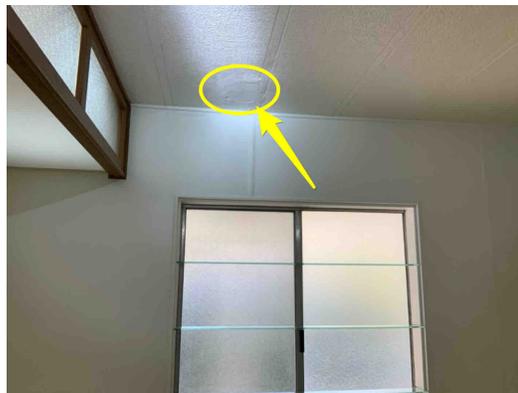
FI DS 146: Evidence of past ceiling repairs found in the PRIMARY BEDROOM BATHROOM above the tub. Client should investigate further to satisfy themselves as to the cause and if additional repairs or upgrades are needed.

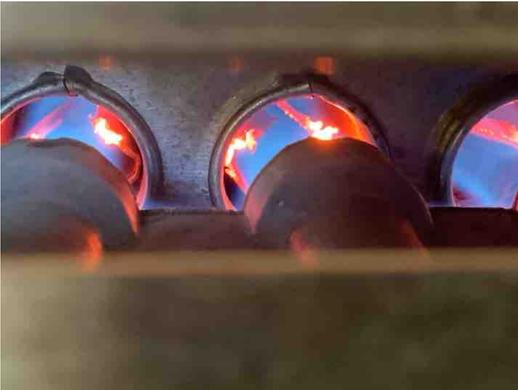
SU 150: Damaged or Deteriorated "NOx" SCREENS found inside the furnace burn chamber. Simple removal or replacement is recommended. Recommend further review recommendations by a qualified and licensed HVAC professional familiar with the minimum installation requirements.

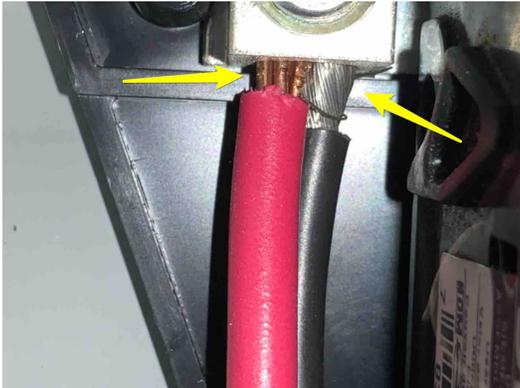
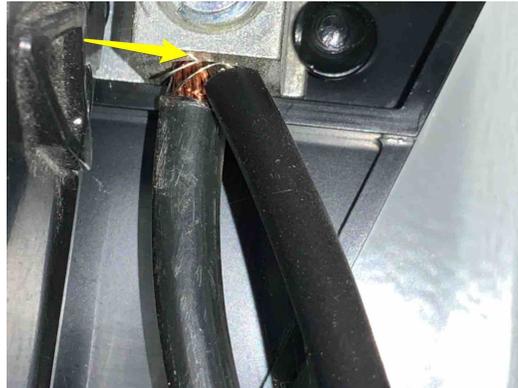
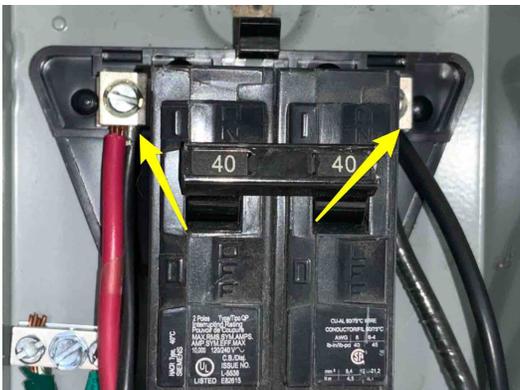
SC 161: Improper unsafe double tap AND two wires of different wire type (copper and aluminum) and gauge in the same lug at the air conditioner electrical service disconnect.

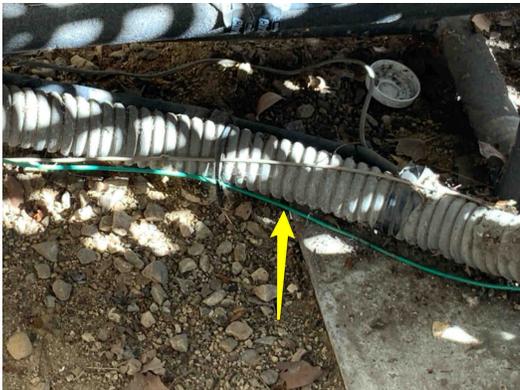
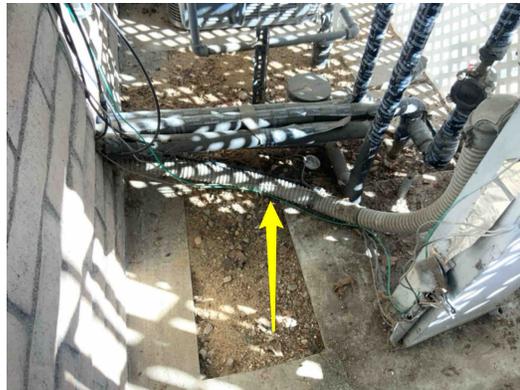
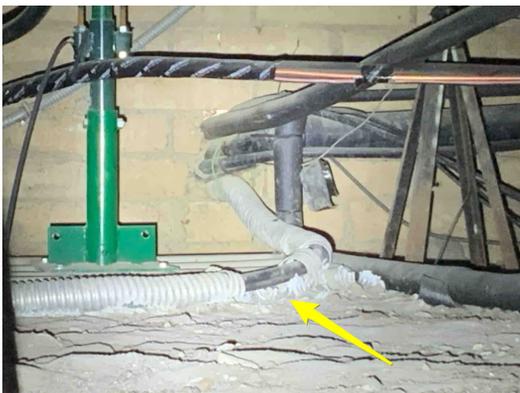
Example

SC UPG 164: The metal electrical service conduit from the main electrical panel (park riser) to the house sub panel found laying in contact with the ground in the crawlspace. This has or can cause deterioration or damage to the conduit as this conduit is NOT rated for earth contact. Evaluation and correction recommended for electrical safety.

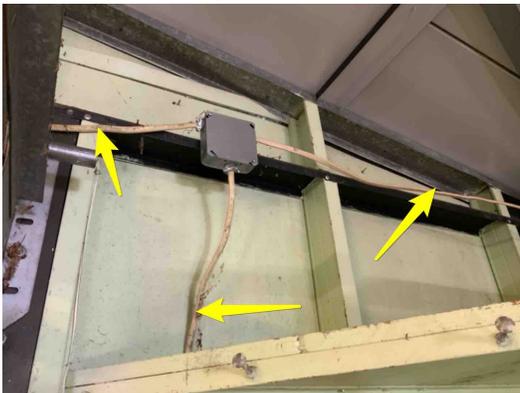
SC 168: Improper exposed electrical wiring, "Romex" improperly installed subject to physical damage, not in a conduit or raceway per standards: GARAGE

All wiring in the garage should've been in a conduit

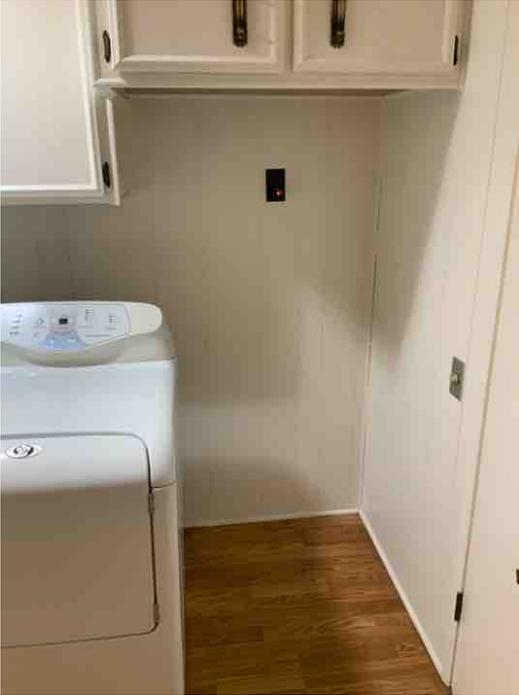
SC 169: Three-prong electrical outlets did not test properly grounded: AT THE LAUNDRY ROOM at the refrigerator outlet. Contact a licensed electrical contractor for evaluation and repairs.

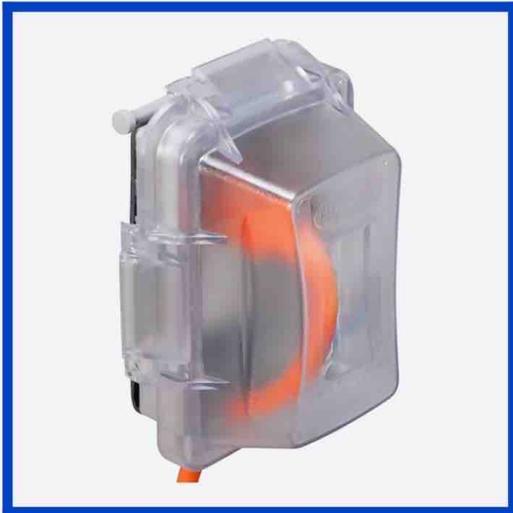
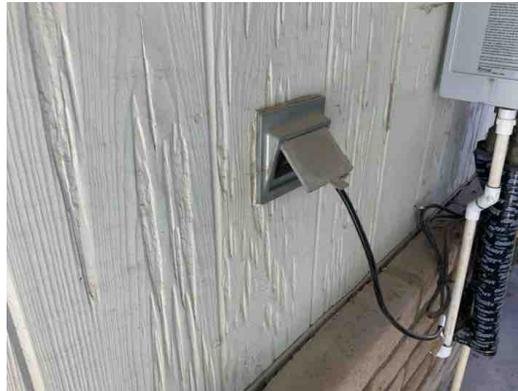
SU 173: Missing a proper plastic dome type exterior cover plate at the exterior outlet that the tankless water heater is permanently plugged into. A Domed exterior electrical cover plates should be installed on all exterior outlets where permanently installed electrical cords are plugged-in to an exterior outlet. This will help ensure the water tightness of the electrical connections during wet weather.

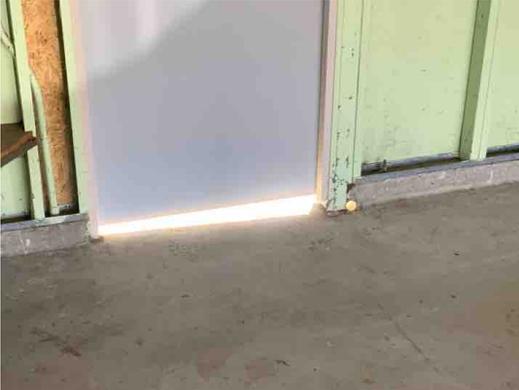
MR 187: Some visible daylight noted around the GARAGE exterior pedestrian door. Adding, adjustment and/or repair of the weather stripping is recommended to help prevent water and critter intrusion.

MR 188: Missing weather stripping at the doorframe at the Garage Pedestrian door.
