AZTEC PROPERTY INSPECTIONS

PROPERTY INSPECTION REPORT

1890 Calmin Dr
Fallbrook, CA 92028

Imelda Enriquez
02/09/2026

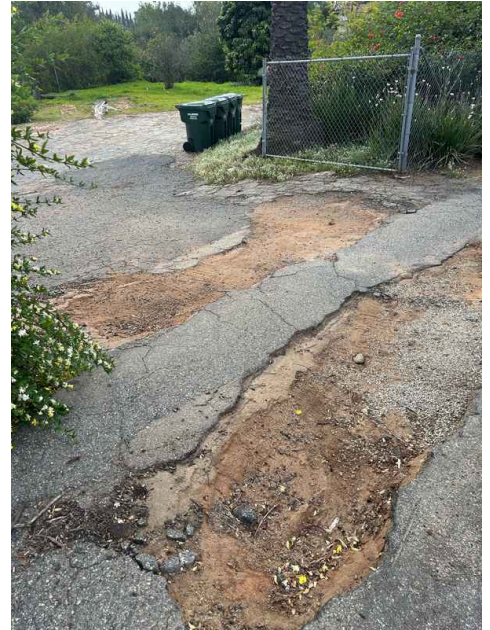
DAMAGE / DETERIORATION - REPAIR

Damage and or deterioration was present at one or more areas. Correction is recommended.

Contact a qualified professional.

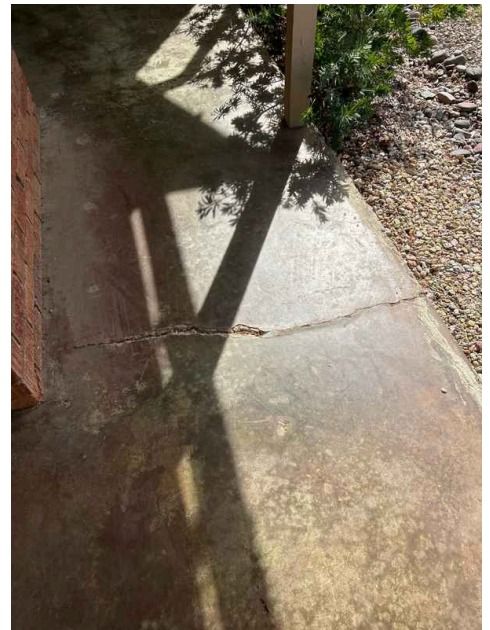
4.1.2 Driveways, Sidewalks, Patios

COMMON TO MODERATE CRACKS NOTED

Common to moderate cracks noted in one or more areas. Sealing the cracks properly is recommended to avoid water intrusion which can cause further cracking and or damage.

Contact a qualified handyman.

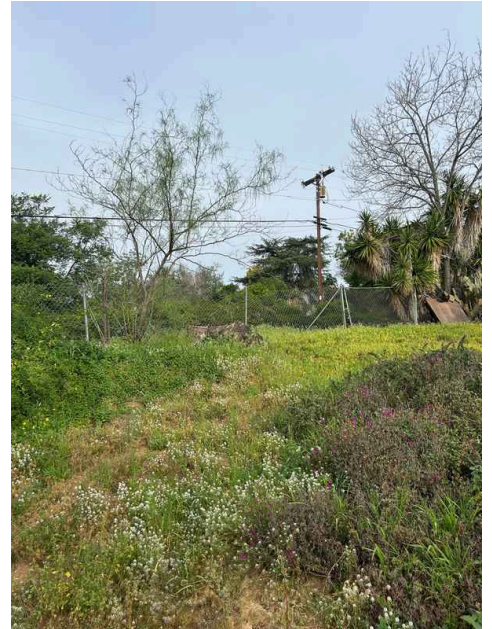
FENCE REPAIR - MINOR

Fences and/or gates are damaged and/or deteriorated in some areas. Make repairs or replace sections as necessary.

Contact a handyman or DIY project

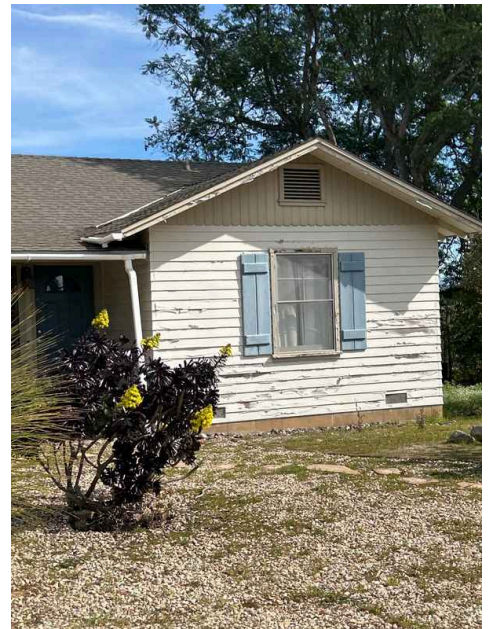
4.4.1 Exterior Walls / Trim

PAINT / STAIN FAILING

Paint and or stain was failing / peeling in one or more areas. A qualified and licensed painter is recommended for further evaluation.

Contact a qualified painting contractor.

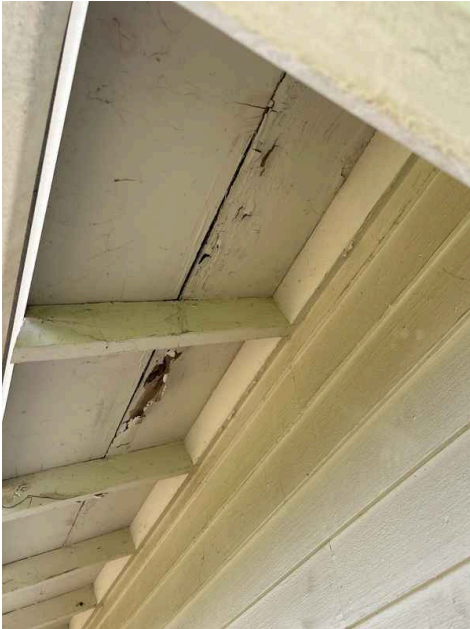
4.5.1 Eaves / Soffits

PAINT FAILING

The paint on eaves/fascia was failing/loose. We recommend prep and paint as needed.

Contact a qualified painting contractor.

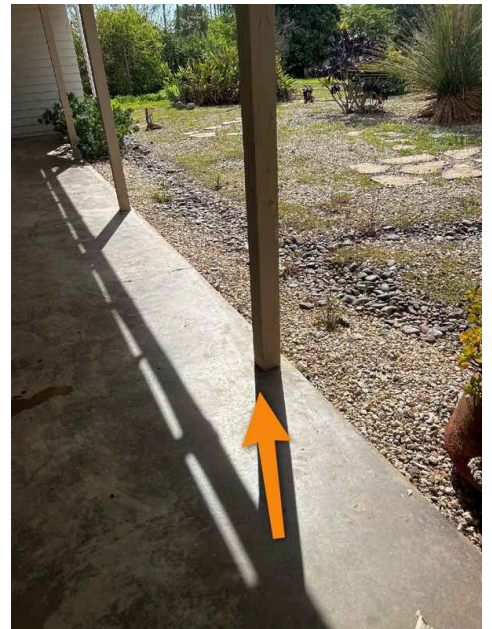
4.7.1 Patio Cover(s) / Trellis(es)

POST CLEARANCE

Wood posts at the patio cover were observed in direct contact with concrete. This may have been acceptable years ago. Currently post are required to be elevated 1" off concrete unless pressure treated or naturally decay resistant (red wood/cedar) post is used.

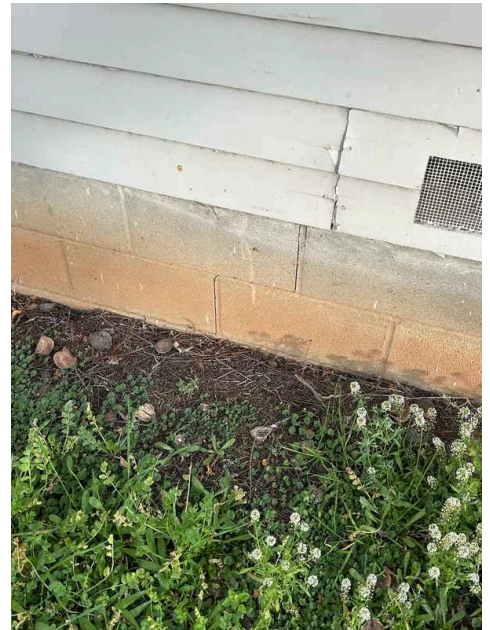
5.2.1 Foundation

CRACKING AT STEM-WALL

Cracking noted at the stem-wall. This did not appear to be effecting the overall performance of the home. However, I recommend further review by a qualified/licensed professional.

Contact a qualified professional.

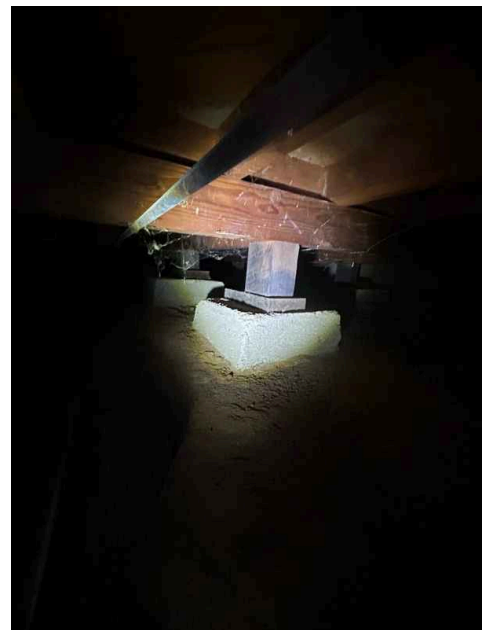
5.3.1 Substructure / Framing

METAL FRAMING STRAPS / HANGERS MISSING

Metal straps and or hangers were missing at one or more areas (for seismic strength). A qualified professional is recommended for further evaluation and/or repairs.

Contact a qualified professional.

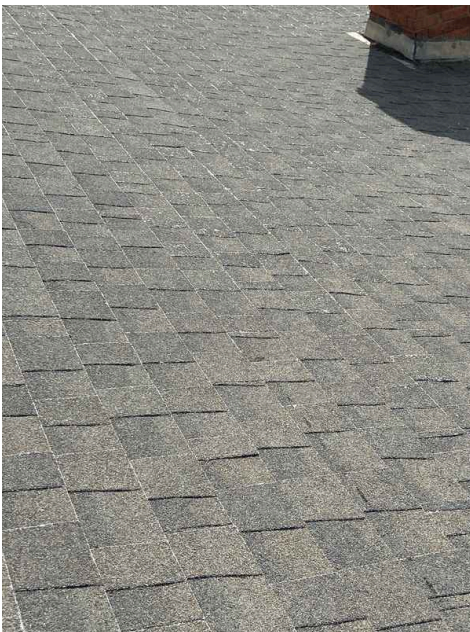
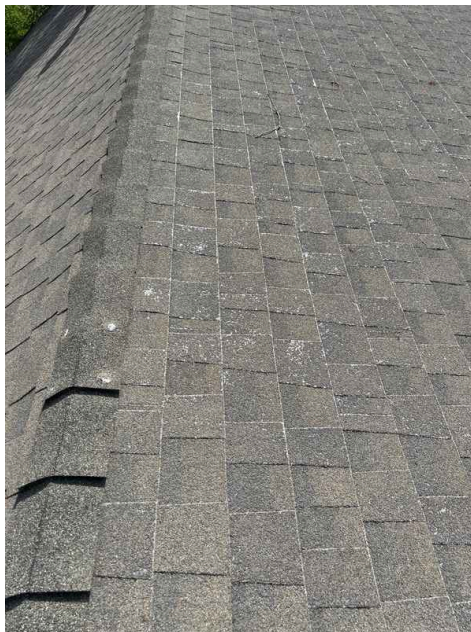
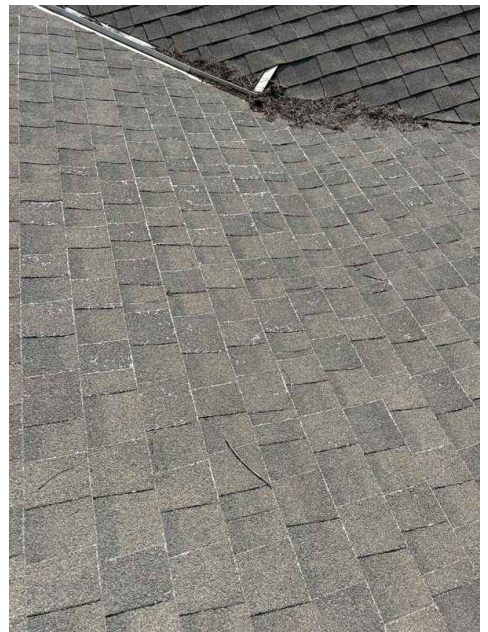
6.2.6 Coverings

WORN ROOF SHINGLES

Contact a qualified professional.

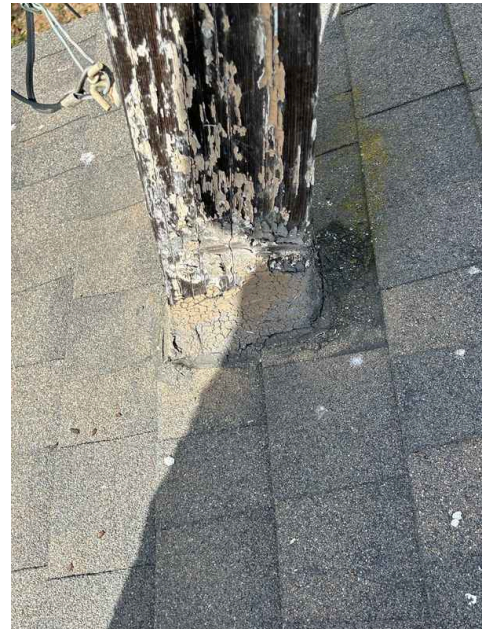
6.3.1 Flashings

MASTIC COVERED

Contact a qualified professional.

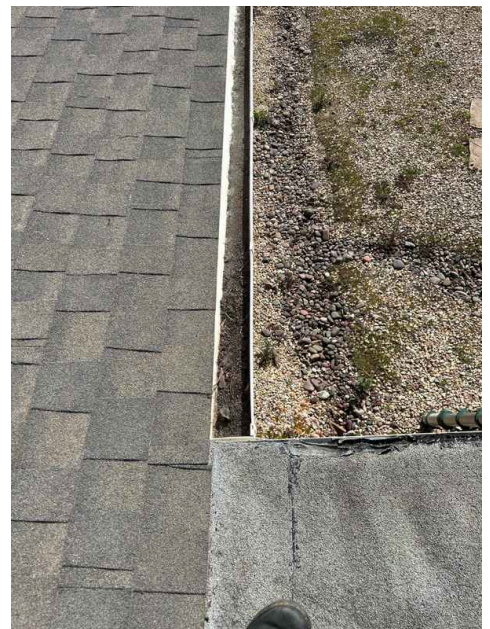
6.5.1 Roof Drainage Systems

DEBRIS IN GUTTER(S) AND/OR DOWNSPOUT(S)

Contact a handyman or DIY project

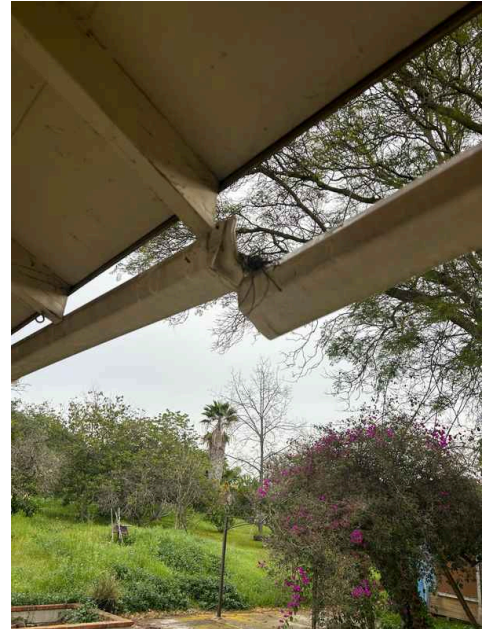
6.5.2 Roof Drainage Systems

PARTIAL GUTTERS NOTED

Contact a qualified gutter contractor

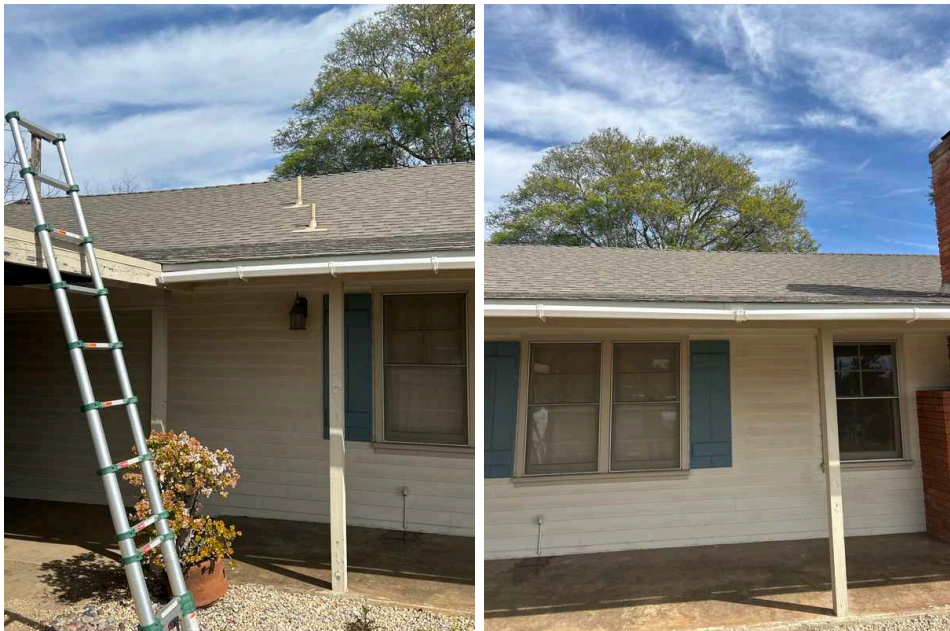
6.5.4 Roof Drainage Systems

GUTTER(S) IMPROPERLY SLOPED, LOOSE AND/OR SAGS

Contact a qualified gutter contractor

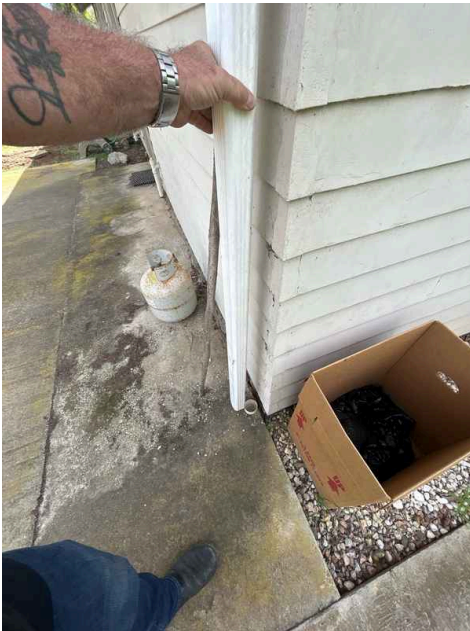
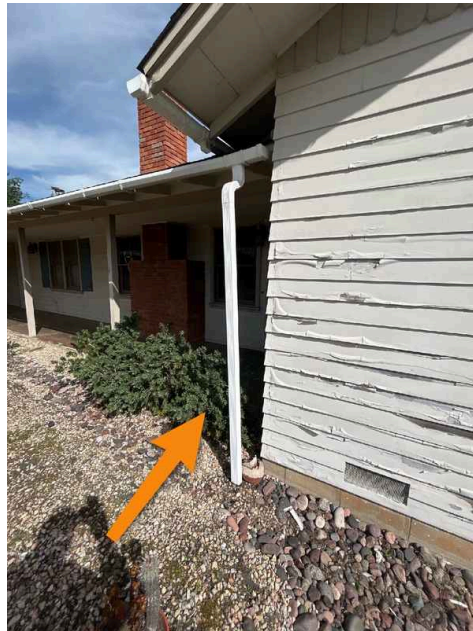
6.5.5 Roof Drainage Systems

LOOSE DOWNSPOUT

Contact a handyman or DIY project

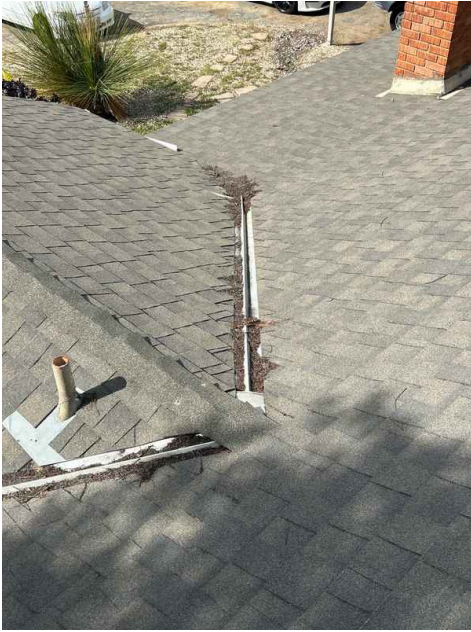
6.5.6 Roof Drainage Systems

MISSING DOWNSPOUT

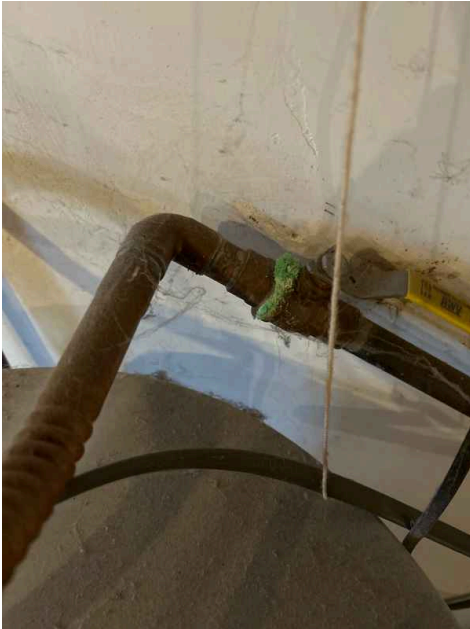
8.5.2 Water Heater(s)

STRAPPING MISSING

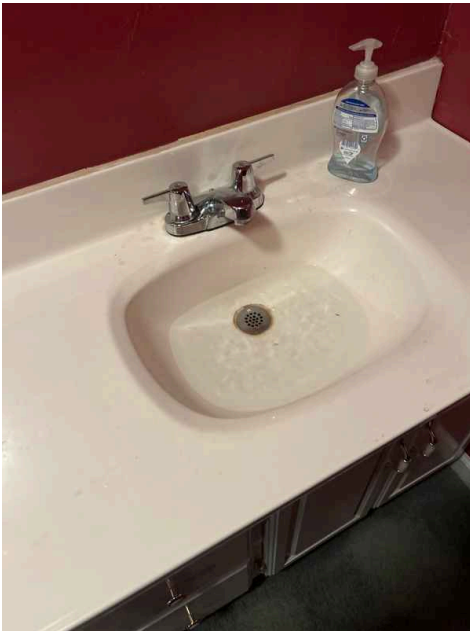
8.6.2 Sinks / Fixtures

CORROSION / DAMAGE - ANGLE STOPS

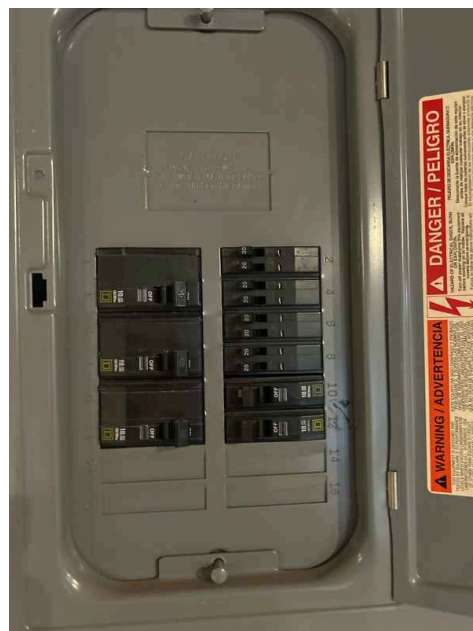
9.3.1 Electrical Panel(s)

MORE THAN 6 BREAKERS / NO MAIN DISCONNECT

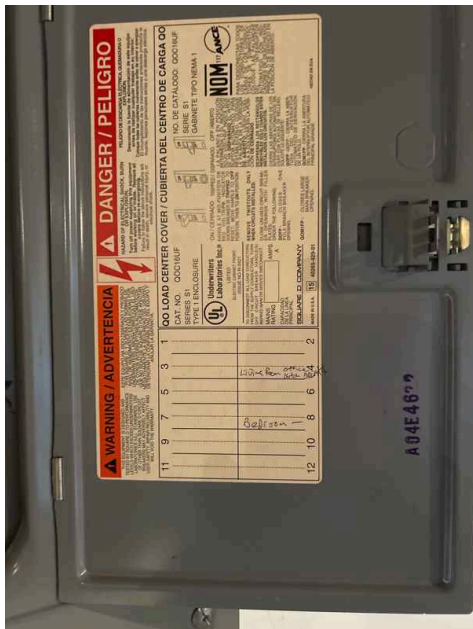
9.4.1 Breakers & Panel Wiring

BREAKERS NOT LABELED PROPERLY

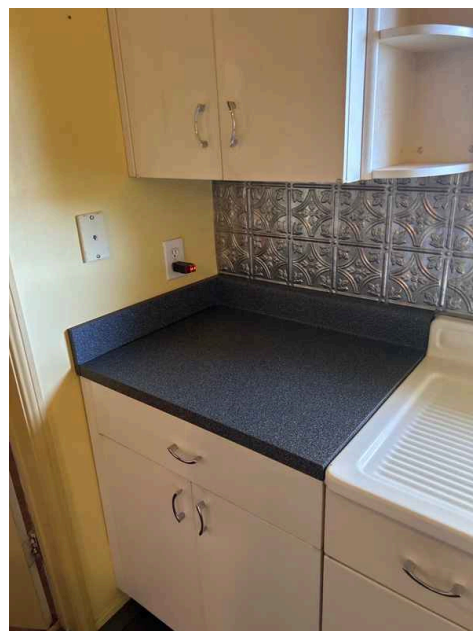
9.5.1 GFCI / AFCI Protection

RECOMMEND GFCI UPGRADE

Contact a qualified professional.

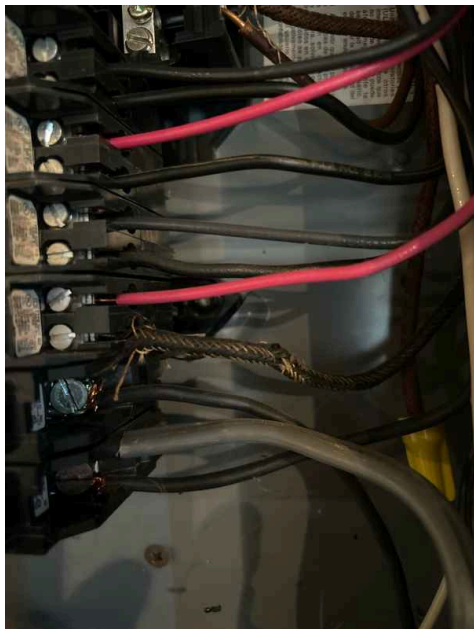
9.6.1 Electrical Wiring

CLOTH COVERED

Contact a qualified electrical contractor.

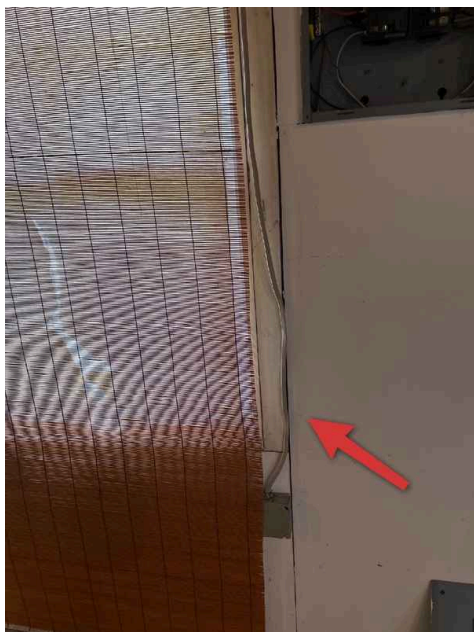
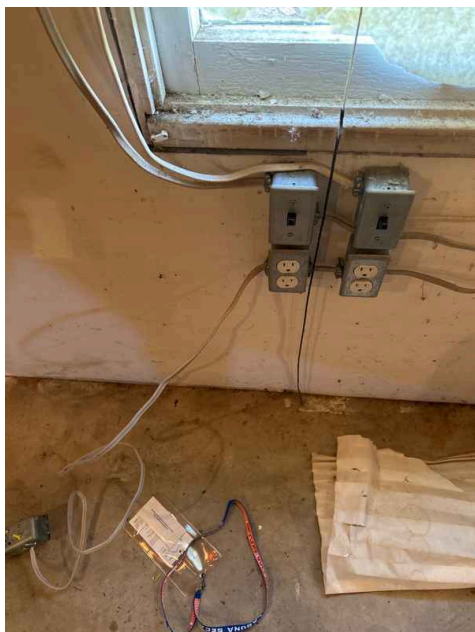
9.6.2 Electrical Wiring

EXPOSED WIRING - SUBJECT TO DAMAGE

Contact a qualified professional.

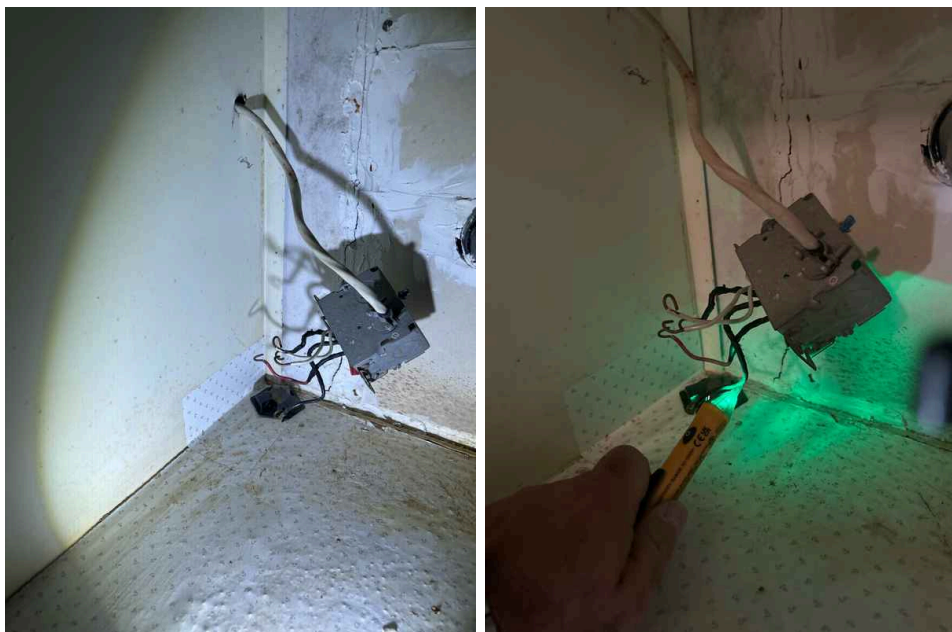
9.6.3 Electrical Wiring

IMPROPER WIRE TERMINATION

Contact a qualified professional.

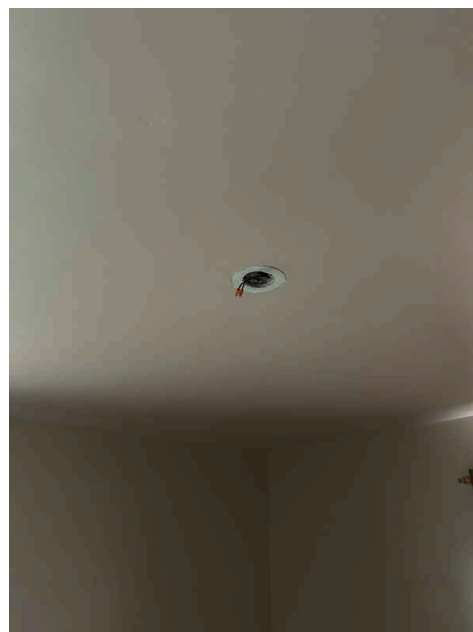
9.7.1 Outlets / Switches / Lighting / Fans

IMPROPERLY TERMINATED WIRING

Contact a qualified professional.

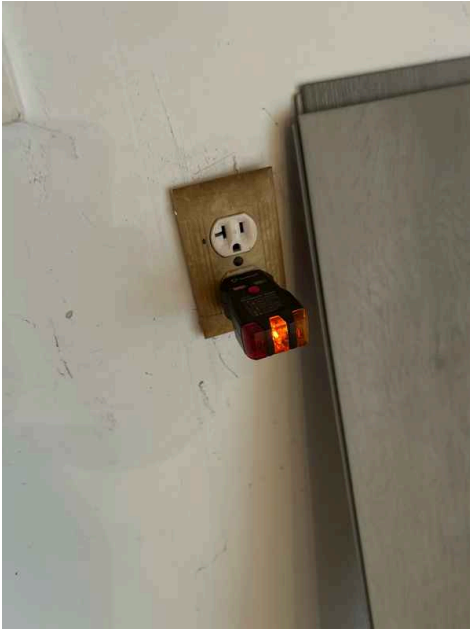
9.7.2 Outlets / Switches / Lighting / Fans

OPEN GROUNDED OUTLET(S)

Contact a qualified electrical contractor.

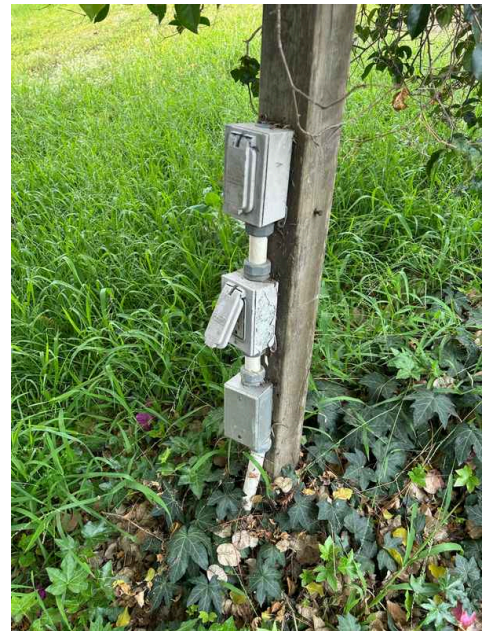
9.7.3 Outlets / Switches / Lighting / Fans

NO POWER OUTLET(S)

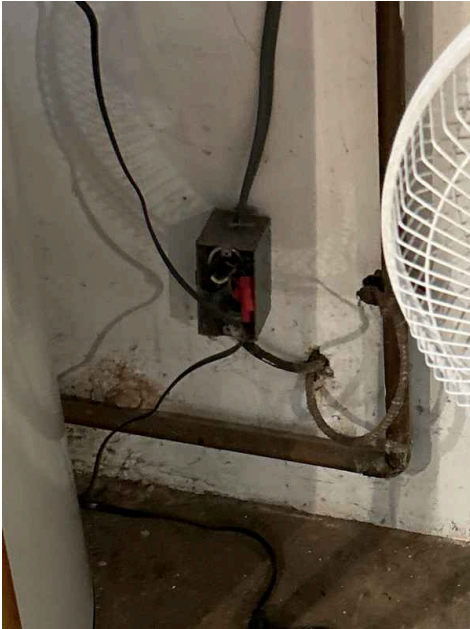
9.7.4 Outlets / Switches / Lighting / Fans

JUNCTION BOX COVERS MISSING

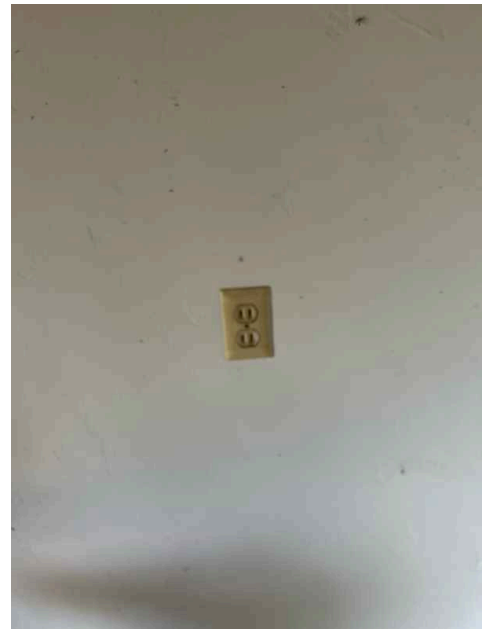
9.7.5 Outlets / Switches / Lighting / Fans

2 PRONG OUTLET(S) NOTED
