Inspection Report

Property Address:
110 8th St
Templeton CA 93465

2/23/2026

Harper Homes: Home Inspection Services

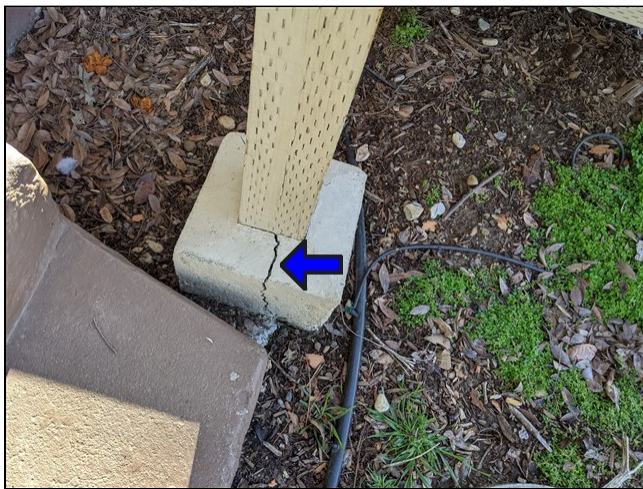
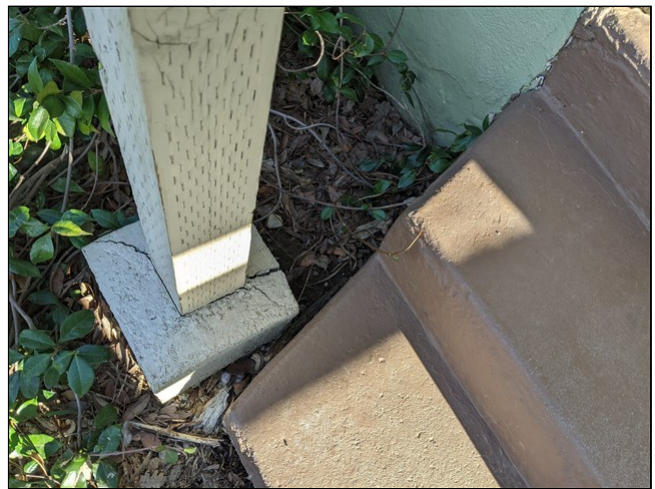
1.1 Item 1(Picture)

The concrete support bases at the front handrail posts were observed to have minor cracking. This type of cracking is common over time due to normal settling and shrinkage of concrete. At the time of inspection, the handrails appeared secure and functional. As a preventative maintenance measure, the cracked areas can be sealed and monitored to help reduce moisture intrusion and prolong the life of the concrete. If cracking becomes more pronounced or movement is observed in the posts, further evaluation and repair may be warranted.

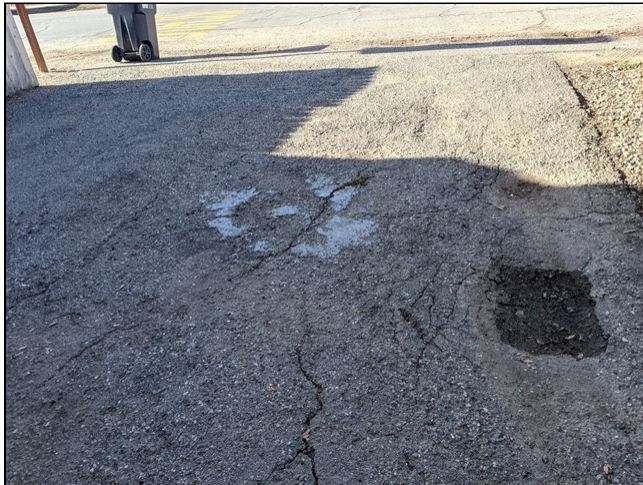
1.2 Item 1(Picture)

Asphalt cracks noted on the driveway. Recommend cracks be properly sealed in these areas to prevent further or excessive damage to the asphalt driveway.

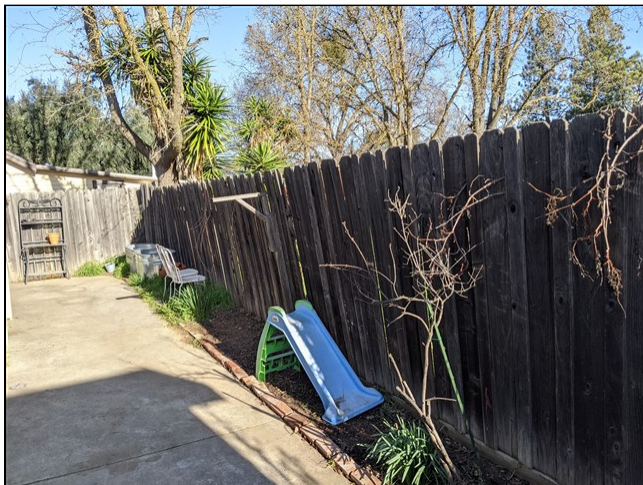
1.3 Item 1(Picture)

Loose or damaged fence posts were noted and sections of the fence are loose and leaning. Fence repairs can be made, as needed.

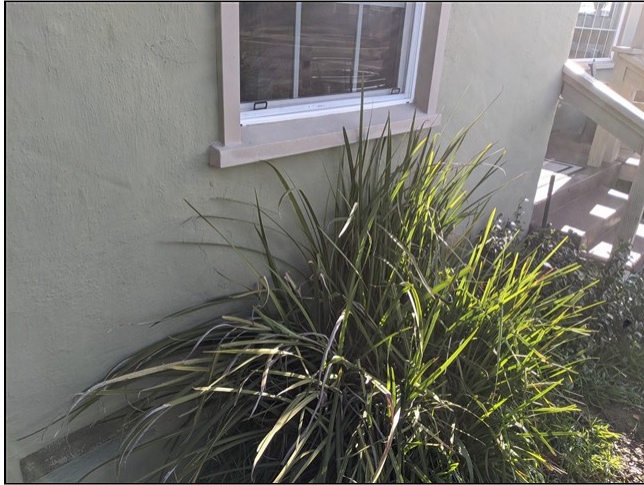
1.4 Item 1(Picture)

Foliage needs trimmed back from contacting the siding. This will decrease the probability of moisture and pest intrusion.

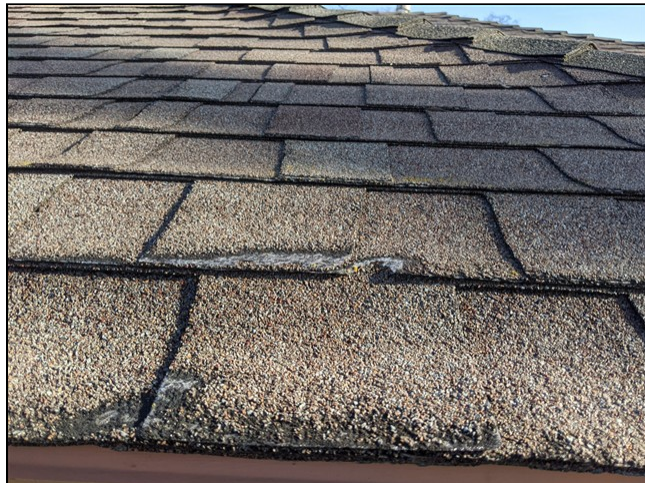
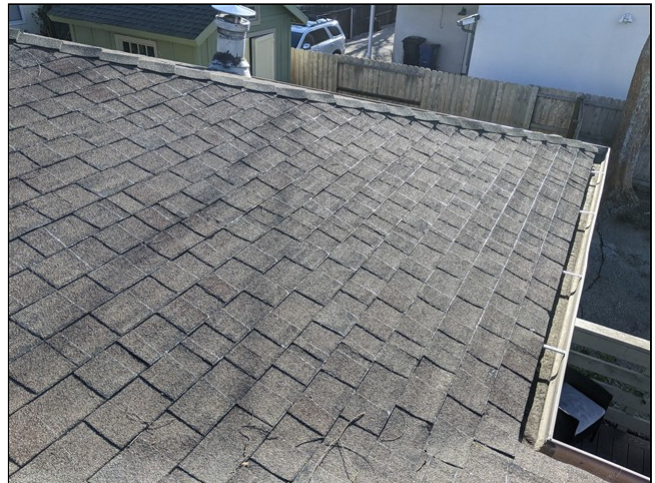
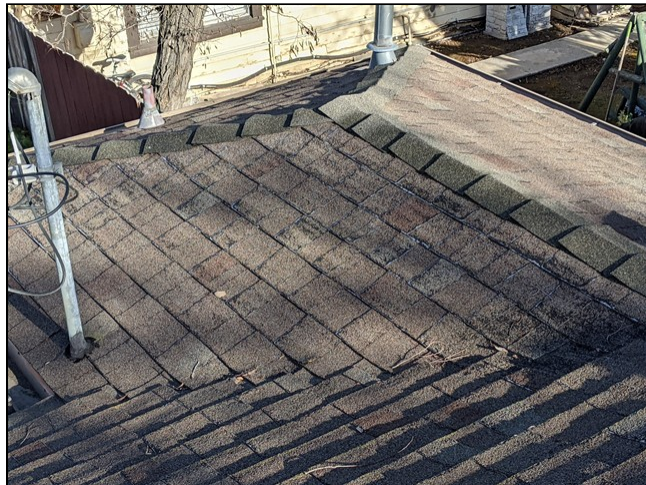
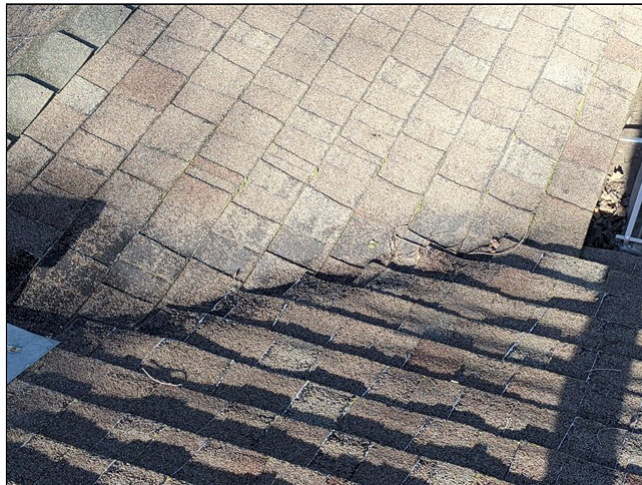
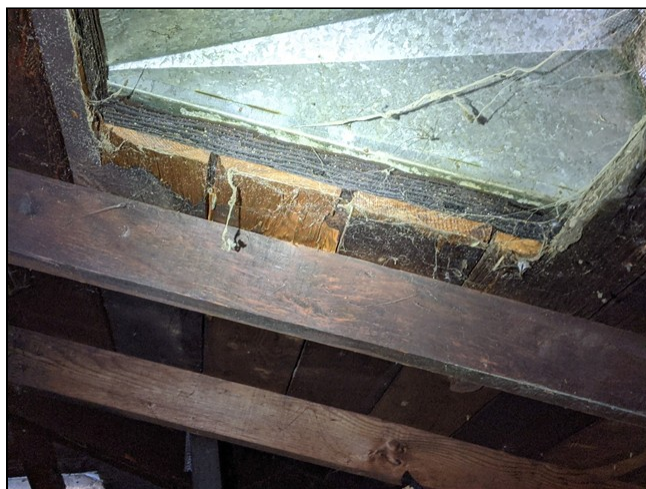
2.0 Item 1(Picture)

Areas of the roofing material are weathered and showing signs of age. The roof also appears to have over 3 layers which is more than allowed. No leaks were noted in the attic or interior. Recommend further evaluation with cost to replace and remaining life determined by a licensed roofing contractor.

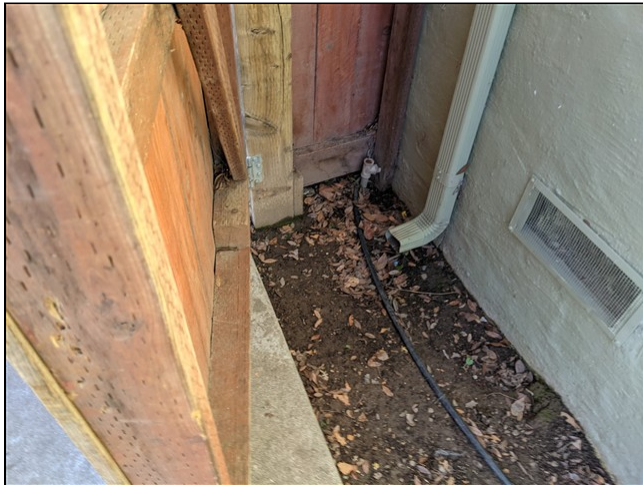
2.3 Item 1(Picture)

Downspout extension needed at various locations to channel rain water away from the foundation and help promote functional drainage.

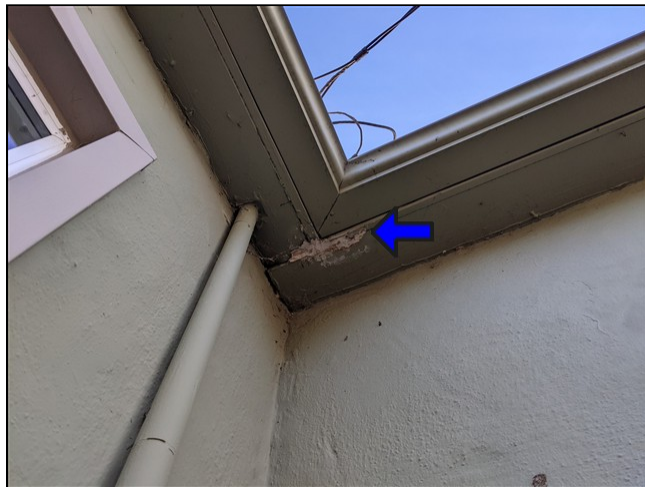
2.4 Item 1(Picture)

Areas of the fascia contain moisture damage. Refer to the pest report for further information on this condition and make repairs as prescribed.

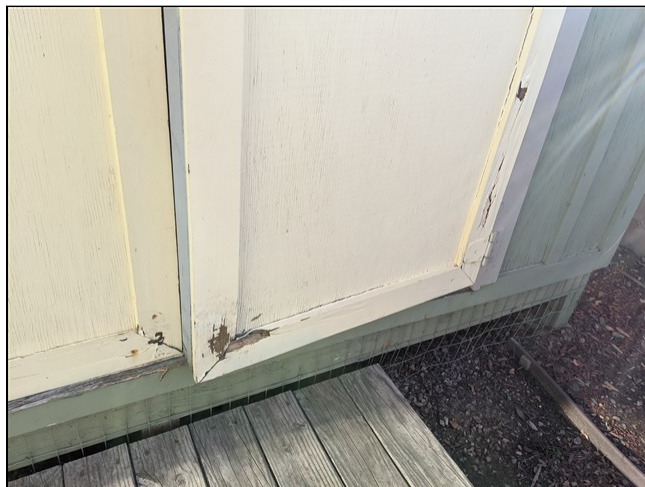
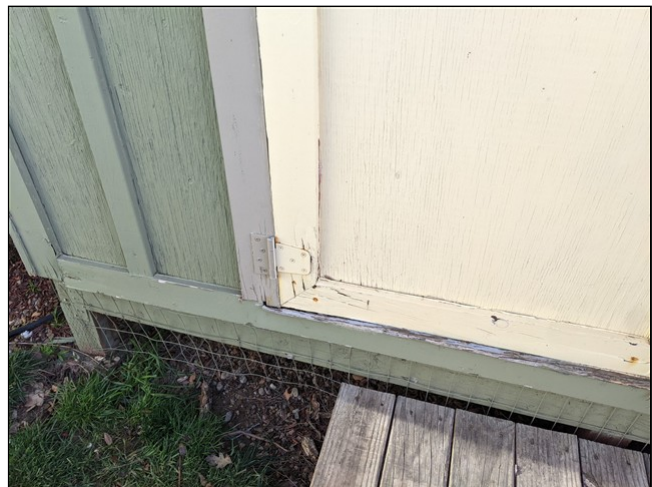
2.4 Item 2(Picture)

Areas of the trim and siding of the shed contain moisture damage. Refer to the pest report for more information on this condition and make repairs as prescribed.

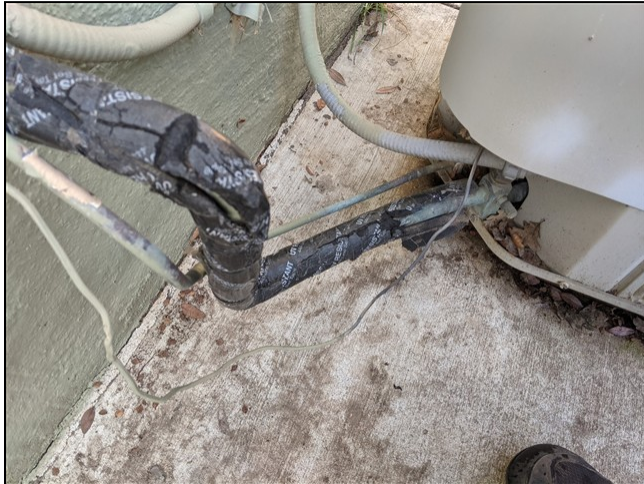
3.4 Item 1(Picture)

(2) REPAIR NEEDED
Foam sleeve on the suction line is damaged or missing near the condenser at the exterior of the building, causing energy loss, and should be properly installed or replaced for intended efficiency of the system

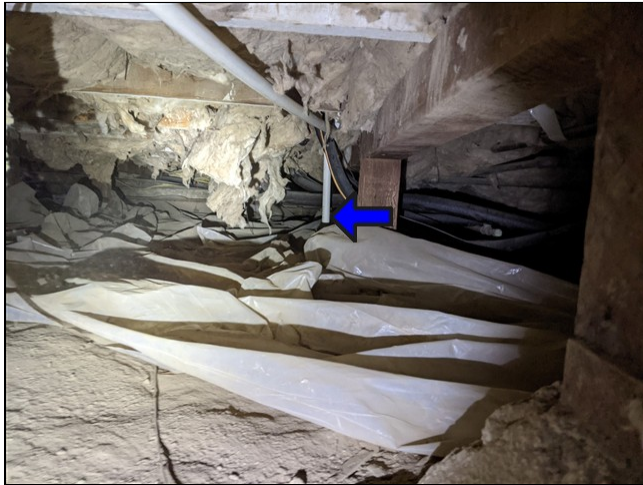
3.4 Item 2(Picture)

The condensate drain line terminates in the sub-area and needs to be extended out to the exterior at an approved location.

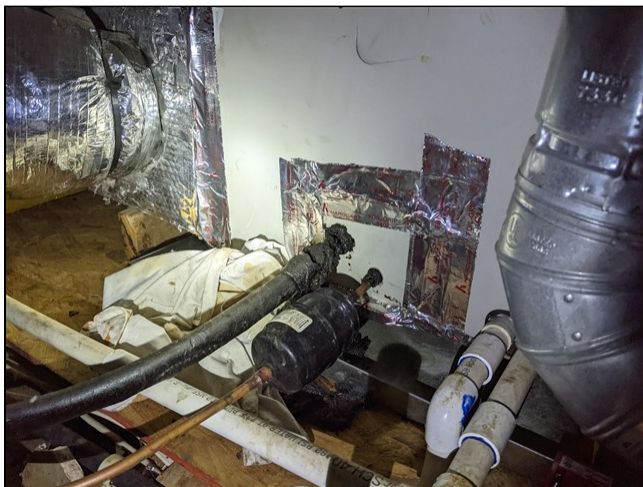
3.4 Item 3(Picture)

Perforation in the evaporator coil housing at the suction line, noted in the attic, needs suction line insulation improved and proper sealing at the housing to prevent conditioned air from blowing into the attic, insure maximum efficiency of the system, and prevent condensation dripping at the furnace platform.

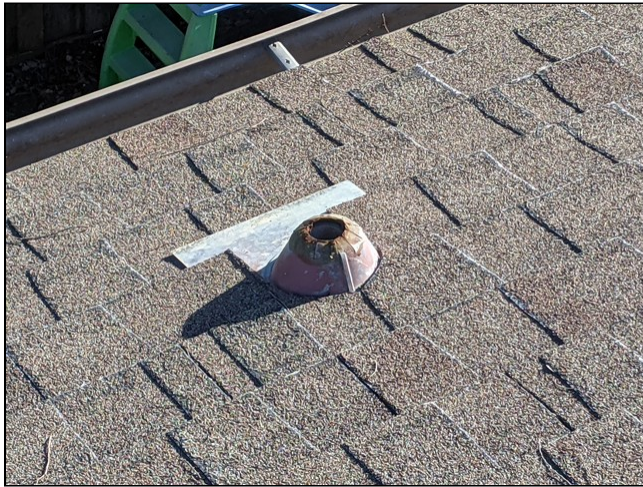
4.1 Item 1(Picture)

Plumbing vent terminates too close to the roof at rear exterior and needs properly extended to ensure proper ventilation of drain line gasses.

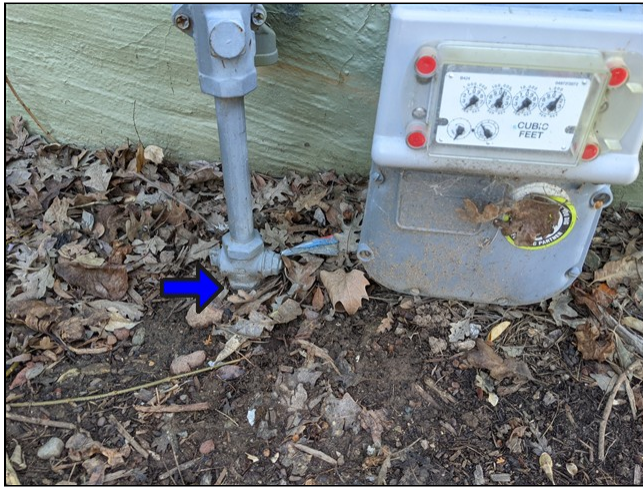
4.3 Item 2(Picture)

Steel gas pipe is buried in the soil without the protective coating, noted at the left exterior, and rusted pipe was noted. Recommend further evaluation and repairs made to prevent a leak from damaged pipe.

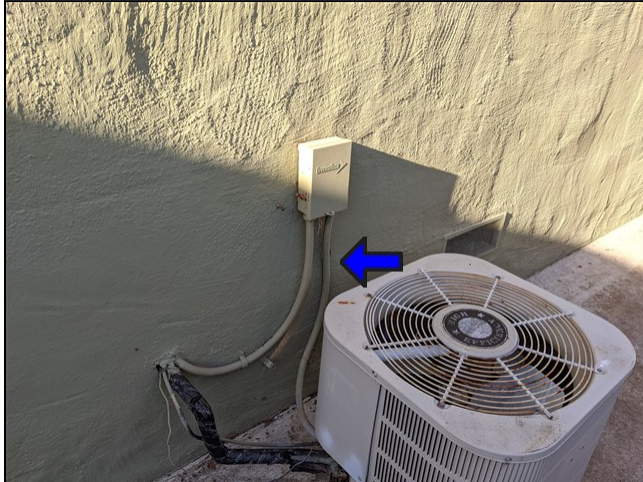
5.4 Item 1(Picture)

Conduit needs properly secured at the air conditioner power supply.

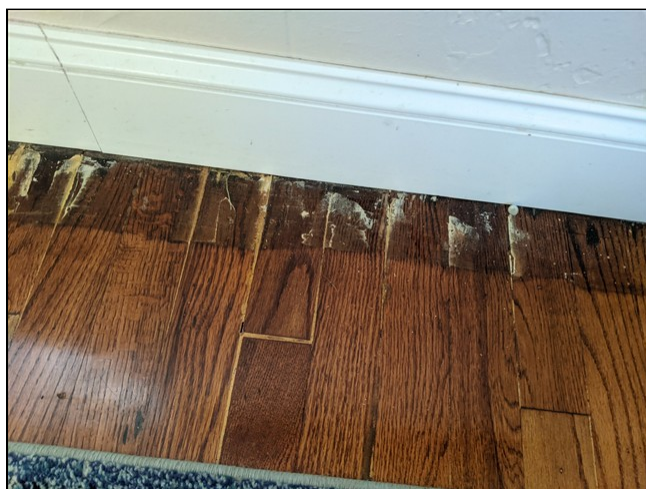
7.1 Item 1(Picture)

Signs of possible damage was noted at the wood flooring. Refer to the pest report for further information on this condition and make repairs as prescribed.

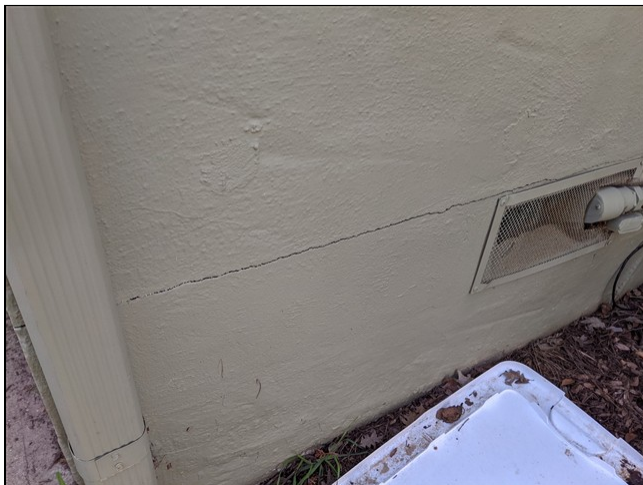
9.0 Item 1(Picture)

Foundation movement noted in a few areas and full evaluation by a qualified engineering contractor is recommended to determine the cause, significance, and remedy for this condition.

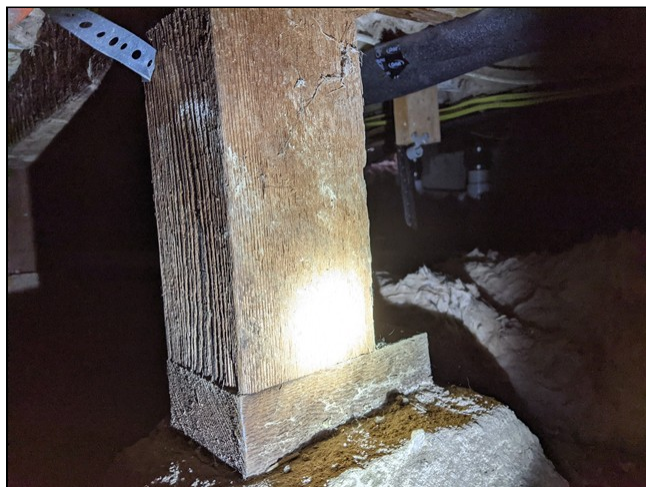
9.0 Item 2(Picture)

While typical for the age of construction, areas of the foundation do not meet current standards. Seismic upgrades can be made to help prevent displacement during earthquake activity.

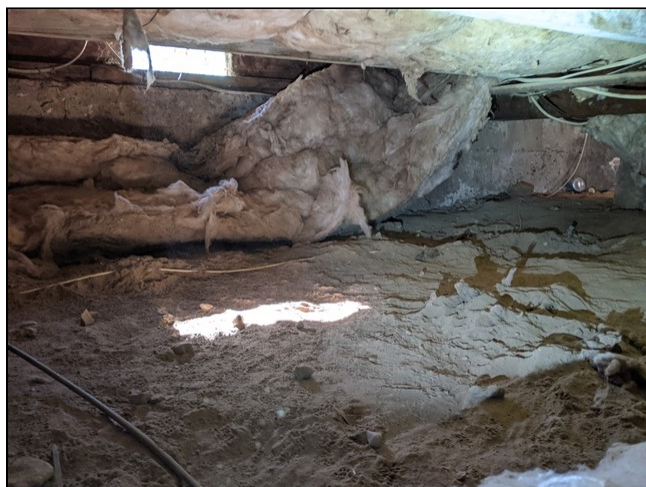
9.2 Item 1(Picture)

A few areas of displaced insulation were noted in the sub-area and need properly reinstalled to insure full efficiency of the home.

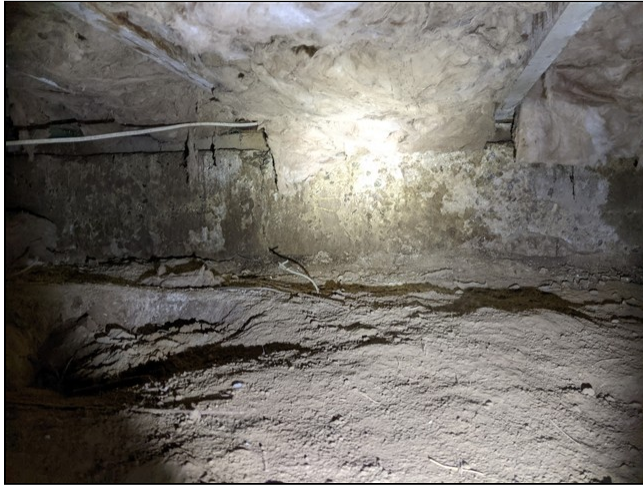
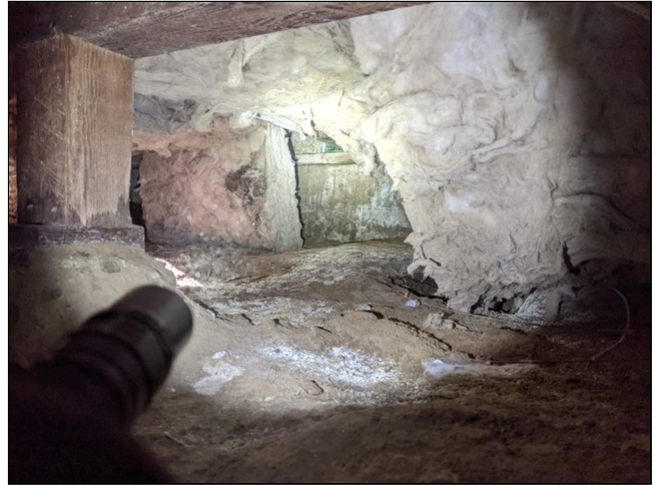
9.2 Item 2(Picture)

The front exterior deck is installed above the lower portion of the sub-area foundation vents. Due to this configuration, rainwater runoff from the deck area may enter or collect near the vents, which could allow

moisture into the sub-area during wet conditions. Recommend alterations are made as needed to prevent excess moisture from entering the sub area.

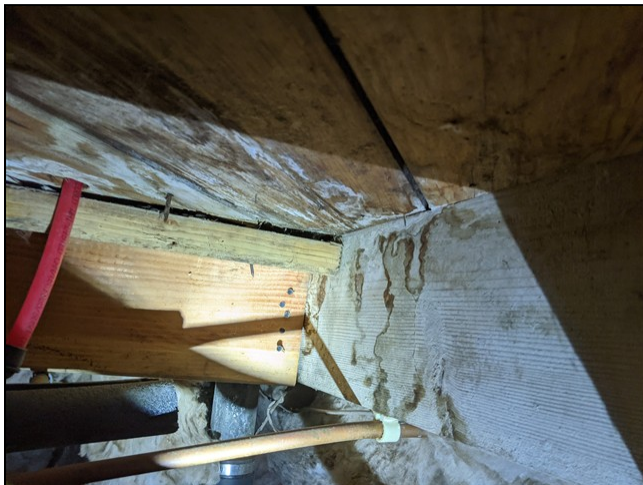
9.2 Item 4(Picture)

Moisture damage noted under the bathroom in the sub area. Refer to the pest report or have further evaluated by the pest inspector, and make repairs as prescribed. No current moisture was noted.
