Item	Trade	Contractor	Scope 1	Cost to repair / replace	Note	Pages
1	General	NHI	General Inspection	\$0.00		2 - 26
2	Electrical	1st Touch Electric	Complete rewire	\$16,000.00		27 - 36
3	Plumbing	Al Garcia	repipe / repair	\$8,650.00		37 - 39
4	HVAC	Al Garcia	furnace vent	\$850.00		37 - 39
5	Plumbing	Al Garcia	cap off plumbing in shed	\$2,800.00		40
6	Termite	Escocia Termite Inc	tent / repairs	\$5,453.00		41 - 51
7	Roof / HVAC	A1 All American Roofing	Hood vent reloc and maintnance	\$3,200.00		52 - 60
8	HVAC	Estimated with Claude Ai	Demo ceramic pipe	TBD	abestos may be present	61 - 64
9	Structure	-	Shed	-	Permit not complete - withdrawn	65
10	Structure	-	Patio	-	Permit not complete - withdrawn	66
11	Sewer	Al Garcia - No Bid	Cracked Tee "Y" by side walk	\$0.00	https://youtu.be/haijGu0EQI	67 - 71
12	Sewer	n/a	Cracked Tee "Y" by side walk	TBD	unable to obtain quotes	67 - 71

NHI SERVICES

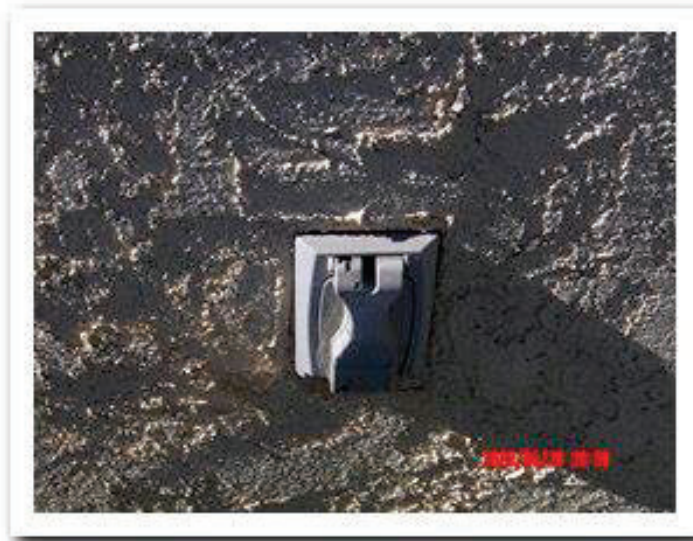
101 Driveway:	Serviceable; concrete.
102 Walks:	Serviceable; brick/concrete.
103 Fences/Walls:	Serviceable; block/wood.
103a Gates:	Serviceable; vinyl.
104 Siding:	Serviceable; brick/stucco/wood.
105 Trim:	Serviceable; wood.
106 Window Frames:	Serviceable; vinyl. House is equipped with thermo-pane windows for added insulation. Verifying the seal between the two panes of glass is beyond the scope of this inspection.
106a Screens:	Torn screen noted at front.
107 Electrical Fixtures:	Ground fault interrupter noted at rear provided for safety is inoperable.

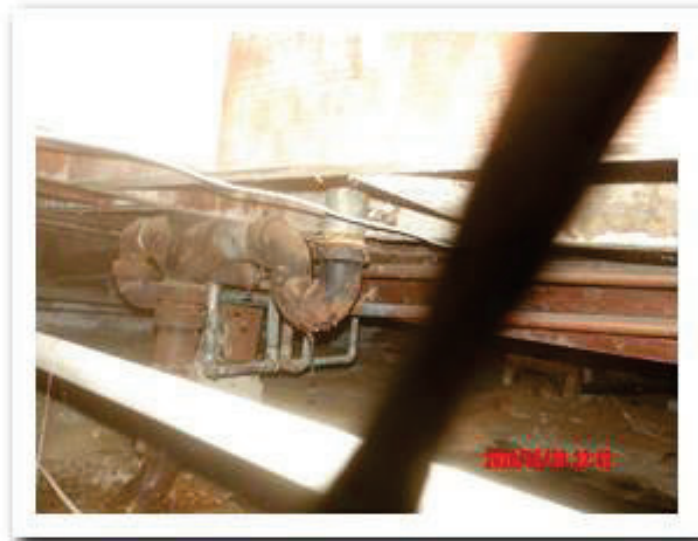
111 Bell/Chime:	Serviceable.
112 Chimney:	Non-Applicable.
112a Steps/Railing:	Serviceable.
112b Hose Bib:	Serviceable.
113 Lot grade/Drainage:	Home is built on a flat lot. Grade at foundation appears to be adequate.
114 Gas Meter:	Serviceable. Located at left side.
115 Foundation:	Serviceable; raised foundation/pier and post construction.
115a Ventilation:	Ventilation appears to be adequate.
115b Bolted to Foundation:	Yes, under house.
115c Cripple Walls:	No.
116 Sub-Floor:	Accessible in front right bedroom closet. Plumbing leaking: Leak noted under shower; suggest consulting with specialist for further review prior to close of escrow.

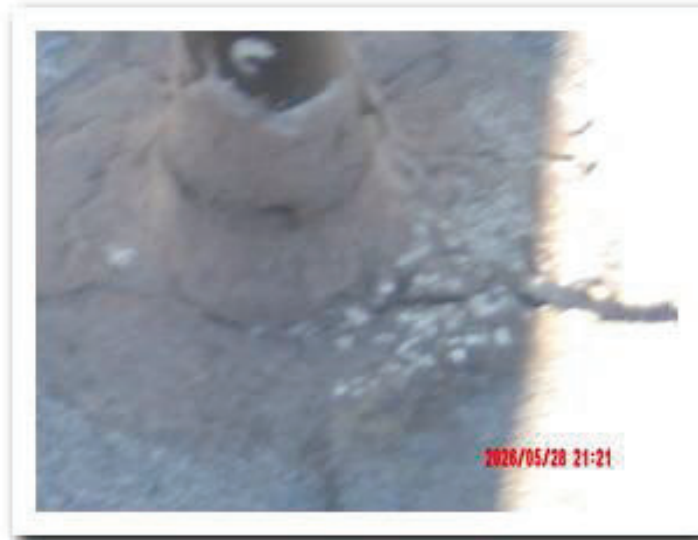
127 Roof Comments: Roof shows normal wear for its age and type; appears to be in serviceable condition.
We advise resealing all through roof vents and projections noted at rear as part of routine maintenance.

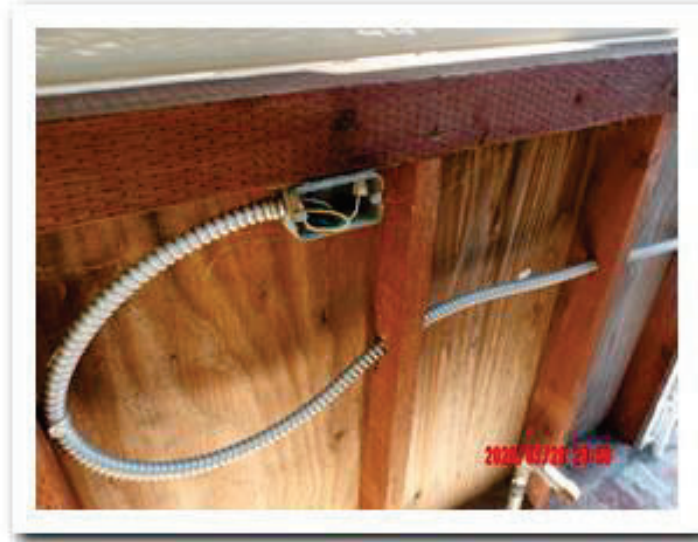
- 201 Cover: Serviceable; wood.
- 202 Enclosure: Non-Applicable.
- 203 Electrical: **Exposed wiring noted at ; suggest covering.**

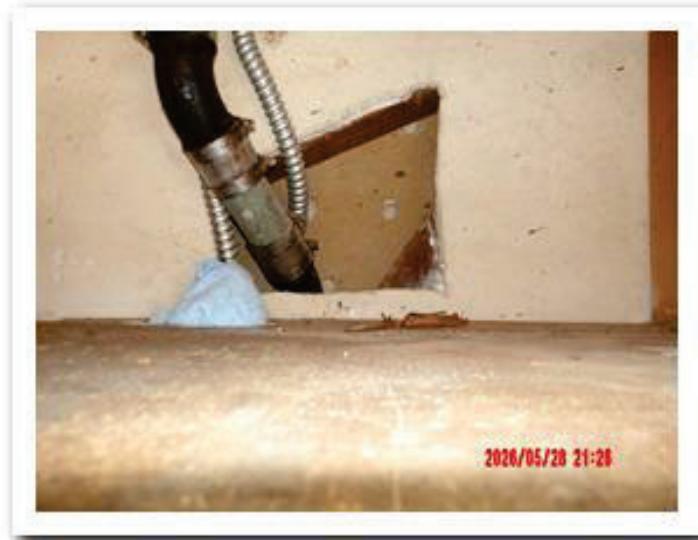
301 Exterior:	Serviceable; stucco.
302 Roof:	Please see roof comments.
303 Slab:	Serviceable; concrete.
304 Overhead Door:	Serviceable; metal.
305 Garage Door Hardware:	Serviceable.
306 Door Opener:	Serviceable. This garage door opener is equipped with a safety reverse device that operated when tested at the time of our inspection. The U.S. Product Safety Commission recommends these devices be checked monthly.
307 Windows:	Serviceable.
308 Access Door:	Non-Applicable.
309 Fire Door:	Non-Applicable.
310 Fire Wall:	Plaster. Holes noted above, behind and under sink; suggest sealing all holes with an approved material.

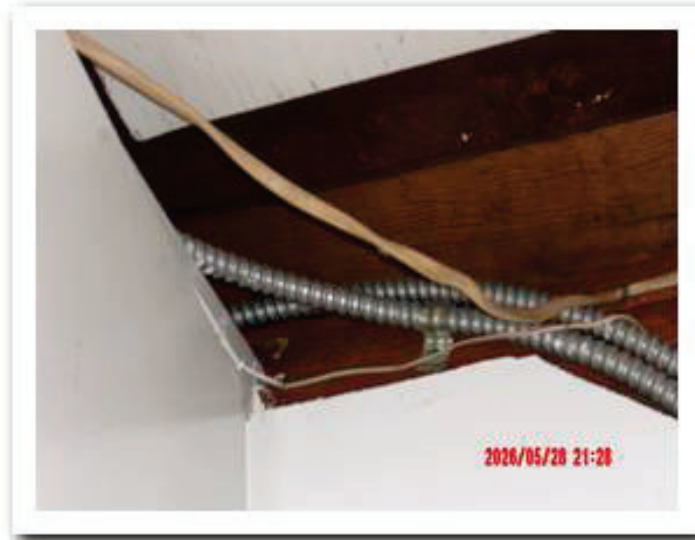
Exposed Romex wiring noted at right side. This may be a safety concern if used where it could be subject to physical damage. Client may wish to encase as a safety upgrade.

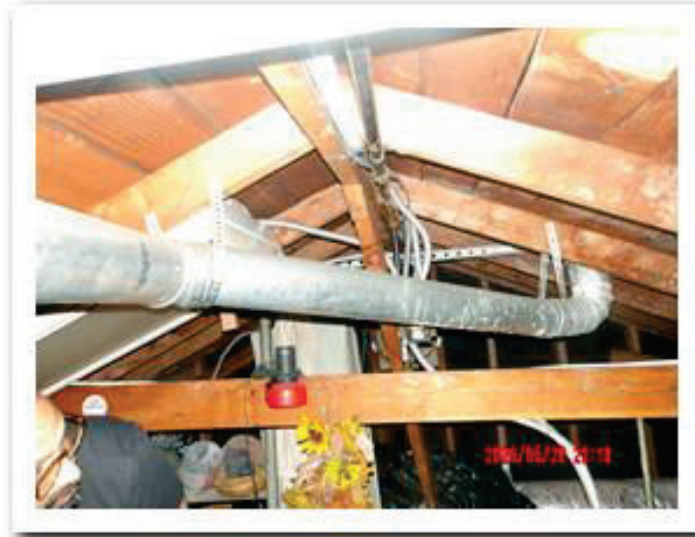
Vent pipe noted is at an improper slope. This will allow products of combustion to escape, which is a safety hazard requiring immediate attention by a licensed contractor for repairs/replacement as required to ensure safety.

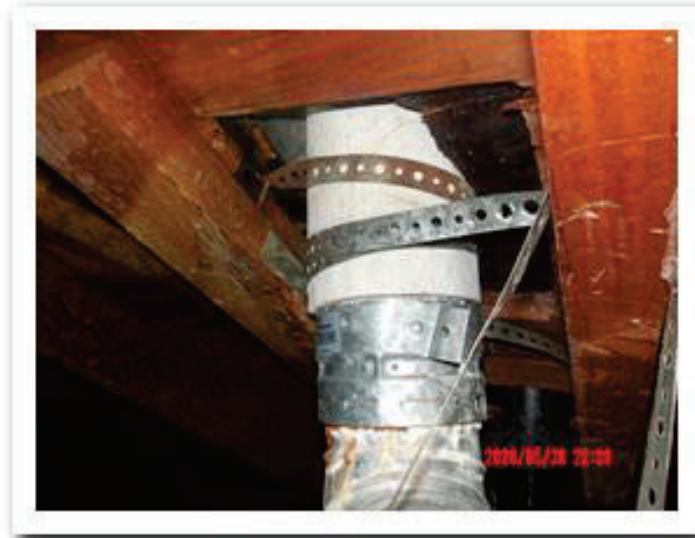
A newer furnace has been installed to the existing ceramic pipe, which may cause moisture to drop onto the furnace. When a furnace is installed today, a double wall pipe is required for the flue. If concerned we suggest consulting with the local building department for further review.

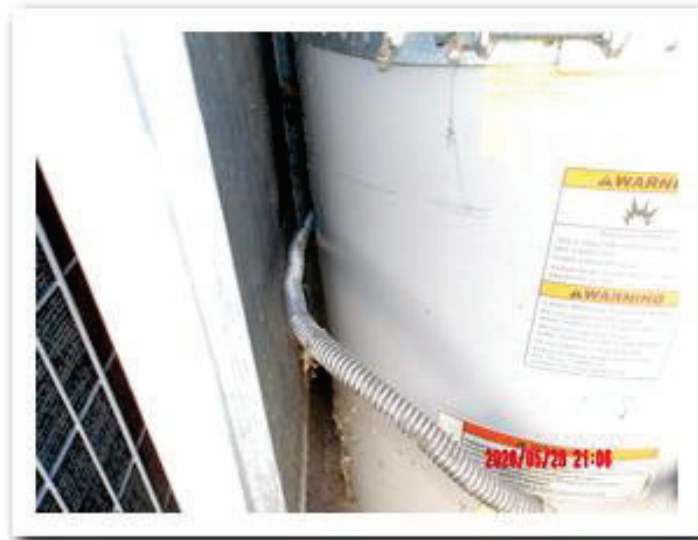
- Rust noted in burner compartment which indicates the water heater is getting older; no leak noted at time of inspection.**
- Unable to locate gas valve noted appears to be blocked by water heater; suggest checking prior to close of escrow.**

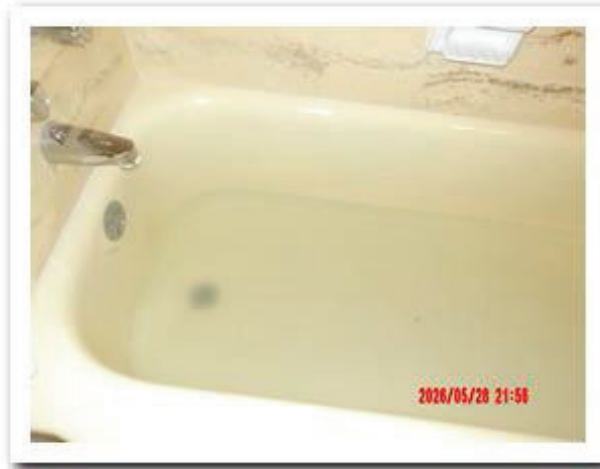
709 Tub & Surround:	Serviceable.
710 Tub Faucet:	Serviceable.
711 Shower & Surround:	Serviceable.
712 Shower Enclosure:	Serviceable.
713 Shower Faucet:	Serviceable.
714 Sink:	Serviceable.
715 Sink Faucet:	Serviceable.
716 Traps/Drains/Supply:	Shower and tub drains noted are clogged; we advise making necessary corrections.

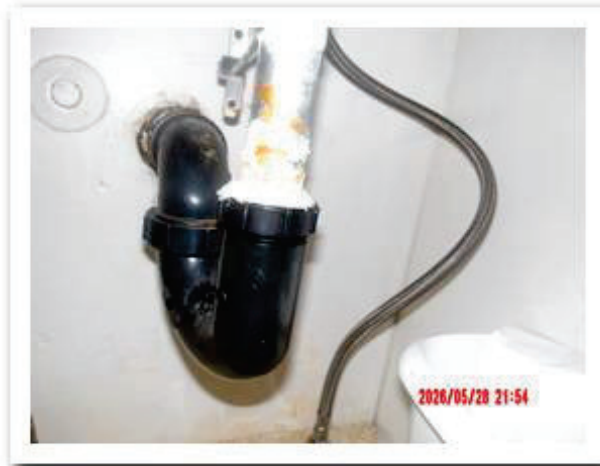
Corrosion noted at sink drain; no evidence of leakage at time of inspection.
