# PROPERTY INSPECTION REPORT

**FOUR POINT**  
HOME INSPECTION INC.

**6390 Navajoa Ave**

**Date of Inspection: 1/16/2026**

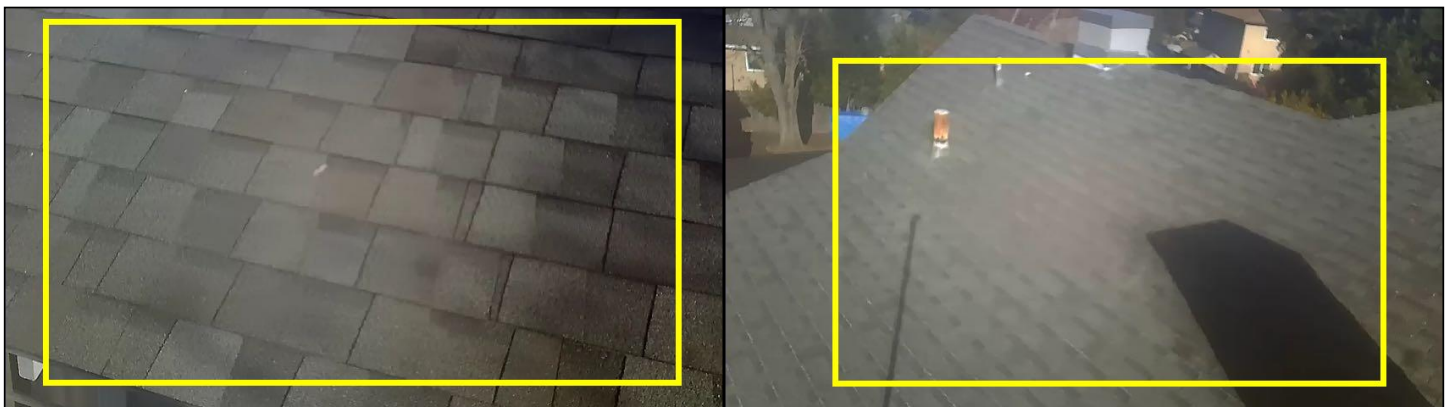
**Maintenance Needed:** Areas of the roof had moss growing on it. This condition indicates high moisture levels. Moss growth can increase the chances of roof leakage by slowing drainage. Moss is easily removed using a soft-bristle brush. The Inspector recommends removal by a qualified roofing contractor.

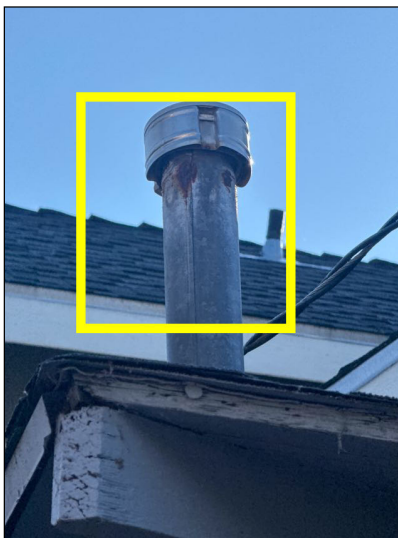
**Monitor:** Combustion vents exhibited general corrosion and rust. Vents in this condition should be replaced prior to rusting through to avoid damage to the combustion appliance from roof leakage. The Inspector recommends that before the expiration of your Inspection Objection Deadline, you consult with a qualified roofing contractor to discuss options and costs for replacement.

**Monitor:** Combustion vents exhibited general corrosion and rust.

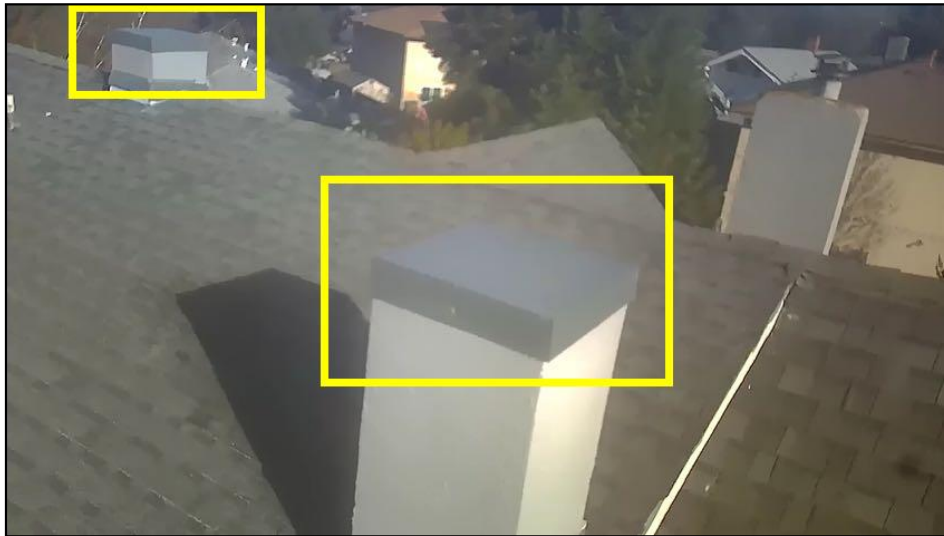
**Monitor:** Old chimneys are capped. The inspector recommends that these caps are checked on an annual bases to insure the cap remain sealed to not allow any moisture intrusion.

**Monitor:** Old chimneys are capped.

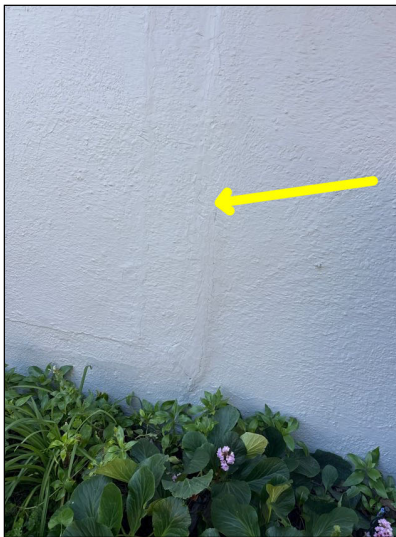
**Monitor:** Normal cracking was visible in stucco covering exterior walls of the home at the time of the inspection. This cracking appeared to be consistent with that caused by normal soil settlement. Settlement typically takes place in the first few years after original construction, and then stops. Cracks exceeding 1/16-inch (about the thickness of a penny) in width should be filled with an appropriate material to prevent future damage from moisture and monitored in the future for continued activity. Repainting with an Elastomeric paint on the stucco surface will help seal all surface cracks.

**Monitor:** Normal cracking was visible in stucco covering exterior walls of the home at the time of the inspection.

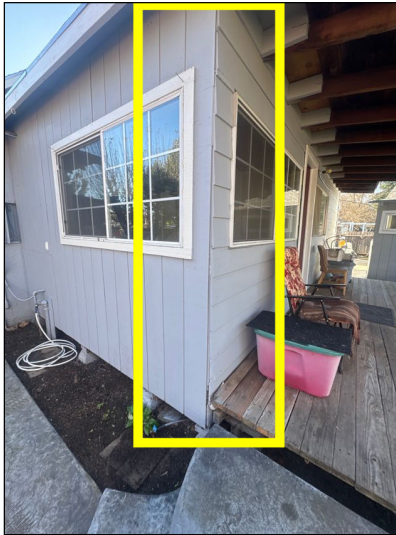
Missing trim should be replaced by a qualified contractor.

| | Page 15 Item: 3 | Trim Condition | <ul style="list-style-type: none"> <li>• Missing trim should be replaced by a qualified contractor.</li> </ul> |

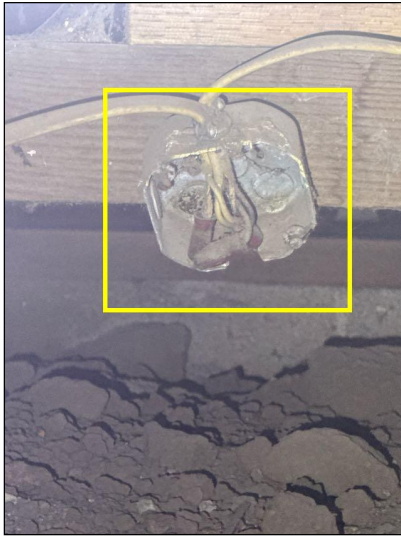
| | Page 20 Item: 7 | Foundation Electrical | <ul style="list-style-type: none"> <li>• A junction box in the crawlspace was missing cover plates at the time of the inspection. An approved cover plate should be installed by a qualified electrical contractor to prevent shock or electrocution.</li> <li>• Electrical wires visible in the crawlspace terminated outside of the junction box. Although they were not energized at the time of the inspection, these wires may have the potential to become energized and should be correctly terminated in an approved junction box with a cover by a qualified electrical contractor.</li> <li>• Electrical wires visible in the crawlspace had splices exposed to touch. This condition is a shock potential shock/electrocution hazard. Splices should be contained within an approved junction box with a cover installed. Corrections should be performed by a qualified electrical contractor.</li> </ul> |

A junction box in the crawlspace was missing cover plates at the time of the inspection.

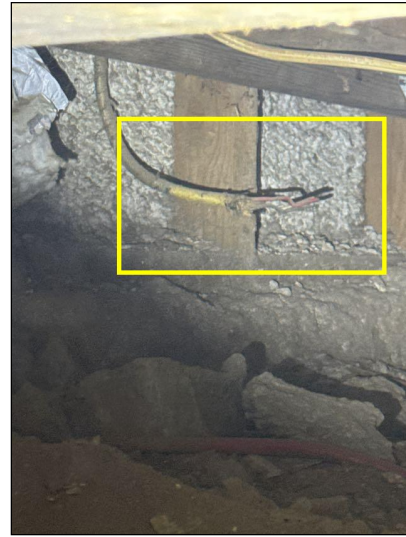
Electrical wires visible in the crawlspace terminated outside of the junction box.

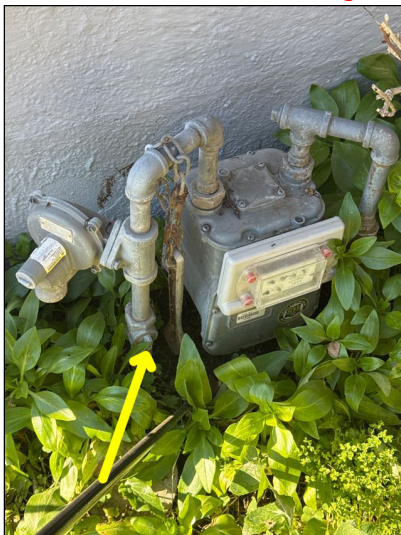
- **Safety Improvement:** The main gas supply shut-off valve was difficult to access due to overgrown vegetation. Recommend having the vegetation cut back to make the main valve more accessible for use during an emergency.

Main gas shut off to the home.

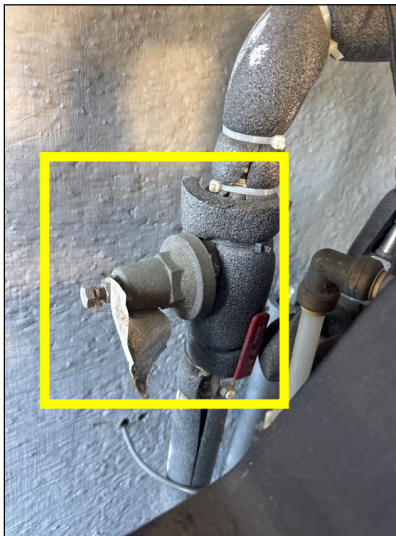
The water distribution system was equipped with a pressure regulator.

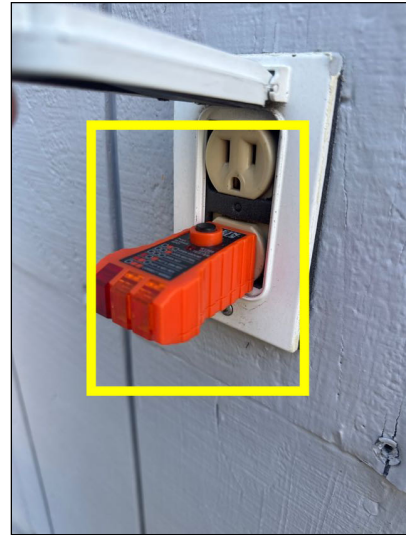
The exterior had an inoperable electrical receptacle.

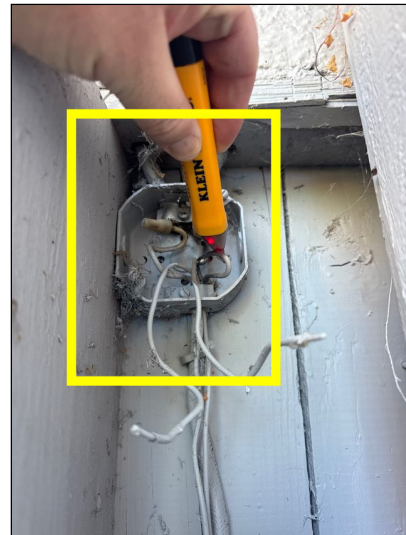
Energized electrical wires on the exterior were improperly terminated.

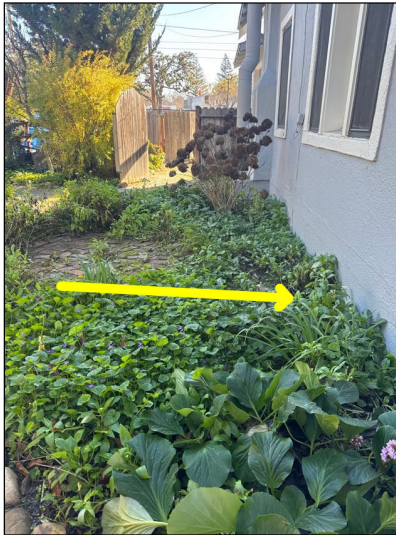
The home had areas of neutral or negative drainage that will route runoff from precipitation toward the foundation. Excessively high moisture levels in soil supporting the foundation can effect its ability to support the weight of the structure above. The ground should slope away from the home a minimum of ¼-inch per foot for a distance of at least six feet from the foundation. The Inspector recommends that these areas be re-grading to improve drainage near the foundation.

The home had areas of neutral or negative drainage that will route runoff from precipitation toward the foundation.

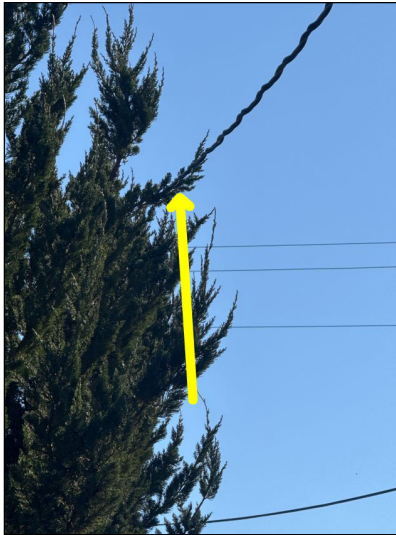
The overhead service-drop conductors had inadequate clearance from tree branches. This condition should be corrected by a qualified contractor or the utility service provider to avoid abrasion and damage to the conductors. Work around the service conductors should be performed by a qualified personnel only. Injury or death may result from attempts at correction by those without proper qualifications.

The overhead service-drop conductors had inadequate clearance from tree branches.

| | Page 30 Item: 1 | Cable Feed Condition | <p>The overhead service-drop conductors had inadequate clearance from tree branches. This condition should be corrected by a qualified contractor or the utility service provider to avoid abrasion and damage to the conductors. Work around the service conductors should be performed by a qualified personnel only. Injury or death may result from attempts at correction by those without proper qualifications.</p> |

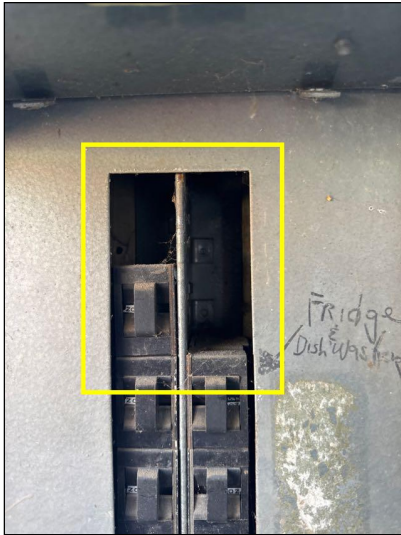
Filler plates missing in open breaker slot in the dead front cover of the service panel

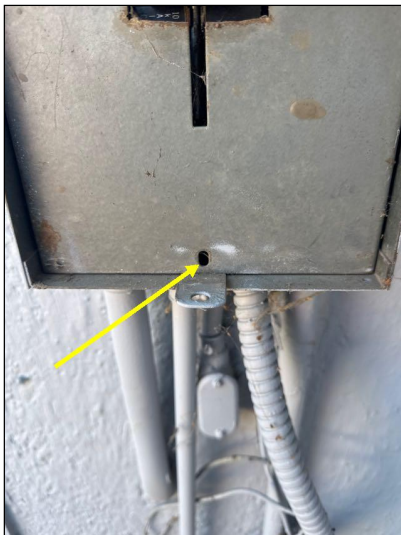
The electrical service dead front cover panel was missing mounting screws.

| | Page 31 Item: 2 | Electrical Panel | <p><b>-SERVICE PANEL EXTERIOR</b><br/>The electrical service dead front cover panel was missing mounting screws. The Inspector recommends replacement with proper screws by a qualified electrical contractor. Improper screws are a potential safety hazard.</p> <p><b>-SERVICE PANEL INTERIOR</b><br/>Unfilled holes or knockouts in the electrical service panel may allow persons to come into contact with energized electrical components, may allow insect or rodent entry, or may allow moisture intrusion that can cause corrosion of interior components that can degrade electrical connections. This condition is a potential shock/electrocution hazard and should be corrected by a qualified electrical contractor.</p> <p><b>-SUB PANEL EXTERIOR</b><br/>Filler plates missing in open breaker slot in the dead front cover of the sub panel may allow a person to come into contact with energized electrical components. This condition is a potential shock/electrocution hazard and should be corrected by a qualified electrical contractor.</p> <p><b>-BAD BRANDS</b><br/>The service panel brand was Pushmatic. Pushmatic service panels are outdated and no longer manufactured. Pushmatic components have become unreliable with age and replacement is recommended. Before the expiration of your Inspection Objection Deadline, you should consult with a qualified electrical contractor concerning the necessity for replacing this service panel.</p> |

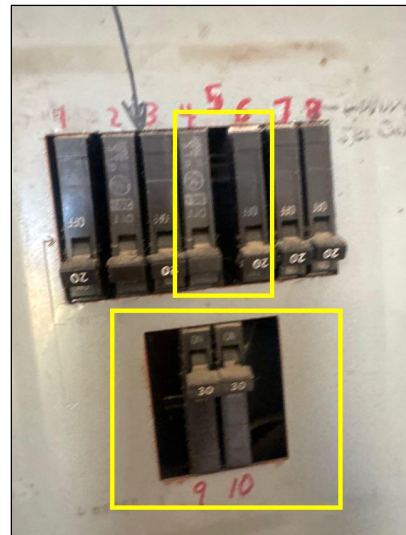
Filler plates missing in open breaker slot in the dead front cover of the sub panel

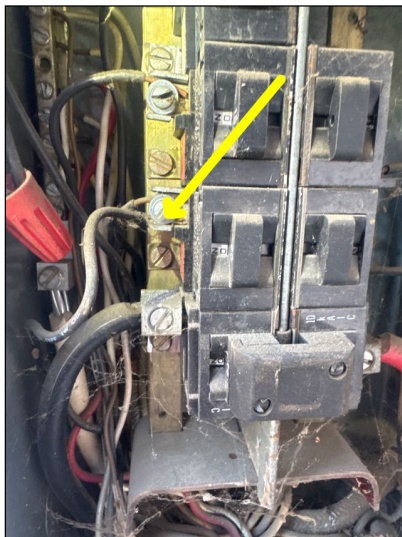
**Double tapping observed.** Double tapping (i.e. 2 wires on a single pole breaker) can add to the load of the affected circuit causing a possible overload and tripping breakers, or result in loose connections and overheating of the breaker or connections. Ideally, doubled-up circuits should be independently fused. Recommend evaluation by an electrician.

Double tapping observed. Double tapping (i.e. 2 wires on a single pole breaker) can add to the load of the affected circuit causing a possible overload and tripping breakers (main panel)

| | Page 34 Item: 5 | Breakers | <p>Double tapping observed. Double tapping (i.e. 2 wires on a single pole breaker) can add to the load of the affected circuit causing a possible overload and tripping breakers, or result in loose connections and overheating of the breaker or connections. Ideally, doubled-up circuits should be independently fused. Recommend evaluation by an electrician.</p> |

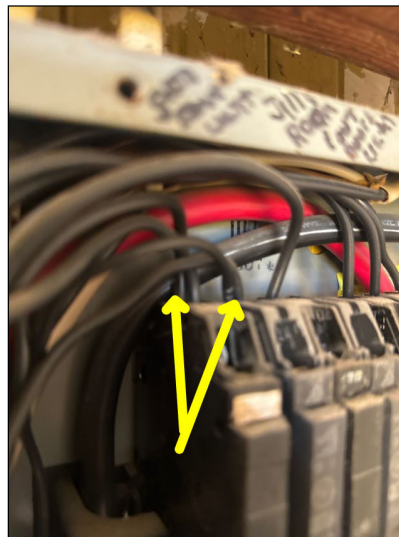
Double tapping observed. Double tapping (i.e. 2 wires on a single pole breaker) can add to the load of the affected circuit causing a possible overload and tripping breakers (sub panel)

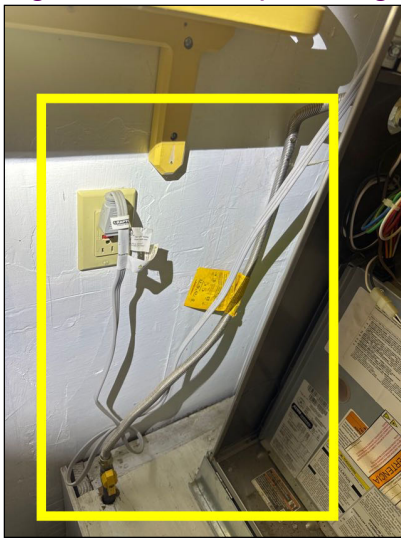
**Recommended Improvement:** The gas supply pipe contained no sediment trap. A sediment trap is generally recommended but not always required, depending on the local Authority Having Jurisdiction (AHJ). The purpose of a sediment trap is to prevent sediment or debris particulates from entering and clogging the heaters gas valve, which can cause the heater to shut down. You may wish to consult with local contractor concerning the advisability of installing a sediment trap in the gas line.

**Improvement:** The gas supply pipe contained no sediment trap.

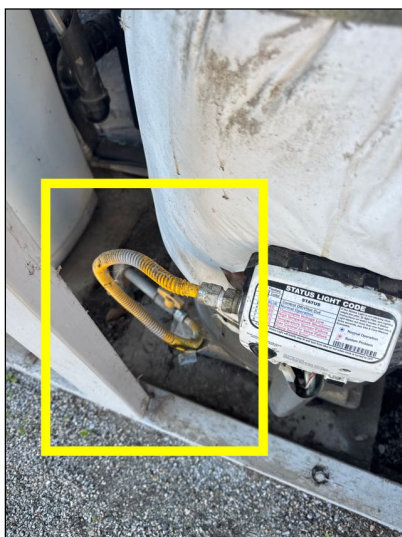
**Recommended Improvement:** The gas supply pipe contained no sediment trap. The purpose of a sediment trap is to prevent sediment or debris particulates from entering and clogging the water heater gas valve, which can cause the water heater to shut down. You may wish to consult with local contractor concerning the advisability of installing a sediment trap in the gas line.

**Improvement:** The gas supply pipe contained no sediment trap.

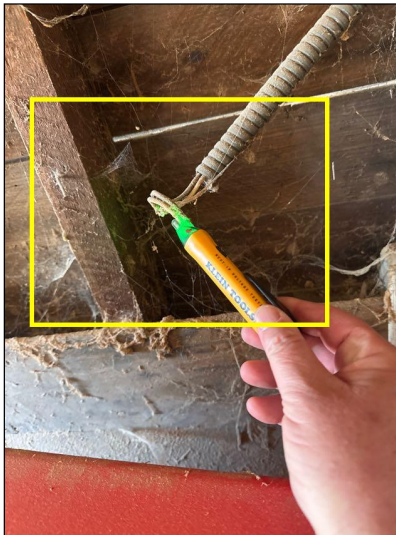
Abandoned wiring visible in the garage at the time of the inspection should be inspected by a qualified electrical contractor to determine whether safe conditions exist and properly terminated in a junction box or removed.

Abandoned wiring visible in the garage at the time of the inspection

| | Page 44 Item: 2 | Garage Electrical | <p>Abandoned wiring visible in the garage at the time of the inspection should be inspected by a qualified electrical contractor to determine whether safe conditions exist and properly terminated in a junction box or removed.</p> |

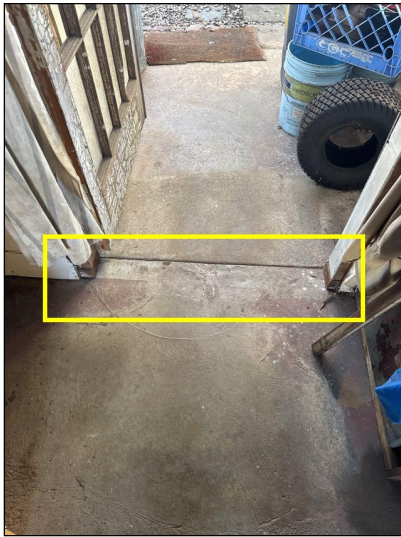
At the time of inspection there was no threshold installed at the exterior door.

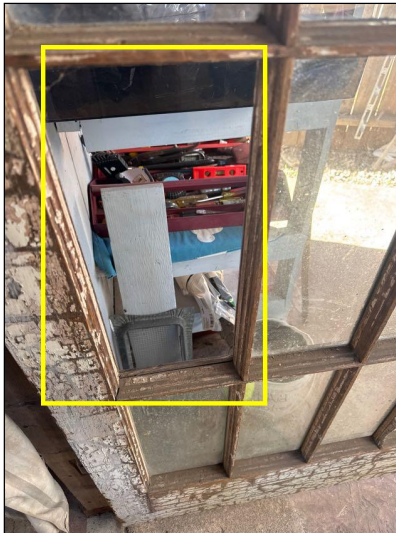
The door had a broken/missing pane of glass. The Inspector recommends repair by a qualified contractor.

broken glass in door

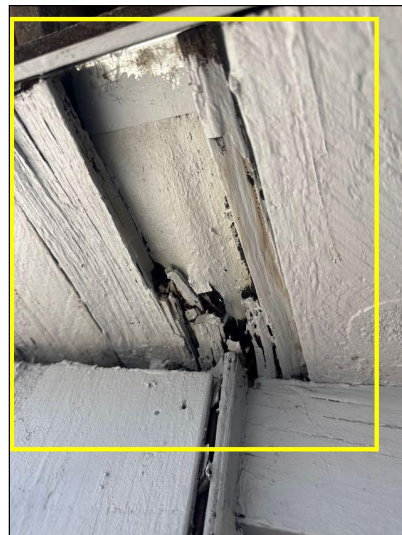
**Moisture damage, wood rot, observed to the sheathing/soffit areas of the garage. Refer to pest report for further details and repair damage as needed.**

Moisture damage, wood rot, observed to the sheathing/soffit areas of the garage.

| | Page 47 Item: 9 | Garage Roof | <p>Moisture damage, wood rot, observed to the sheathing/soffit areas of the garage. Refer to pest report for further details and repair damage as needed.</p> |

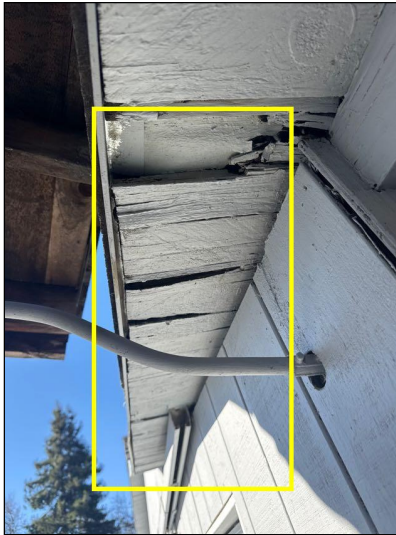
Moisture damage, wood rot, observed to the sheathing/soffit areas of the garage.

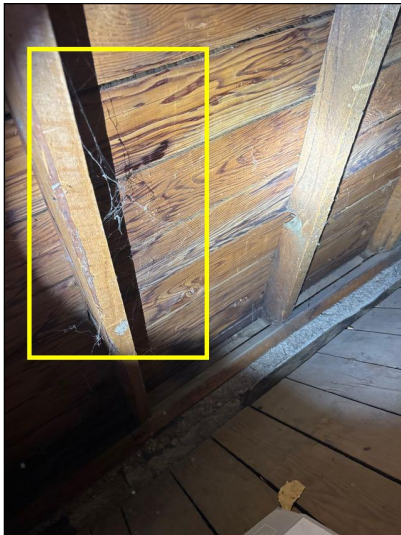
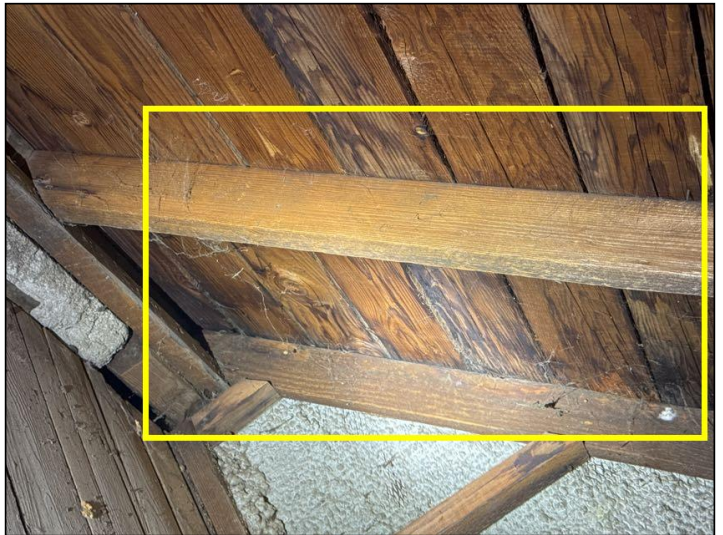
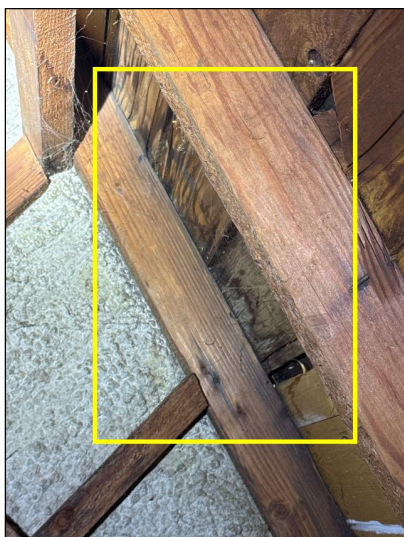
**Monitor:** Roof sheathing had areas of discoloration that appeared to be the result of roof leakage.

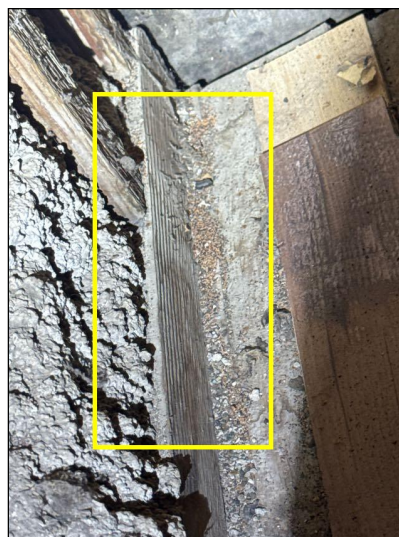
| | Page 49 Item: 2 | Structure | <p>Termite droppings visible in the attic indicated infestation by wood-destroying insects. The Inspector recommends an inspection be performed by a pest control contractor.</p> |

Termite droppings visible in the attic indicated infestation by wood-destroying insects. The Inspector recommends an inspection be performed by a pest control contractor.

Termite droppings visible in the attic indicated infestation by wood-destroying insects. (hallway wall access)

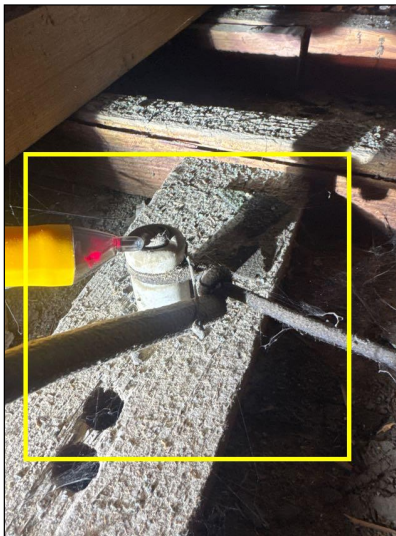
| | Page 51 Item: 3 | Electrical | <p>Energized knob and tube wiring visible in the attic was commonly installed prior to 1950. It is ungrounded, and considered unsafe by today's standards. Problems with knob and tube wiring are as follows:</p> <ul style="list-style-type: none"> <li>• Limited wire gauge in conjunction with the use of modern appliances may result in wire overheating; a potential fire hazard.</li> <li>• With repeated overheating/cooling cycles, insulation encapsulating the wire conductors can become brittle, deteriorated and cracked, resulting in energized electrical conductors becoming exposed to touch: a shock/electrocution and fire hazard.</li> <li>• Knob and tube wiring is designed to dissipate heat to the surrounding air.</li> </ul> <p>When covered by thermal insulation (a common condition in attics), wiring is often no longer able to dissipate heated adequately and becomes a potential fire hazard.</p> <p>The Inspector recommends evaluation of all knob and tube wiring by a qualified electrical contractor with whom you should consult concerning the possibility of wiring replacement.</p> |

Energized knob and tube wiring visible in the attic

The Inspector recommends evaluation of all knob and tube wiring by a qualified electrical contractor with whom you should consult concerning the possibility of wiring replacement.

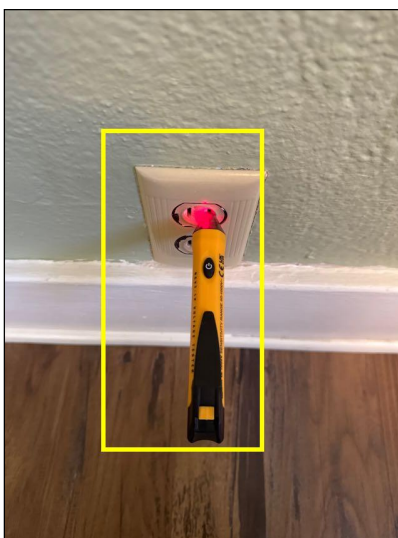
| | Page 53 Item: 2 | Electrical | <p><b>Safety:</b> The home contained some outdated, ungrounded 2-prong electrical receptacles. Although this condition may have been commonly considered safe or acceptable at the time the home was originally constructed, as general knowledge of safe building practices has improved with the passage of time, building standards have changed to reflect current understanding. For safety reasons, the Inspector recommends that receptacles are replaced with grounded receptacles by a qualified contractor.</p> |

**Safety:** The home contained some outdated, ungrounded 2-prong electrical receptacles. Although this condition may have been commonly considered safe or acceptable at the time the home was originally constructed, as general knowledge of safe building practices has improved with the passage of time, building standards have changed to reflect current understanding. For safety reasons, the Inspector recommends that receptacles are replaced with grounded receptacles by a qualified contractor.

**Safety:** The home contained some outdated, ungrounded 2-prong electrical receptacles.

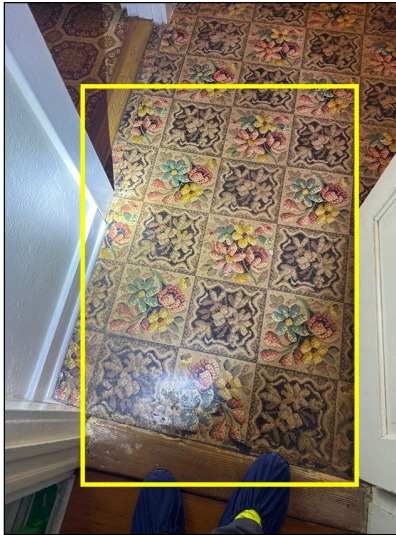
**Monitor:** The home had area(s) of uneven floor that may be caused by settlement or poorly attached sub flooring.

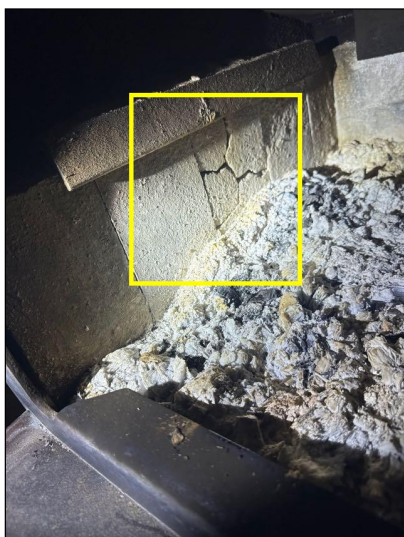
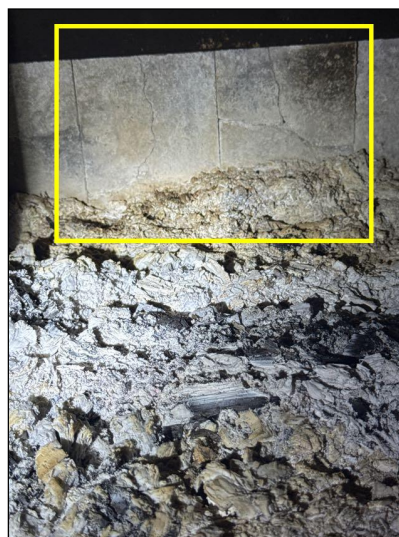
| | Page 56 Item: 13 | Fireplace | <p><b>Safety:</b> Firebrick lining the wall of the firebox of the wood-burning fireplace in the Living Room was cracked. This condition may allow the toxic, corrosive products of combustion to damage the chimney structure or enter the living space. The Inspector recommends repair by a qualified contractor.</p> |

**Safety:** Firebrick lining the wall of the firebox of the wood-burning fireplace in the Living Room was cracked. This condition may allow the toxic, corrosive products of combustion to damage the chimney structure or enter the living space. The Inspector recommends repair by a qualified contractor.

**Safety:** Firebrick lining the wall of the firebox of the wood-burning fireplace in the Living Room was cracked.

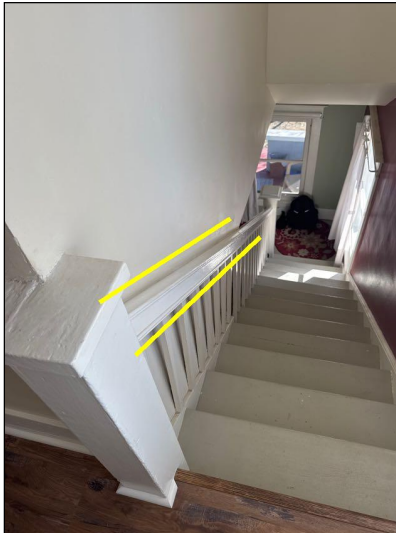
A handrail at this staircase did not meet the definition of "graspable" as defined by generally-accepted current standards. The Inspector recommends that before the expiration of your Inspection Objection Deadline you consult with a qualified contractor to discuss options and costs for repair or replacement.

A handrail at this staircase did not meet the definition of "graspable" as defined by generally-accepted current standards.

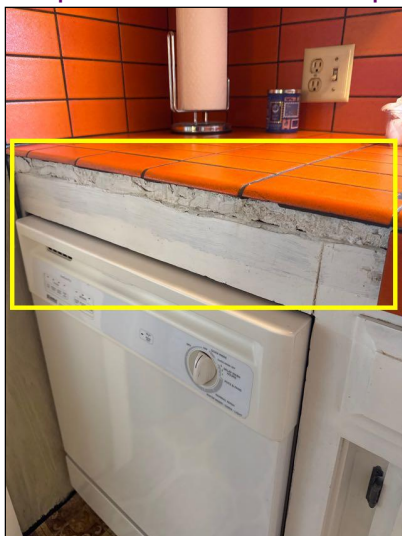
The kitchen countertops had visible moderate damage or deterioration. Before the expiration of your Inspection Objection Deadline you may wish to consult with a qualified contractor to discuss options and costs for repair/replacement.

Missing tiles

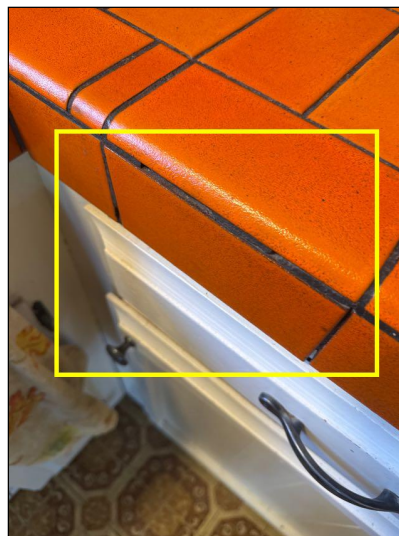
Loose tiles

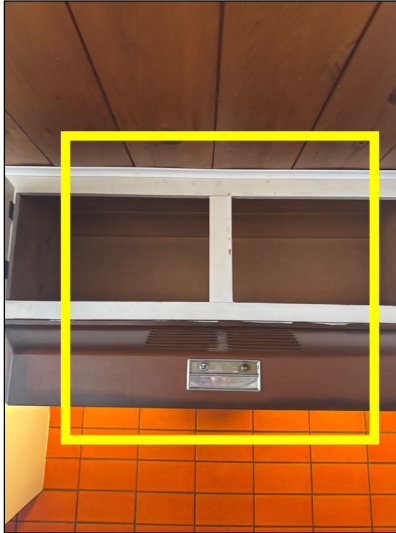
**Safety Improvement:** The exhaust fan is only re-circulating so no exhaust duct is vented to the exterior.

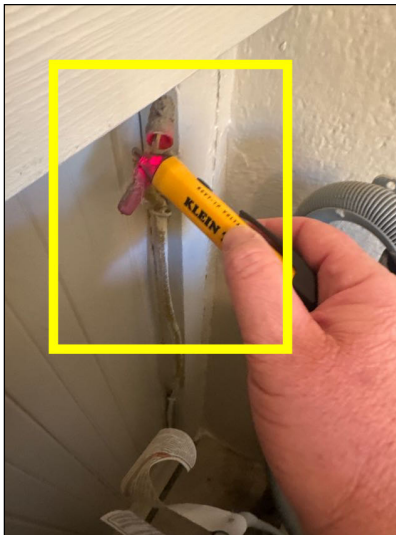
| Laundry | | | |
|---|---|---|---|
| | Page 62 Item: 3 | Electrical | Energized electrical splices not contained within a junction box and exposed to touch were visible in the laundry room at the time of the inspection. Electrical splices should be contained within an approved junction box with a cover plate installed. This condition is a shock/electrocution and potential fire hazard and should be corrected by a qualified electrical contractor. |

Energized electrical splices not contained within a junction box and exposed

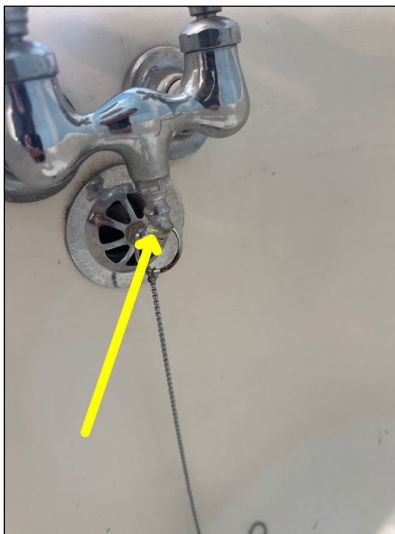
| Laundry | | | |
|---|---|---|---|
| | Page 67 Item: 6 | Bath Tubs | In this bathroom, the bathtub faucet leaked when off, indicating that a control valve seal needed replacement. The Inspector recommends maintenance be performed by a qualified plumbing contractor. |

In this bathroom, the bathtub faucet leaked when off

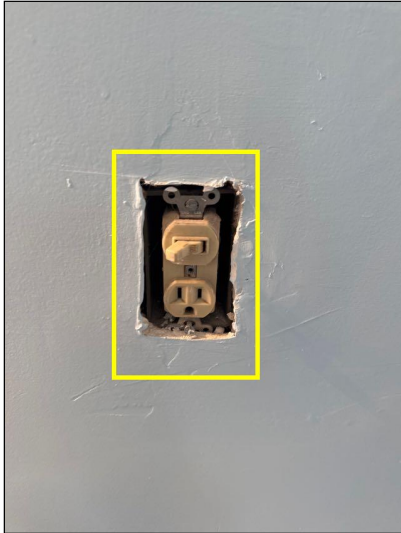
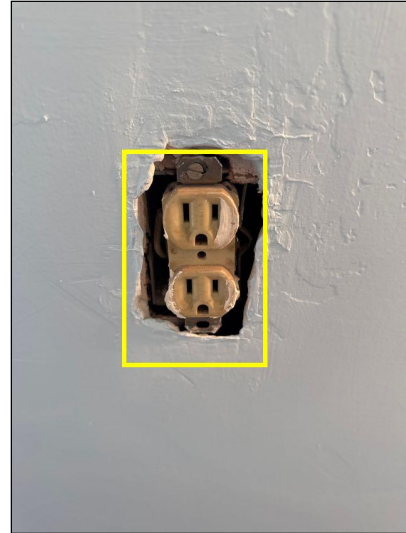
| Laundry | | | |
|---|---|---|---|
| | Page 68 Item: 7 | Electrical | At the time of the inspection, an electrical receptacle cover plate was missing in this bathroom. This condition left energized electrical components exposed to touch, a shock/electrocution hazard. The Inspector recommends a cover plate be installed by a qualified electrical contractor.<br><br>An electrical outlet in this bathroom had an open ground. Other outlets in the home were grounded. This outlet should be corrected by qualified electrical contractor. |

At the time of the inspection, an electrical receptacle cover plate was missing

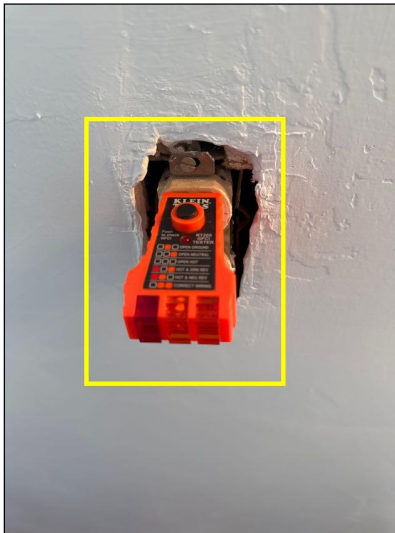
An electrical outlet in this bathroom had an open ground. Other outlets in the home were grounded. This outlet should be corrected by qualified electrical contractor.

An electrical outlet in this bathroom had an open ground.

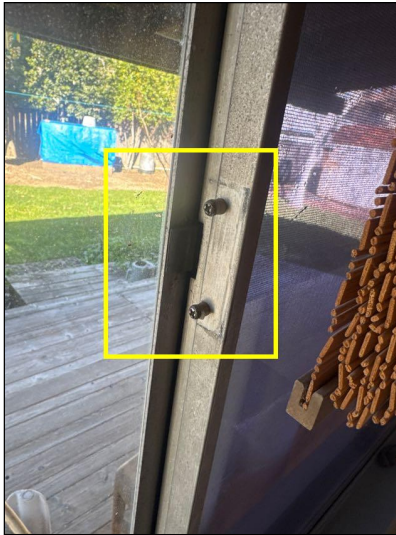
| Laundry | | | |
|---|---|---|---|
| | Page 71 Item: 11 | Window Condition | A window had inoperable hardware (broken lock). The Inspector recommends service by a qualified contractor. |

A window had inoperable hardware (broken lock).

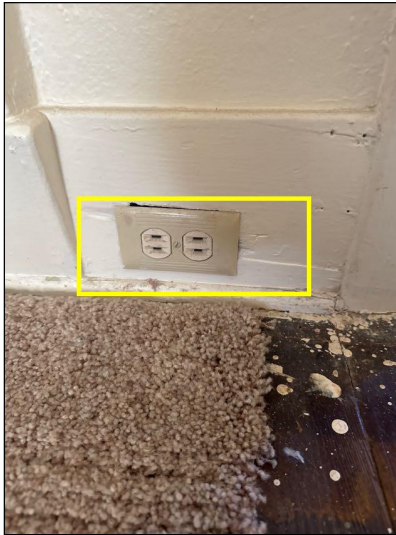
| Laundry | | | |
|---|---|---|---|
| | Page 72 Item: 2 | Electrical | <b>Safety:</b> This bedroom contained outdated, ungrounded 2-prong electrical receptacles. Although this condition may have been commonly considered safe or acceptable at the time the home was originally constructed, as general knowledge of safe building practices has improved with the passage of time, building standards have changed to reflect current understanding. For safety reasons, the Inspector recommends that receptacles are replaced with grounded receptacles by a qualified contractor. |

**Safety:** This bedroom contained outdated, ungrounded 2-prong electrical receptacles.

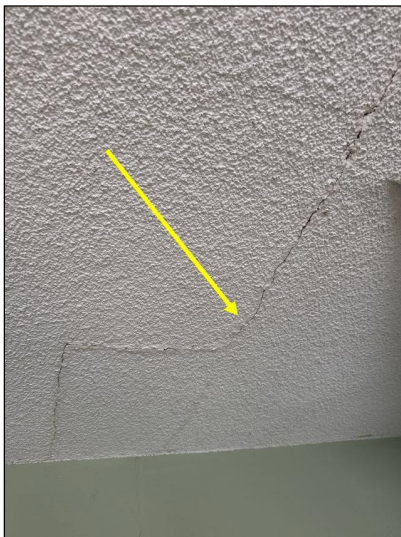
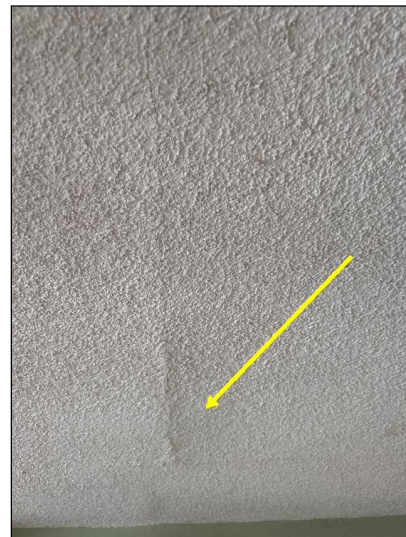
**Monitor:** Normal settlement cracking was visible in interior ceiling at the time of the inspection.
